# 2019 Annual Inspection Report

Gavin Power, LLC

Bottom Ash Pond and Stingy Run Fly Ash  
Reservoir

Gavin Power Plant  
Cheshire, Ohio

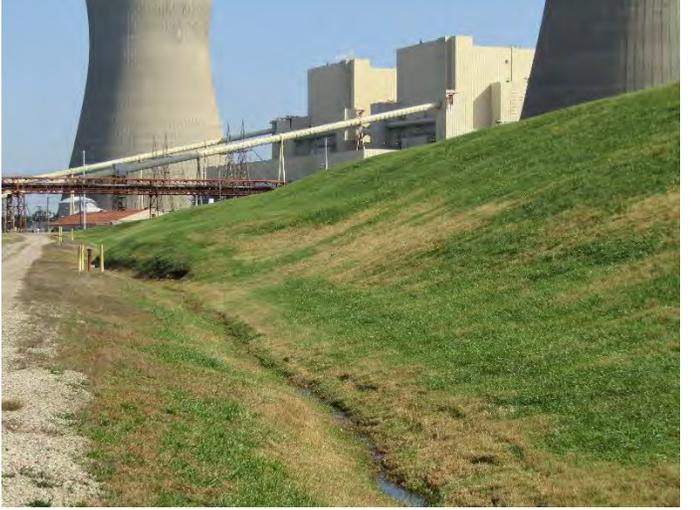
<b>Photograph #1</b>

1. The exterior slope had no visual indication of settlement, rutting, or misalignment except for an earthen bulge noted halfway down the slope (Photograph 1), recent grading for a slip and associated earthen bulge noted along the south end of the slope (Photograph 2), and minor vegetated erosion rills and gullies along the exterior of the slope in localized areas (Photograph 3). The existing earthen bulge halfway down the slope (Photograph 1) (noted previously in the 2017 and 2018 Annual Inspection Report) does not appear to be active or expanding. The bulge in this area has reportedly existed since original construction. The new earthen bulge and crest grading work (Photograph 2) does not appear to be active or expanding. Minor vegetated erosion gullies do not appear to have been expanding since previous inspections which noted these (2016 through 2018 Annual Inspection Reports).

Condition of outer bank along west edge embankment and drainage ditch including apparent inactive earthen bulge along slope (looking north).	
<b>Photograph #2</b>

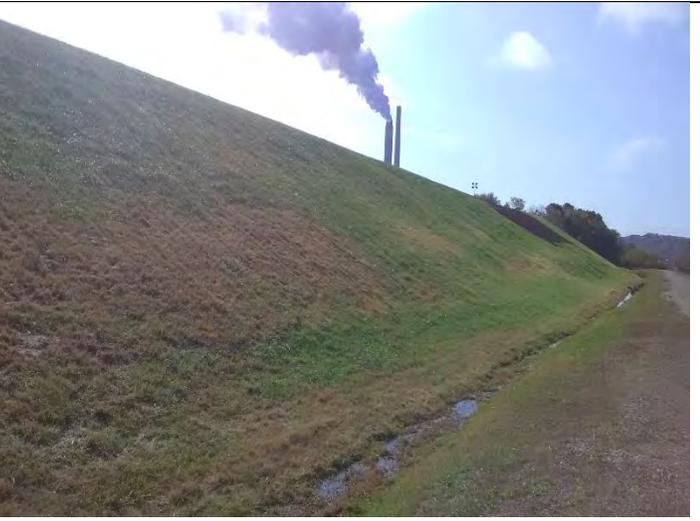
Condition of outer bank and drainage ditch along west edge (looking south). To south and along a portion of the exterior west bank, there appeared to be a recent surficial slip that had been recently repaired. Note, the bulge near the toe and the grading work near the crest. At time of inspection, there appeared to be no active signs of movement for this surficial slip.	
<b>Photograph #3</b>

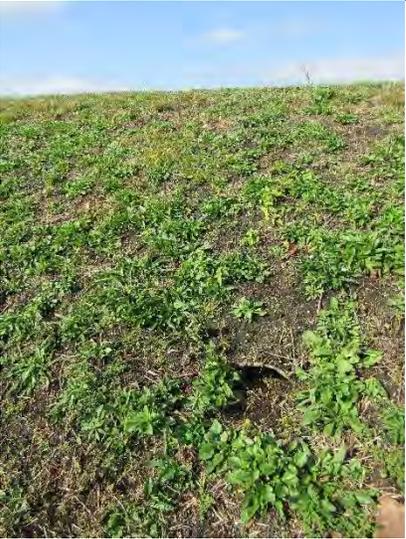
<p><b>Photograph #4</b></p>

3. A remnant culvert pipe partially crushed and currently plugged with soil was observed (Photograph 4). It is recommended the remnant culvert be partially removed and backfilled on the interior side of the embankment. Refer to Section 7.2.1 for specific recommendations.

<p>View of remnant culvert pipe, currently plugged with soil (looking east).</p>	
<p><b>Photograph #5</b></p>

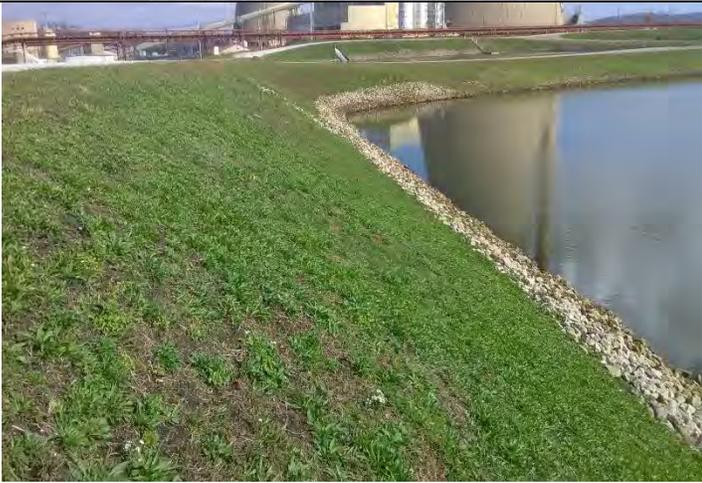
4. The interior slope had no visible indication of settlement, rutting, or misalignment. The rip rap along the toe of the interior embankment appeared to be in satisfactory condition (Photograph 5) (e.g., not displaced, in-filled, or incorrectly sized). The interior of the slope was generally well vegetated, but there were localized areas of sparse vegetation (Photograph 5). Developing erosion such as creation of a gully was not apparent at time of inspection.

<p>Slope of interior embankment (looking north). The slope appears well vegetated with a few less well vegetated spots.</p>	
<p><b>Photograph #6</b></p>

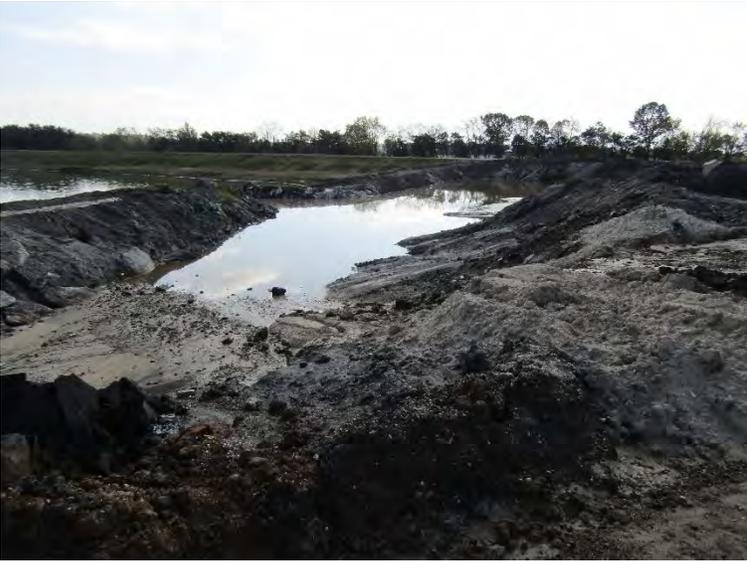
<p>Residual coal ash piles along inner slope of west dike (looking east).</p>

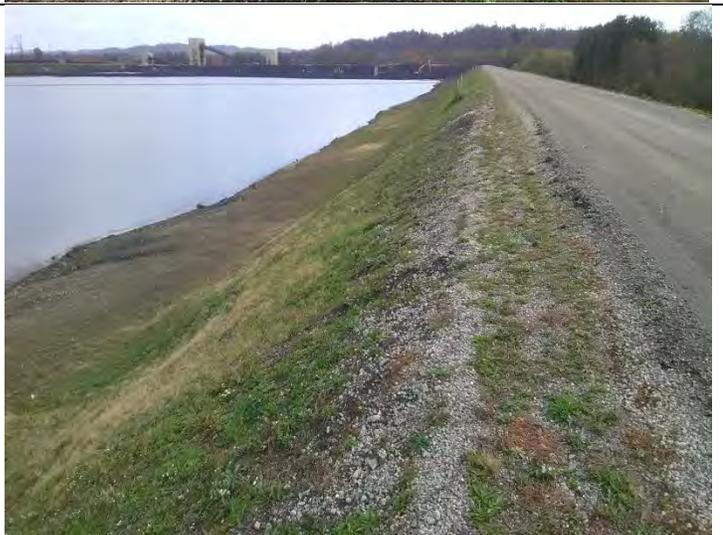
<p>View of interior embankment (looking east). A few rills were noted during the inspection</p>	
<p><b>Photograph #9</b></p>

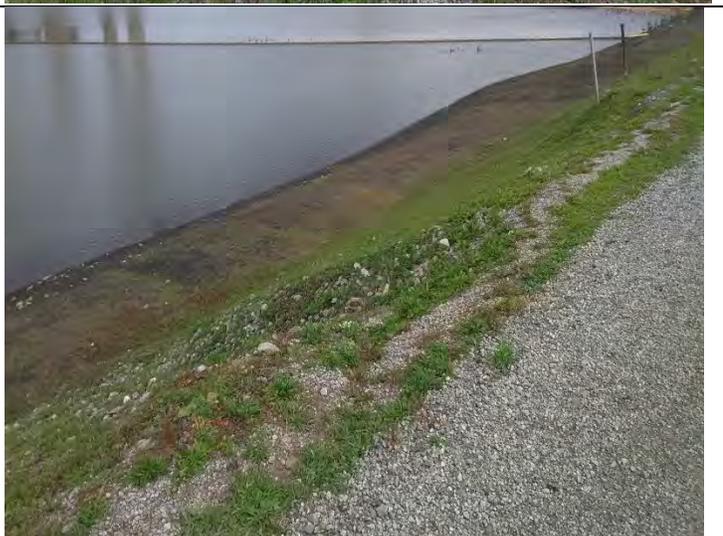
2. To the east along the interior slope, sparse vegetation was identified that may be the result of the placement of bottom ash along the road surface (Photographs 9 and 15). The inert nature of bottom ash and the associated lack of nutrients were likely the cause of the sparse vegetation in that area. A few isolated areas to the west with sparse vegetation on the interior and exterior portion of embankment were also identified (Photographs 7, 8, and 11).

<p>View eastern interior slope (looking southeast).</p>

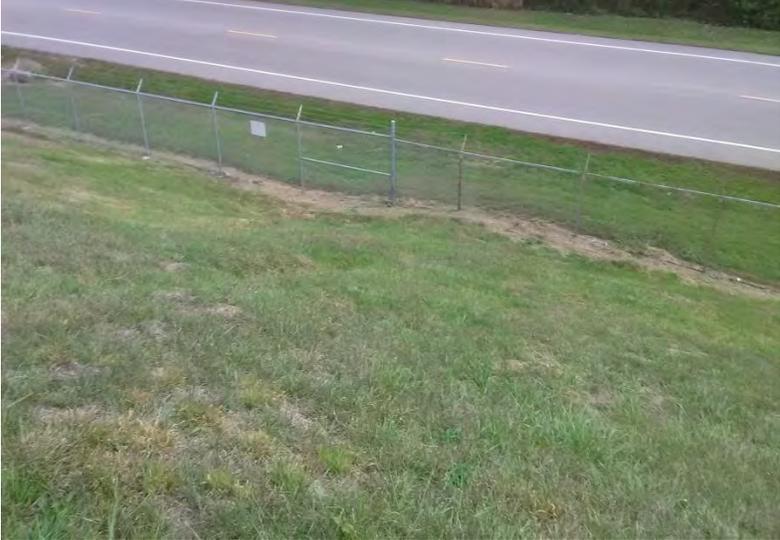
<p>View of vegetative coverage on southern side of exterior eastern embankment (looking east). The sloughing noted from last year's inspection did not have signs of recent movement.</p>

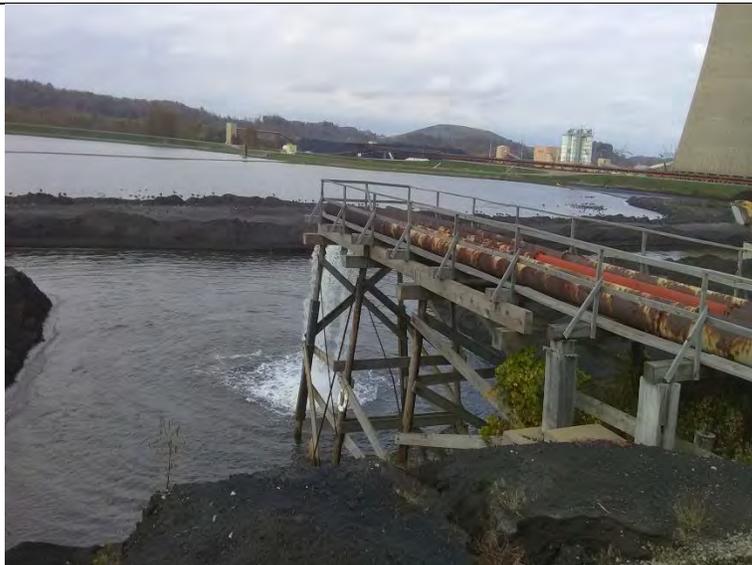
**Photograph #28**

3. The pipe and support structures for the two nests of slurry lines entering the pond had minor rusting in localized areas but appeared to be structurally sound and in satisfactory condition (Photographs 28). Several pipes were discharging from the plant into the BAP during the site walkthrough and no signs of leaking from the pipes was observed along this eastern face of the embankment. The pipe structures along the bench appeared to be structurally stable with minor, surface rusting in localized areas (Photographs 19 through 21, 25, and 26).

View of spillway and interior slope of embankment (looking west).

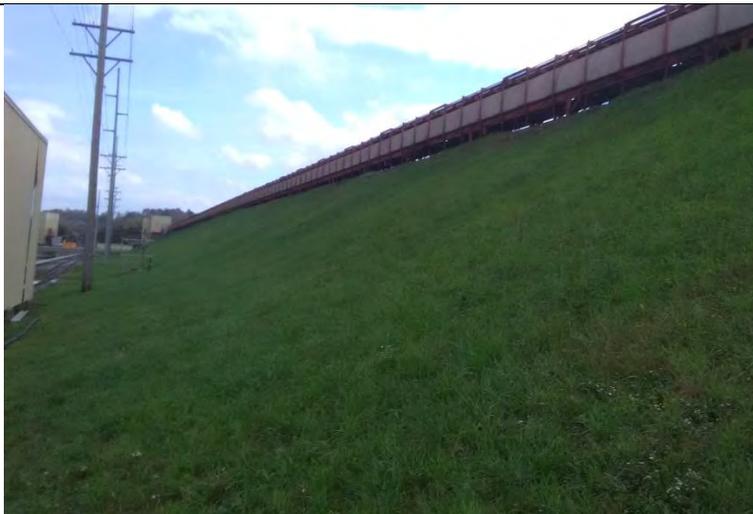
**Photograph #39**

6. A drainage ditch and grass swale adjacent to the toe of the exterior slope had positive slope and were effectively draining water into downstream inlet structures (Photograph 438). There was localized shallow standing water near to the toe of the slope, most likely from recent rainfall that had not completely drained yet (Photograph 39). No evidence of seeps along the toe of the embankment were observed.

Localized wet spot near to toe of exterior slope (looking south).

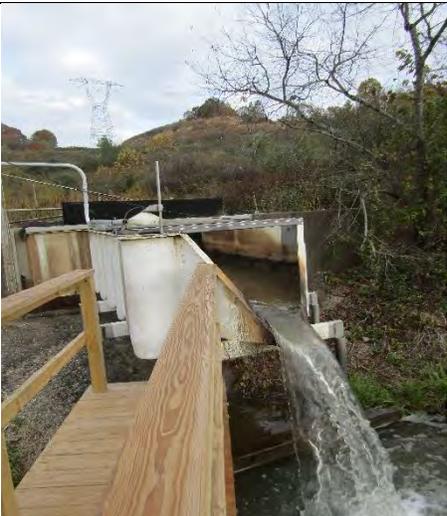
3. The overflow weir and mixing point for water pumped from the upstream Fly Ash Pond had an unobstructed flow condition and the supporting structure appeared to be in satisfactory condition (Photograph 48). Within the small settling basin upstream of overflow weir, rock filter curtains, and geotextile curtains had been placed. At the entrance of the overflow weir a turbidity curtain had been installed to minimize siltation build-up. Downstream of the discharge, a geotextile curtain/rock filter had been placed in the discharge channel prior to effluent leaving the site.

View of mixing point and overflow weir to Stingy Creek (looking west).

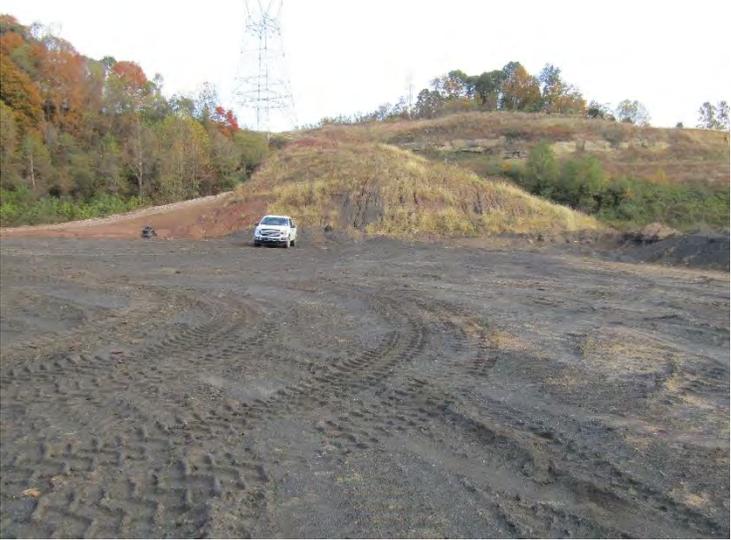
<b>Photograph #54</b>

Crest of dam where elevation has been lowered significant as intermediate staged grading as part of FAR Closure Plan (looking south).	
<b>Photograph #55</b>
