2017 Annual Inspection Report

*Residual Waste Landfill
Gavin Power Plant
Cheshire, Ohio*

8 January 2018

Project No. 0402270

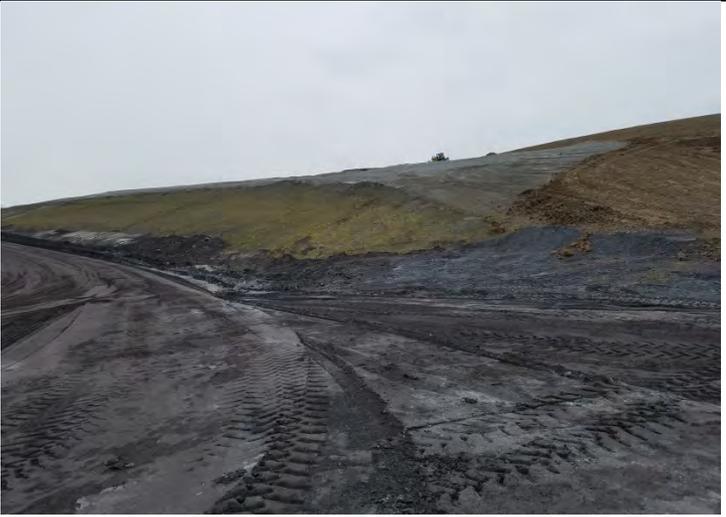
Photograph #1

View of SE facing slope condition adjacent to stack out pad and haul road (looking northwest). <i>Direct seeded FGD having layer of intermediate soil cover applied.</i>	
Photograph #2

2. Complete placement of intermediate soil cover, seed, and mulch on areas of direct FGD seeding where poor vegetative growth has been experienced. Soil pH and nutrient tests are recommended to target appropriate amounts of lime and fertilizer application to accomplish successful vegetative growth while minimizing the potential for over application.

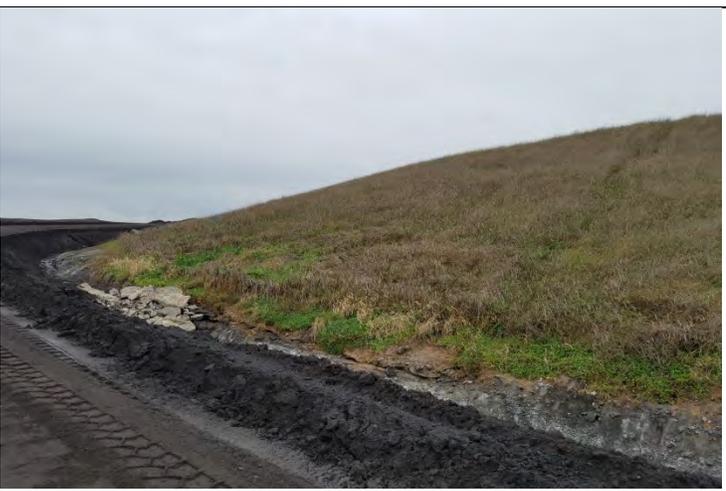
View of south facing slope along haul road with minor vegetated gully noted in intermediate cover (looking north).

3. Seed and fertilize localized bare spots along completed slopes to aid in the re-vegetation process. Add soil amendments and lime as needed.
4. Continue to repair erosion gullies and rills as they are encountered. Continue to monitor areas where rills or gullies have formed.

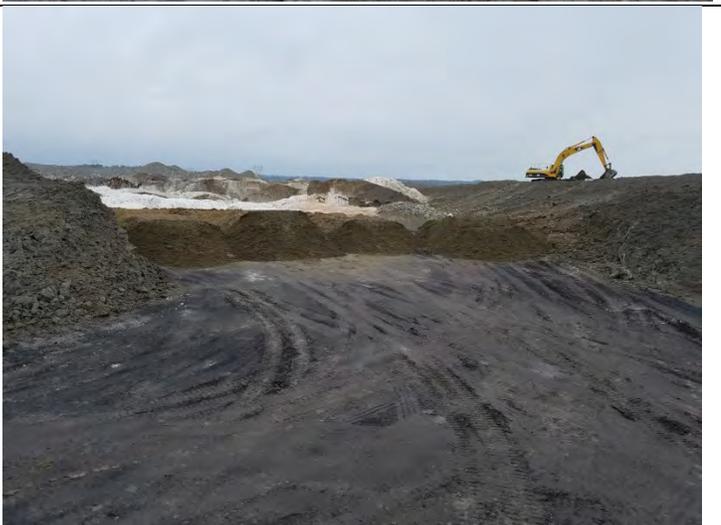
<p>View of lime and high moisture content CCR placement within vertical expansion area (looking east).</p> <p><i>Material mixed with drier CCR and placed within landfill away from slopes.</i></p>

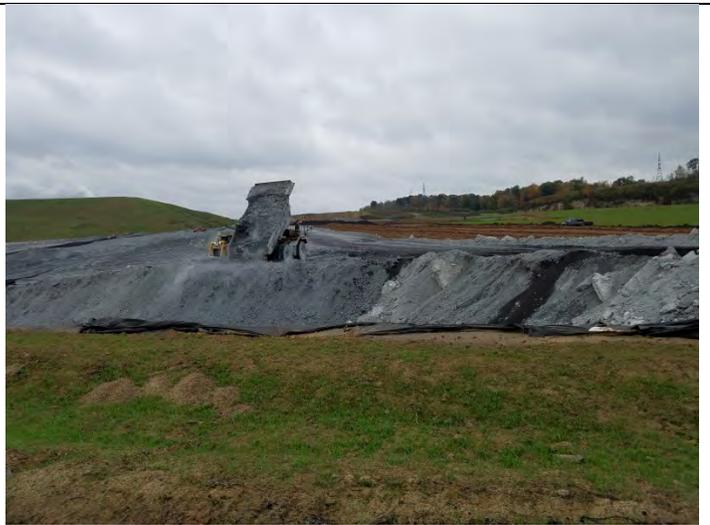
Photograph #21

Spreading of CCR across liner system within lateral expansion (looking south).

Large haul trucks can be seen staying on top of thick layer of FGD to avoid point loads.

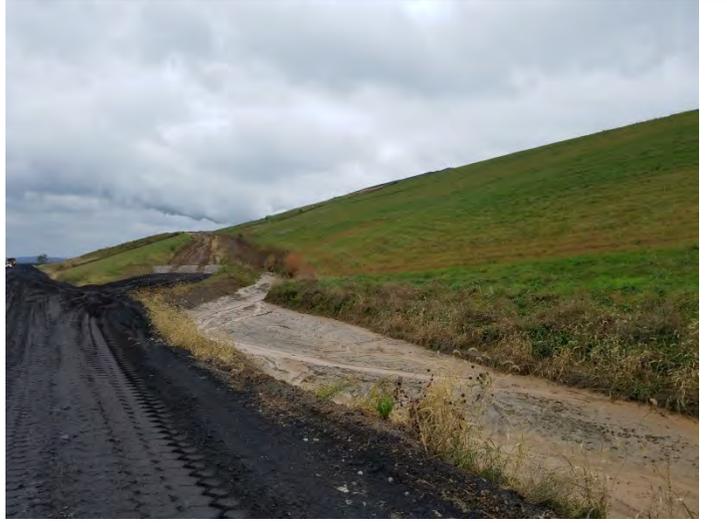
used by construction equipment. The lower end of the road has an installed water bar as shown in Photograph 22. The road was observed to have minor erosion occurring.

<p>View of eastern slope and dirt equipment access road (looking southwest).</p> <p><i>Moderate erosion observed and sedimentation in roadside channel.</i></p>	
<p>Photograph #23</p>

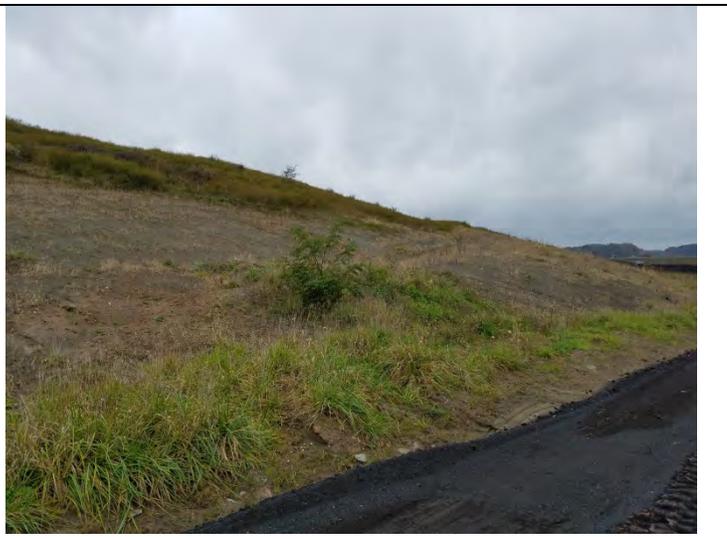
<p>View of eastern slope with localized bare spots/sporadic vegetation (looking northwest).</p>	
<p>Photograph #24</p>
