# 2018 Annual Inspection Report

Gavin Power, LLC

## Residual Waste Landfill

Gavin Power Plant  
Cheshire, Ohio

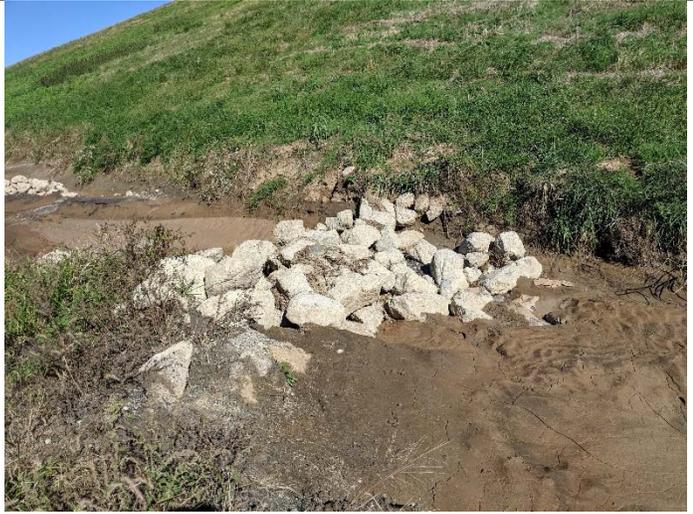
<b>Photograph #1</b>

Sediment buildup on south-western slope and rock check dam (looking north)	
<b>Photograph #2</b>

6. Maintain storm water channels and sediment traps on the southwestern slopes.
7. Fill gullies and add more rock check dams and riprap armoring as needed.

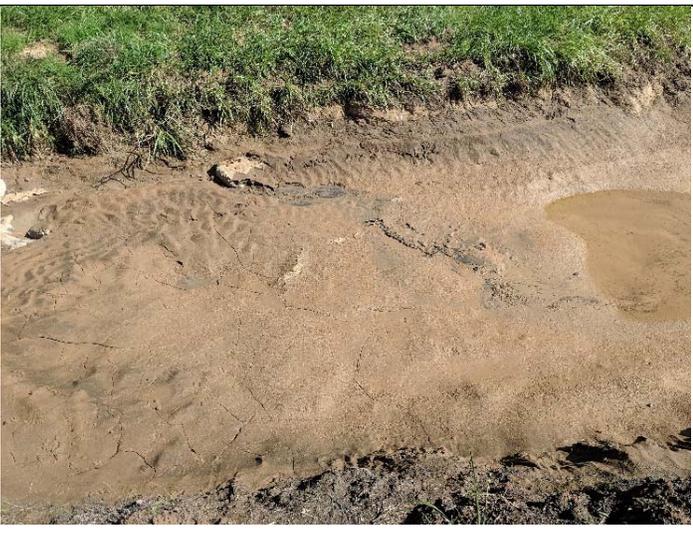
Full sediment trap on south-western slope (looking east)	
<b>Photograph #3</b>

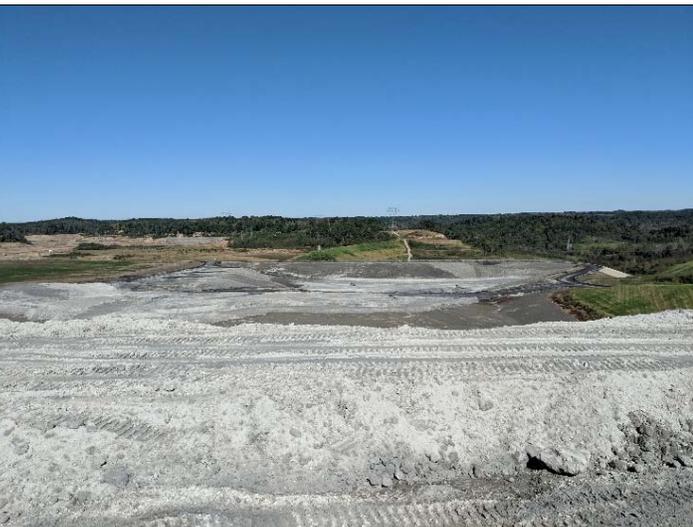
Overview of new landfill cell (looking north)

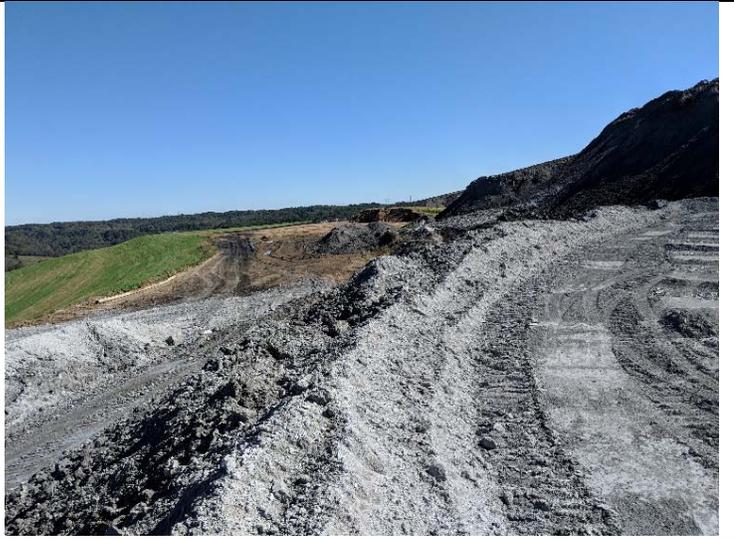
<p><b>Photograph #4</b></p>

<p>Soil stockpile near current summit (looking east)</p>	
<p><b>Photograph #5</b></p>

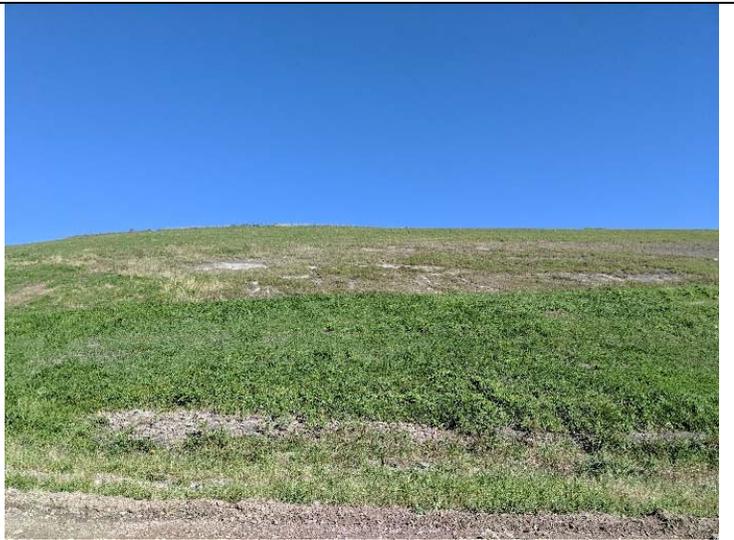
<p>Sparse vegetation on southwest slope (looking northeast)</p>	
<p><b>Photograph #6</b></p>

3. Seed and fertilize localized bare spots along completed slopes to aid in the revegetation process. Add soil amendments and lime as needed.
4. Continue to repair erosion gullies and rills as they are encountered. Continue to monitor areas where rills or gullies have formed.

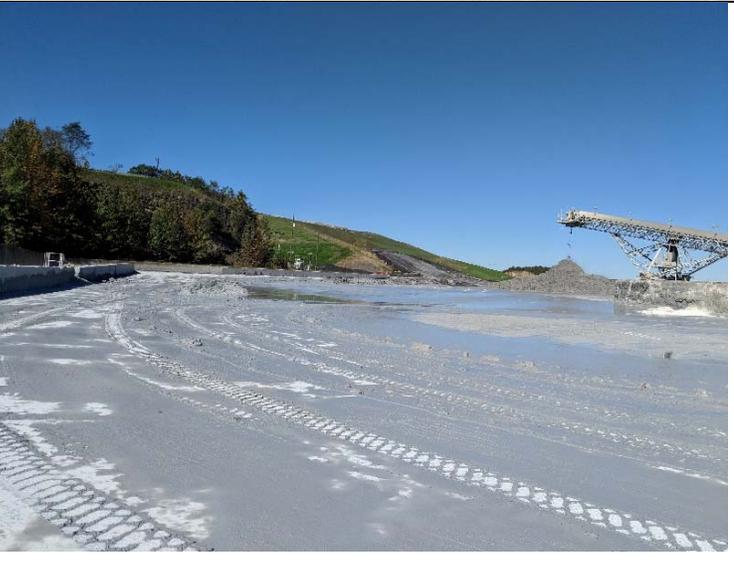
Photographs 6 through 9 show operating conditions at the FGD stack-out pad during ERM's visit. It appeared during the inspection that FGD material at the stack-out pad was being satisfactorily handled and contained on the pad. It was observed that large haul trucks were filled by an end loader and then directed to the designated placement location. During the inspection, the FGD material was being placed at the current lateral expansion while pond cleanings and limited truckloads of FGD material were being placed within the vertical expansion area.

<p>View of FGD stack out pad operations and slope (looking north).</p>

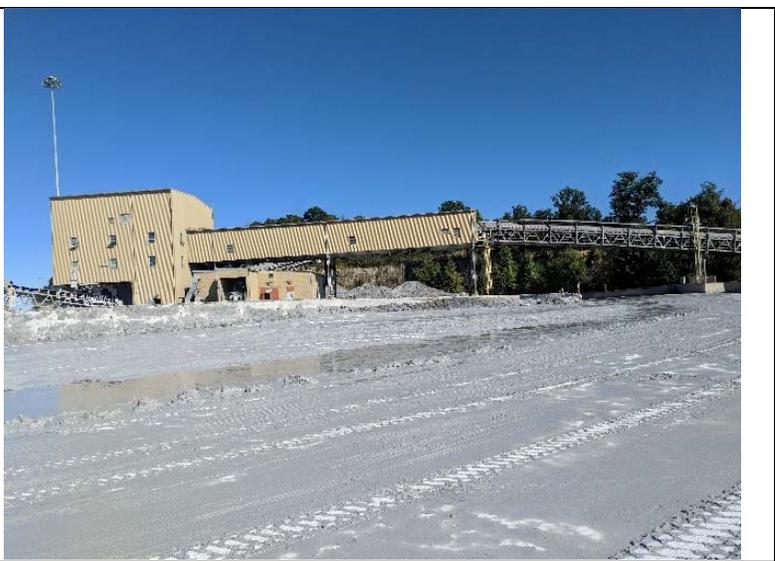
<p><b>Photograph #7</b></p>

<p>View of FGD stack out pad operations (looking east).</p>

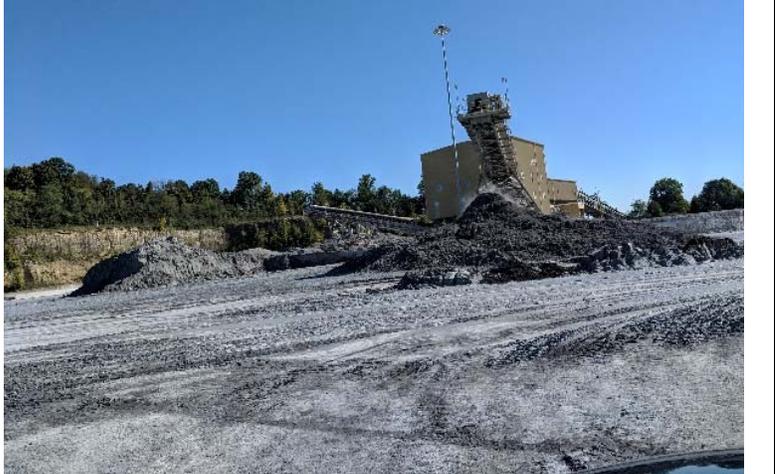
<p><b>Photograph #8</b></p>

<p>View of FGD stack out pad operations (looking south).</p>

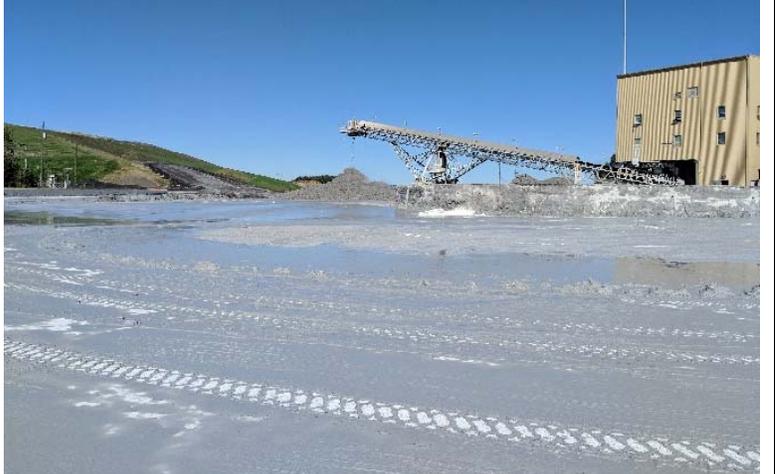
<p><b>Photograph #9</b></p>

<p>View of FGD stack out pad operations (looking north).</p>

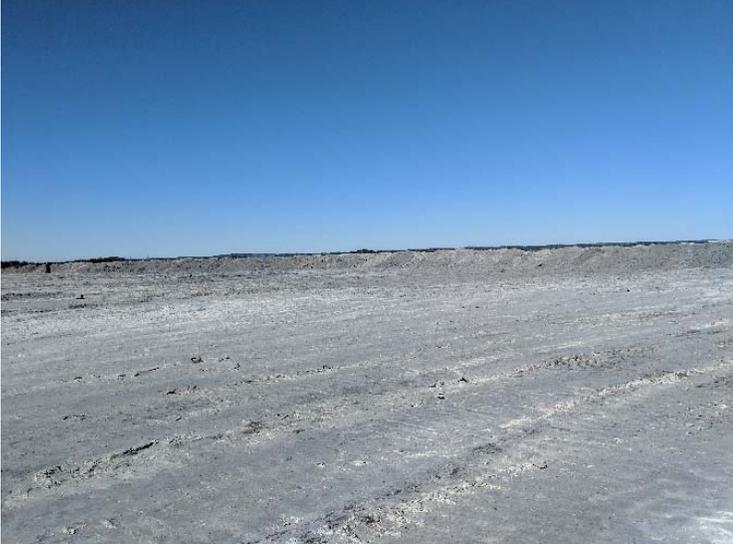
<p><b>Photograph #10</b></p>

<p>View of current summit of landfill (looking north).</p>	
<p><b>Photograph #11</b></p>

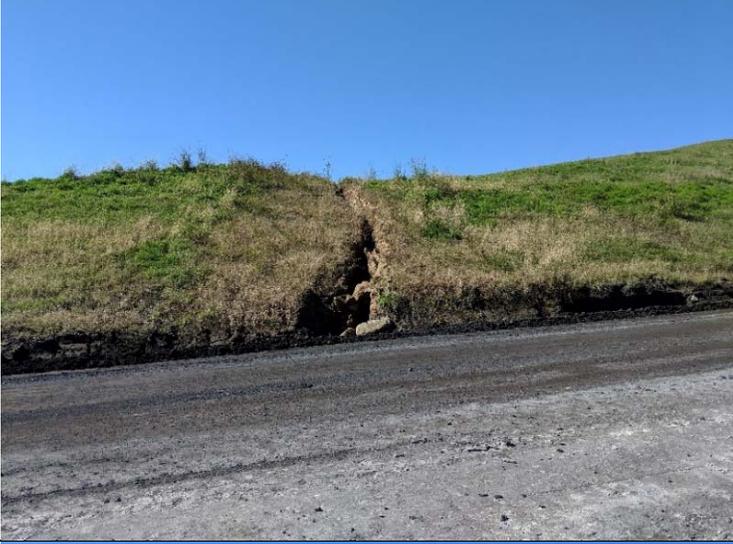
<p>Erosion gully on main haul road to summit (looking west)</p>	
<p><b>Photograph #12</b></p>

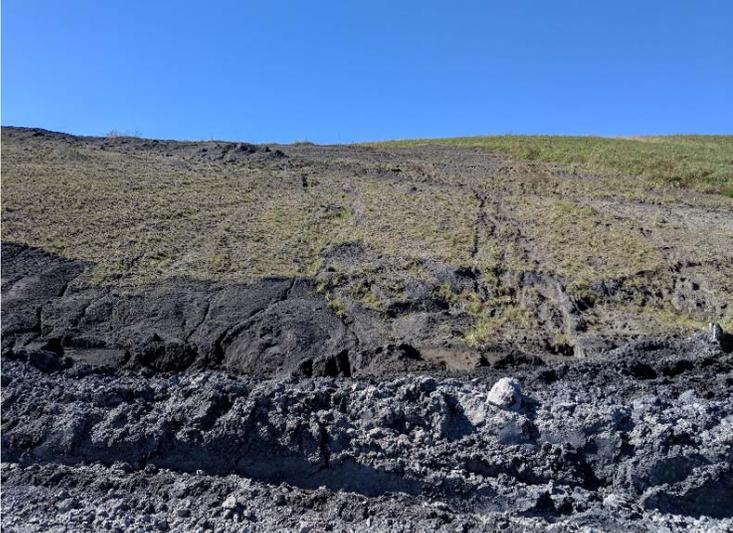
<p>Sparse vegetation on southern slope (looking north)</p>

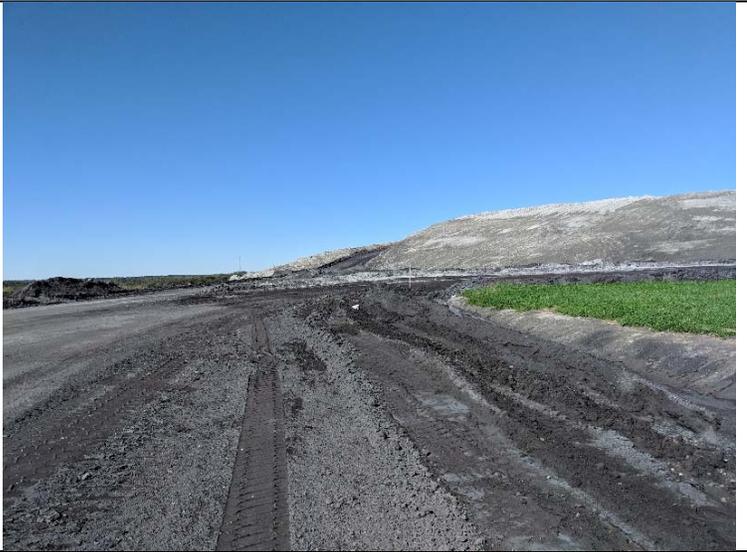
<p><b>Photograph #14</b></p>

The haul roads use bottom ash as a base course (as shown in Photographs 14, 17, and 20). The base course appears to compact well and holds up to repeated heavy equipment hauling. The haul roads observed by ERM appeared to be stable during the site drive/walkthrough and there was no visual evidence of significant distress (i.e., rutting or pumping). In addition, the roads generally had positive drainage from the centerline and there was no visual evidence of pooling water on the road surface. Storm water runoff from adjacent slopes is caught by drainage channels running parallel to the roads, and directed to stabilized outlets at the surrounding site treatment ponds. Sporadic evidence of minor erosion in the channel bottoms was observed, but overall roadside channels appeared to be well maintained.

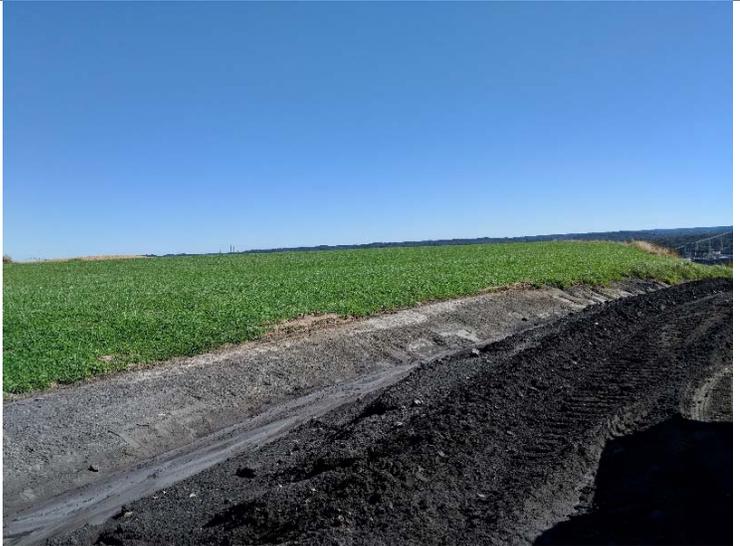
<p>Grassy area near summit (looking southeast)</p>	
<p><b>Photograph #17</b></p>

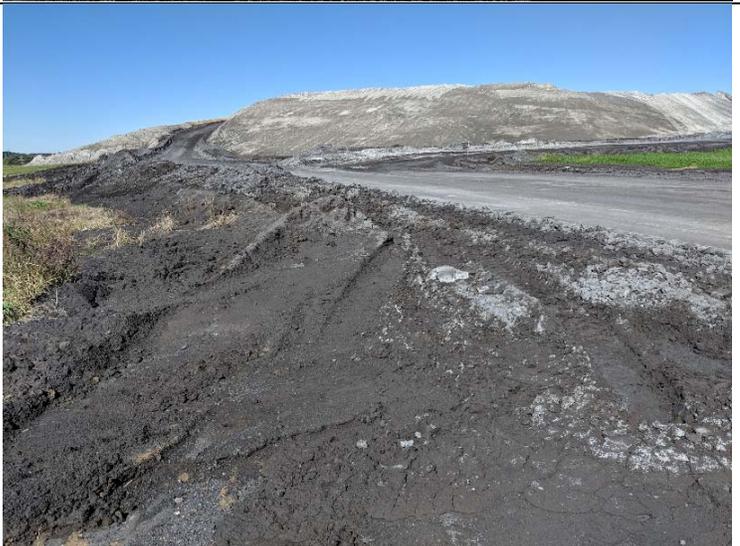
<p>Main haul road near summit (looking north)</p>	
<p><b>Photograph #18</b></p>

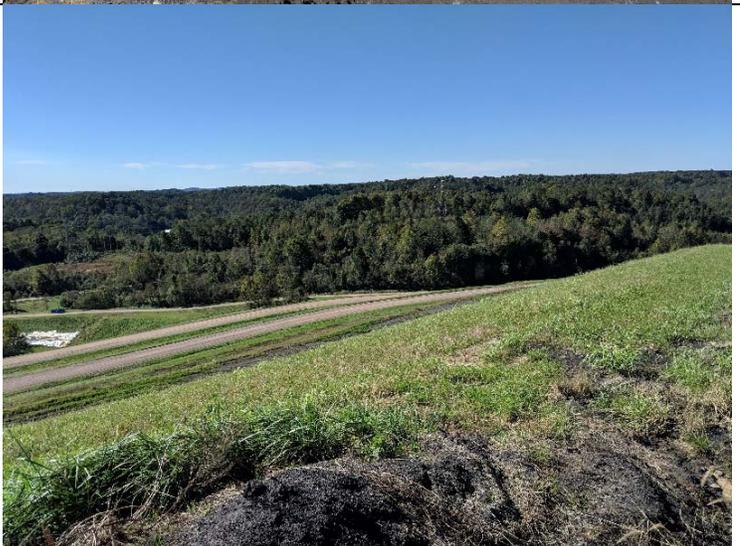
There were several sections of more frequently used permanent roads that have a gravel base course (as shown in Photographs 18, 19, 33, and 36). These roads also appeared to be stable with no visual evidence of distress. More frequently used roads had robust drainage channels adjacent to slopes that were positively graded and had rock check dams (Photograph 1). The drainage channels on the eastern slopes appeared well-maintained with no visual evidence of obstructions. The drainage channels on the southwestern slopes showed signs of erosion and rutting into the FGD material in areas with temporary cover. ERM recommends that this area be repaired and monitored. If issues are persisting, increasing the number of rock check dams and additional riprap armoring may fix the issue. ERM also recommends maintenance of the sediment traps below areas where erosion has been noted. On the eastern haul road leading to the new landfill cell, leachate was identified percolating to the land surface and flowing to Pond 3 via the drainage channel, where runoff and leachate are treated, as described in Section 3.3 below.

<p>Southwestern access roads (looking west)</p>

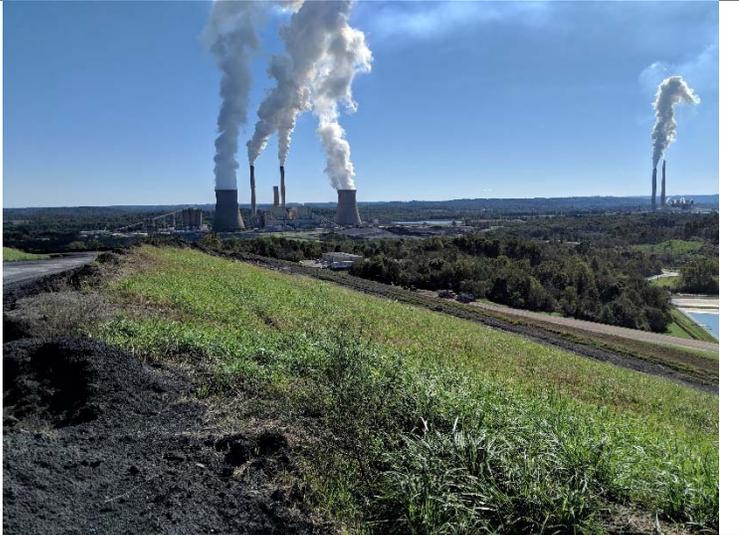
<p><b>Photograph #19</b></p>

<p>Southwestern access road (looking south)</p>	
<p><b>Photograph #20</b></p>

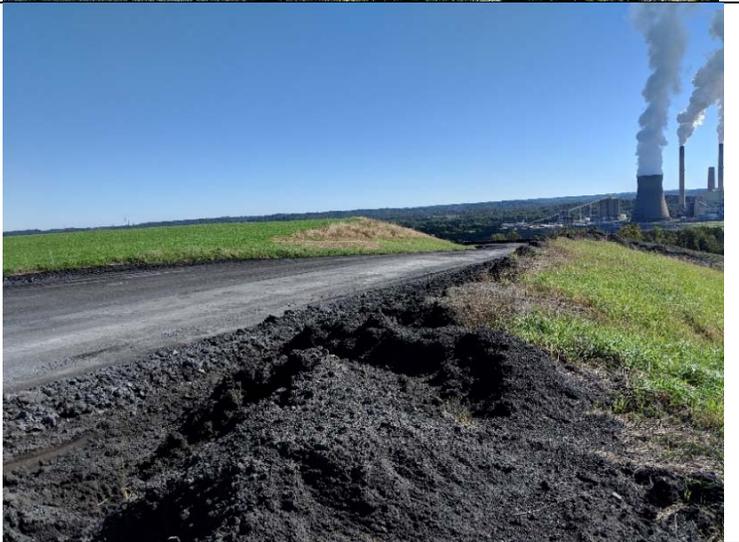
<p>Main haul road near summit (looking south)</p>	
<p><b>Photograph #21</b></p>

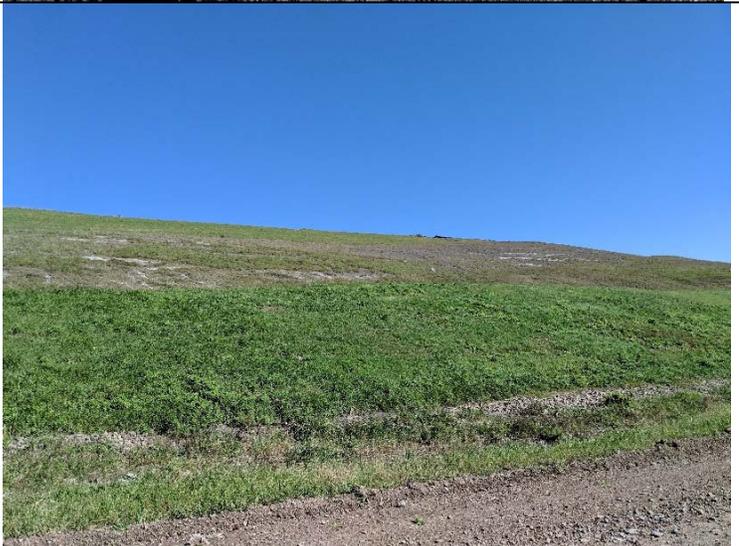
<p>Sparse vegetation on southern slope (looking north)</p>

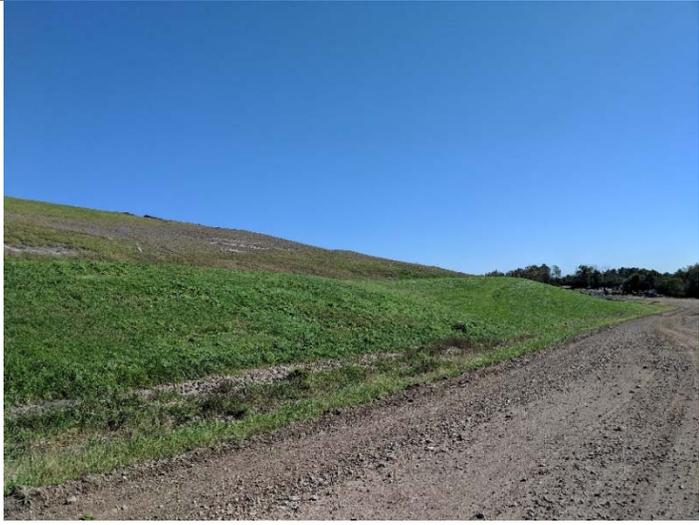
<p><b>Photograph #22</b></p>

<p>Sparse vegetation on southern slope (looking northeast)</p>	
<p><b>Photograph #23</b></p>

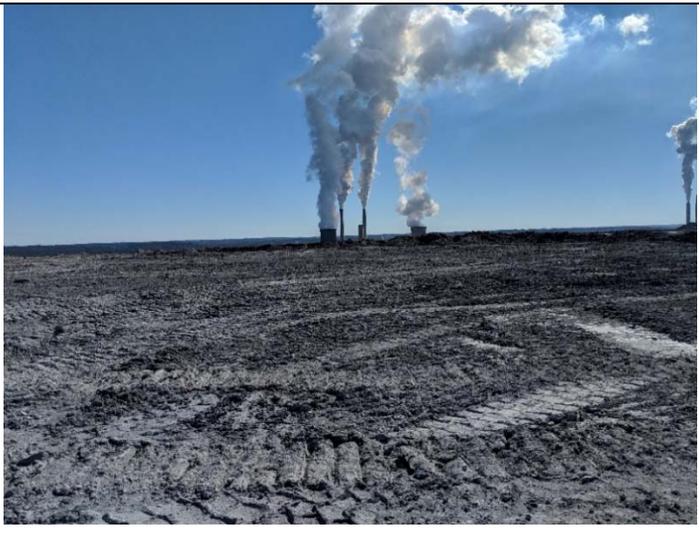
<p>Summit of landfill (looking south)</p>	
<p><b>Photograph #24</b></p>

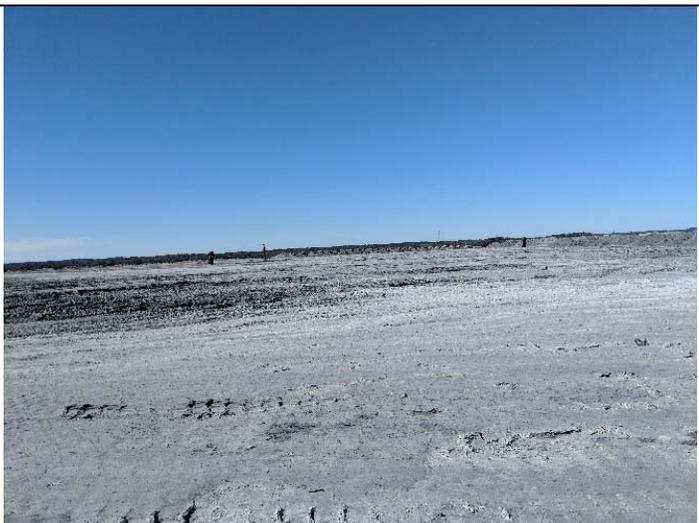
<p>Summit of landfill and chimney drains (looking west)</p>

11. Add drainage stone around the top of current chimney drains.

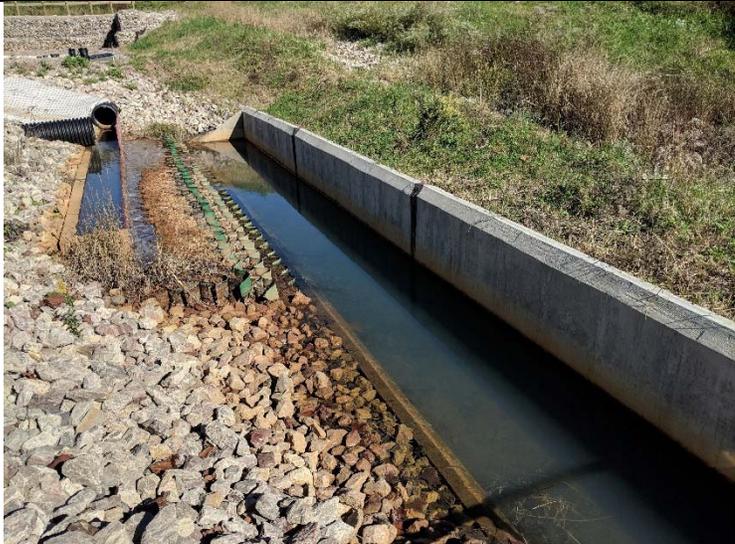
<p><b>Photograph #28</b></p>

<p>Outlet for vertical flow wetland at Pond No. 1 (looking west)</p>	
<p><b>Photograph #29</b></p>

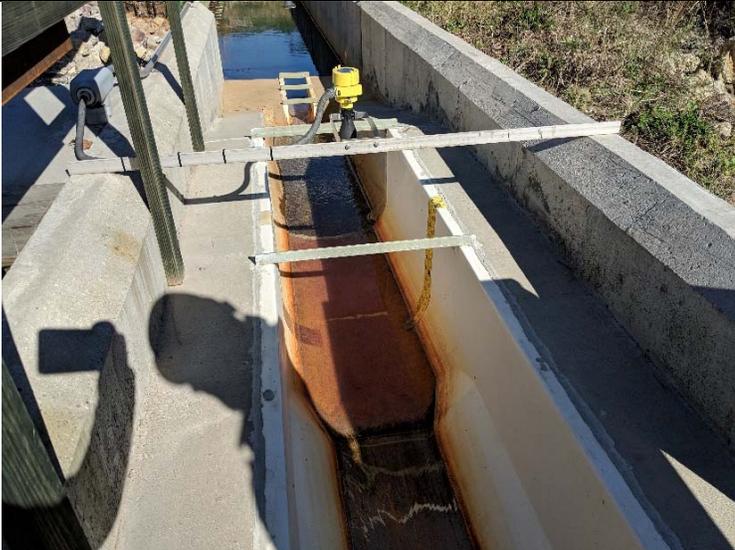
<p>Flow meter looking north at Pond 1</p>	
<p><b>Photograph #30</b></p>

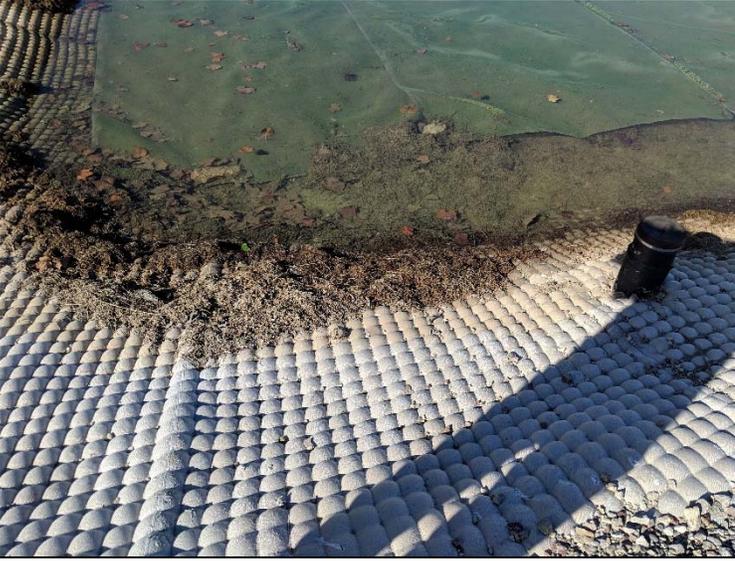
<p>Wetland material out of water (looking west) At Pond 1</p>

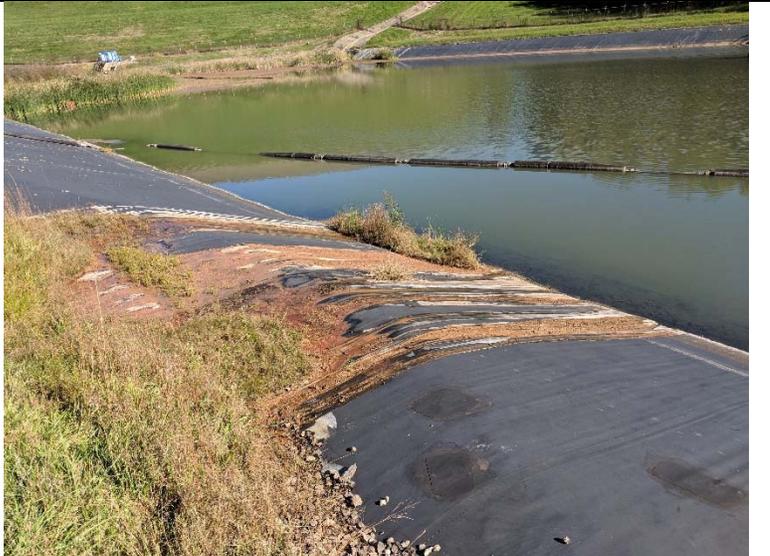
<p><b>Photograph #31</b></p>

<p>View of slope and Pond No. 1 (looking north).</p>	
<p><b>Photograph #32</b></p>

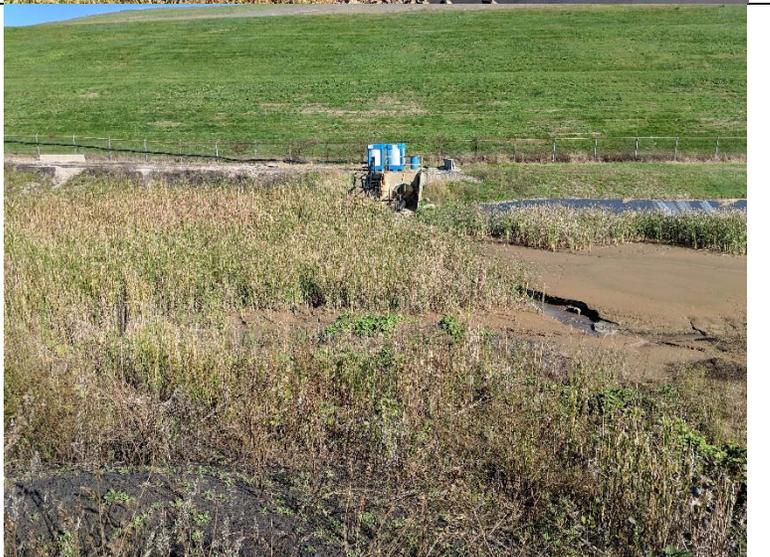
The sedimentation/treatment portion of Ponds 1 and 3 were observed to have varying amounts of solids within their limits, as shown in Photographs 32 and 39. The clarifying portion of Pond 3 was also observed to have a minor amount of sedimentation, as shown in Photograph 41, which was being cleaned out at the time of the inspection. These ponds are routinely cleaned of accumulated solids, typically through the use of extended-reach excavators or a floating dredge.

<p>View of vegetated sediment patch in Pond No. 1 (looking north)</p>	
<p><b>Photograph #33</b></p>

8. Remove excessive vegetation growth from inside Ponds 1 and 3 and continue maintenance on other ponds. Clean channel inlets on both Ponds 1 and 3 to removed sediment buildup.

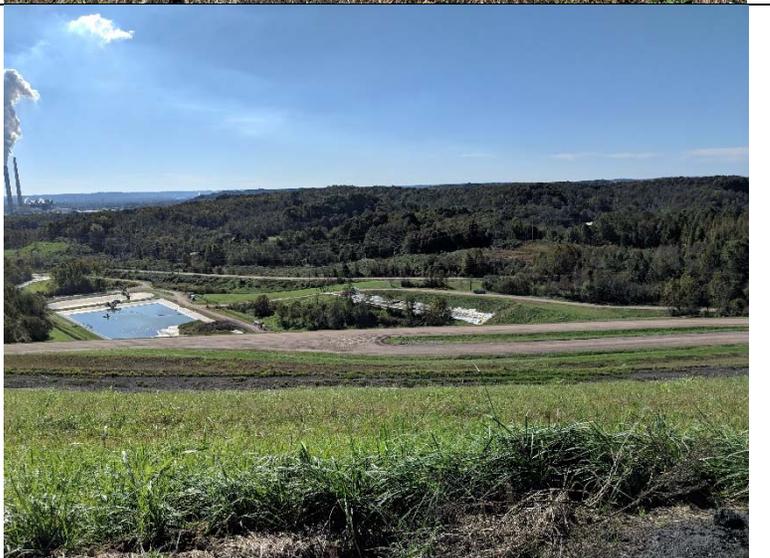
<p>View of Pond No. 1 and southwest slope into pond (looking south).</p>

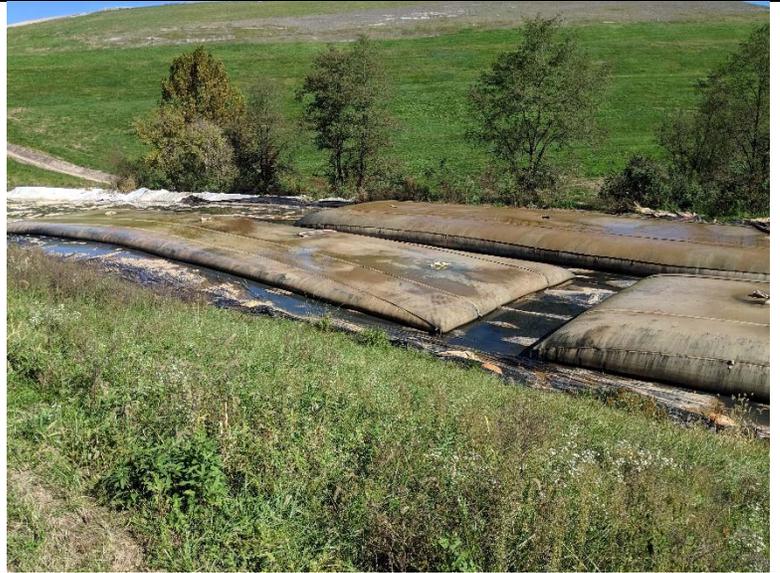
**Photograph #34**

Pond 1 appeared to be functioning properly during ERM's visit. An active dewatering bag observed during the inspection is shown on Photograph 34. The bag appeared to be functioning satisfactorily at the time of inspection and was discharging relatively clear effluent. A buildup of sediments and vegetation was observed at the inflow to Pond 1. For maintenance purposes these materials should be removed and properly disposed. A small tear was observed in the liner of the clarifying pond on the southern corner. ERM recommends that this tear be repaired as part of routine maintenance.

View of dewatering bags for sludge collected from Pond 1 (looking north).

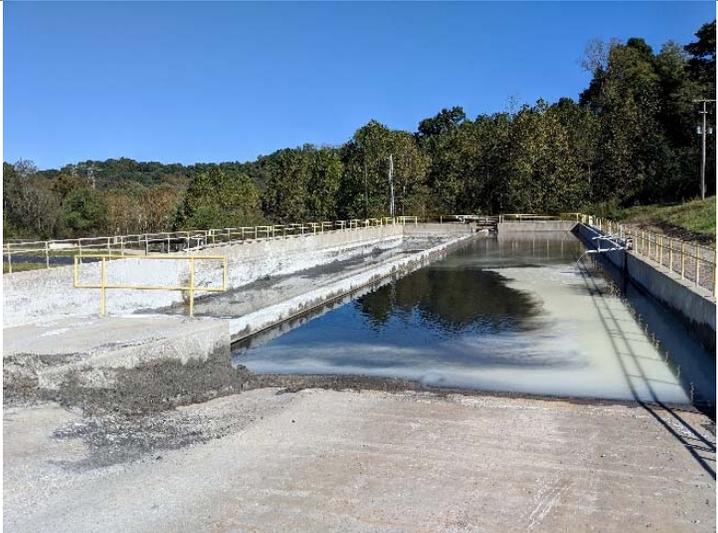
<p><b>Photograph #35</b></p>

Pond 2 also appeared to be functioning satisfactorily. To assist with the removal of FGD solids coming from the stack out pad and to minimize dredging, Gavin Power operates a concrete settling basin at Pond 2. This basin is routinely cleaned with an extended-reach excavator. A dewatering bag was also observed on an elevated layer of bottom ash within this pond to manage materials collected with a floating dredge. Within the sedimentation/treatment portion of Pond 2, rock from maintenance and grading operations on

<p>Settling basin adjacent to Pond No. 2. (looking east)</p>	
<p><b>Photograph #36</b></p>

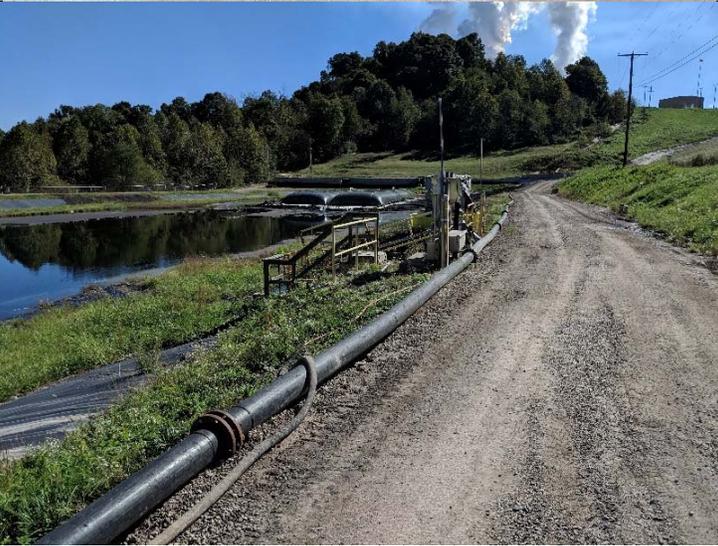
<p>View of leachate inlet for Pond No. 2. (looking south)</p>	
<p><b>Photograph #37</b></p>

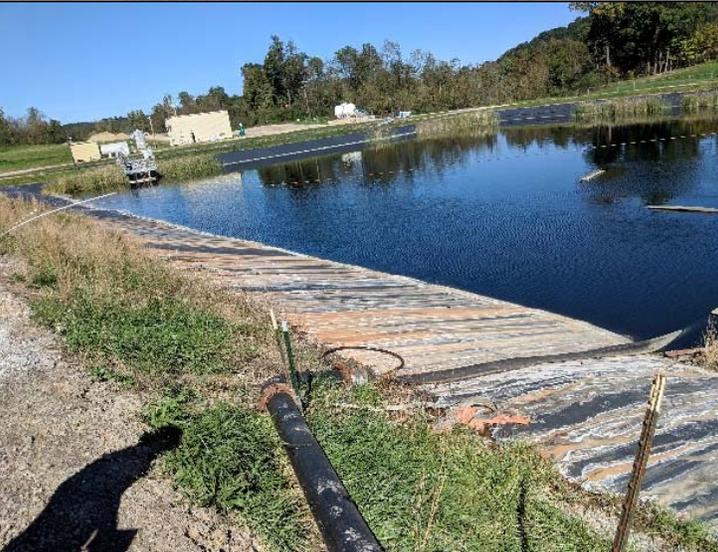
<p>View of northern banks of Pond No. 2 (looking northeast).</p>

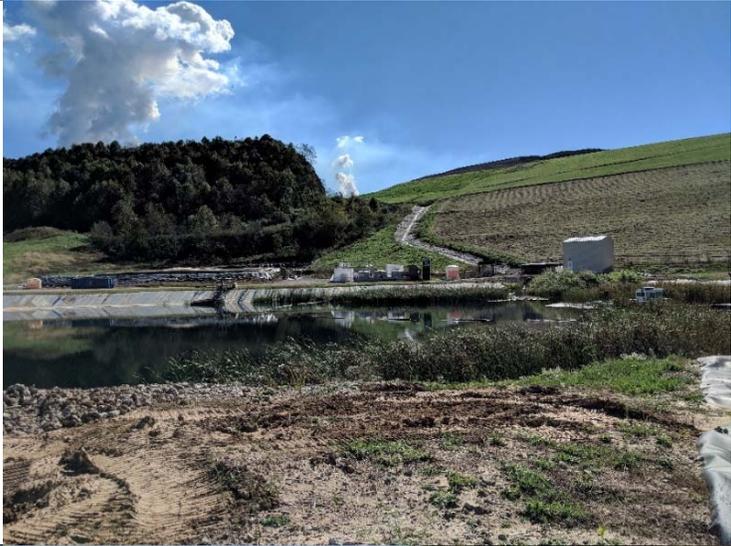
Overall, the clarifying portion of the pond systems, and the associated vertical flow wetland systems, showed evidence of tearing in the outermost protective liner. The liner was being cleaned of debris and gravel from recent heavy rains. Maintenance workers there at the time noted that the outermost liner was for UV protection and not meant to be the impermeable liner as shown on Photograph 41. The impermeable layer underlies the outermost layer. Various outlet structures for the ponds and vertical flow wetlands were also observed to be largely clear of sedimentation and debris as shown on Photographs 38 and 39.

<p><b>Photograph #38</b></p>	
<p>Pond 3 overview (looking south)</p>

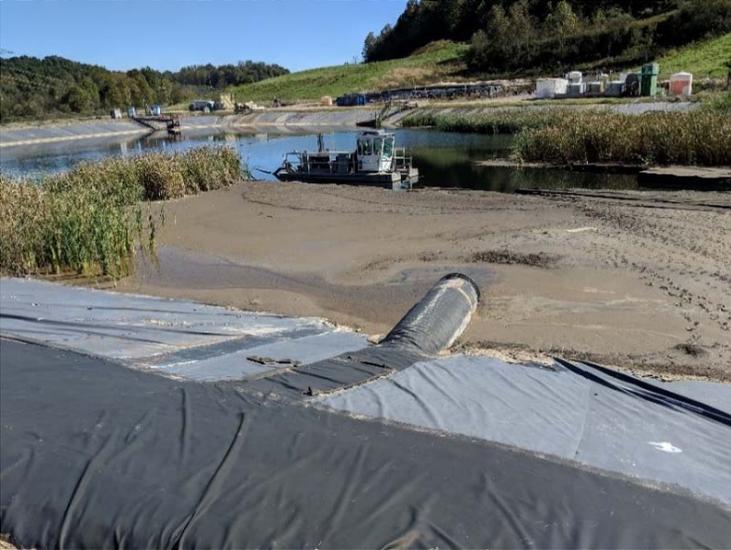
<p><b>Photograph #39</b></p>	
<p>Sediment and vegetation in pond 3 (looking south)</p>

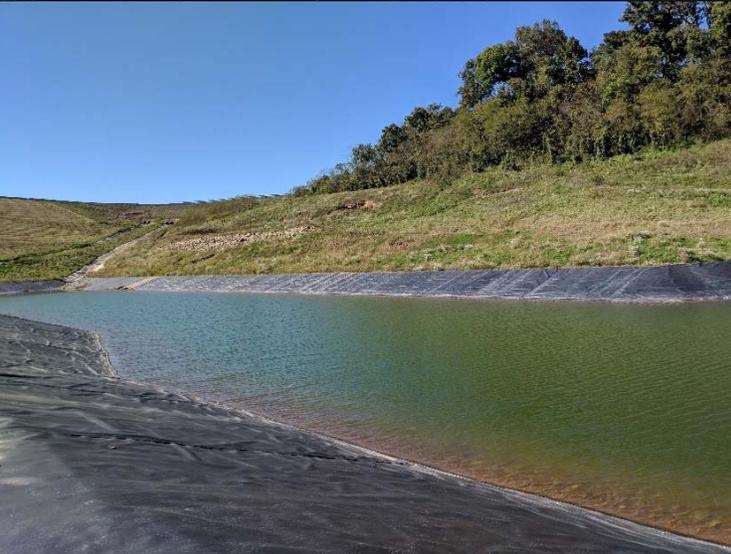
<p><b>Photograph #40</b></p>	
<p>Pond 5 (looking north)</p>

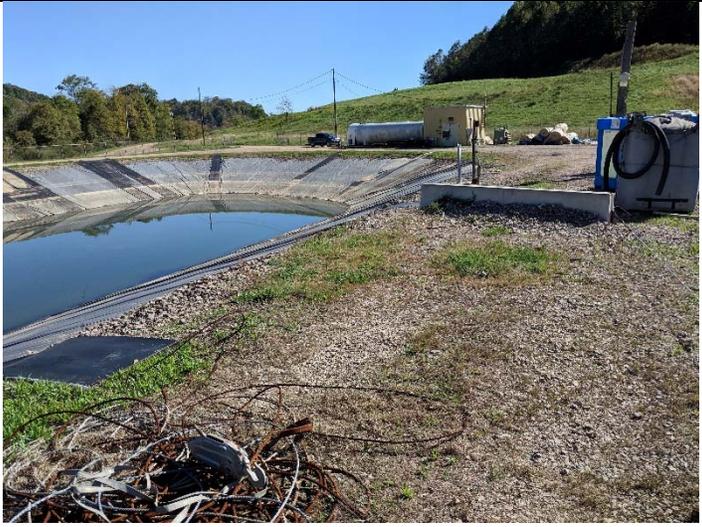
<p><b>Photograph #41</b></p>

<p>Clarifying pond next to pond 3 (looking south)</p>	
<p><b>Photograph #42</b></p>

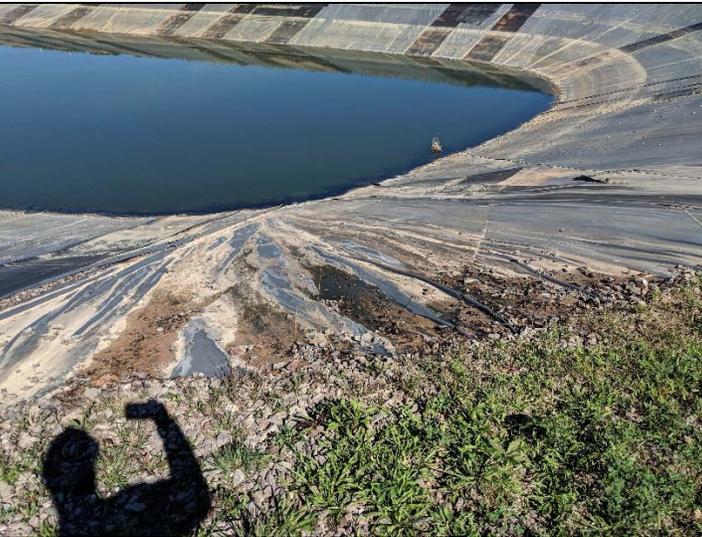
<p>Clarifying pond surface wear (looking north)</p>	
<p><b>Photograph #43</b></p>

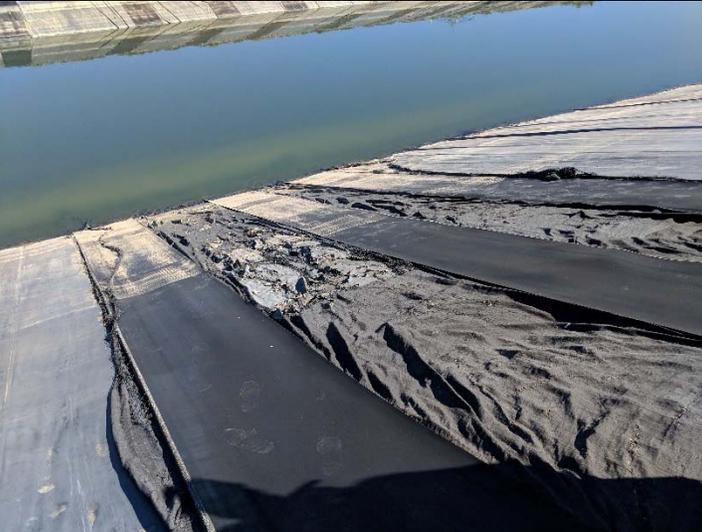
<p>Clarifying pond surface wear (looking east)</p>
