# STRUCTURAL STABILITY ASSESSMENT

**CFR 257.73(d)**

Stingy Run Flyash Pond

Gavin Plant  
Cheshire, Ohio

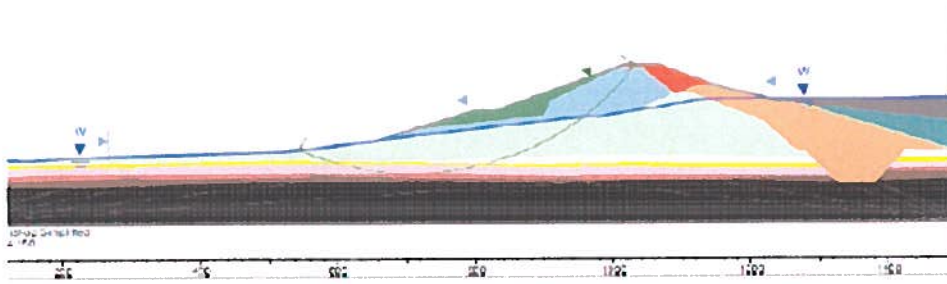
The foundation soils under the embankment consist of layers of sand and clay underlain with shale and competent rock. The clay core was extended through overburden foundation layers of clay, sand, and weathered shale and keyed into intact foundation bedrock and abutments. The abutments are formed of the natural hillside sandstone. A core trench extended the full length of the dam into the rock. A grout curtain was provided in the abutments of the dam. The dam was arched in the upstream direction and camber was provided to compensate for settlement. The foundation soils were typically very stiff to hard, red-brown mottled with gray silty clay characteristics similar to very soft shale. Hand penetrometer measurements of cohesive samples within this stratum ranged from 3.75 to 4.5+ tons per square foot and SPT (N-values) ranged between 31 and 69 blows per foot. Based on the subsurface soil properties of soils and rock supporting the dam, the foundation and abutments of this dam is found to be in good and stable condition. Typical cross-section and engineering properties of the foundation soils/rock under the embankment are illustrated below.

Material Name	Color	Unit Weight (lbs/ft <sup>3</sup> )	Sat. Unit Weight (lbs/ft <sup>3</sup> )	Cohesion (psf)	Phi (deg)
'88 U/S Clay Core	Red	120	129	700	16
'88 D/S Random Fill	Green	126	129	800	16
Bottom Ash zone	Light Blue	105	115	0	35
'74 Clay Core	Orange	130	133	0	23
'74 D/S Random Fill	White	130	136	0	27
'74 U/S Random Fill	Dark Blue	127	130	0	21
Upstream Fly Ash	Grey	100	100	0	30
Upper Clay	White	127	127	860	21
Upper Sand	Yellow	127	130	0	30
Intermediate Clay	White	126	126	0	22
Lower Sand	Red	127	130	0	30
Lower Clay/Shale	Brown	130	131	0	22
Competant Rock	Dark Grey	130	131	5000	0
