2018 Annual Inspection Report

Gavin Power, LLC

Bottom Ash Complex and Stingy Run Fly Ash
Reservoir

Gavin Power Plant
Cheshire, Ohio

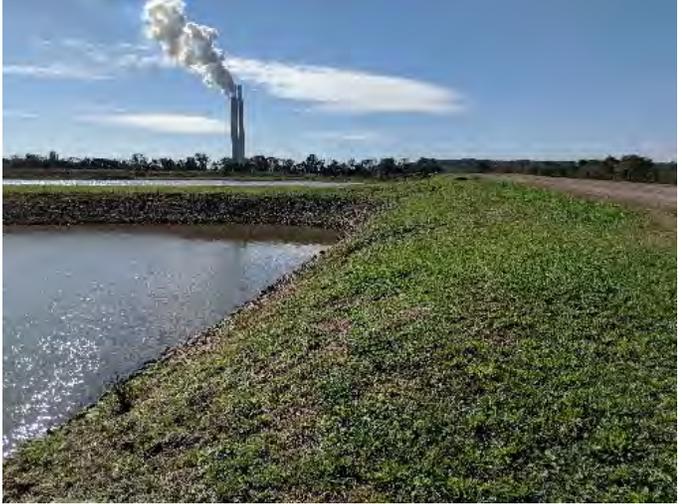
Photograph #1

1. The interior slope had no visual indication of settlement, rutting, or misalignment. The rip rap along the toe of the interior embankment appeared to be in satisfactory condition (Photograph 1). Vegetation on the interior of the slope was sparse and ERM recommends developing more robust vegetative cover in this area. (Photograph 1).

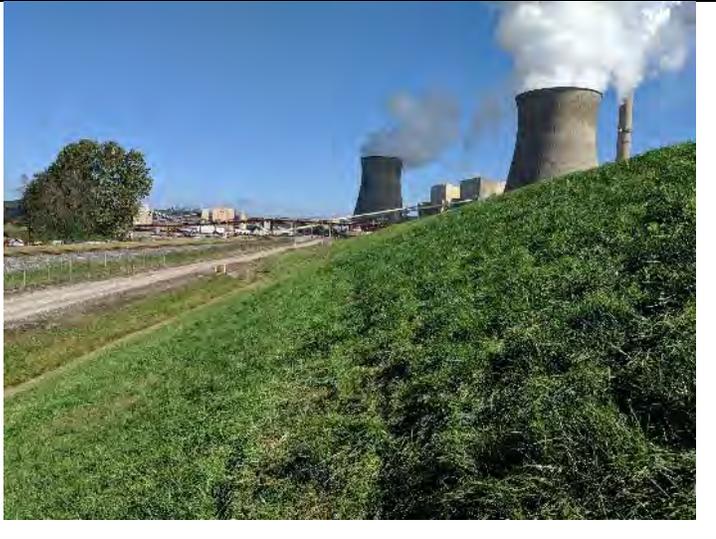
3. The exterior slope had no visual indication of settlement, rutting, or misalignment except for an earthen bulge noted halfway down the slope (Photograph 4), a vegetated erosion gully (Photograph 5), and minor vegetated erosion rills and gullies along the exterior of the slope in localized areas (Photograph 6). The earthen bulge and vegetated erosion gully do not appear to be active or expanding. The earthen bulge was previously noted in the 2016 and 2017 Annual Inspection Reports, and did not appear to be active during the 2016 or 2017 inspections. The bulge in this area has reportedly existed since original construction.

<p>Photograph #4</p> <p>Slope of exterior embankment including apparent inactive earthen bulge along slope (looking north).</p>

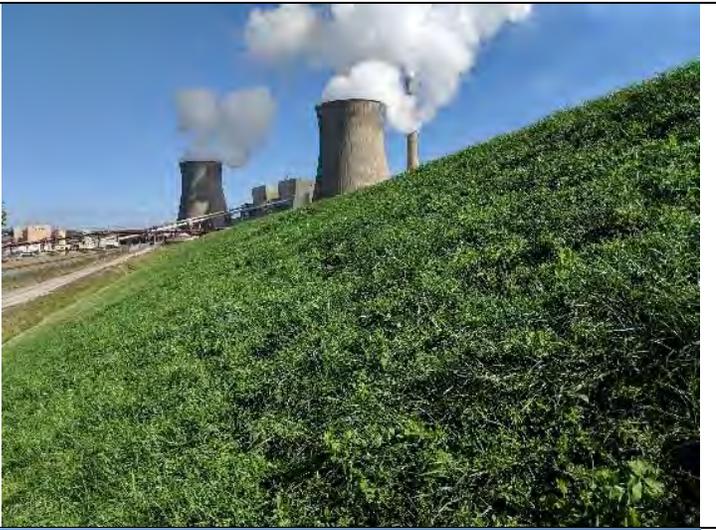
<p>Photograph #5</p> <p>Slope of exterior embankment including apparent inactive earthen bulge along slope (looking north).</p>

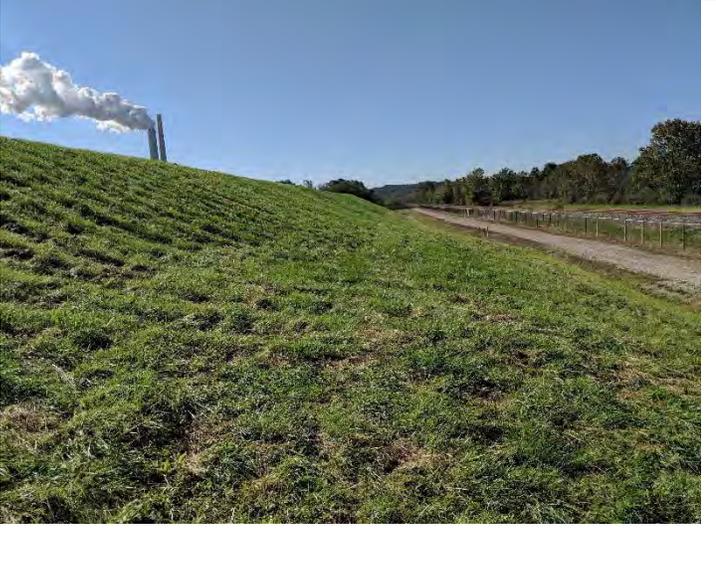
<p>Photograph #6</p> <p>Slope of exterior embankment including apparent inactive earthen bulge along slope (looking south).</p>

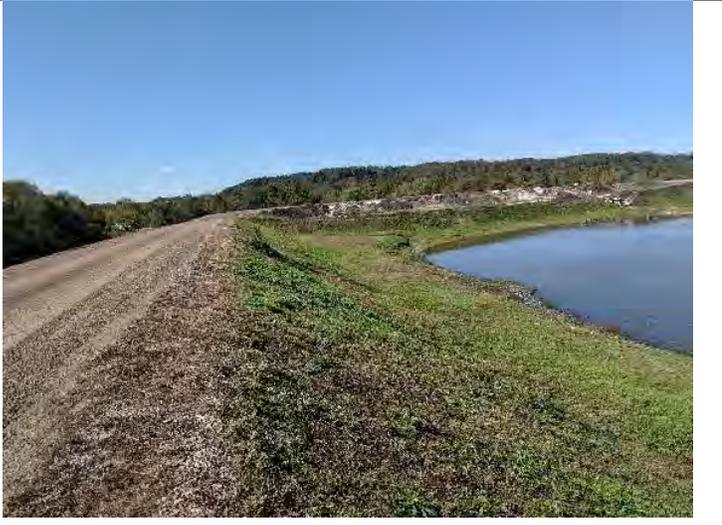
Photograph #7

2. To the east along the interior slope, sparse vegetation was identified that may be the result of the placement of bottom ash along the road surface (Photograph 7). The inert nature of bottom ash and the associated lack of nutrients were likely the cause of the sparse vegetation in that area. A few isolated areas to the west with sparse vegetation were also identified (Photograph 11).

View of interior embankment including crest and slope (looking west).	
Photograph #8

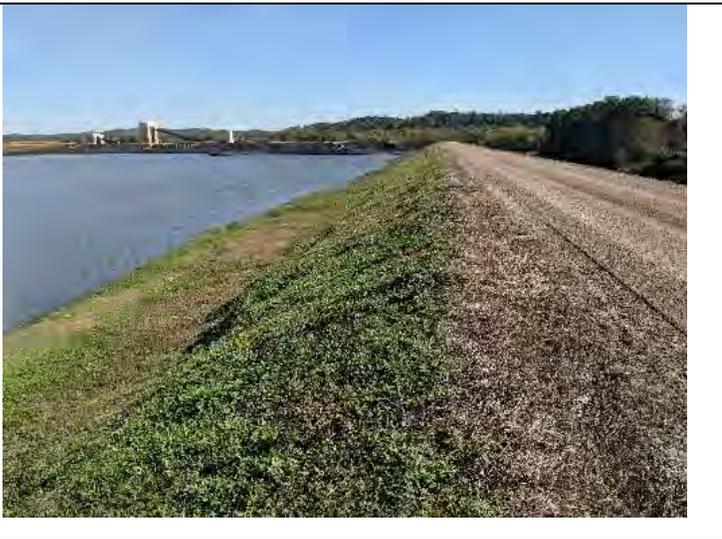
View of interior embankment (looking east). A few rills were noted during the inspection	
Photograph #9

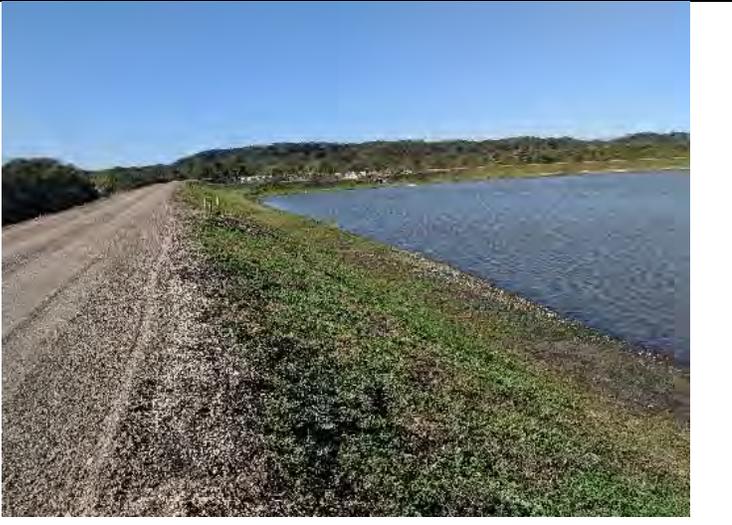
<p>Photograph #10</p>

1. The interior and exterior slope had no visual indications of misalignment or settlement (Photographs 7, 8, and 9). The riprap along the toe of the interior embankment also appeared to be in satisfactory conditions (Photograph 10).

<p>View of slopes on the eastern half of interior embankment (looking west)</p>	
<p>Photograph #11</p>

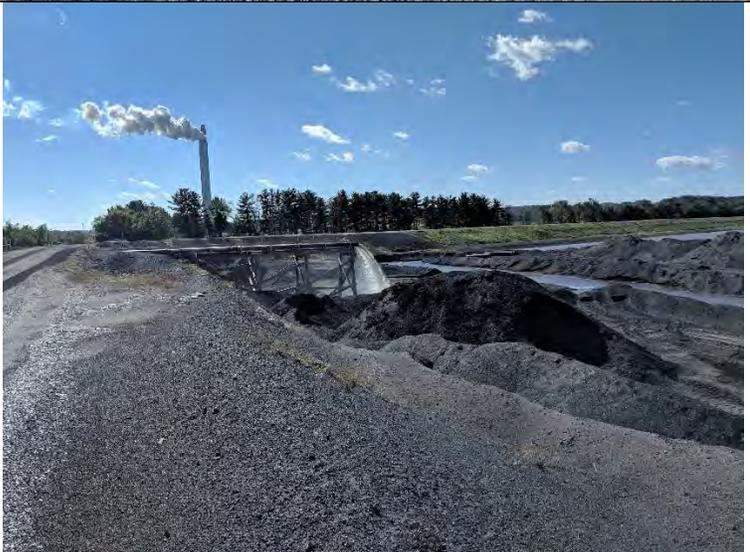
2. The pipe and support structures for the two slurry lines entering the pond had minor rusting in localized areas but appeared to be structurally sound and in satisfactory condition (Photographs 18 and 19).

<p>Ash slurry sluice pipes and support structure in middle of embankment (looking south).</p>

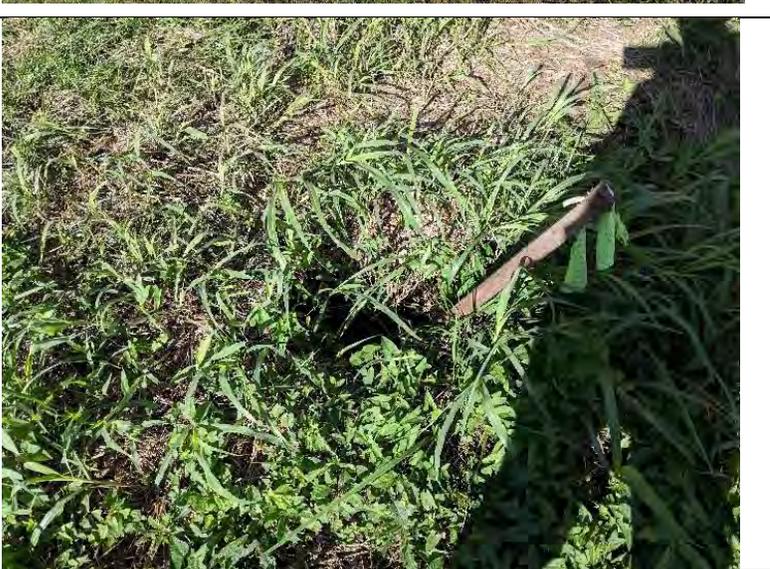
5. A small depression, 1 foot in diameter and approximately 18 inches deep, was identified during the inspection. The depression was marked with a stake and flag to help identify it for people working in the area (Photograph 39). It did not appear from visual inspection to impact the structural stability of the embankment. ERM recommends that this area be monitored in the future for additional depressions or settlement.

<p>View of localized settlement at toe of exterior embankment.</p>

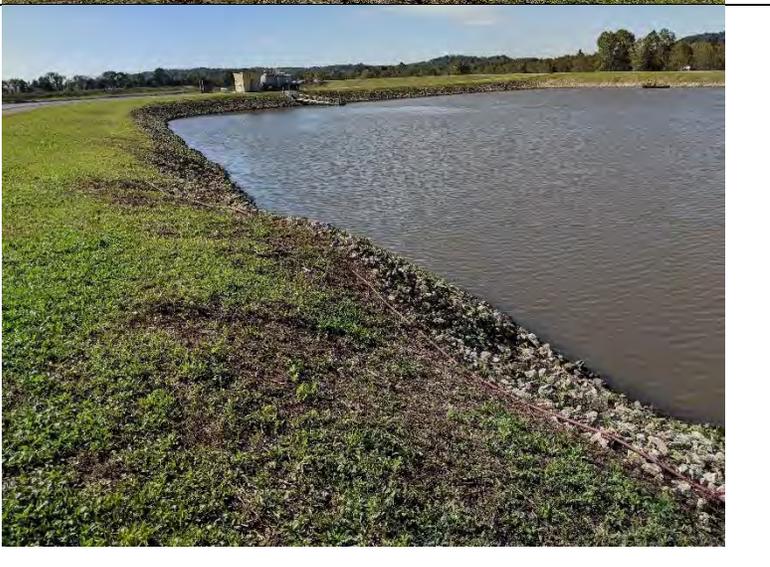
3. A limited area of shallow sloughing was identified along the interior slope in the northwest corner of the Recirculation Pond embankment (Photograph 41). This area was noted during previous inspections. This area was vegetated, and no tension cracks or other signs of recent soil movement were identified.

<p>View of interior embankment and discharge pipes and support structure (looking east). Also in view is a localized area of sloughing that does not appear to be active.</p>	
<p>Photograph #42</p>

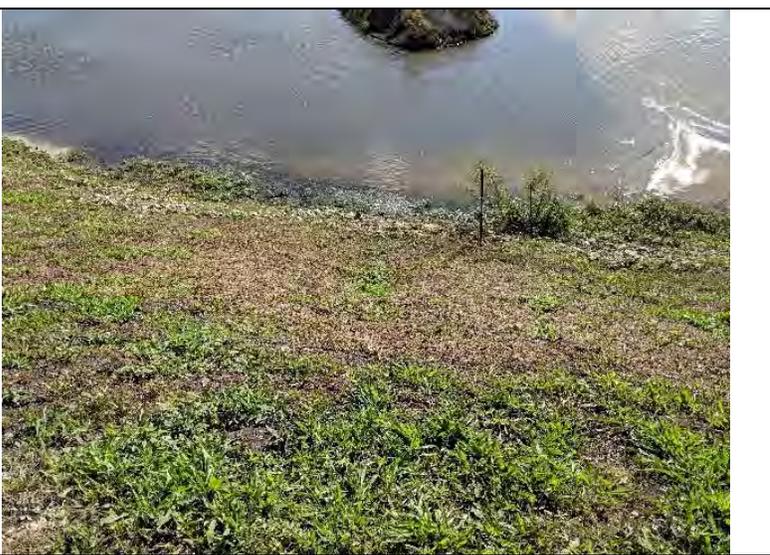
<p>View of localized limited vegetation along interior embankment (looking south).</p>

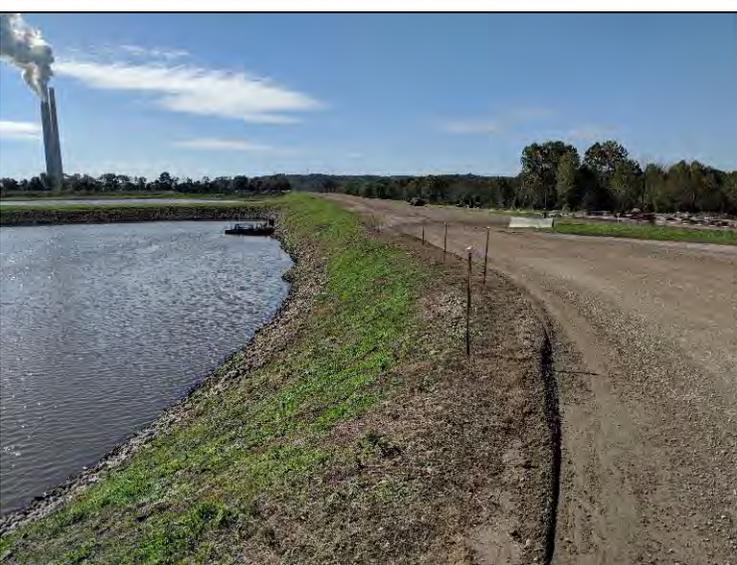
<p>View of interior embankment (looking south). Note, there are localized bare spots near top portion of embankment.</p>	
<p>Photograph #45</p>

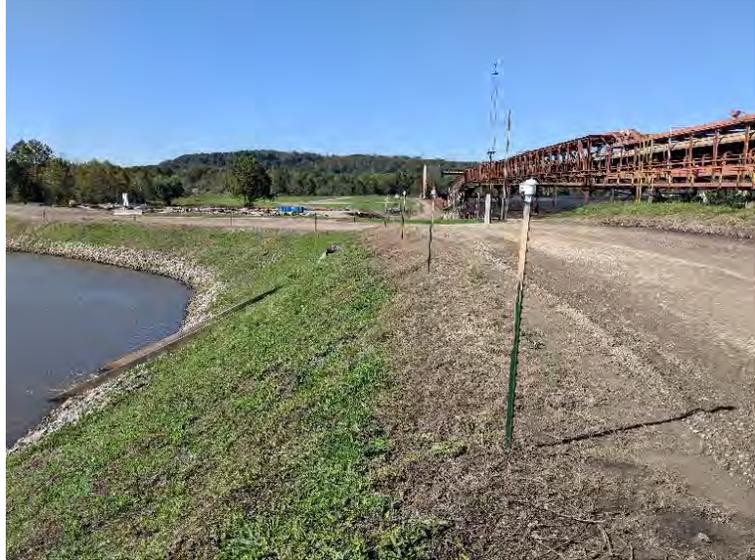
Photograph #46

View of slope along interior embankment with noticeable subsidence (looking east)

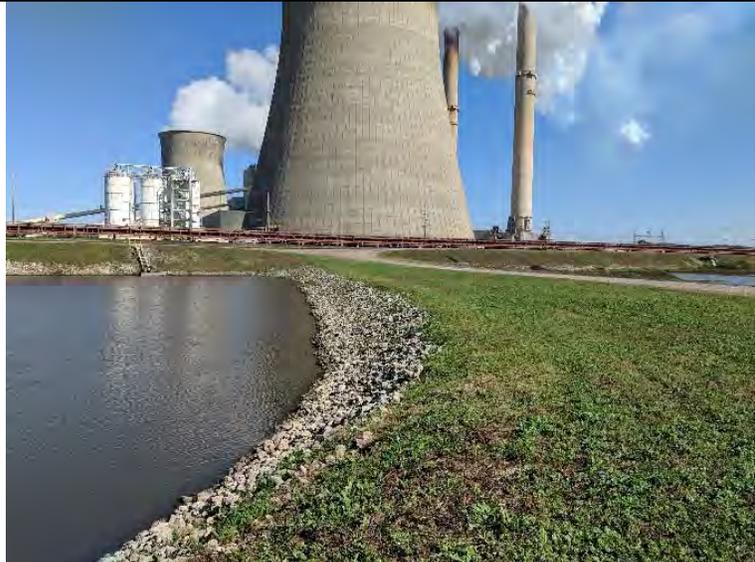
Photograph #47

4. Near the northwest corner on the interior of the pond, a small depression was noted just above the line of the rip rap (Photograph 47). The depression was approximately 1.5 feet in diameter and 2 feet deep. ERM recommends that this area be monitored in the future for additional depressions or settlement.

View of slope with riprap placed at toe and lower portions of slope (looking north). A small depression approximately 1.5 feet in diameter and 2 feet deep was noted. There were not visual signs that there was active settling in this area.

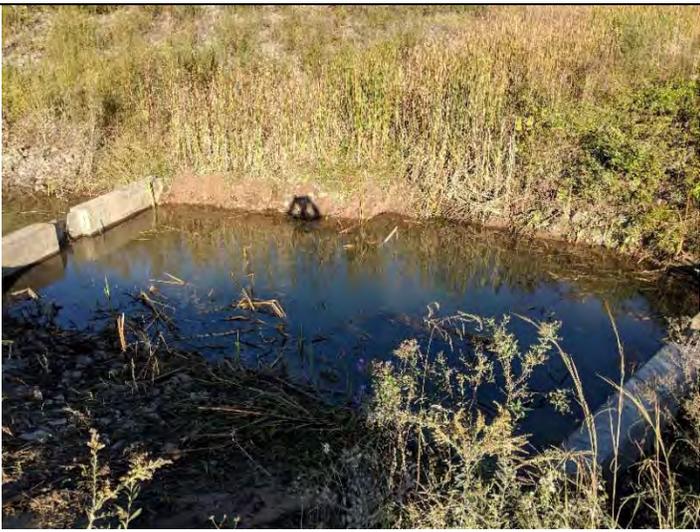
Photograph #48

3. Saturated soil was observed at the base of the embankment (Photograph 48). Because there was no measurable change in discharge between the 2017 and 2018 inspection, and considering the functionality of the weirs, the observation of saturated soils would not indicate a stability or structural issue with this dam.

View of discharge coming out of V-notched weir, VW-2 (looking west).	
Photograph #49

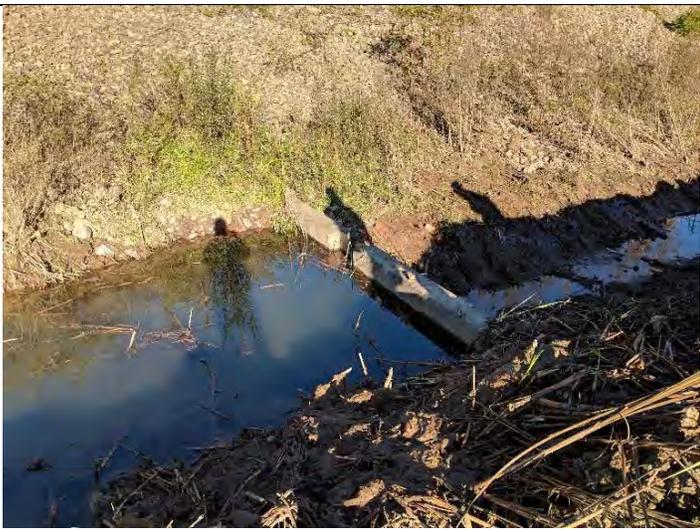
View of discharge coming out of V-notched weir, VW-3 (looking west). There was some ponding directly below this weir structure.	
Photograph #50

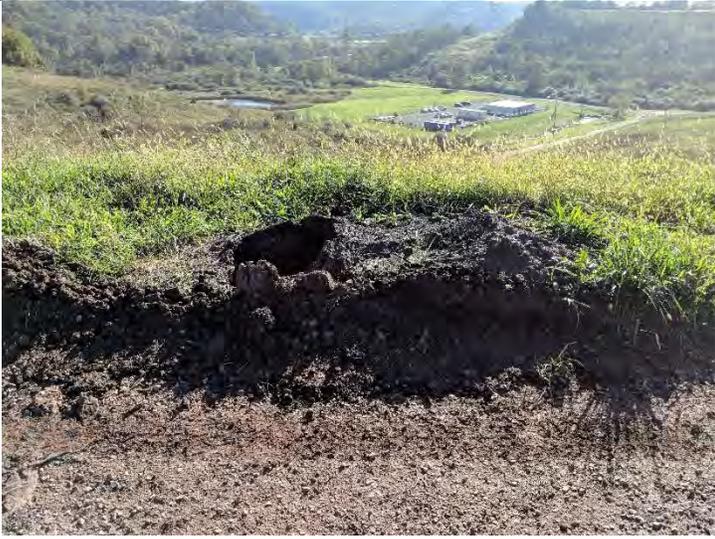
4. Localized subsidence from a previous borehole was identified (Photograph 56 and 57). The local subsidence should be filled in controlled lifts and compacted. As noted above, this does not pose a safety concern, as the pond elevation is maintained well below this local subsidence and the subsidence noted is not a result of active movement on the dam.

<p>Photograph #56</p>	
<p>Location of borehole on crest of dam (looking east).</p>

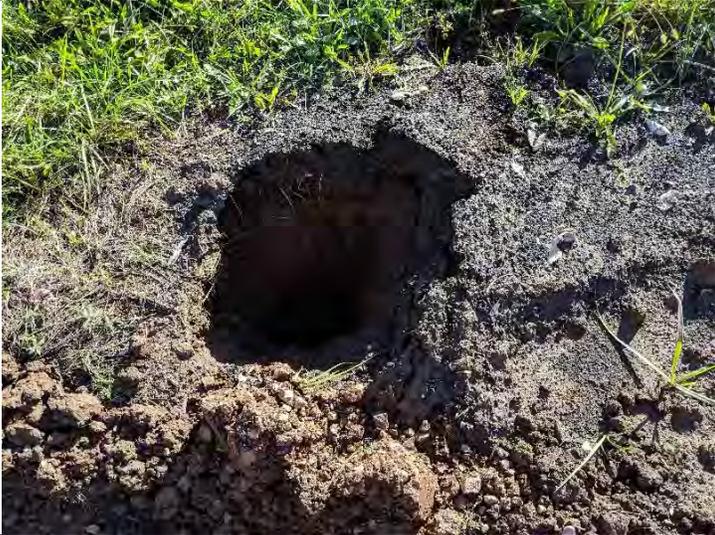
<p>Photograph #57</p>	
<p>Close up of near borehole on crest of dam (looking east).</p>

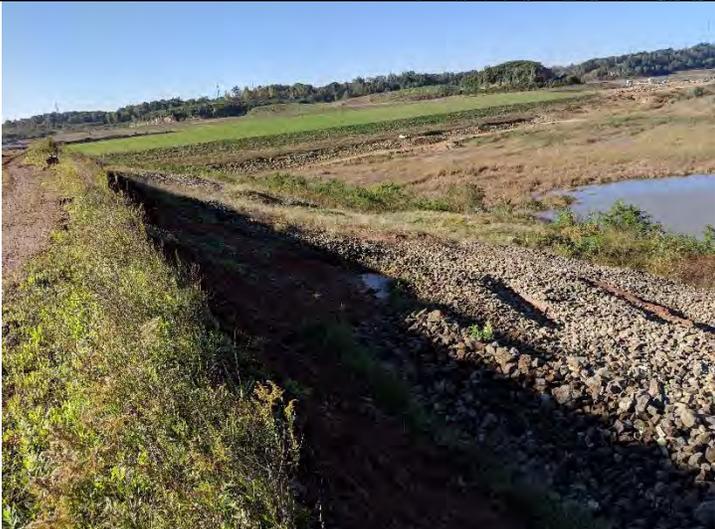
3. Sections of the above noted soil movement have encroached up to the access road on the crest of the embankment (Photograph 58). As noted above, this does not impact the stability or integrity of the impoundment and this situation should continue to be monitored.

<p>Photograph #58</p>	
<p>View of interior slope on Fly Ash Dam (looking south). Pictured here is the soil movement first noted by ODNR during the May 2017 inspection.</p>

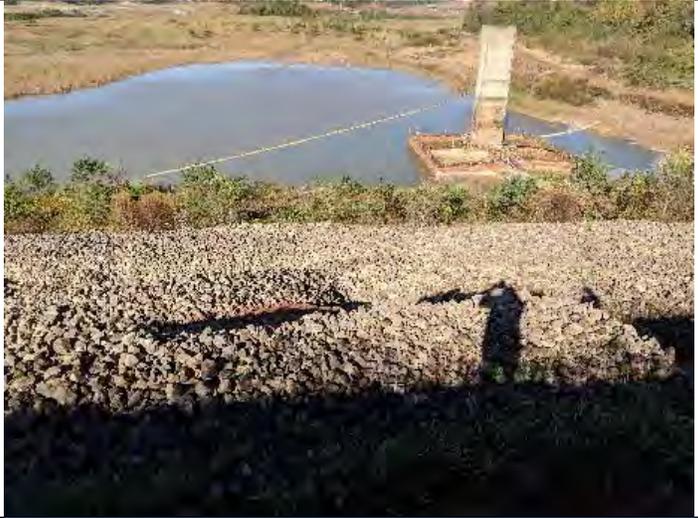
Photograph #59

View of west slope and Fly Ash Pond (looking west). Pictured here is a localized area of settlement that does not appear to be active.		
Photograph #60
