2025 Annual Inspection Report

Residual Waste Landfill

PREPARED FOR
Gavin Power, LLC

DATE
10 January 2026

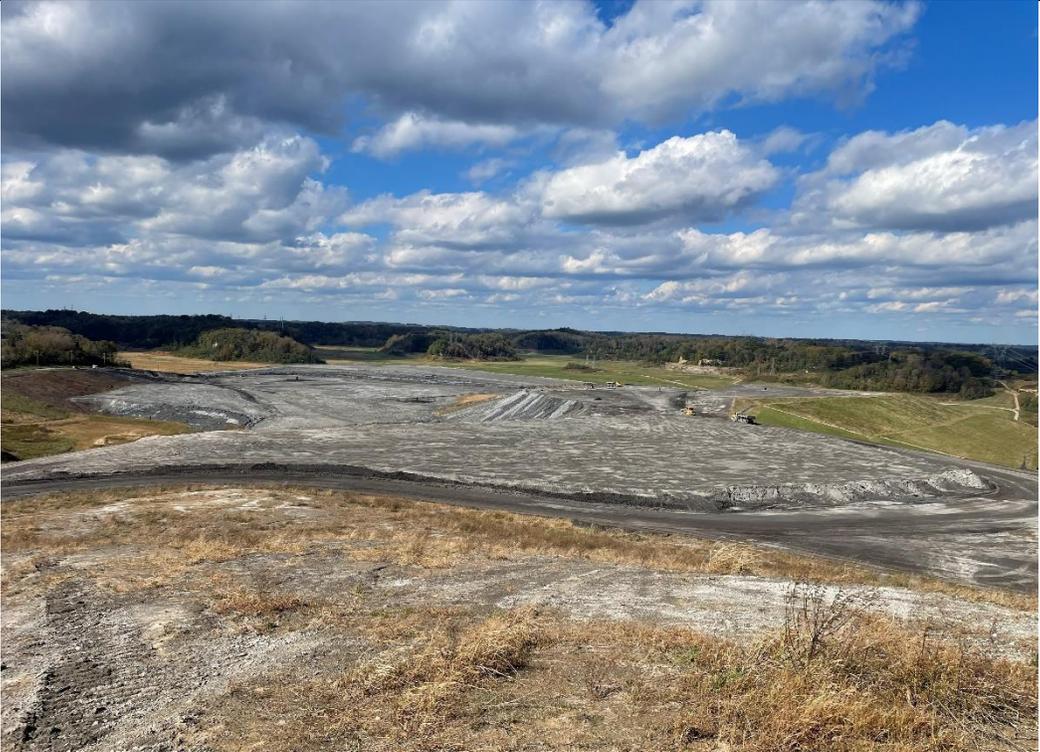
PHOTO NO. 1.	DATE 21 October 2025

DIRECTION PHOTO TAKEN North.		
DESCRIPTION View of RWL Phases H & I from top of landfill.

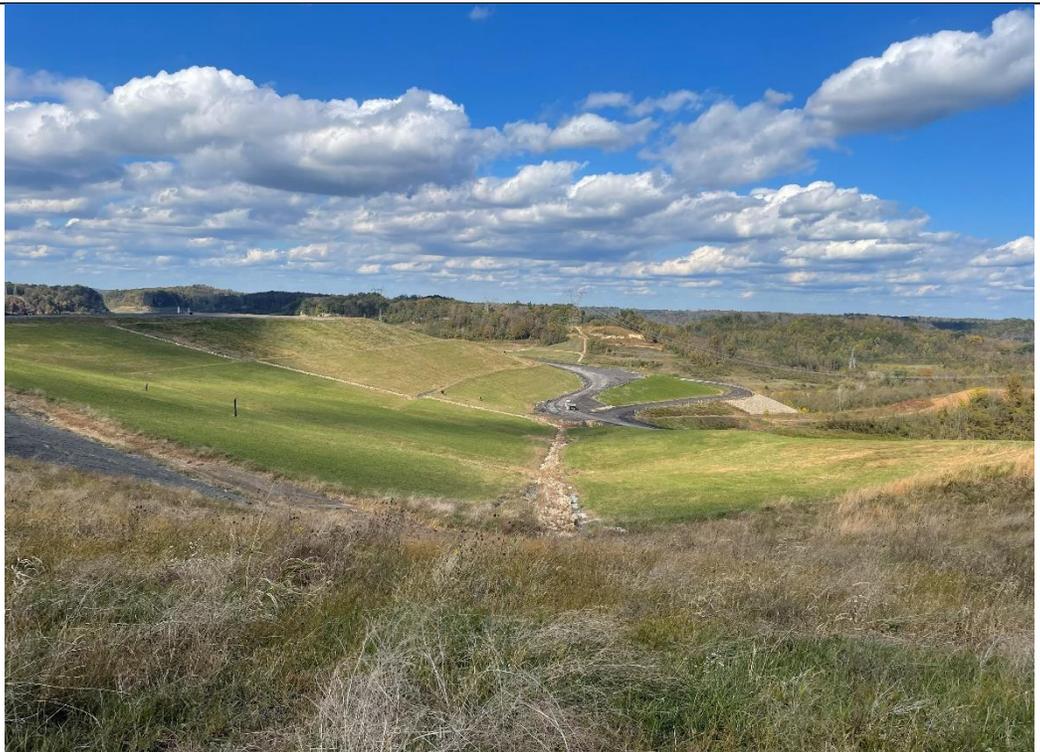
PHOTO NO. 2.	DATE 21 October 2025

DIRECTION PHOTO TAKEN South.		
DESCRIPTION View of RWL Phases F2 and H intersection.

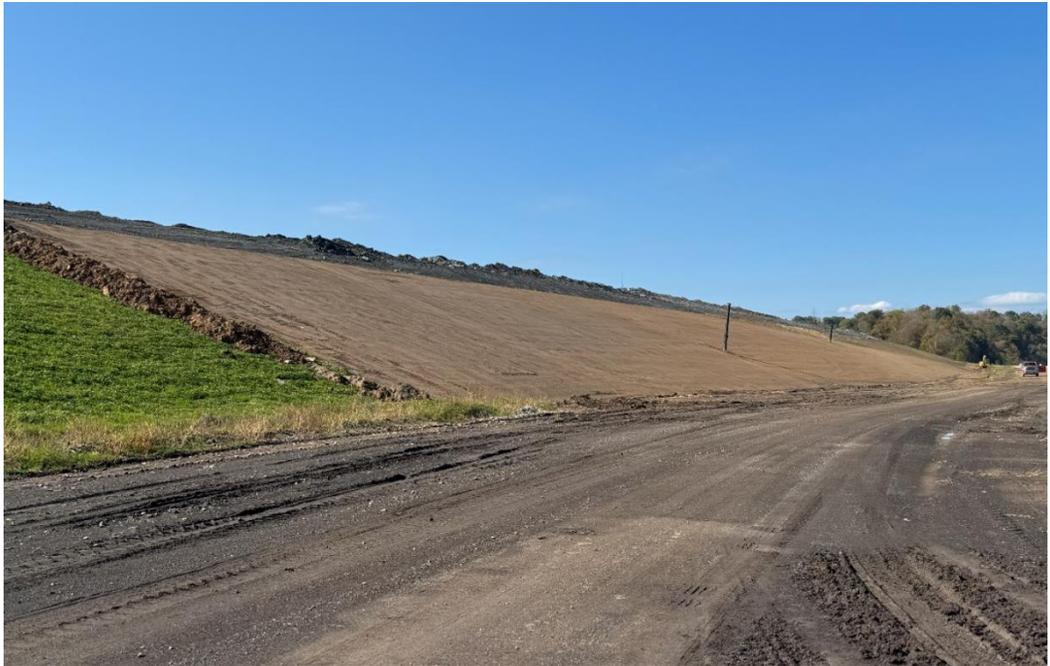
PHOTO NO. 3.	DATE 21 October 2025

DIRECTION PHOTO TAKEN West.		
DESCRIPTION Surface prepared for placement of final cap on eastern face of Phase H.

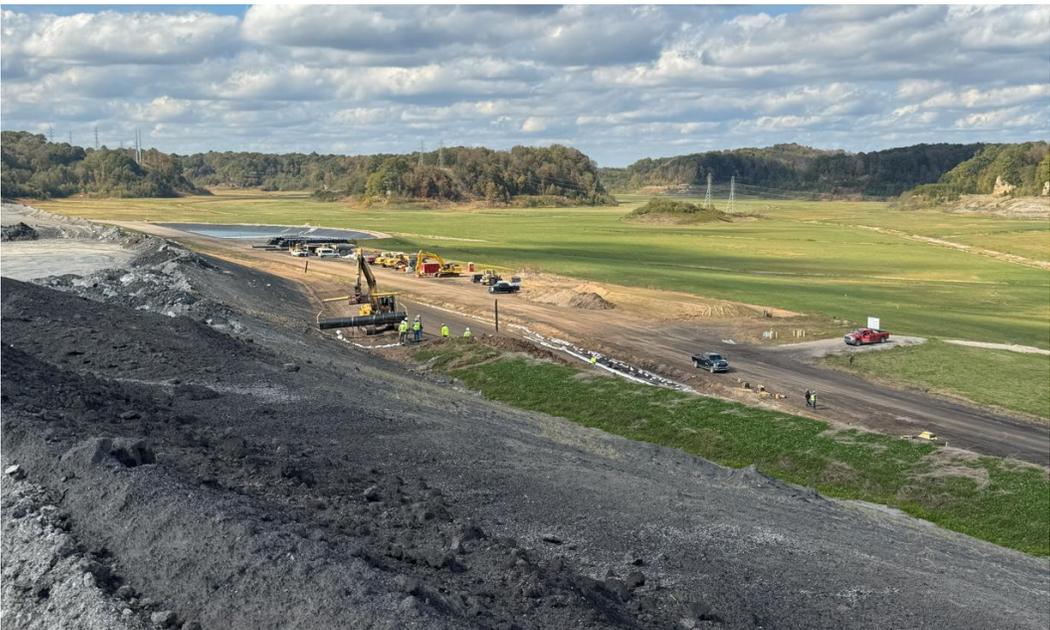
PHOTO NO. 4.	DATE 21 October 2025

DIRECTION PHOTO TAKEN North.		
DESCRIPTION Geomembrane cap being readied for deployment on east face of Phase H.

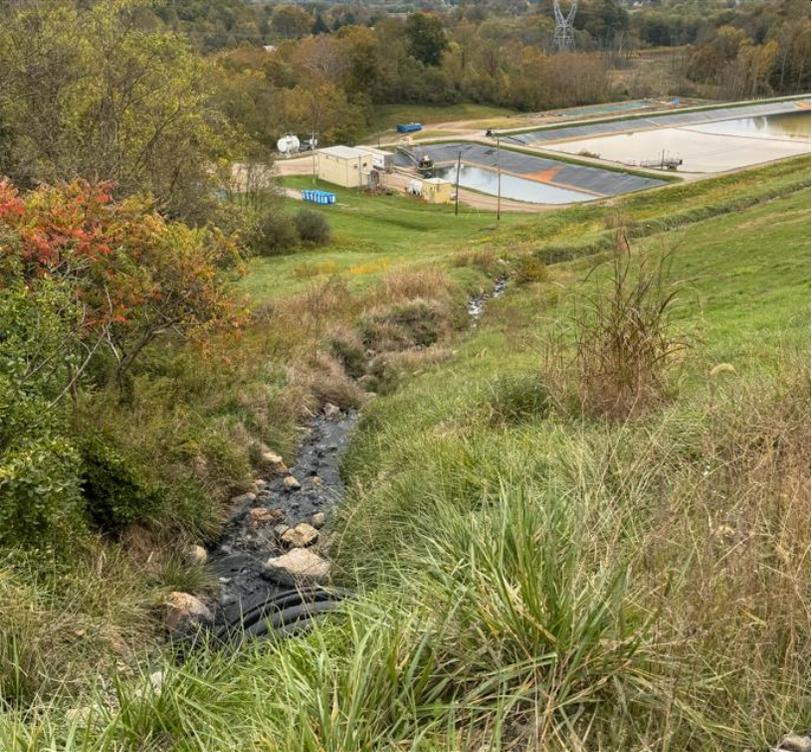
PHOTO NO. 5.	DATE 21 October 2025

DIRECTION PHOTO TAKEN East.		
DESCRIPTION View of leachate seep being directed into Pond 2 through surface channel on top of RWL liner system.

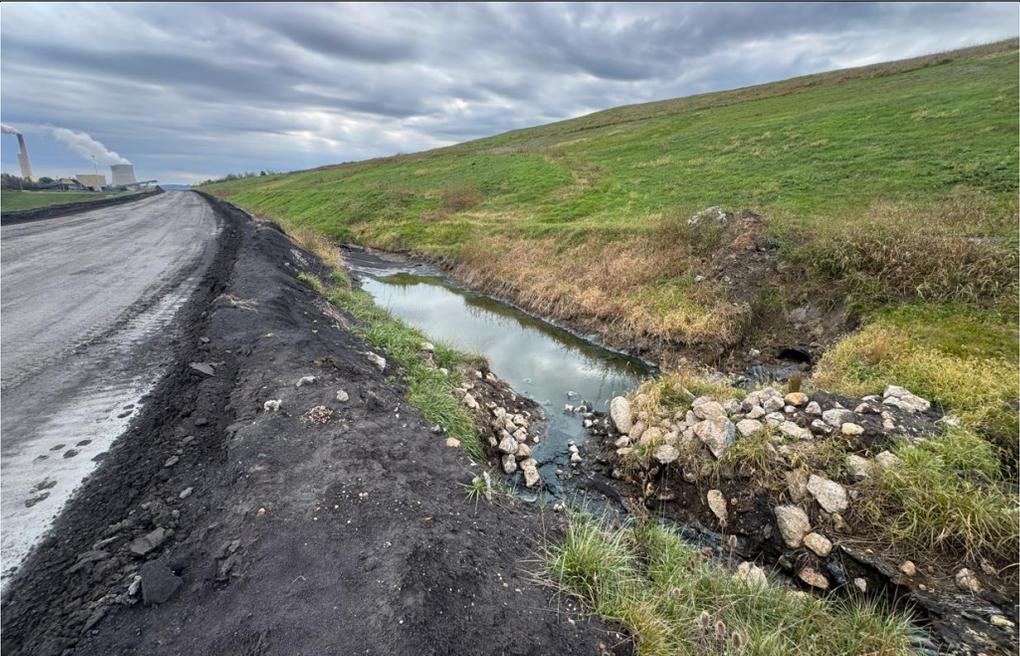
PHOTO NO. 6.	DATE 21 October 2025

DIRECTION PHOTO TAKEN South.		
DESCRIPTION View of leachate seep on eastern slope along main haul road above Pond 2.

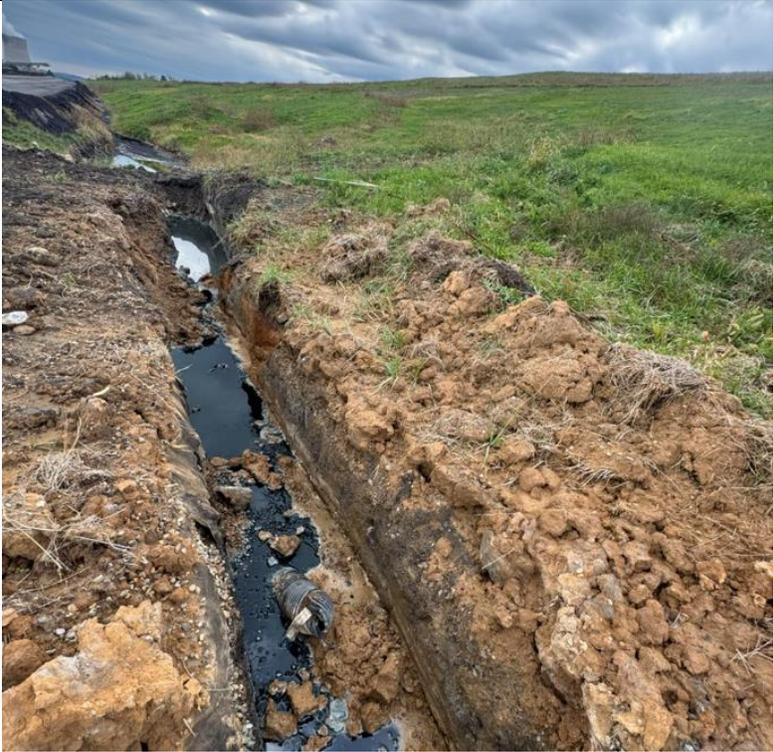
PHOTO NO. 7.	DATE 21 October 2025

DIRECTION PHOTO TAKEN Top view.		
DESCRIPTION View of exploratory test trenches to determine path of leachate seep on Eastern slope above Pond 2.

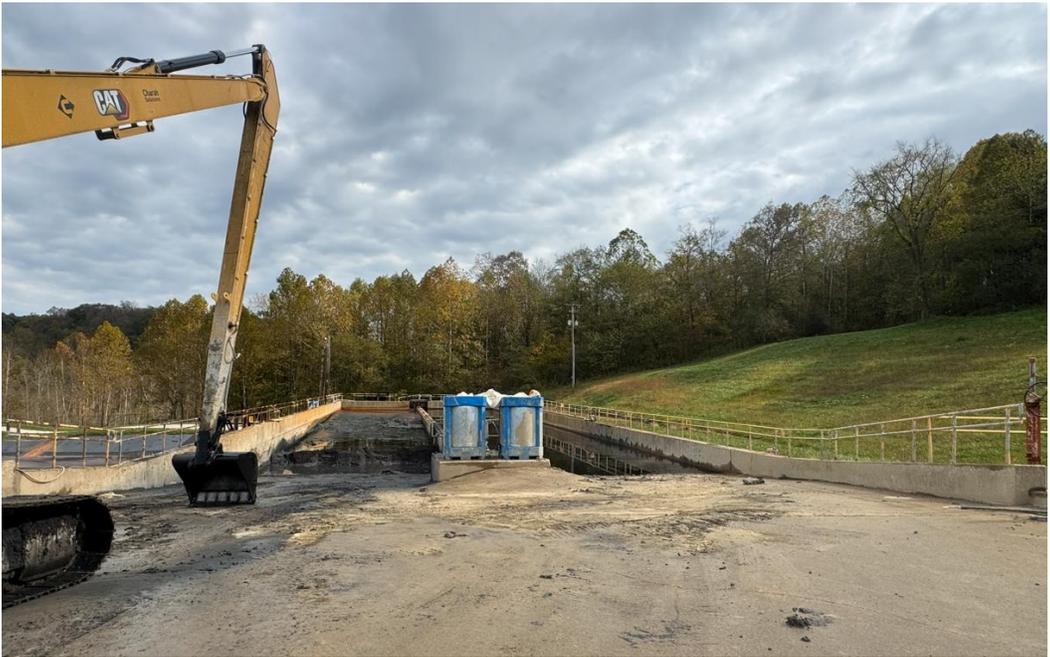
PHOTO NO. 8.	DATE 21 October 2025

DIRECTION PHOTO TAKEN East.		
DESCRIPTION View of concrete headworks settling basin adjacent to Pond 2 in the process of being cleaned.

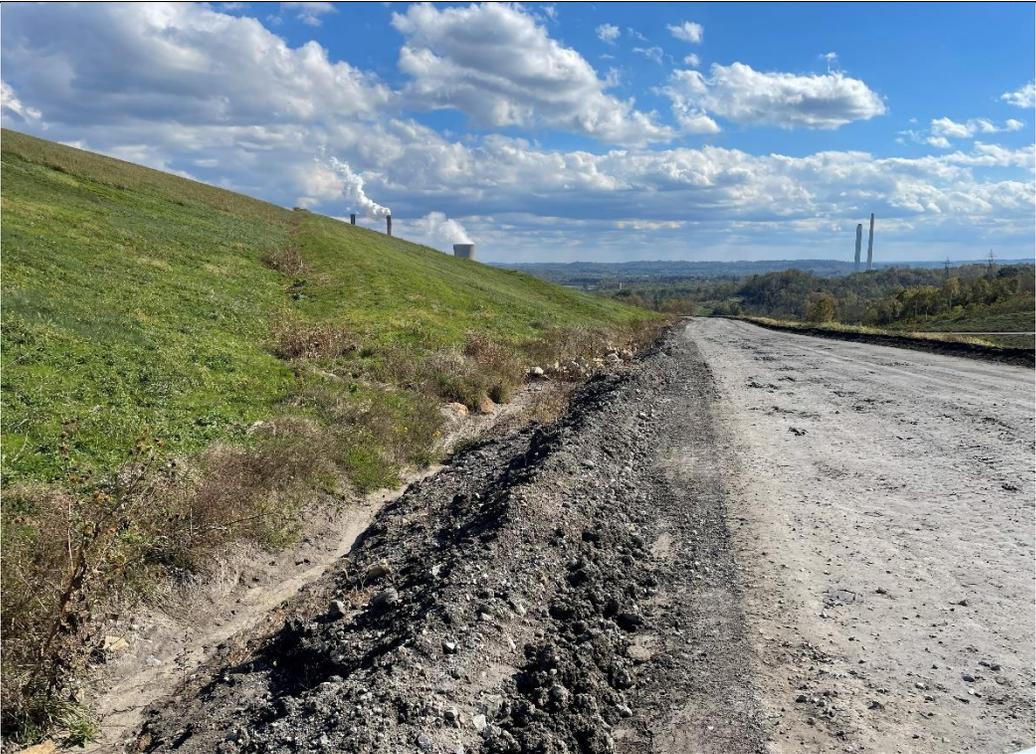
PHOTO NO. 9.	DATE 21 October 2025

The haul roads in active areas of CCR placement use bottom ash as a base course (Photograph 9). This base course compacts well and withstands repeated heavy equipment traffic based on experience. The haul roads observed by ERM appeared to be stable during the site drive/walkthrough, and there was no visual evidence of significant distress (i.e., rutting or pumping). The roads had positive drainage from the centerline or were sloped to an adjacent drainage channel and there was no visible evidence of ponding water on the traveled roadway surface. Drainage channels paralleling the roadways also captured storm water runoff from adjacent slopes, which is directed to stable outlets that ultimately discharge to the multiple surrounding site treatment ponds. As noted in previous inspections, ERM observed sporadic evidence of erosion in the channel bottoms or at the connection point/confluence of drainage berms that collect water from the landfill side slopes to the channels (Photograph 10). Rock check dams were observed as a common best management practice (BMP) for stormwater deceleration and were located at regular intervals within the constructed channels to slow runoff rates and to capture sediments (Photograph 9). Overall, roadside channels appeared satisfactorily maintained. During the 2025 inspection, ERM observed that continued maintenance has been conducted on roadside channels. Sediment build-up behind the rock check dams in the roadside channels seemed to have been recently cleaned at various locations. Channels are inspected on a biweekly basis as part of the routine maintenance and deficiencies are addressed and repaired as needed.

DIRECTION PHOTO TAKEN East.		
DESCRIPTION View of RWL access road along Phase F2. Ditchline repairs including fill and check dams observed in good condition.

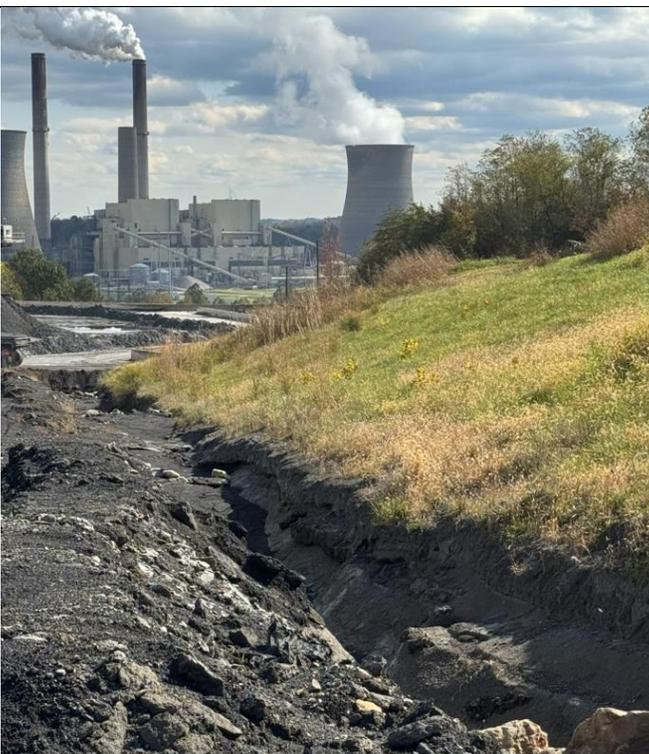
PHOTO NO. 10.	DATE 21 October 2025

DIRECTION PHOTO TAKEN Southeast.		
DESCRIPTION Channel incising at confluence of slope channel with roadside channel north of stack out pad.

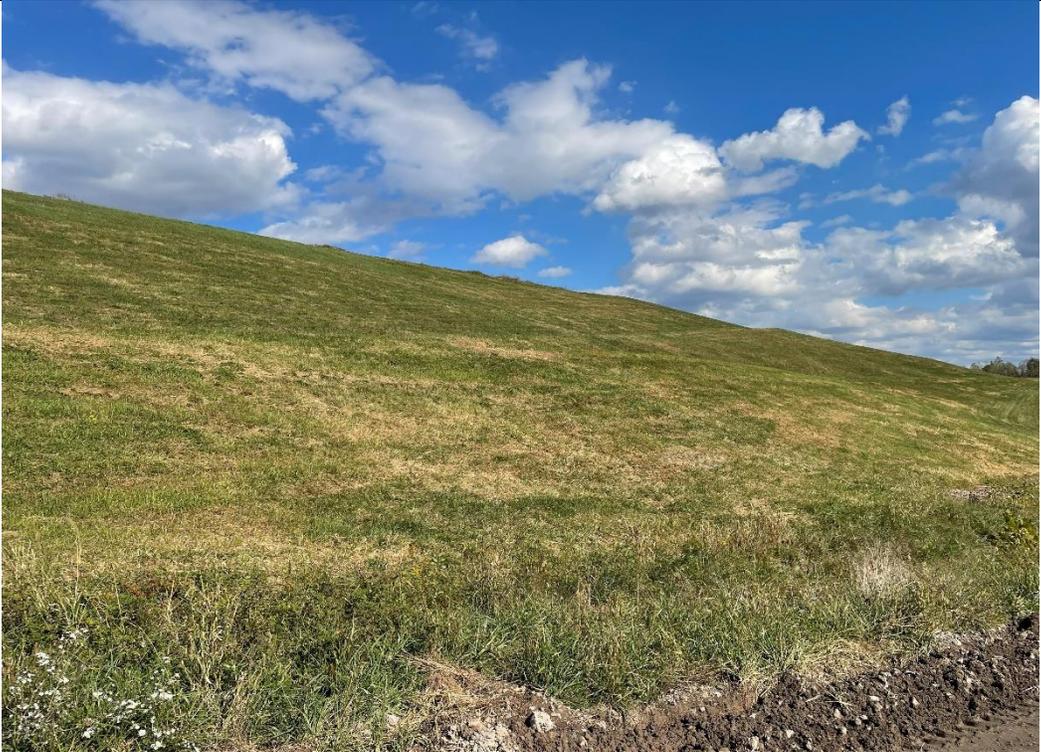
PHOTO NO. 11.	DATE 21 October 2025

It is estimated that over 95 percent of the currently inactive landfill slope surface area appears to have stable vegetation, and 5 percent of the surface area is in the process of stabilization/revegetation or was observed to have been recently seeded and mulched (Photograph 2). The slopes near the summit of Phase F2 and J were vegetating successfully and in similar condition to that noted in 2024 (Photograph 11).

DIRECTION PHOTO TAKEN Northeast.		
DESCRIPTION View of RWL Phase F2 slope coverage near SE corner. Observed in good condition.

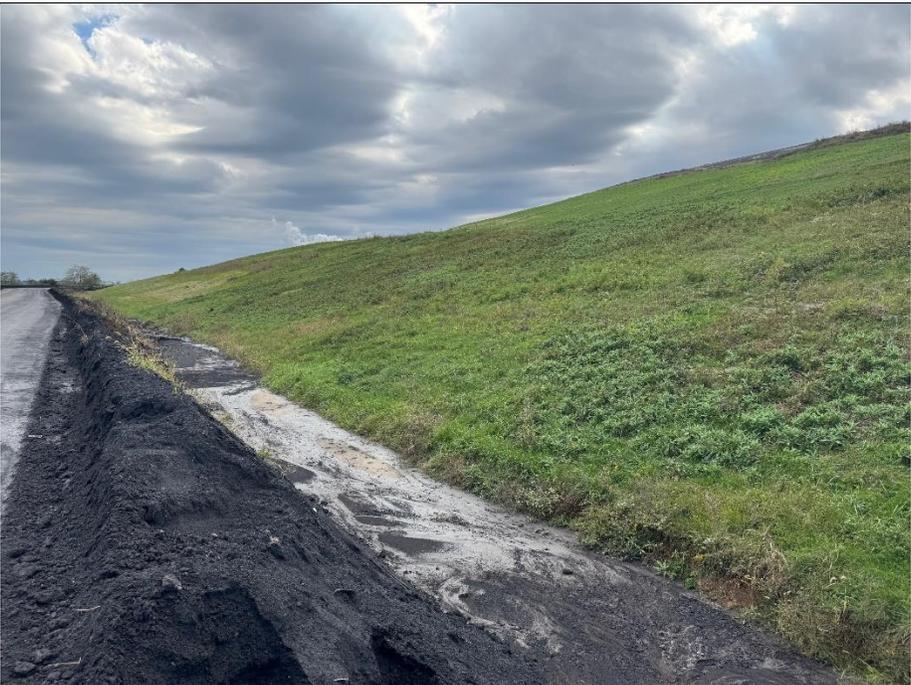
PHOTO NO. 12.	DATE 21 October 2025

DIRECTION PHOTO TAKEN South.		
DESCRIPTION View of eastern slope of the RWL along main haul road. Final cover system is seen on slope.

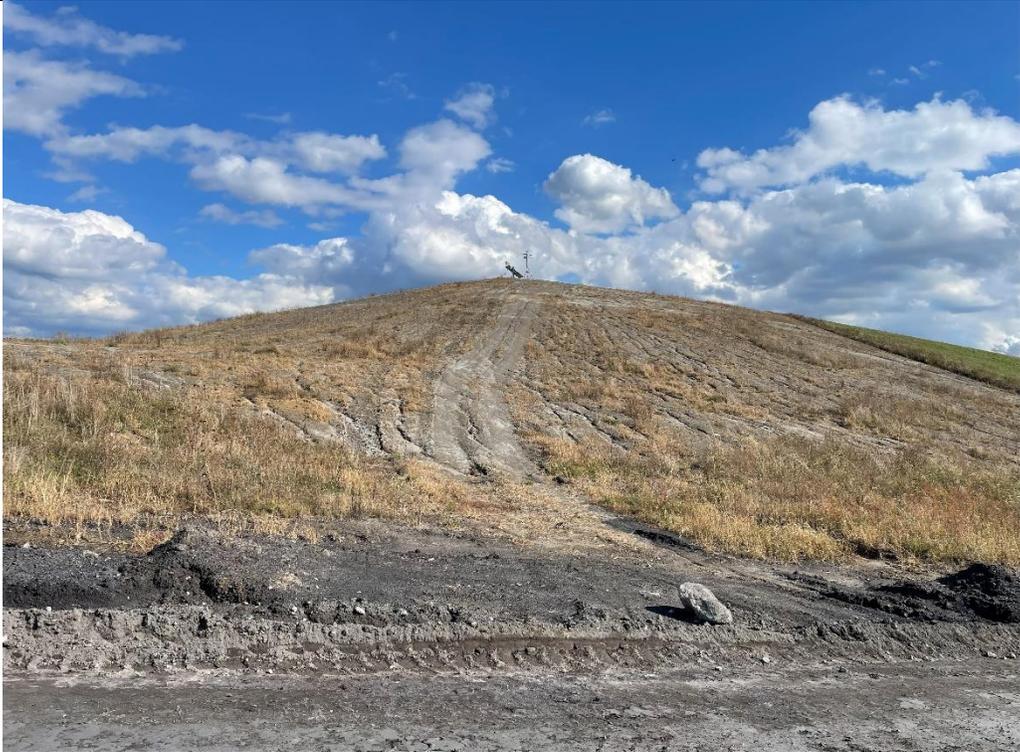
PHOTO NO. 13.	DATE 21 October 2025

There was an area on the southeastern RWL slope where erosion rills were observed (Photograph 13) in the surface of the intermediate cover. Sedimentation appeared to be collected in the stormwater channel along the eastern haul road with stormwater eventually being directed to the Pond 2 treatment system. There was no visible evidence that this area of erosion has the potential to disrupt the operation and safety of the RWL or that observed erosion features were creating an unstable condition. ERM recommends that this minor erosion area be repaired and reseeded in the Spring of 2026. In the interim, to the extent practical, upslope run-on should be minimized in

DIRECTION PHOTO TAKEN North.		
DESCRIPTION View of northern slope of Phase F2/J facing Phases H and I consisting of removed intermediate cover and direct seeded FGD material. Erosion rills observed along face of slope.

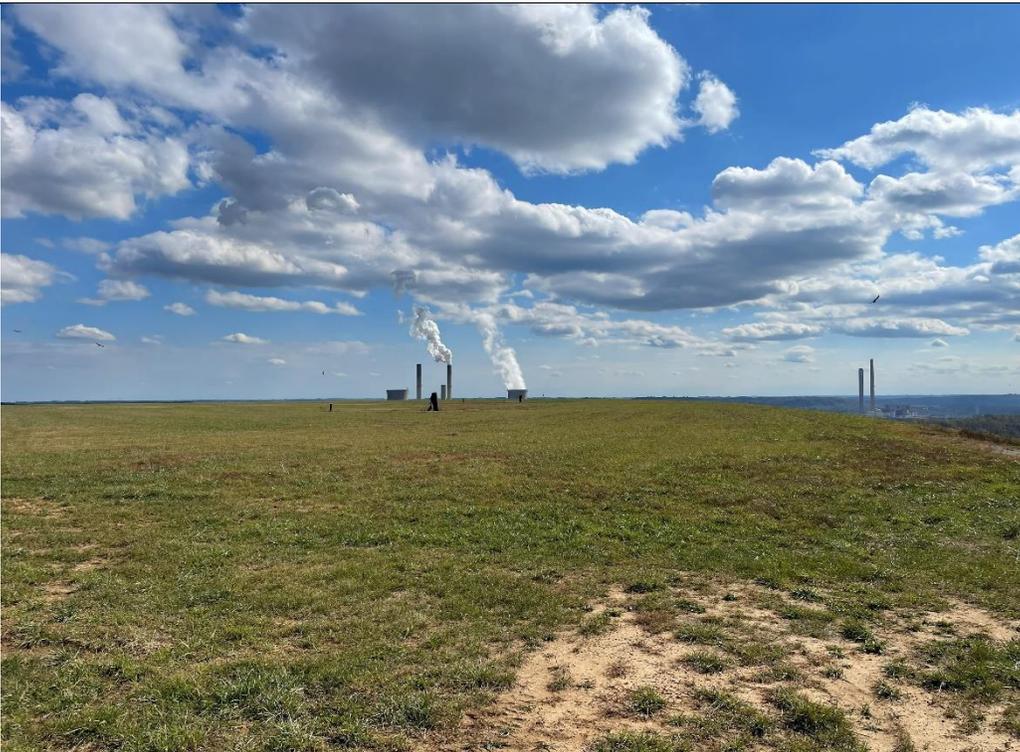
PHOTO NO. 14.	DATE 21 October 2025

DIRECTION PHOTO TAKEN South.		
DESCRIPTION View of interim summit of landfill with intermediate soil cover and vegetation growth.

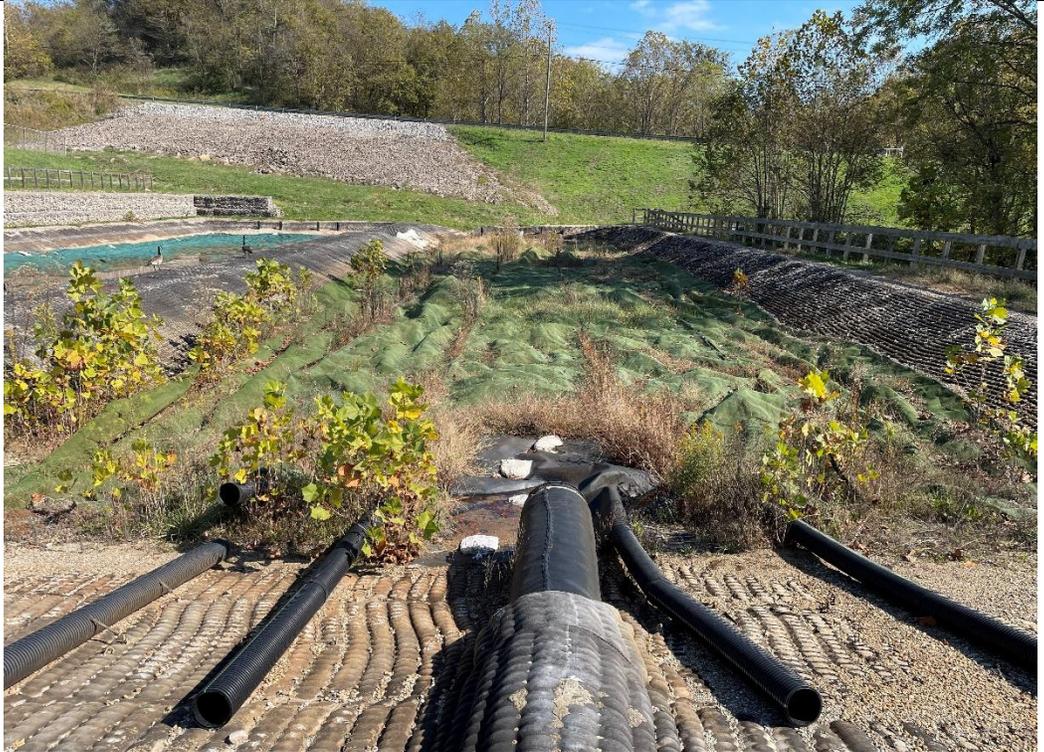
The vertical flow wetlands for Pond 1 were observed and appeared to be in satisfactory working order (Photographs 15 through 17). Vegetation is beginning to build up in the weir area at the downstream end of the features that should continue to be removed as part of the routine maintenance of the facility. The flume shows slight algal buildup and it is recommended that it be cleaned on a routine basis. A groundwater interceptor pipe designed to maintain the natural groundwater surface below the vertical flow wetland liner system elevation was observed to have no flow during the 2025 site visit. Historic iron precipitation was observed at the outfall of the groundwater interceptor, but downstream conditions appeared to be satisfactory (Photograph 25). As relayed in the 2024 inspection, RWL staff indicated that review of analytical results from this location indicate that this is naturally occurring iron.

PHOTO NO. 15.	DATE 21 October 2025
DIRECTION PHOTO TAKEN East.	
DESCRIPTION View of Pond 1 southern vertical flow wetland, inactive during inspection. Overgrown vegetation observed.

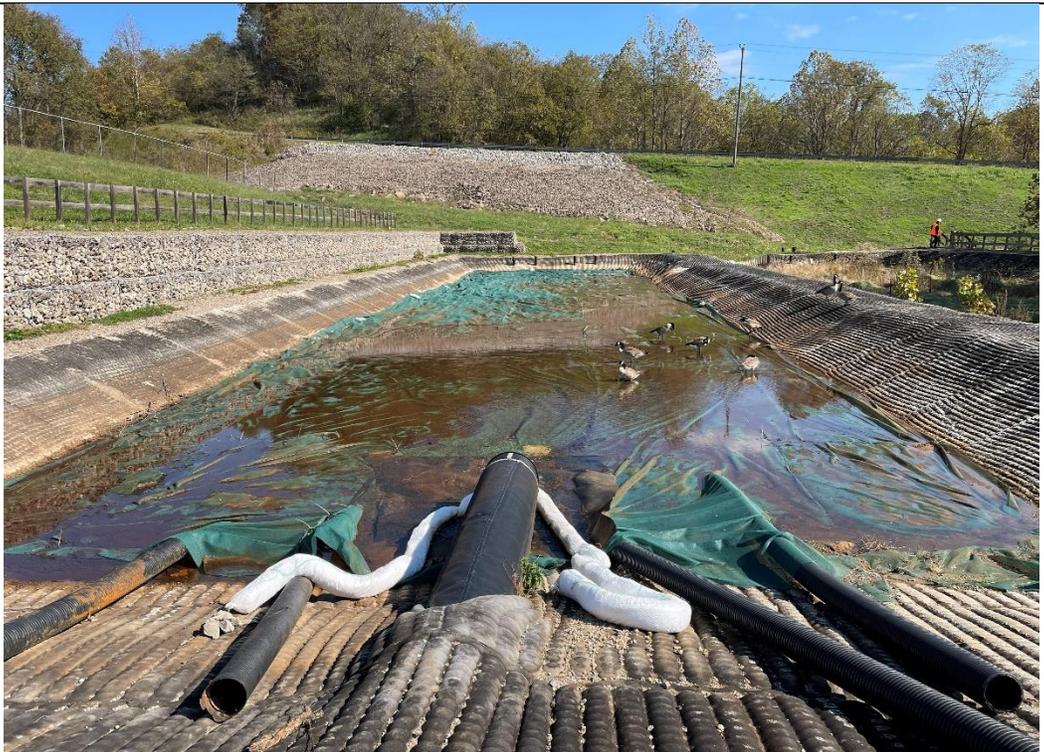
PHOTO NO. 16.	DATE 21 October 2025
DIRECTION PHOTO TAKEN East.	
DESCRIPTION View of Pond 1 northern vertical flow wetland, observed in good condition.

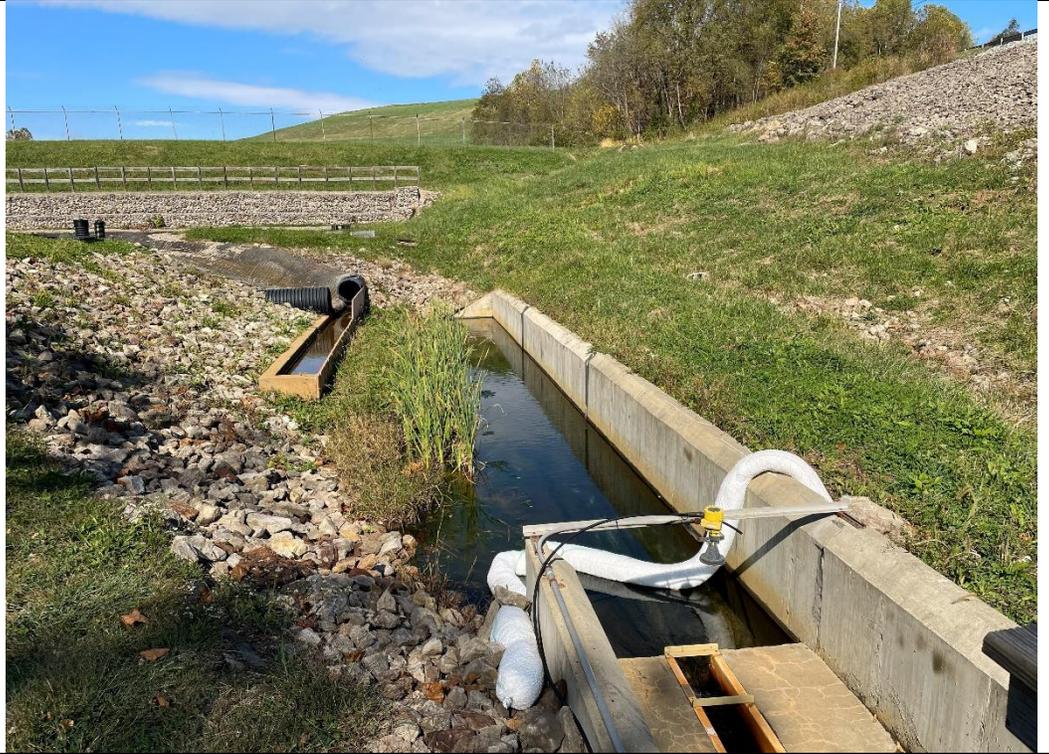
PHOTO NO. 17.	DATE 21 October 2025
DIRECTION PHOTO TAKEN North.	
DESCRIPTION View of Pond 1 vertical flow wetland outlet. Some overgrown vegetation observed along concrete channel.

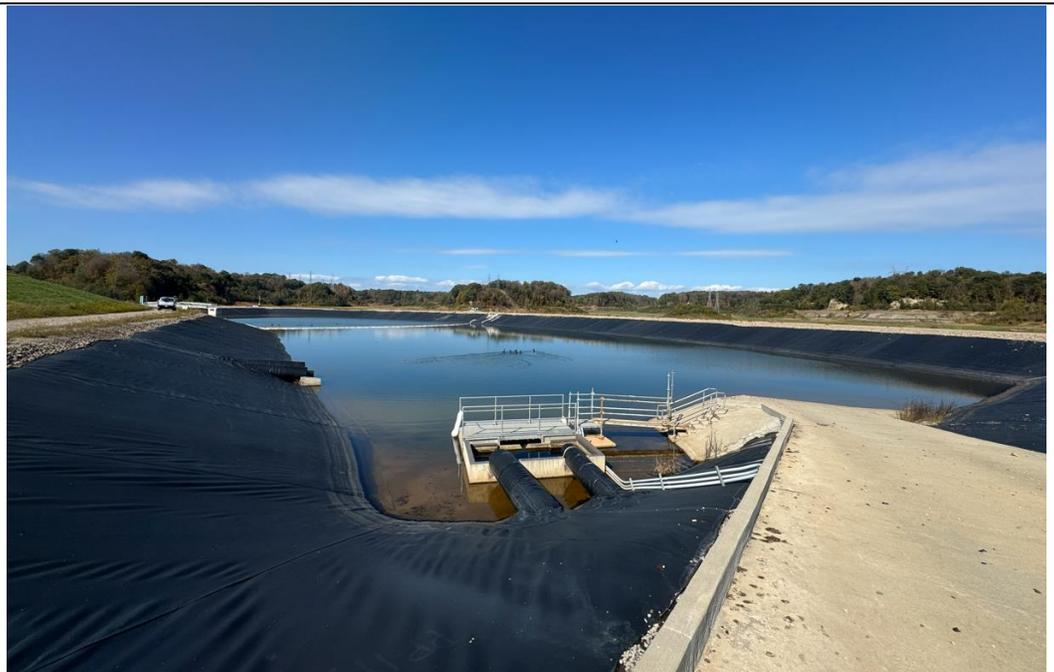
PHOTO NO. 18.	DATE 21 October 2025
DIRECTION PHOTO TAKEN West.	
DESCRIPTION View of Pond 6, observed in generally good condition. Some instances of road surface gravel rolled onto liner observed.

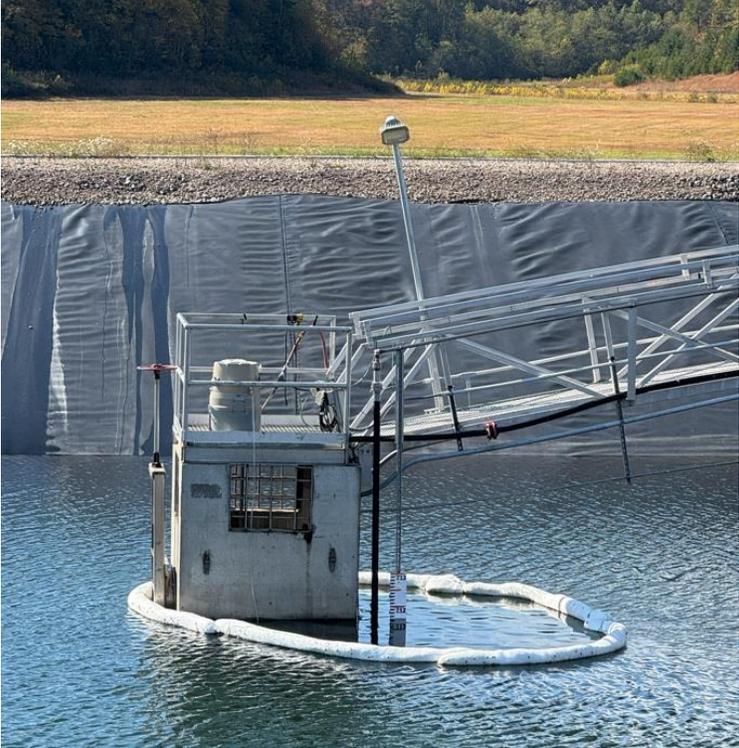
<p>PHOTO NO. 19.</p>	<p>DATE 21 October 2025</p>

<p>DIRECTION PHOTO TAKEN Front view.</p>		
<p>DESCRIPTION View of newly installed water level staff gauge at Pond 6.</p>

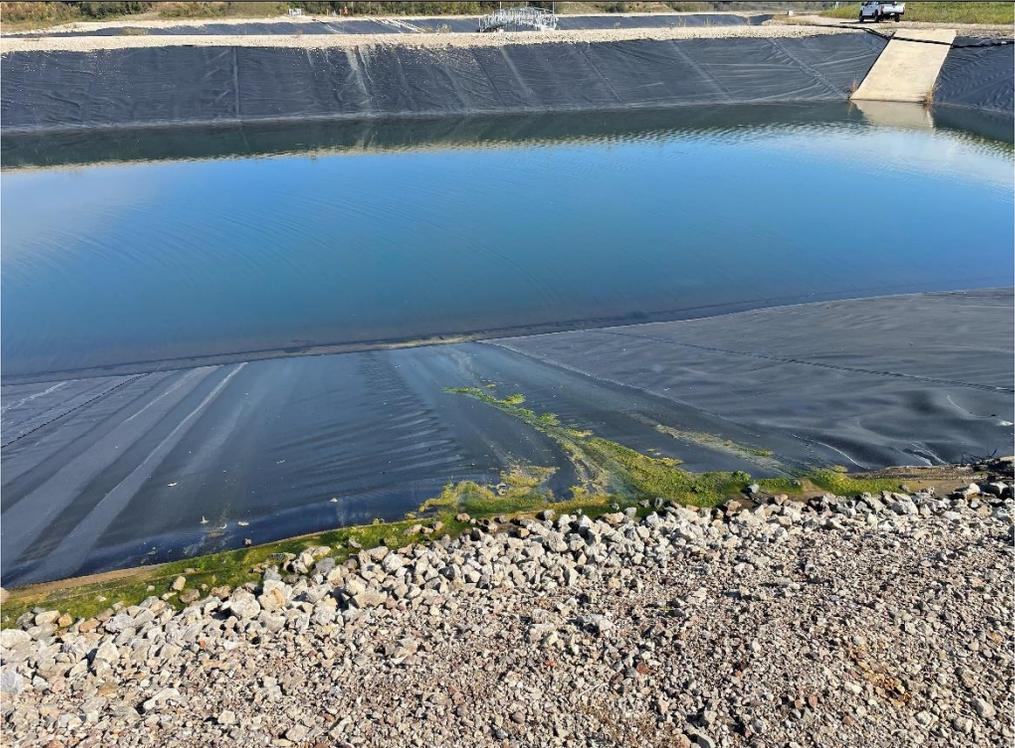
<p>PHOTO NO. 20.</p>	<p>DATE 21 October 2025</p>

<p>DIRECTION PHOTO TAKEN Northeast.</p>		
<p>DESCRIPTION View of Pond 6 clarifying pond. Surface sheet flow observed flowing into pond from western side at time of inspection. Algae growth also observed. Monitoring recommended.</p>

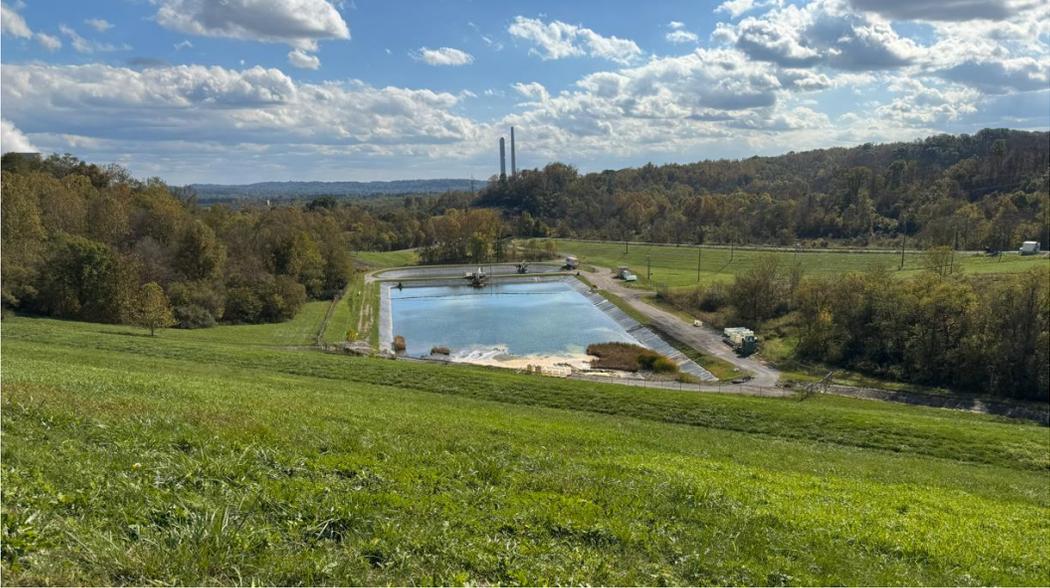
PHOTO NO. 21.	DATE 21 October 2025

Pond 1 on the south side of the RWL was observed to be functioning in a satisfactory condition during the annual inspection (Photograph 21). The sedimentation/treatment portion of Pond 1 was observed to contain sufficient depth and capacity for retention of solids (Photograph 22). This pond is routinely cleaned of accumulated solids, typically through the use of extended-reach excavators or a floating dredge. Based on a visual assessment, Pond 1 was noted to have accumulated sediments significantly below previous levels observed in 2023 and similar to observations in 2024.

DIRECTION PHOTO TAKEN South.		
DESCRIPTION Panoramic view of Pond 1.

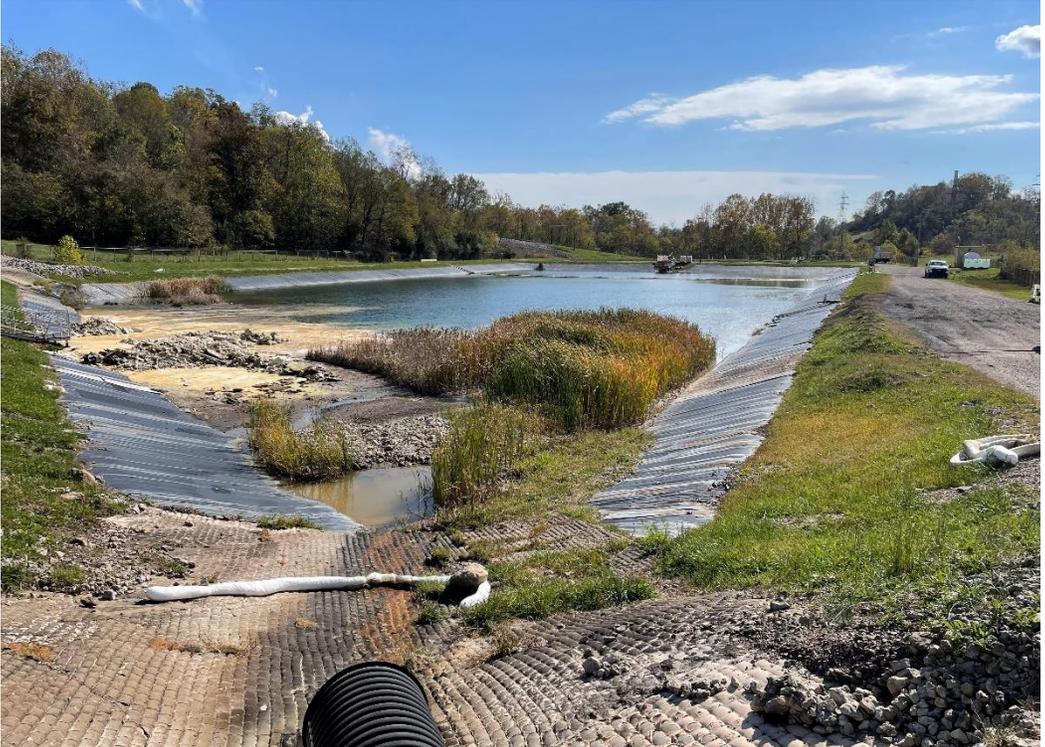
PHOTO NO. 22.	DATE 21 October 2025

A build-up of sediments, aggregate, and vegetation continues to be observed in the north end of the pond near the two inflow channels (Photograph 22). A mobile trailer mounted temporary filter system was staged adjacent to the Pond 1 clarifying pond (Photograph 23). This filter system continues to transfer water from the clarifying pond using a suction hose, filters the water and then pumps it into the inflow structures to the vertical flow wetland system. During the 2025 inspection a supplemental aerator was seen operating in the clarifying pond (Photograph 24) with power being supplied from a cable coming from the filter trailer. The filter continues to be used as a supplemental measure to improve water quality going to the next stage of treatment. The filter system was secured in the interior of the trailer and was not observed. There were no leaks observed, and the trailer appeared to be in satisfactory condition.

DIRECTION PHOTO TAKEN Southeast.		
DESCRIPTION View of Pond 1 from NW corner inlet. Vegetation on accumulated sediment and precipitate from hydrogen peroxide treatment of leachate observed.

Stone from the access roadway continues to be observed to be deposited in the stormwater inflow channels. It is recommended that steps continue to be taken to mitigate the displacement of stone from the roadway by vehicles and during the application of maintenance aggregate to the surface. No perforations of the geomembrane were identified during the site visit. Patching that was observed during 2024 appears to have corrected previously identified perforations. ERM

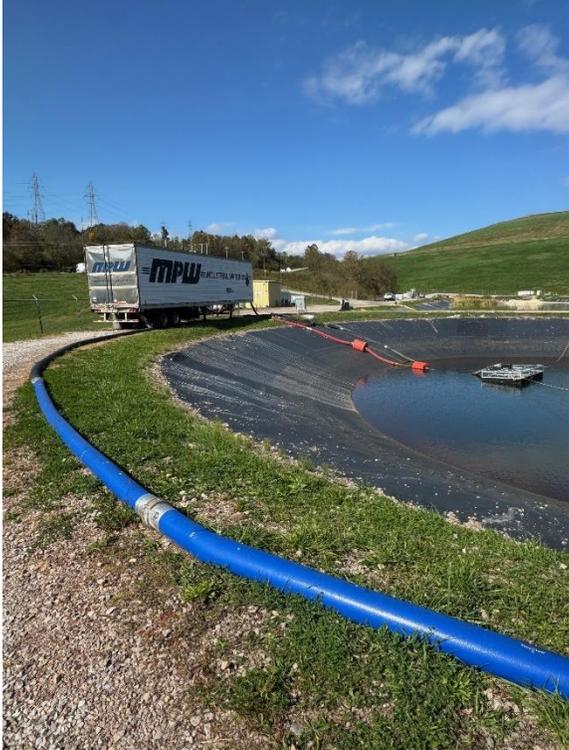
<p>PHOTO NO. 23.</p>	<p>DATE 21 October 2025</p>

<p>DIRECTION PHOTO TAKEN Northwest.</p>		
<p>DESCRIPTION View of Pond 1 clarifying pond and water treatment process equipment.</p>

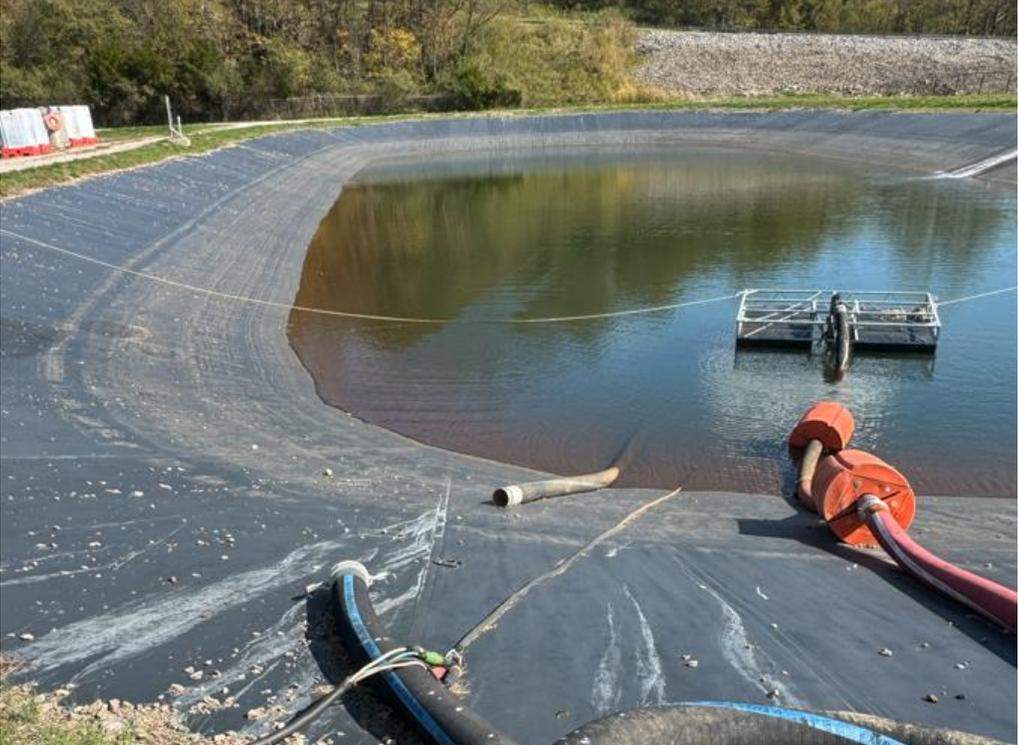
<p>PHOTO NO. 24.</p>	<p>DATE 21 October 2025</p>

<p>DIRECTION PHOTO TAKEN South.</p>		
<p>DESCRIPTION View of Pond 1 clarifying pond and supplemental floating aeration equipment.</p>

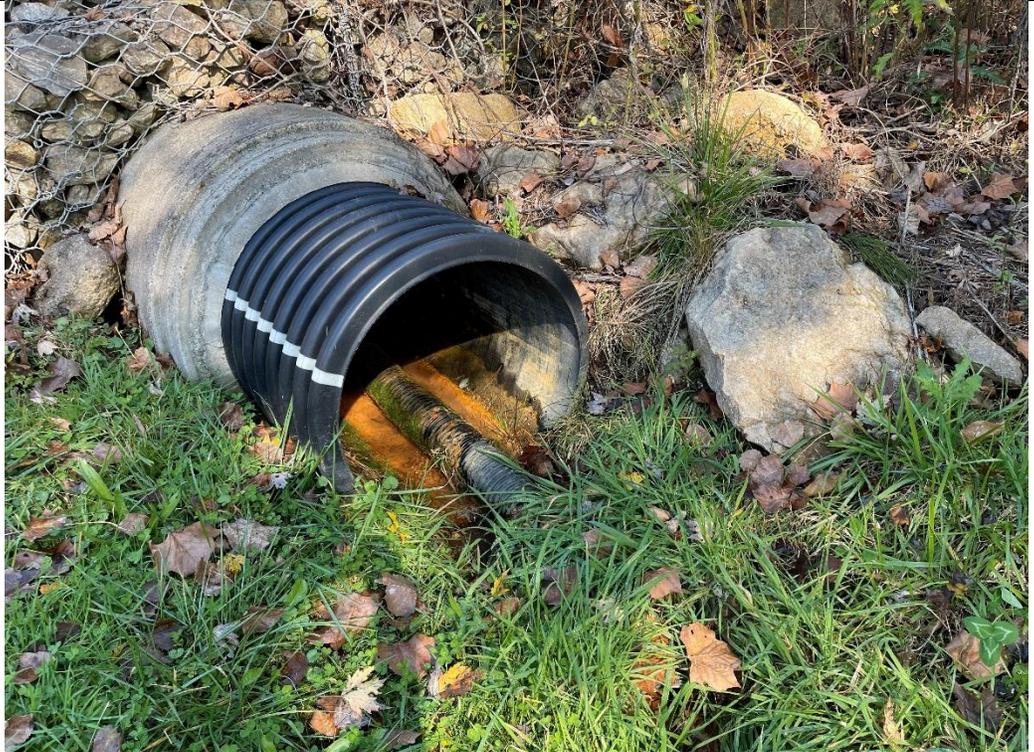
PHOTO NO. 25.	DATE 21 October 2025
DIRECTION PHOTO TAKEN Top view.	
DESCRIPTION View of Pond 1 groundwater interceptor. Mostly clear water observed at outlet. Improved condition.

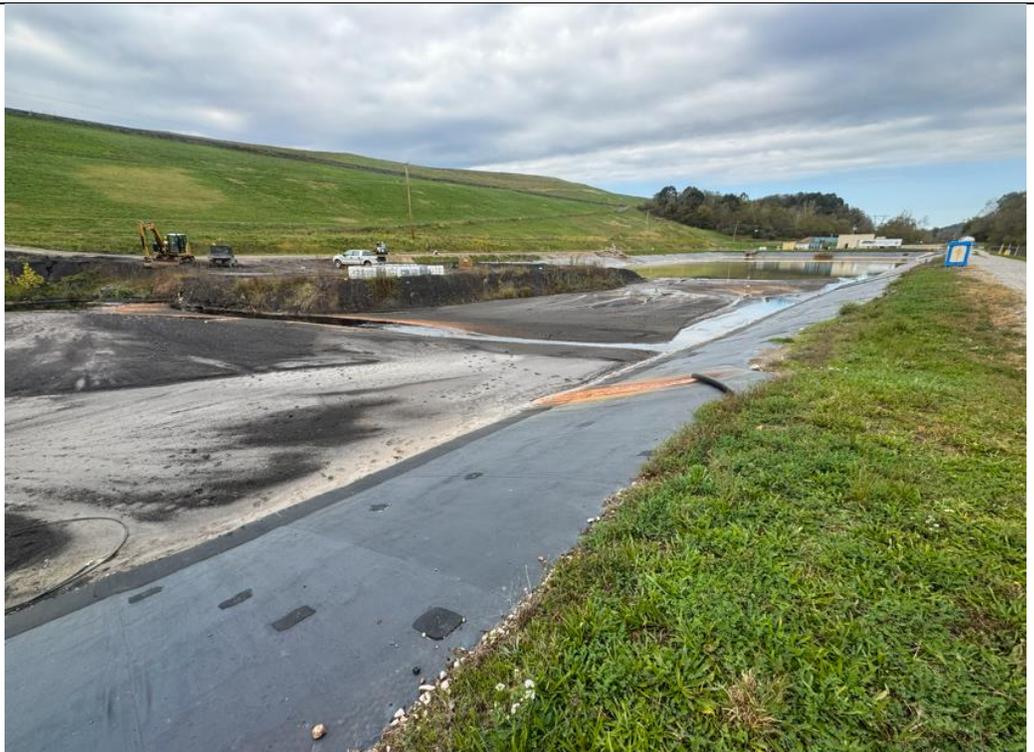
Pond 2 on the southeast side of the RWL was observed and appeared to be functioning in a satisfactory condition during the inspection (Photograph 26). To assist with the removal of FGD solids derived from the stack-out pad and to minimize dredging, Gavin Power operates a concrete settling basin at Pond 2 (Photograph 8). This basin is routinely cleaned with an extended-reach excavator and was observed to be in the process of being cleaned during the 2025 inspection. The leachate inflow pipe located on the west side of the Pond 2 sedimentation basin has been connected to a pump station which directs the flow into the concrete headworks settling basin for initial treatment prior to entering the southern end of the geosynthetic-lined pond. During the site visit, it was observed that a new high density polyethylene (HDPE) pipeline was being fabricated as a replacement force main from the western leachate force main to the pond headworks. Discussions with RWL personnel indicated that the former pipe had significant scaling and installation of a new force main was determined to be the desired corrective action.

PHOTO NO. 26.	DATE 21 October 2025
DIRECTION PHOTO TAKEN Northwest.	
DESCRIPTION View of Pond 2 geomembrane lined sedimentation basin.

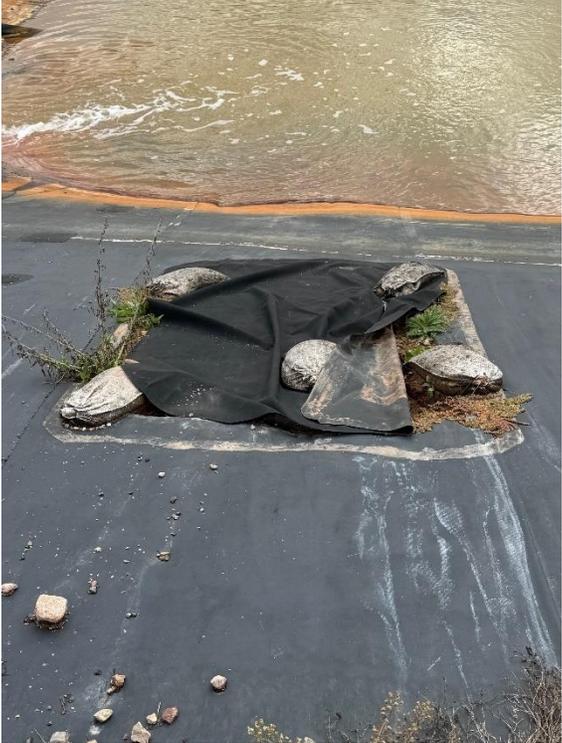
PHOTO NO. 27.	DATE 21 October 2025

DIRECTION PHOTO TAKEN Top down.		
DESCRIPTION Area of missing geomembrane above the operating level at the northern end of Pond 2.

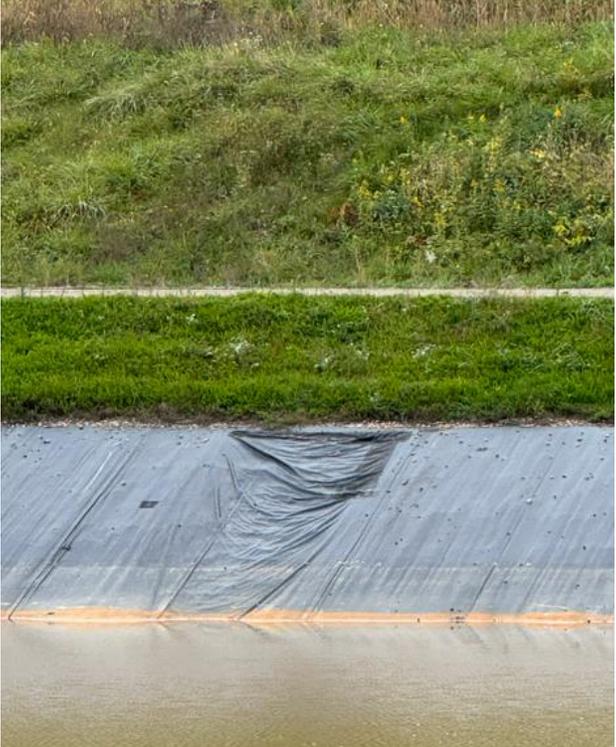
PHOTO NO. 28.	DATE 21 October 2025

DIRECTION PHOTO TAKEN Front view.		
DESCRIPTION View of Pond 2 liner. Wrinkle observed in previous inspections along slope on western side.

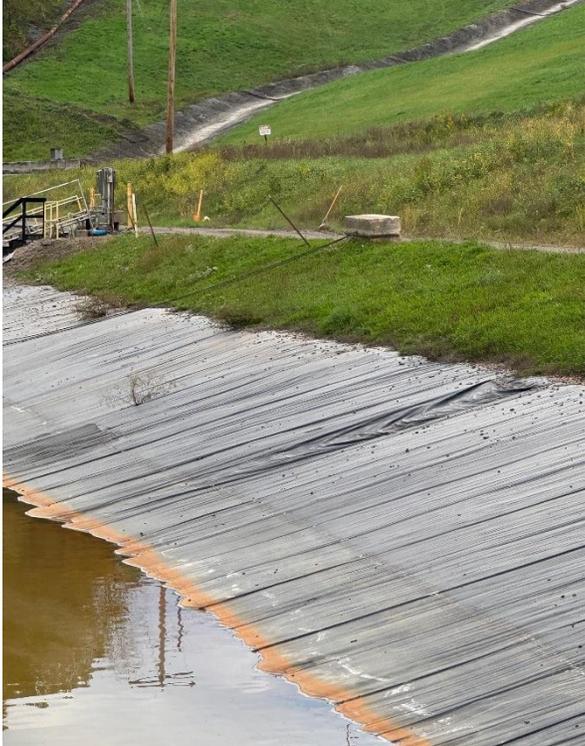
<p>PHOTO NO. 29.</p>	<p>DATE 21 October 2025</p>

<p>DIRECTION PHOTO TAKEN South.</p>		
<p>DESCRIPTION View of Pond 2 liner. Small patch of vegetation indicative of a small hole visible near bunching of geosynthetic material.</p>
