2025 Annual Inspection Report

Residual Waste Landfill

PREPARED FOR
Gavin Power, LLC

DATE
10 January 2026

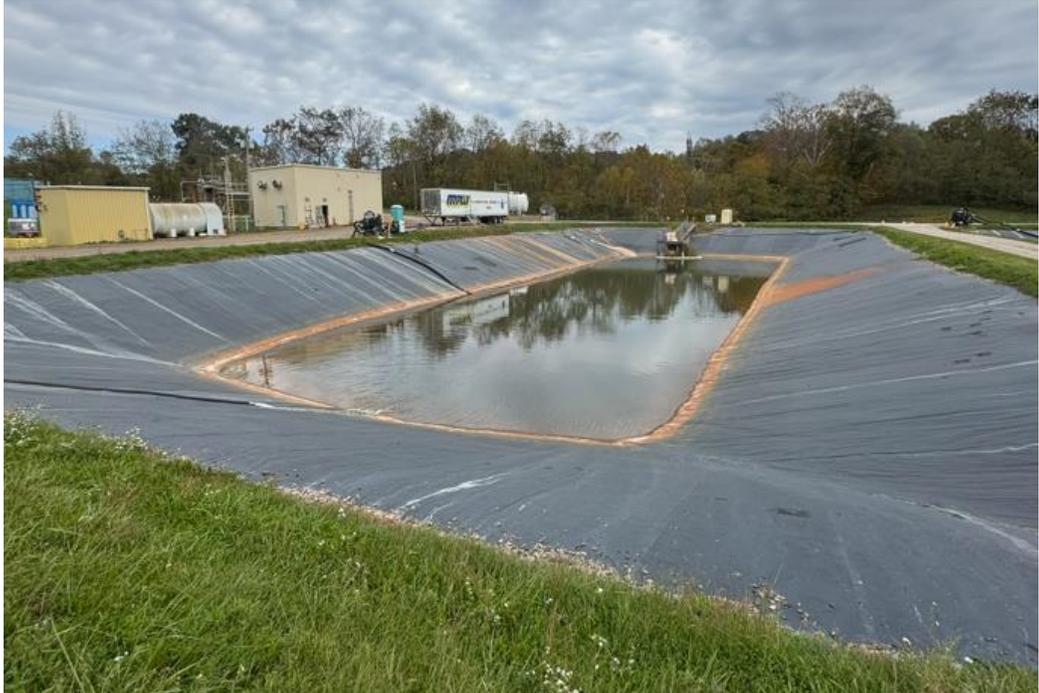
<p>PHOTO NO. 30.</p>	<p>DATE 21 October 2025</p>

The clarifying pond for Pond 2 was observed to have a supplemental, mobile trailer mounted temporary filter system similar to that present at other ponds (Photograph 30). There were no leaks observed, and the trailer appeared to be in satisfactory condition. The clarifying pond liner

<p>DIRECTION PHOTO TAKEN East.</p>		
<p>DESCRIPTION View of Pond 2 clarifying pond.</p>

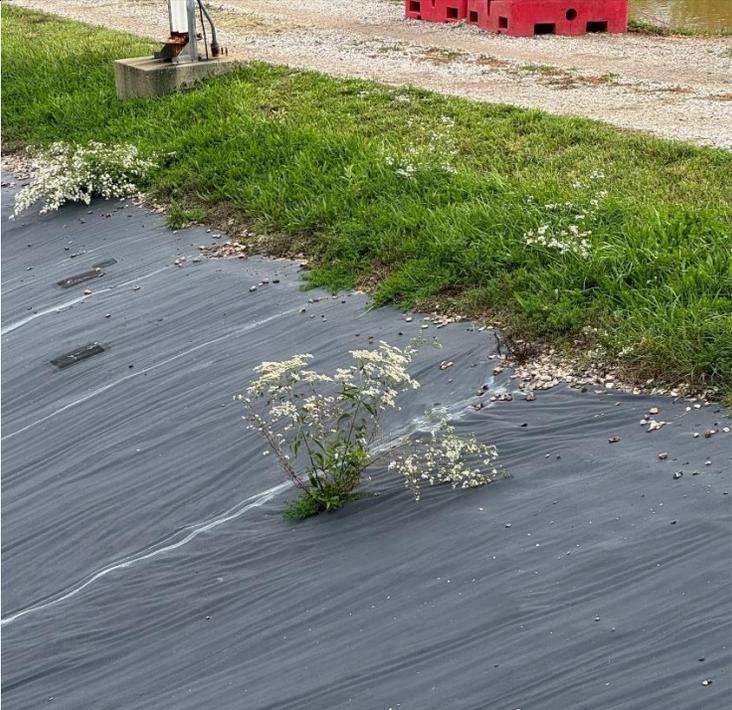
PHOTO NO. 31.	DATE 21 October 2025

system was observed to have two small perforations (Photographs 31 and 32) above the operating level of the pond near the crest and evidenced by the presence of vegetation growing up through them. These perforations should be repaired as part of normal pond maintenance.

DIRECTION PHOTO TAKEN Front view.		
DESCRIPTION View of eastern end of Pond 2 clarifying pond liner. Small perforation indicated by vegetation visible.

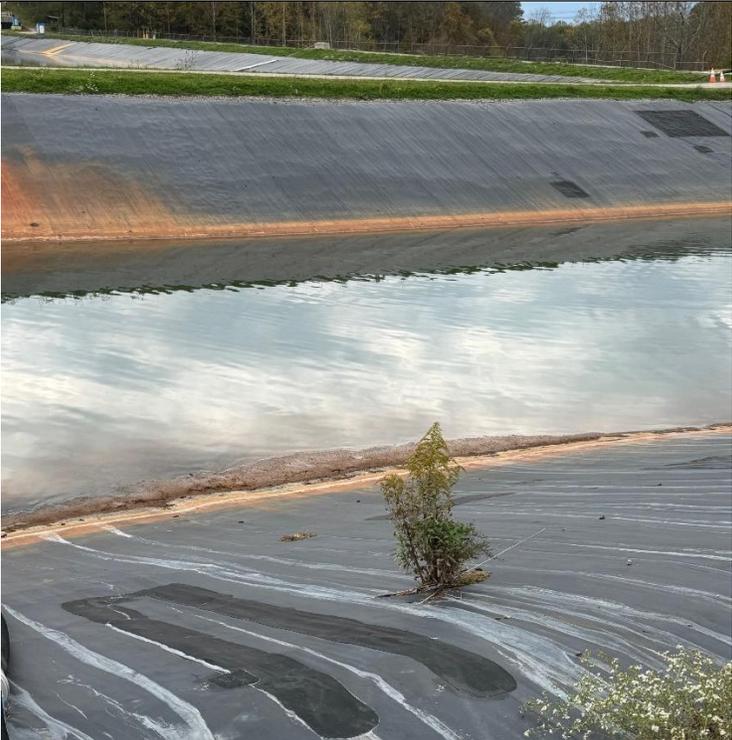
PHOTO NO. 32.	DATE 21 October 2025

DIRECTION PHOTO TAKEN South.		
DESCRIPTION View of northern end of Pond 2 clarifying pond liner. Small perforation indicated by vegetation visible.

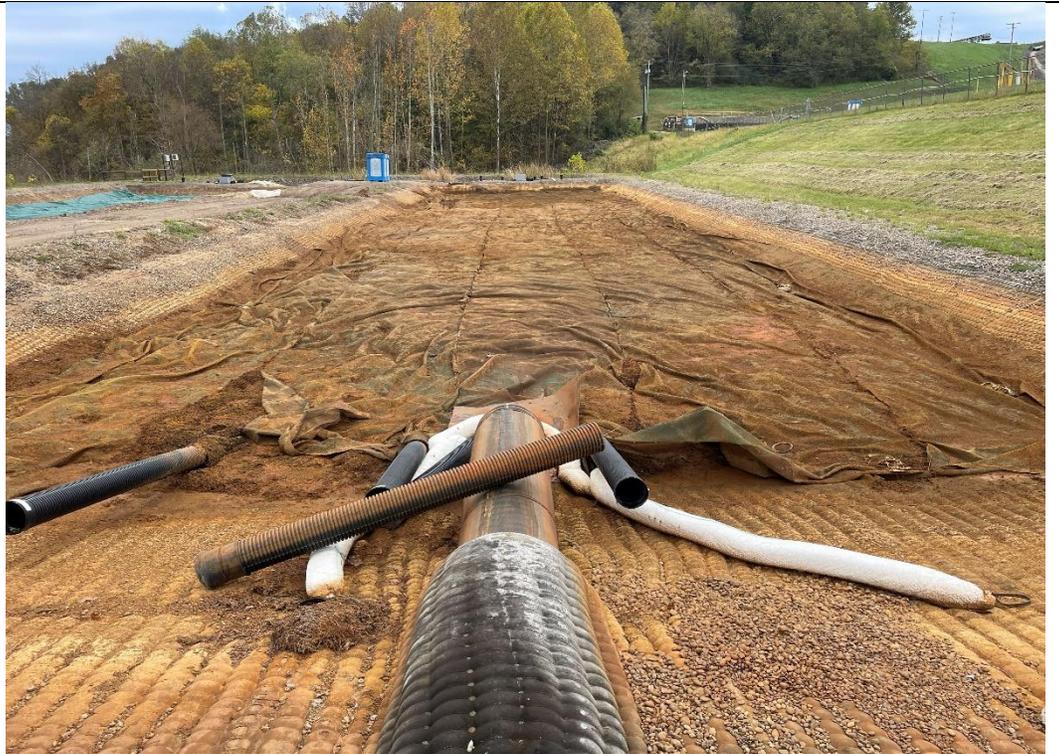
PHOTO NO. 33.	DATE 21 October 2025
DIRECTION PHOTO TAKEN Southeast.	
DESCRIPTION View of Pond 2 western vertical flow wetland. Observed inactive at time of inspection.

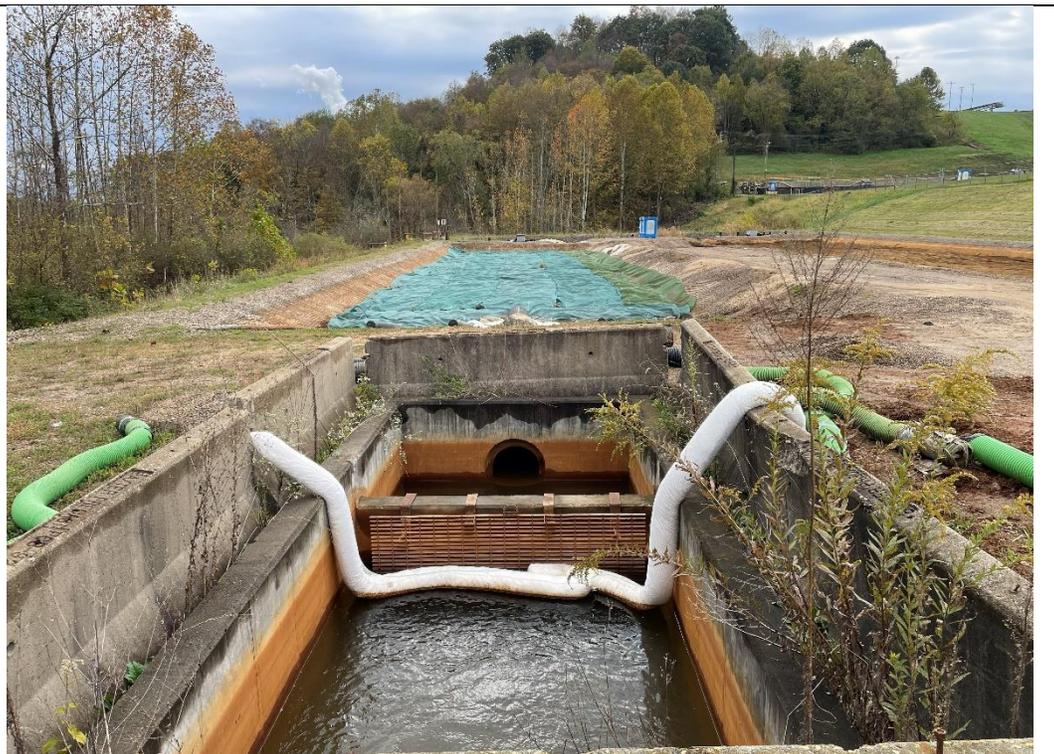
PHOTO NO. 34.	DATE 21 October 2025
DIRECTION PHOTO TAKEN Southeast.	
DESCRIPTION View of Pond 2 eastern vertical flow wetland and inlet basin, observed in good condition.

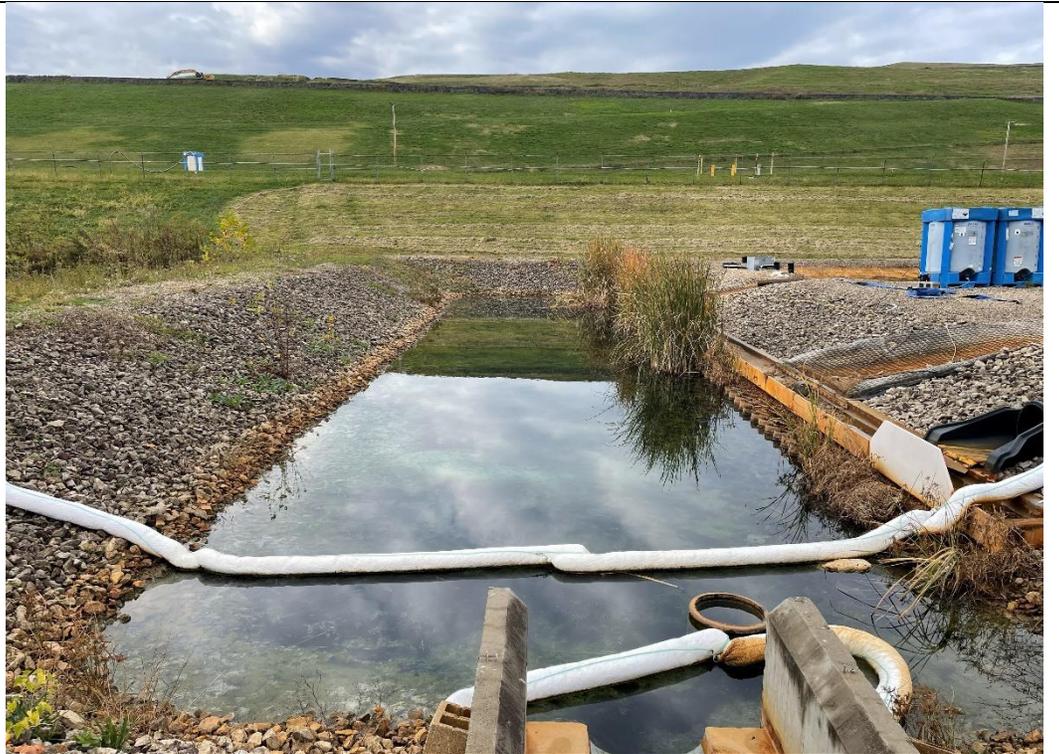
PHOTO NO. 35.	DATE 21 October 2025
DIRECTION PHOTO TAKEN West.	
DESCRIPTION View of Pond 2 vertical flow wetland clarifying basin. Some overgrown cattail vegetation observed within basin.

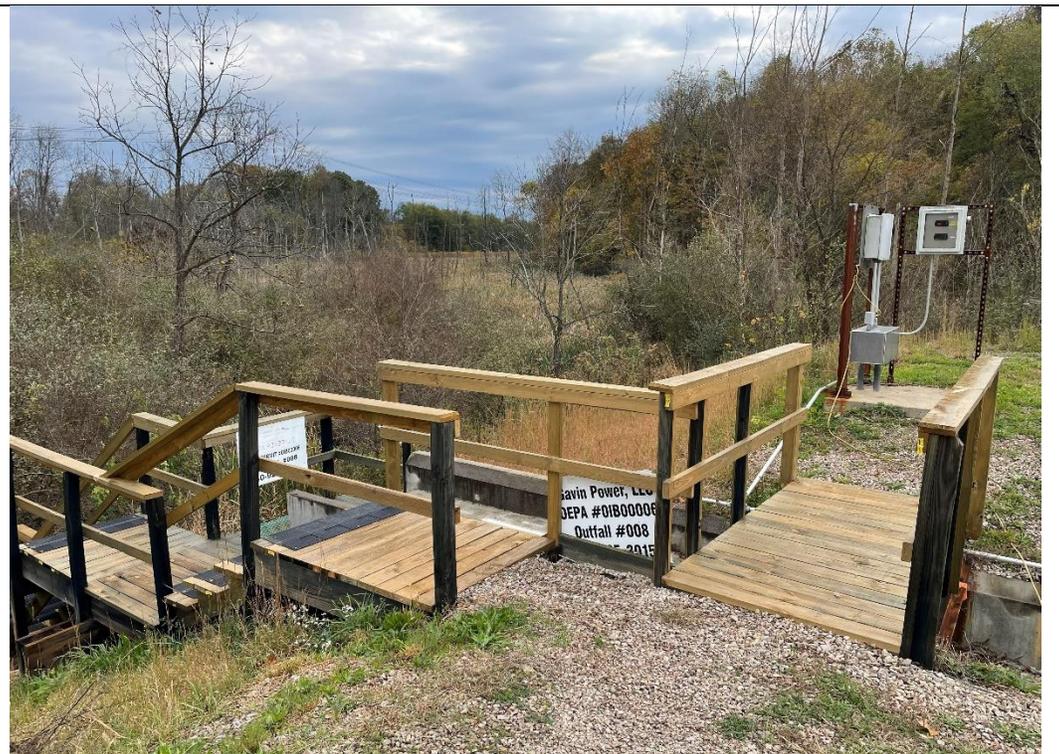
PHOTO NO. 36.	DATE 21 October 2025
DIRECTION PHOTO TAKEN East.	
DESCRIPTION View of Pond 2 Outfall 008. Newly installed access stairs observed in good condition.

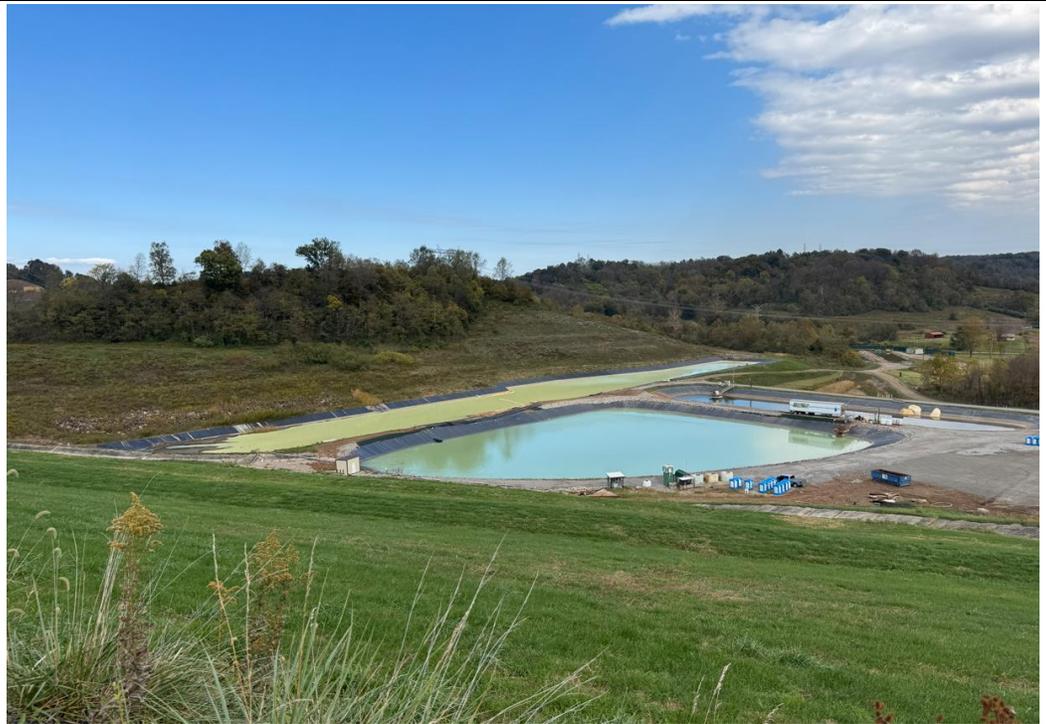
Pond 3 on the northeast side of the RWL was observed to be performing in a satisfactory manner (Photograph 37). Pond 3 was identified to have undergone a significant renovation during 2025. In 2024, the pond was in an idled condition with leachate being redirected into Pond 5 through a pump system at the inlet pipe and discharging the leachate into the head of Pond 5. In 2025 the sedimentation side of Pond 3 was dredged of sediments which were removed and deposited into the RWL. The underlying geomembrane was removed and then the Pond 3 sedimentation basin was completely relined with 60 mil HDPE geomembrane. On the northwestern side of Pond 3, the damaged culvert pipe identified in previous inspections was replaced with twin HDPE pipes which discharge into Pond 3 on top of the new liner system (Photograph 38). Riprap was utilized on the upstream entrance to the twin culverts to anchor the piping and direct water into the pipes. It is recommended that a concrete or similar headwall be installed around the twin pipes to maximize the direction of stormwater through the pipes.

PHOTO NO. 37.	DATE 21 October 2025
DIRECTION PHOTO TAKEN North.	
DESCRIPTION Panoramic view of Pond 3 in foreground and Pond 5 behind.

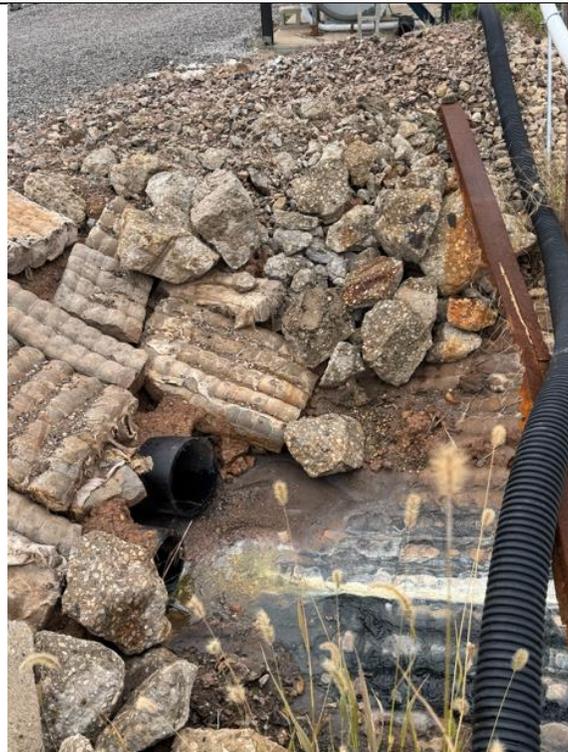
PHOTO NO. 38.	DATE 21 October 2025
DIRECTION PHOTO TAKEN Top view.	
DESCRIPTION View of Pond 3 surface water channel inlet. Former corroded pipe replaced with dual HDPE pipes using broken concrete and riprap for pipe anchoring.

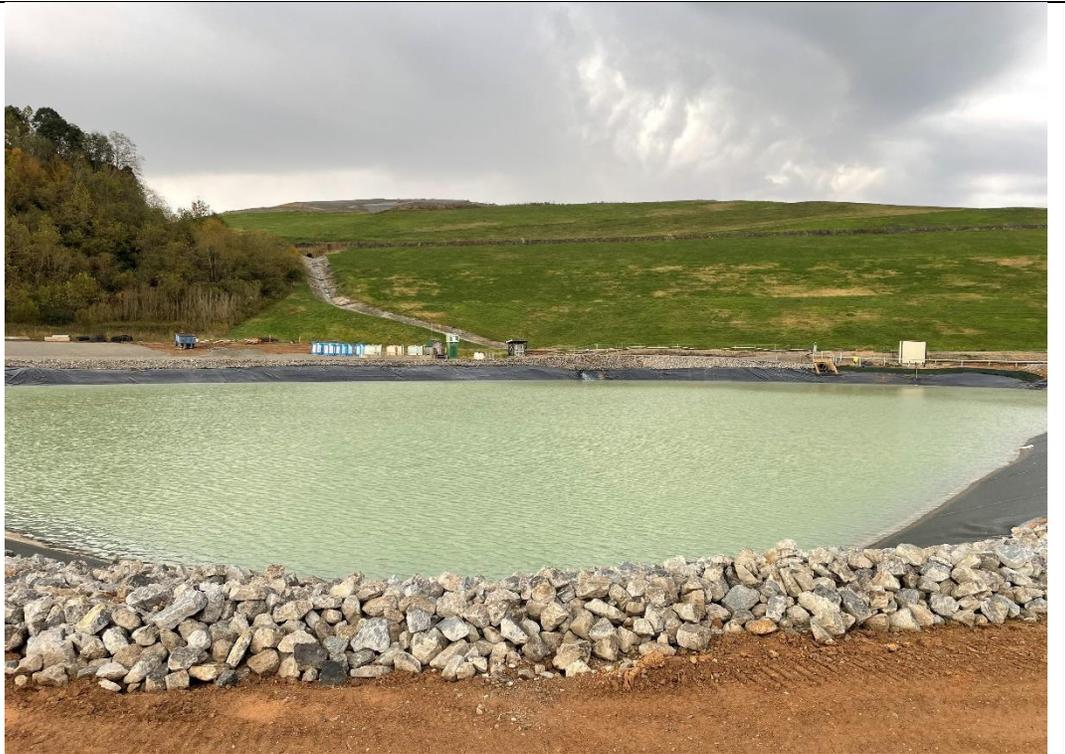
PHOTO NO. 39.	DATE 21 October 2025
DIRECTION PHOTO TAKEN South.	
DESCRIPTION View of relined Pond 3 sedimentation basin. Entire pond relined with HDPE geomembrane. Riprap protection placed around crest.

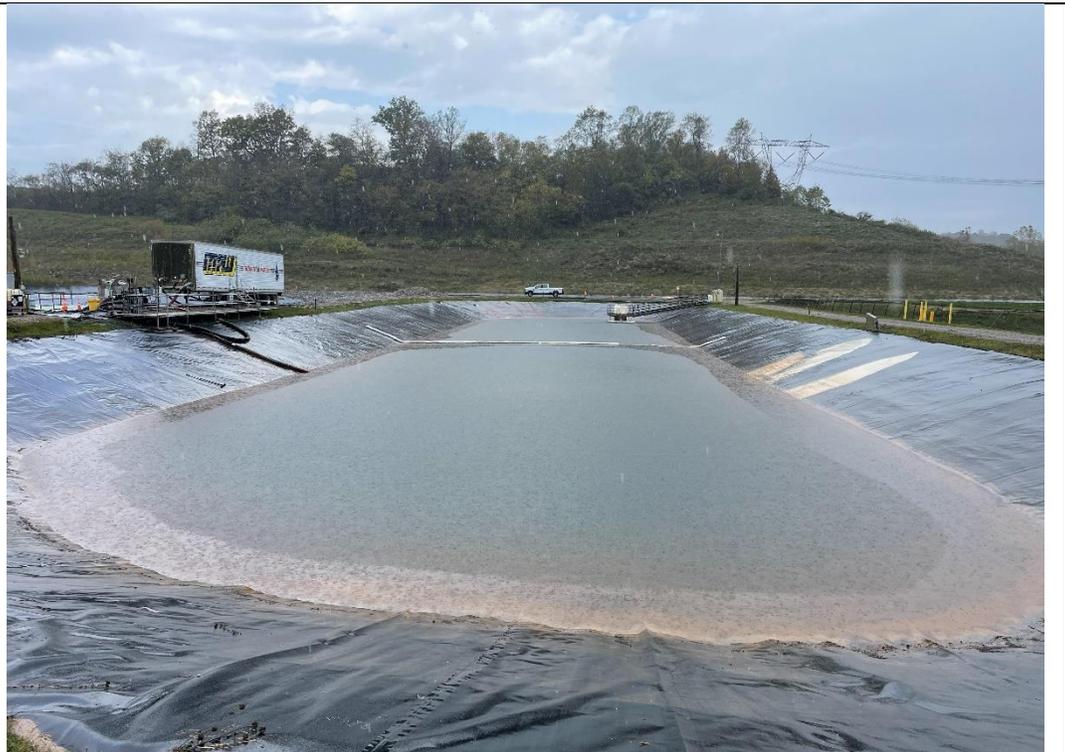
PHOTO NO. 40.	DATE 21 October 2025
DIRECTION PHOTO TAKEN Northwest	
DESCRIPTION View of Pond 3 clarifying pond with supplemental filter trailer on left. Erosion blanket visible at top of geomembrane slope on both sides.

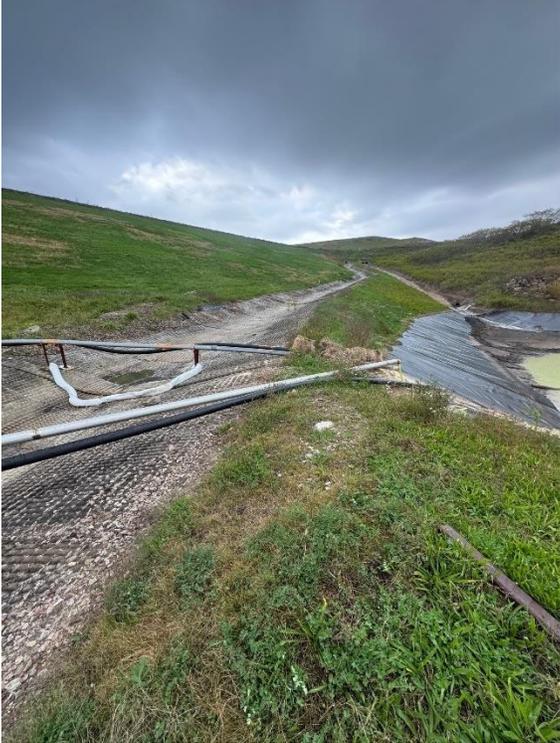
PHOTO NO. 41.	DATE 21 October 2025

DIRECTION PHOTO TAKEN North.		
DESCRIPTION View of pipes containing leachate directed into the western edge of Pond 5.

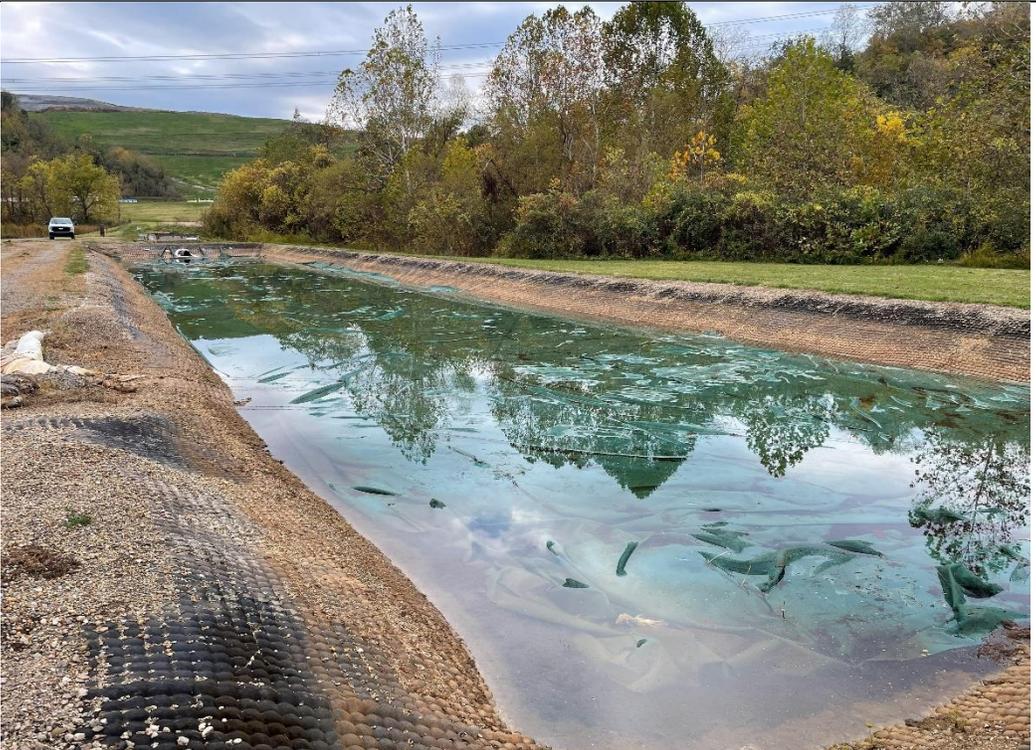
PHOTO NO. 42.	DATE 21 October 2025

DIRECTION PHOTO TAKEN South.		
DESCRIPTION View of Pond 3/5 (western) vertical flow wetland, observed in good condition.

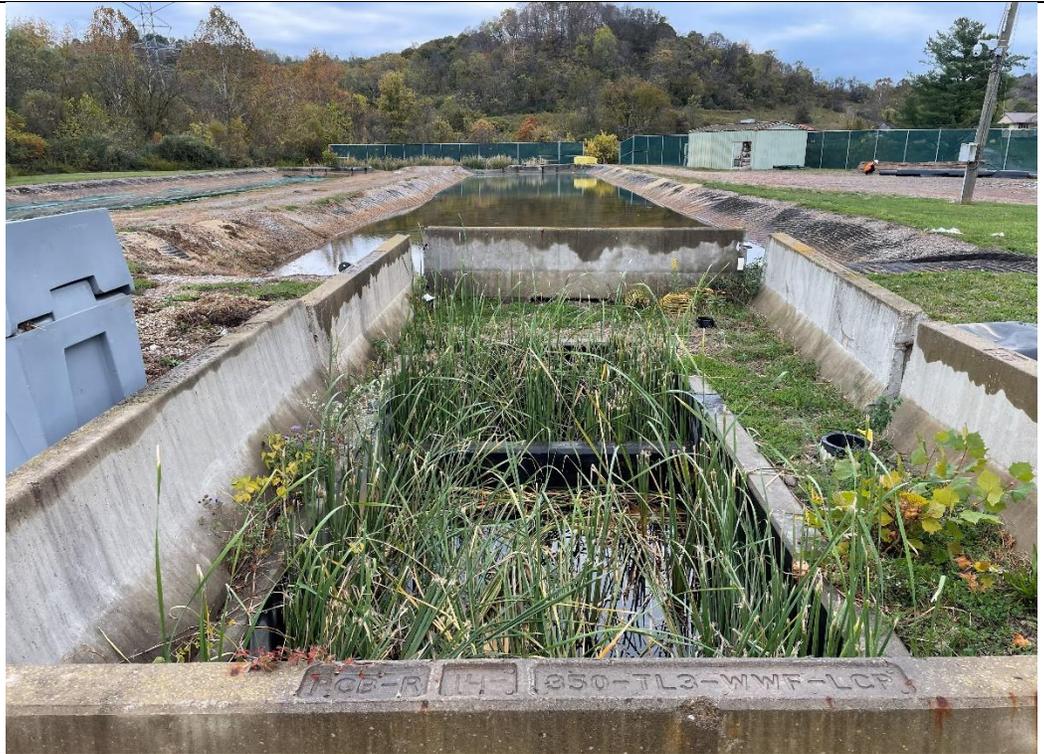
PHOTO NO. 43.	DATE 21 October 2025
DIRECTION PHOTO TAKEN North.	
DESCRIPTION View of Pond 3/5 (eastern) vertical flow wetland. Overgrown vegetation observed within inlet basin.

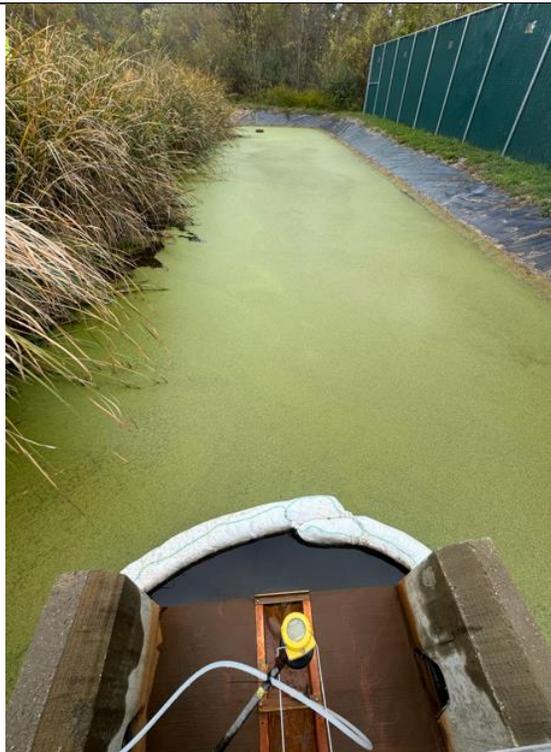
PHOTO NO. 44.	DATE 21 October 2025
DIRECTION PHOTO TAKEN Top view.	
DESCRIPTION Duckweed observed in polishing pool of Pond 3/5 vertical flow wetland.

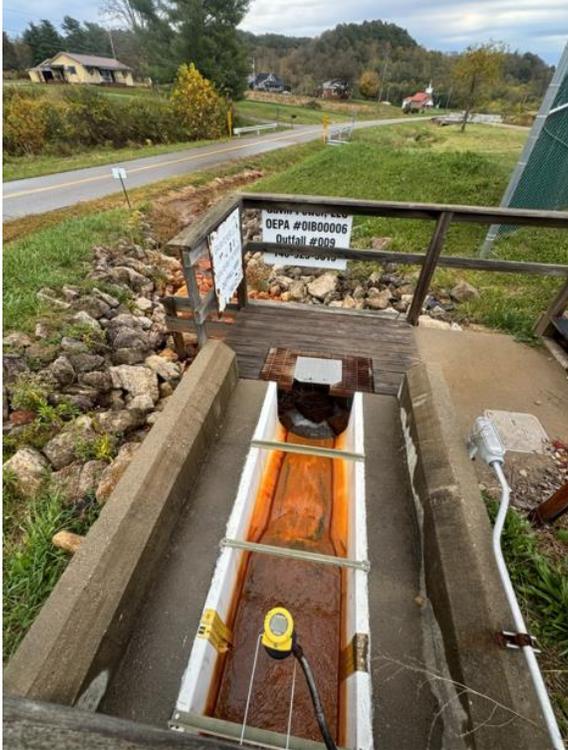
PHOTO NO. 45.	DATE 21 October 2025

DIRECTION PHOTO TAKEN Top view.		
DESCRIPTION View of flow measurement flume at outlet for Pond 3 and Pond 5 vertical flow wetlands. Flume discharges into Outfall 009.

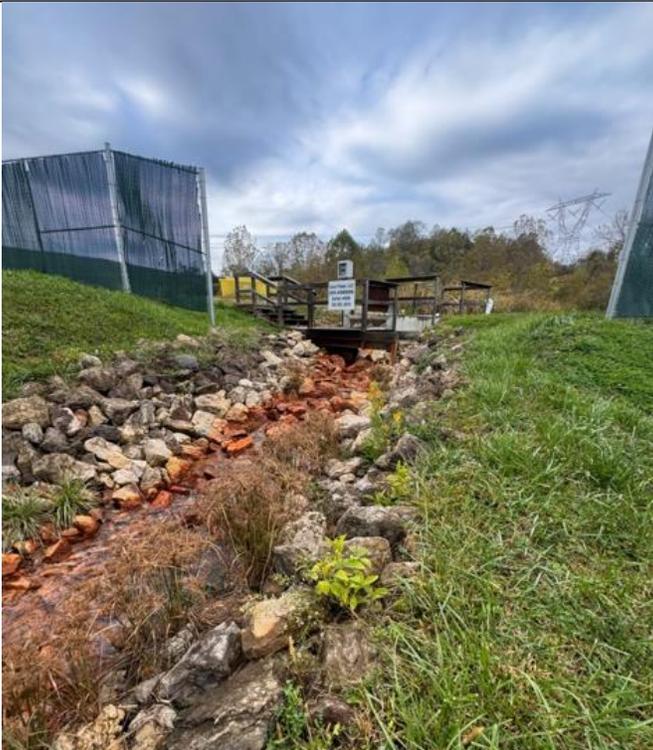
PHOTO NO. 46.	DATE 21 October 2025

DIRECTION PHOTO TAKEN South.		
DESCRIPTION Outflow channel from Pond 3/5 Vertical Flow Wetland.

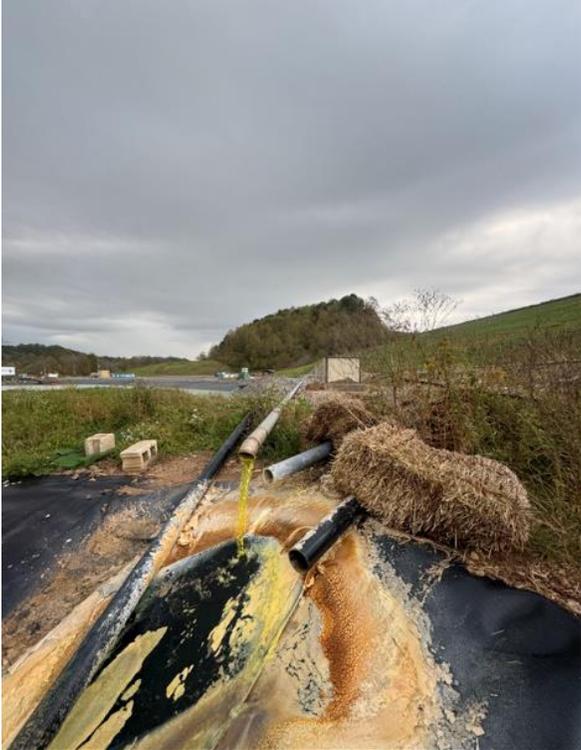
PHOTO NO. 47.	DATE 21 October 2025

DIRECTION PHOTO TAKEN Southeast.		
DESCRIPTION View of eastern side of Pond 5 where the Pond 3 temporary bypass system discharges.

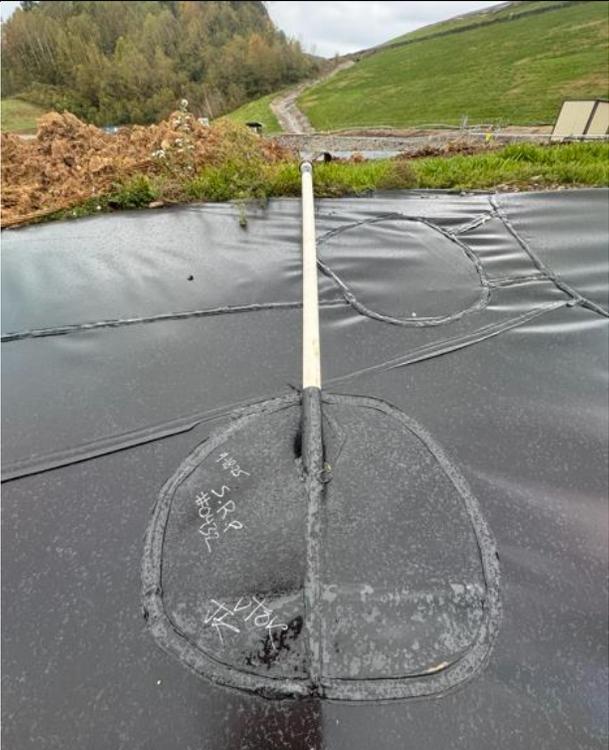
PHOTO NO. 48.	DATE 21 October 2025

DIRECTION PHOTO TAKEN Southeast.		
DESCRIPTION Pipe placed under geomembrane with fabricated pipe boot on southwest side of Pond 5. Used to remove accumulated water from under geomembrane when identified.

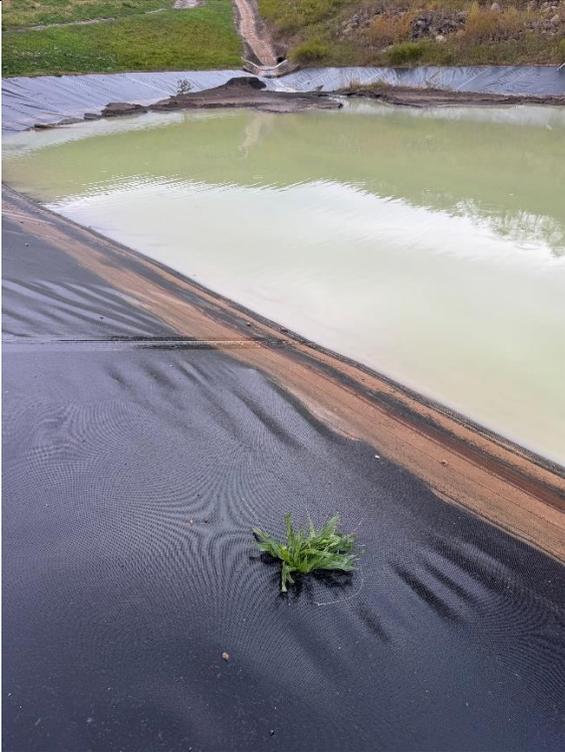
PHOTO NO. 49.	DATE 21 October 2025

DIRECTION PHOTO TAKEN Top view.		
DESCRIPTION View of Pond 5 liner northern slope. Small perforation with visible vegetation is shown.

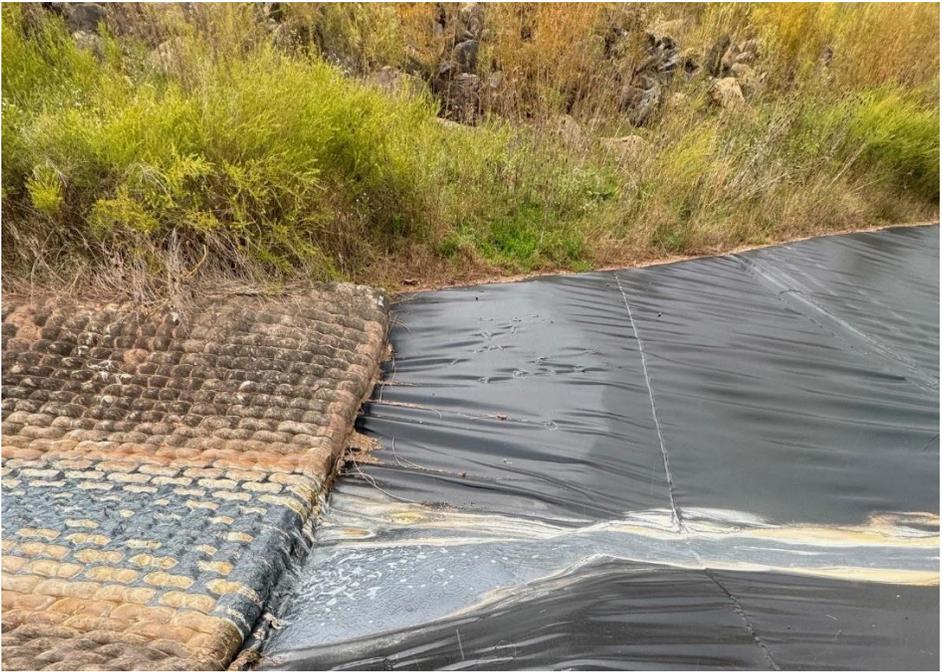
PHOTO NO. 50.	DATE 21 October 2025

DIRECTION PHOTO TAKEN North.		
DESCRIPTION View of Pond 5 liner near western end. Small perforations suggestive of animal tracks are visible at top of liner.

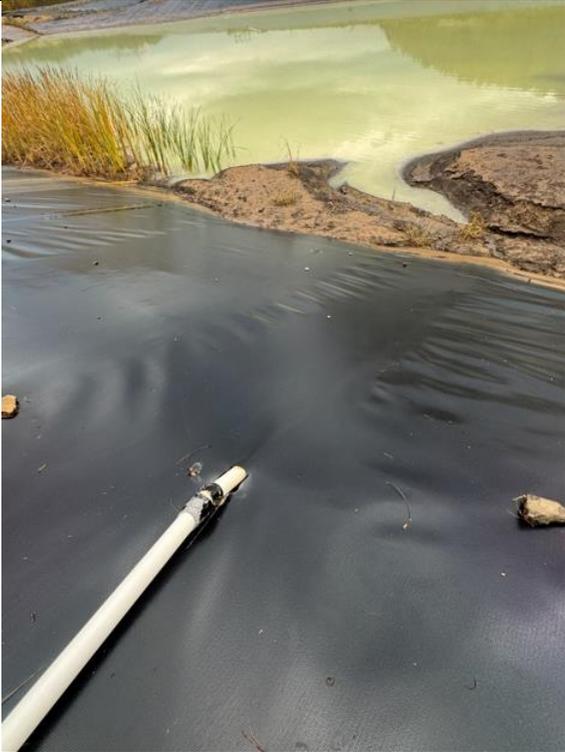
PHOTO NO. 51.	DATE 21 October 2025

DIRECTION PHOTO TAKEN Top View.		
DESCRIPTION Pipe under liner on north side of Pond 5 for removal of water from under geomembrane when identified.

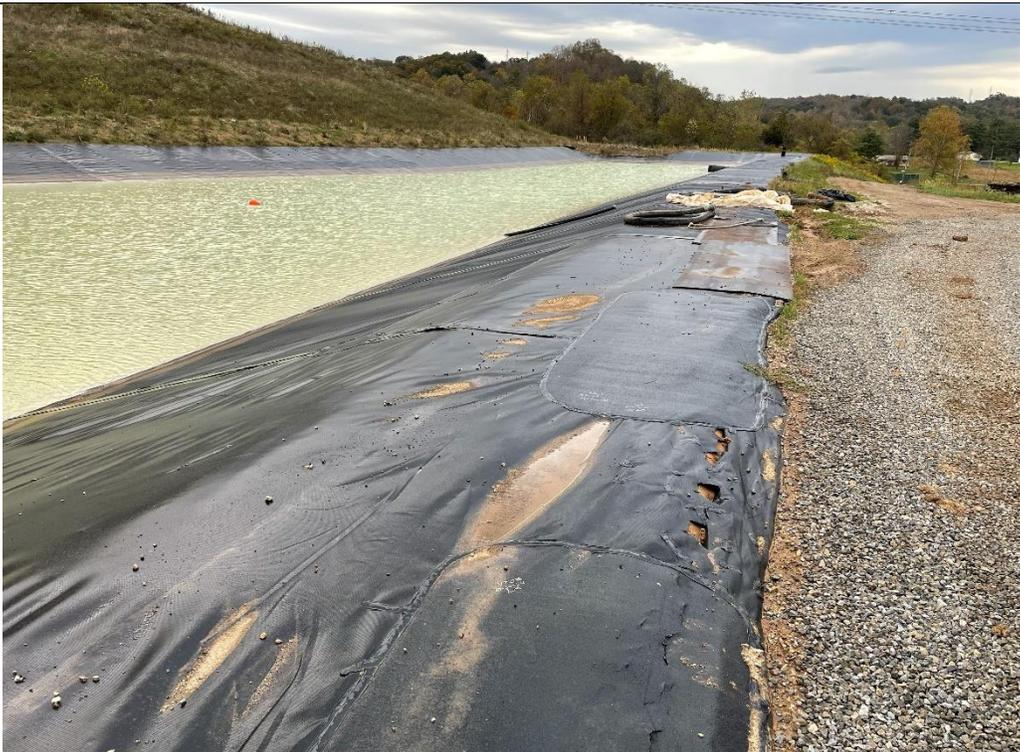
PHOTO NO. 52.	DATE 21 October 2025

DIRECTION PHOTO TAKEN Northeast.		
DESCRIPTION View of Pond 5. Anchor trench geomembrane runout damaged by equipment track. Located above operating level.

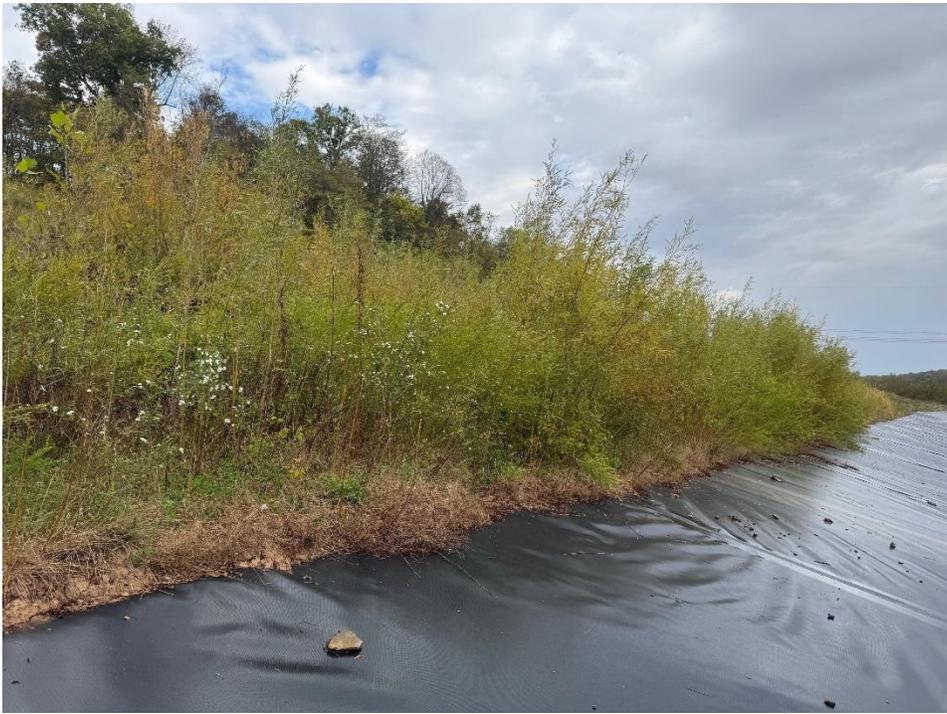
PHOTO NO. 53.	DATE 21 October 2025

DIRECTION PHOTO TAKEN East.		
DESCRIPTION Northern slope of the Pond 5 liner. Thick vegetation is visible adjacent to the liner.

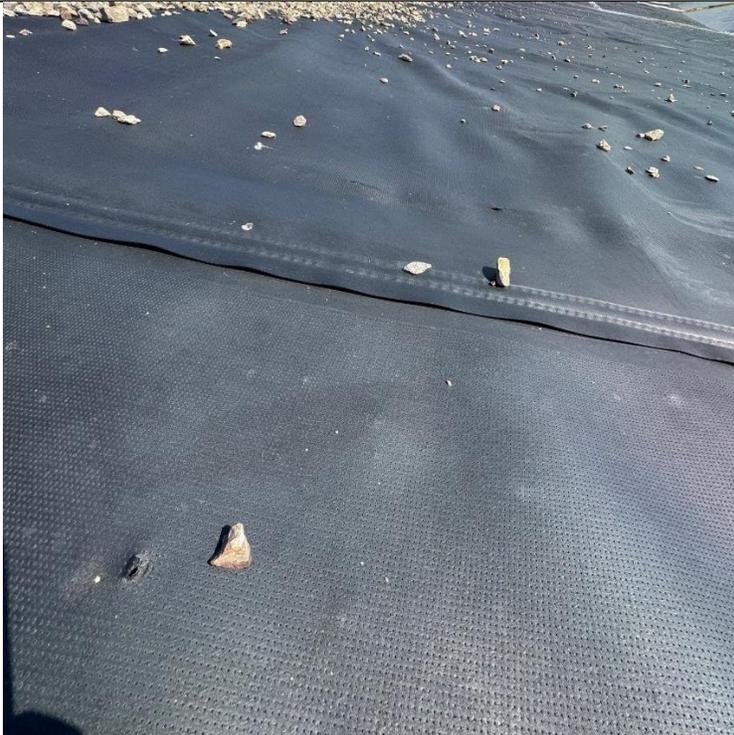
PHOTO NO. 54.	DATE 21 October 2025

DIRECTION PHOTO TAKEN Top view.		
DESCRIPTION View of the Pond 6 liner. Small perforations are visible above the operating level of the pond.

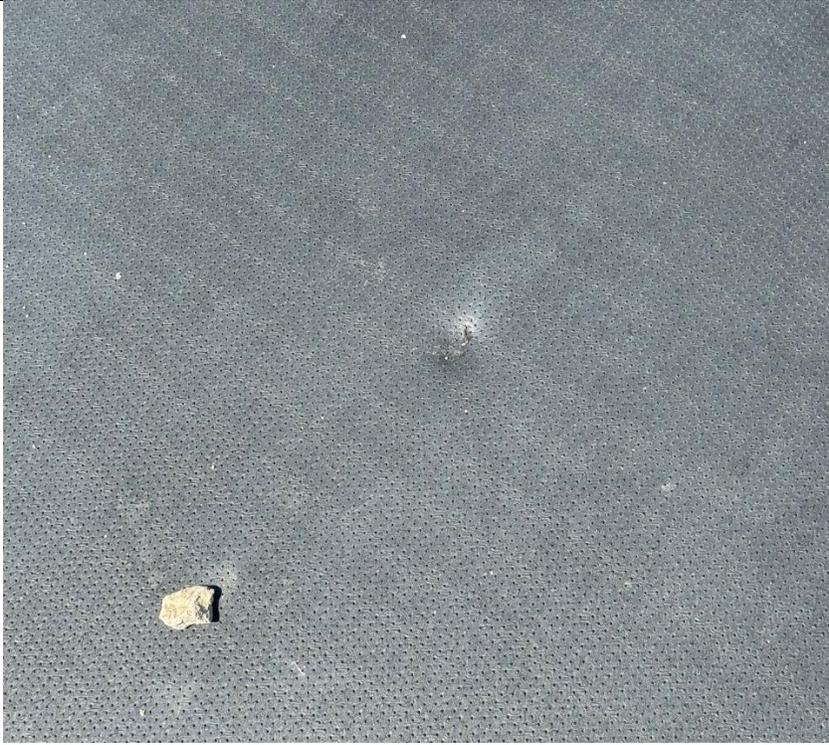
PHOTO NO. 55.	DATE 21 October 2025

DIRECTION PHOTO TAKEN Top view.		
DESCRIPTION View of the Pond 6 liner. Small perforations are visible above the operating level of the pond.

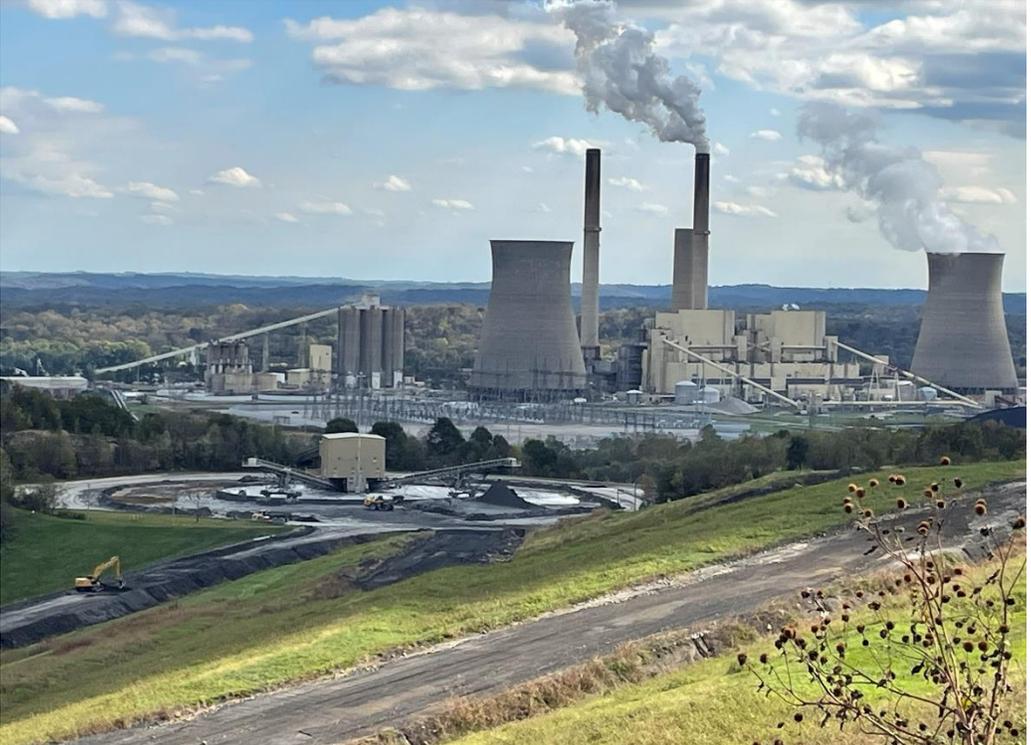
PHOTO NO. 56.	DATE 21 October 2025

DIRECTION PHOTO TAKEN South.		
DESCRIPTION View of FGD stack-out pad and powerplant in background. Active access road repairs also observed near stack-out pad operations.

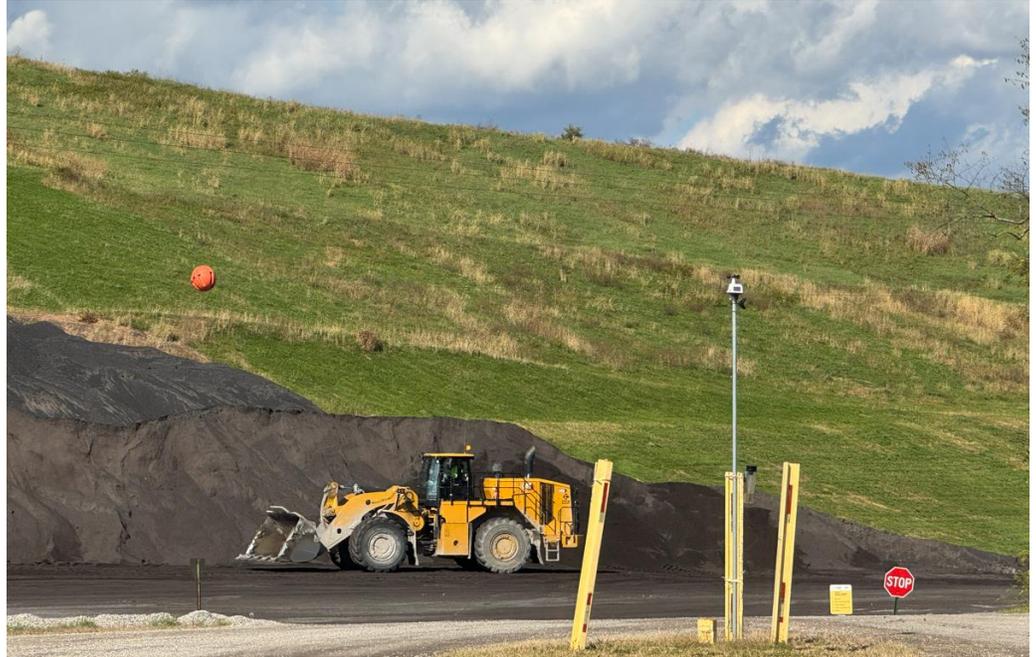
PHOTO NO. 57.	DATE 21 October 2025
DIRECTION PHOTO TAKEN Southeast.	
DESCRIPTION View of improved soil and vegetation cover along southern slope face near RWL office. Slope was previously direct seeded FGD.
