2025 Annual Inspection Report

Bottom Ash Pond

PREPARED FOR
Gavin Power, LLC

REFERENCE
0767401

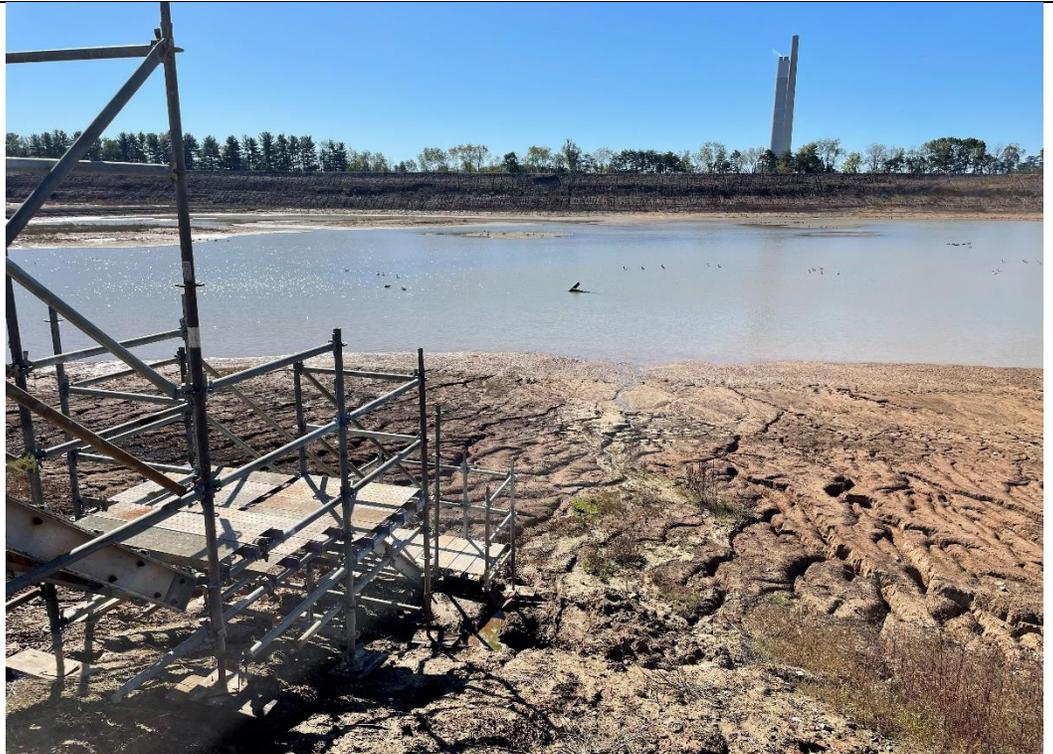
Formerly accumulated bottom ash during the operational days of the BAP appeared to be removed from within the interior of the BAP. Accumulated precipitation was estimated at a maximum depth of 3 to 4 feet and appeared to be within the deepest incised portion of the BAP floor. This water was not being retained against the exterior BAP embankment at any observed location, nor is any smaller accumulation of standing water (Photographs 1, 2 & 3).

PHOTO NO. 1.	DATE 20 October 2025
DIRECTION PHOTO TAKEN South.	
DESCRIPTION View of BAP from northern embankment at area of potential seepage under investigation.

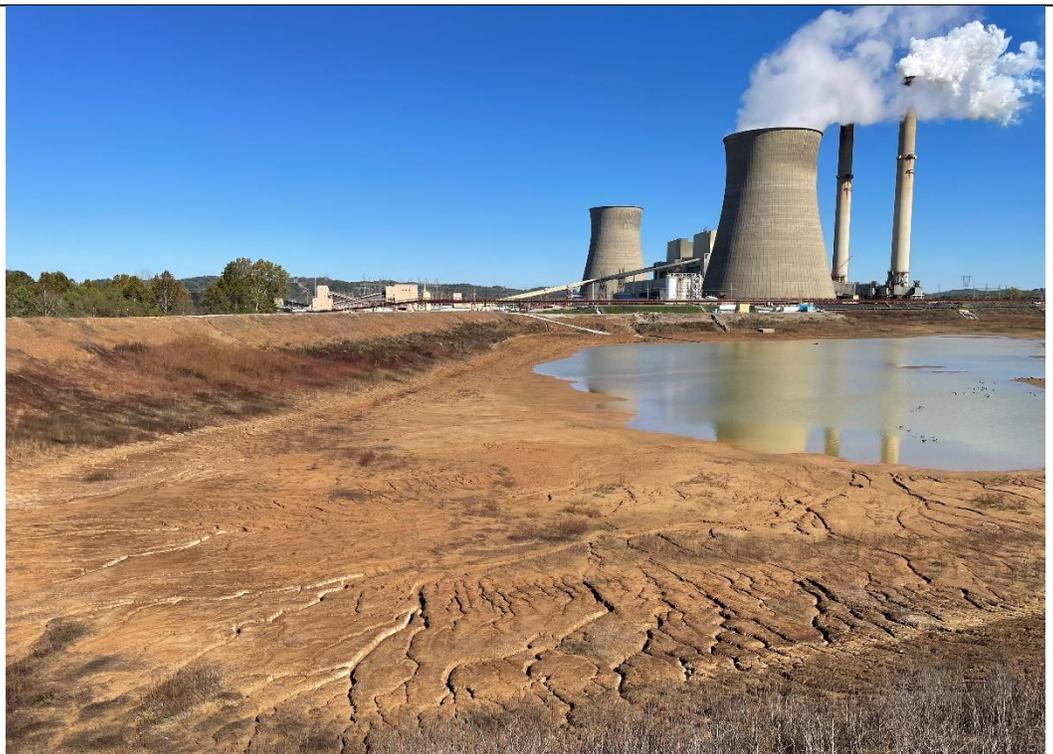
Consistent shallow rill erosion was observed around the inside perimeter of the embankment (Photographs 1 & 2). At several locations rills have increased in size since the 2024 inspection into small gulleys with an average depth of approximately 12 inches. Eroded soil from the side slope erosion is captured within the BAP and is not leaving the location. Interior side slopes appeared stable and no significant changes in geometry indicative of slope movement were observed.

PHOTO NO. 2.	DATE 20 October 2025
DIRECTION PHOTO TAKEN North.	
DESCRIPTION View of BAP western and southern embankment interior slopes from SW corner. Erosion rills observed along interior slopes and bottom surface. Surface stormwater accumulation within BAP observed to be up to approximately 3-4 feet deep at time of inspection.

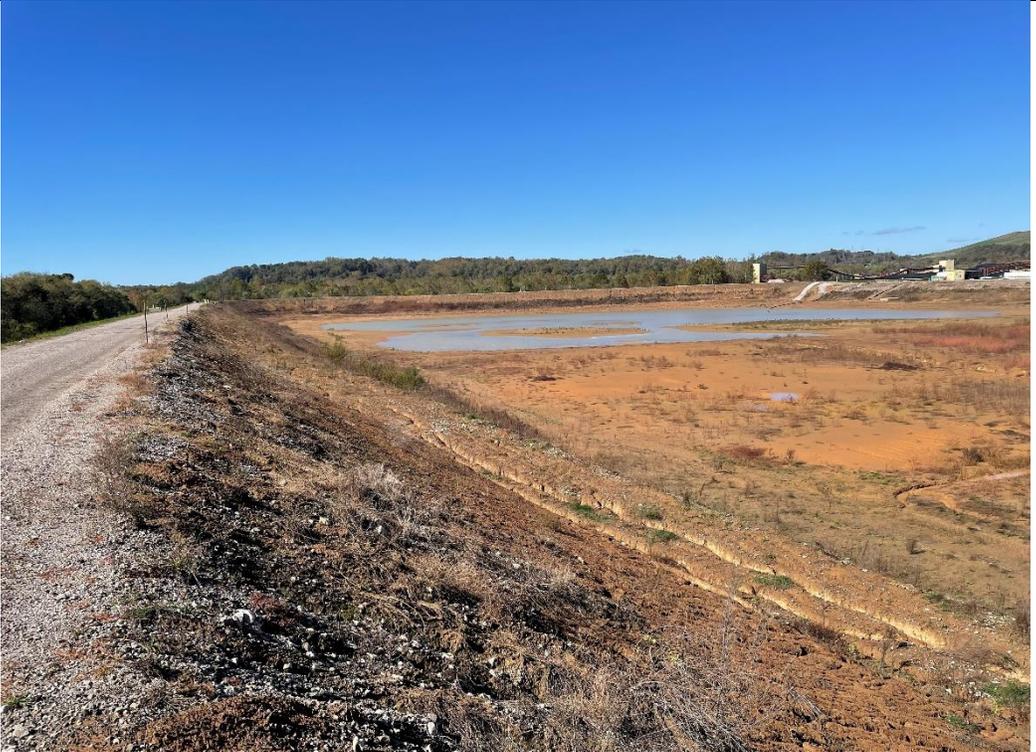
PHOTO NO. 3.	DATE 20 October 2025

DIRECTION PHOTO TAKEN West.		
DESCRIPTION View of BAP southern embankment interior slope. Erosion rills and forming gullies observed along interior slope.

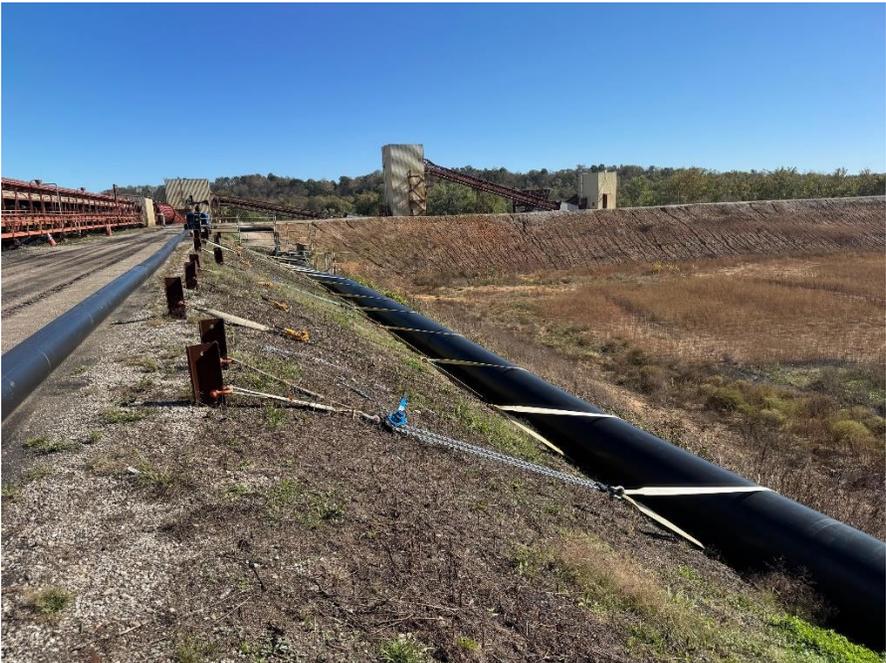
PHOTO NO. 4.	DATE 20 October 2025

DIRECTION PHOTO TAKEN East		
DESCRIPTION View of the northern embankment of the BAP, taken from the center of the northern embankment looking east. HDPE piping is visible on the interior embankment.

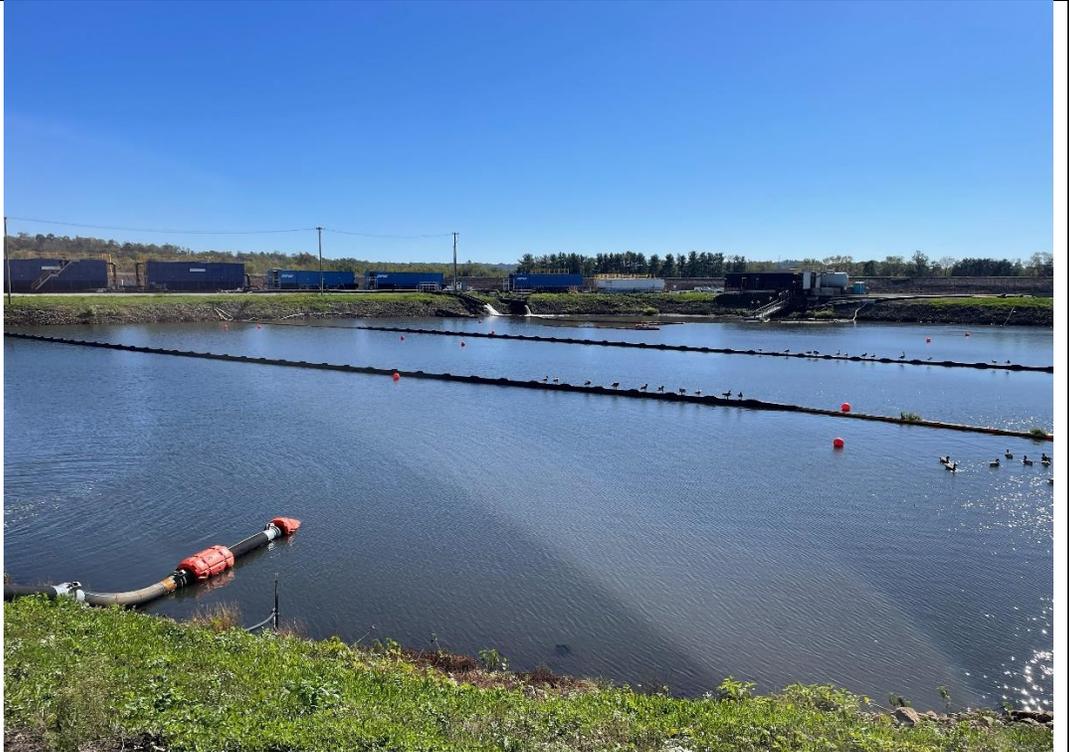
The Reclaim Pond internal embankments were found to be in satisfactory condition. No visible indications of settlement, instability or erosion were apparent. The crest and slopes along the interior were vegetated (with only minor isolated bare spots) and the toe was armored with riprap. The riprap-protected areas appeared to be in stable condition (Photograph 5).

PHOTO NO. 5.	DATE 20 October 2025
DIRECTION PHOTO TAKEN Southeast.	
DESCRIPTION View of Reclaim Pond from NW corner of BAP. Water filtration process trailers observed in background.

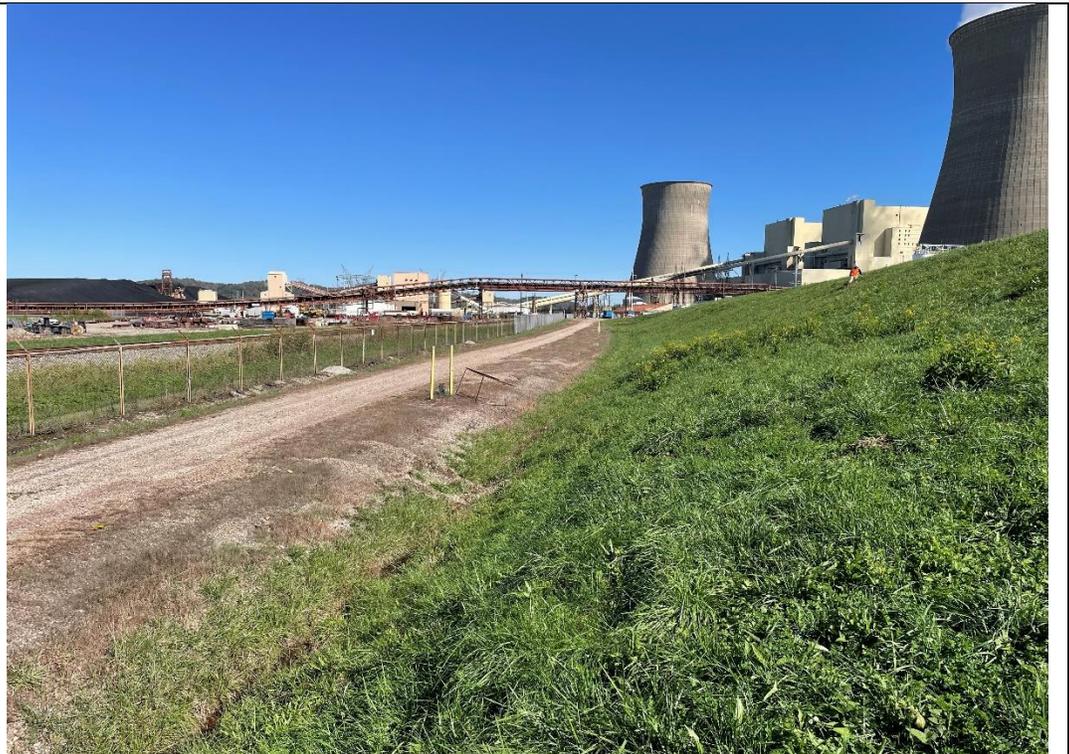
PHOTO NO. 6.	DATE 20 October 2025
DIRECTION PHOTO TAKEN North.	
DESCRIPTION View of BAP western embankment exterior slope near NW corner. Vegetation is well maintained. Hummocky areas observed stable. Some minor exposed areas and mowing tracks observed.

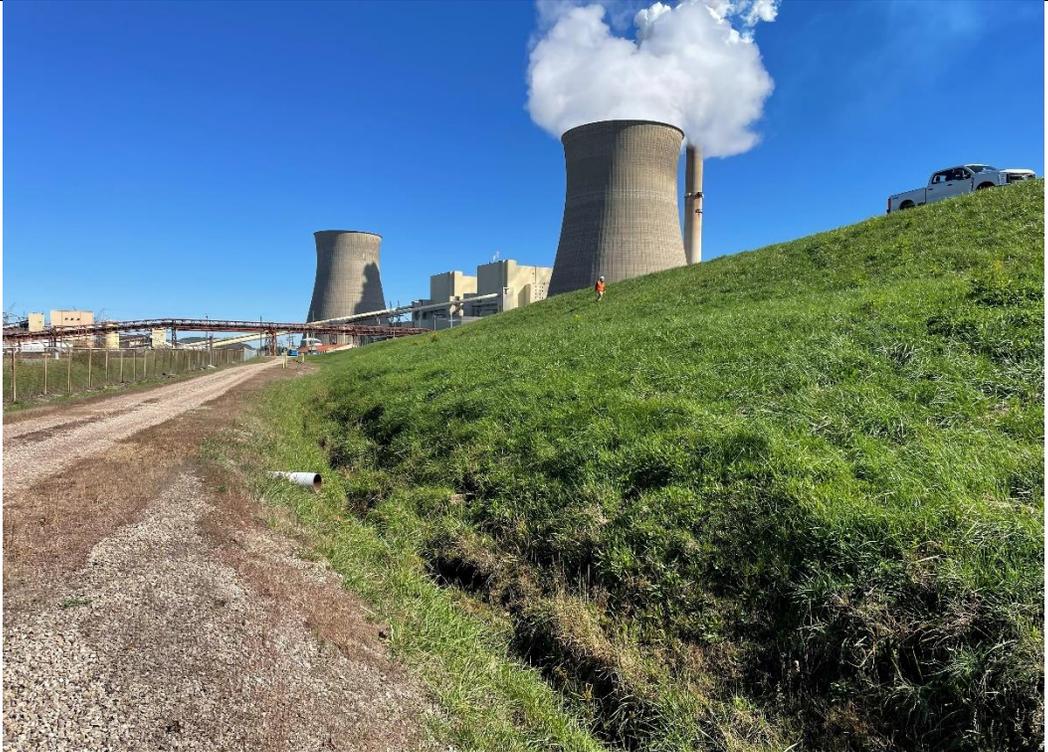
PHOTO NO. 7.	DATE 20 October 2025

4. As identified in previous reports, a stormwater pipe culvert at the toe of the western embankment that crosses the western access road would benefit from placement of outlet protection stone (Photograph 7). Stormwater flow has created a minor depression at the outlet area. Regardless, the culvert is in satisfactory condition.

DIRECTION PHOTO TAKEN North.		
DESCRIPTION View of BAP western embankment exterior slope. Bottom slope ditchline and drain pipe observed in good condition.

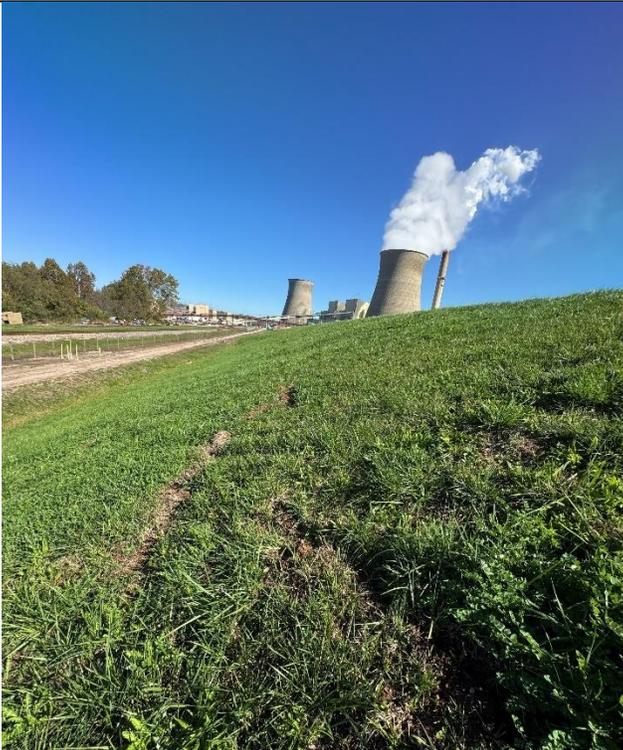
PHOTO NO. 8.	DATE 20 October 2025

DIRECTION PHOTO TAKEN North.		
DESCRIPTION View of BAP western embankment exterior slope. Area of apparent tension cracking across slope.

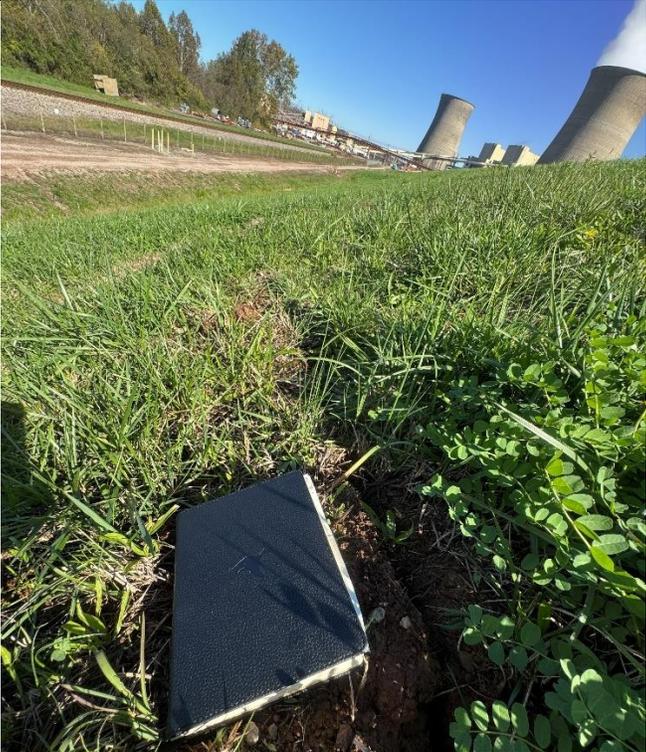
PHOTO NO. 9.	DATE 20 October 2025

The western embankment section (including crest, slope, and toe) was in satisfactory condition (i.e., well vegetated and in a mostly stable condition) based on the visual inspection. There was no observable settlement, rutting, or significant erosion observed (Photographs 6 through 13). The beginning of a shallow tension crack observed in 2024 and apparent shallow movement of surface soils was observed in similar condition to last year on the exterior vegetated slope just south of the midpoint of the embankment approximately a quarter of the distance down the slope

from the crest (Photograph 9). Gavin personnel are aware of this tension crack and it has been noted on the 7-day inspections and continues to be monitored for noticeable movement on a routine basis.

DIRECTION PHOTO TAKEN North.		
DESCRIPTION View of BAP western embankment exterior slope. Area of apparent tension cracking across slope (fieldbook shown for scale).

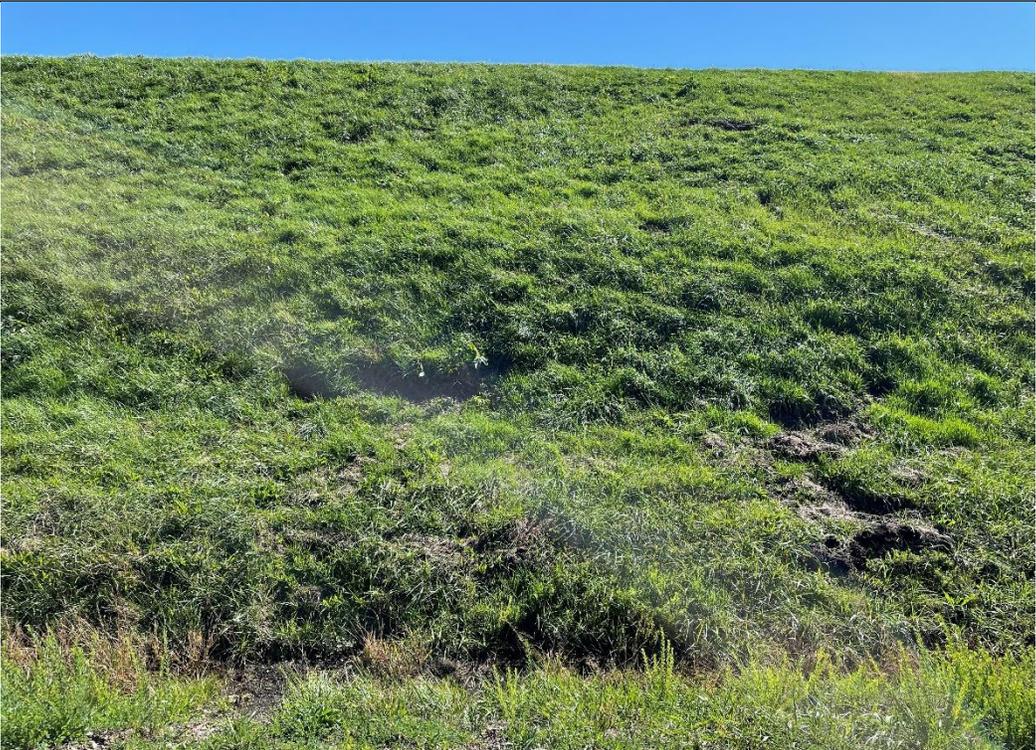
PHOTO NO. 10.	DATE 20 October 2025

DIRECTION PHOTO TAKEN Front view.		
DESCRIPTION View of BAP western embankment exterior slope. Hummocky terrain observed stable. Small exposed areas and mowing tracks observed.

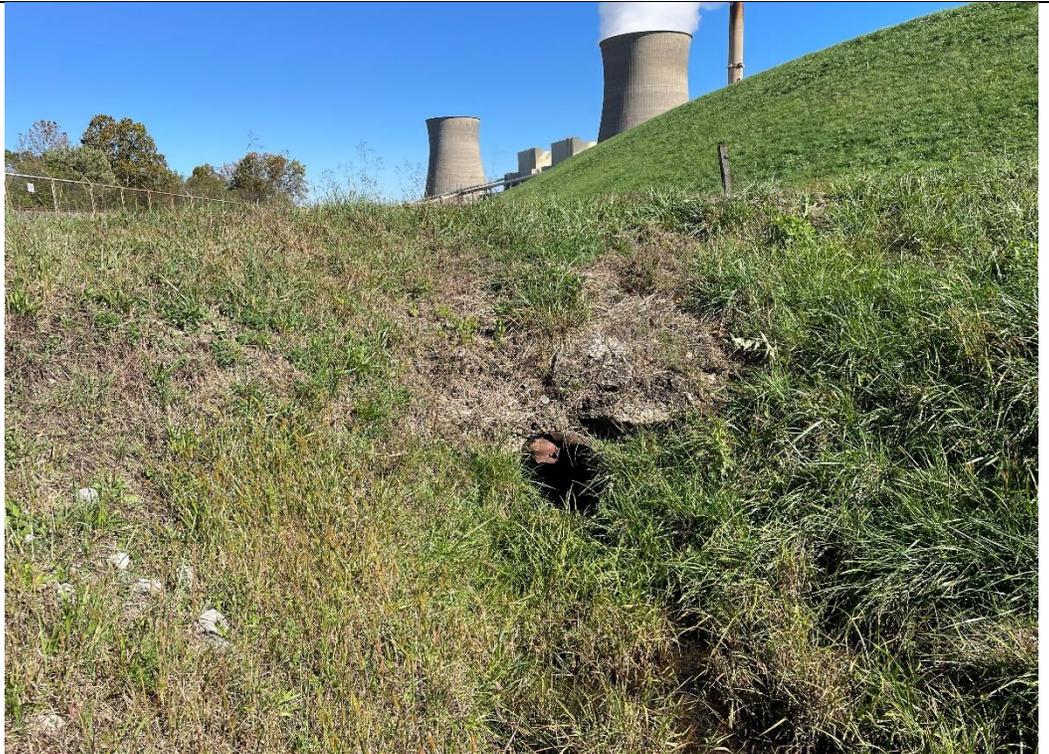
PHOTO NO. 11.	DATE 20 October 2025
DIRECTION PHOTO TAKEN North.	
DESCRIPTION View of BAP western embankment exterior slope near southwest bottom corner. Bottom ditchline drain outlet observed rusted and with minor damage but not affecting through flow.

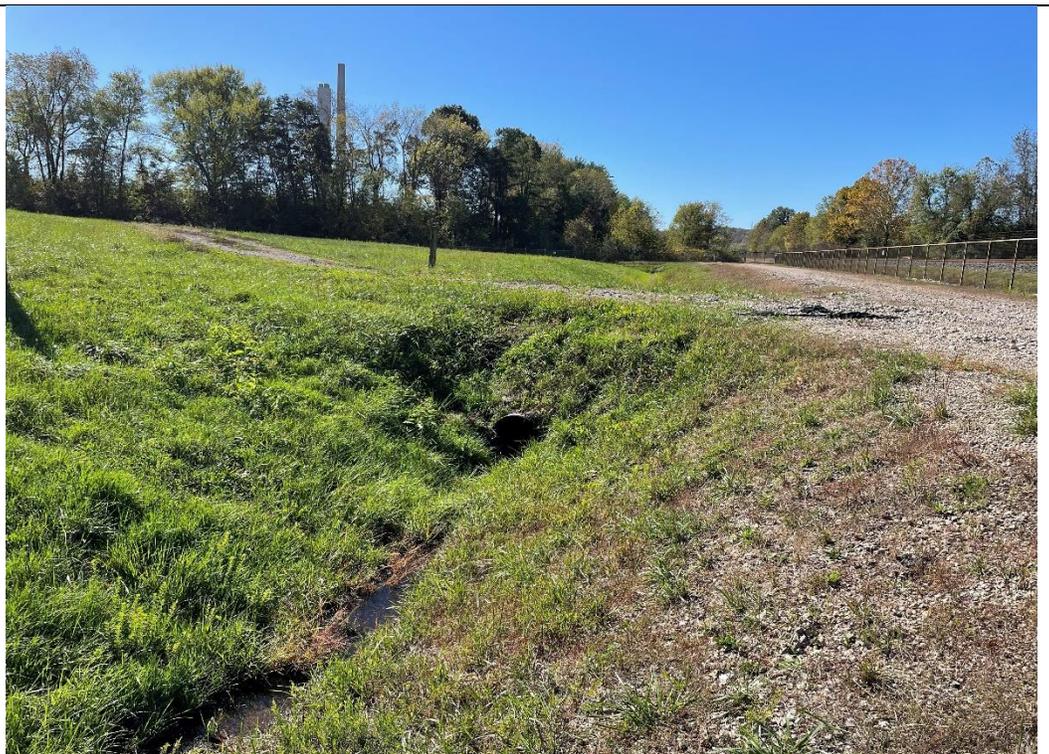
3. The stormwater pipe culvert observed under the monitoring well access toward the end of the ditch in the southwestern corner appeared to be in good working condition and free of debris. (Photograph 12).

PHOTO NO. 12.	DATE 20 October 2025
DIRECTION PHOTO TAKEN South.	
DESCRIPTION View of BAP western embankment exterior slope near southwest bottom corner. Bottom ditchline drain inlet observed in good condition.

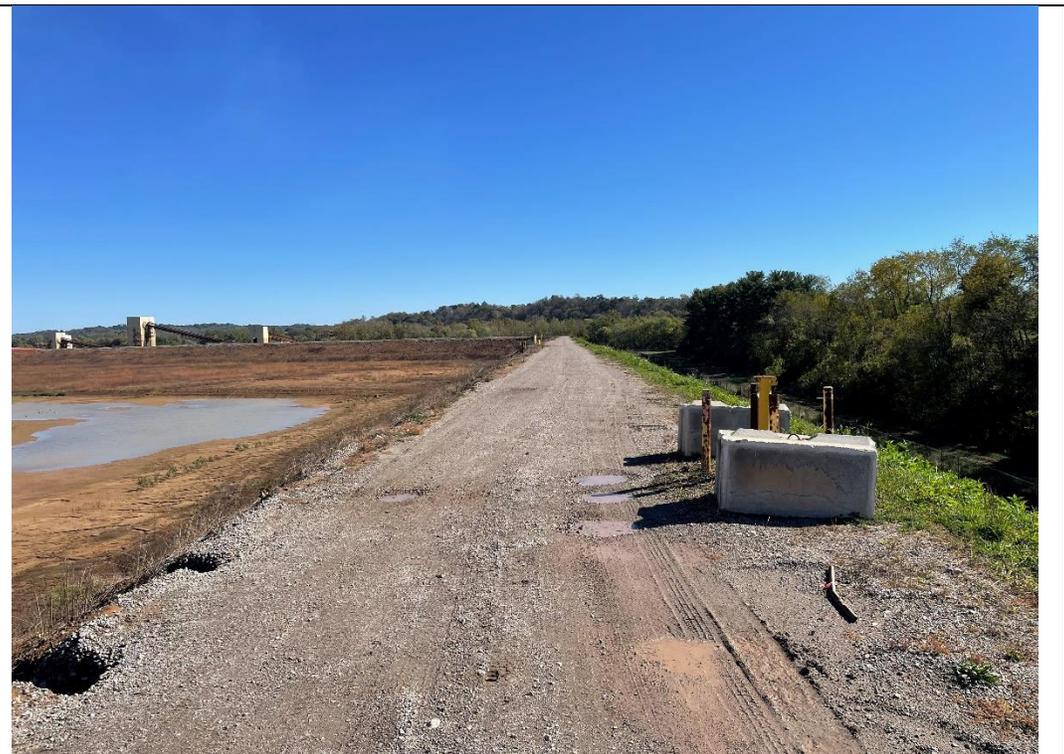
1. No evidence of seeps along the toe of the embankment were observed.
2. The exterior slope exhibited no visual indications of significant misalignment, erosion, rutting or settlement and was well vegetated (Photographs 15 through 21).
3. The interior embankment slope appeared stable (Photographs 3 and 14). In several isolated locations, the shallow rill erosion has progressed into deeper erosion features approximately 12 inches deep on average. These deeper features appear to be related to preferential runoff pathways from the crest access road. Monitoring of the progression of these deeper features is

PHOTO NO. 14.	DATE 20 October 2025
DIRECTION PHOTO TAKEN East.	
DESCRIPTION View of BAP southern embankment crest road. Erosion gullies observed cutting into road from interior slope on left side.

recommended and the addition of stone into the headcut of the features to slow runoff velocities may eventually be necessary to prevent progression of erosion into the roadway.

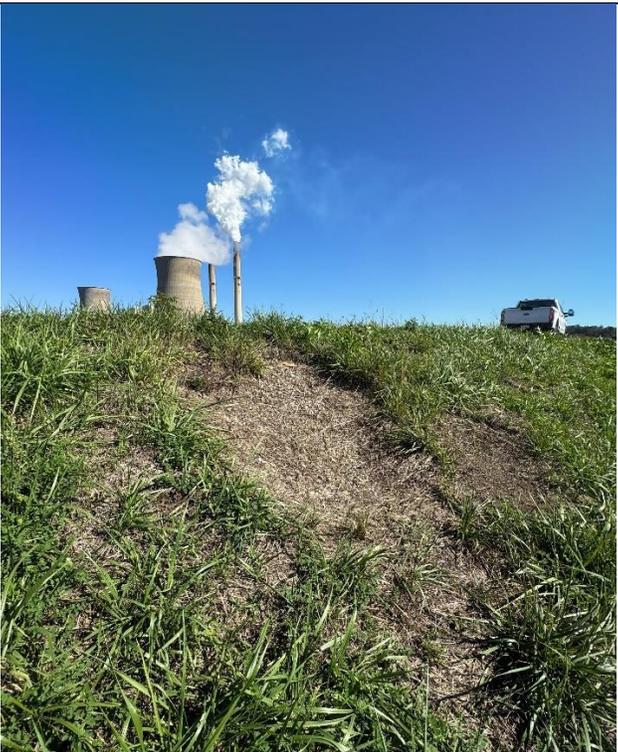
PHOTO NO. 16.	DATE 20 October 2025

DIRECTION PHOTO TAKEN Northeast.		
DESCRIPTION View of BAP southern embankment exterior slope top near SW corner. Small area of sparse vegetation observed across slope.

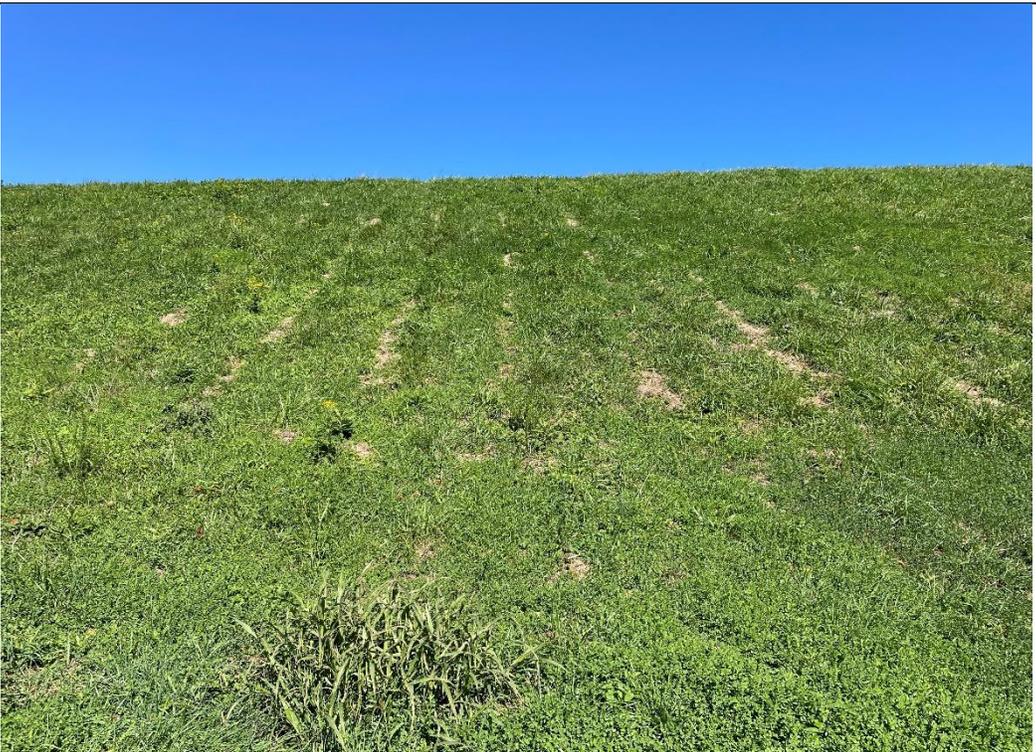
PHOTO NO. 18.	DATE 20 October 2025

DIRECTION PHOTO TAKEN Front view.		
DESCRIPTION View of BAP southern embankment exterior slope from bottom. Small isolated areas of overgrown vegetation and exposed tracks from mowing observed.

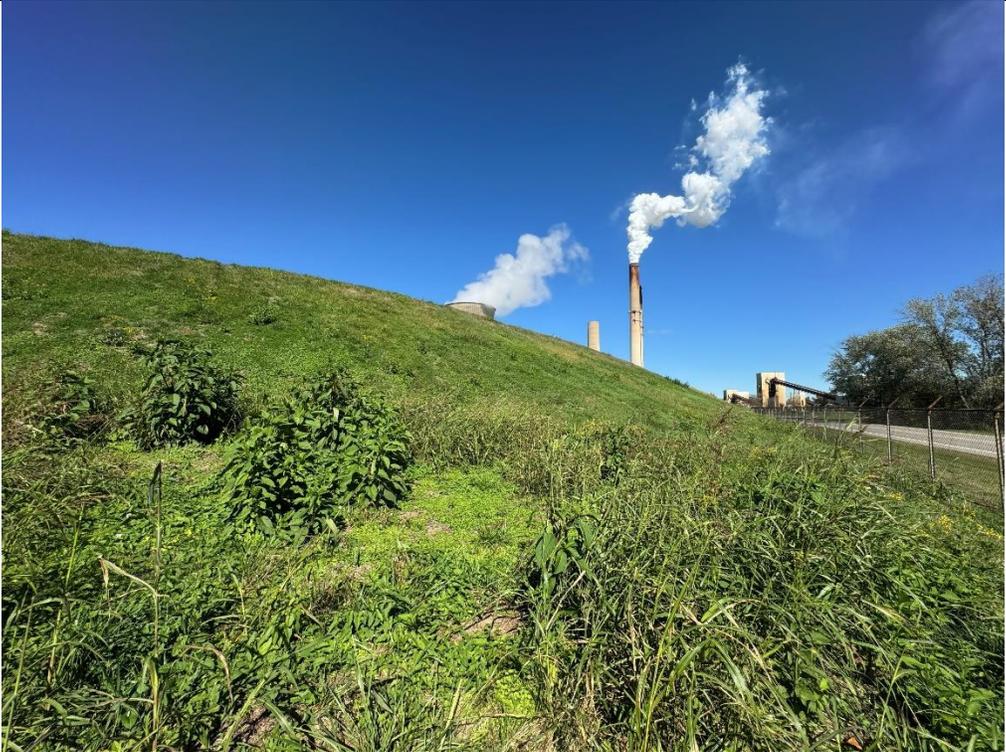
PHOTO NO. 21.	DATE 20 October 2025

DIRECTION PHOTO TAKEN North.		
DESCRIPTION View of BAP southern embankment exterior slope at SE bottom corner. Isolated areas of overgrown vegetation observed.

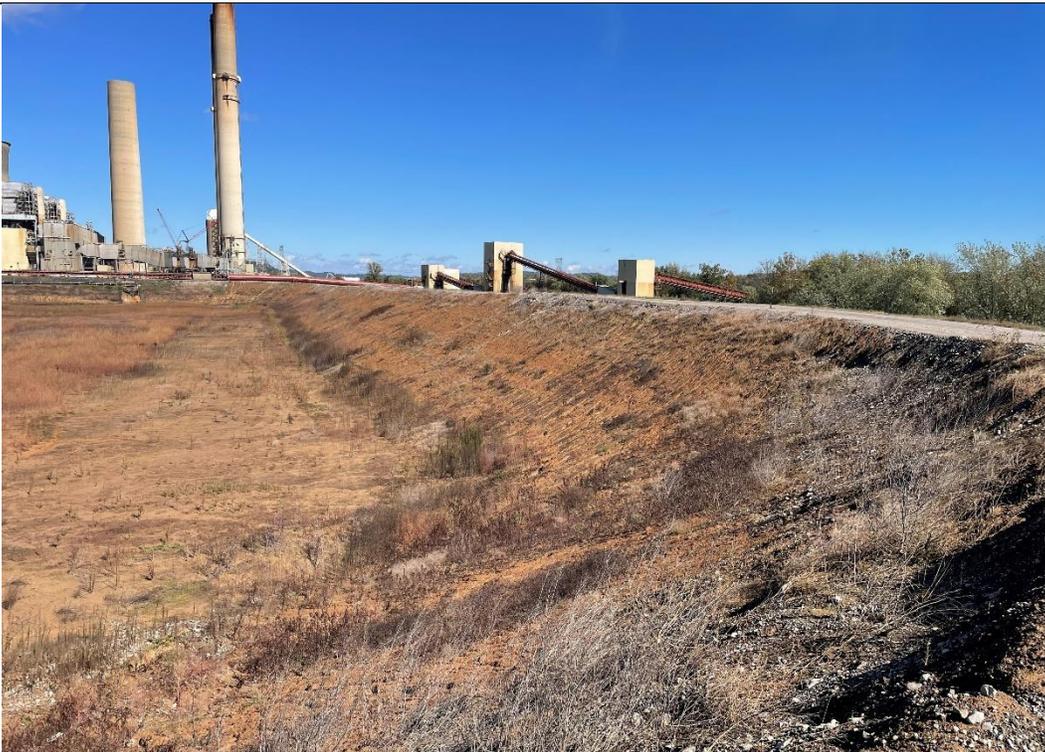
PHOTO NO. 22.	DATE 20 October 2025

DIRECTION PHOTO TAKEN North.		
DESCRIPTION View of BAP eastern embankment interior slope from access road. Erosion rills and forming gullies observed along slope.

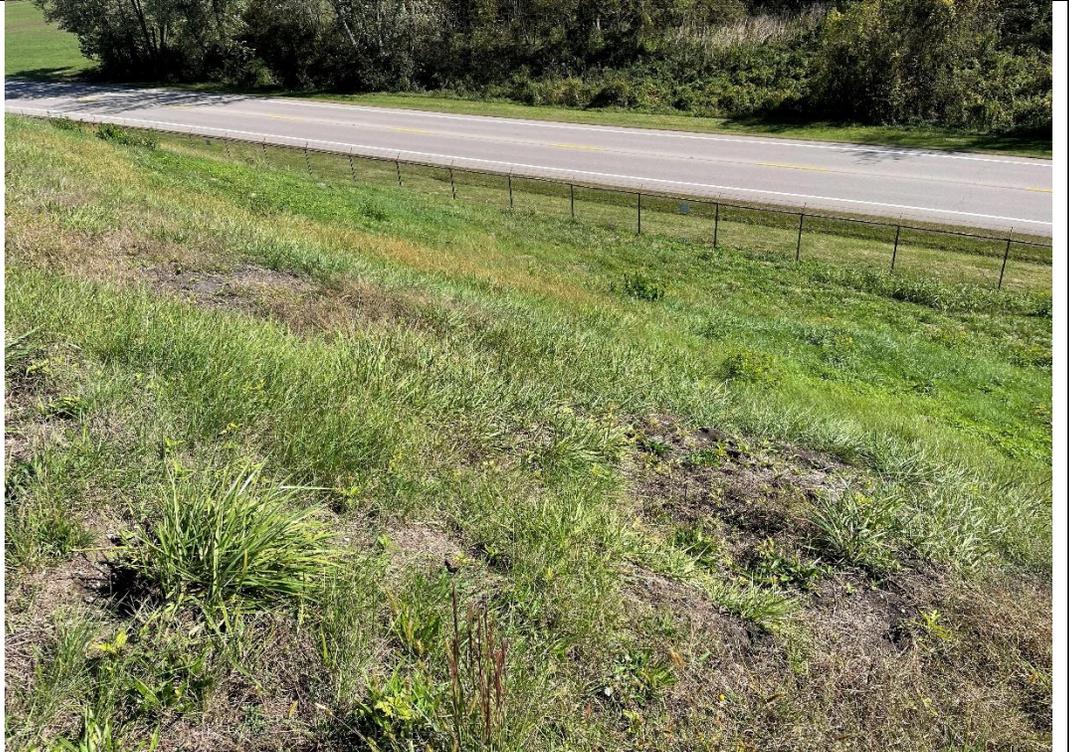
PHOTO NO. 23.	DATE 20 October 2025
DIRECTION PHOTO TAKEN Top view.	
DESCRIPTION View of BAP eastern embankment exterior slope near SE corner. Small exposed areas and apparent erosion from access road surface observed.

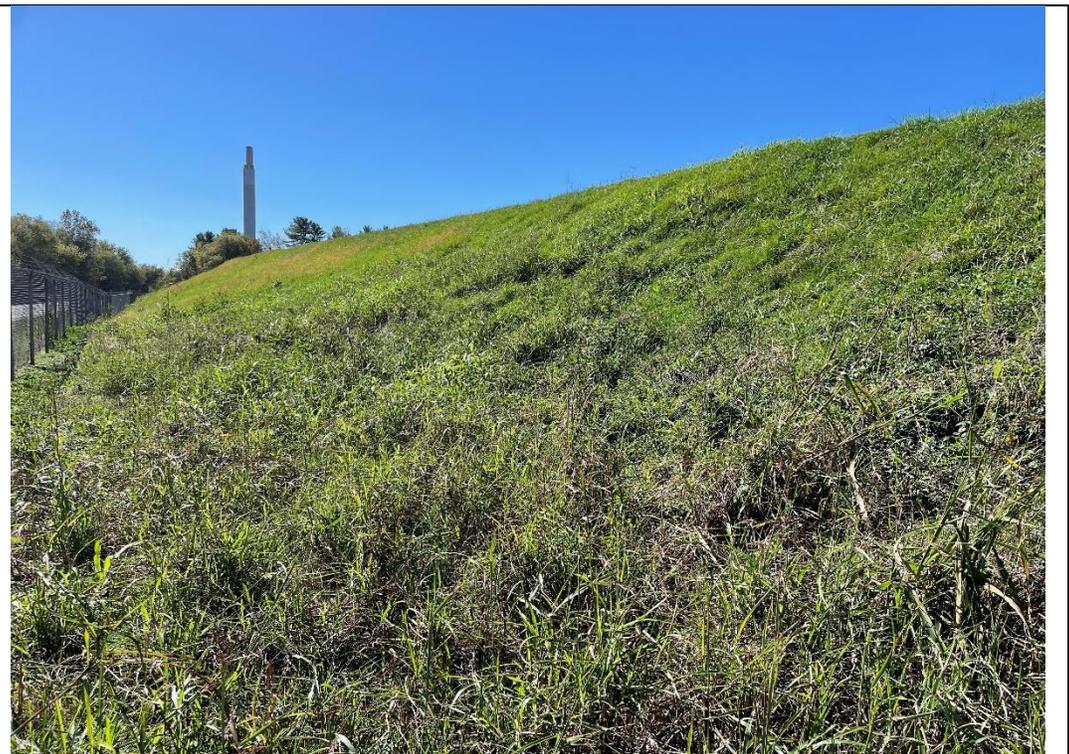
1. No evidence of seeps along the toe of the embankment were observed.
2. The exterior slope appeared stable, and the majority of the slope had well-established vegetative growth with isolated areas of sparse vegetation coverage (Photographs 23 through 27, & 29). Previously identified small crescent shaped scarp areas were observed near the toe. These areas continue to be well vegetated and show no sign of seepage, instability or movement (Photographs 24 through 26).

PHOTO NO. 24.	DATE 20 October 2025
DIRECTION PHOTO TAKEN South.	
DESCRIPTION View of BAP eastern embankment exterior slope. Scarp area #1 (northmost) observed stable.

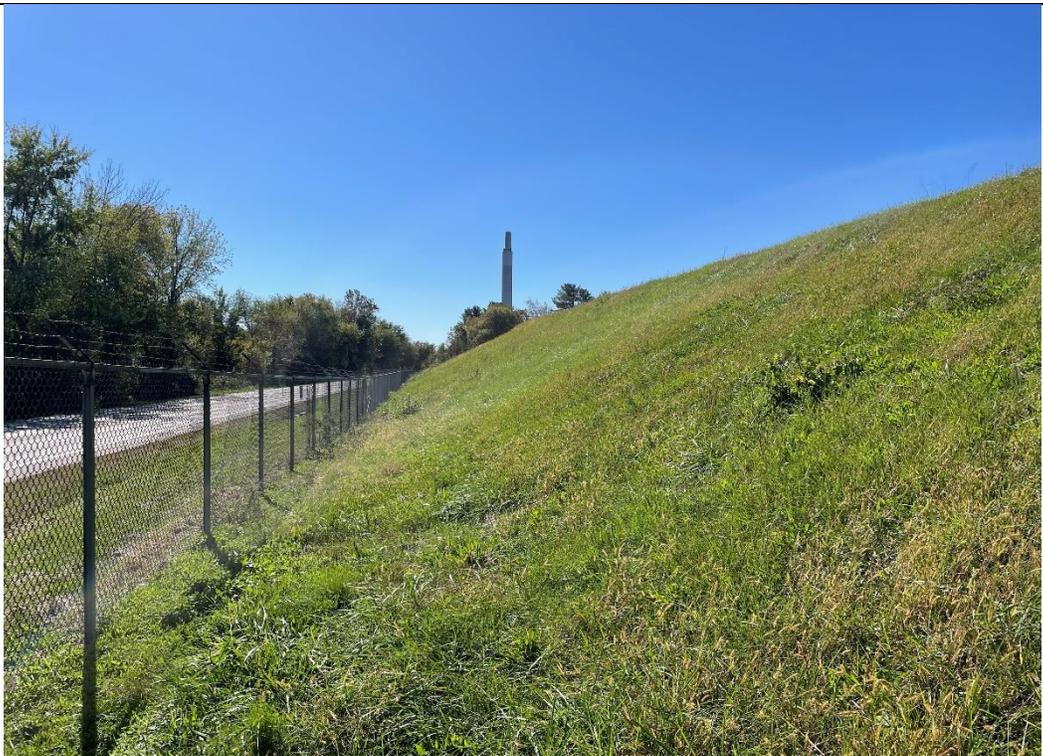
<p>PHOTO NO. 25.</p>	<p>DATE 20 October 2025</p>

<p>DIRECTION PHOTO TAKEN South.</p>		
<p>DESCRIPTION View of BAP eastern embankment exterior slope. Scarp area #2 observed stable.</p>

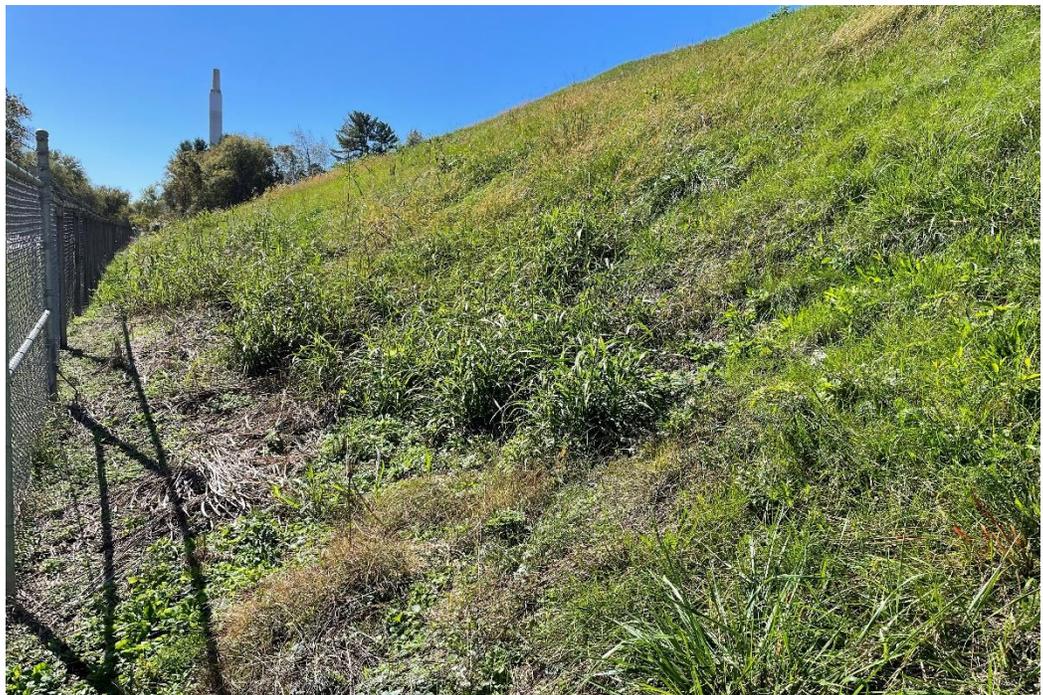
<p>PHOTO NO. 26.</p>	<p>DATE 20 October 2025</p>

<p>DIRECTION PHOTO TAKEN South.</p>		
<p>DESCRIPTION View of BAP eastern embankment exterior slope. Scarp area #3 (southmost) observed stable. Isolated areas of overgrown vegetation observed.</p>

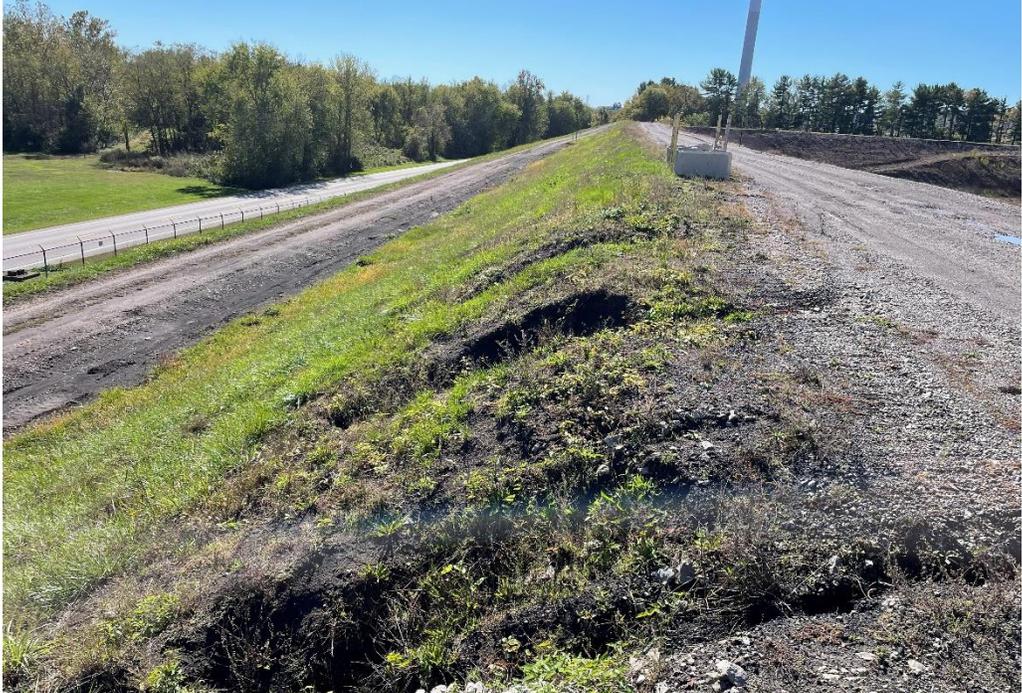
<p>PHOTO NO. 27.</p>	<p>DATE 20 October 2025</p>

4. The eastern embankment access road was found in stable condition and remains well maintained (Photographs 22 and 27).
5. Former bottom ash sluice steel piping has been completely removed from the exterior face eastern embankment (Photograph 27). The piping formerly ran along the mid slope access road parallel with but elevated above Route 7. Bottom ash was observed in an assumed layer along the former path of the piping and appeared to have been historically placed as a base material under the piping run. This material appears to be present only on the outside of the berm, is superficial, and serves no structural function. Therefore, this material will be considered for removal during the vegetative growing season and placed within the Residual Waste Landfill (RWL). Disturbed areas should either have aggregate reapplied or disturbed soil seeded and mulched.

<p>DIRECTION PHOTO TAKEN South.</p>		
<p>DESCRIPTION View of BAP eastern embankment exterior slope. Exposed areas of removed piping.</p>

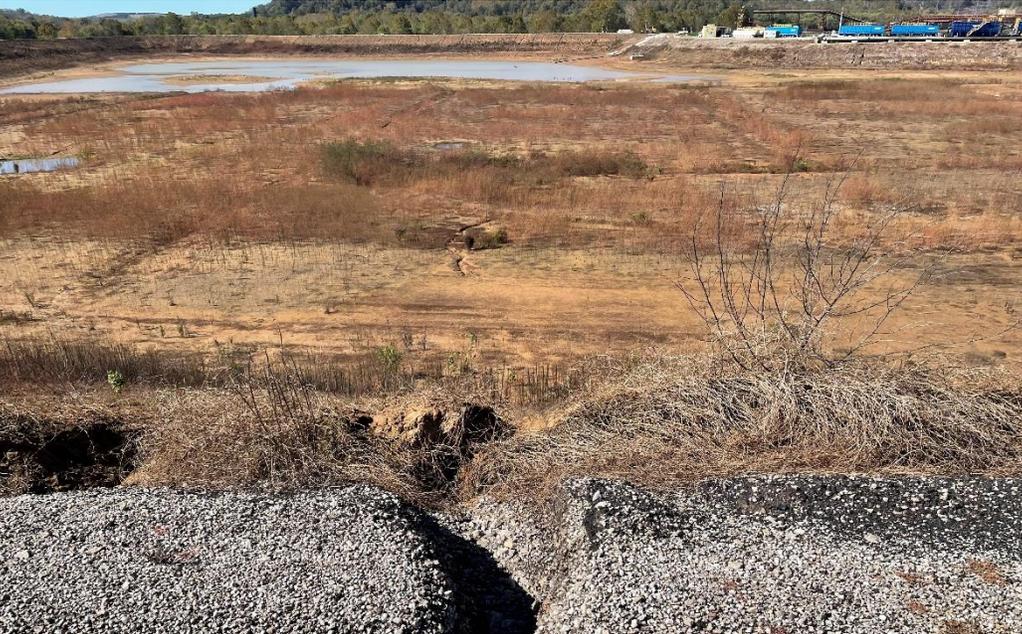
<p>PHOTO NO. 28.</p>	<p>DATE 20 October 2025</p>

<p>DIRECTION PHOTO TAKEN West.</p>		
<p>DESCRIPTION View of BAP eastern embankment interior slope top from access road. Erosion gullies (up to approximately 3 ft deep) observed starting to cut into access road surface.</p>

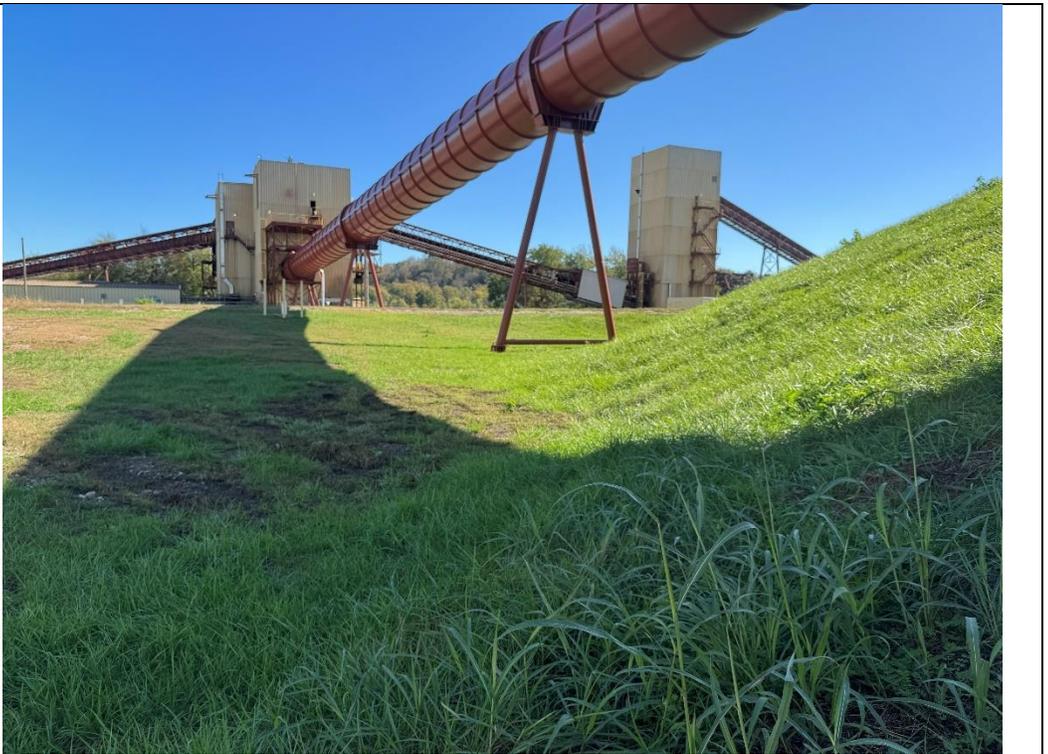
<p>PHOTO NO. 31.</p>	<p>DATE 20 October 2025</p>

<p>DIRECTION PHOTO TAKEN East.</p>		
<p>DESCRIPTION View of BAP northern embankment exterior slope near NE bottom corner. Isolated areas of sparse vegetation observed.</p>

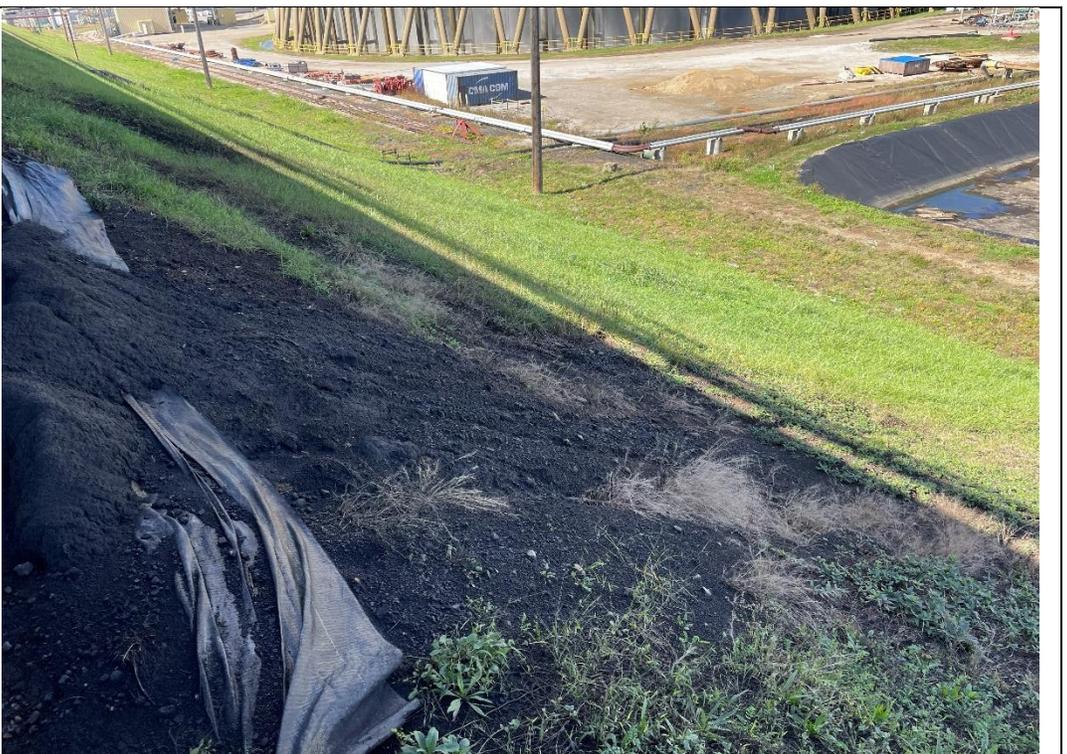
<p>PHOTO NO. 32.</p>	<p>DATE 20 October 2025</p>

<p>DIRECTION PHOTO TAKEN Top view.</p>		
<p>DESCRIPTION View of BAP northern embankment exterior slope from top. Some areas of excess coal accumulation observed along slope.</p>

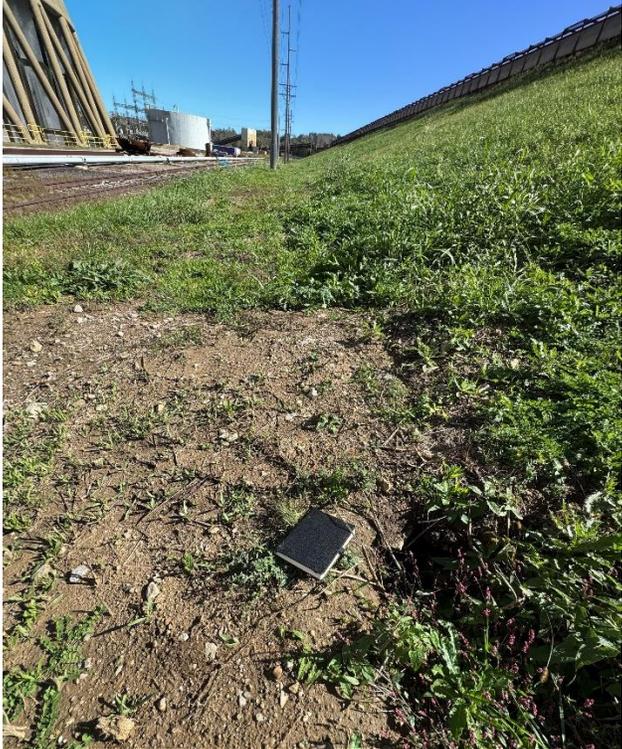
PHOTO NO. 33.	DATE 20 October 2025

DIRECTION PHOTO TAKEN East.		
DESCRIPTION View of BAP northern embankment exterior slope bottom. Isolated areas of sparse vegetation cover (fieldbook shown for scale).

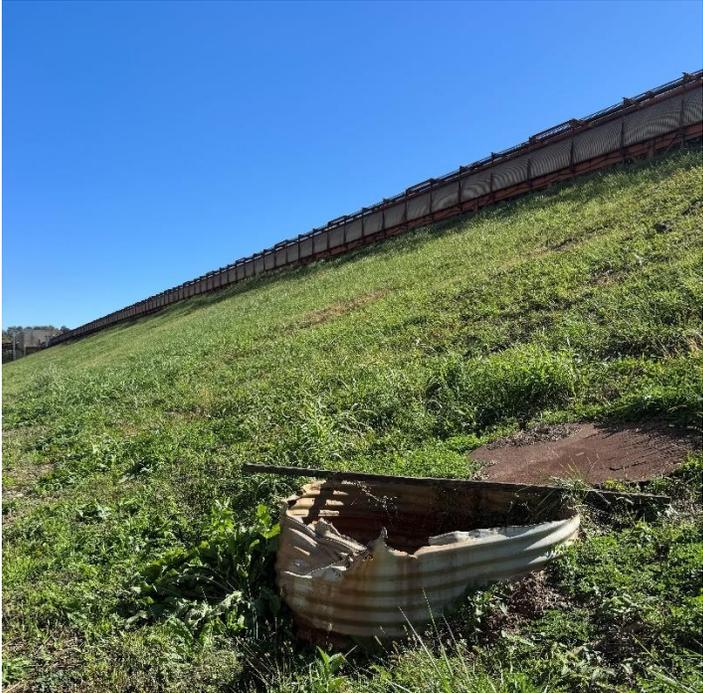
PHOTO NO. 34.	DATE 20 October 2025

4. A corrugated metal riser pipe on the northern exterior slope that was inaccessible in previous inspections had the heavy-steel lid removed during this site visit. This riser contained numerous valves and hose attachments and appeared in good condition (Photograph 34). The damaged CMP riser is a protective vault for this nest of valves and appears to be protecting them in a satisfactory condition. This riser is in the same condition as noted in previous reports being rusted and damaged. Repair of this riser mentioned in previous reports is a minor issue and should be monitored for progression and repaired if required to be protective of the valve system.

DIRECTION PHOTO TAKEN East.		
DESCRIPTION View of BAP northern embankment exterior slope from bottom. Open-top corrugated riser observed with apparent damage at surface.
