2025 Annual Inspection Report

Bottom Ash Pond

PREPARED FOR
Gavin Power, LLC

REFERENCE
0767401

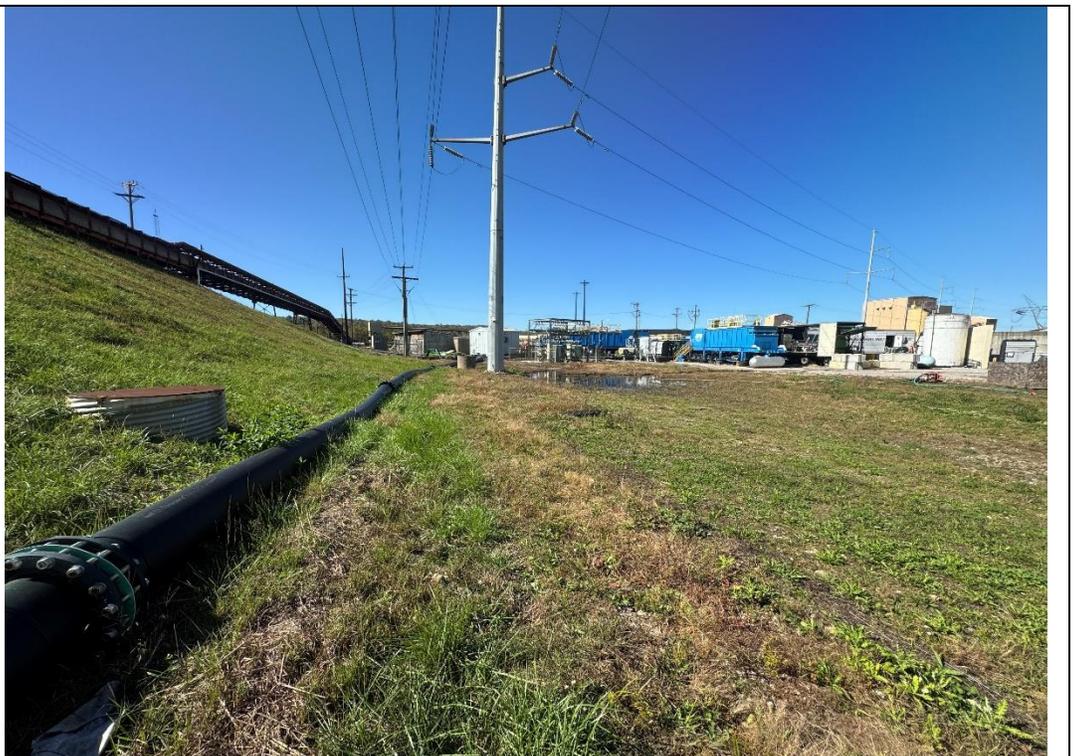
<p>PHOTO NO. 35.</p>	<p>DATE 20 October 2025</p>

<p>DIRECTION PHOTO TAKEN West.</p>		
<p>DESCRIPTION View of BAP northern embankment exterior slope bottom. Standing water observed at bottom area of recent excavation backfill in background. Temporary piped discharge to NPDES outfall.</p>

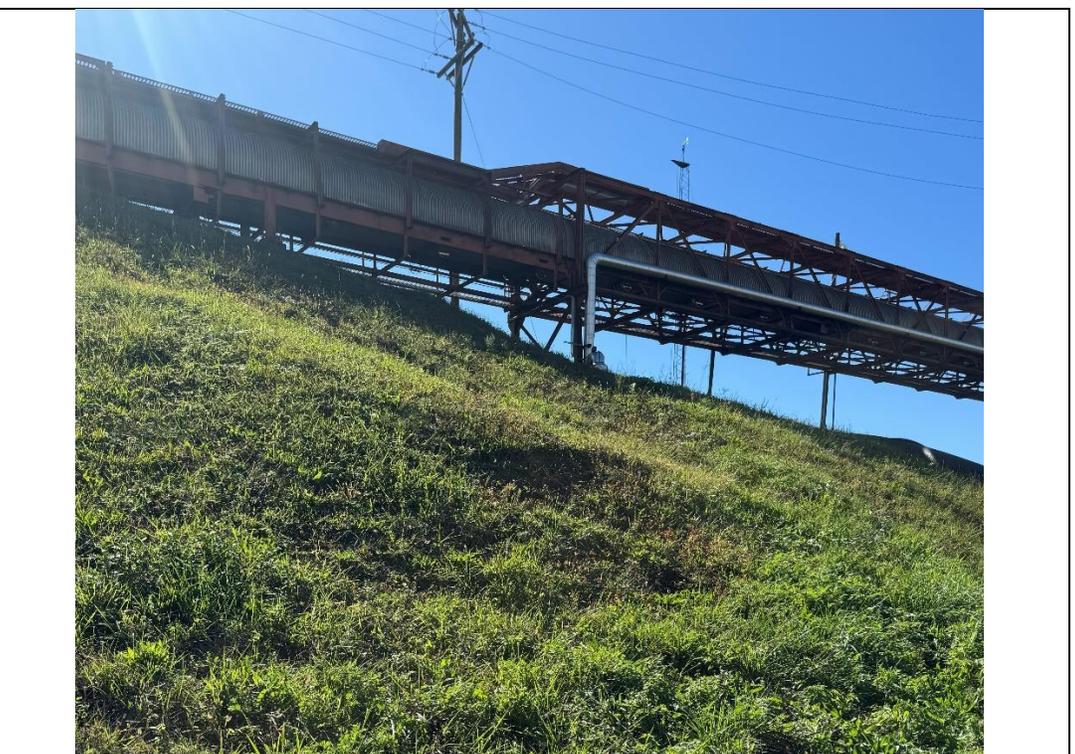
<p>PHOTO NO. 36.</p>	<p>DATE 20 October 2025</p>

<p>DIRECTION PHOTO TAKEN Southwest.</p>		
<p>DESCRIPTION View of BAP northern embankment exterior slope near NW top corner. Hummocky terrain observed in stable condition. Isolated areas of sparse vegetation observed.</p>

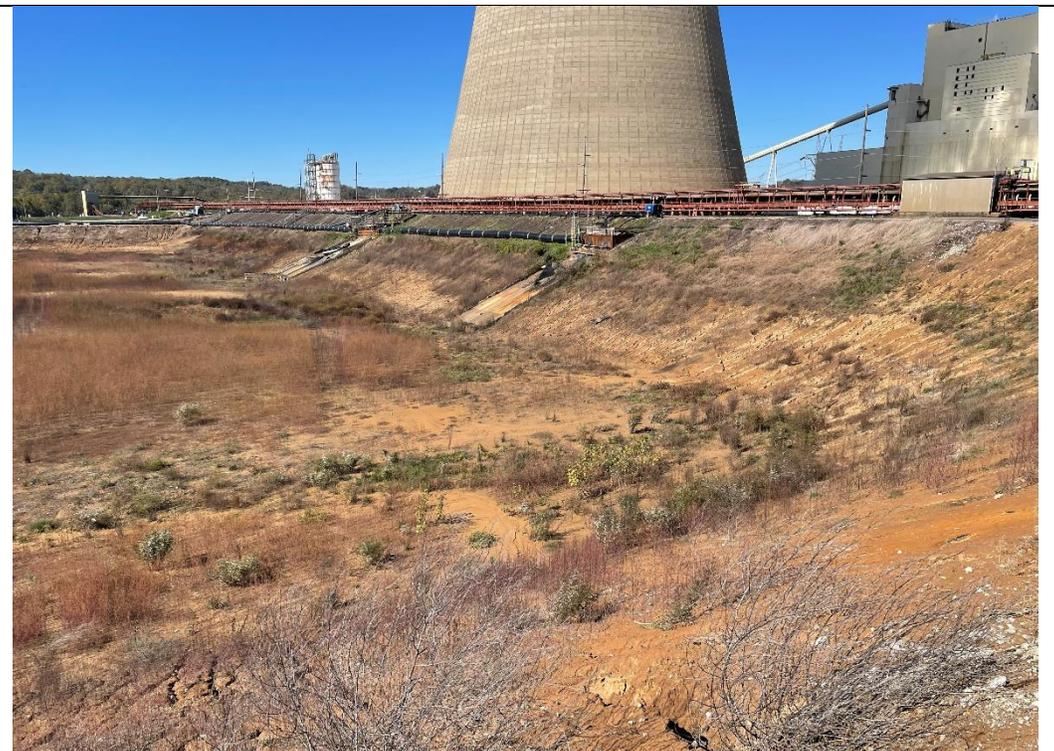
<p>PHOTO NO. 38.</p>	<p>DATE 20 October 2025</p>

5. The Gavin facility ceased placement of CCR in the BAP in 2022 to facilitate the BAP closure. Discharges of non-CCR waste streams into the BAP ceased in April 2023. Non-CCR process water is generated from facility operations, piped into two steel collection structures located on the northern embankment of the BAP, and routed through high-density polyethylene diversion piping (Photograph 4) to the ancillary modular treatment system and then to the Reclaim Pond. The diversion piping appeared to be functioning in a satisfactory manner with no pipe leakage observed. The steel collection structures were observed to have minor leakage from each. Practices consisting of temporary collection sumps and portable pumps were being used to capture and reintroduce this leaked process water back into the treatment system. A minimal observable amount of leakage was also observed going into the floor of the BAP. This water appears to comingle with periodically accumulated stormwater and is pumped back into the treatment system from the low area near the western embankment (Photographs 38 and 39). ERM observed that two replacement steel collection structures were being fabricated during the site inspection. Discussions with Gavin personnel confirmed that

<p>DIRECTION PHOTO TAKEN Northwest.</p>		
<p>DESCRIPTION View of BAP northern embankment interior slope near NE corner. Seepage observed at effluent discharge spillways on northern slope into BAP. Facility personnel actively working on repair plan.</p>

the leaking steel troughs were successfully replaced with the newly fabricated structures, which were installed from 17 November 2025 to 25 November 2025.

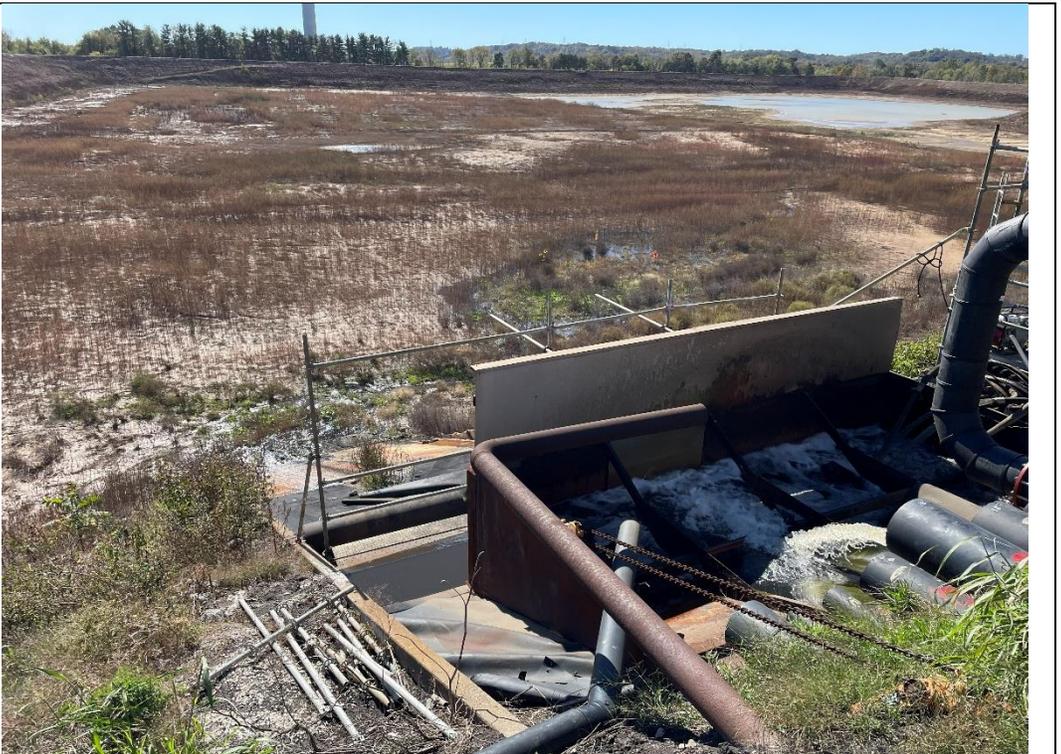
<p>PHOTO NO. 39.</p>	<p>DATE 20 October 2025</p>

<p>DIRECTION PHOTO TAKEN South.</p>		
<p>DESCRIPTION View of BAP northern embankment interior slope from top access road. Seepage observed at effluent discharge spillway into BAP. Facility personnel actively working on repair plan.</p>

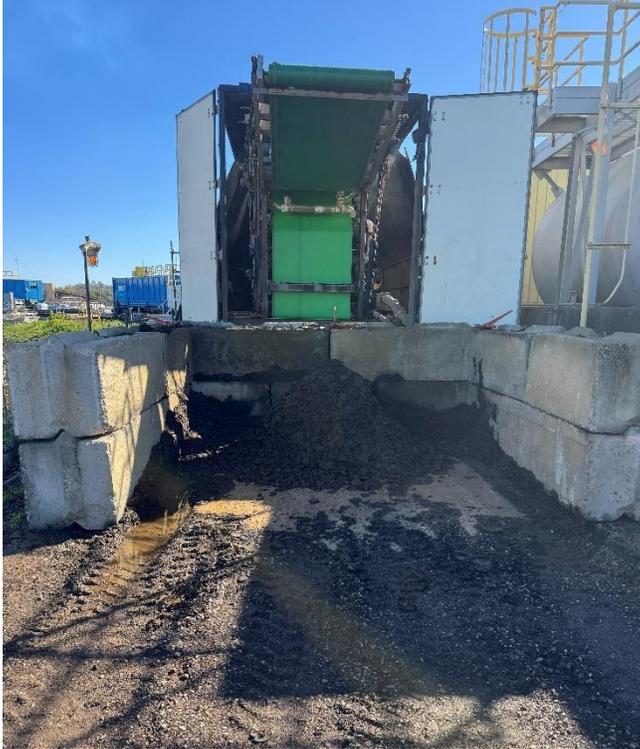
PHOTO NO. 41.	DATE 20 October 2025

Temporary storage of filter press material from the modular treatment system was observed both on the Reclaim Pond embankment within a collection bin at the end of the press and in a temporary concrete block bunker on the inside crest of the western BAP embankment. The material handling procedure appeared to be the same procedure as observed during the 2024 inspection. ERM understands that this material is consolidated and regularly hauled to the RWL for disposal. ERM further understands that the filter press material is an acceptable waste for placement in the Residual Waste Landfill and the permit has been updated accordingly. Filter press material appeared to be contained and managed properly. Current BMPs to prevent spillage and tracking of this filter material should continue to be implemented (Photographs 41 and 42).

DIRECTION PHOTO TAKEN Northeast		
DESCRIPTION View of filter cake active stockpile from Reclaim Pond water filtration operations.

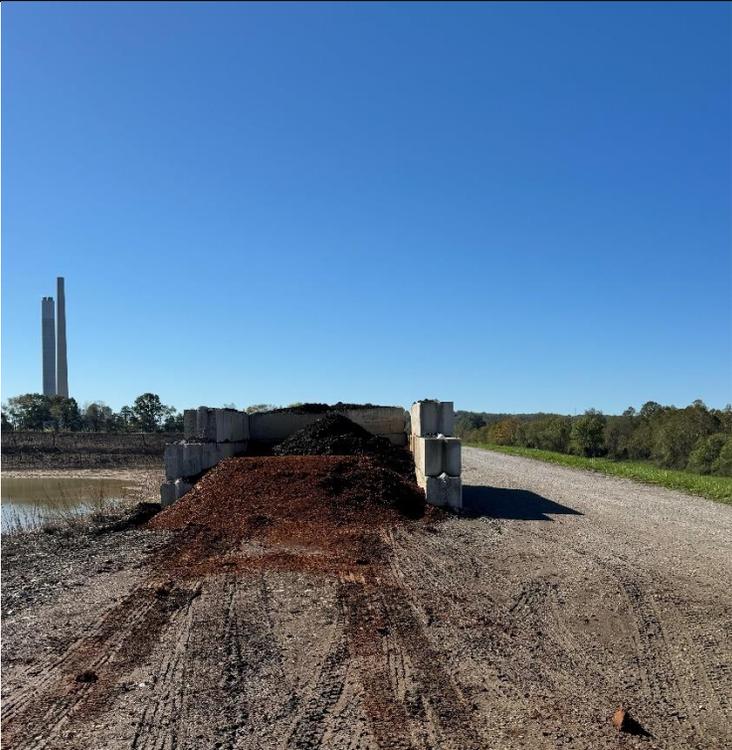
PHOTO NO. 42.	DATE 20 October 2025

DIRECTION PHOTO TAKEN South.		
DESCRIPTION View of filter cake active stockpile from Reclaim Pond water filtration operations.

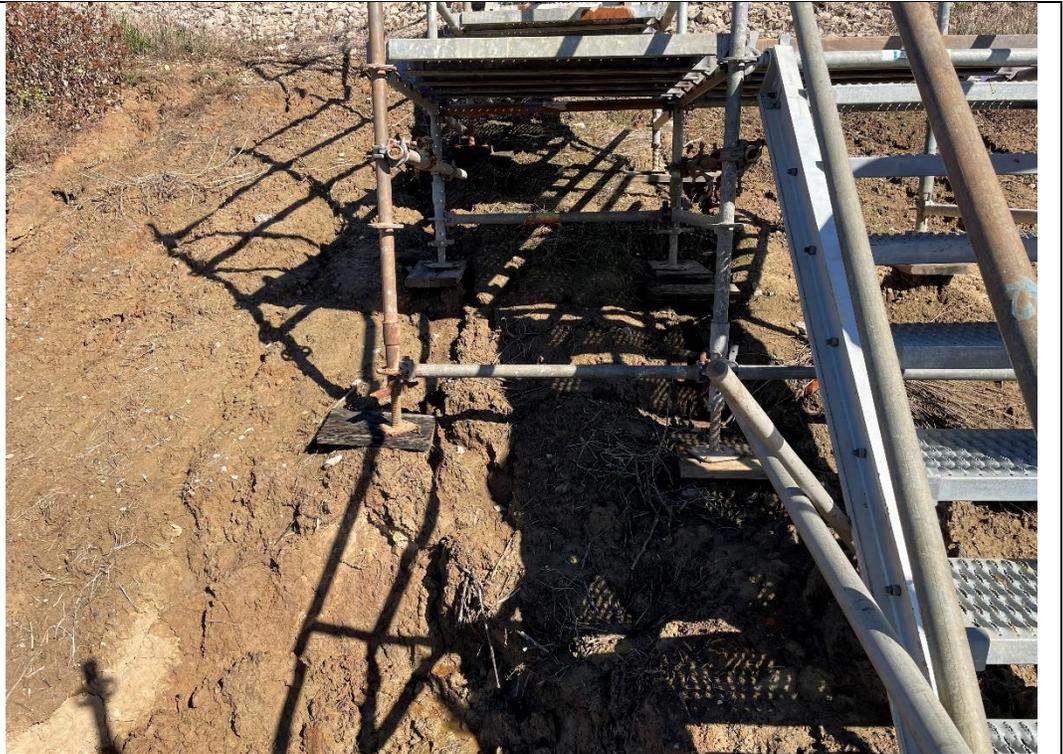
The single minor point of potential seepage observed in 2024 was observed to still be present in 2025. This seepage point is located near the toe of the Reclaim Pond embankment on the dewatered BAP side of the southern Reclaim Pond embankment. This was located at the approximate horizontal halfway point of the embankment and near the toe at an elevation similar to that of the former discharge piping from the demolished riser structure (Photographs 1 and 43). The potential seep continues to have no visible sheen or color that might be indicative of impaired water quality.

PHOTO NO. 43.	DATE 20 October 2025
DIRECTION PHOTO TAKEN Front view.	
DESCRIPTION View of Reclaim Pond southern embankment, BAP interior slope at area of potential seepage under investigation.
