2020 Annual Inspection Report

Gavin Power, LLC

Residual Waste Landfill

Gavin Power Plant
Cheshire, Ohio

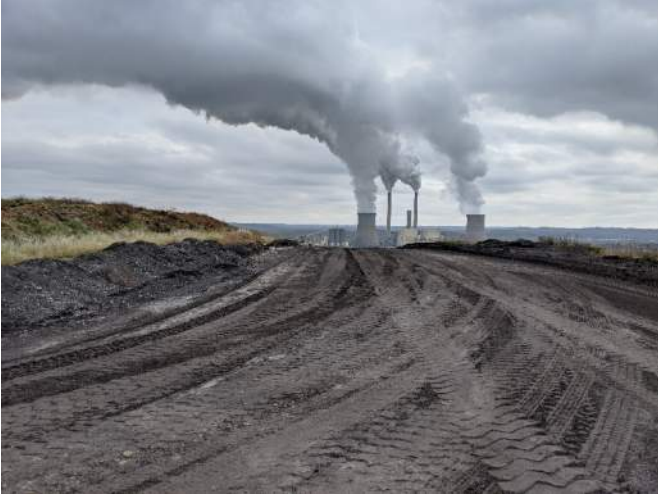
Photograph #1

The haul roads across or to the active areas of CCR placement use bottom ash as a base course (as observable in Photographs 1, 2, and 3). This base course appears to compact well and withstands repeated heavy equipment traffic. The haul roads observed by ERM appeared to be stable during the site drive/walkthrough, and there was no visual evidence of significant distress (i.e., rutting or pumping). In addition, the roads generally had positive drainage from the centerline, and there was no visible evidence of ponding water on the roadway surface. Drainage channels paralleling the roadways capture stormwater runoff from adjacent slopes, which is directed to stable outlets that ultimately discharges to the surrounding site treatment ponds. ERM observed sporadic evidence of minor erosion in the channel bottoms, but overall, roadside channels appeared well maintained. ERM observed active cleaning of roadside channels along the eastern haul road during the site visit.

Main haul road constructed of bottom ash near midpoint of landfill (looking southeast)	
Photograph #2

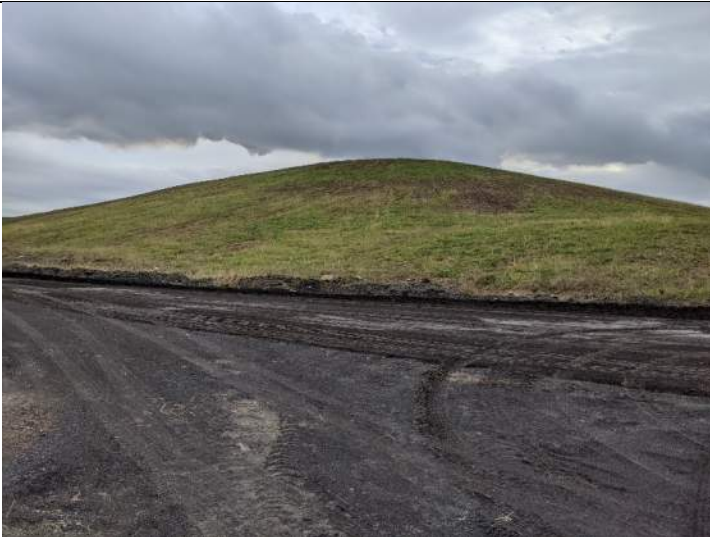
Main haul road constructed of bottom ash heading up the north western side of the landfill (looking southeast)	
Photograph #3

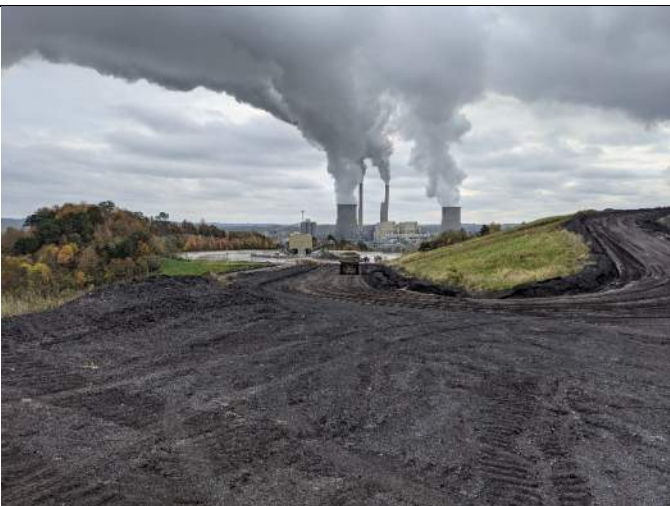
Main haul road constructed of bottom ash near east side of interim summit elevation (looking south)

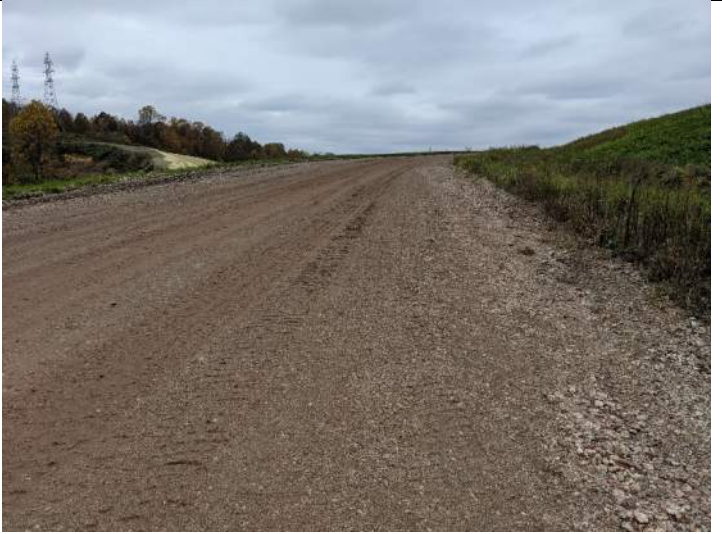
<p>Photograph #4</p>

There were several sections of permanent roads that have a gravel base course depicted in Photographs 4, 5, and 6. These roads also appeared to be stable with no visible evidence of distress. More frequently used roadways incorporate robust drainage channels adjacent to slopes, which were positively graded and include rock check dams (Photograph 6 and 7). The drainage channels on the eastern slopes appeared well maintained with no visible evidence of obstructions or deterioration.

<p>Southwestern gravel access roads (looking west)</p>	
<p>Photograph #5</p>

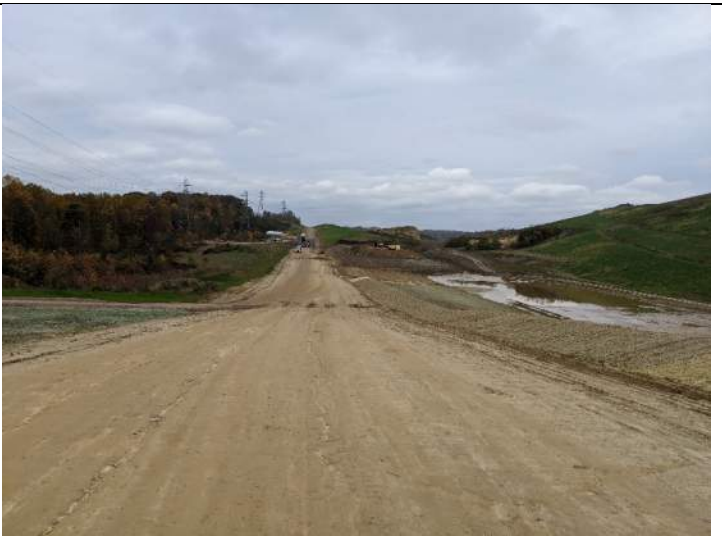
<p>Southwestern gravel access roads and vegetated soil covered slope heading to Phase I (looking northwest)</p>	
<p>Photograph #6</p>

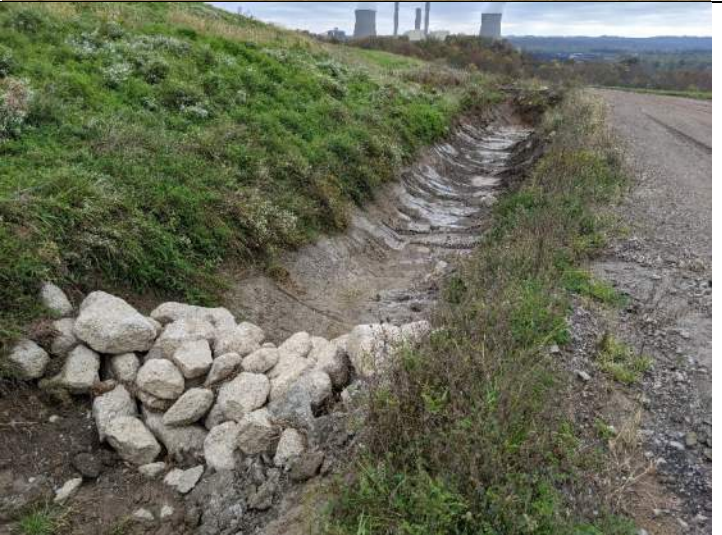
<p>Southeast gravel access road and roadside channel with rock check dams. (Looking south)</p>

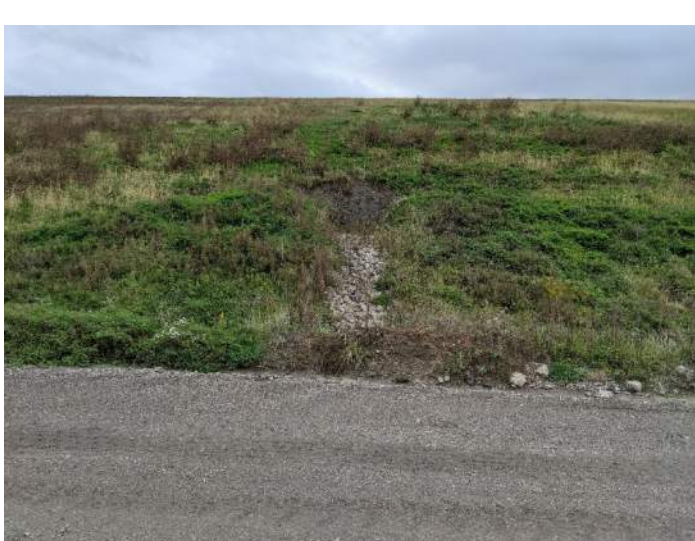
There were infrequent instances where significant erosion rills/gullies were observed (Photograph 12 and 13) in the surface of the intermediate cover. It appeared that repair attempts were in progress based upon the presence of newly-placed soil near the observed features. Sedimentation was contained, and there was no visible evidence that erosion has the potential to disrupt the operation and safety of the RWL or that observed erosion features were creating an unstable situation.

<p>Erosion gully into FGD material in recent soil covered section of directly seeded FGD. (looking west)</p>

3. Seed and fertilize localized bare soil areas along completed slopes to aid in the revegetation process, adding soil amendments and lime as needed.
4. Continue to repair erosion gullies and rills as they are encountered. Continue to monitor areas where rills or gullies have formed.

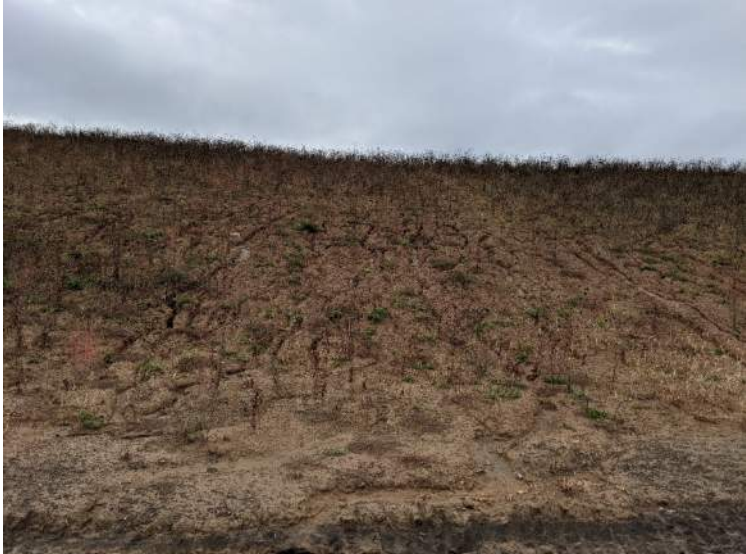
<p>Photograph #13</p> <p>Erosion riling on limited area of slope and localized erosion of channel into FGD. Slope repair in progress. (looking west)</p>

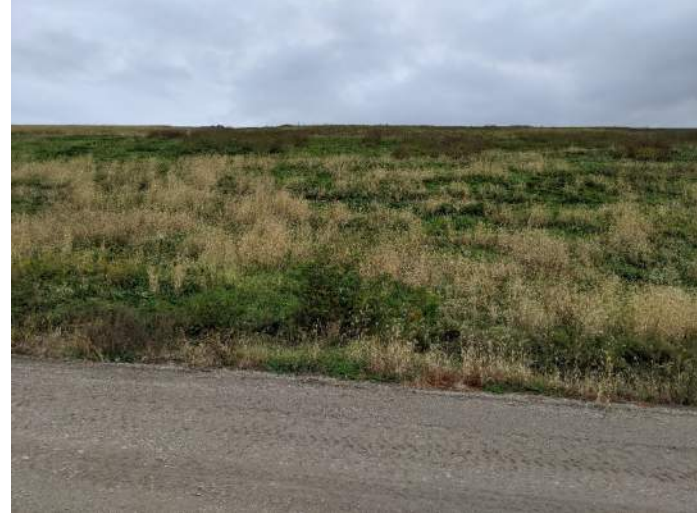
<p>Photograph #14</p> <p>Southeast slope with satisfactory vegetation. (looking southeast)</p>

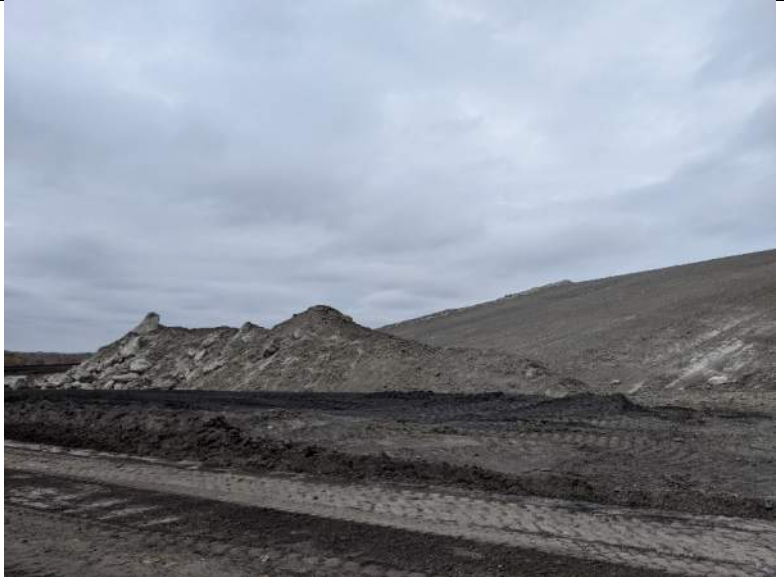
<p>Photograph #15</p> <p>Southeast slope with sporadic areas of sparse vegetation. (looking southeast)</p>

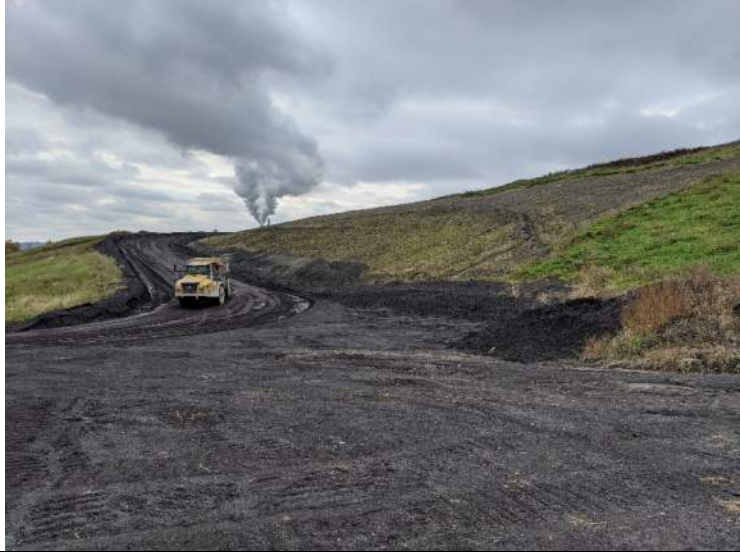
Photograph #22

Sparse vegetation on southern slope where direct seeding of FGD was attempted (looking southwest)

1. Deficiencies identified during weekly inspections should be documented and addressed in a timely manner as a Best Management Practice.
2. Complete placement of intermediate soil cover, seed, and mulch on areas of direct FGD seeding where poor vegetative growth has been experienced. Soil pH and nutrient tests are recommended to target appropriate amounts of lime and fertilizer application to accomplish successful vegetative growth while minimizing the potential for over application.

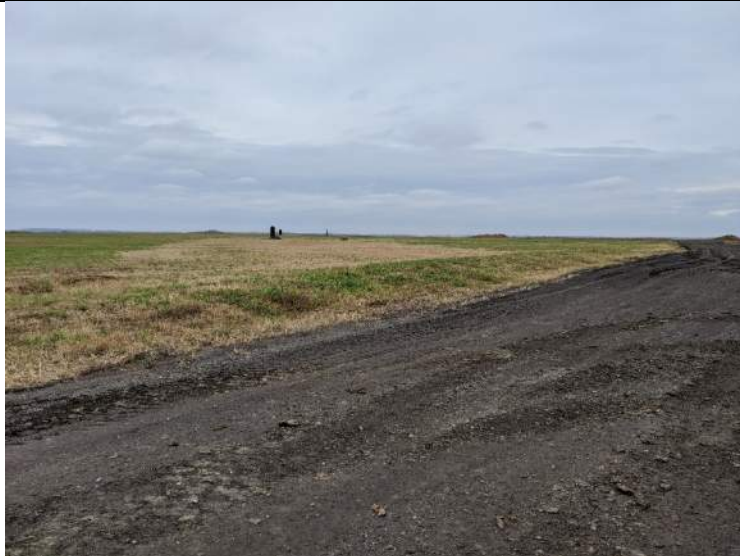
Photograph #23

Interim summit of landfill with soil cover with additional seed and mulch applied to correct areas of sparse vegetation. Chimney drains in the distance. (looking northwest)

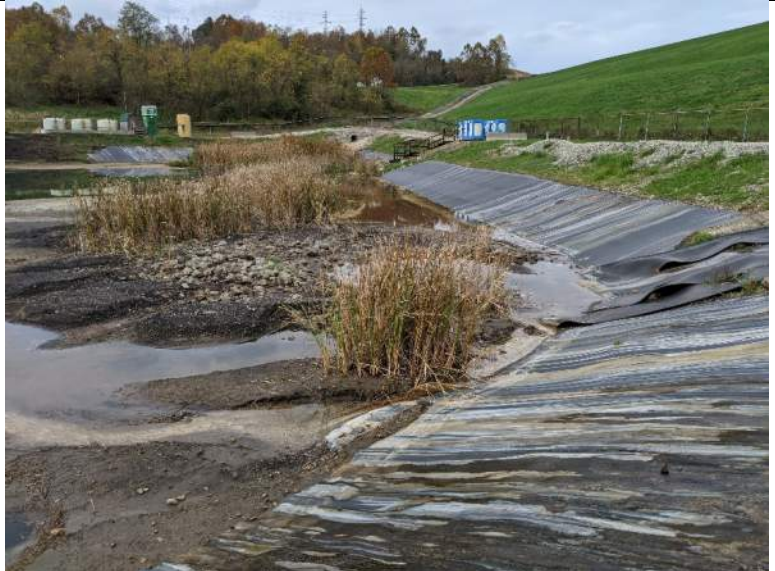
<p>Photograph #30</p>

Pond No. 1 on the south side of the RWL appeared to be functioning properly during the annual inspection. The sedimentation/treatment portion of Pond No. 1 was observed to contain varying amounts of solids within the limits, as observable in Photographs 29, 30, and 31. This pond is routinely cleaned of accumulated solids, typically through the use of extended-reach excavators or a floating dredge. Based on a visual assessment, Pond No. 1 was noted to have a similar amount of sedimentation as observed during the 2019 inspection.

<p>View of vegetated sediment patch in Pond No. 1 (looking east)</p>

8. Schedule and commence removal of vegetative growth and sediments from inside Pond No. 1 and No. 3 in appropriate sequence with other ongoing maintenance and repairs. Clean channel inlets on both Pond No. 1 and No. 3 to remove sediment buildup.

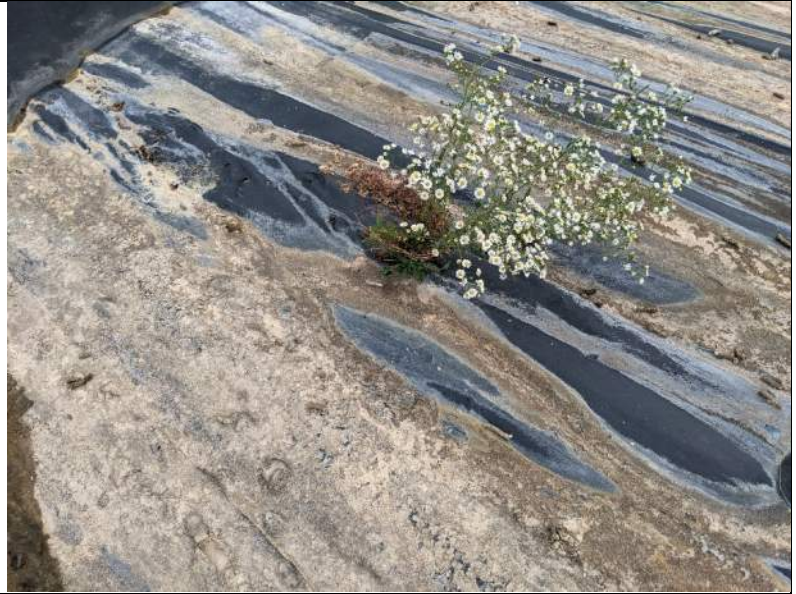
Photograph #33

Small tear in crest run out portion of the liner of Pond 1 with vegetation growing through. (looking east)

10. Repair small tears and perforations identified in the geomembranes at Pond No. 1, No. 3 and No. 5. Routinely monitor all ponds for any additional tears and promptly repair when identified.

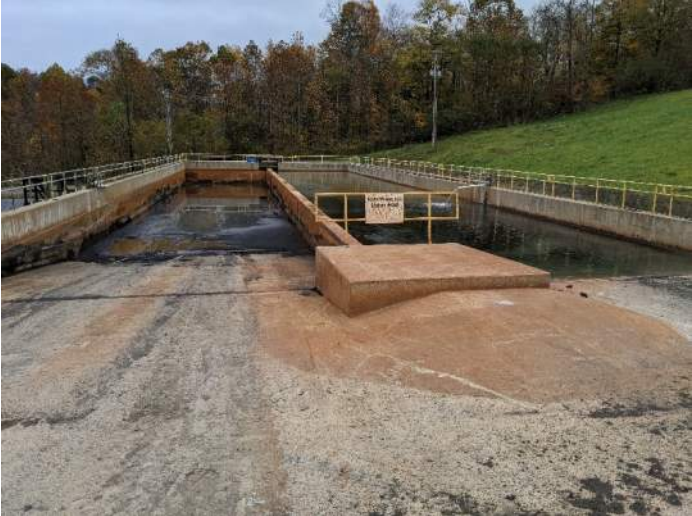
Pond No. 2 on the southeast side of the RWL was observed to be under repair during the annual inspection. To assist with the removal of FGD solids derived from the stack-out pad and to minimize dredging, Gavin Power operates a concrete settling basin at Pond No. 2 (Photograph 34). This basin is routinely cleaned with an extended-reach excavator.

<p>Photograph #34</p>	
<p>Concrete Settling basin adjacent to Pond No. 2. (looking east)</p>

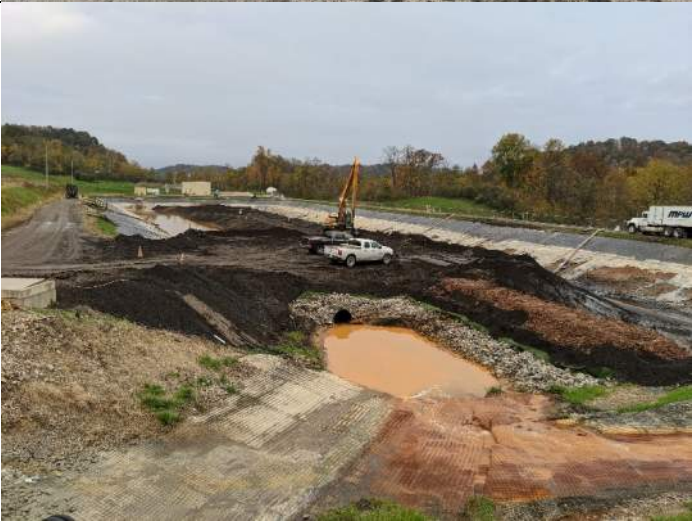
An elevated pad of bottom ash was observed within the limits of Pond No. 2 which split the pond longitudinally from north to south (Photograph 35). The resulting eastern one-half of the pond was under repair while allowing the western one-half to continue to provide treatment of the incoming leachate. The leachate inflow from the pipe from under the RWL to the west was observed to have been captured and was being pumped to the concrete settling basin. This allowed the leachate to enter the pond through the headworks in combination with runoff from the stacker pad. A smooth bucket, long-reach excavator was operating on top of the bottom ash pad for purposes of cleaning the eastern edge of the pond geomembrane. Portable pumps were being used to drain water from the eastern one-half of the pond to

allow for flushing of the geomembrane for cleaning prior to repair. Multiple laborers were observed making heat gun/glue patch liner repairs to identified holes on the eastern slope. The southeastern corner of the pond liner was identified to be in poor condition and was being scheduled for a complete panel replacement for several hundred feet along the operating level of the pond. The western one-half of the pond was also observed to have multiple holes and several areas of compromised geomembrane. It appeared that the facility was generally maintaining water levels below these locations. Gavin Power personnel indicated that once the eastern pond repairs were complete, the activities would be reversed for the western pond.

9. Complete the substantial repair to the Pond No. 2 geomembrane in an expeditious manner. Document repairs and test these for water tightness, particularly for repairs made below the operating water level.

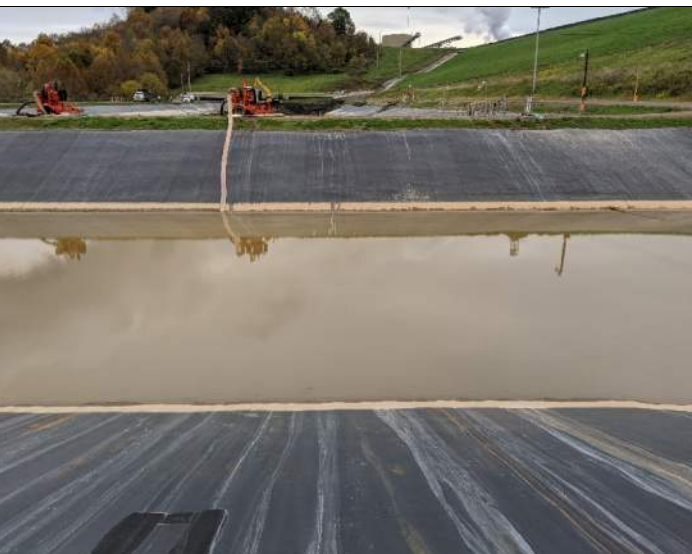
The clarifying pond appeared to be in adequate working condition with only a few minor rips or holes identified in the geomembrane above the water level (Photographs 36).

<p>Photograph #36</p>	
<p>Clarifying pond for Pond No. 2. Recent liner maintenance repair visible in bottom of image (looking south).</p>

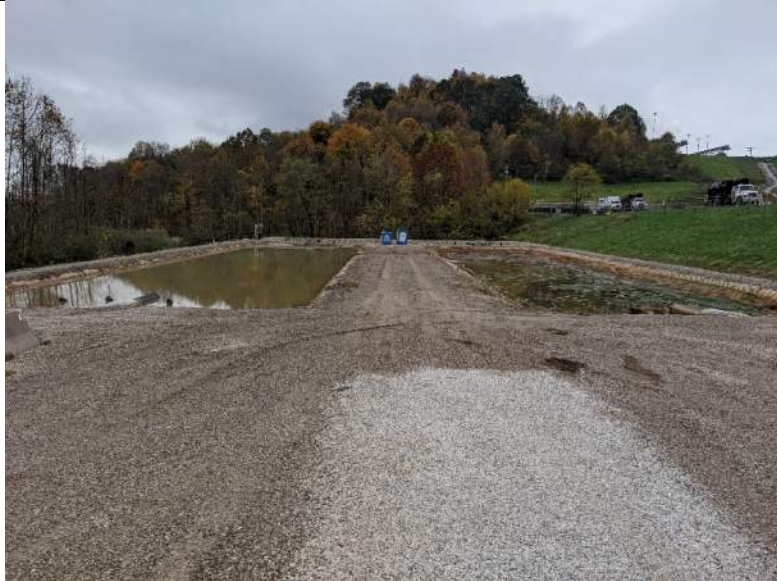
Photograph #37

The vertical flow wetlands for Pond No. 2 appeared to be in general working order; however, water was observed to be more turbid than observed in the past. Gavin Power personnel believes this to possibly be related to the churning associated with dewatering activities associated with the Pond No. 2 geomembrane repairs and the temporary condition of decreased detention time (Photograph 37).

Vertical flow wetlands for
Pond No. 2. (looking south).

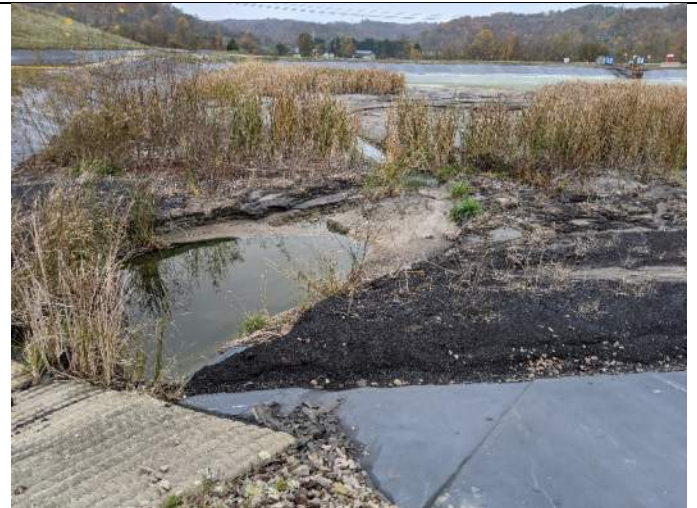
Pond No. 3 on the northeast side of the RWL was observed to be functioning satisfactorily during the annual inspection. Within Pond No. 3 there was vegetation observed within the central portion and along the western end as indicated in Photographs 38 and 39 (closest to the RWL), similar to the observations in the 2019 inspection. Pond No. 3 appears to have accumulated more solids in the open water portion of the pond since the previous annual inspection. This is based on observation that the solids level appeared to be just below the operating water level in several locations. Hydrogen peroxide was observed being added at the leachate inflow point this pond resulting in elemental Sulphur and white colored solids accumulating near the headworks of the pond. A small number of minor holes and tears were noted above the operating level of the main pond.

<p>Sediment and vegetation in pond 3 (looking east)</p>	
<p>Photograph #40</p>

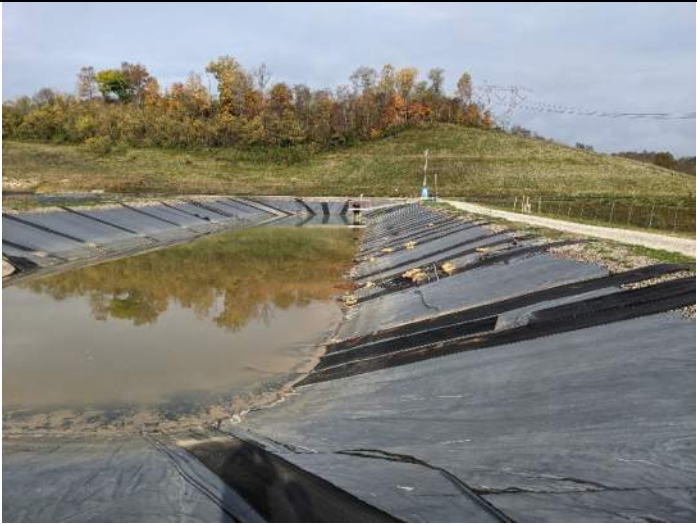
Within the clarifying pond, multiple holes and tears were identified in the geomembrane during the inspection with some having vegetative growth from beneath. Surficial layers of a protective PVC geomembrane were also suggesting significant levels of deterioration. This surficial PVC geomembrane was installed at some time in the past for ultraviolet protection over the primary geomembrane in the Pond No. 3 clarifying pond. (Photograph 40), and therefore is deemed to be a sacrificial layer. The tears and holes identified in the liner within the clarifying pond appear to be above the normal operating level.

<p>Clarifying pond for Pond 3. (looking west)</p>

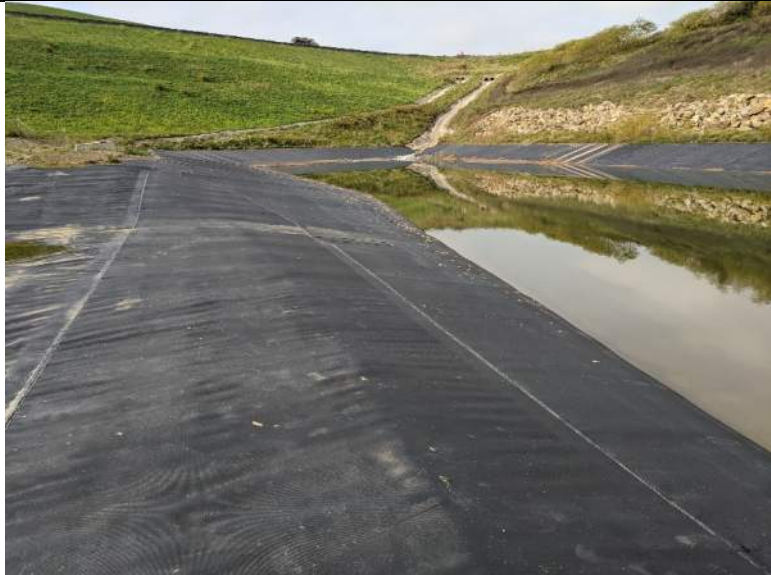
Photograph #41

Pond No. 5 (Photographs 41 and 42) on the northeast side of the RWL, adjacent to Pond No. 3, was observed to be functioning satisfactorily with respect to water flow and sedimentation during the annual inspection. The section of anchor trench on the southern edge of Pond No. 5 (adjacent to Pond No. 3) identified as being pulled out in the 2019 inspection has been repaired (see photographs 43 and 44). There was no indication of tearing of the geomembrane within the basin. During the inspection it was noted that there was accumulated water under the Pond No. 5 liner system along a limited section of the southwest edge and a much smaller portion of the northwest corner of the pond. This water was evidenced by a slight bulge at an elevation above the operating pond level. In discussions with Gavin Power personnel, a similar accumulation of water was removed during the anchor trench repair. This water was reportedly clear and appeared to be groundwater related. It appears, based on the reappearance of this condition that a perched groundwater condition may exist with a connection to the

Pond 5. Repaired anchor trench visible in center left of image. (looking west)

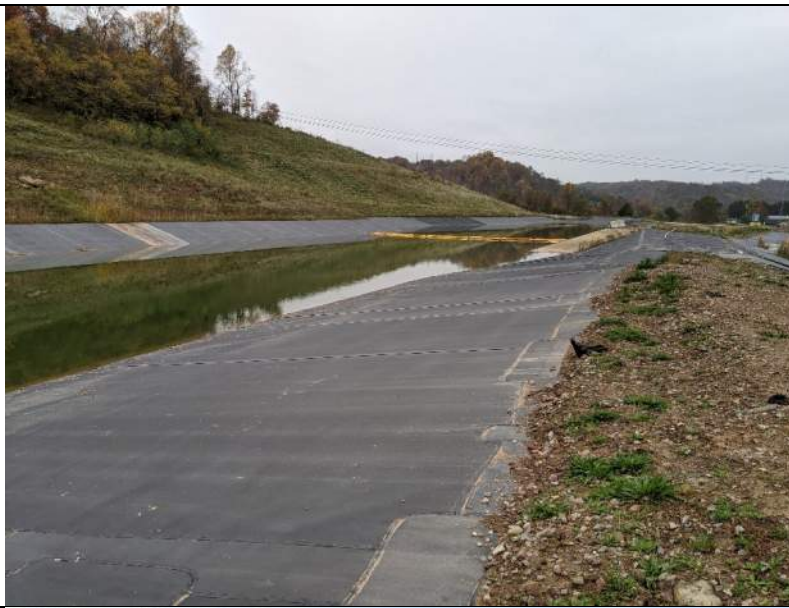
Photograph #43

Anchor trench on southern end has been repaired (looking east)

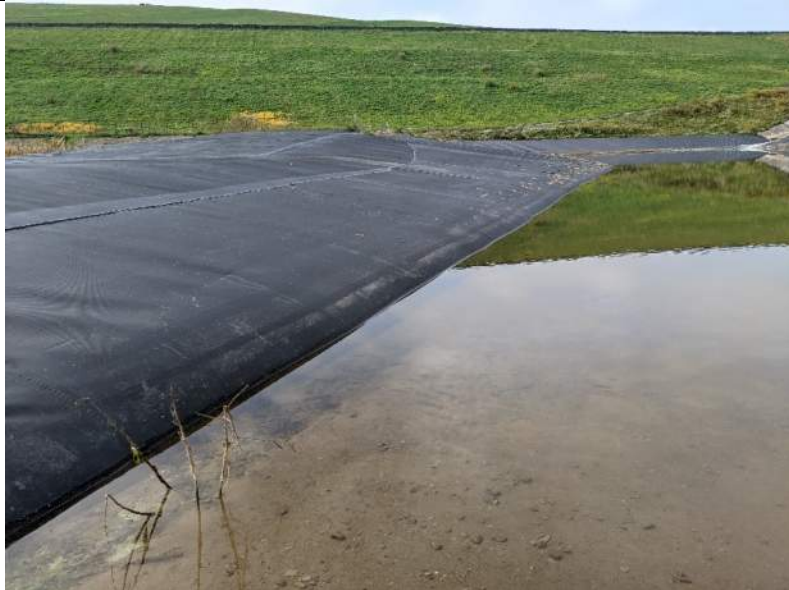
Photograph #44

Pond 5 area. The source of this water has not been identified but is apparently not from leaking of the pond since it accumulated above the operating level of the facility. The facility has installed slits in the geomembrane several feet above the operating level of the pond for purposes of inserting a suction withdrawal pipe for removal of accumulating water. A small pump is utilized to withdraw this water as needed to avoid stress and uplift pressures on the liner system from accumulated water. During the annual inspection this condition was reported to facility personnel and the facility mobilized laborers immediately to withdraw this water, which was discharged into the pond. There was one small rip and one small perforation identified in the geomembrane near the stormwater inflow in the northwest corner of the pond (Photograph 48). The vertical flow wetlands for Pond No. 3 and No. 5 appeared to be in working condition (Photograph 45).

View of southern edge of Pond 5 near concrete access. Bulge of water above pond operating level seen in geomembrane. (looking west).

12. Maintain drainage stone around the existing current chimney drains and protect these from sedimentation.
13. Drain water from underneath the pond liner system on the southwest and northwest corner of Pond No. 5 via dewatering perforations. Continue to monitor these portions of the pond for water buildup and drain water buildup when identified to avoid the addition of tension into the geomembrane until a permanent solution is implemented. During 2021, it is recommended to further assess the source of the water gaining entrance underneath the liner system and identify potential steps to prevent the build-up of water under the liner system from occurring in the future. If a correction is identified and implemented, repair the geomembrane dewatering perforations using appropriate patching and leak detection methods once the water source has been identified and further build-up is mitigated.

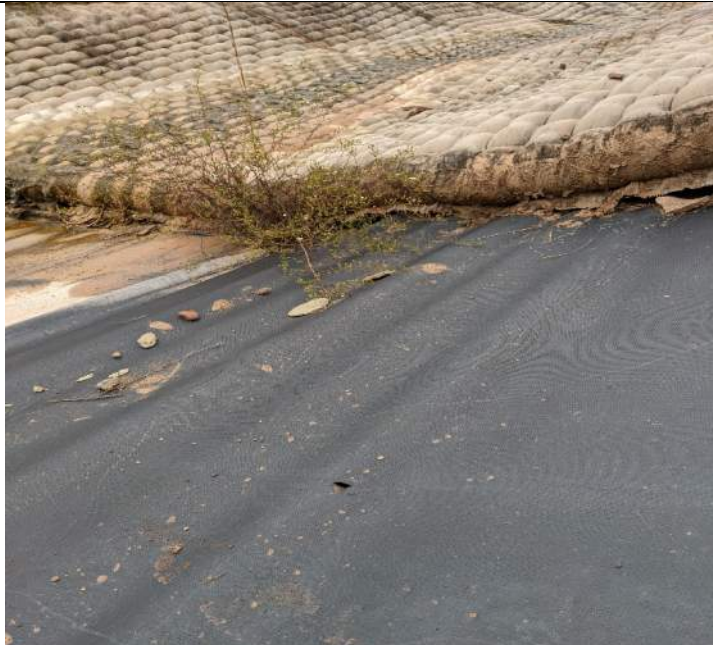
Photograph #48

View of inflow channel to Pond 5 with small liner tear visible in center of image. (looking west).
