DAM & DIKE INSPECTION REPORT

Bottom Ash Complex Stingy Run Fly Ash Dam

**GAVIN PLANT
CHESHIRE, OHIO**

INSPECTION DATE October 25, 2016

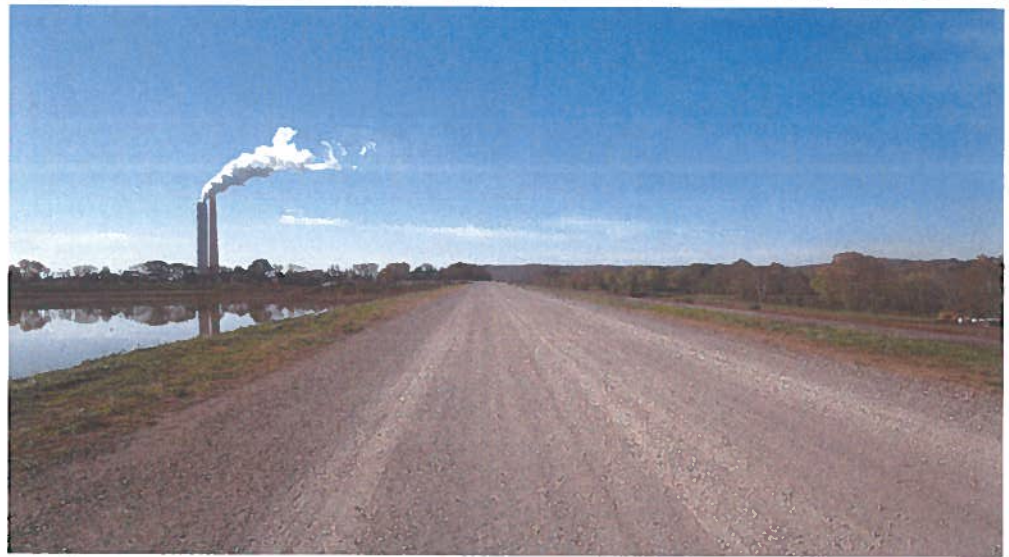
Photo # 1

- (i) The crest of the dike appeared in good condition as indicated in Photograph No. 1. No misalignment, settlement, or excessive rutting was noticed. The typical view of the upstream slope is shown in Photograph No. 2. Overall, the upstream slope appeared in good and stable condition with controlled vegetation. The bottom section of the slope was repaired due to minor erosion by placing riprap (Photograph No. 2).

An overall view of the crest of the dike (looking south).

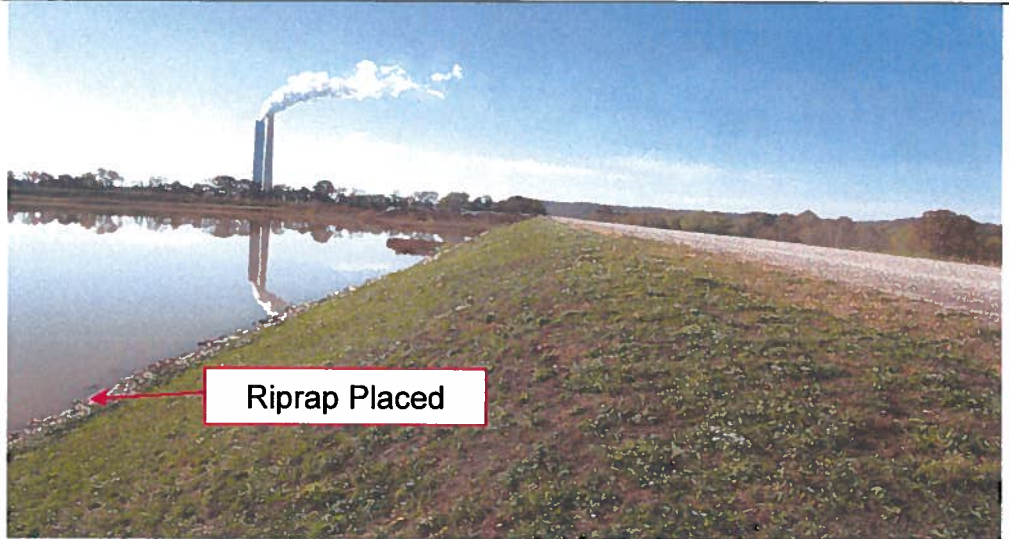
Photo # 2

Upstream slope of the dike (looking south).

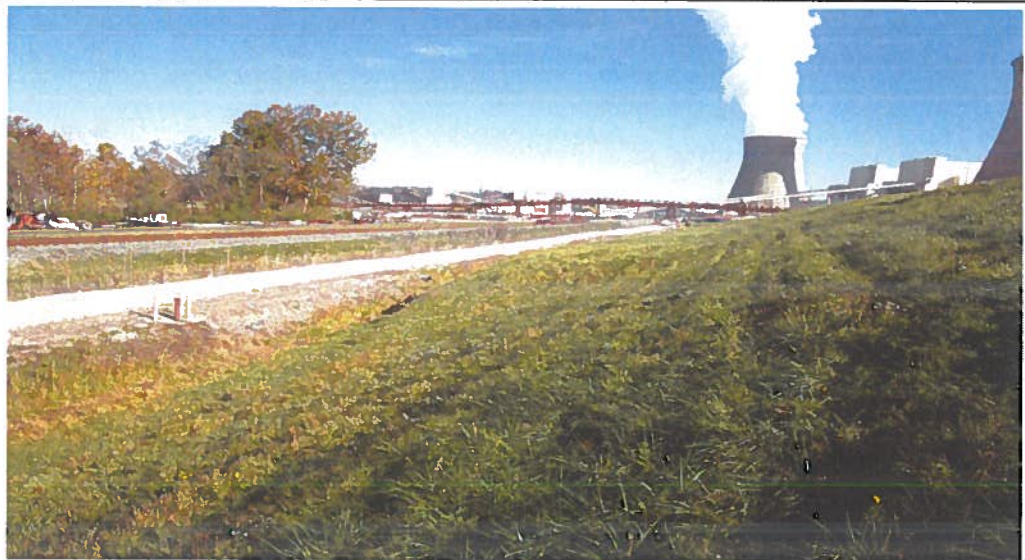
Photo # 3

- (ii) View of the downstream slope is illustrated in Photographs No. 3 and 4. Also shown is the service road to the west of the dike in these photographs. In general the entire slope appeared in good and stable condition with well-maintained and controlled vegetation growth. The service road and drainage ditch along the toe of the downstream slope were in good condition, positive grade, and clear from weeds and bushes.

The downstream slope of the west dike (north section).

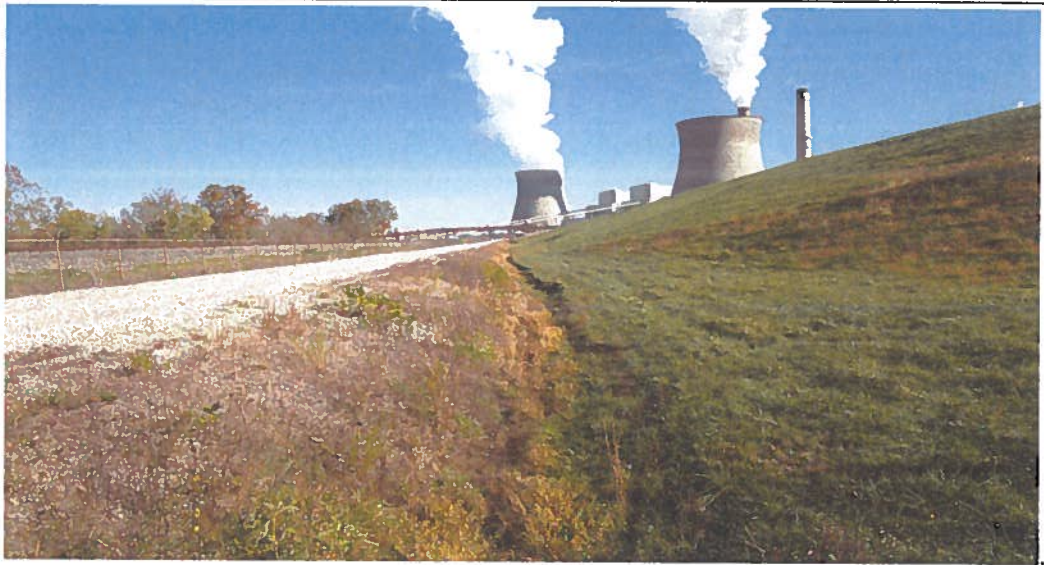
Photo # 4

The downstream slope of the west dike and toe ditch (south section).

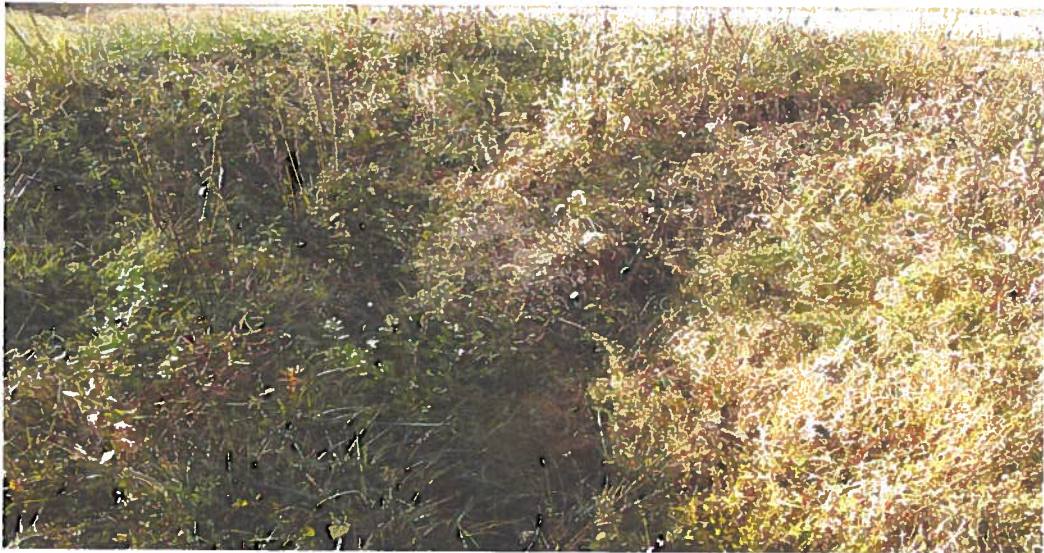
Photo # 5

- (iii) The pipe culvert at the end of the ditch to the south is illustrated in Photographs No. 5 and 6. The pipe culvert indicated some standing water but flow was still exiting the ditch through the culvert indicating positive drainage. The inlet and outlet end of the pipe was covered with vegetation.

The pipe culvert inlet along the ditch.

- (i) Clear the areas around the pipe culverts free from excessive vegetation as much as possible.
- (ii) If the erosion gullies at the north dike downstream slope degrades further, plan on backfilling and compacting with compatible material.
- (iii) Perform backfilling of the area around the decant structure at the downstream slope of the north dike.

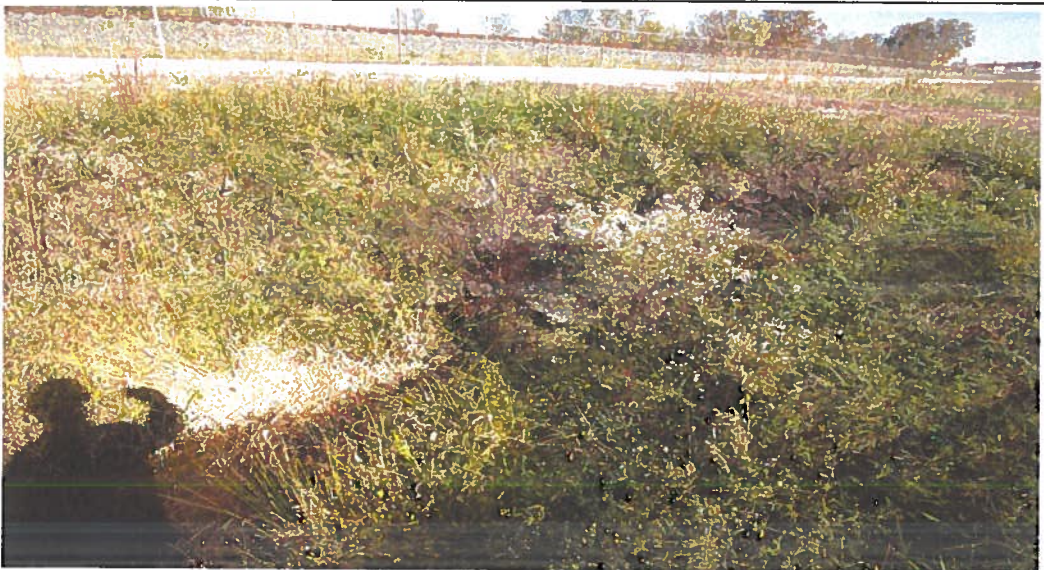
Photo # 6

The pipe culvert outlet along the ditch.

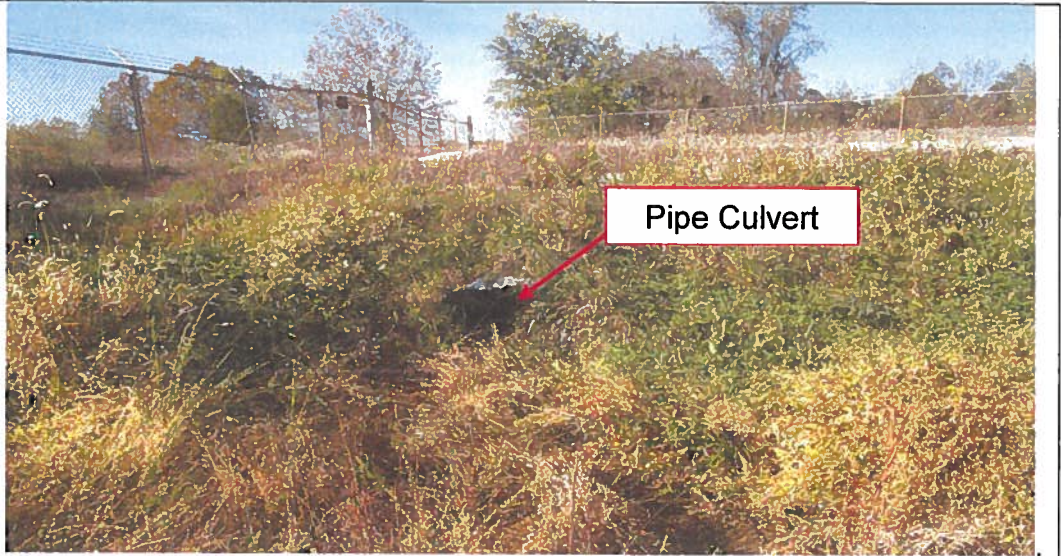
Photo # 7

- (iv) The southwest corner adjacent to the downstream slope is illustrated in Photograph No. 7. The water from the toe ditch exit the property via pipe culvert illustrated in Photograph 7. The pipe indicated positive drainage but was covered with vegetation and some standing water.

The pipe culvert at the exit point.

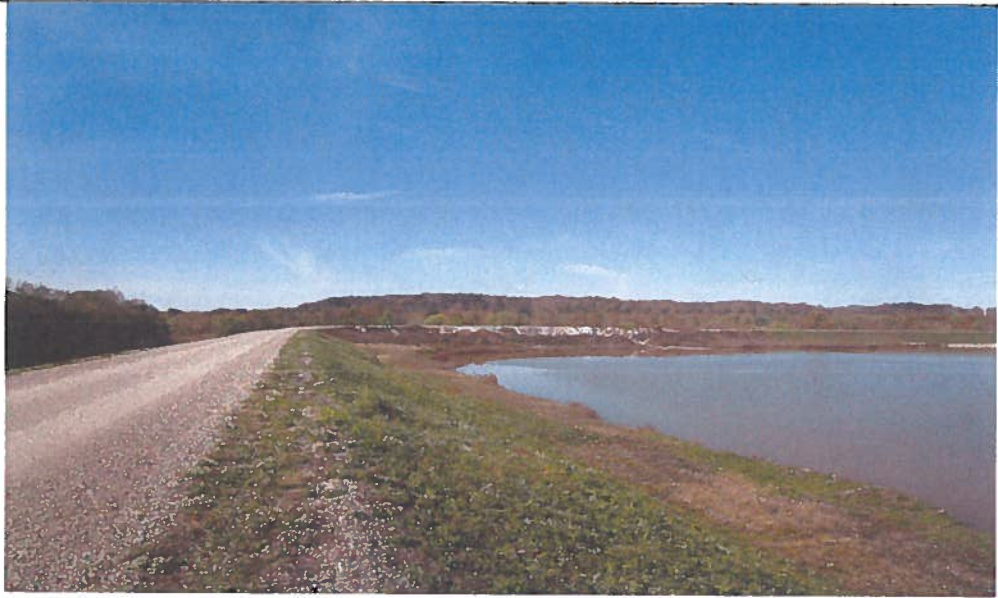
Photo # 11

- (iii) Photographs No. 11 and 12 illustrate the upstream slope of the south dike. A buttress at the toe of the interior slope was placed using bottom ash. Overall the upstream slope appeared in good and stable condition. Erosion gullies previous backfilled and repaired appeared in place and good condition.

Upstream slope and crest of the dike (looking west).

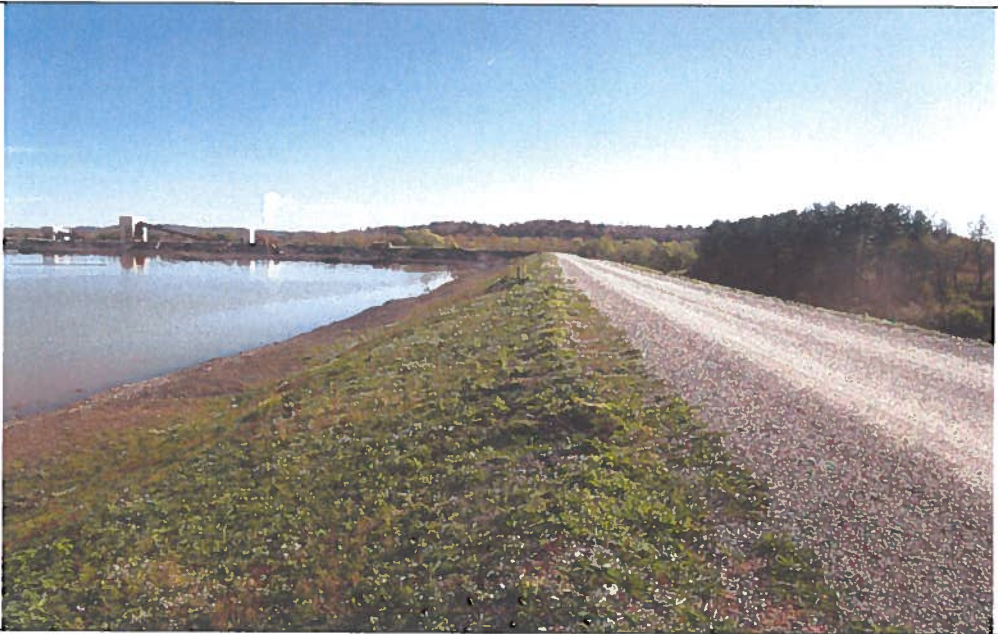
Photo # 12

Another view of the upstream slope of the dike (looking east).

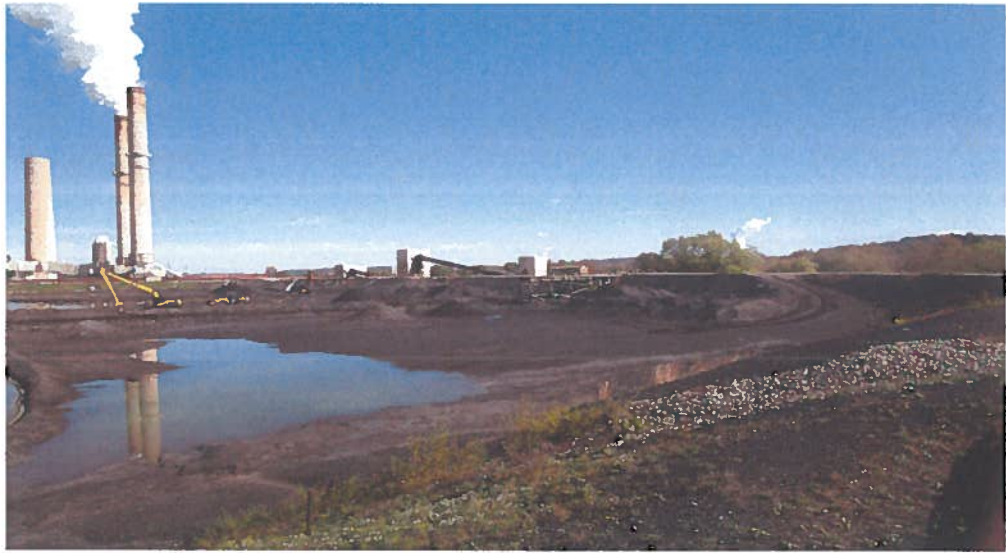
Photo # 13

- (i) Photograph No. 13 illustrate the bottom ash temporary storage and management area and also an overall view of the upstream slope of the east dike. Most of the interior slope was buttressed with stockpiles of bottom ash. This area of the pond is historically used for bottom ash management (excavating and hauling operations). The upstream slope appeared good and in stable condition.

Bottom ash management area.

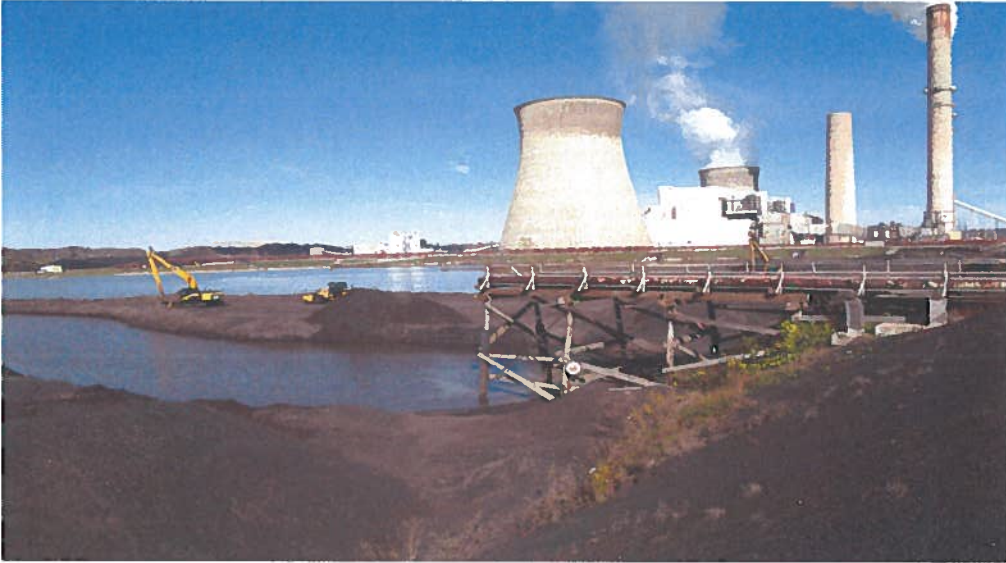
Photo # 14

- (ii) Photographs No. 14-16 illustrate the three sets of ash pipes and support structures. The pipes and structure appeared to be in good and functional condition.

Ash sluice pipes and support structure (south).

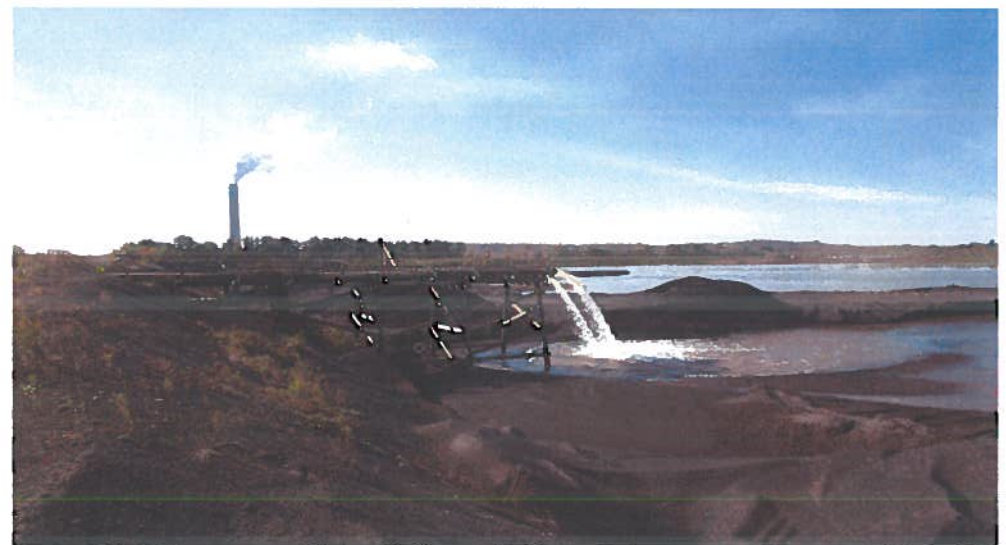
Photo # 15

Ash sluice pipes and support structure (middle).

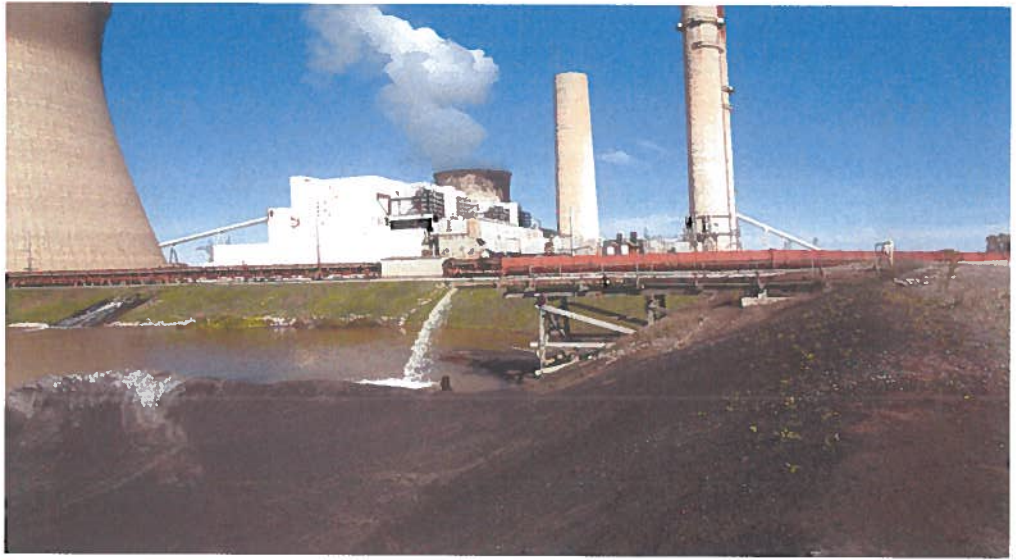
Photo # 16

Ash sluice pipes and support structure (north).

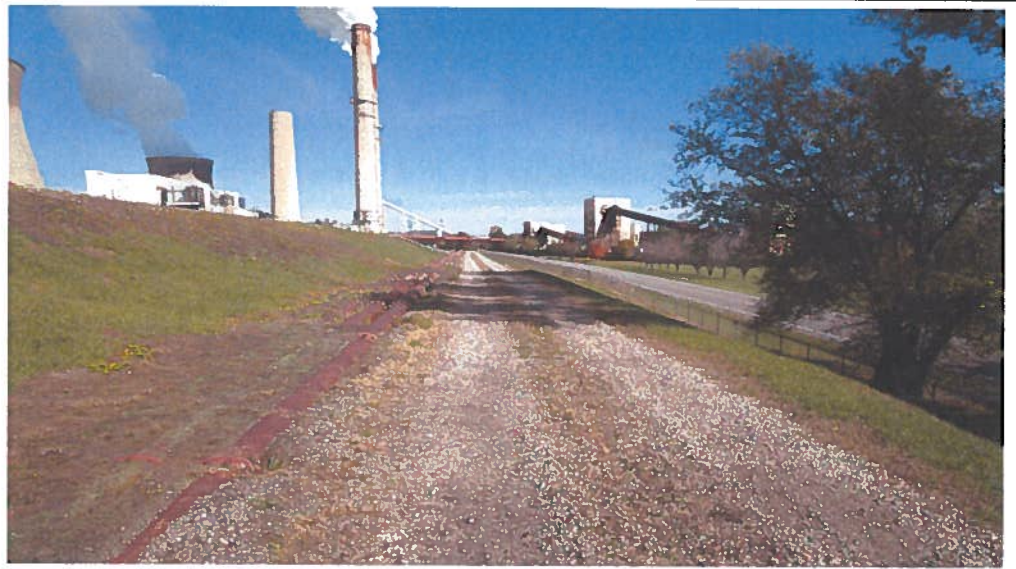
Photo # 17

- (iii) Photographs No. 17 and 18 illustrate upper downstream slope, intermediate bench, and the lower section of the downstream slope and State Route 7 located east of the dike. The intermediate bench also used as access road appeared in good condition and no sign of settlement or misalignment was noticed. The toe of the slope appeared dry and no standing water or soft areas were noticed.

Intermediate bench.

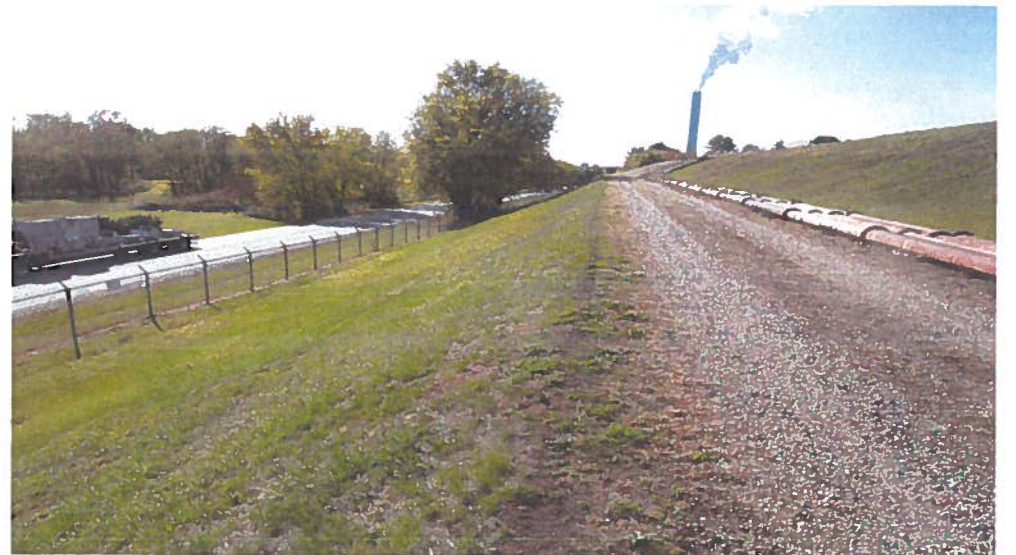
Photo # 18

Downstream slope, sluice pipes and intermediate bench.

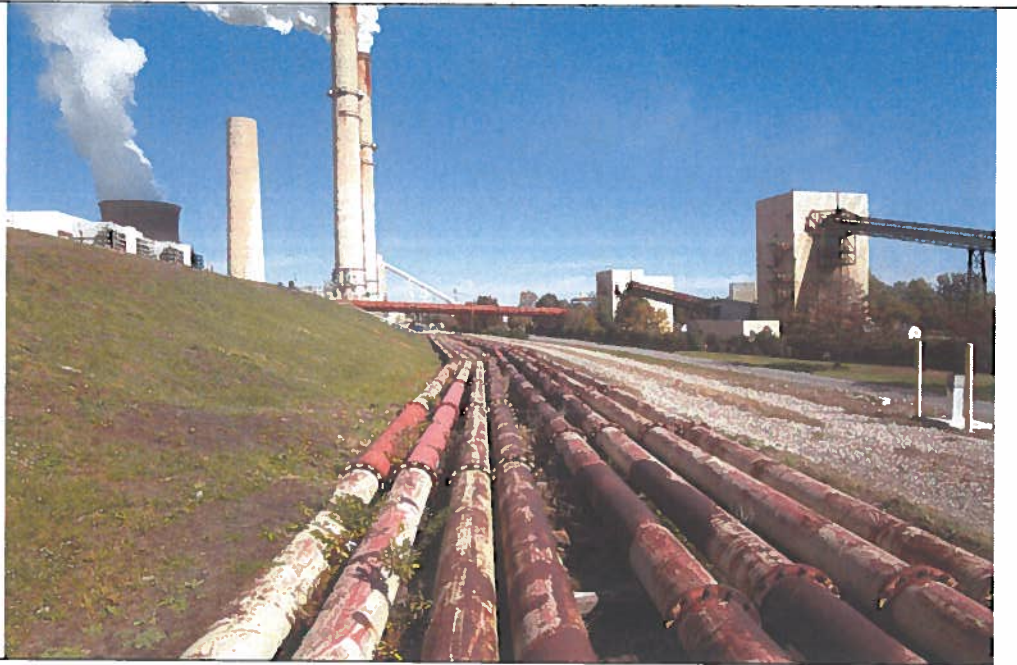
Photo # 19

- (iv) The bottom ash sluice pipes are illustrated in Photograph No. 19. Sluice pipes, pipe support, and alignment appeared in good condition.

Upstream slope and
sluice pipes.

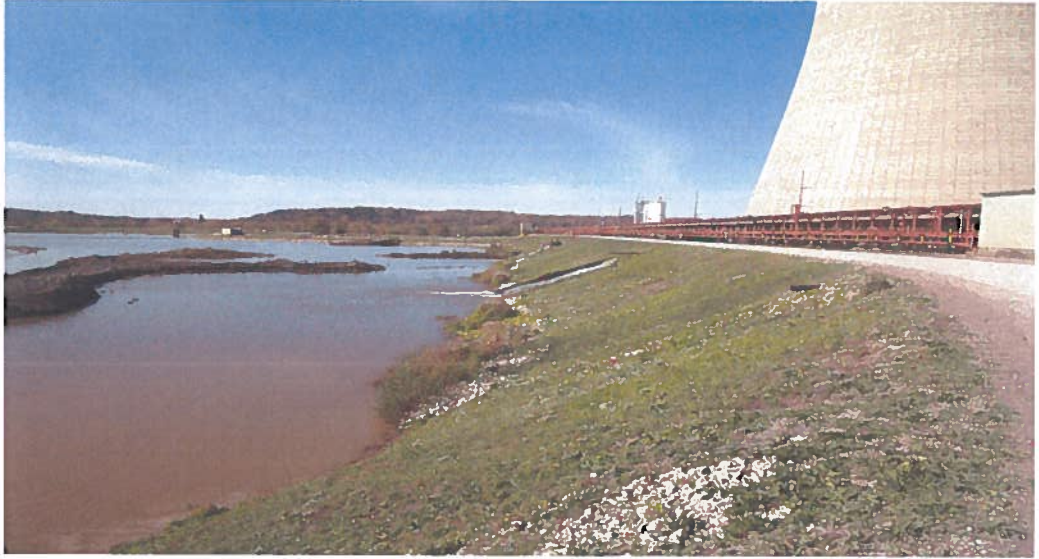
Photo # 20

- (i) The upstream slope of the north dike is illustrated in Photographs No. 20 and 21. The slope appeared in good and stable condition. Several discharge pipes are present along this slope. The discharge pipes and support structures were in good functional condition.
- (ii) A typical view of the crest of this dike and in general is illustrated in Photograph No. 22. The crest appeared in good and stable condition and no sign of misalignment, settlement or cracks was observed.
- (iii) The downstream slope is illustrated in Photographs No. 23-25. Overall, the downstream slope was in good and stable condition. Some minor erosion was noticed along the slope (Photograph No. 24) that appeared to be from leakage of the conveyor along the crest.

Overall view of the north dike upstream slope.

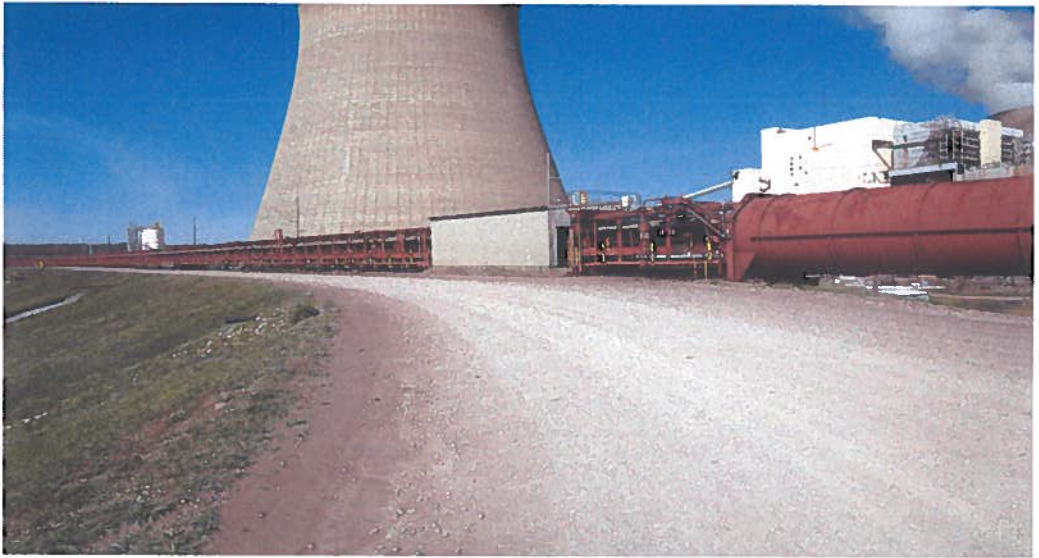
Photo # 21

Crest of the dike.

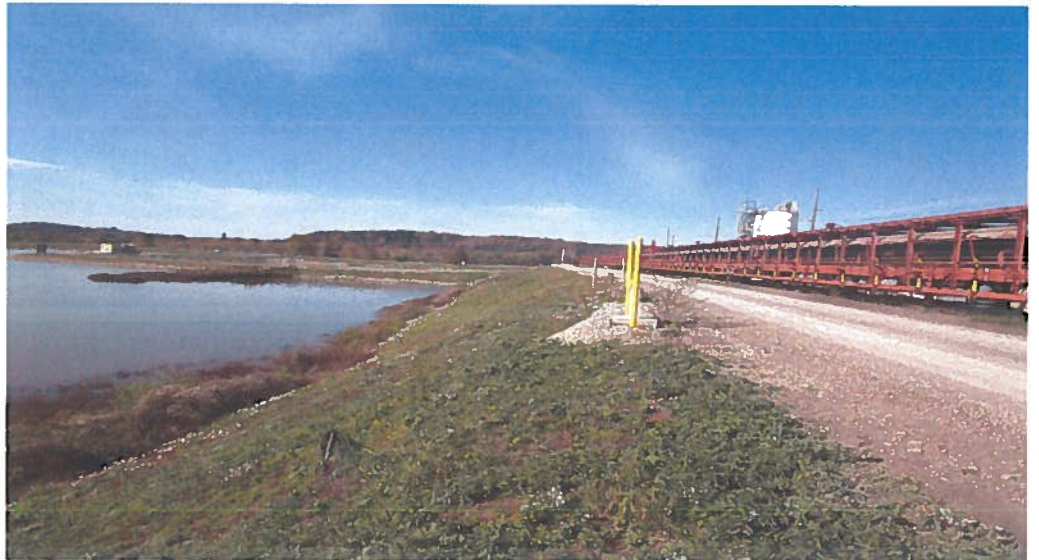
Photo # 22

Upstream slope (looking west).

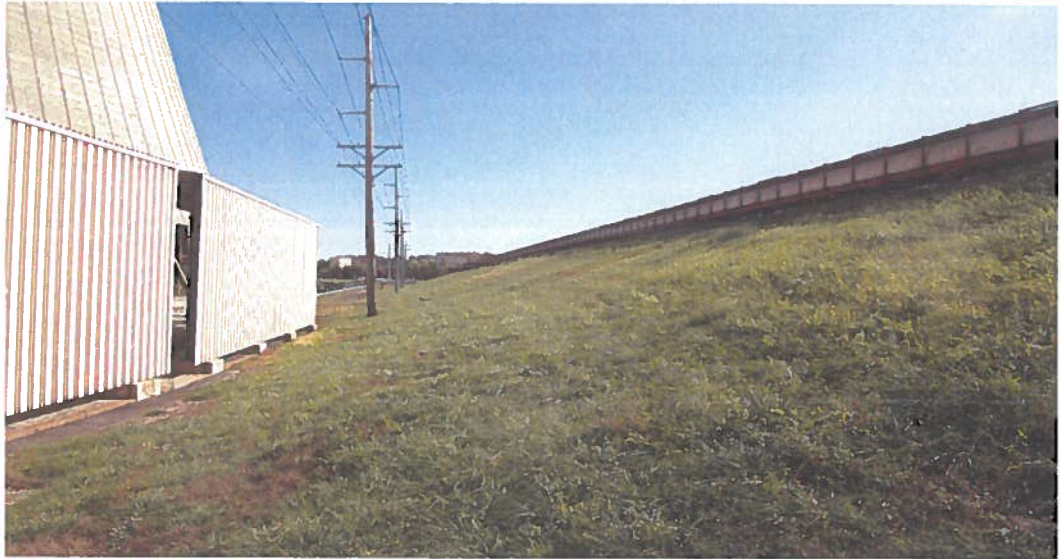
Photo # 23

Downstream slope of the dike (looking east).

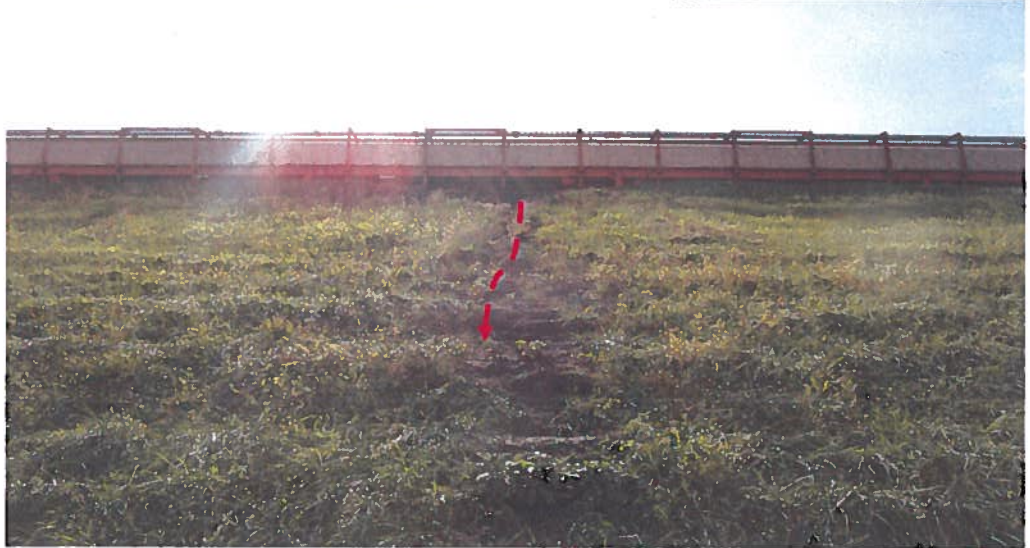
Photo # 24

A typical erosion gully (as shown by arrow) along the downstream slope.

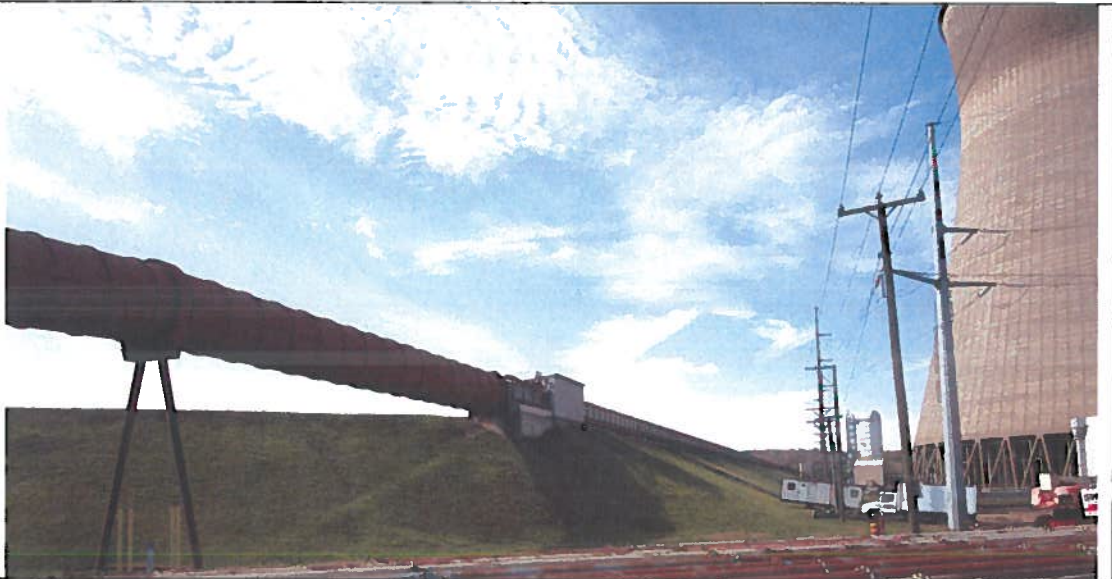
Photo # 25

Downstream slope (northwest corner).

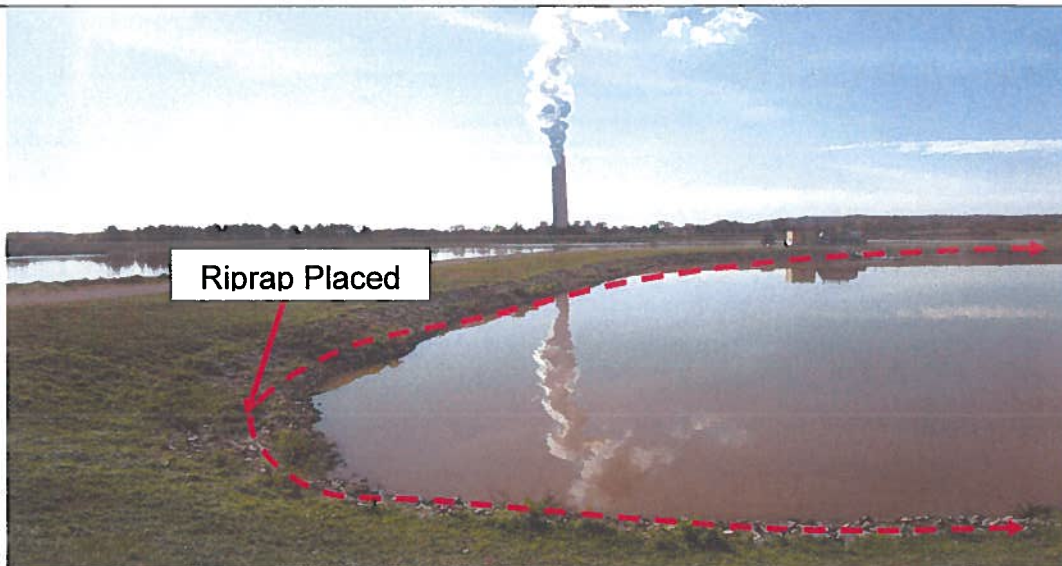
Photo # 26

- (i) Overall typical view of the interior slope of the reclaim pond is shown in Photographs No. 26 and 27. The slope appeared in good and stable condition with controlled vegetation. As noted in previous inspections, sloughing and scarping along the interior slope was noticed. This section of the slope is repaired by placing riprap as seen in these photographs.
- (ii) The overflow decant structures at the north and south dikes are illustrated in Photographs No. 28 through 30. These structures including visible concrete, metal steps, railing, and deck platform appeared in good and functional condition.
- (iii) The decant structure near the toe of the downstream slope is illustrated in Photographs No. 31 and 32. No leak or settlement around the structure was noticed. Some minor erosion was noticed around the structure. The plant

Interior slope with lower section having riprap.

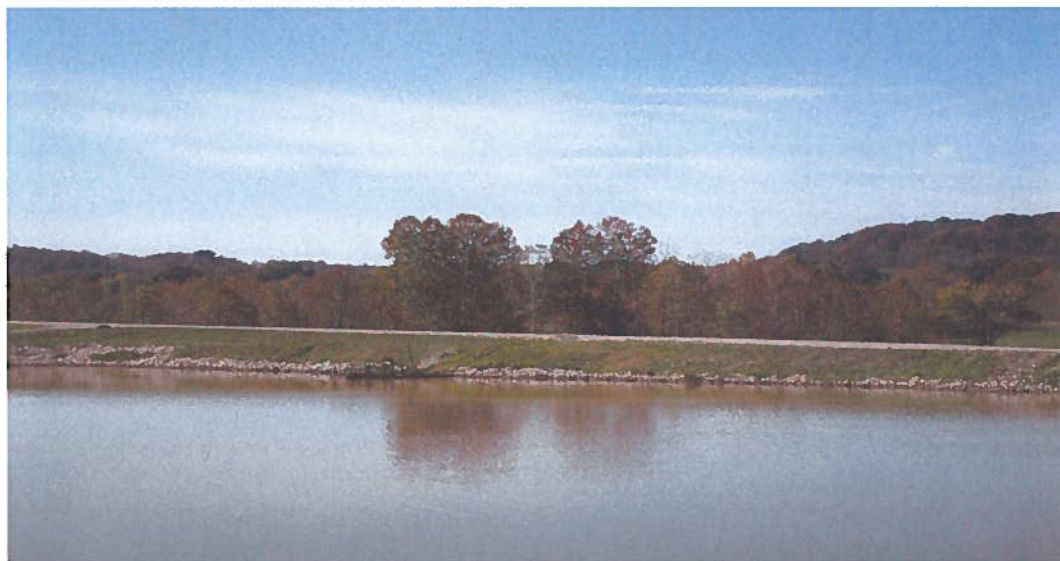
Photo # 27

Another view of the interior slope with riprap.

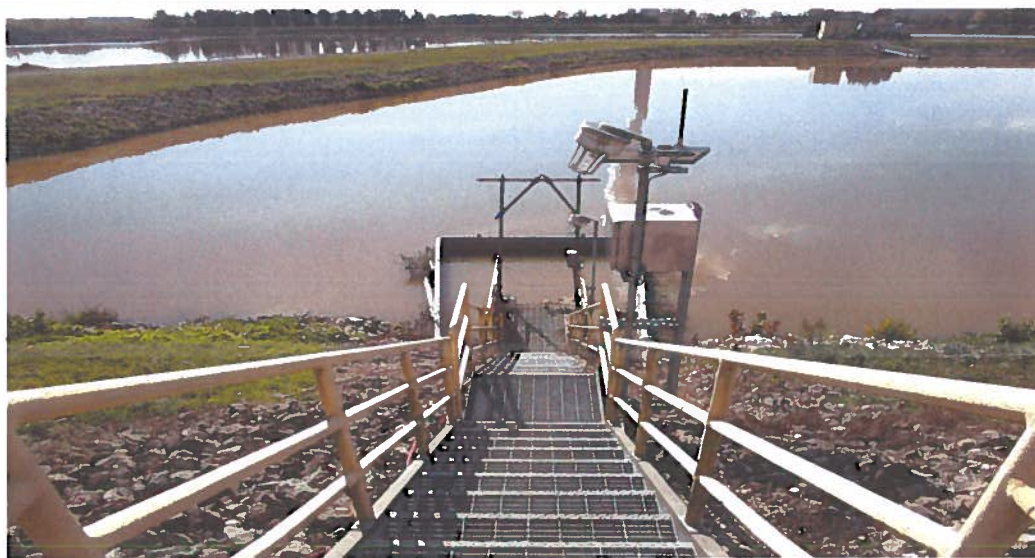
Photo # 28

Overflow discharge structure at the north dike.

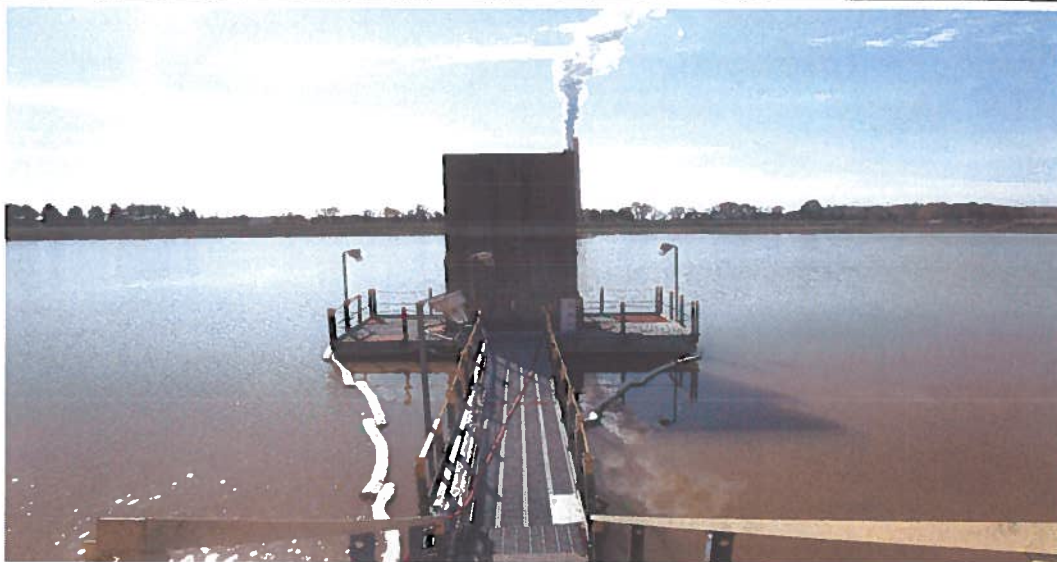
Photo # 29

Overflow discharge structure at the south dike.

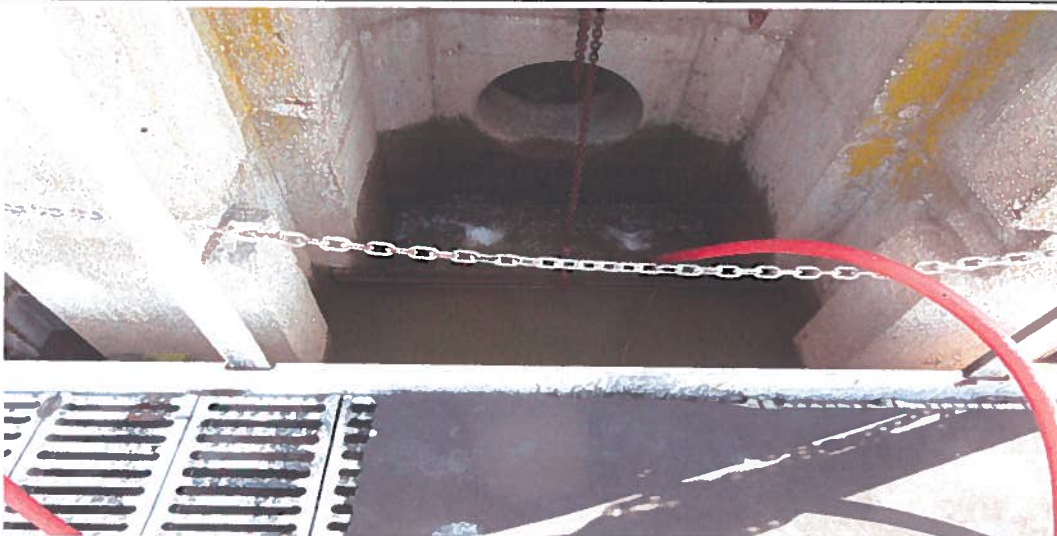
Photo # 30

Interior of the overflow discharge structure.

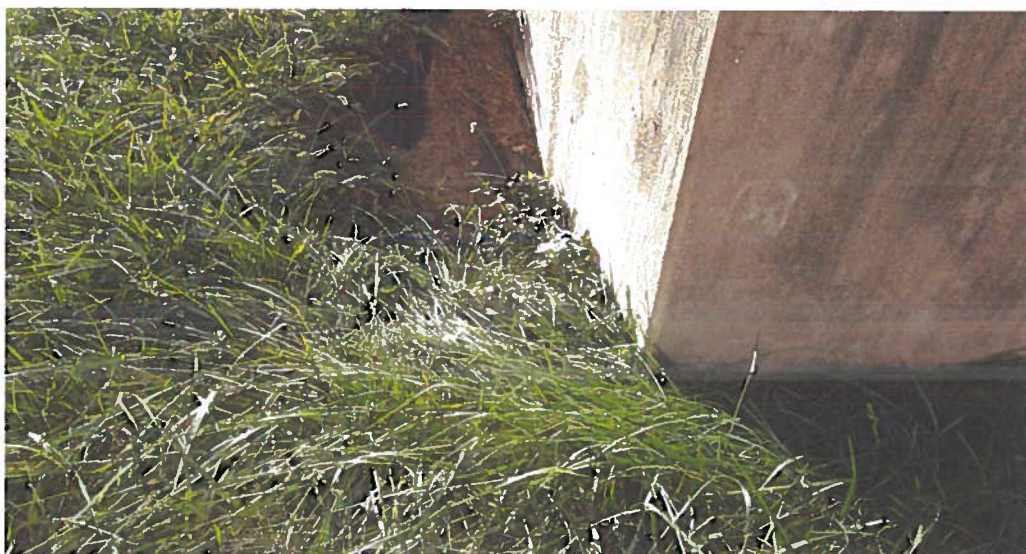
Photo # 31

Decant structure at the toe of north dike exterior slope.

was notified and repair will be performed by backfilling and compacting the eroded area with stone.

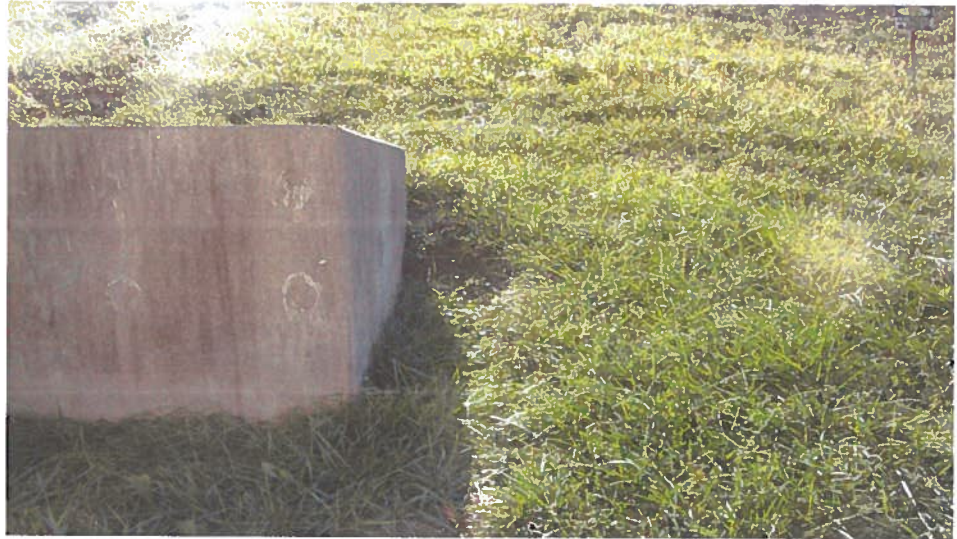
Photo # 32

Another view of the
decant structure.

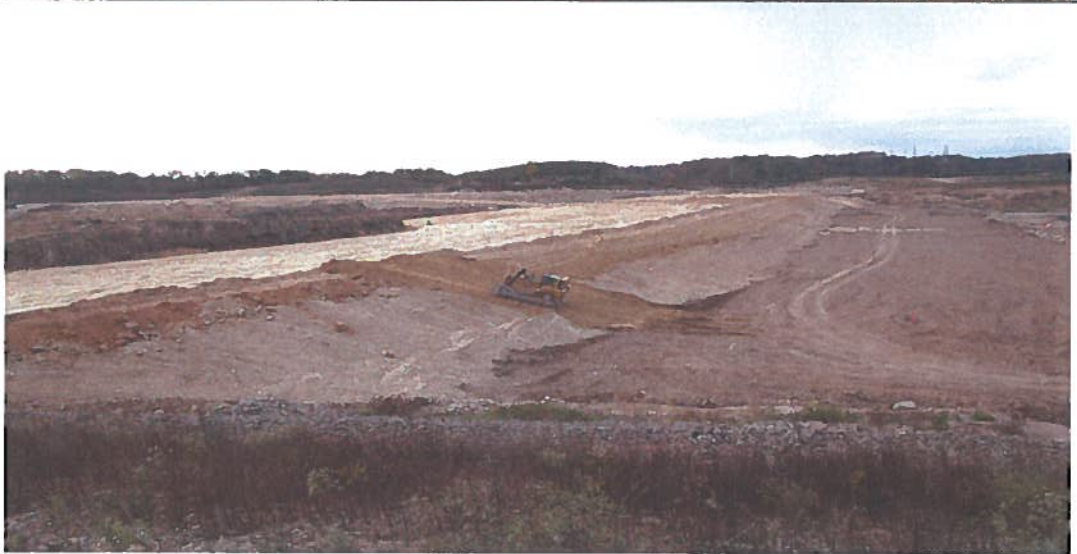
Photo # 34

Right abutment, groin at the upstream slope.

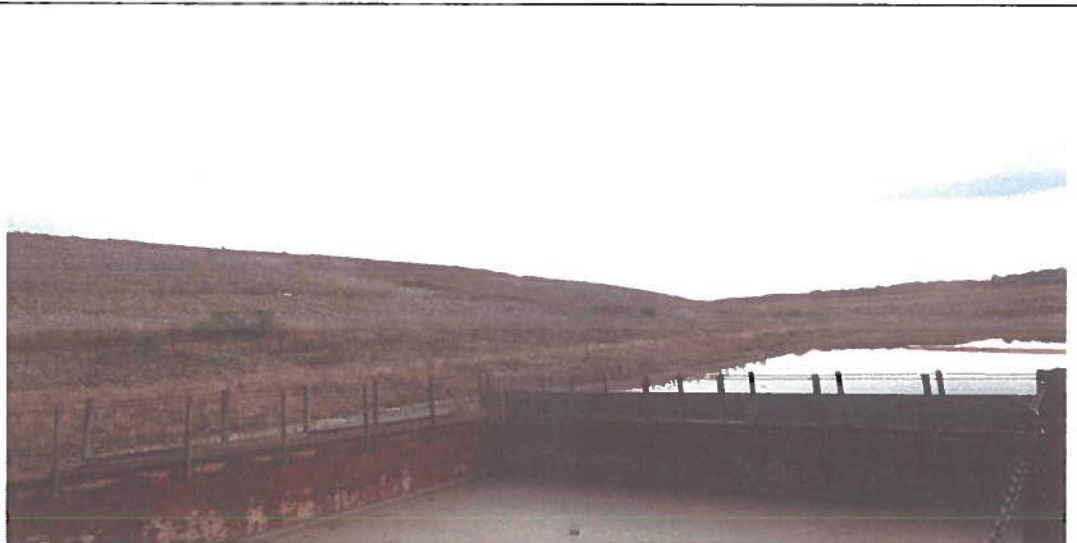
Photo # 35

- (ii) The entire upstream slope was protected by riprap cover placed over a geotextile fabric. The riprap is mostly removed and used in the construction of the new landfill. The upstream slope appeared in fair and stable condition (Photographs No. 35 and 37). Along upstream edge of the crest the erosion gullies were formed due to construction activities. A typical view of the erosion gully is shown in Photograph No. 36.

This photograph illustrates typical condition of the slope and riprap along the upstream slope.

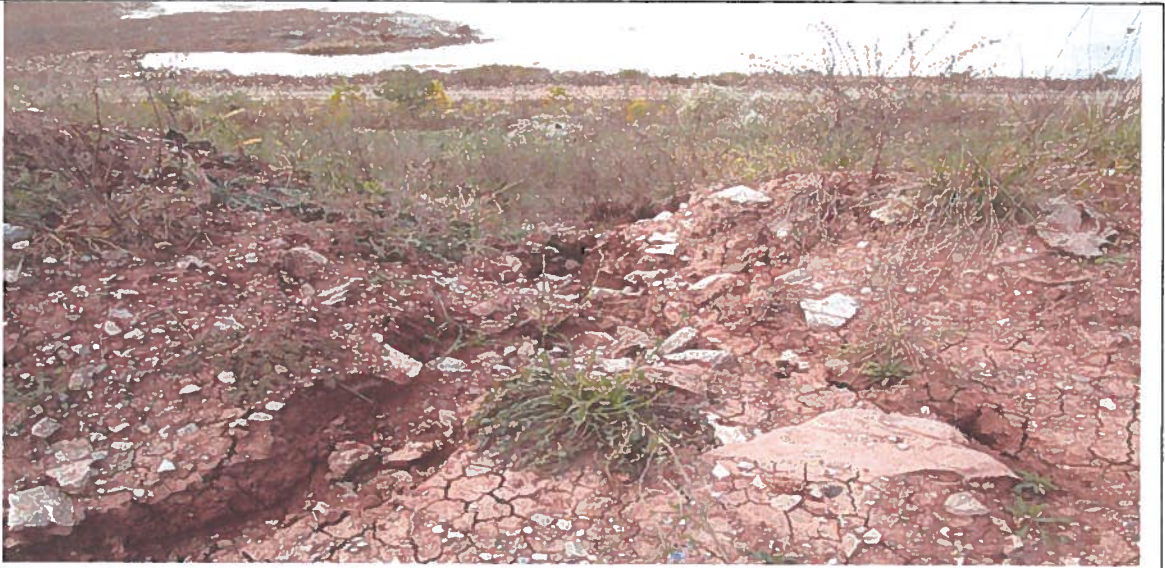
Photo # 36

Typical erosion gullies along the edge of the crest of the upstream slope.

- (i) Erosion gullies at the crest shall be repaired on a regular basis before the area is significantly degraded further. Alternately, permanent letdown notches should be formed with riprap in order to drain runoff due to construction activities.
- (ii) The channels, toe ditch, and intermediate pipe culverts downstream of the dam shall be kept clear of debris and vegetation with positive flow condition.

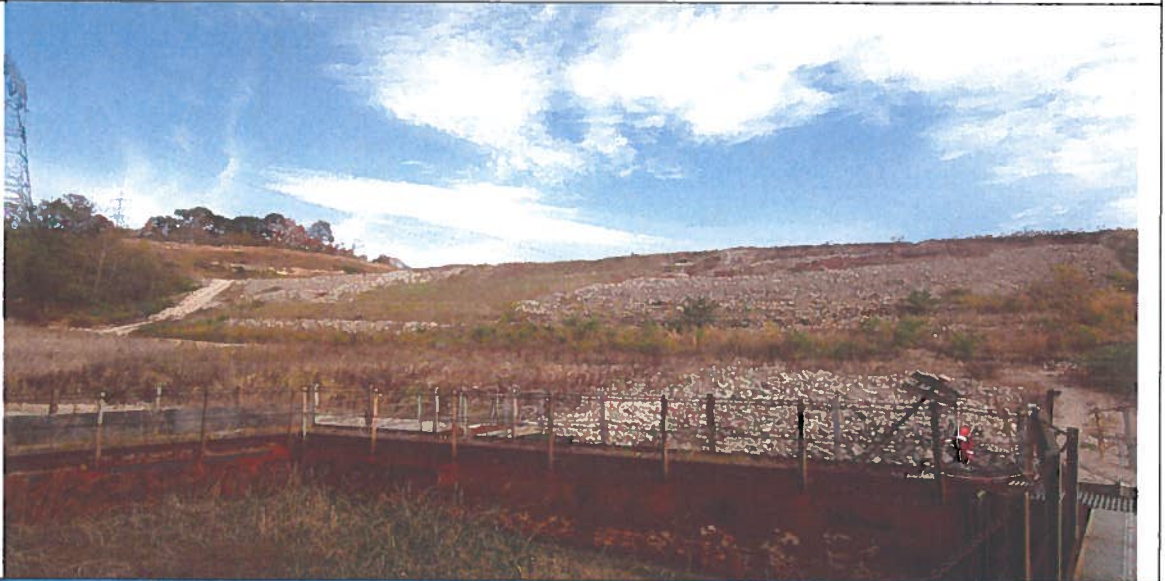
Photo # 37

Another view of the upstream slope (north end).

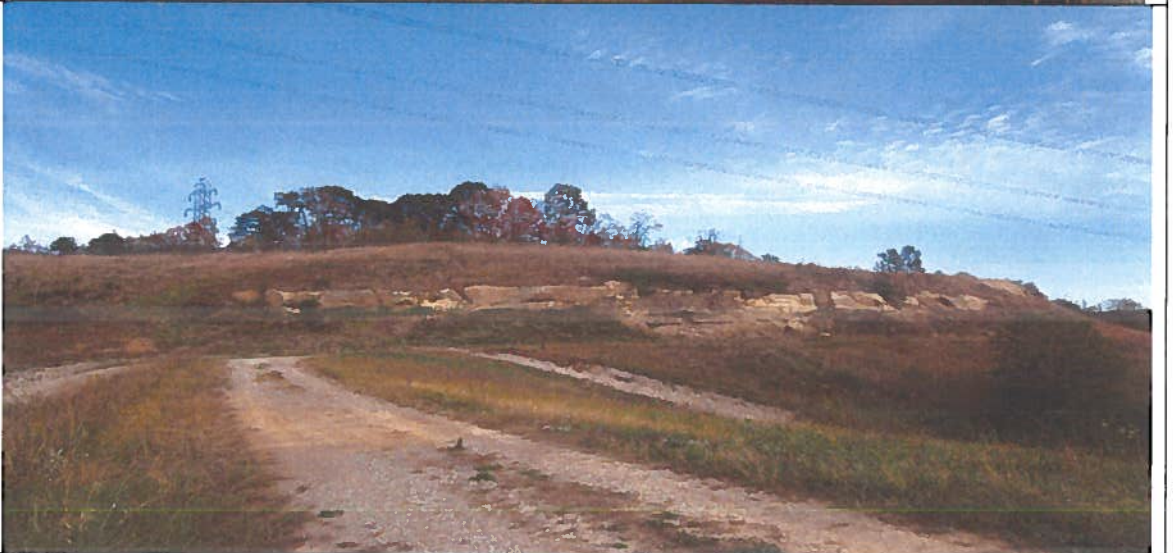
Photo # 38

- (iii) The north (left) abutment is illustrated in Photograph No. 38. The hillside and abutment appeared in good and stable condition.
- (iv) Photographs No. 39-41 illustrate the overflow discharge and supporting structures. A new access deck structure from the dam was installed. The stop logs from the overflow structure have been removed and syphons are installed for lowering water level (Photograph No. 41). The overflow structure and the supporting structure are in stable condition.

The hillside and the left (north) abutment.

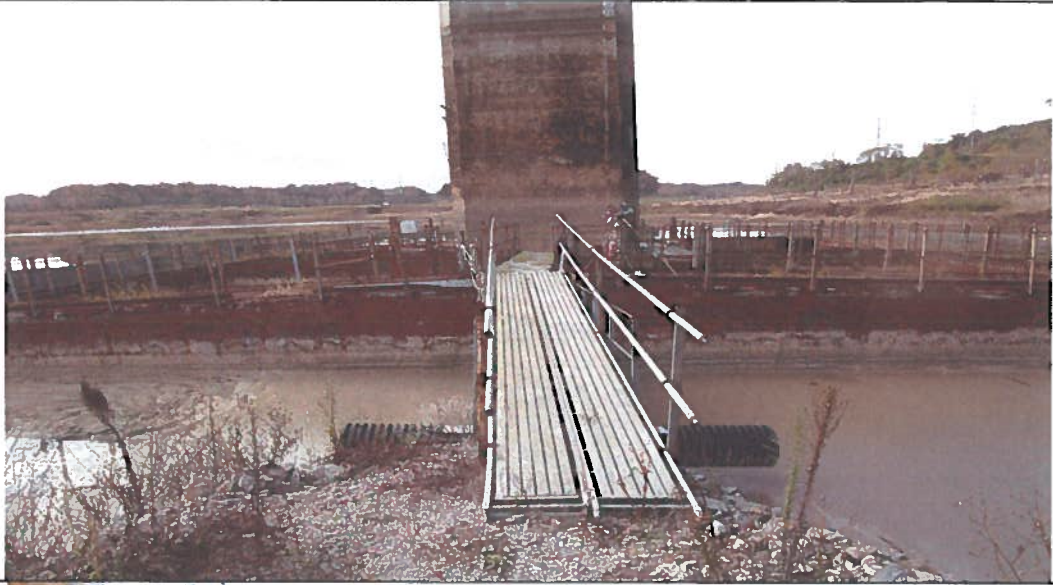
Photo # 39

This photograph illustrates the overflow discharge structure.
