DAM & DIKE INSPECTION REPORT

Bottom Ash Complex Stingy Run Fly Ash Dam

**GAVIN PLANT
CHESHIRE, OHIO**

INSPECTION DATE October 25, 2016

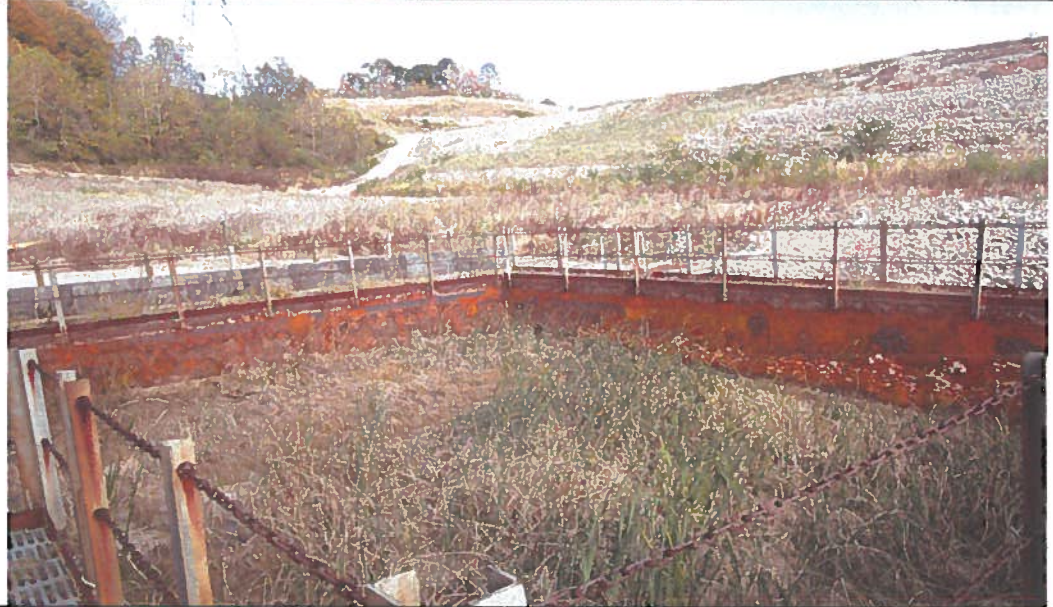
Photo # 40

- (iii) The north (left) abutment is illustrated in Photograph No. 38. The hillside and abutment appeared in good and stable condition.
- (iv) Photographs No. 39-41 illustrate the overflow discharge and supporting structures. A new access deck structure from the dam was installed. The stop logs from the overflow structure have been removed and syphons are installed for lowering water level (Photograph No. 41). The overflow structure and the supporting structure are in stable condition.

Close up view of the overflow discharge supporting structures.

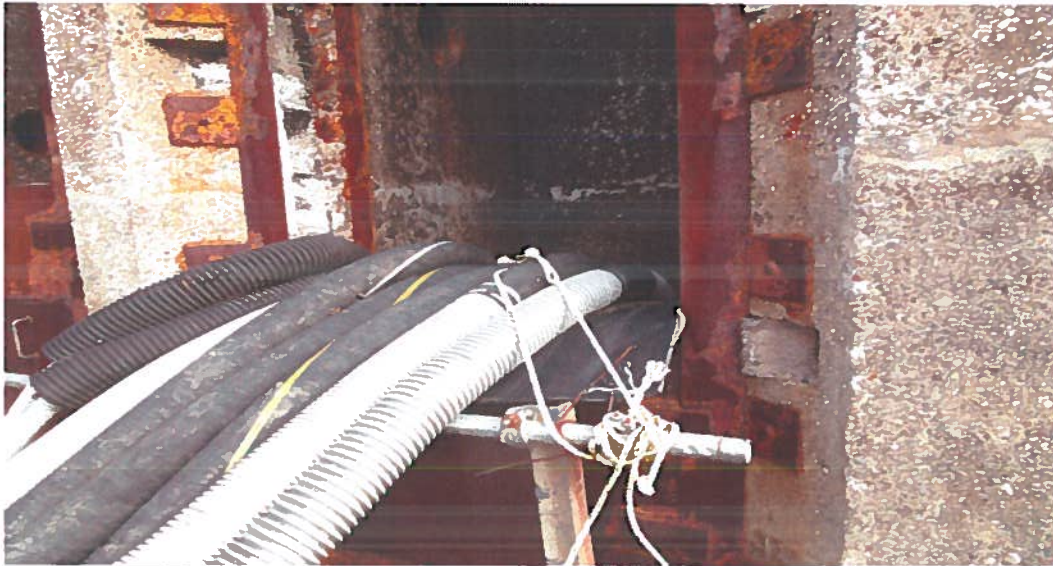
Photo # 41

Syphon pipes installed at the overflow structure.

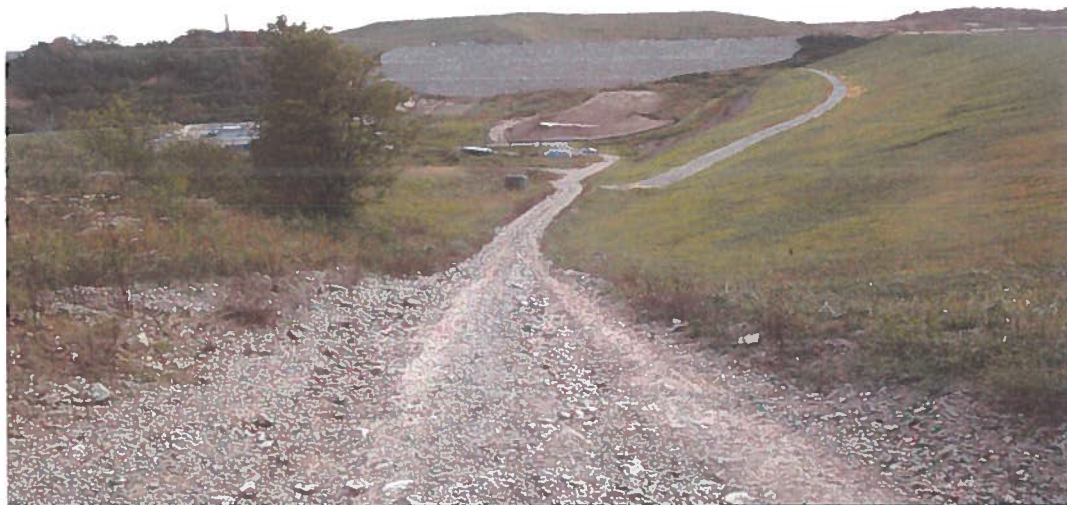
Photo # 42

- (v) The left and right groins of the downstream slope are illustrated in Photographs No. 42-45. Temporary access road is installed at the groins for landfill related construction activities. Overall, the downstream slope along the groins appeared good and in stable condition with controlled vegetation and intact riprap.

Left groin at the downstream slope.

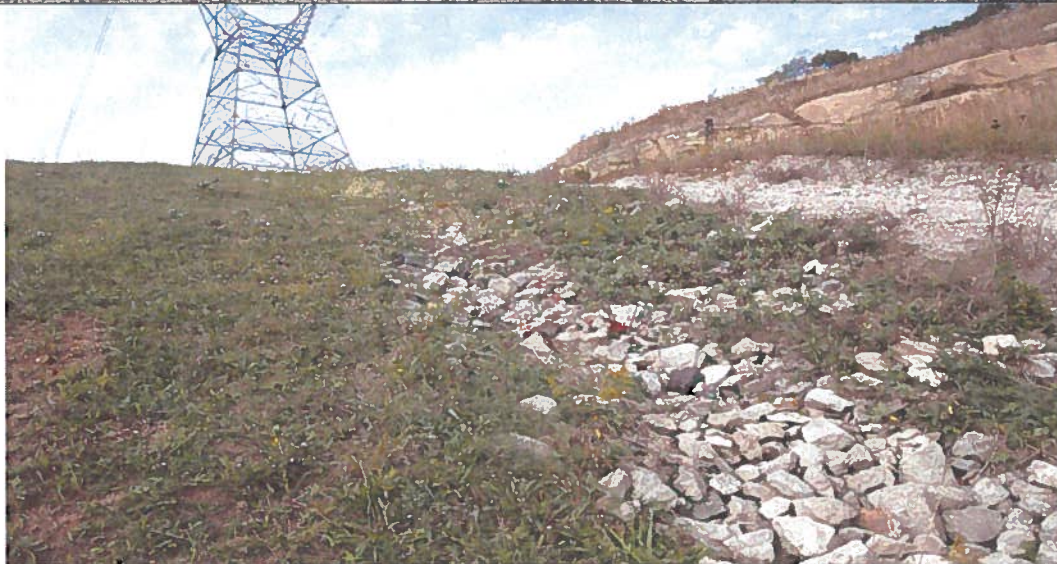
Photo # 43

Another view of the left groin, riprap good.

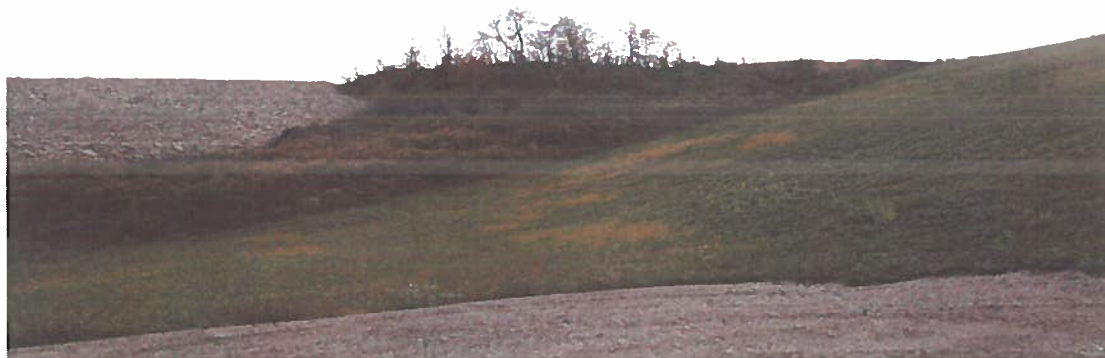
Photo # 44

The right abutment and hillside, and downstream slope.

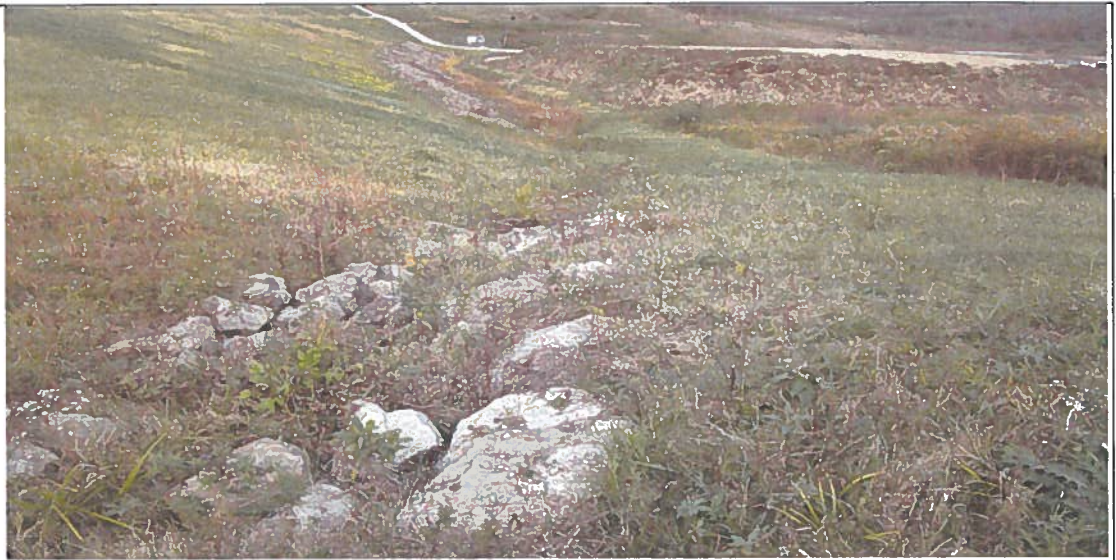
Photo # 45

The right groin at the downstream slope.

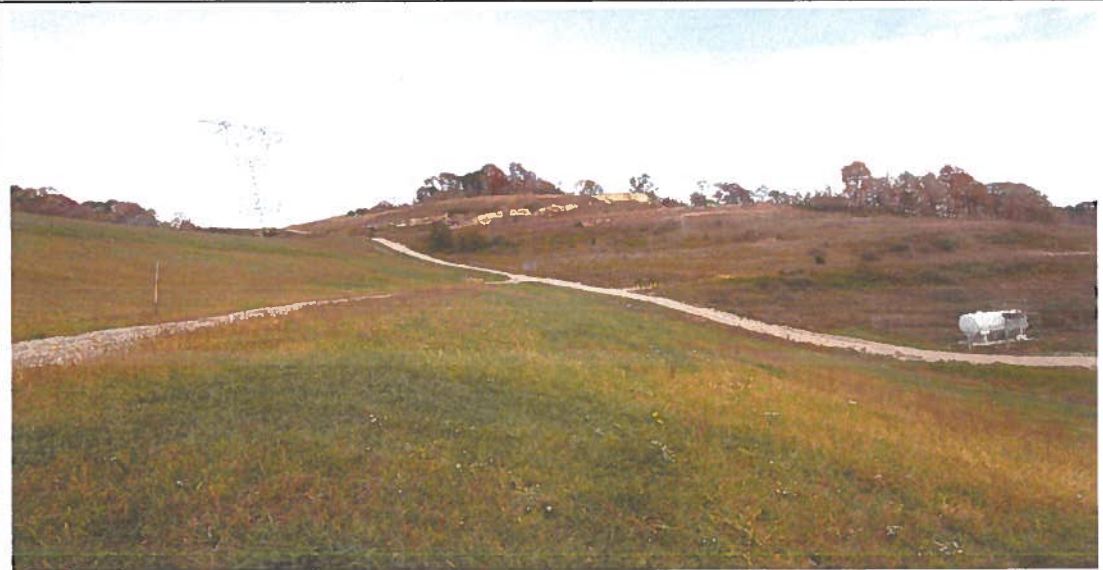
Photo # 47

- (vi) Overall view of the downstream slope is illustrated in Photograph No. 46. The intermediate bench, lower section of the downstream slope with riprap is illustrated in Photographs No. 47 and 48. A new gravel base is placed at the intermediate bench to be used for access road. The downstream slope appeared in good and stable condition with well controlled vegetation.

Another view of the downstream slope (looking north).

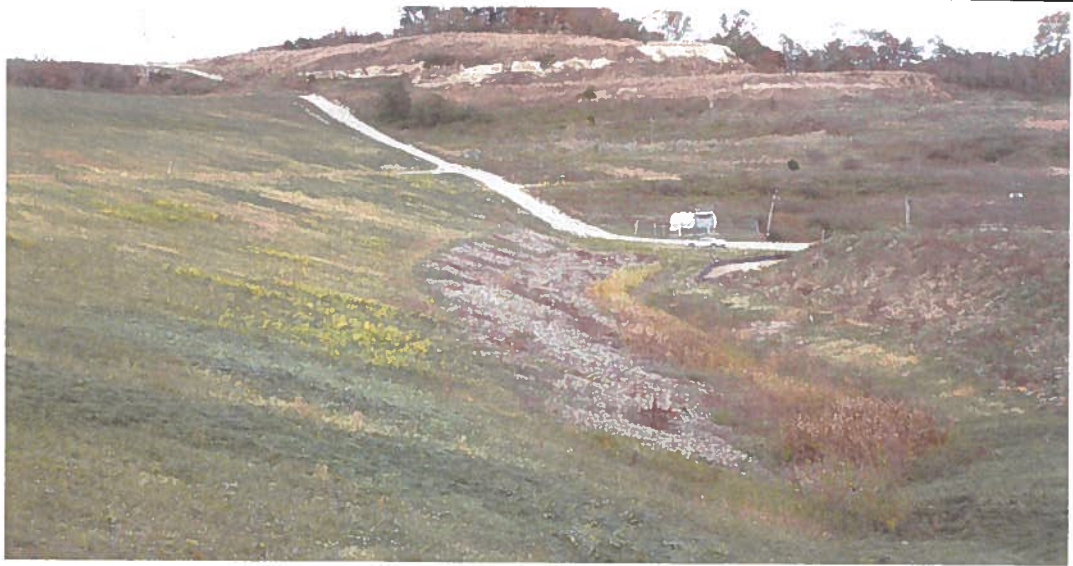
Photo # 48

Downstream slope
below the
intermediate bench.

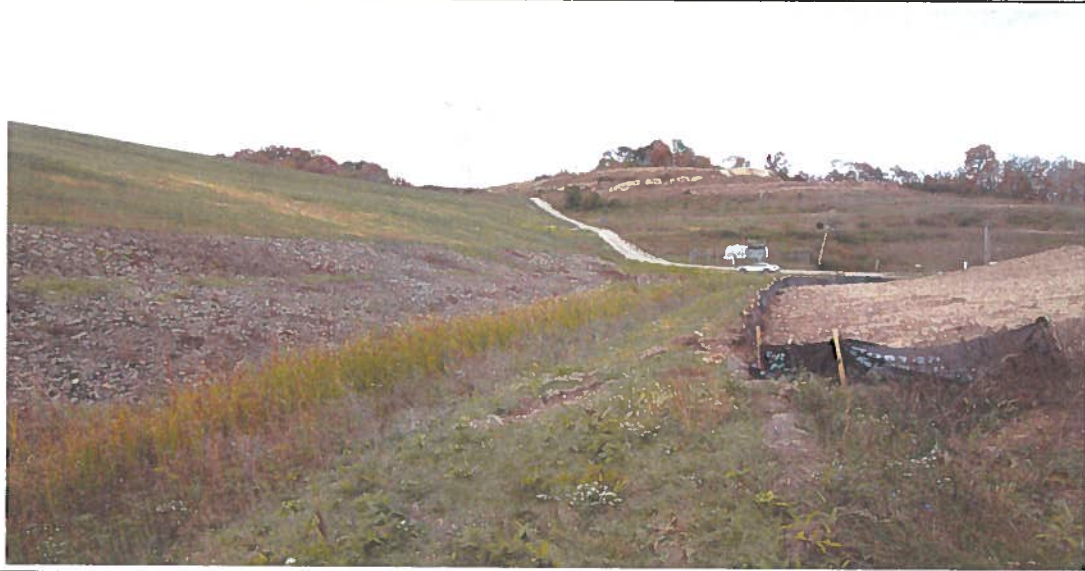
Photo # 49

- (vii) The toe ditch (Photograph No. 49) is functioning with positive drainage but need clearing of vegetation growth on a regular basis. A stockpile of soil is temporarily stored to the east side of the ditch and appeared to be in place. V-notched weirs (VW-1, VW-2, and VW-3) are located in the toe ditch. Photographs No. 50-52 illustrate weirs VW-1, VW-2, and VW-3 located on the north at the downstream end of the ditch. All the weirs indicated negligible amount and unobstructed flow condition.

Toe ditch.

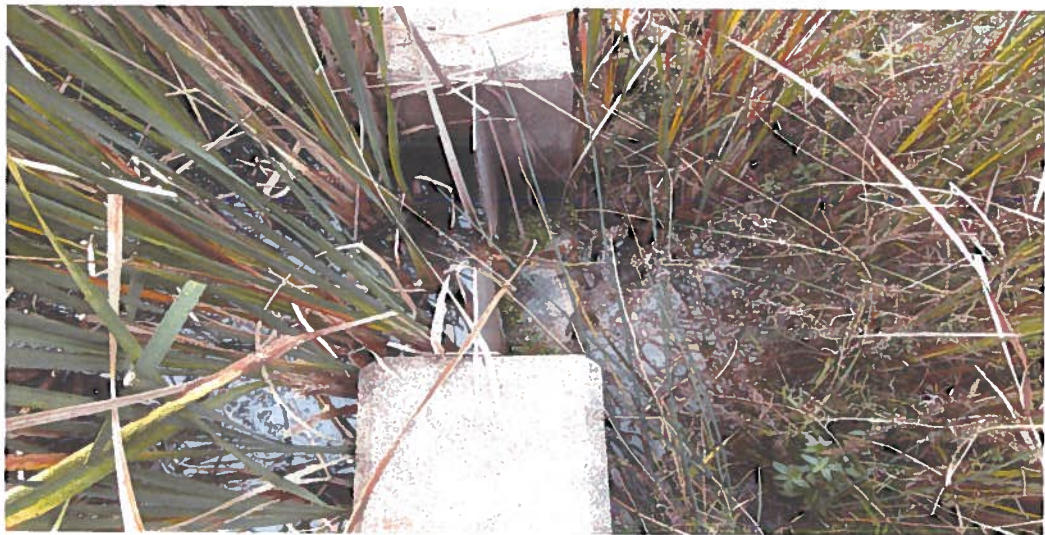
Photo # 50

Seepage control
weir VW-3.

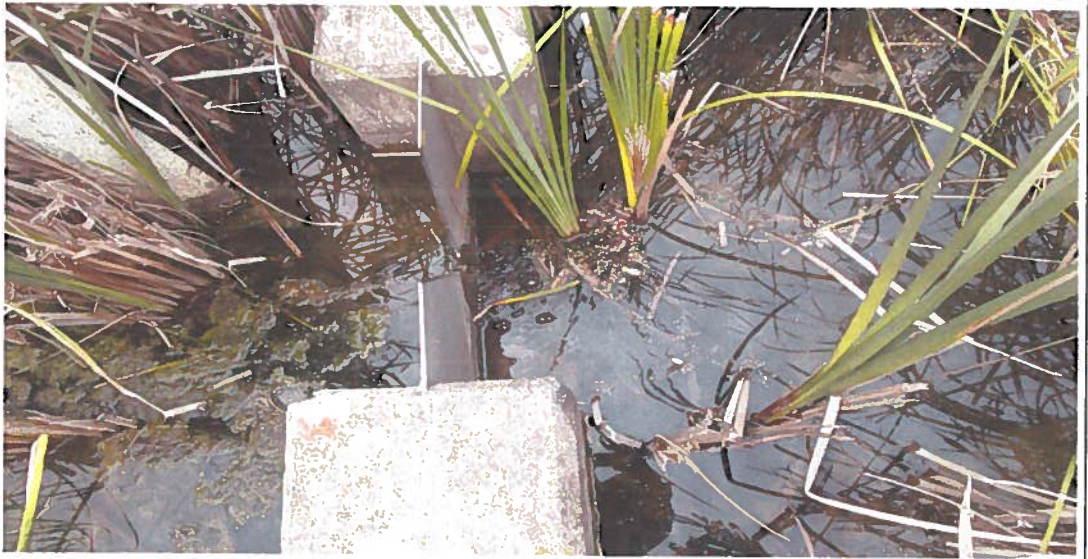
Photo # 51

Seepage control weir
VW-2.

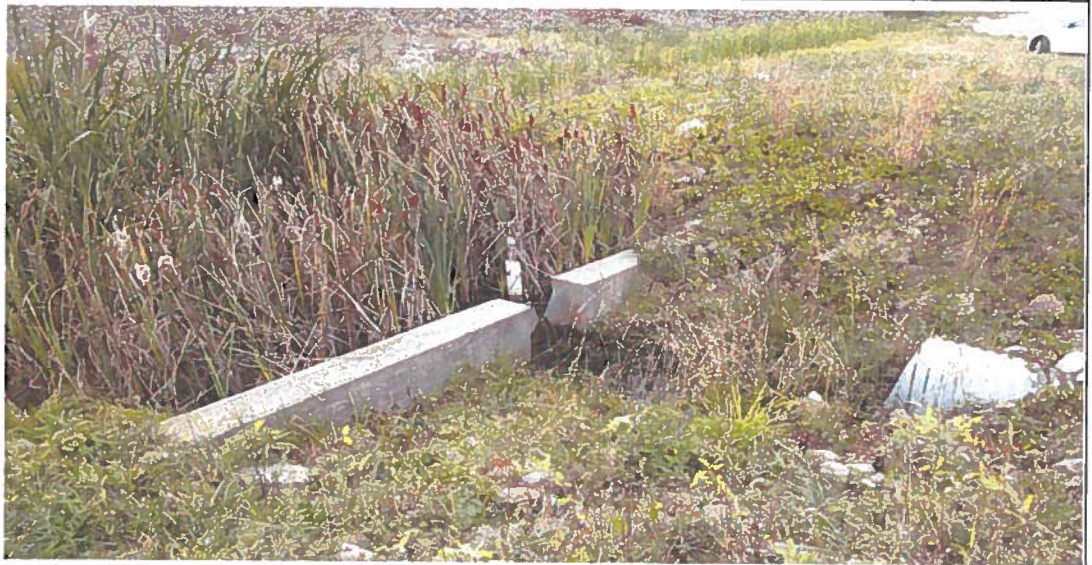
Photo # 52

Seepage control weir
VW-1.

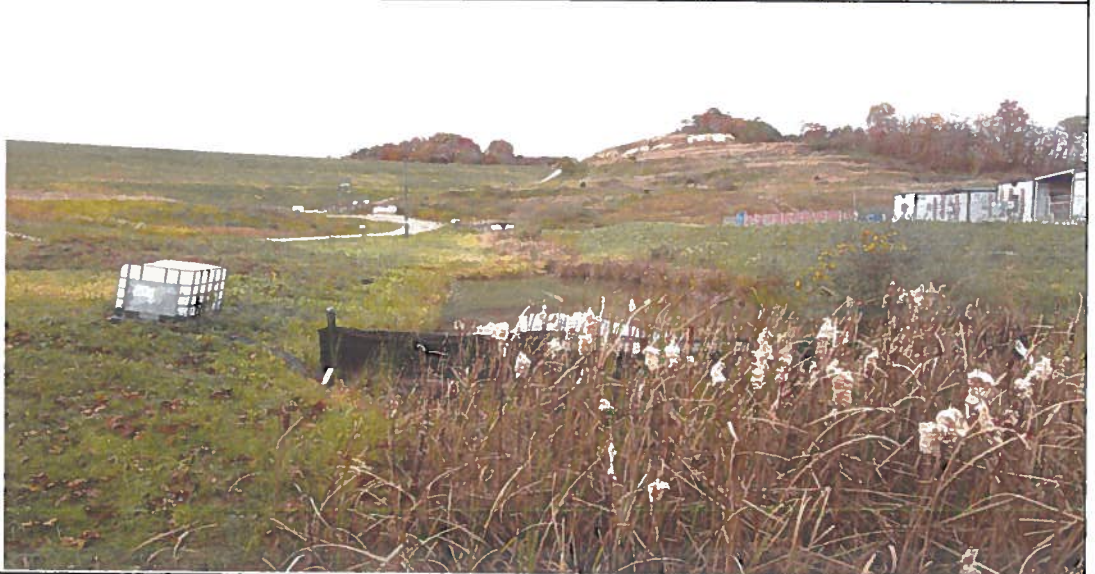
Photo # 53

- (viii) The channel downstream of the weir was in fair and stable condition and indicated positive flow (Photograph 53). Overgrown vegetation was noticed along the channel but still indicated positive drainage.

Open channel
downstream of the
chemical feed
building.

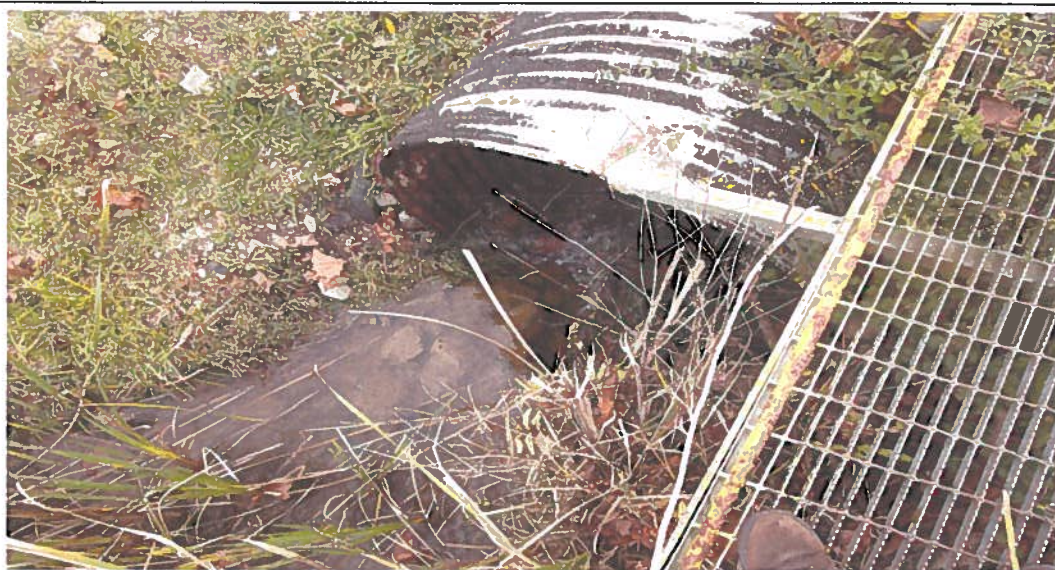
Photo # 54

- (ix) Two pipes culvert is located at the Outfall #001 (Photographs No. 54 and 55). Both the inlet and outlet ends of the pipes are illustrated in these photographs. Typically, one pipe culvert carries majority of the flow and the other pipe culvert is used during high flows. During inspection, both pipes indicated water flowing through them. These pipes connect the open channel and a tributary that lead to the Stingy Creek. The culvert appeared to have enough capacity for the present flow condition and increased flow due to lowering of the reservoir.

Pipe culvert inlet end
at the Outfall 001.

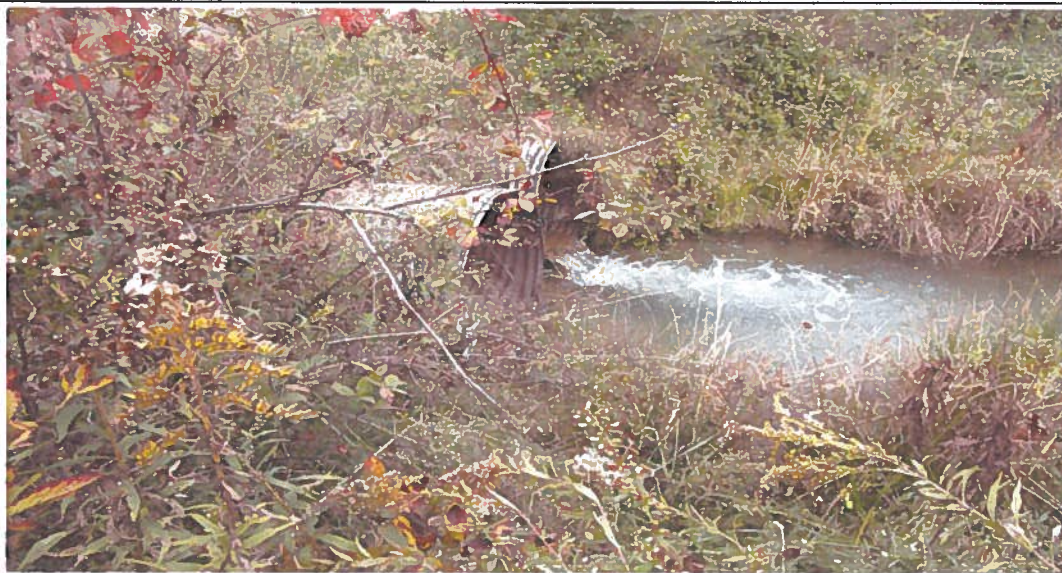
Photo # 55

Outlet end of the pipe
culverts to the Stingy
Creek.
