**2017 Annual Inspection Report**

*Bottom Ash Complex and  
Stingy Run Fly Ash Reservoir  
Gavin Power Plant  
Cheshire, Ohio*

*8 January 2018*

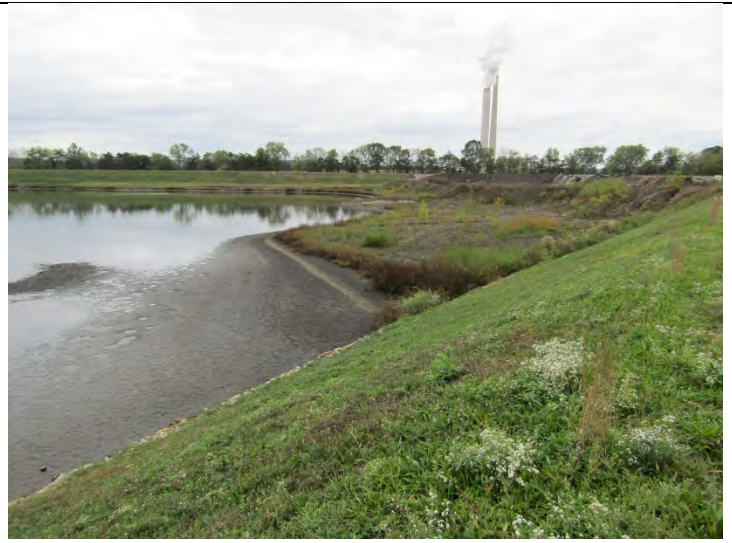
<b>Photograph #1</b>

1. Recently (as of 2016), the bottom section of the interior embankment had been repaired with riprap as shown in Photograph 1. The riprap appeared to be in satisfactory condition.

An overview view of interior slope and condition of riprap at toe (looking south).	
<b>Photograph #2</b>

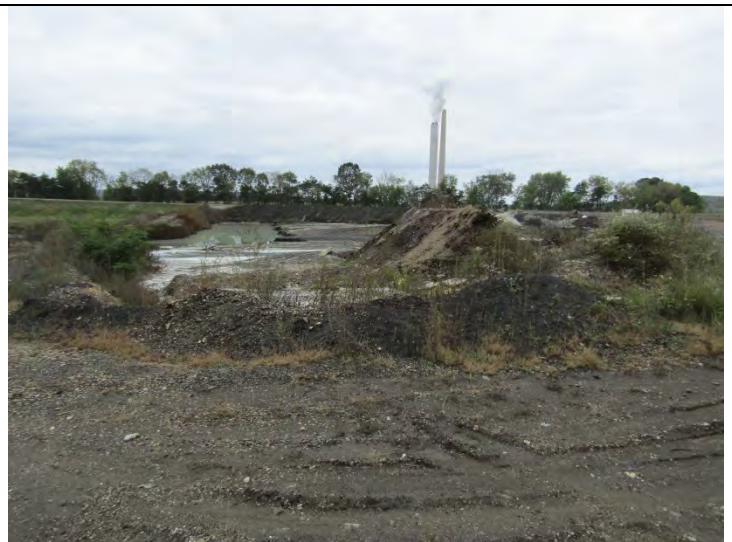
2. Photograph 2 illustrates a bottom ash temporary storage and management area with a typical view of residual ash piles. The piles appear to be in stable condition and buttress portions of the interior slope. The adjacent embankment slope appears to be stable.

Residual coal ash piles along inner slope of west dike (looking south).	
<b>Photograph #3</b>

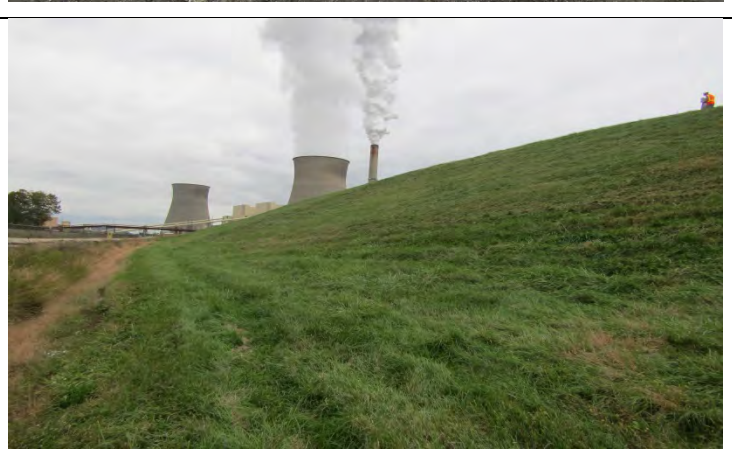
3. The drainage ditch along the western toe of the exterior embankment appeared to be in satisfactory condition, with positive drainage and was clear of weeds and brush (Photographs 3 and 4). The pipe culvert located at the end of the ditch to the south had some wet soil, but there were no obstructions in the culvert, and the grade was sloped to have positive drainage. The inlet and outlet of the pipe had vegetation in the path of flow.

Condition of outer bank and drainage ditch along west edge (looking north)

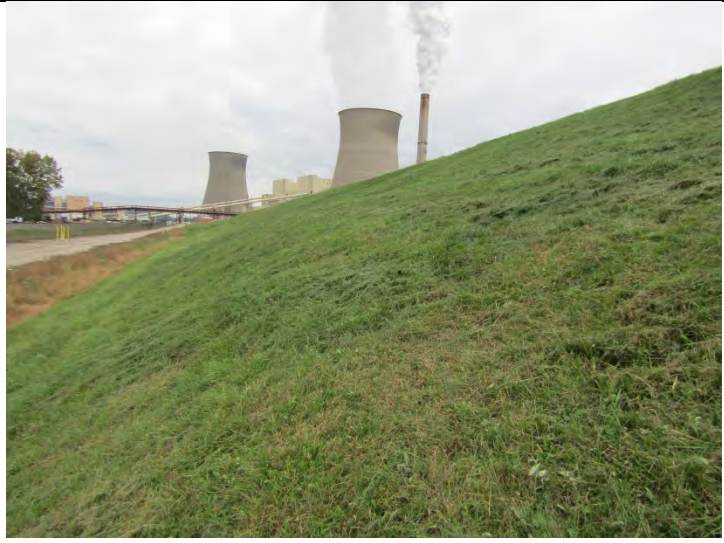
**Photograph #4**

3. The exterior slope had no visual indication of settlement, rutting, or misalignment noted except for an earthen bulge noted halfway down the slope where Photograph 4 was taken and a vegetated erosion gully shown where Photograph 5 was taken (Figure 4). The earthen bulge and vegetated erosion gully do not appear to be active or expanding. The earthen bulge was previously noted in the 2016 Annual Inspection Report, and this bulge also did not appear to be active during the 2016 inspection. The bulge in this area has reportedly been like this since original construction.

4. The exterior slope was generally in satisfactory condition. An inactive earthen bulge shown in Photograph 4 was noted about halfway down the slope. Gavin staff will continue to visually monitor this feature to look for signs of activity. An erosion gully was also noted running east-west along the exterior slope (Photograph 5). The erosion gully was vegetated and did not appear to be expanding.

Slope of exterior embankment including apparent inactive earthen bulge along slope (looking north).

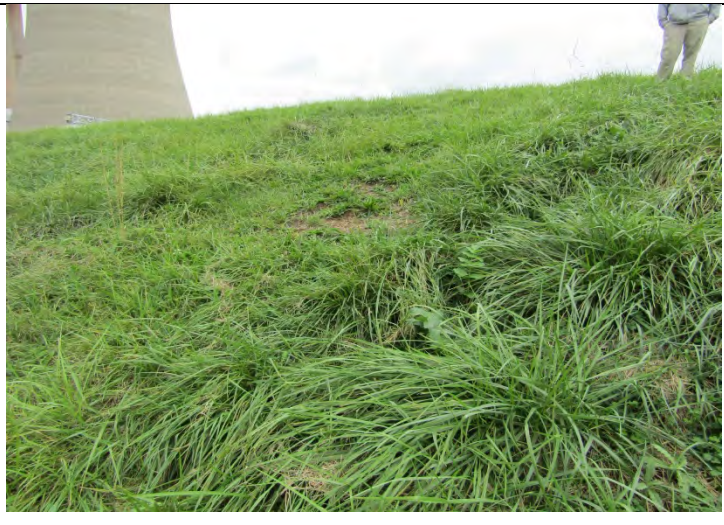
**Photograph #5**

Vegetated erosion gullies running along exterior slope (looking east).

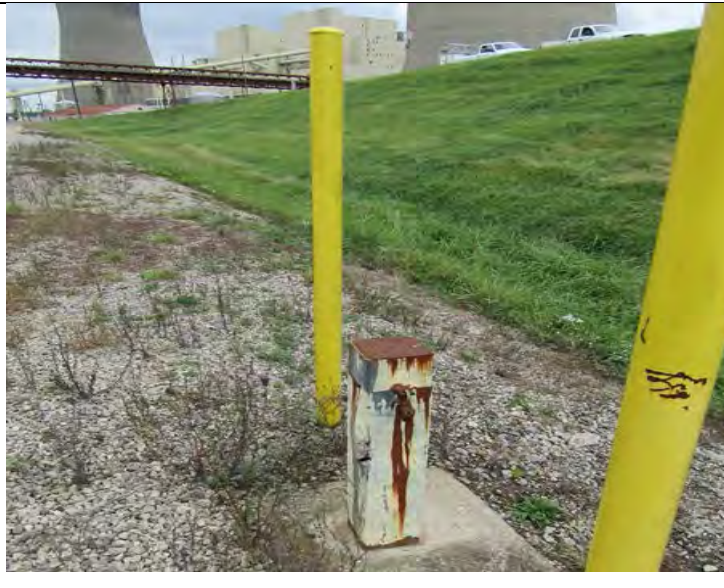
**Photograph #6**

5. The casing at Piezometer BAP-1 appeared to have been damaged and there was no lock on the casing (Photograph 6). The piezometer itself still appeared to be in satisfactory working condition. This is one of two piezometers used to measure daily water levels near to the toe of the embankment.

View of Piezometer BAP-1 (looking north).

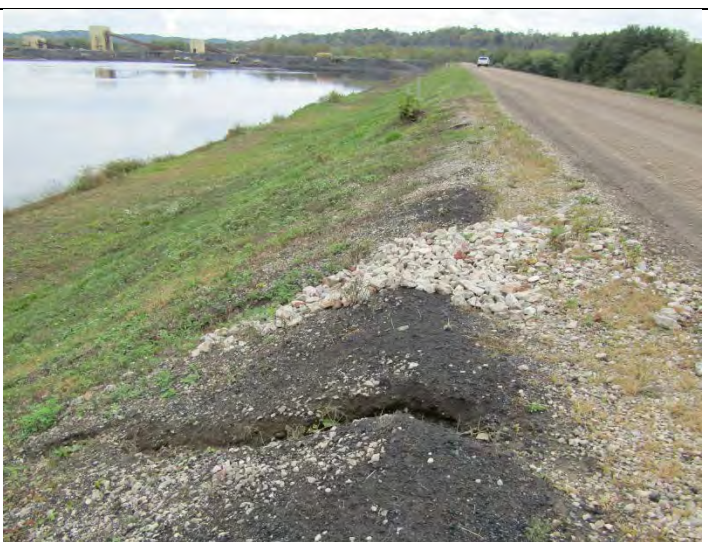
2. To the east along the interior slope, sparser vegetation was noted, which may have resulted from recent placement of bottom ash at the surface. The inert nature of bottom ash and the associated lack of nutrients were likely the causes of sparse vegetation in that area. A few isolated areas to the west with sparser vegetation were also noted.

<p>Rill formation on eastern portion of interior embankment where coal ash had been recently placed (looking west).</p>

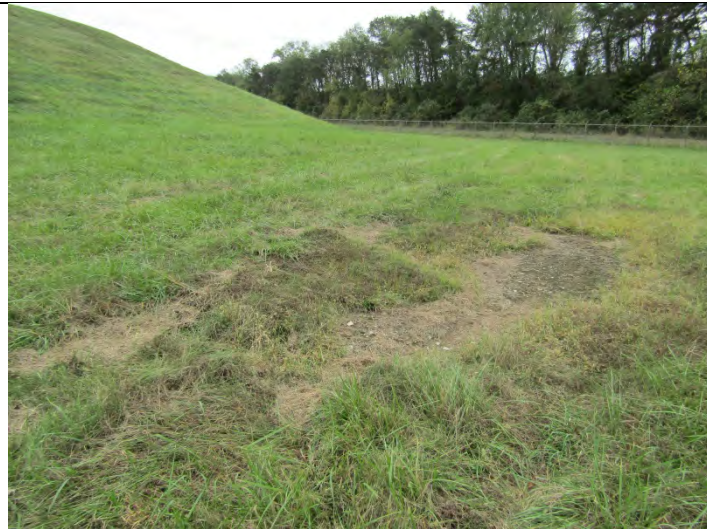
**Photograph #14**

View of sparsely vegetated low area at western toe of exterior bank (looking south).

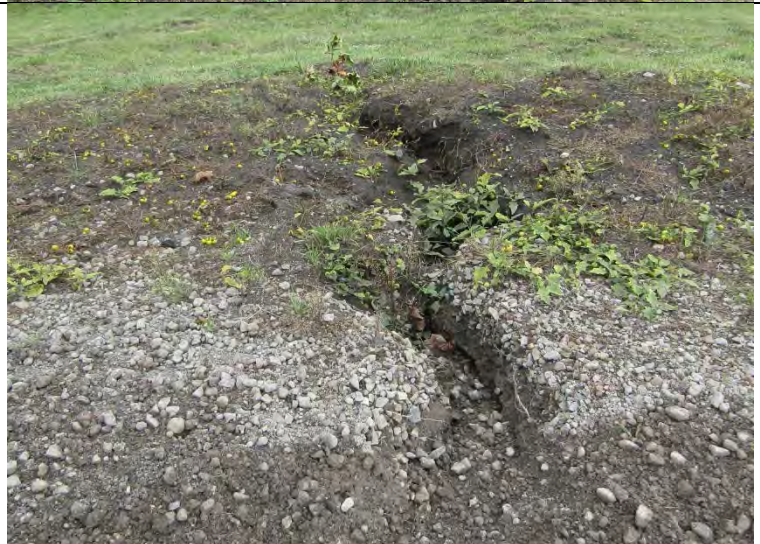
**Photograph #24**

Localized gully on bare spot of exterior slope (looking east).

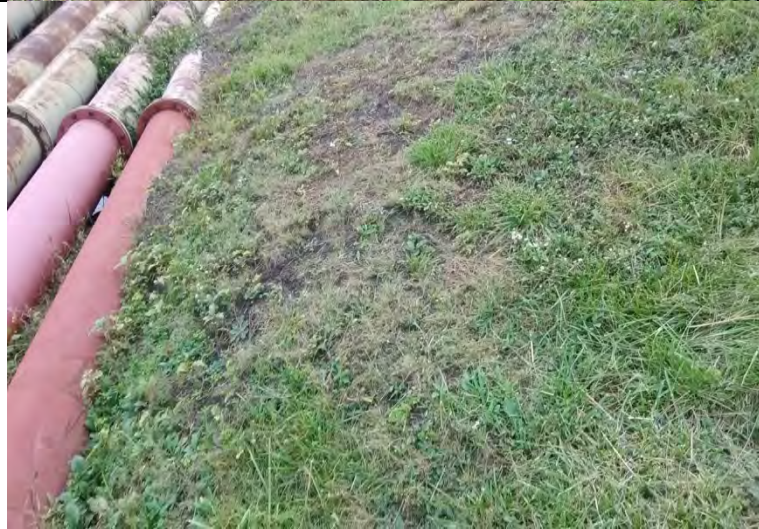
**Photograph #28**

View of localized wet slope along toe (looking south).

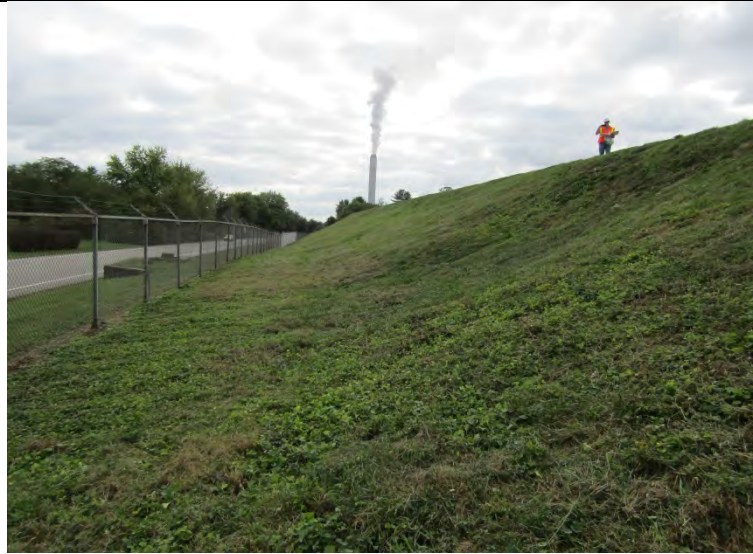
**Photograph #29**

View of slope where evidence of soil subsidence was noted (looking south).

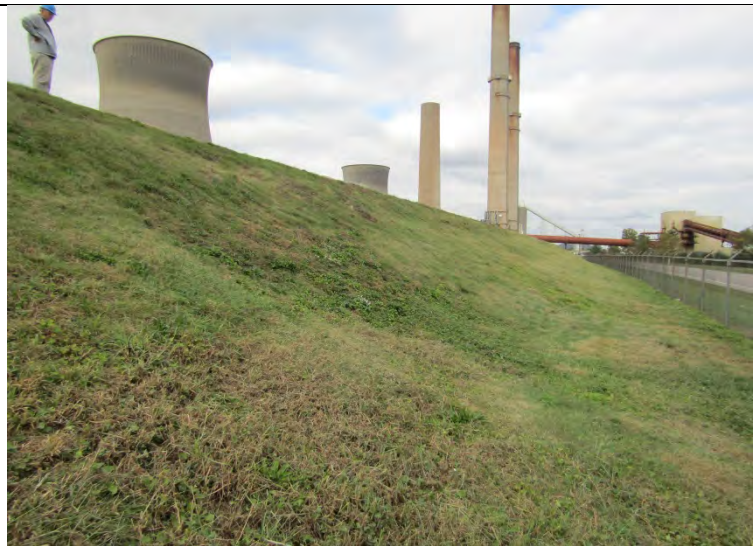
**Photograph #30**

View of slope where evidence of soil subsidence was noted (looking north).

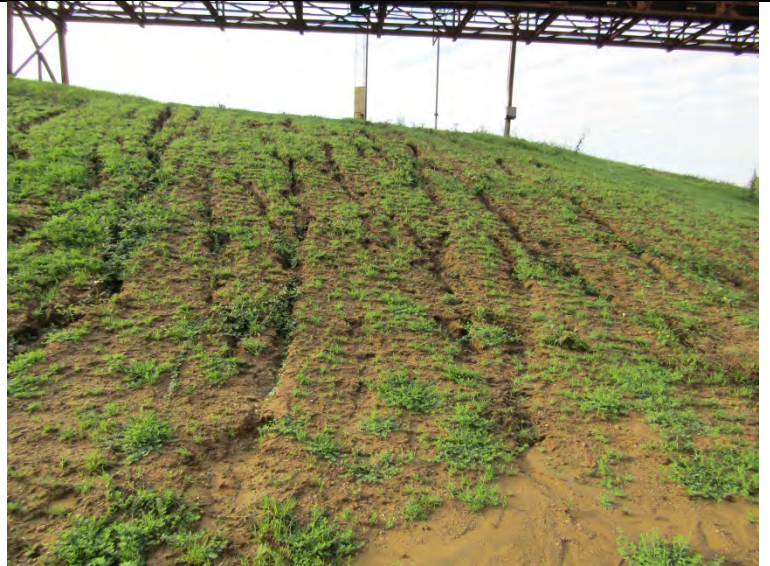
**Photograph #34**

View of exterior slope with apparent rills and gullies along slope (looking south).

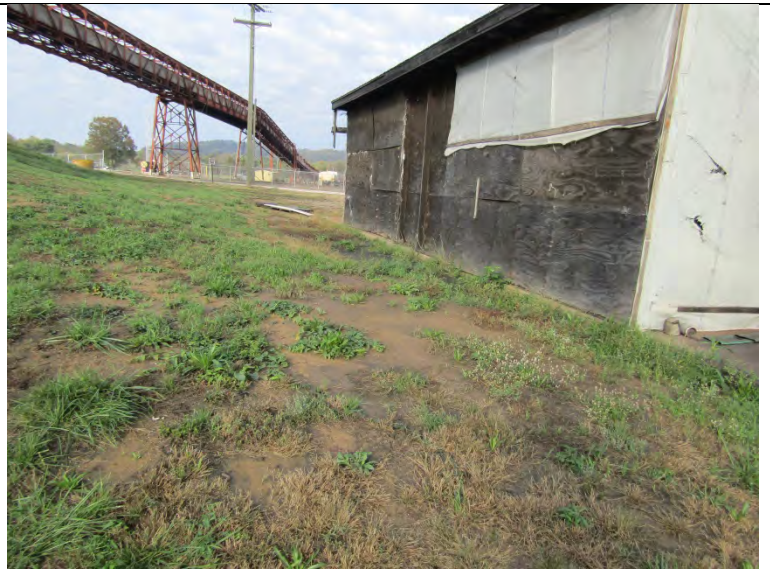
**Photograph #35**

View of bare spot with localized wet/saturated surface at toe of exterior slope (looking west).

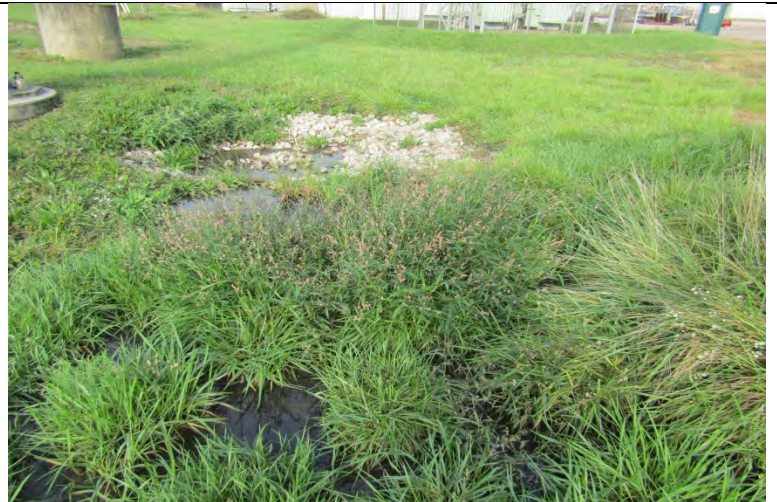
**Photograph #39**

View of standing water in drainage ditch (looking west).

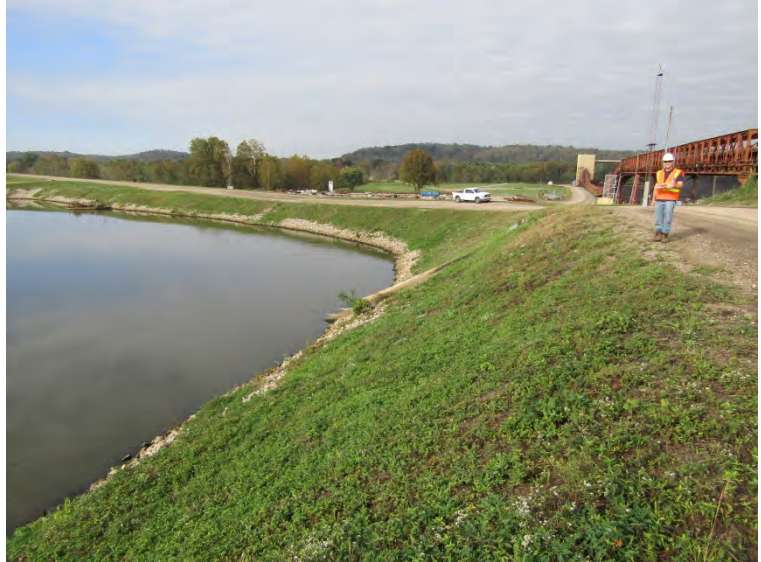
**Photograph #46**

View of slope along interior embankment with noticeable subsidence (looking east)

5. Repair the isolated area of apparent shallow soil sloughing in the northwest corner of the Reclaim Pond. The area is estimated to be approximately 40 feet wide by 10 vertical feet tall. Remove the affected soil and replace with a geotextile cover and riprap, or a similar approach approved by an engineer.

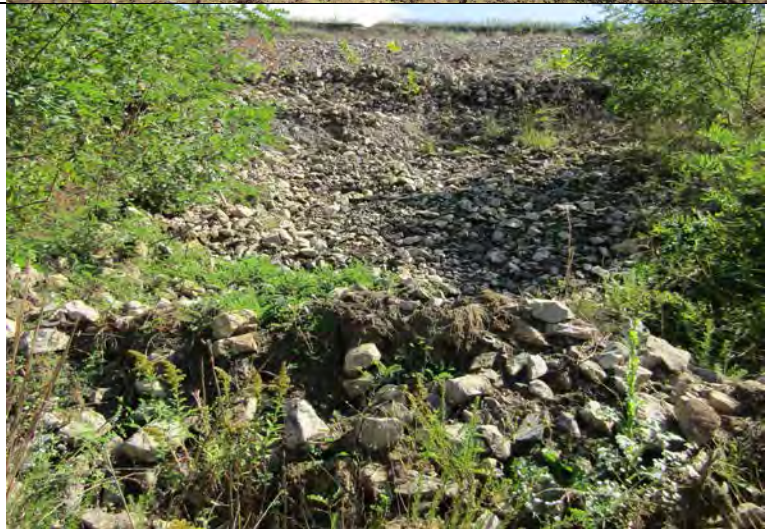
**Photograph #63**

View of location where soil had recently settled and was repaired with riprap (looking south).

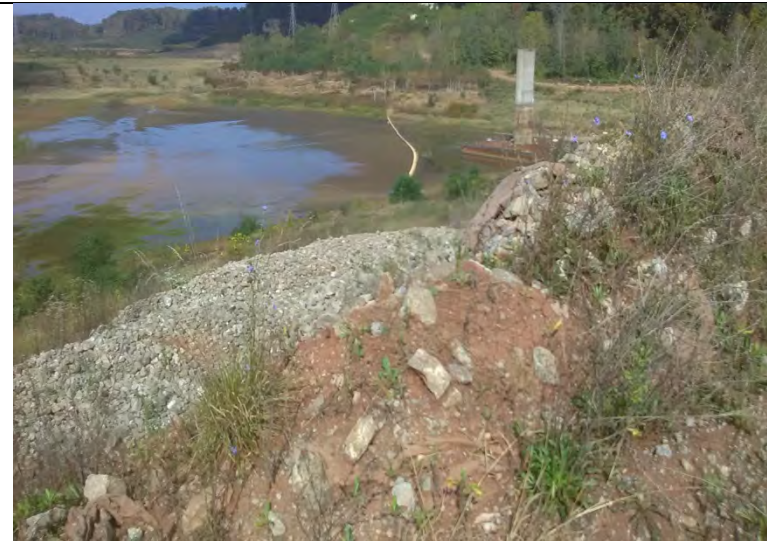
**Photograph #64**

View of Fly Ash Pond and soil bulge at bench (looking west).
