DAM & DIKE INSPECTION REPORT

Bottom Ash Complex Stingy Run Fly Ash Dam

**GAVIN PLANT
CHESHIRE, OHIO**

INSPECTION DATE December 1, 2015

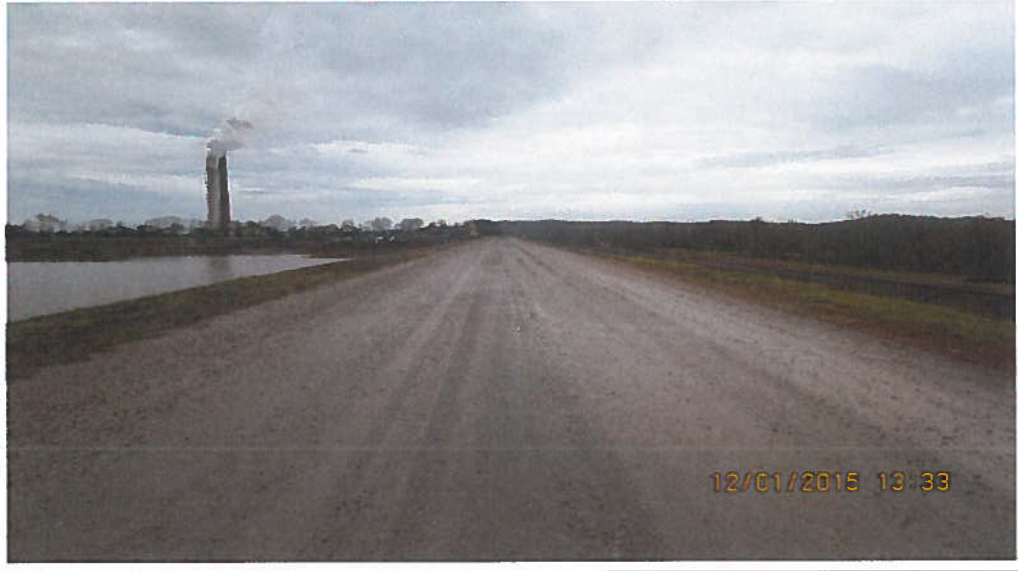
- (i) The crest of the dike appeared in good condition as indicated in Photograph No. 1. No misalignment, settlement, or excessive rutting was noticed. The typical view of the upstream slope is shown in Photograph No. 2. Overall, the upstream slope

<p>Photo # 1</p> <p>An overall view of the crest (looking south).</p>

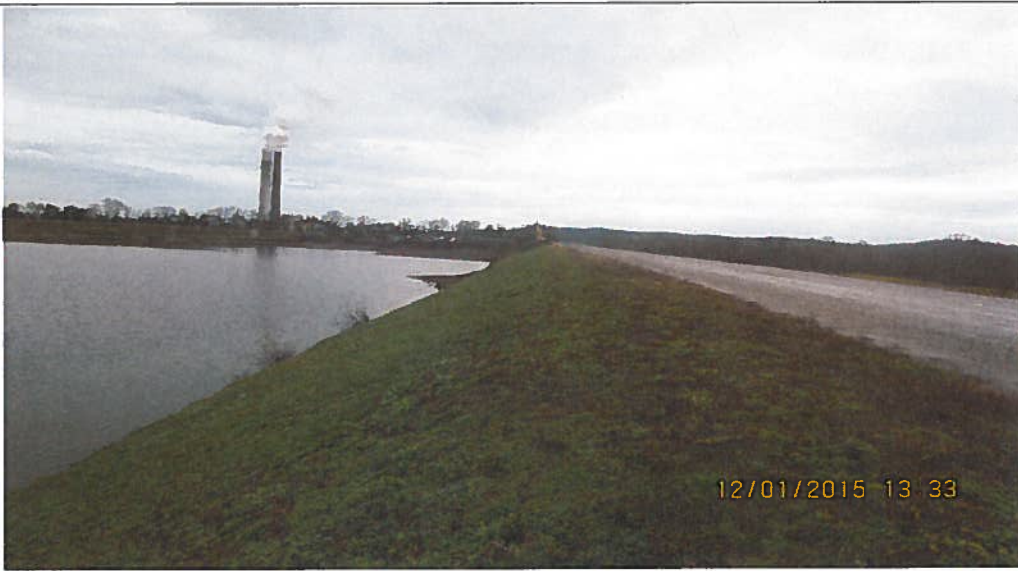
<p>Photo # 2</p> <p>Upstream slope of the dike (looking south) appeared good with controlled vegetation.</p>

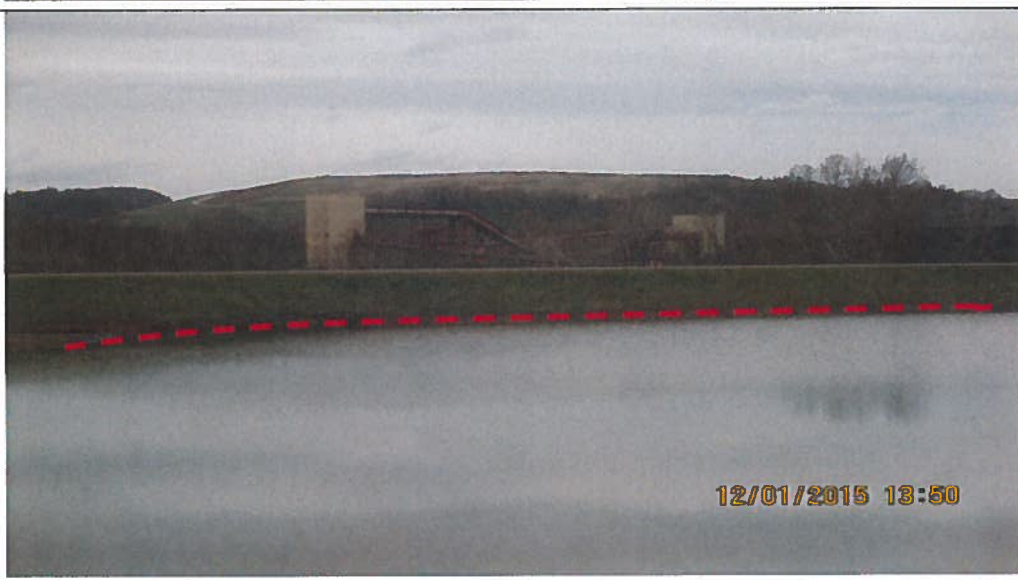
appeared in good and stable condition with controlled vegetation. Some minor erosion due to beach action was noted along the waterline (Photograph No. 3).

<p>Photo # 3</p> <p>Lower section of the upstream slope illustrates minor erosion.</p>

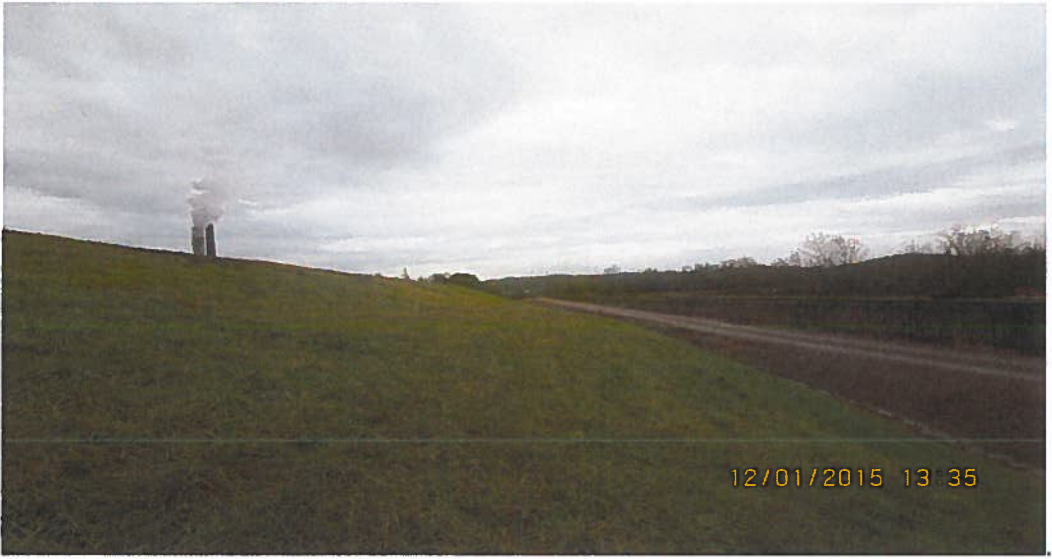
- (ii) View of the downstream slope is illustrated in Photographs No. 4 and 5. Also shown is the service road in these photographs. In general the entire slope appeared in good and stable condition with well-maintained and controlled vegetation growth. The service road and drainage ditch along the toe of the downstream slope were in good condition, positive grade, and clear from weeds and bushes.

<p>Photo # 4</p> <p>The downstream slope of the west dike (north section).</p>

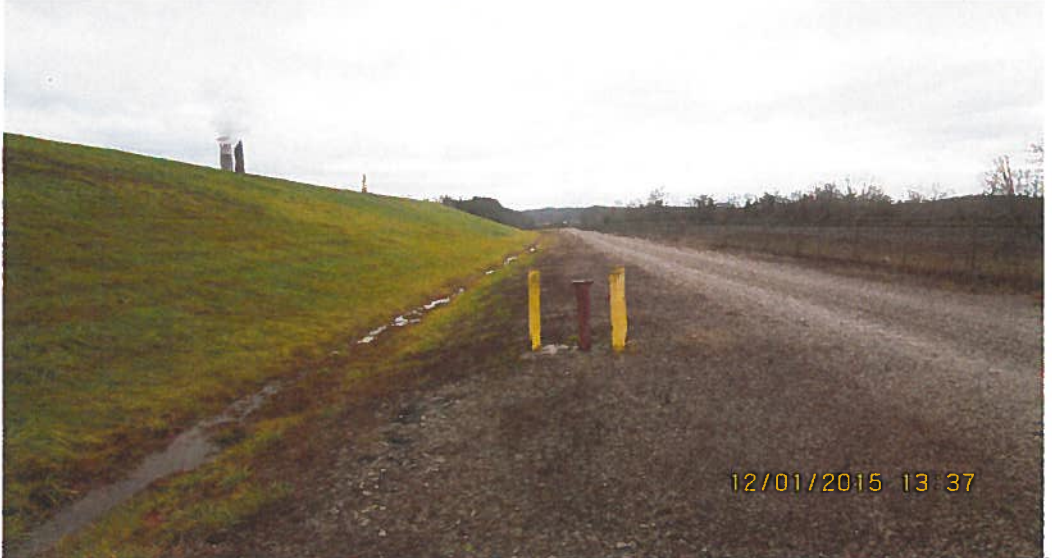
<p>12/01/2015 13:35</p>
<p>Photo # 5</p> <p>The downstream slope of the west dike, access road, and toe ditch (looking south).</p>

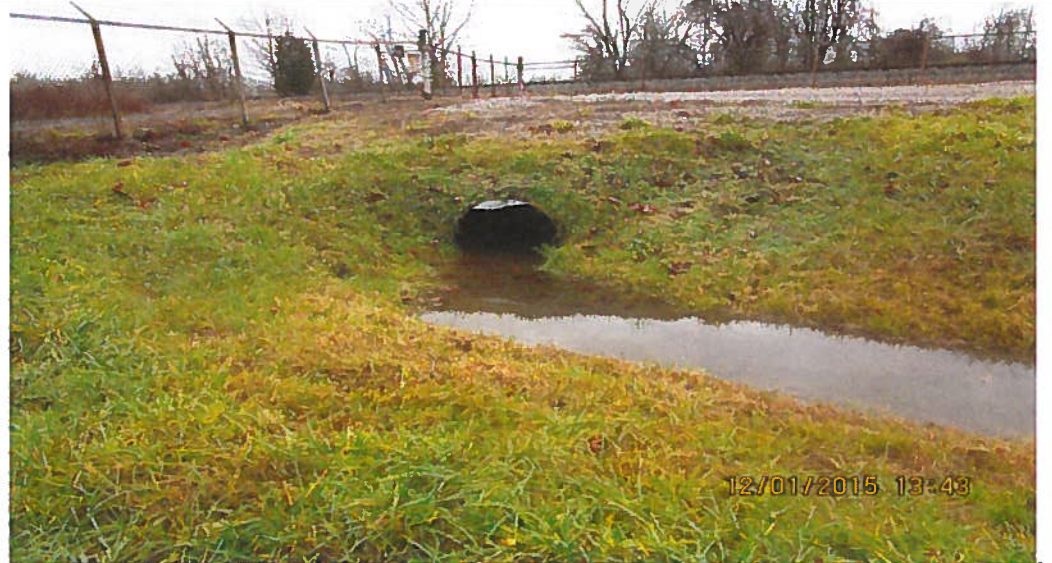
- (iii) The pipe culvert at the end of the ditch to the south is illustrated in Photograph No. 6. The pipe culvert indicated some standing water but flow was still exiting the ditch through the culvert indicating positive drainage.

<p>12/01/2015 13:37</p>
<p>Photo # 6</p> <p>The pipe culvert the exit point of the ditch.</p>

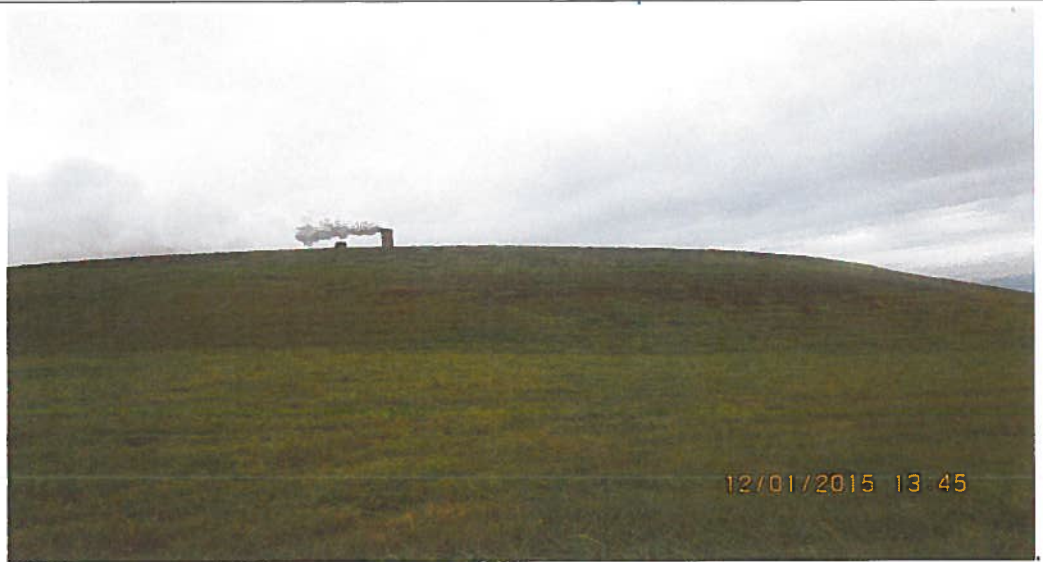
Photo # 7

- (iv) The southwest corner of the downstream slope is illustrated in Photograph No. 7. The slope and the toe area adjacent to the slope appeared in good and stable condition with controlled vegetation. The southwest corner at the upstream side is illustrated in Photograph No. 8. This area is designated for temporary storage of plant waste materials. This area was well maintained and confined to this area.

The downstream slope and adjacent toe area.

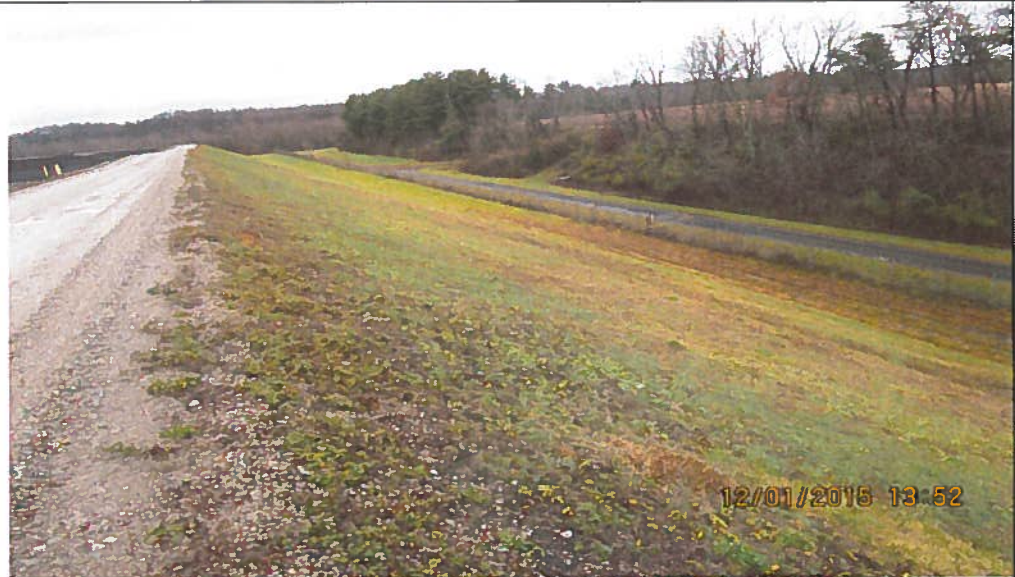
Photo # 10

- (i) An overall view of the downstream slopes of the south dike is illustrated in Photographs No. 9 and 10. Overall the vegetation cover on the slopes was well maintained and in good condition. The crest of the dike is illustrated in Photograph No. 9 appeared in good and stable condition without any signs of settlement, misalignment, and depression. The toe ditch along the chain link fence appeared in good condition with positive flow.
- (ii) Photograph No. 11 shows an area where the underground culvert is located and collects the surface runoff and drains to the ditch on the other side of the property boundary. A chain link fence is located where the underground pipe culvert is

Another view of the downstream slope (looking east).

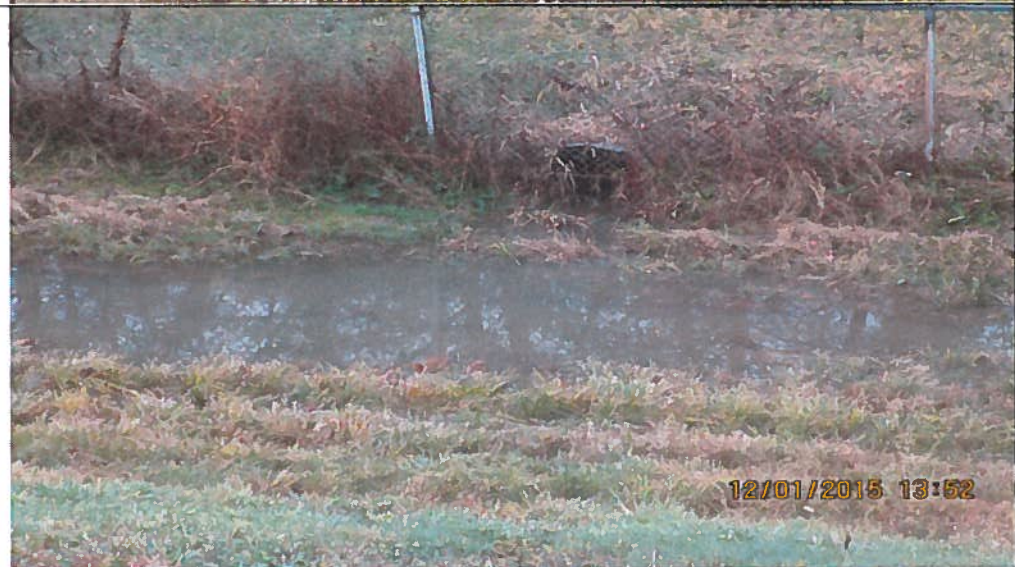
Photo # 11

The area around the culvert at the toe of the slope in good condition.

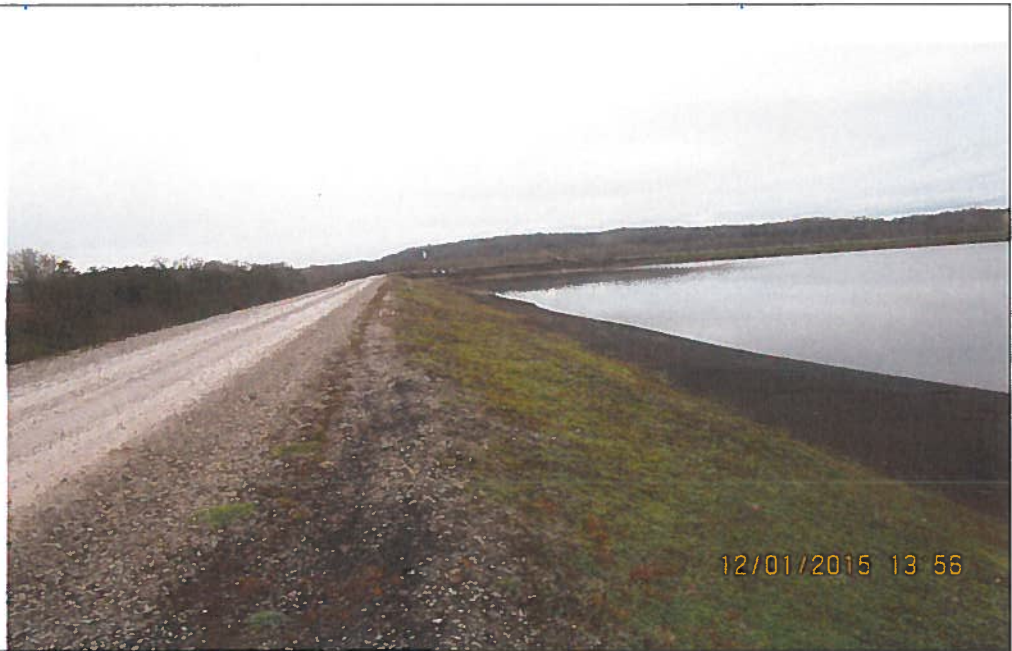
Photo # 12

- (iii) Photograph No. 12 illustrate the upstream slope of the south dike. A buttress at the toe of the interior slope is placed using bottom ash. Overall the upstream slope appeared in good and stable condition. Erosion gullies previous noticed have being repaired (Photograph No. 13).

Upstream slope of the dike (looking west) appeared in good and stable condition with controlled vegetation.

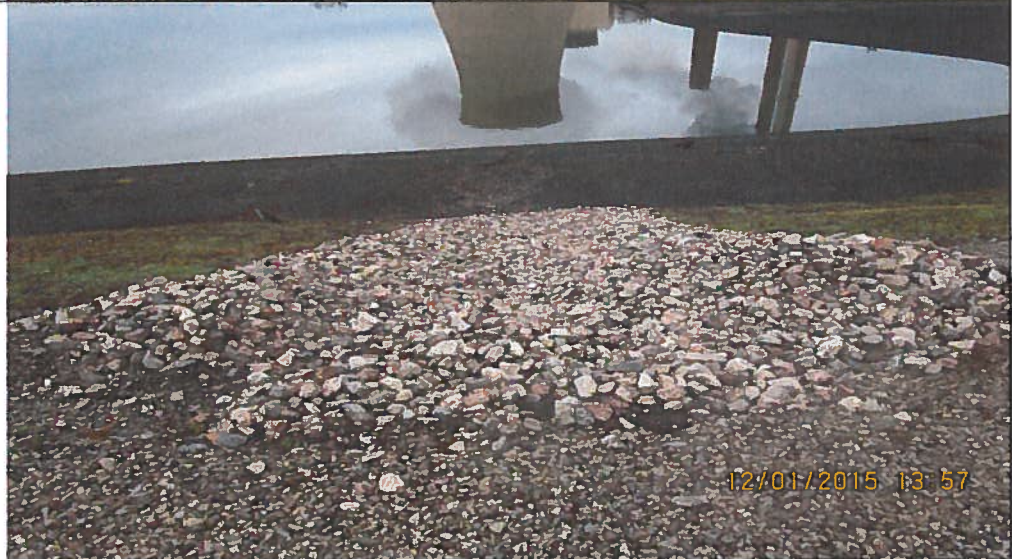
Photo # 13

Typical view of erosion gully repaired.

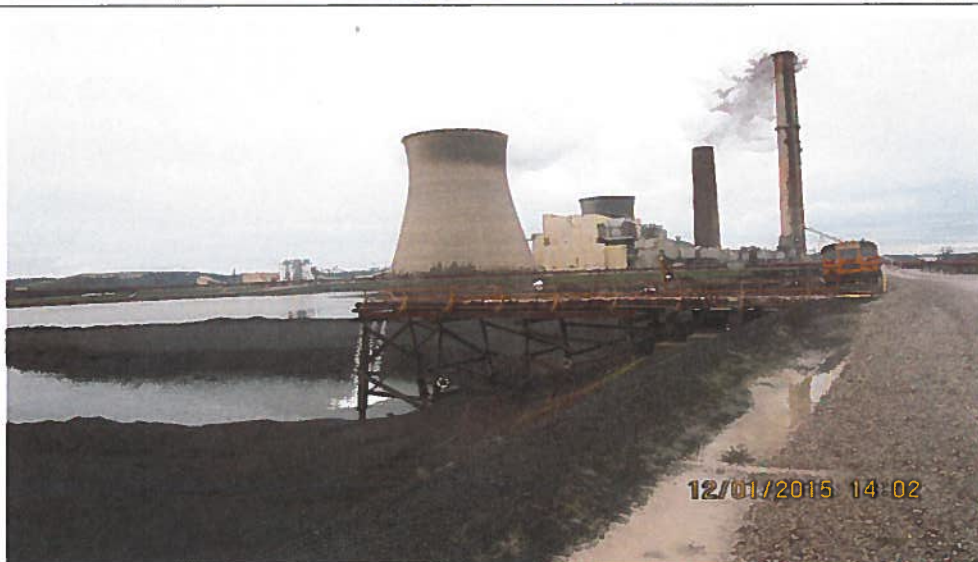
Photo # 15

- (ii) Photographs No. 15-17 illustrate the three sets of ash pipes and support structure. The pipes and structure appeared to be in good and functional condition.

Ash sluice pipes and support structure (south).

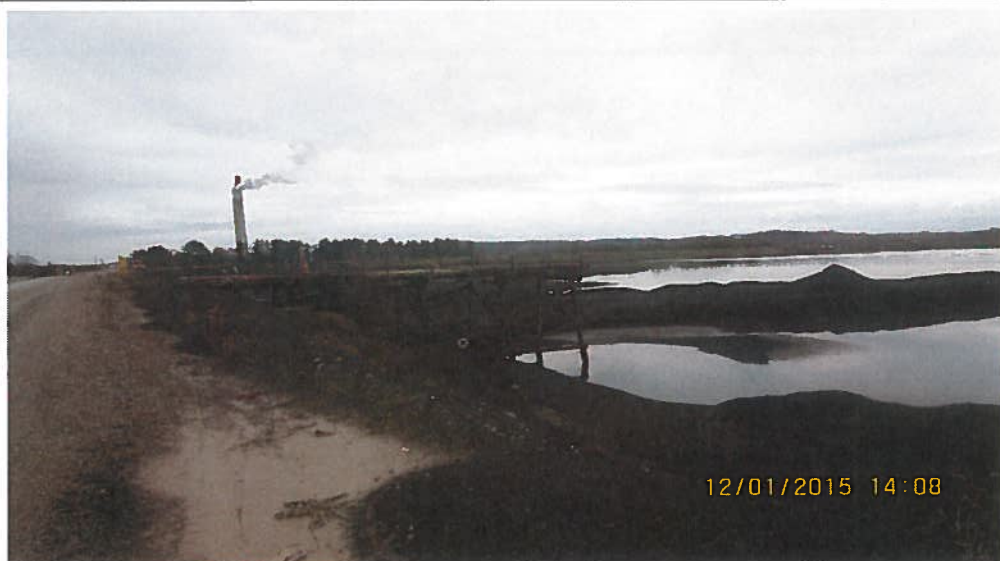
Photo # 16

Ash sluice pipes and support structure (middle).

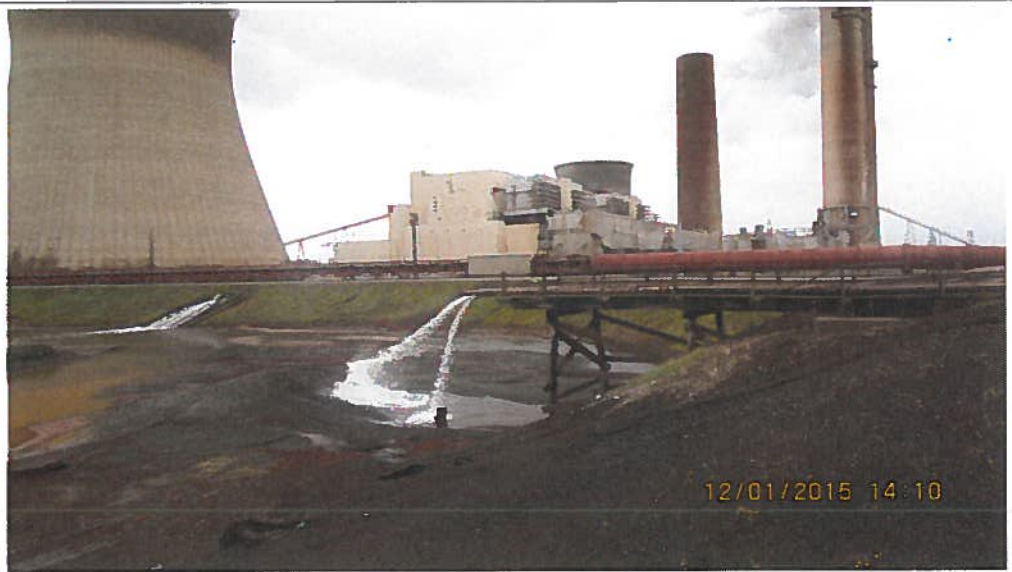
Photo # 17

Ash sluice pipes and support structure (north).

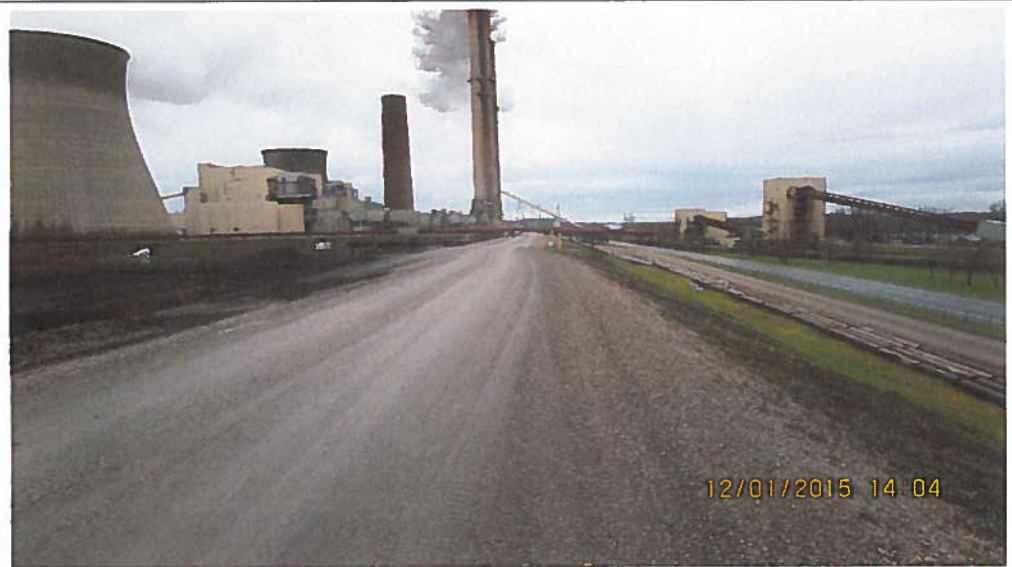
Photo # 18

- (iii) The crest also used for vehicular traffic and upstream slope is illustrated in Photograph No. 18. The crest appeared in good and stable condition and no sign of significant misalignment or settlement was observed.

Typical view east dike crest (looking north).

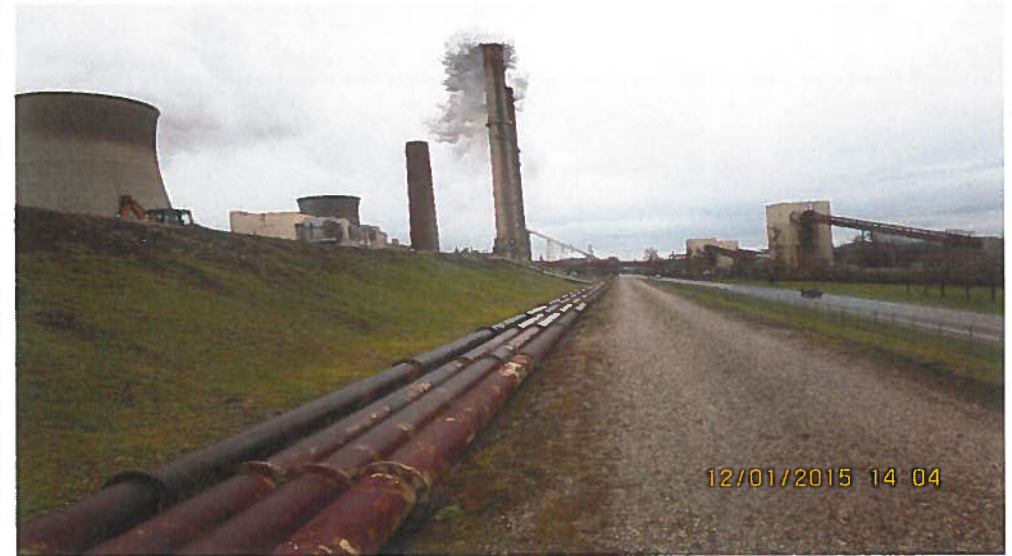
Photo # 19

- (iv) Photographs No. 19 and 20 illustrate upper downstream slope, intermediate bench, and the lower section of the downstream slope and State Route 7 located east of the dike. The intermediate bench appeared in good condition and no sign of settlement or misalignment was noticed. The ash pipes are functioning as designed. The toe of the slope appeared dry and no standing water or soft areas were noticed. Few small depressed areas on the lower slope were noticed.

Downstream slope, sluice pipes and intermediate bench.

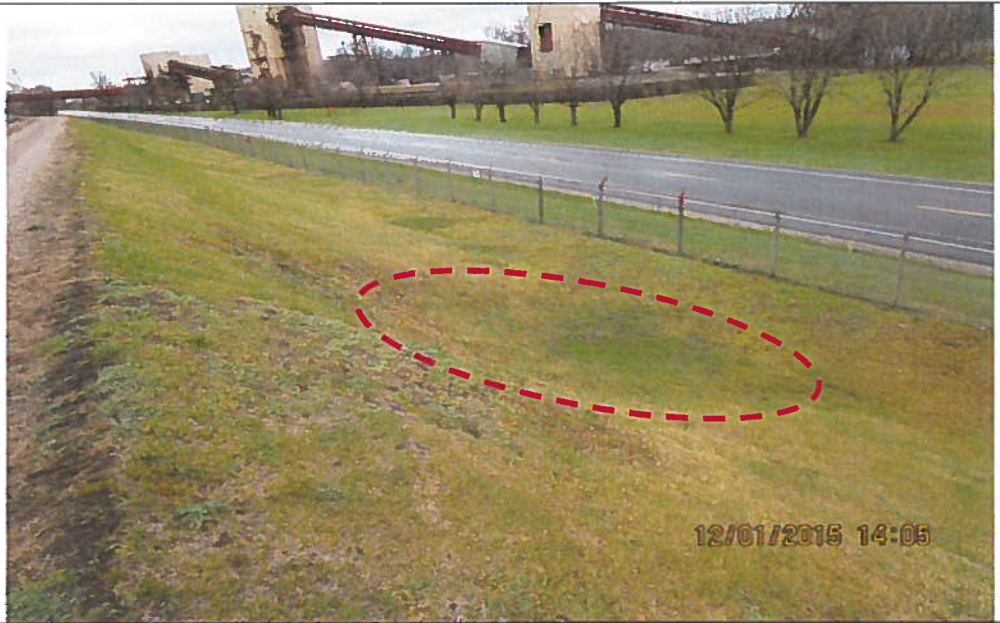
Photo # 20

Downstream slope
(looking north).

- (i) Repair erosion gullies and depressed area as noted. These areas shall be backfilled with compatible clean material followed by compaction.
- (ii) We recommend that the sloughing (beach erosion) at the Clearwater dike shall be recorded by the plant personnel in the quarterly inspection report. Alternately, plan on repairing the sloughing of the slopes by removing loose material, place geotextile

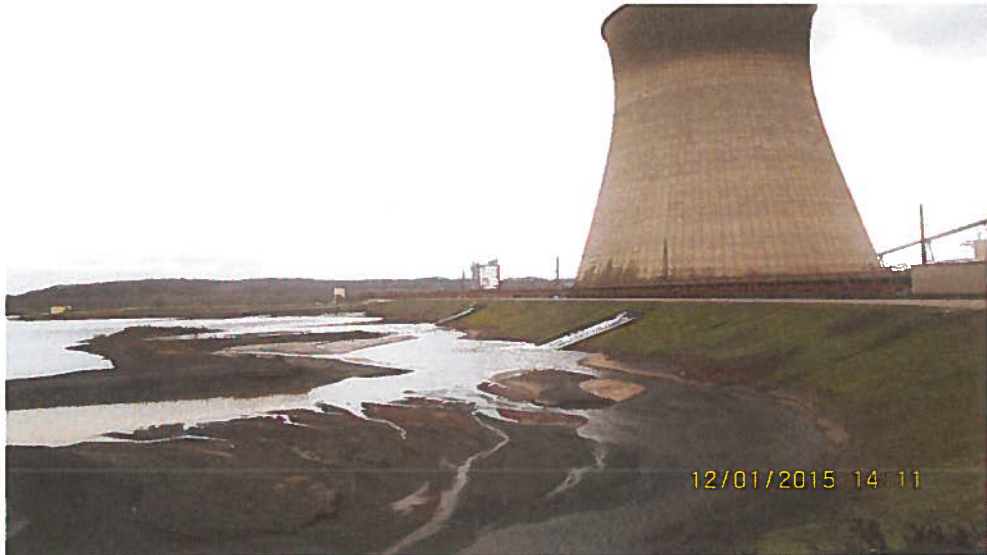
- (i) The upstream slope of the north dike is illustrated in Photograph No. 21. The slope appeared in good and stable condition. Several discharge pipes are present along this slope. Ash deposits were present along the toe of the upstream slope of the dike. The discharge pipes and support structures were in good functional condition. An erosion gully with depression (Photograph No. 22) was noticed at the northeast end. The two sets of discharge pipes and supports illustrated in Photographs No. 23 and 24 were functioning properly. It appears that the slope liner of the north east discharge pipes may have a split seam at one location (see Photograph No. 23).

<p><u>Photo # 21</u></p> <p>Overall view of the north dike.</p>

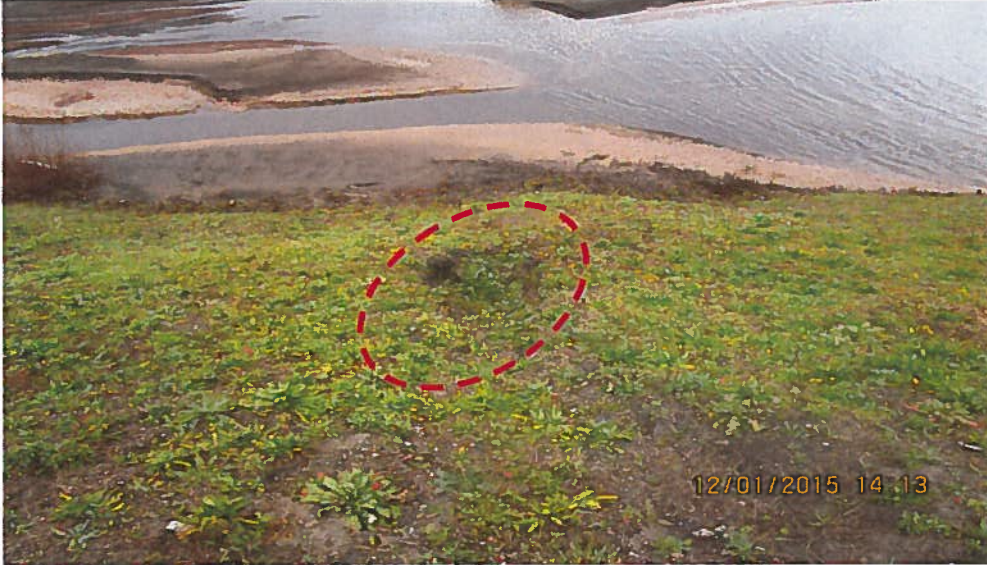
<p>12/01/2015 14:11</p>
<p><u>Photo # 22</u></p> <p>Erosion gully.</p>

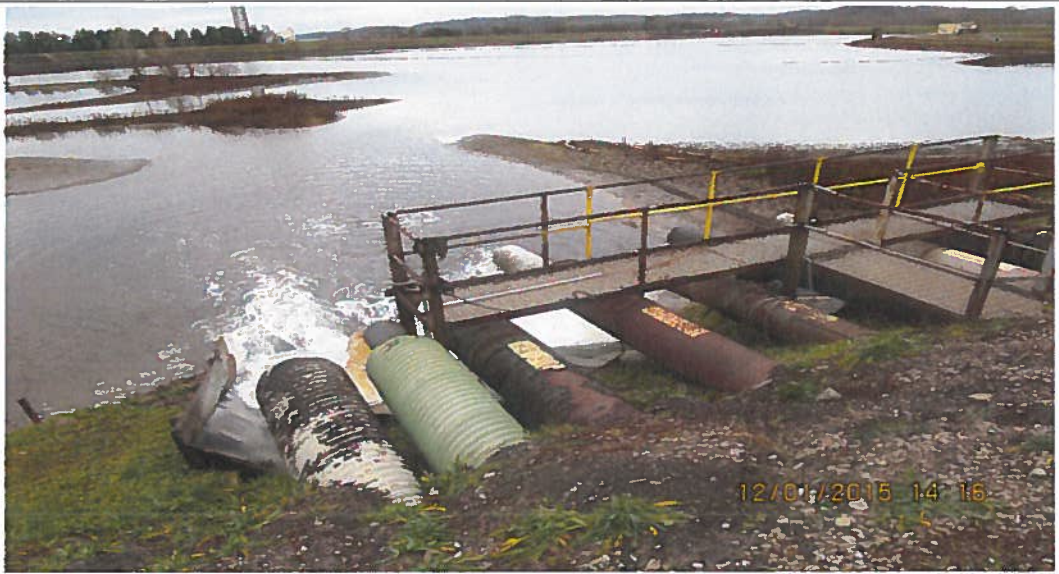
Photo # 24

Discharge pipes
(middle).

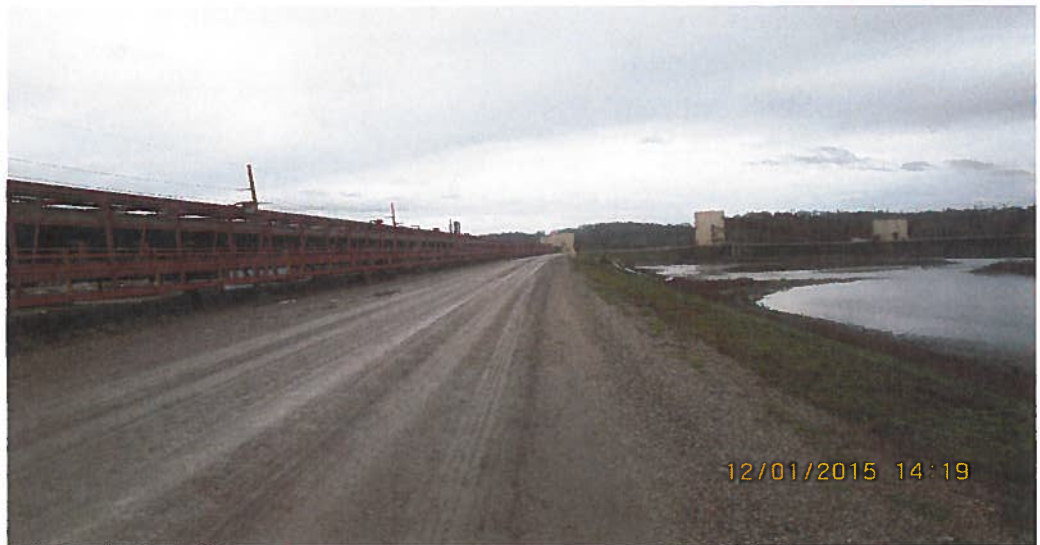
Photo # 25

- (ii) The crest of this dike is illustrated in Photograph No. 25. The crest appeared in good and stable condition and no sign of misalignment, settlement or cracks was observed.

An overall view
of the crest of the
dike (looking
east).

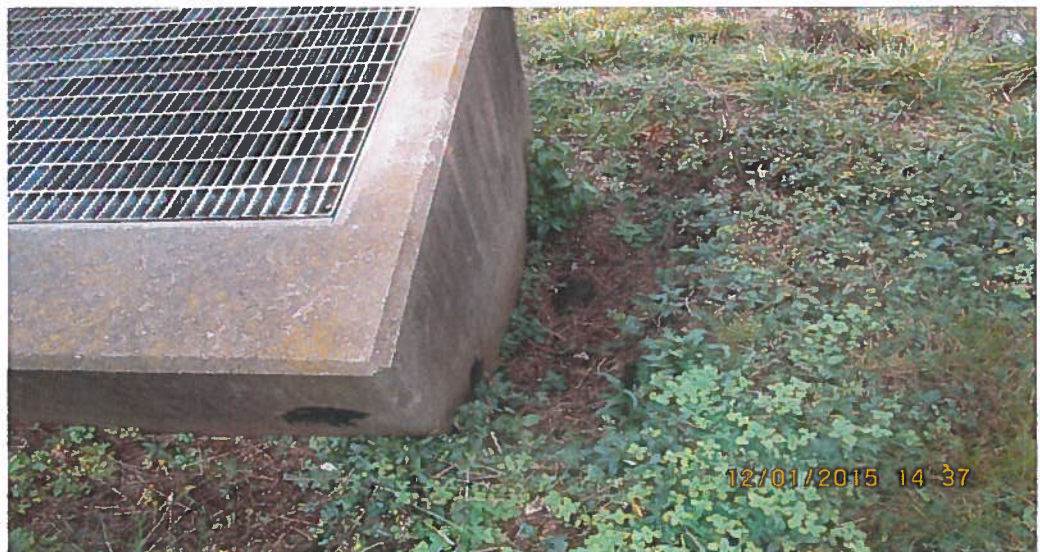
Photo # 26

- (iii) The decant structure near the toe of the downstream slope is illustrated in Photographs No. 26 and 27. No leak or settlement around the structure was noticed. The water was flowing in the decant structure without and obstruction.

The decant
structure is
illustrated in this
photograph.

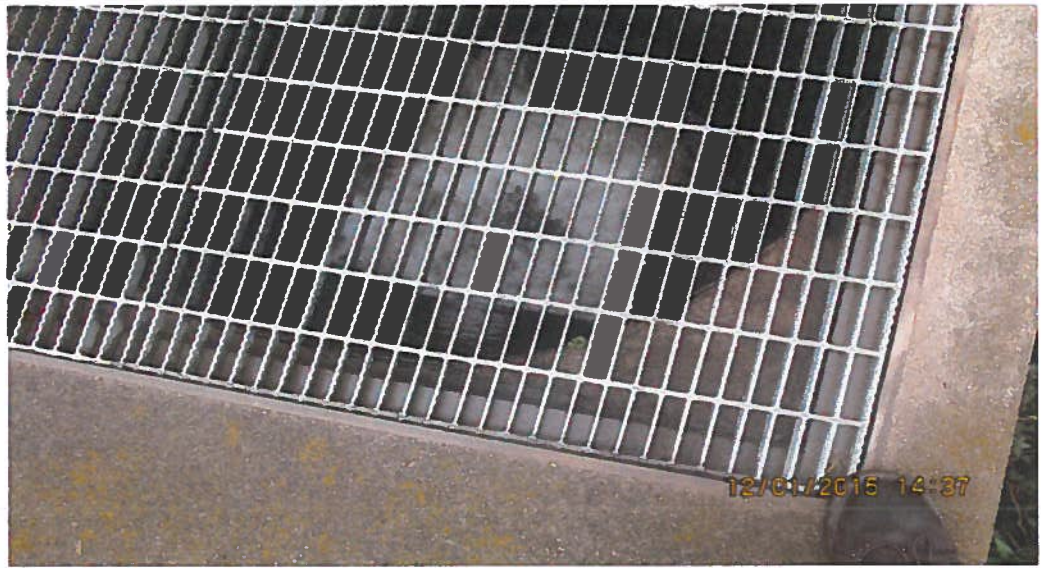
Photo # 27

Interior of the decant structure.

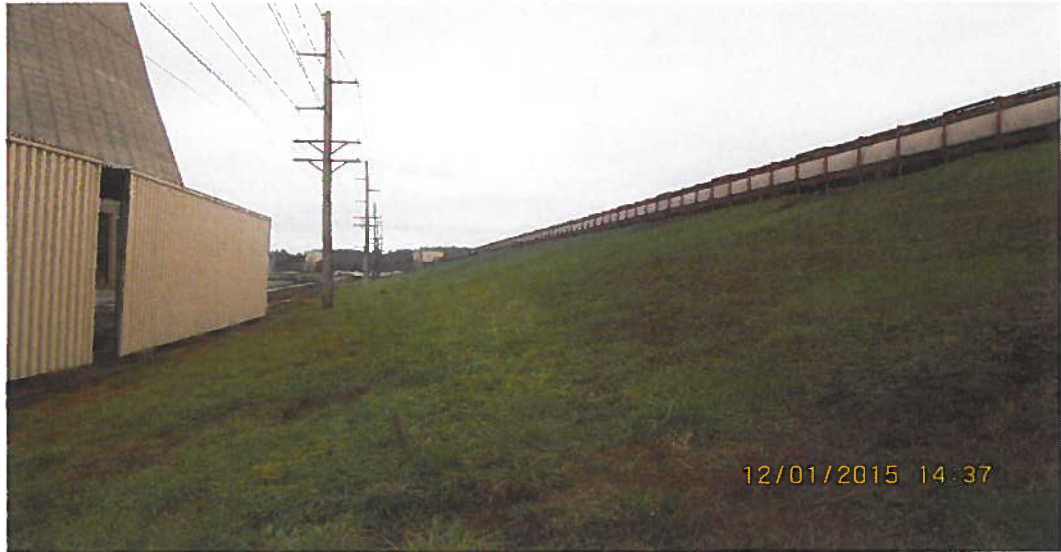
Photo # 28

- (iv) The downstream slope is illustrated in Photographs No. 28 and 29. Overall, the downstream slope was in good and stable condition. Some minor erosion was noticed along the slope, which appeared to be from leakage of the conveyor along the crest. A typical condition is illustrated in Photograph No. 29.

Downstream slope of the dike. The slope appeared in good condition (looking east).

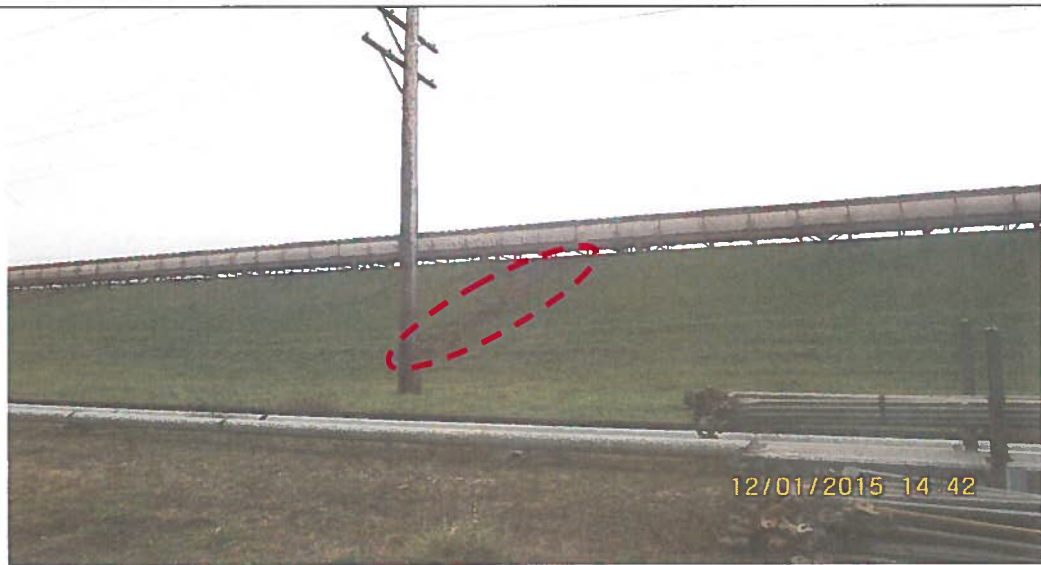
Photo # 29

Typical erosion.

- (iii) Investigate the suspected liner seam split at the east discharge pipes of the north dike. If the liner seam is found split, it could be glued together. If there is any undermining of the slope, than the slope should be repaired before seaming the liner.
- (iv) Investigate the root cause of the erosion at the downstream slope of the north dike. It appears that it may be due to leaks in the conveyor belt along the crest of the dike. Repair erosion gullies by placing riprap to minimize frequent erosion of those locations.

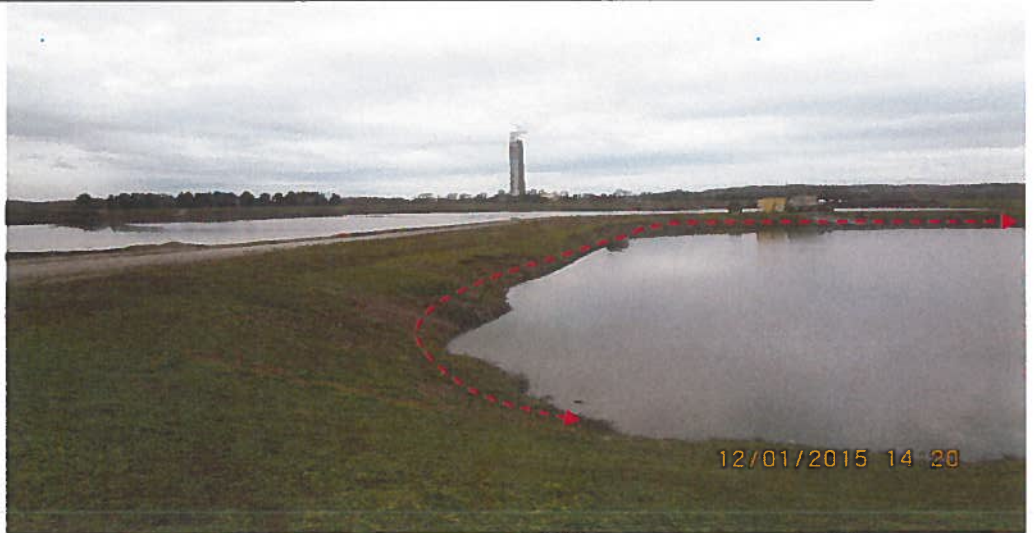
Photo # 30

- (i) Overall typical view of the interior slope of the reclaim pond is shown in Photographs No. 30 and 31. The slope appeared in fair and stable condition with controlled vegetation. As noted in previous inspections, sloughing and scarping along the interior and also exterior slope was noticed. This condition had not significantly change since it was noticed in 2009. Sections of the interior slope protected by stone/riprap have not degraded compared to sections without protection. Plant is planning to repair the lower section of the slope.

Sloughing along the interior slope shown by dotted line.

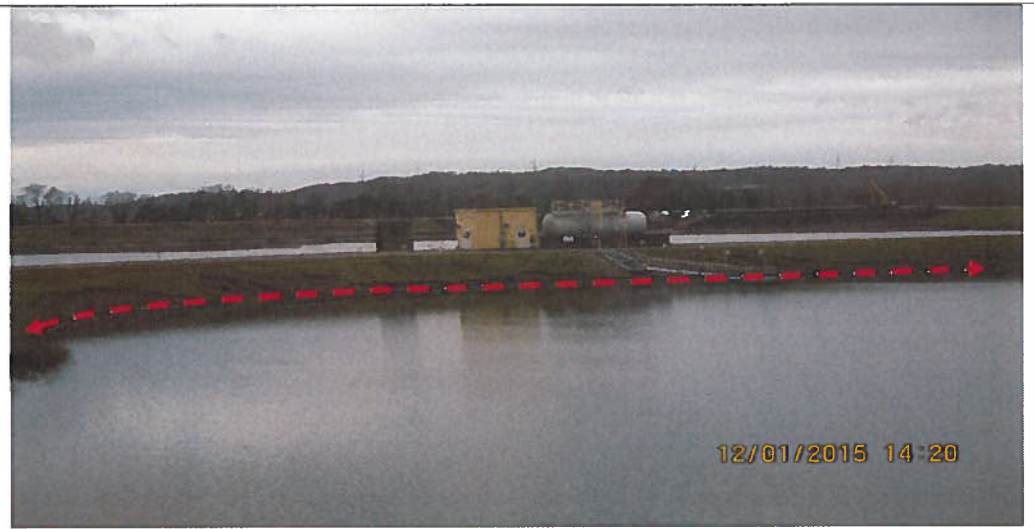
Photo # 31

Another view of sloughing at the interior slope.

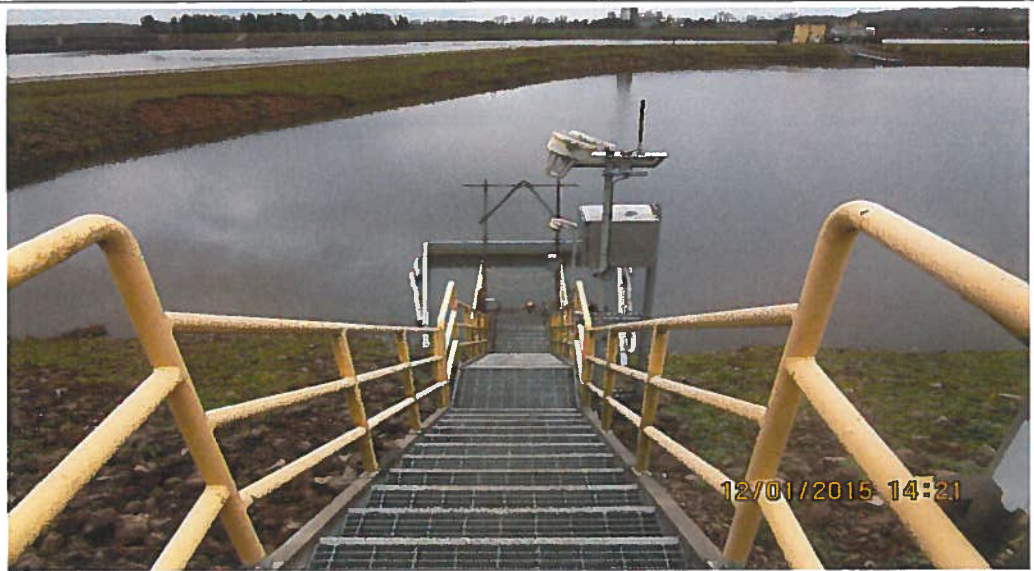
Photo # 32

- (ii) The overflow structures at the north and south dikes are illustrated in Photographs No. 32 through 35. The overflow structure including visible concrete, metal steps, railing, and deck platform appeared in good and functional condition.

An overall view of the overflow discharge structure.

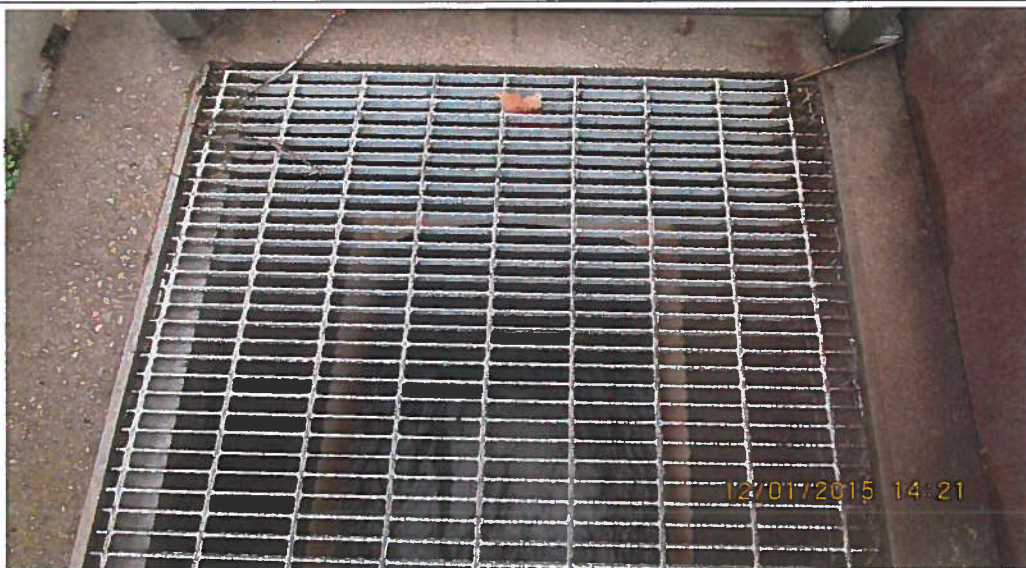
Photo # 33

Interior of the discharge structure pipe.

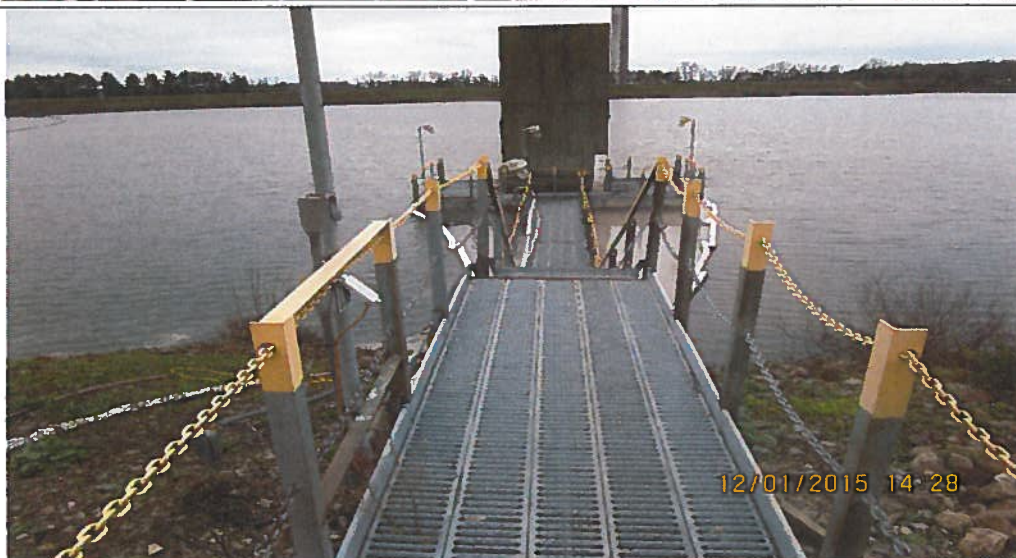
Photo # 34

An overall view of the overflow discharge structure.

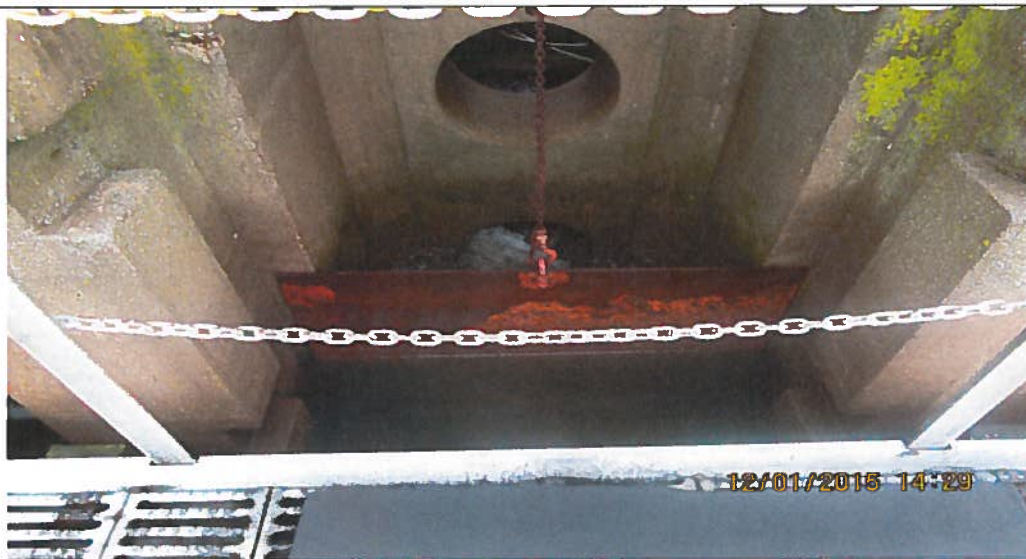
Photo # 35

Interior of the overflow discharge structure.

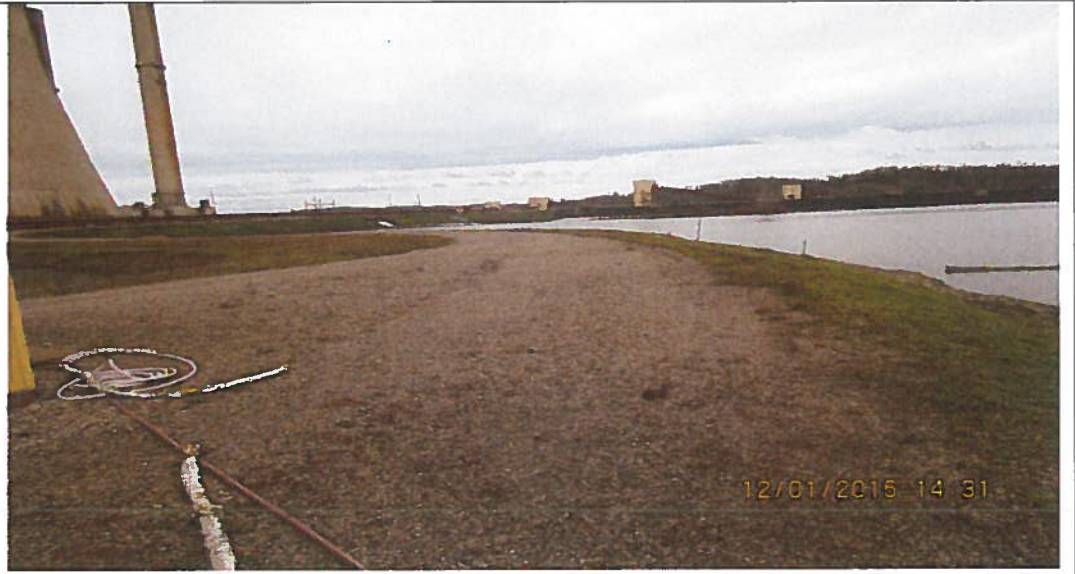
Photo # 36

- (iii) A typical view of the crest of the reclaim pond dike is illustrated in Photograph No. 36. The crest was in good and stable condition and no settlement, cracks, or misalignment was observed.

Typical condition of the
crest of the Reclaim Pond

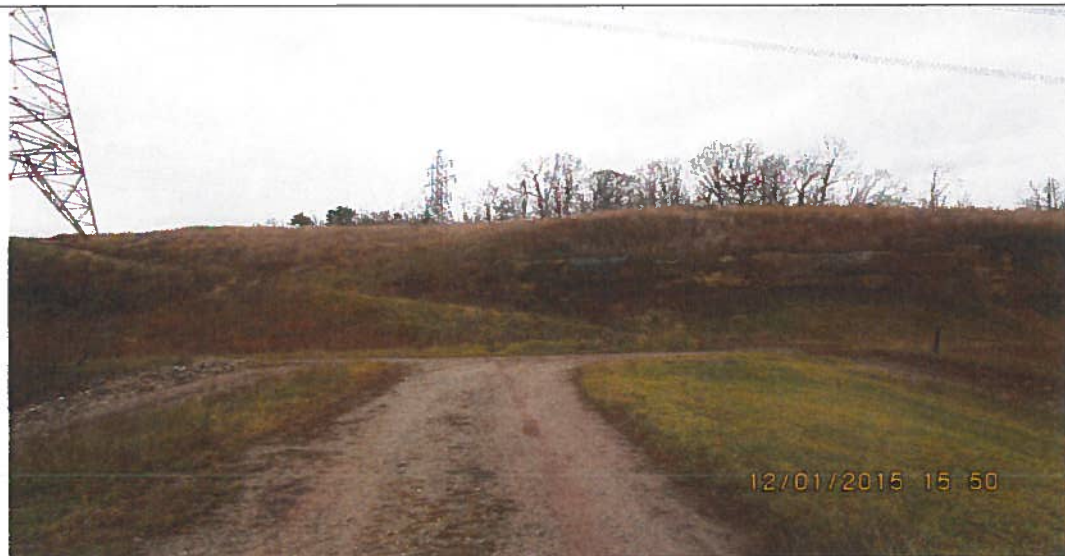
Photo # 37

- (i) Photograph No. 37 illustrates the hillside and left (north) abutment. The abutment and hillside appeared in good and stable condition. Unstable trees and excessive vegetation previously present were cleared.
- (ii) Typical views of the crest are shown in Photographs No. 38 and 39. Overall, the crest of the dam appeared in fair and stable condition. No signs of significant

The hillside and the left (north) abutment.

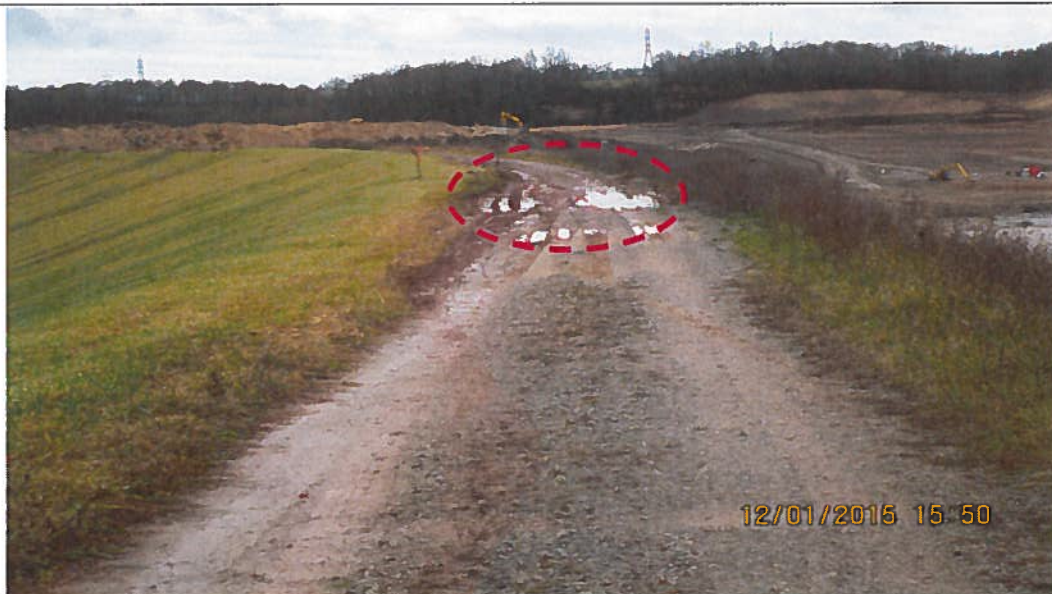
Photo # 38

- misalignment, cracking, significant depression, or settlement were observed. Due to construction activities rutting and potholes were noticed (see Photographs No. 38 and 39).

A view of the crest of the dam (north section).

- (i) Ruts and potholes at the crest shall be repaired on a regular basis before the area is significantly degraded further.
- (ii) Dam should be inspected with respect to the construction activities for the new landfill to make sure that the components of the dam are not significantly impacted.
- (iii) The channels, toe ditch, and intermediate pipe culverts downstream of the dam shall be kept clear of debris and vegetation with positive flow condition.
