DAM & DIKE INSPECTION REPORT

Bottom Ash Complex Stingy Run Fly Ash Dam

**GAVIN PLANT
CHESHIRE, OHIO**

INSPECTION DATE December 1, 2015

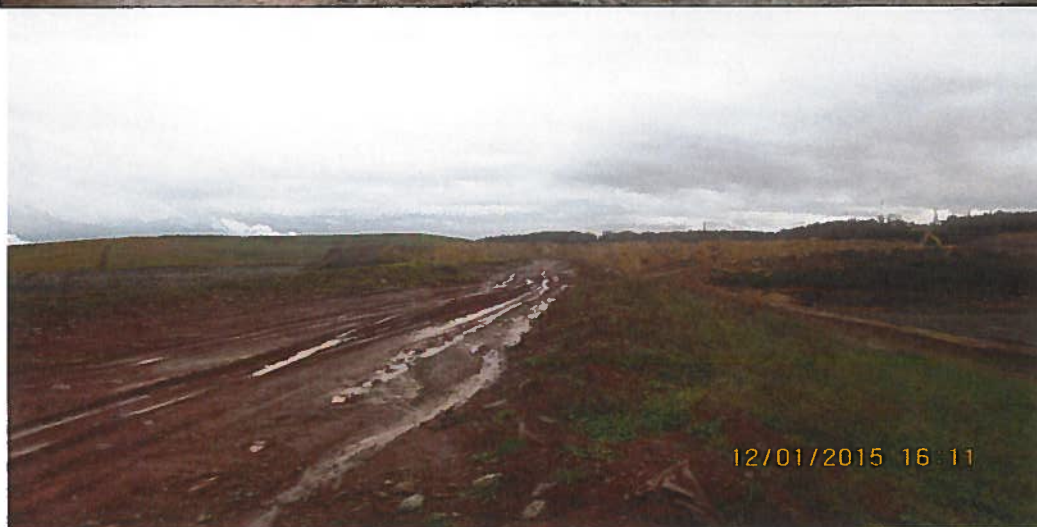
Photo # 39

- misalignment, cracking, significant depression, or settlement were observed. Due to construction activities rutting and potholes were noticed (see Photographs No. 38 and 39).

Another typical view of the crest.

- (i) Ruts and potholes at the crest shall be repaired on a regular basis before the area is significantly degraded further.
- (ii) Dam should be inspected with respect to the construction activities for the new landfill to make sure that the components of the dam are not significantly impacted.
- (iii) The channels, toe ditch, and intermediate pipe culverts downstream of the dam shall be kept clear of debris and vegetation with positive flow condition.

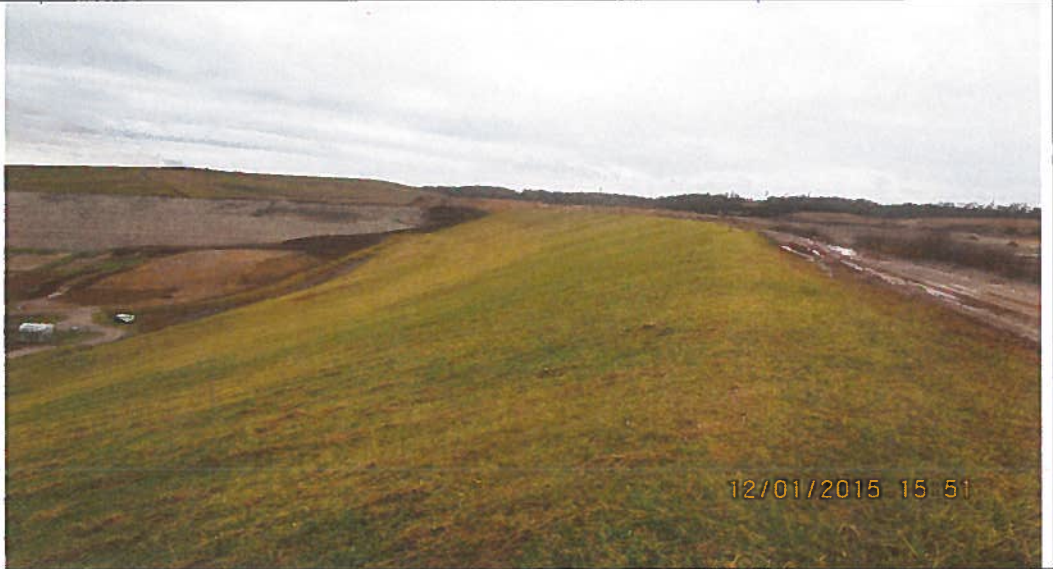
Photo # 40

- (iii) A typical view of the downstream slope (looking south) above the intermediate bench is illustrated in Photographs No. 40. The upper downstream slope appeared in good and stable condition with well controlled vegetation.

The downstream slope
(looking south).

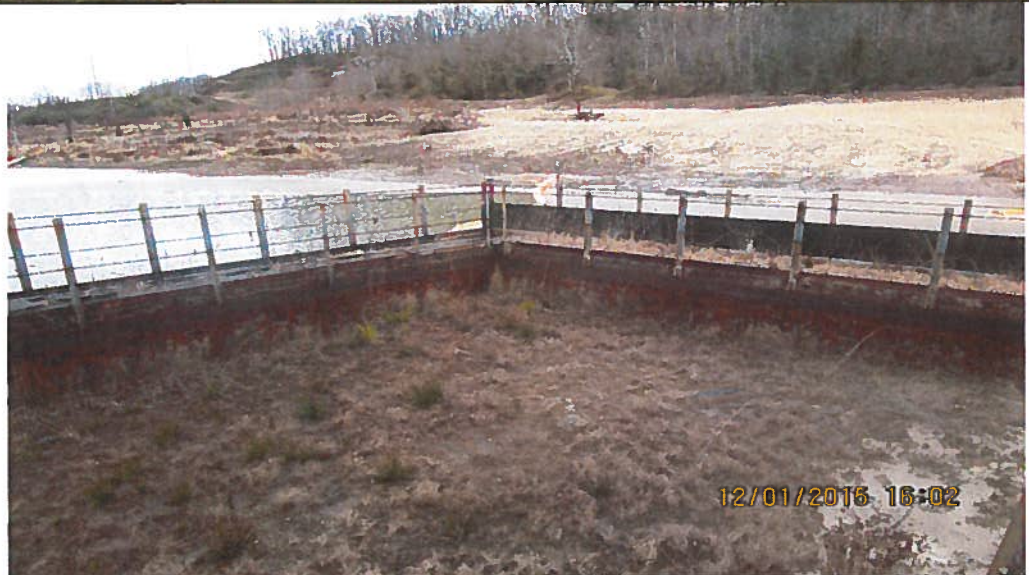
Photo # 41

- (iv) Photographs No. 41 and 42 illustrate the overflow discharge structure and supports. A new access deck structure from the dam was installed. The stop logs from the overflow structure have been removed and syphons are installed for lowering water level (Photograph No. 43). The overflow structure and the supporting structure is in stable condition.

Close up view of the
overflow discharge
supporting structures.

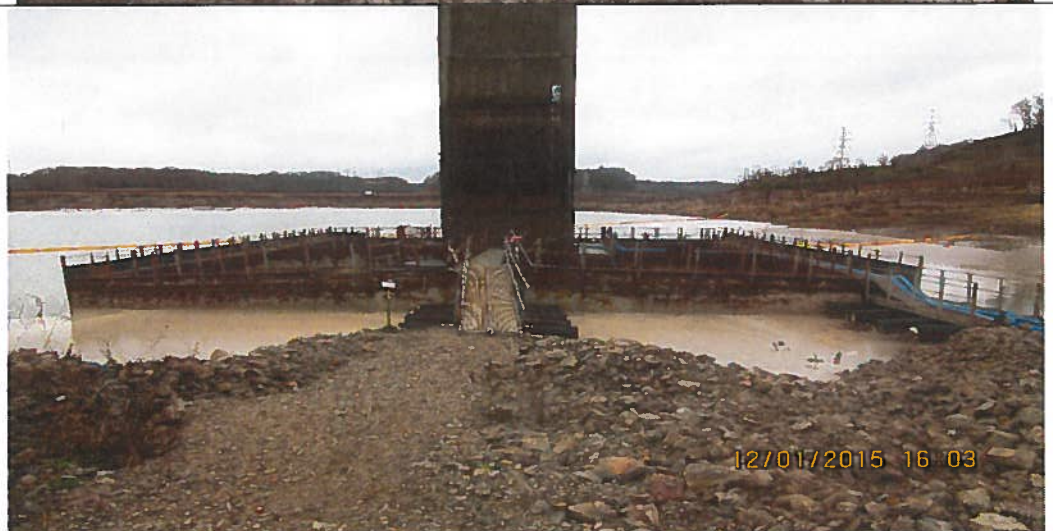
Photo # 42

This photograph
illustrates the overflow
discharge structure.

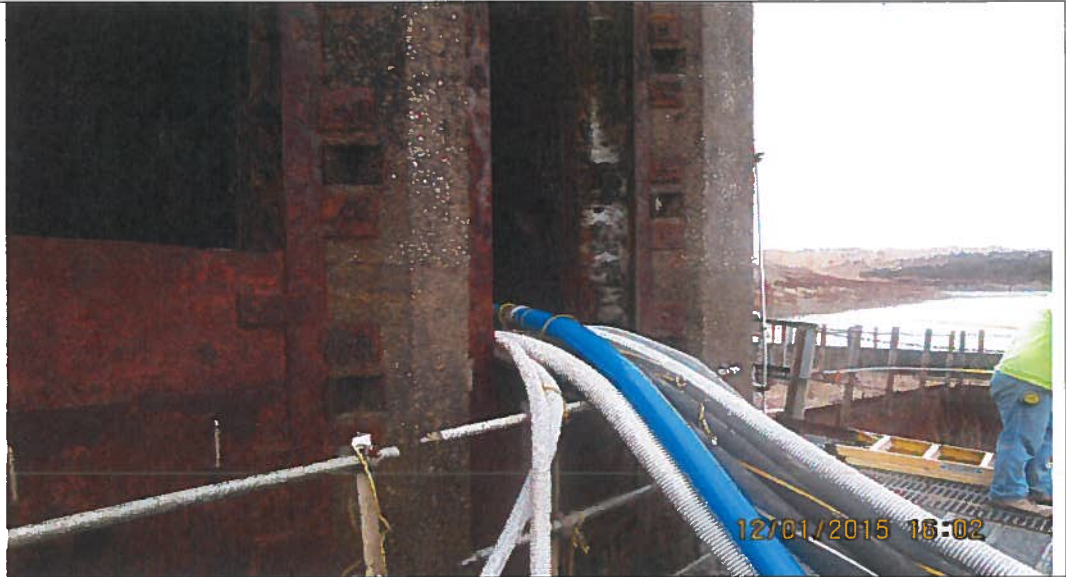
Photo # 43

Syphon pipes installed at the overflow structure.

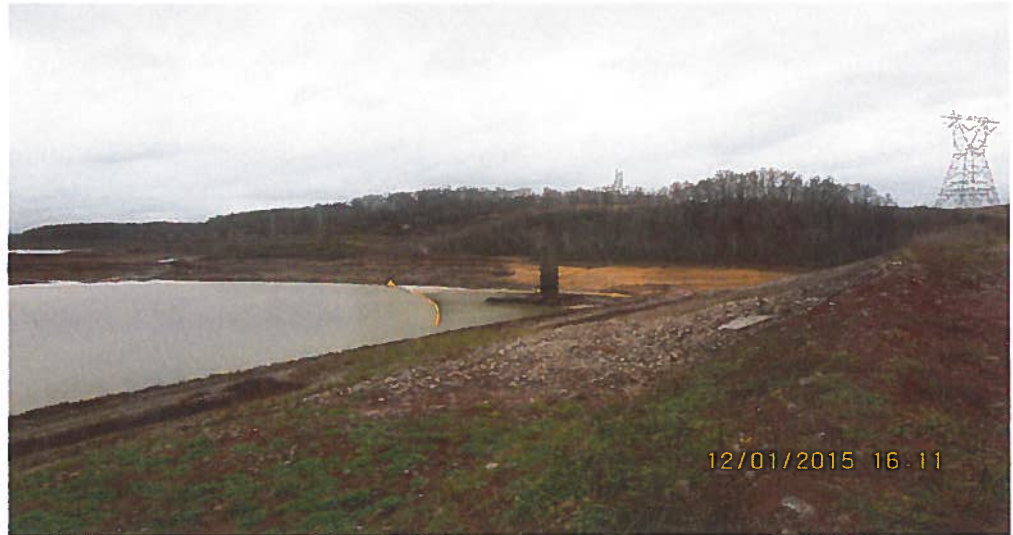
Photo # 44

- (v) The entire upstream slope was protected by rip rap cover placed over a geotextile fabric. The riprap is mostly removed and used in the construction of the new landfill. The upstream slope appeared in fair and stable condition (Photograph No. 44).

This photograph illustrates typical condition of the slope and riprap along the upstream slope of the dam (looking north).

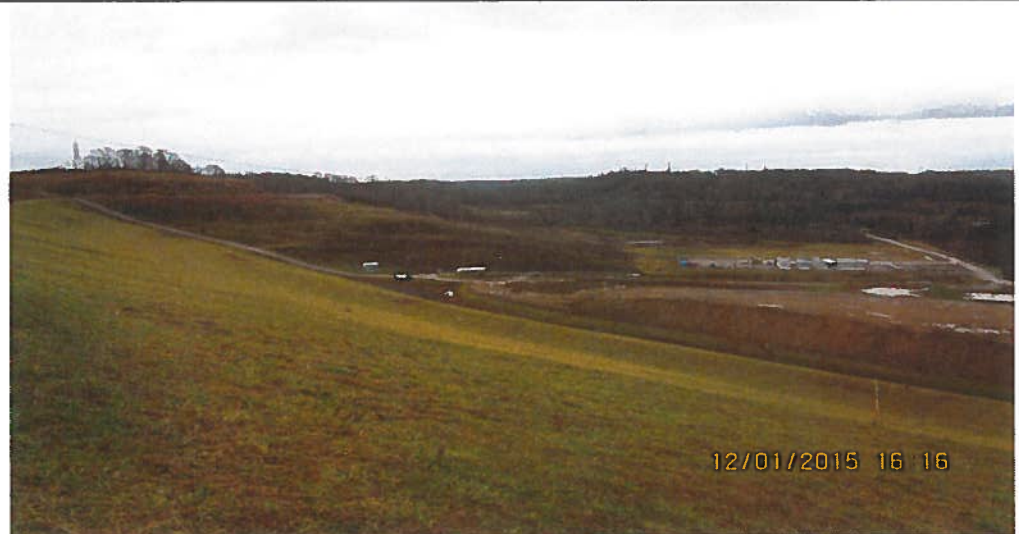
Photo # 45

- (vi) The downstream slope and the south (right) abutment is illustrated in Photographs No. 45 and 46. The hillside and the abutment are lowered due to excavation activities at the new landfill. It can be seen in Photograph No. 46 that the abutment/hillside is almost to the elevation of the dam. The downstream slope and the abutment appeared in good and stable condition.

The downstream slope (looking north).

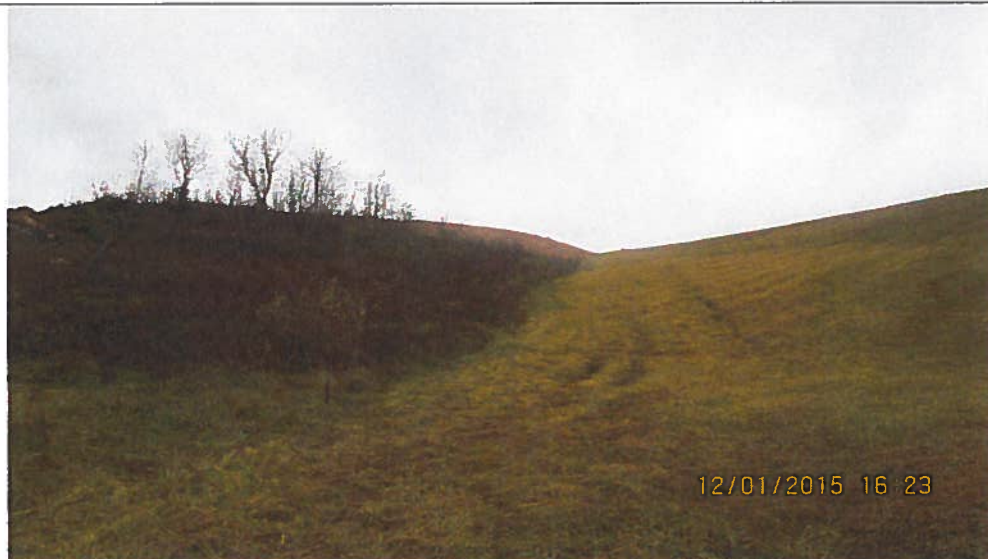
Photo # 47

- (vii) The groin of the right abutment is illustrated in Photographs No. 47 and 48. The upper section of the groin indicated slightly overgrown vegetation but no wetness or soft area was noticed. Overall, the downstream slope along the groin appeared good and in stable condition with controlled vegetation and intact riprap.

The right groin at the downstream slope.

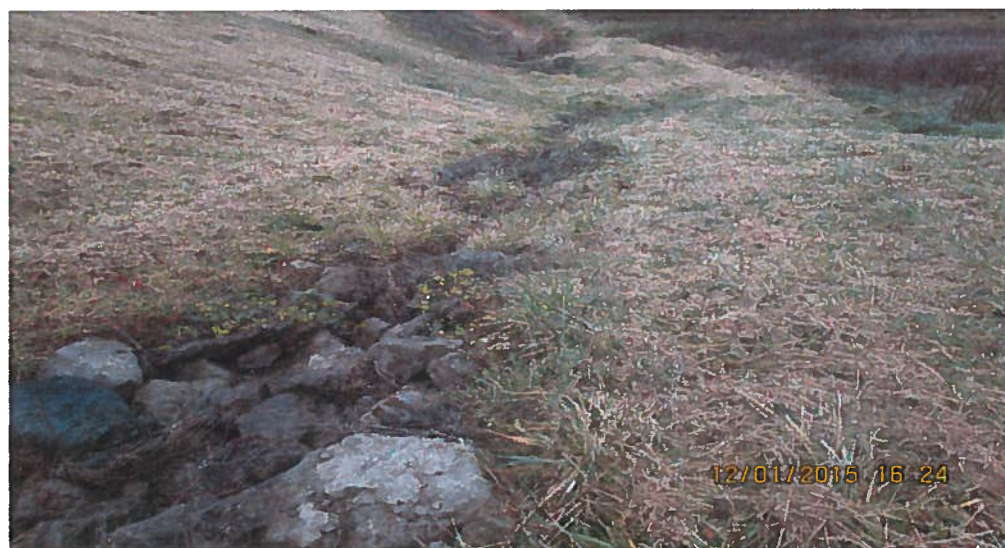
Photo # 48

Right groin at the downstream slope.

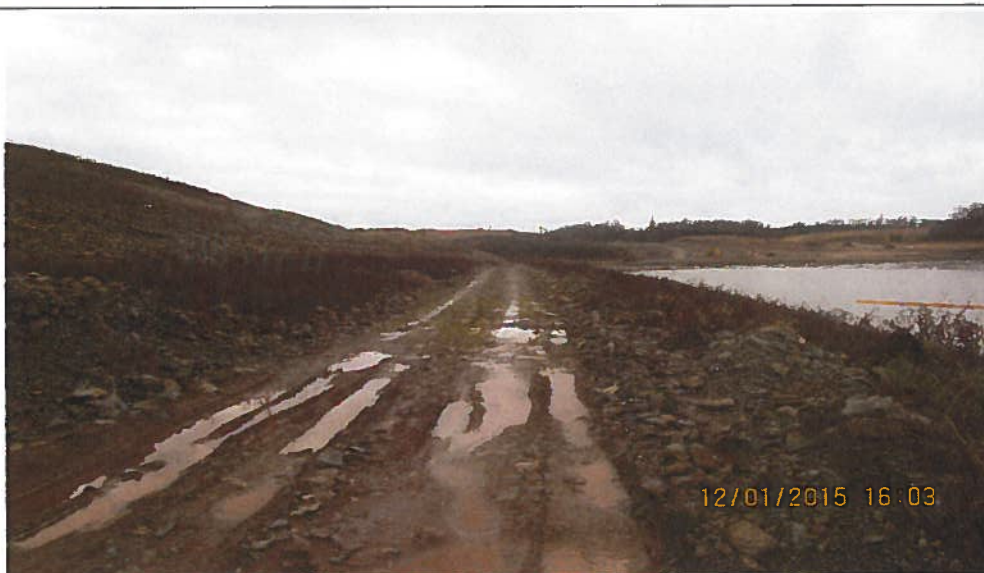
Photo # 53

- (ix) An access road is constructed along the downstream slope at the north groin (Photograph No 52) to the upstream slope groin and connecting to the toe of the dam (Photograph No. 53). The access road is constructed to perform the construction activities at the new landfill and the pond closure. The dam slopes and groin appeared in good and stable condition.

New access road at the toe of the dam.

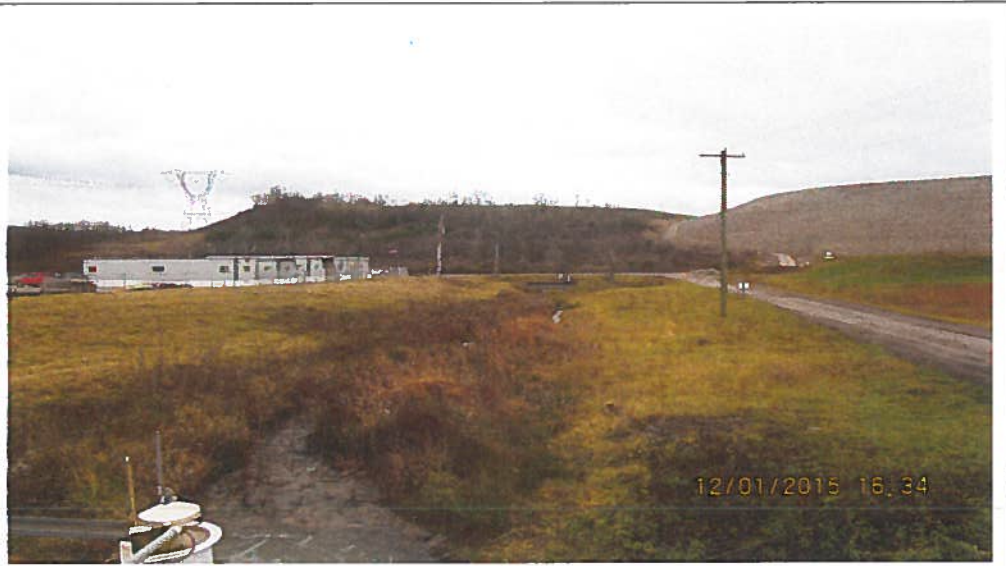
Photo # 55

- (x) The channel downstream of the weir was in fair and stable condition and indicated positive flow (Photographs No. 54 and 55). Few sections of the channel had overgrown vegetation with standing water but still indicated had positive drainage.

Another view of the channel downstream of the chemical feed building.

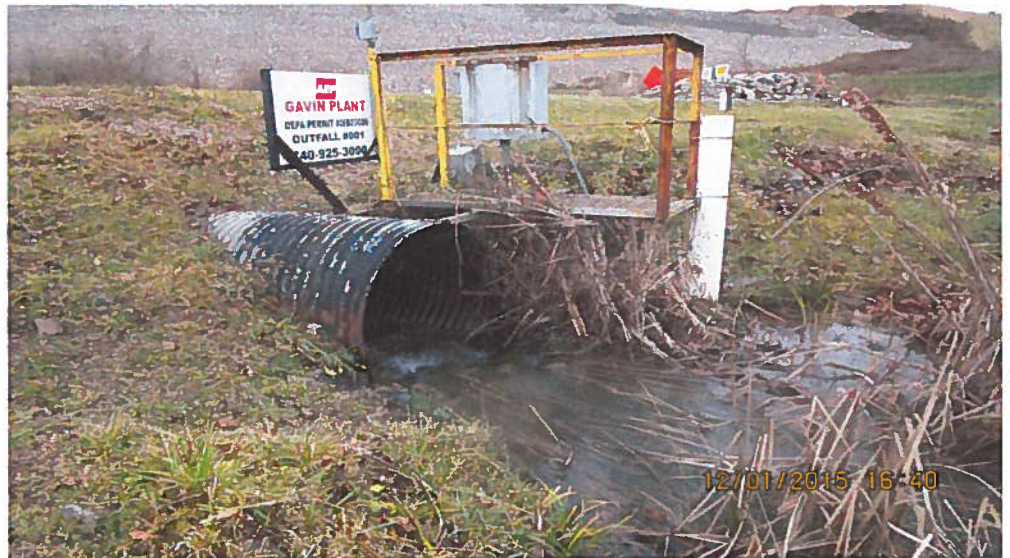
Photo # 56

- (xi) Two pipes culvert is located at the Outfall #001 (Photographs No. 56 and 57). Both the inlet and outlet ends of the pipes are illustrated in these photographs. Typically, one pipe culvert carries majority of the flow and the other pipe culvert is used during high flows. These pipes connect the open channel and a tributary that lead to the creek. The culvert appeared to have enough capacity for the present flow condition and increased flow due to lowering of the reservoir.

Pipe culvert inlet end at the Outfall 001.

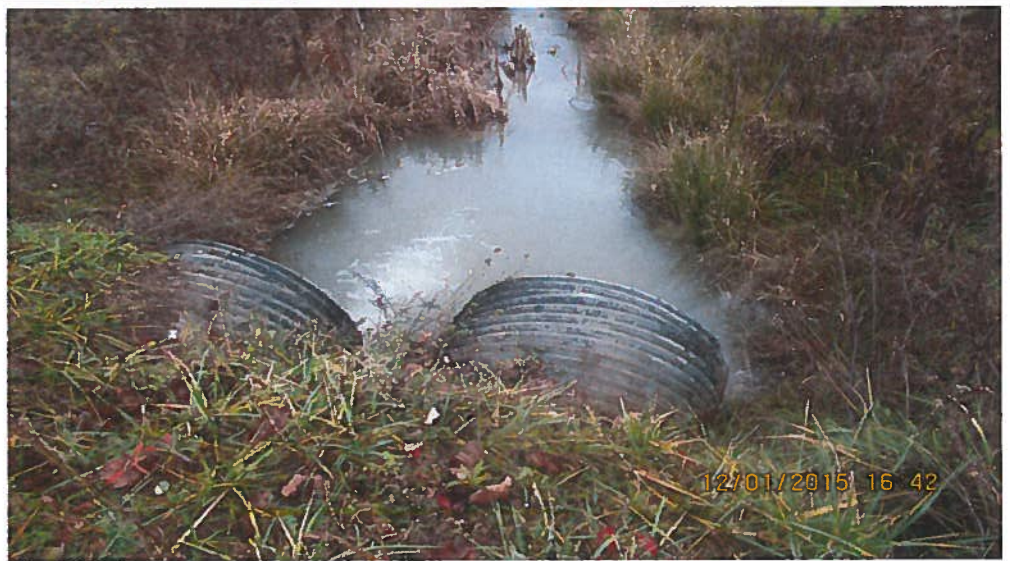
Photo # 57

Outlet end of the pipe culverts.

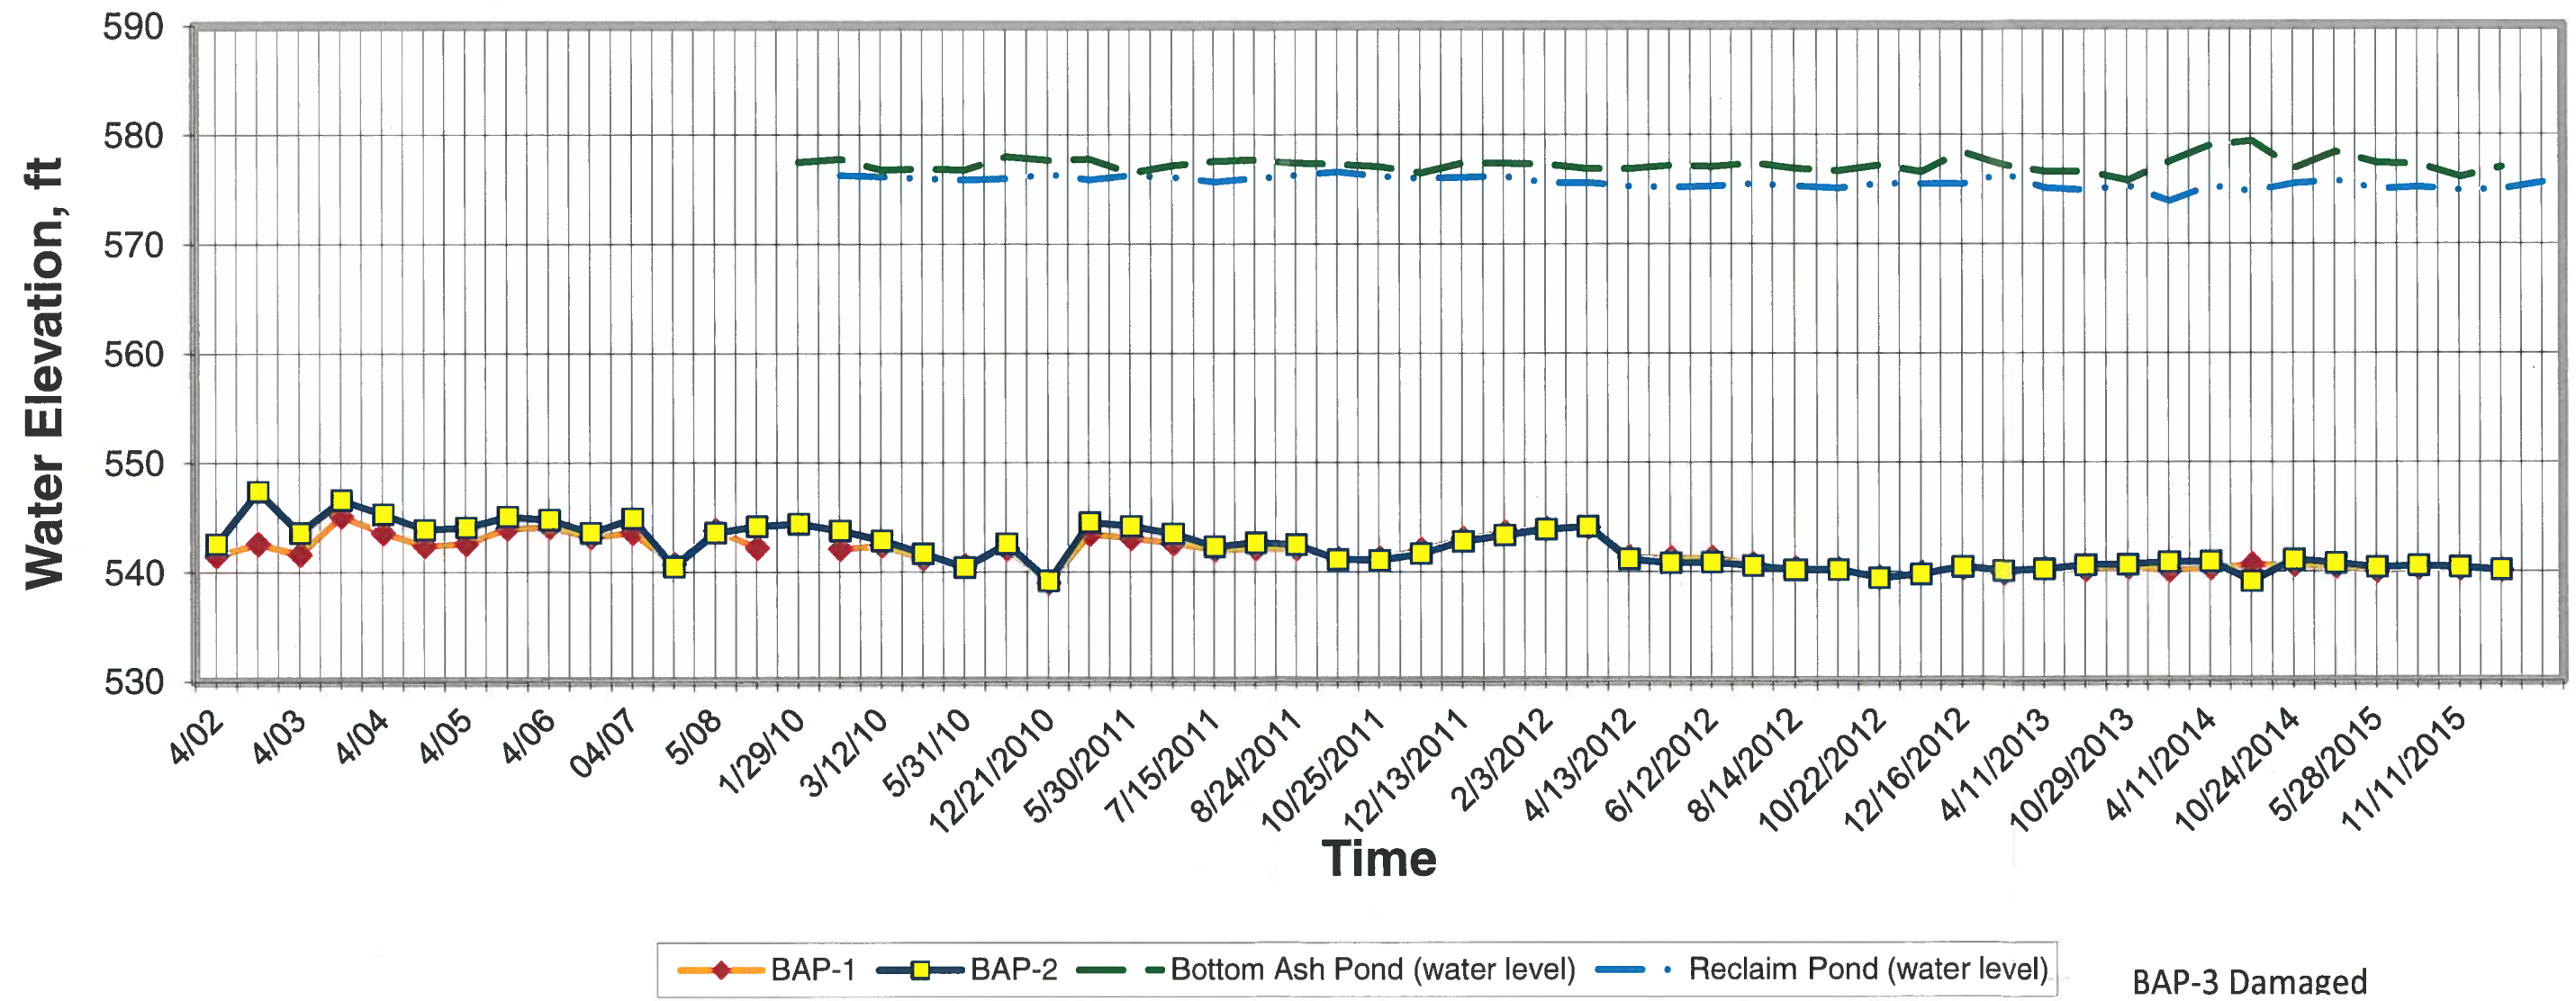
FIGURE 9b - Piezometer Data of the Bottom Ash Pond.

Three piezometers are installed at the Bottom Ash Pond shown on Figure 9a. Two piezometers (BAP-1 and BAP-2) are present at the downstream on the west and south dikes of the complex. Piezometer BAP-3 is located at the east dike and was apparently damaged in the past. Based on AEP Drawing # 12-3015 and 12-3015A, the top elevation of the dikes is approximately 600 feet. Figure 9b provides the static water elevation at the west and southwest section of the pond between April 2002 and December 2015. In last five years the highest static water elevation reading recorded was about 540 feet. The bottom ash and reclaim ponds water elevations are less than 580 feet during normal operations. At these levels there is available freeboard of greater than 15 feet. The fluctuation in water elevation is considered normal and within historic range.
