2021 Annual Inspection Report

Residual Waste Landfill

Gavin Power Plant
Cheshire, Ohio

7 January 2022

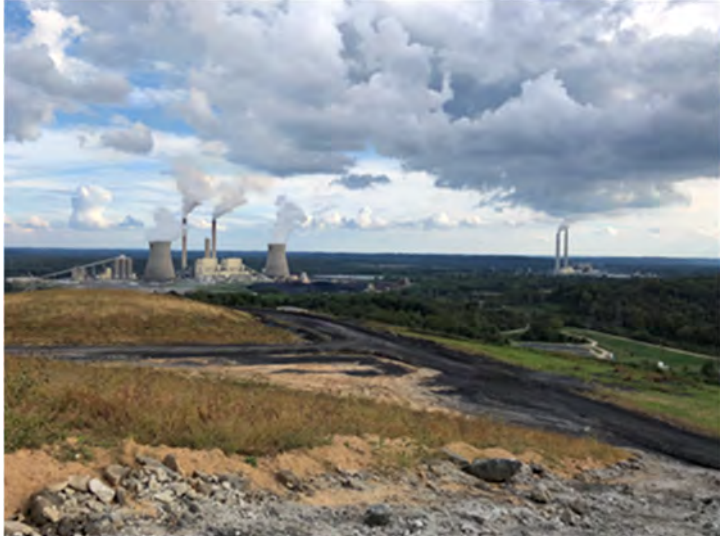
Photograph #1

The haul roads in active areas of CCR placement use bottom ash as a base course (as observed in Photographs 1, 2, and 3). This base course compacts well and withstands repeated heavy equipment traffic based on experience. The haul roads observed by ERM appeared to be stable during the site drive/walkthrough, and there was no visual evidence of significant distress (i.e., rutting or pumping). The roads had positive drainage from the centerline or are sloped to an adjacent drainage channel and there was no visible evidence of ponding water on the roadway surface. Drainage channels paralleling the roadways also capture storm water runoff from adjacent slopes, which is directed to stable outlets that ultimately discharge to the surrounding site treatment ponds. ERM observed sporadic evidence of minor erosion in the channel bottoms or at the connection point/confluence of drainage berms that collect water from the landfill side slopes. Overall, roadside channels appeared well maintained. ERM observed active cleaning of roadside channels along the eastern haul road during the site visit, reportedly completed as needed.

Main haul road constructed of bottom ash. Minor area of FGD slope grading in lower right of image. Picture taken from summit of landfill. (looking southeast)	
Photograph #2

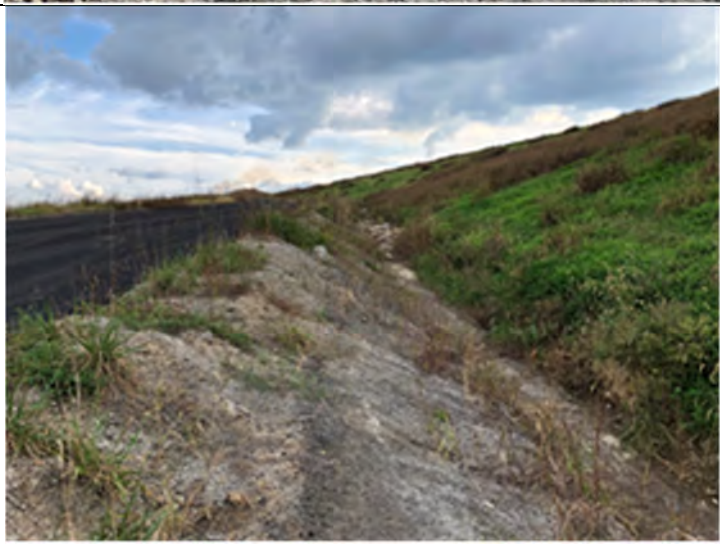
Main haul road constructed of bottom ash heading up the north eastern side of the landfill (looking south)	
Photograph #3

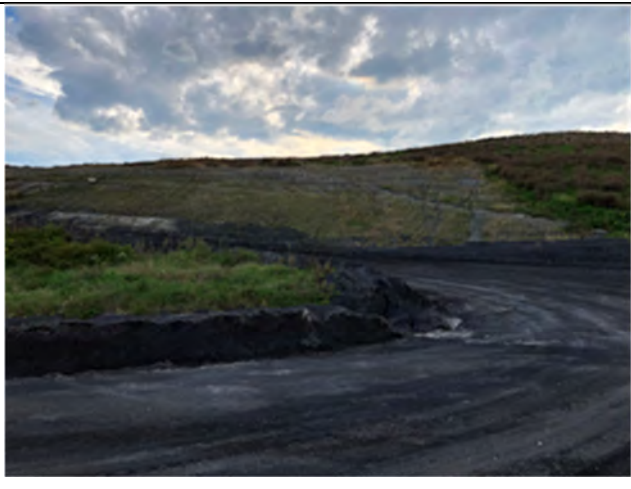
Main haul road constructed of bottom ash near east side of landfill (looking south)

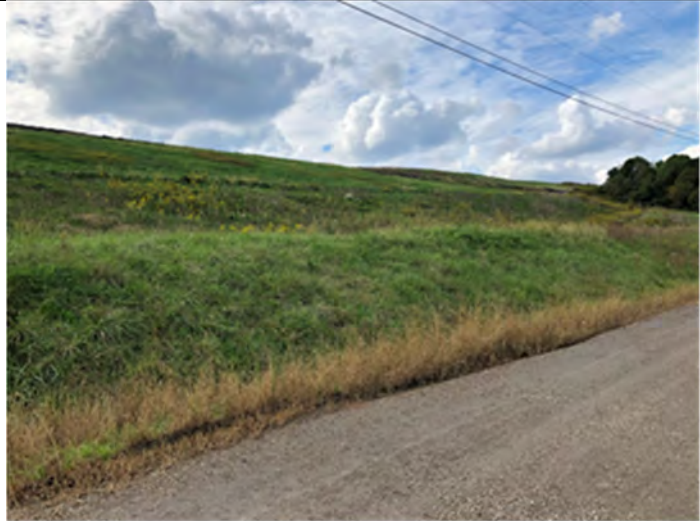
<p>Photograph #4</p>

There were several sections of permanent roads that have a gravel base course, as depicted in Photographs 4, 6, 8, and 9. These roads also were observed to be stable with no visible evidence of distress. More frequently used roadways incorporate robust drainage channels adjacent to slopes, which were positively graded and include rock check dams (Photograph 6 and 7). The drainage channels on the eastern slopes had marginal sediment buildup near the rock check dams (Photograph 7) but cleanout capacity had not been reached and maintenance was not needed at the time of the inspection.

<p>Northeastern gravel access road and vegetated slope (looking north)</p>	
<p>Photograph #5</p>

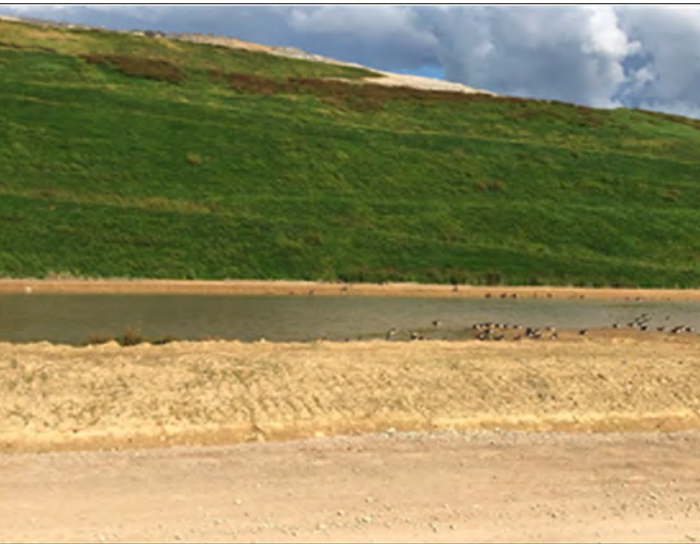
<p>Western vegetated slope and temporary sediment basin from landfill construction activities (looking east)</p>	
<p>Photograph #6</p>

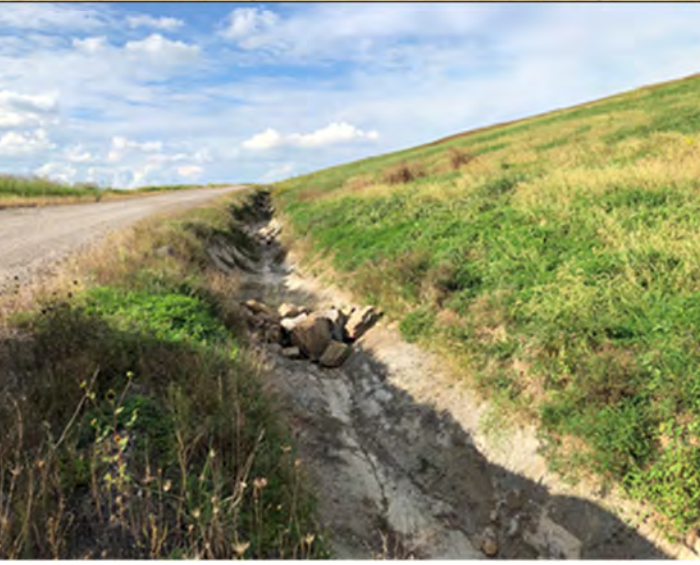
<p>Southwest gravel access road and roadside channel with rock check dams. (Looking north)</p>

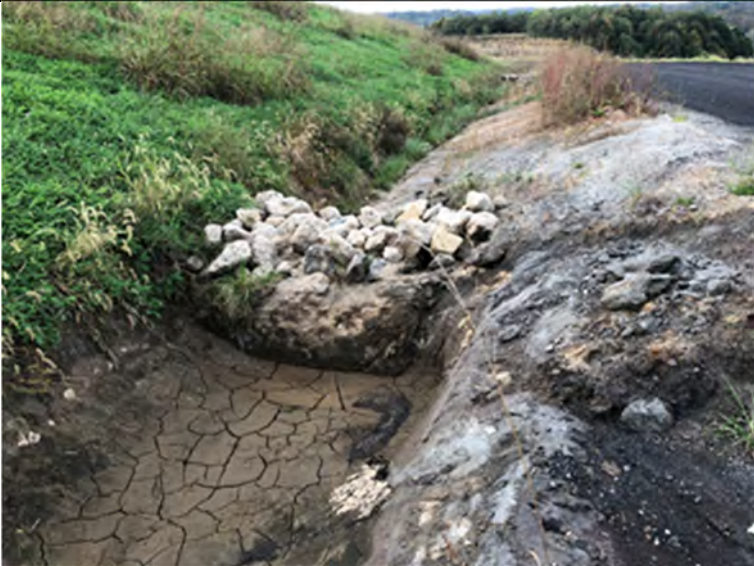
<p>Photograph #7</p>

<p>Rock check dams on eastern slopes. (looking north)</p>	<p>Photograph #8</p>
<p>View of southwest slopes. (looking north)</p>

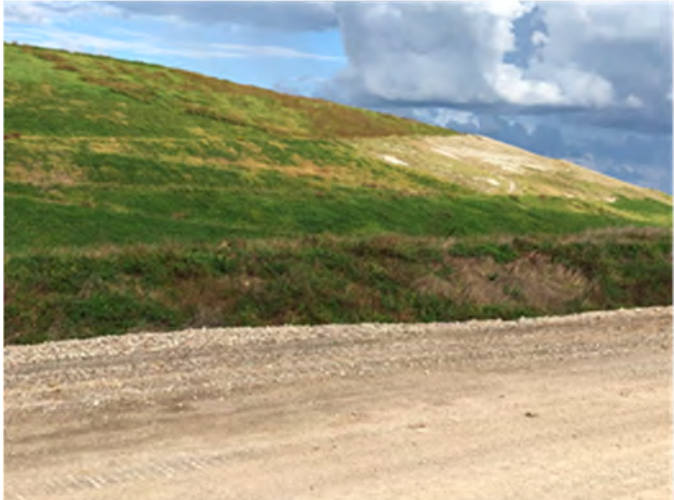
<p>Photograph #9</p>

In the past, the Gavin Power Plant team performed direct seeding of FGD material, which was only partially successful in establishing vegetation. The Gavin Power Plant team thereafter began covering these areas with soil to promote more vigorous stands of vegetation. Some areas with FGD direct seeding still exhibit poor vegetative growth, as indicated in Photographs 3 and 9 (right side of photo), but this was observed to a much-reduced extent when compared to previous inspections. These isolated areas of the slopes, where direct seeding of the placed FGD was attempted, continue to be covered incrementally with an intermediate layer of soil to aid in the establishment of vegetation. The application of this intermediate soil layer as slopes are completed or meet their interim grades are observed in Photograph 9 (left side of photo).

<p>View of southern slope. (looking southeast)</p>

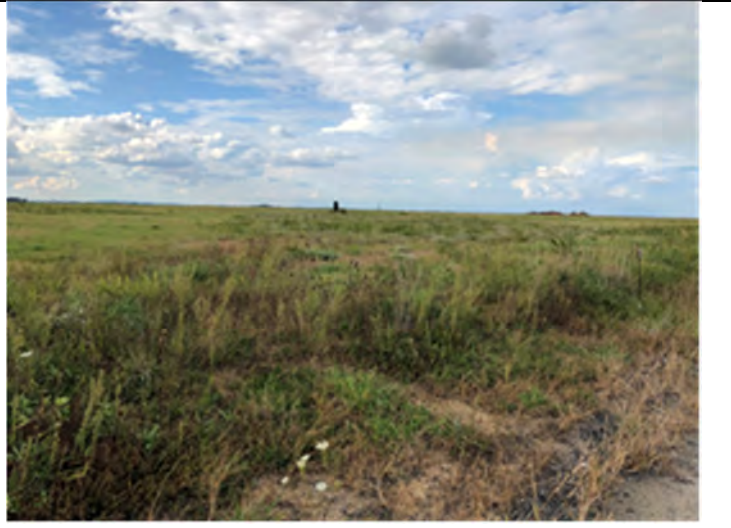
<p>Photograph #10</p>

<p>View of interim summit of landfill with intermediate soil cover and vegetation growing. (looking north).</p>	
<p>Photograph #11</p>

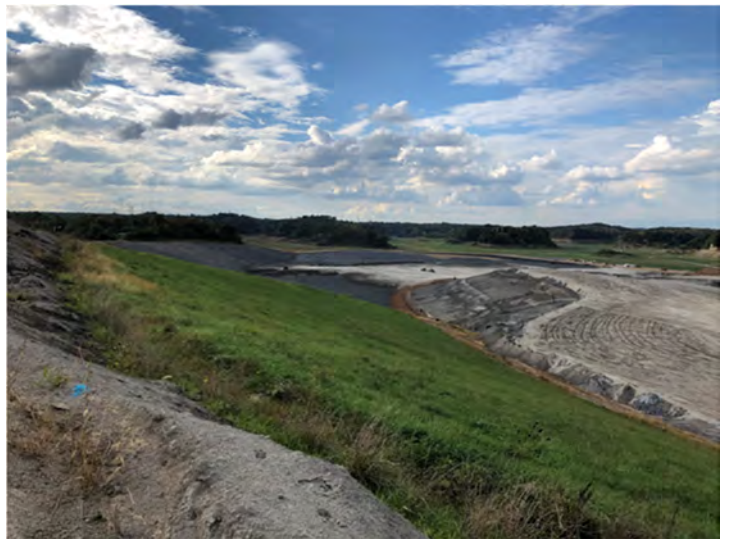
Approximately 75 percent of the existing slope surface area has received final cover, and 25 percent of the surface area has received intermediate cover. In general, intermediate cover consisted of a 6- to 12-inch-thick layer of soil. The western and northern slopes have received intermediate cover that is well vegetated (Photographs 4, 5, 8, and 14). As portions of the lateral expansion are constructed and filled with CCR, this intermediate cover of soil will be removed and reused for cover in other areas of the landfill. This activity was observed by ERM to be on-going on the northern slope as the level of CCR in Phase H increases in elevation (Photograph 11, 12, and 13).

<p>View of Phase H. Intermediate soil covered and vegetated northern slope. (looking northwest)</p>	
<p>Photograph #12</p>

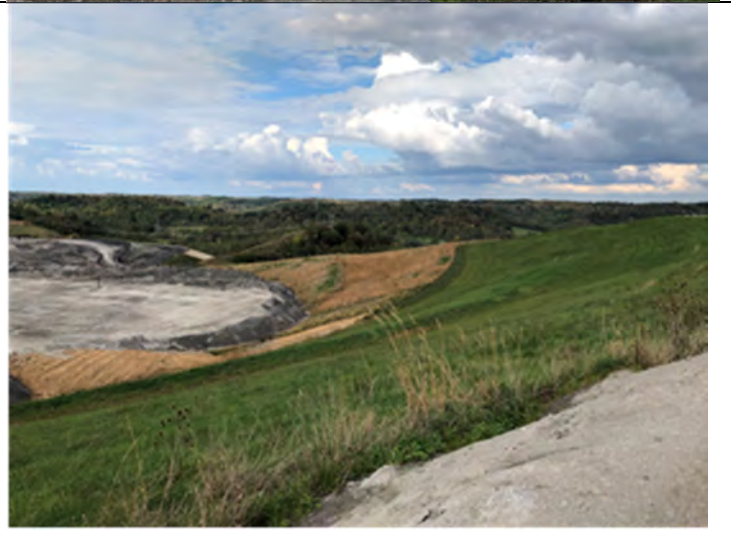
<p>View of Phase H. Intermediate slope covered and vegetated eastern slope (looking east)</p>

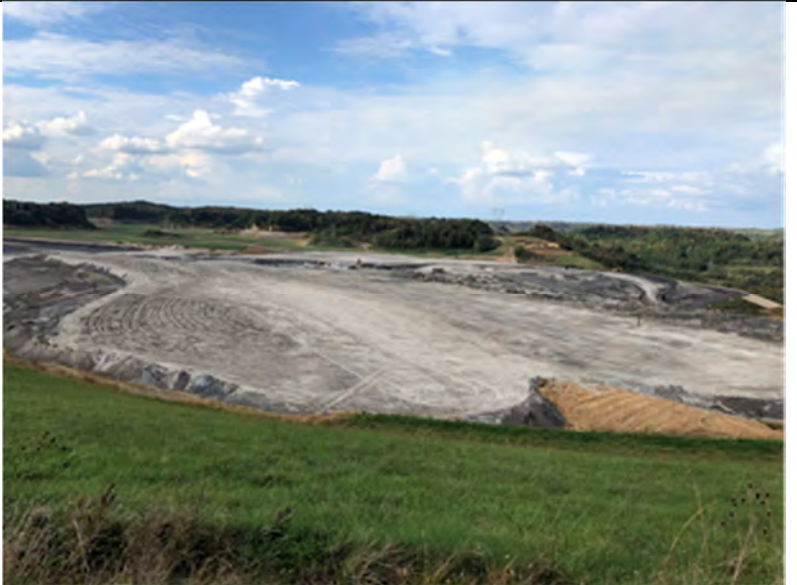
<p>Photograph #13</p>

<p>View of Phase H, vegetated eastern slope, and intermediate soil cover (looking north)</p>	
<p>Photograph #14</p>

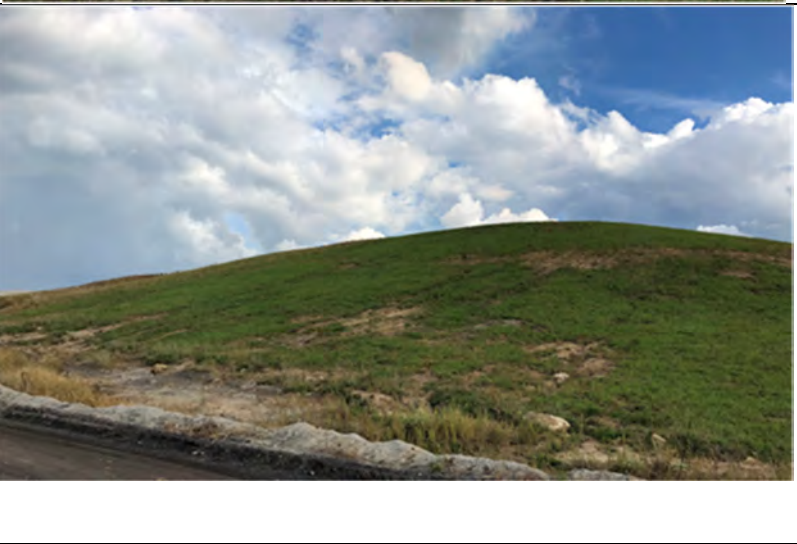
<p>Eastern slope near summit elevation. (looking west)</p>	
<p>Photograph #15</p>

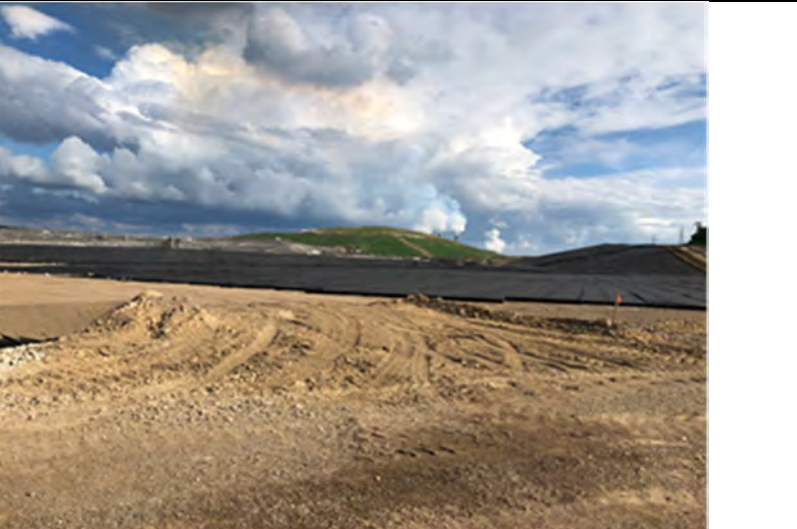
<p>Phase H and I RWL operations (looking south)</p>

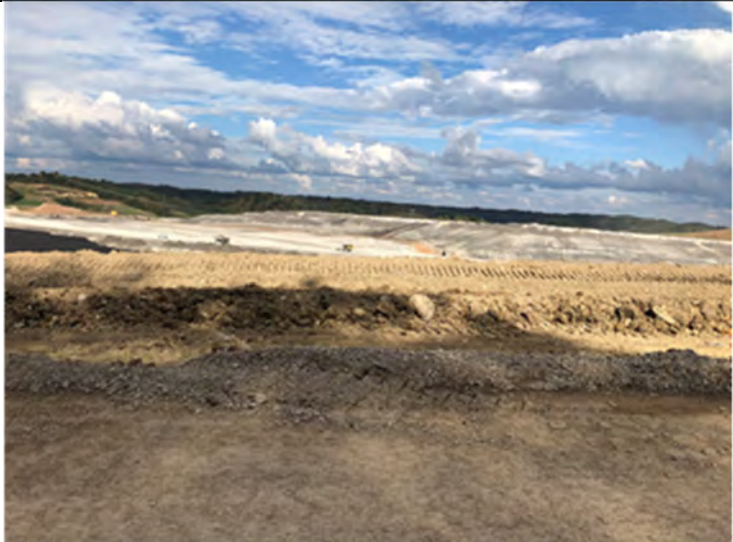
<p>Photograph #16</p>

There were infrequent instances where notable erosion rills/gullies were observed (Photograph 17 and 18) in the surface of the intermediate cover. Sedimentation was fully contained in these areas and directed toward the facility treatment ponds. There was no visible evidence that these isolated areas of erosion have the potential to disrupt the operation and safety of the RWL or that observed erosion features were creating an unstable situation. These erosion areas should be repaired and reseeded in the Spring of 2022. In the interim, to the extent practical, upslope runoff should be minimized in these areas through common industry standard maintenance practices such as reworking the area with temporary seeding or through run-off diversion to prevent water from breaking over the top of slope.

<p>Haul trucks and dozers continuing Phase H and I RWL operations (looking north)</p>	
<p>Photograph #17</p>	 
<p>Erosion gully into FGD material on Western slopes. (looking east)</p>	
<p>Photograph #18</p>

3. Seed and fertilize localized bare soil areas along completed slopes to aid in the revegetation process, adding soil amendments and lime as needed.
4. Repair erosion gullies within the intermediate cover on the northwest end of Phase F2.

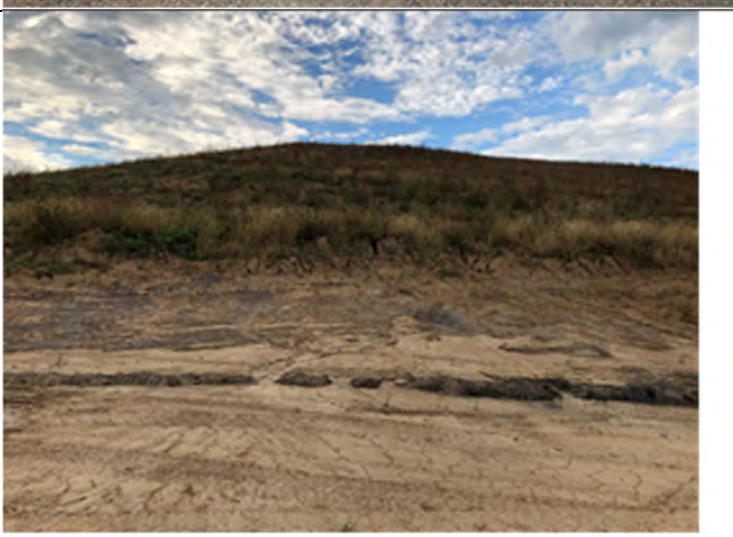
<p>Erosion gully into FGD material on Southeastern slopes (looking west)</p>

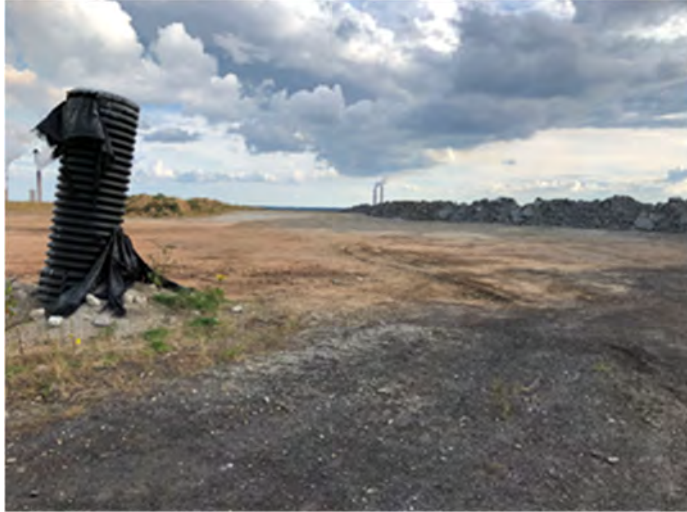
Photograph #19

View of interim summit with multiple stockpiles and chimney drain. FGD stockpile to the right of picture. Soil stockpile to the left of picture. (looking south)

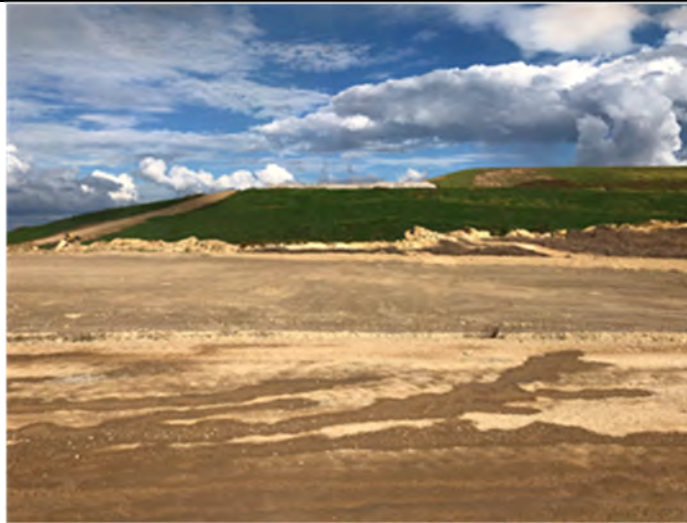
Photograph #20

Western vegetated slope of summit and RWL grading during landfill construction activities. (looking east)

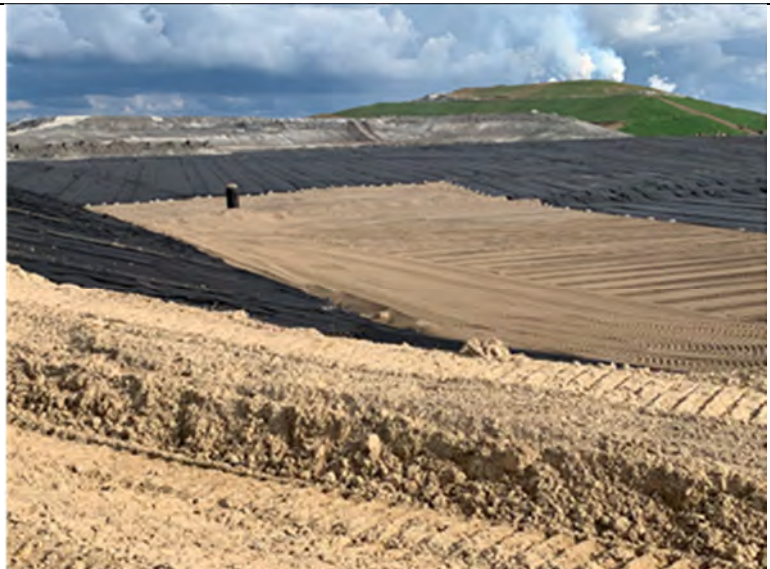
Photograph #21

The liner system components were visually observed along the perimeter tie-in between Phase H and Phase I (Appendix A, Photograph 21) during the 2021 annual inspection. The geonet composite layer was visible and in other layers where the geonet layer was not installed, the gravel leachate collection layer was visible.

RWL overview. Construction chimney drain, leachate gravel, geonet, and filter fabric visible prior to placement of protection layer. (looking south)

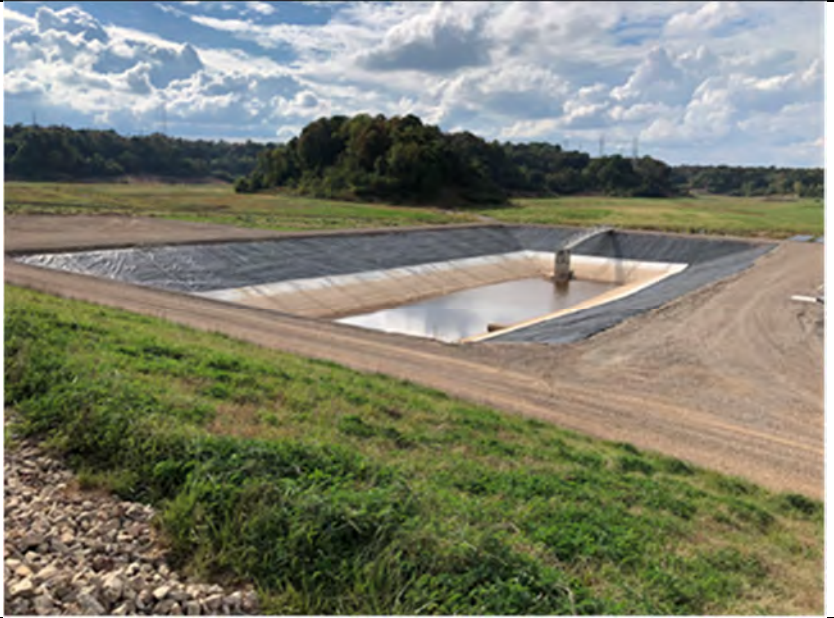
<p>Photograph #22</p>

<p>Newly constructed Pond No. 6 clarifying pond (looking north)</p>	
<p>Photograph #23</p>

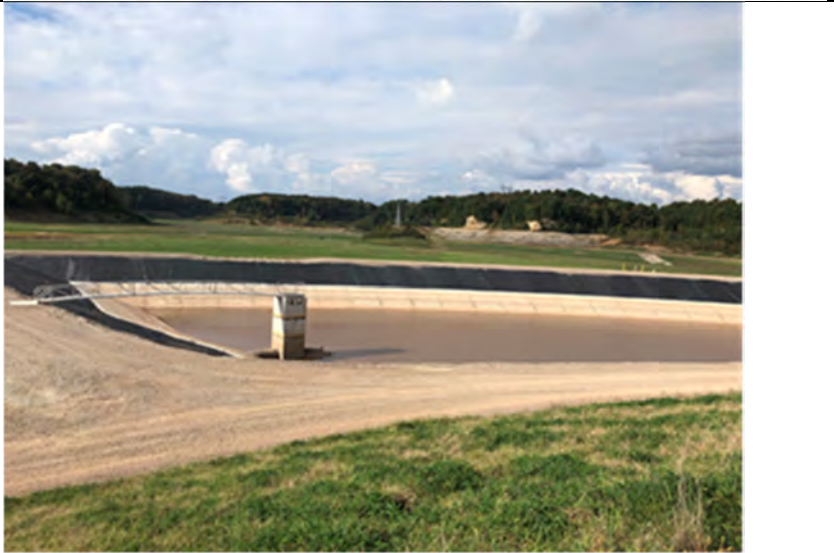
<p>Newly constructed Pond No. 6 primary pond (looking northeast)</p>

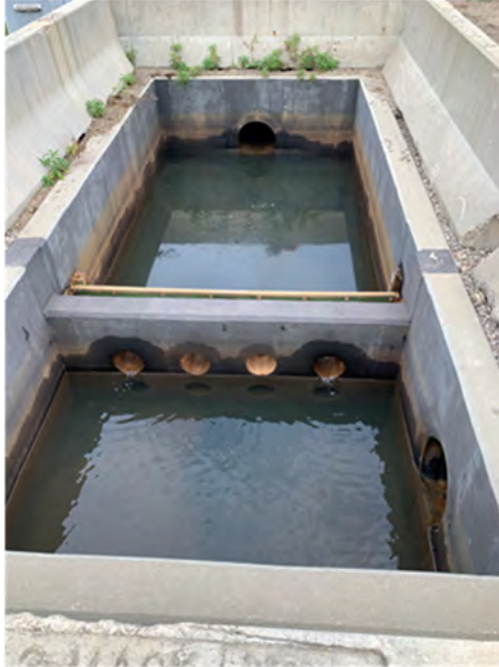
Photograph #26

The vertical flow wetlands for Pond No. 1 observed to be in general working order (Photographs 24, 25, 26, 27 and 28).

View of inlet structures for Pond No. 1 vertical flow wetland.

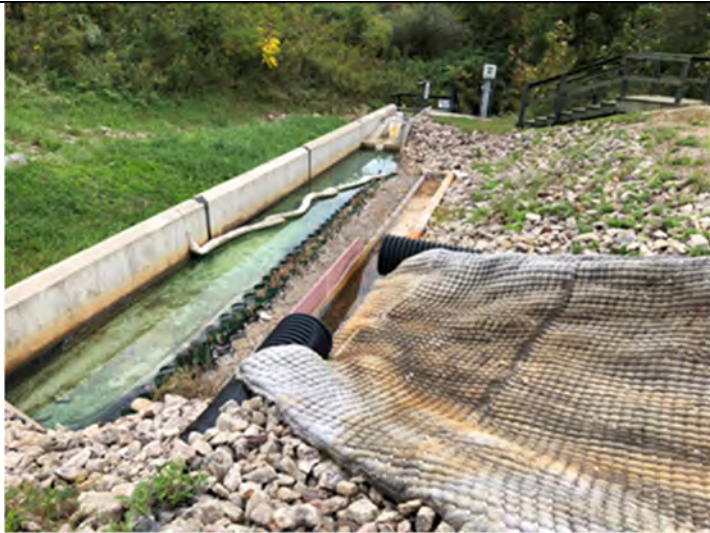
Photograph #27

Outlet for vertical flow wetland at Pond No. 1 (looking southeast)

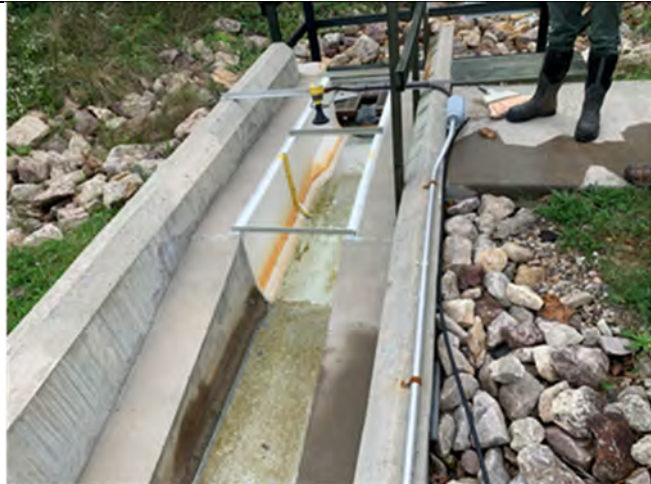
Photograph #28

Flow measurement flume at outlet for Pond No. 1 vertical flow wetlands (looking south)

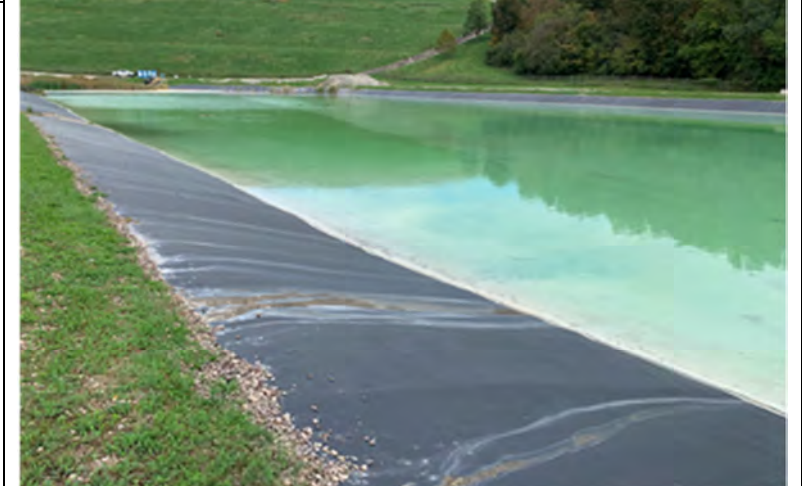
Pond No. 1 on the south side of the RWL observed to be functioning properly during the annual inspection. The sedimentation/treatment portion of Pond No. 1 was observed to contain varying depths of solids, as observable in Photographs 29, 30, and 31. This pond is routinely cleaned of accumulated solids, typically through the use of extended-reach excavators or a floating dredge. Based on a visual assessment, Pond No. 1 was noted to have accumulated sediments above the 2020 levels. The pond was also noted to have a more whitish coloration (Photograph 29) than in 2020, which is due to the flocculation of particles because of water treatment processes.

<p>View of Pond No. 1 (looking north).</p>

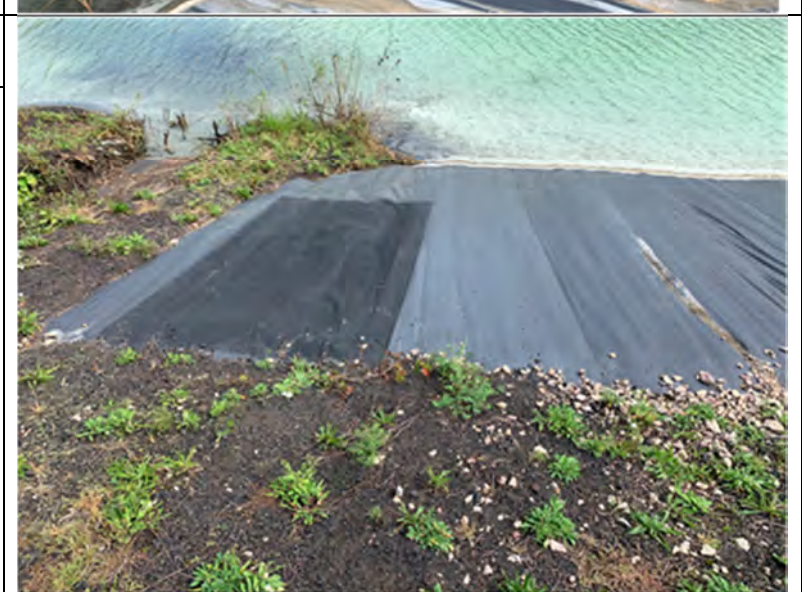
A build-up of sediments, aggregate, and vegetation was observed in the north end of the pond near the two inflow channels (Photograph 30). For maintenance purposes, these materials should be removed and properly disposed. Stone from the access roadway was observed to be deposited in these inflow channels areas. It is recommended that steps be taken to mitigate the tracking of stone from the roadway by vehicles and during the application of maintenance aggregate to the surface. Also, several small tears in the runout portion of the geomembrane at the west embankment of Pond No. 1 were observed; however, these small tears were located above the normal operating level of the pond (Photograph 33). Additionally, there were multiple small tears and holes identified around the perimeter of Pond No. 1; however, were also above the operating water level. No water was standing against these tears, and no discharge through these tears was observed. The small tears identified in the liner noted in the previous inspection have been repaired. ERM recommends that the new tears be repaired by a similar procedure as part of routine maintenance. The 2020 patched repairs were observed in Pond No. 1 (Photograph 31).

<p>View of vegetated sediment patch in Pond No. 1 (looking west)</p>	<p>Photograph #31</p>
<p>View of sediment, vegetation, and patched repair on Pond No. 1 West embankment. (looking east)</p>

7. Continue to schedule maintenance and replacement of media in the vertical flow wetlands for Pond No. 1, Pond No. 2, and Pond Nos. 3 and 5.
8. Schedule and commence removal of vegetative growth and sediments from inside Pond No. 3 and No. 1 in an appropriate sequence with other ongoing maintenance and repairs. Clean channel inlets on both Pond No. 1 and No. 3 to remove sediment buildup.

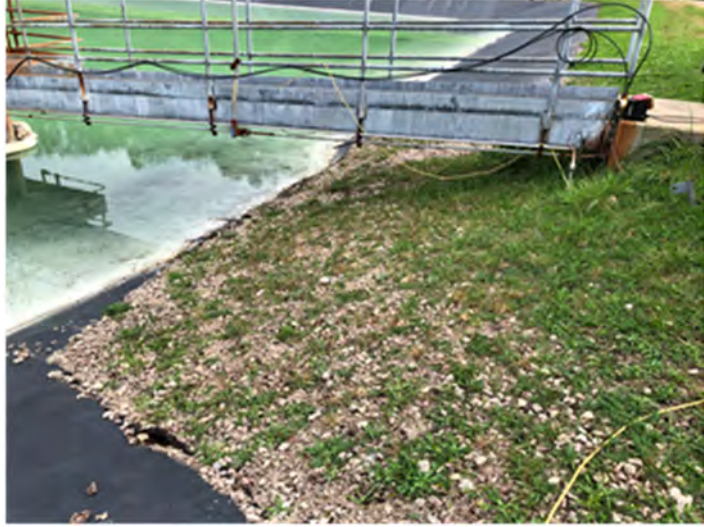
Photograph #32

Pond No. 1 South embankment with vegetation and gravel. (looking east)

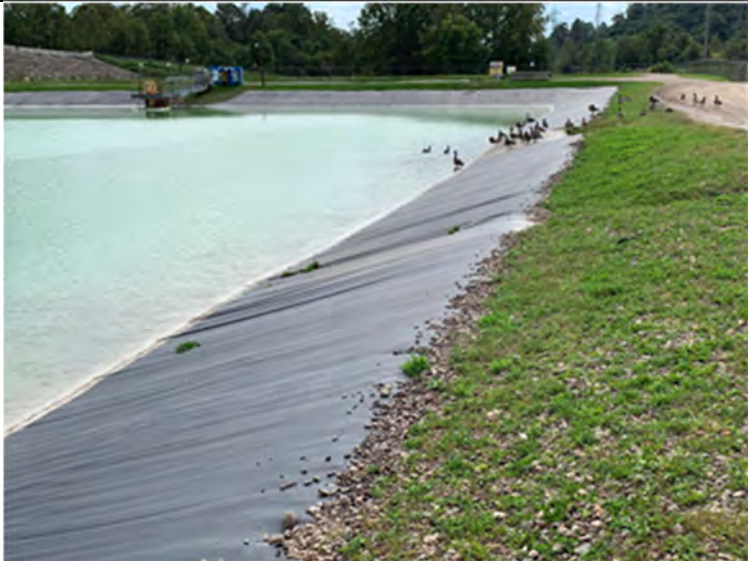
Photograph #33

Multiple tears in West embankment of Pond No. 1 with vegetation growing through. (looking south)

10. Repair small tears and minor perforations identified in the geomembranes at Pond No. 1, No. 2, and No. 5. Remove any vegetation prior to repairs. Routinely monitor all ponds for any additional tears

and promptly repair when identified. Pond No. 1 and No. 2 should be repaired with similar (i.e. PVC/"Hypalon" product) geomembrane using either welding or adhesive techniques. Pond No. 5 is HDPE and will require spot welding techniques (i.e. extrusion gun or similar). Repairs should be completed prior to the next annual inspection in October 2022. The facility should continue to maintain current water operating levels below the level of identified perforations.

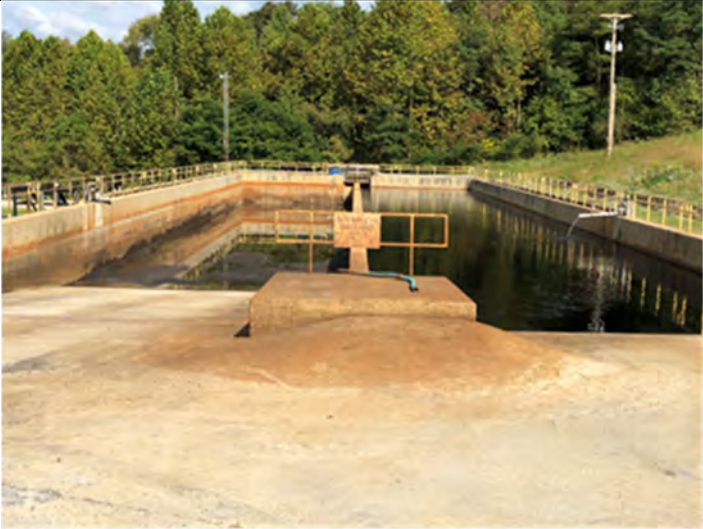
Pond No. 2 on the southeast side of the RWL was observed and appeared to be functioning properly during the inspection. To assist with the removal of FGD solids derived from the stack-out pad and to minimize dredging, Gavin Power operates a concrete settling basin at Pond No. 2 (Photograph 34). This basin is routinely cleaned with an extended-reach excavator.

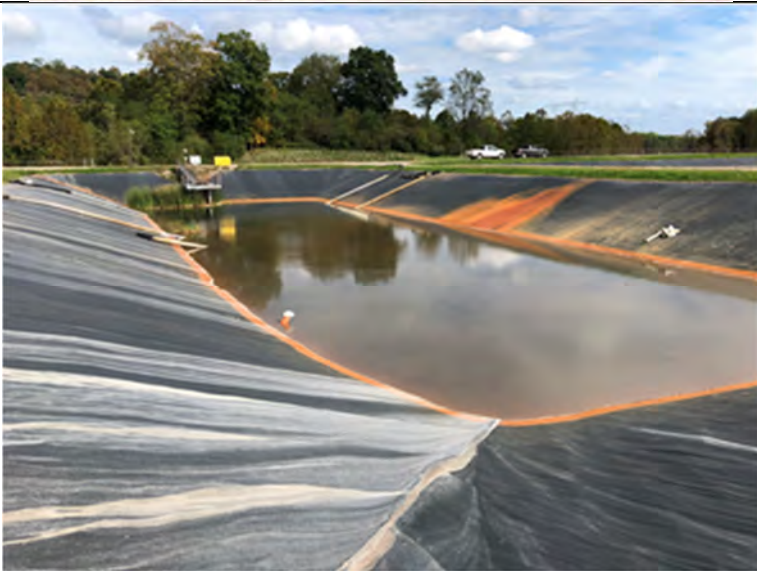
The clarifying pond was observed to be in satisfactory condition with only a few minor rips or holes identified in the geomembrane above the water level (Photographs 35). Orange staining was observed on the southern side slope of the pond liner that was the result of pumping water from the primary treatment pond across the berm into the clarifying pond during previous maintenance.

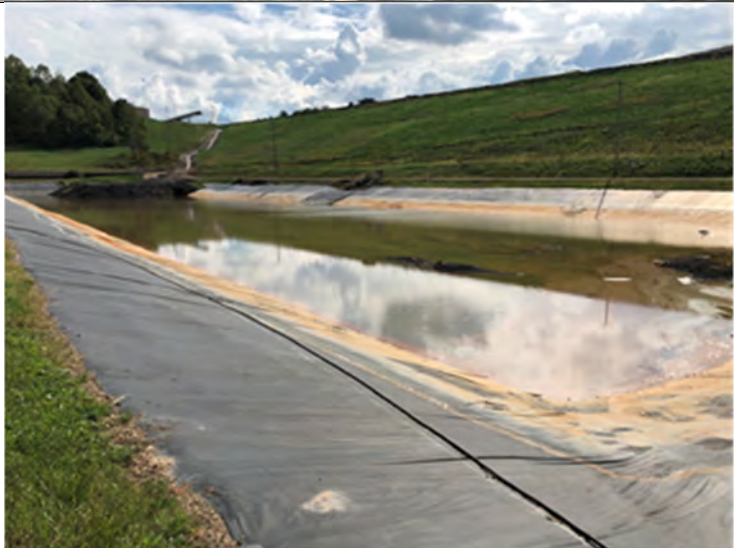
The primary treatment pond observed to be in satisfactory working condition following the maintenance adjustments that continued after the 2020 annual inspection. During 2020 and early 2021 significant spot repairs were made to the geomembrane liner system of this pond. The length of these repairs were inspected and a few minor punctures or rips were identified above the water level. Patch repairs that addressed previous issues throughout the Primary Pond No. 2 are noted (Photograph 37). Additional minor repairs should be addressed in the Northeast corner of Primary Pond No. 2.

A photograph of a primary pond. The pond is lined with a dark material and has a central structure. The water is brownish. There are trees and a blue sky in the background.
<p>Pond No. 2 primary pond overview (looking south)</p>

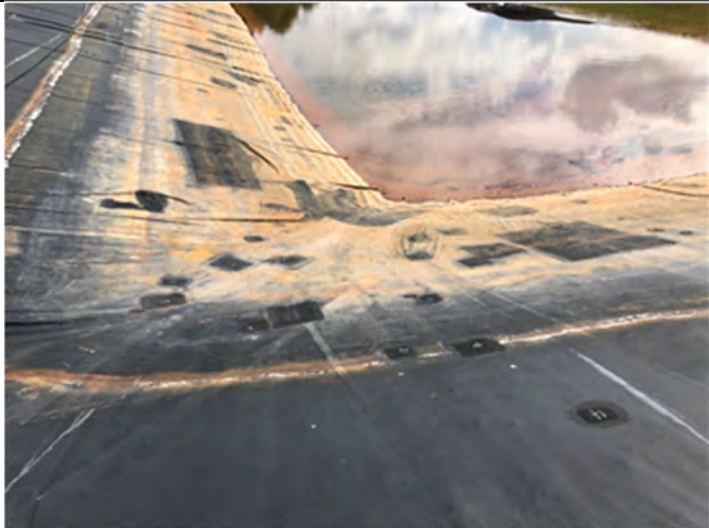
<p>Photograph #37</p> <p>Pond No. 2 primary pond patch repairs on Northeast corner (looking south)</p>

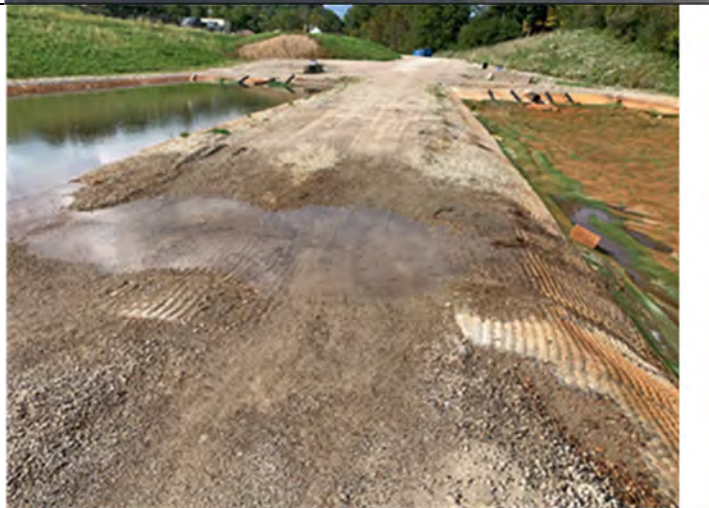
The vertical flow wetlands for Pond No. 2 were observed to be in satisfactory condition. The turbid water that was noted in 2020 has been rectified and was not present during this inspection (Photograph 39). The westernmost wetland was observed to be functioning as designed. The rock ditch line to the West of the vertical flow wetlands did not exhibit significant erosion and was observed to be functioning properly.

<p>Photograph #38</p> <p>Vertical flow wetlands for Pond No. 2. (looking north)</p>

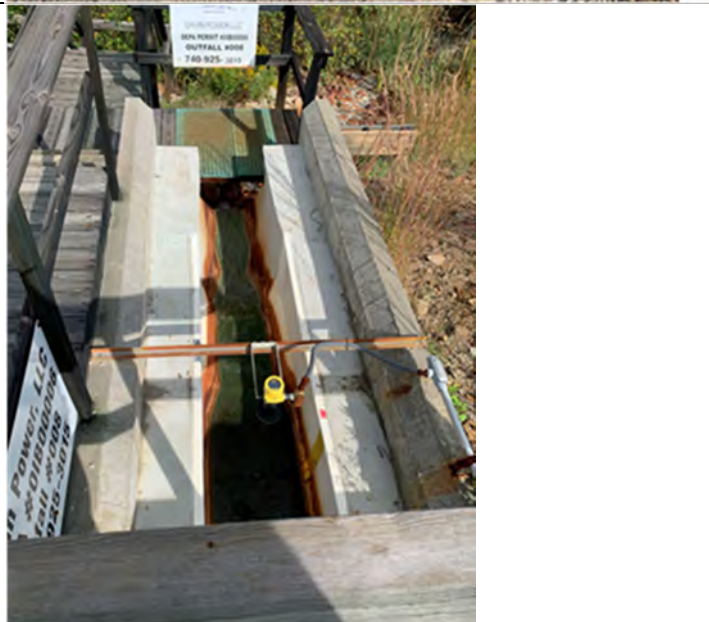
<p>Photograph #39</p> <p>Flow measurement flume at outlet for Pond No. 2 vertical flow wetlands (looking east)</p>

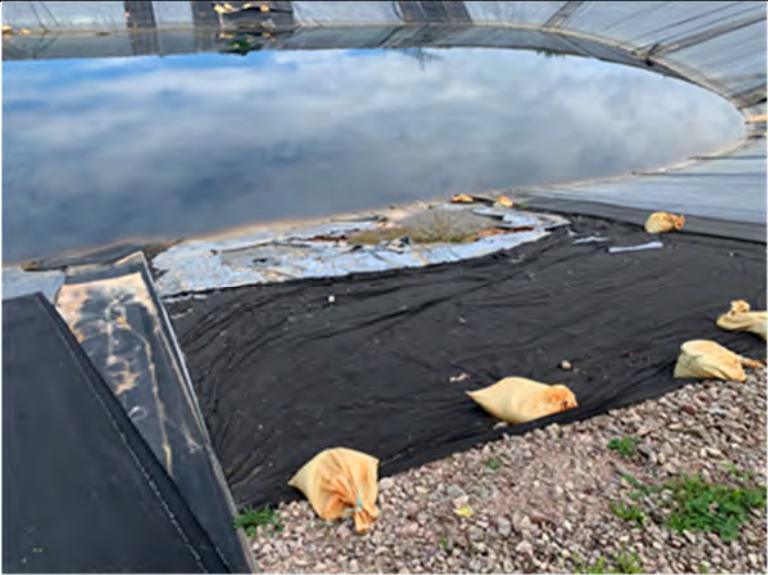
<p>Photograph #43</p>

Within the clarifying pond, numerous holes and tears were identified in the geomembrane during the inspection with some exhibiting vegetative growth from beneath. Surficial layers of a protective PVC geomembrane were also suggesting significant levels of deterioration such as material stiffness due to UV exposure over time and rips/tears. This surficial PVC geomembrane was installed at some time in the past for ultraviolet protection over the primary geomembrane in the Pond No. 3 clarifying pond (Photograph 42, 43 and 44), and therefore is deemed to be a sacrificial layer. The tears and holes identified in the liner within the clarifying pond were observed to be above the normal operating level. Repair of the visible damage to the primary treatment and clarifying pond geomembrane may be necessary during suitable weather in 2022 based on testing results. Water levels within this pond should be kept below visible defects such as small holes and tears in the geomembrane until repairs can be made.

<p>Vegetation growing through the holes within the liner of Clarifying Pond No. 3. (looking east)</p>	
<p>Photograph #44</p>

11. Given the noticeable increase in geomembrane imperfections with this inspection, particularly in the clarifying portion of Pond No. 3, a testing program to assess the material properties of the current in place geomembrane(s) is recommended. This testing program would consist of a representative coupon of material being cut from each of the ponds for strength and puncture testing. These results would be compared to the original material properties to estimate the level of deterioration and aid the facility in scheduling repairs or replacement of the geomembrane liner.

12. The primary portion of Pond No. 3 should have identified minor repairs conducted promptly similar to that specified in Item 11. To the extent determined by the testing described in Item 11 above, the clarifying portion of Pond No. 3 may require more significant repairs and more detailed recommendation will be provided based on the results of Item 11. Conduct recommended coupon testing as soon as practical in 2022 based on weather and when a suitable temporary patch can be made.

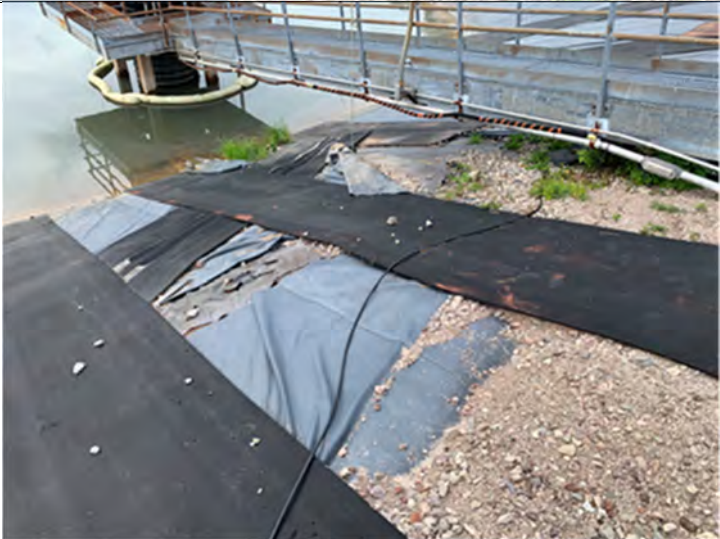
<p>Vegetation and gravel along slopes of Clarifying Pond No. 3. (looking northwest)</p>	
<p>Photograph #45</p>

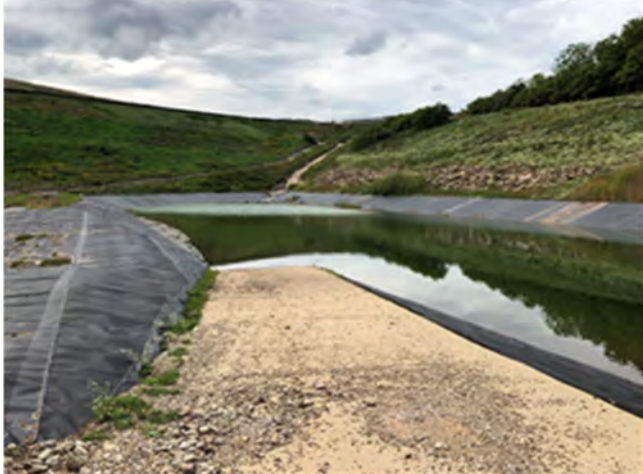
Pond No. 5 (Photographs 45 and 46) on the northeast side of the RWL, adjacent to Pond No. 3, was observed to be functioning satisfactorily with respect to water flow and sedimentation during the annual inspection. There was no indication of tearing of the geomembrane within the basin. During this inspection it was noted, similar to the 2020 inspection, that there was accumulated water under the Pond No. 5 liner system along a limited section of the southwest edge adjacent to Pond No. 3. This accumulation was evidenced by floating liner at the water interface at the pond operating level. The facility has installed a slit in the geomembrane several feet above the operating level of the pond for purposes of inserting a suction withdrawal pipe for removal of accumulating water originating from beneath the geomembrane. A small pump is utilized to withdraw this water as needed to avoid stress and uplift pressures on the liner system from accumulated water. The facility monitors this accumulation and has continued to utilize personnel to withdraw this water and discharge into the pond on an as needed basis. This water is reportedly clear and appeared to be groundwater, but was not observed during the inspection. It appears, based on the continued reappearance of this condition that a perched groundwater condition may exist with a connection to the Pond 5 area. The source of this water has not been identified but is apparently not from the pond, since it accumulates above the operating level within the pond, and groundwater results from down gradient monitoring wells do not indicate a release from Pond No. 5. There were minor punctures noted in the geomembrane near the concrete inflow channel to Pond No. 5 (Photograph 49) that may be the result of animal hoofs. The holes appeared to be above the operating level of the pond and away from concentrated inflow of stormwater. These holes should be repaired as weather conditions allow in 2022.

<p>Pond No. 5 North & West embankment. (looking northwest)</p>

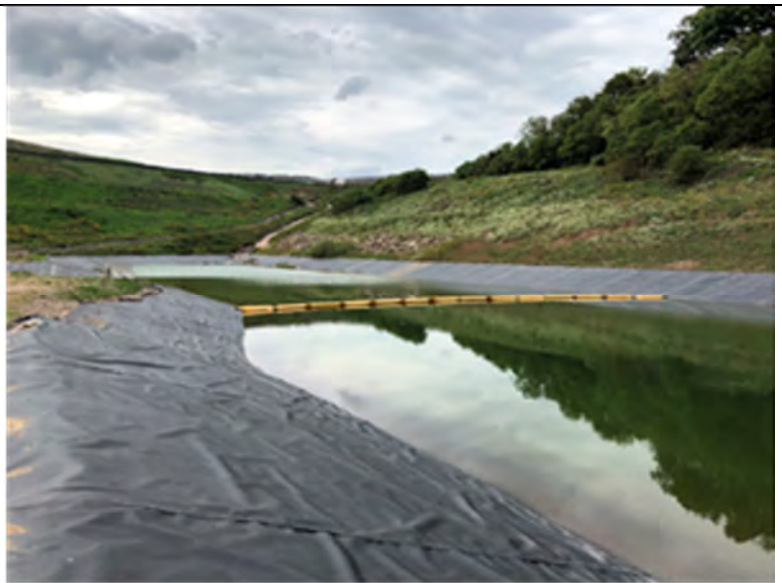
Photograph #46

Pond No. 5 North & West embankment (looking northwest)

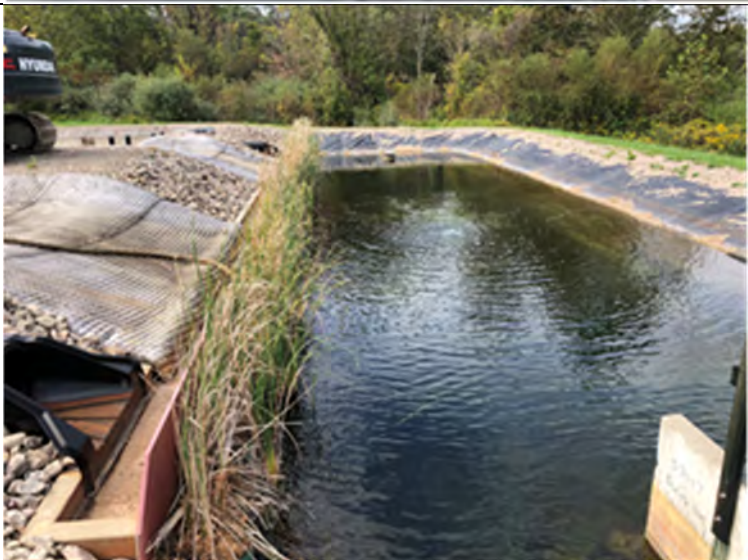
Photograph #47

The vertical flow wetlands for Pond No. 3/Pond No. 5 were undergoing maintenance during the inspection. The northernmost wetland cell was being used for treatment while the southernmost cell was being excavated and filter media being replaced (Photograph 48). The overall discharge was observed to be functioning properly as evidenced by no observable discoloration, scour, or outlet instability below the permitted outfall (Photograph 47).

Outlet for vertical flow wetland at Pond Nos. 3 and 5. (looking west).

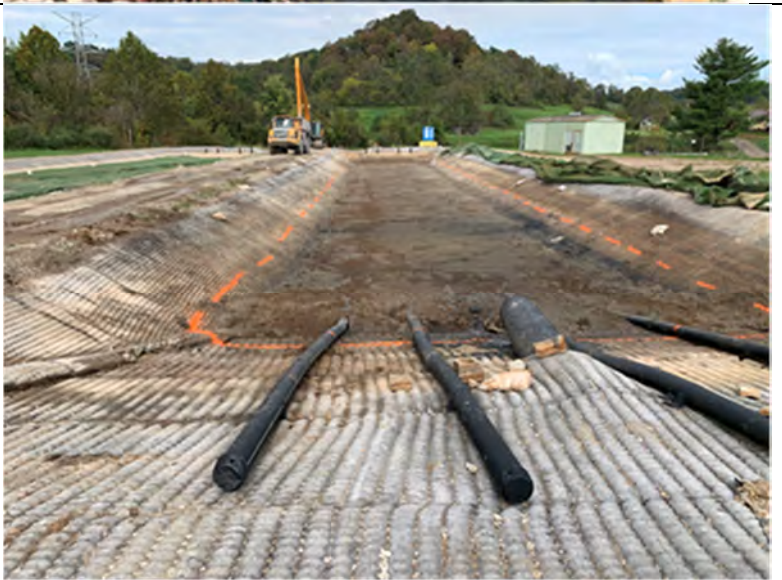
Photograph #48

Maintenance occurring at vertical wetlands for Pond Nos. 3 and 5. (looking north).

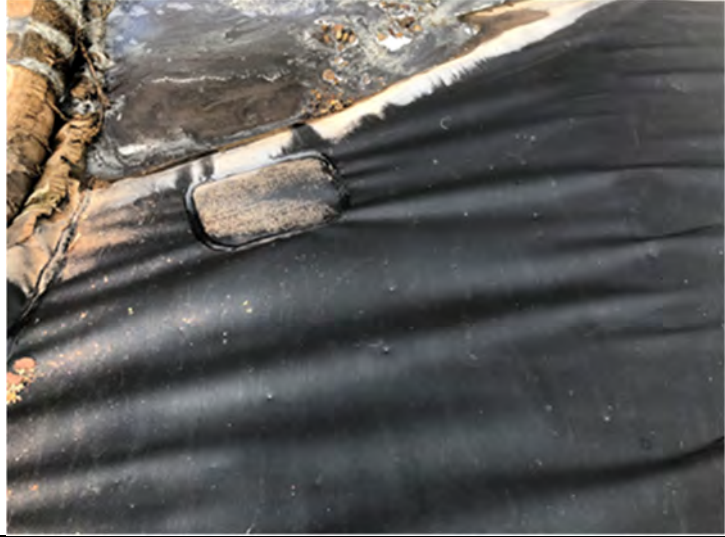
Photograph #49

View of inflow channel to Pond 5 with multiple small liner tears. (looking west).

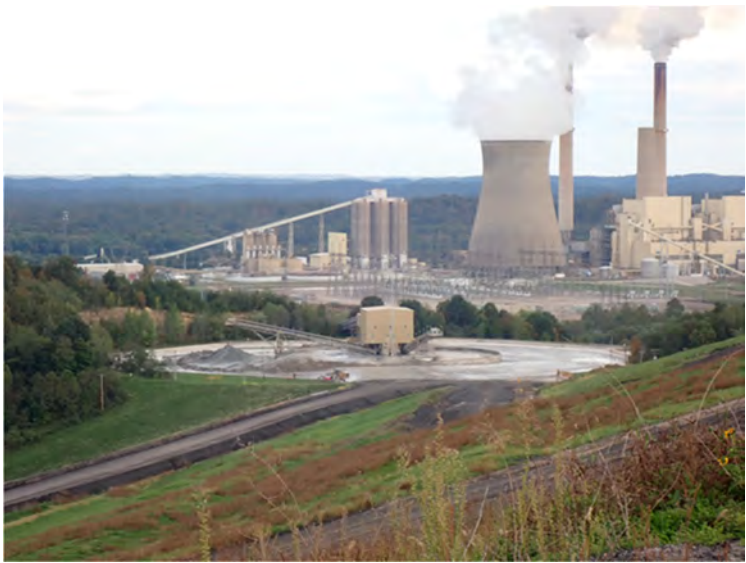
Photograph #50

Photographs 50 and 51 depict operating conditions at the FGD stack-out pad during the annual inspection. There was minimal FGD production on the day of the inspection, and the material was satisfactorily handled and contained on the pad prior to being loaded into haul trucks for disposal in Phase H.

View of FGD stack out pad operations (looking south).	
Photograph #51

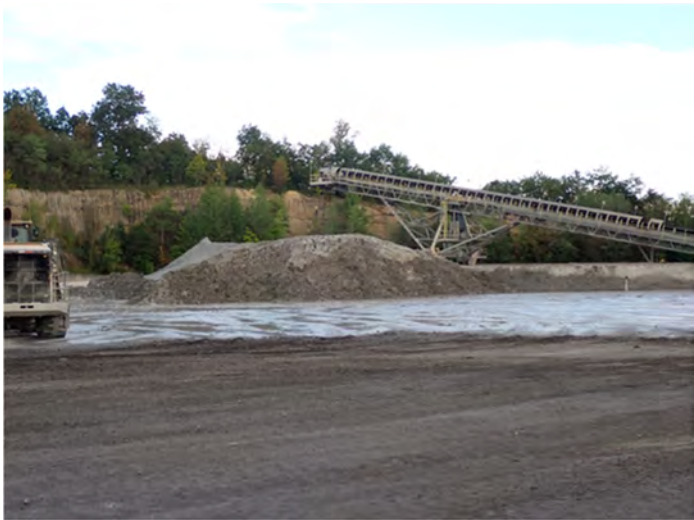
View of FGD stack out pad operations (looking east).
