2021 Annual Inspection Report

Gavin Power, LLC

Bottom Ash Pond

Gavin Power Plant
Cheshire, Ohio

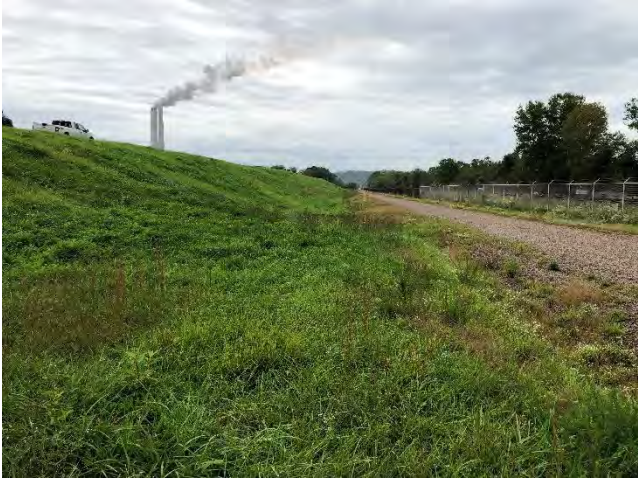
Photograph #1

1. Bare earth cuts and localized areas of sparse vegetation reported in the 2020 Annual Inspection Report have been repaired by the time of the 2021 inspection. The western embankment contained no indications of slope instability and well vegetated, however overgrown grass along the embankment also hindered closer inspection of underlying ground conditions in some areas (Photograph 1).

View of western embankment, from western side of Reclaim Pond. Slope is stable and well vegetated. Tall grass at the time of inspection (looking south).	
Photograph #2

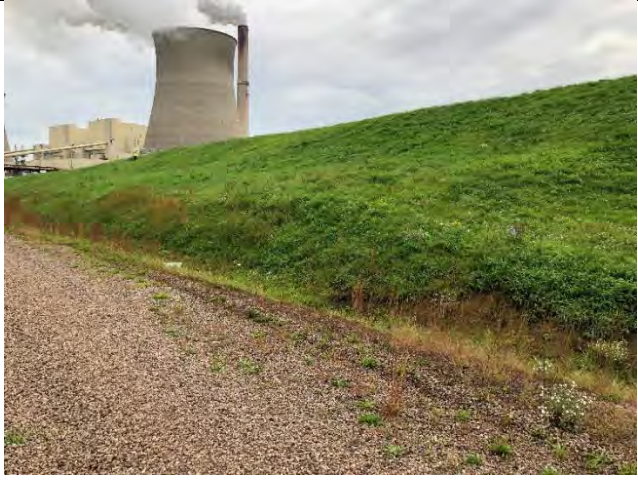
2. On the exterior embankment slope, known and previously documented earthen bulges were observed halfway down the slope near the northwest and southwest corners of the BAP (Photographs 2 and 4, respectively). These existing earthen bulges were reported and described in previous Annual Inspection Reports since 2017, and have reportedly existed since original embankment construction. The earthen bulges appeared stable at the time of the 2021 inspection and did not appear to be active or expanding. These areas will continue to be monitored.

Drainage ditch and culvert along exterior base of western embankment, near west of the Reclaim Pond. Previously documented earthen bulge just above drainage line. Slope is stable and well vegetated (looking northeast).	
Photograph #3

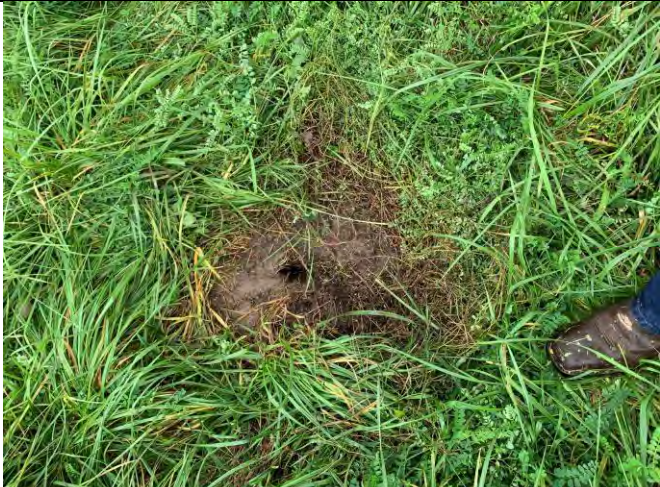
3. One animal burrow, approximately 3 inches in diameter, was observed along the top of the exterior embankment slope midway across the BAP (Photograph 3). This and any additional burrows identified during weekly inspections should be promptly backfilled and areas restored/reseeded as needed.

Animal burrow observed along top of slope midway across exterior western embankment slope, approximately 3 inches in diameter (top view).

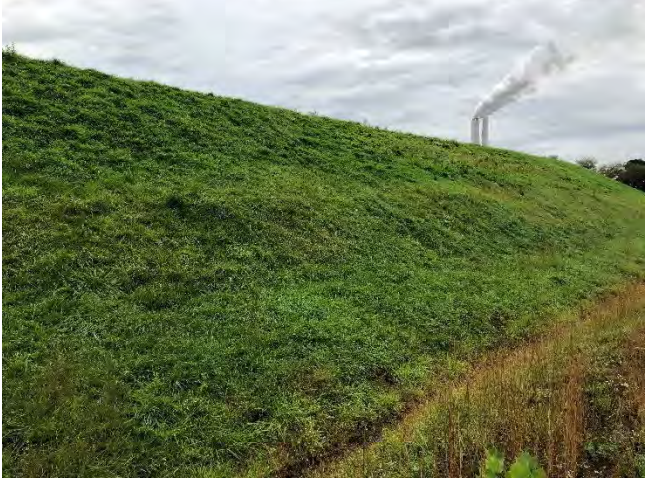
<p>Photograph #4</p>

<p>Western embankment exterior slope and bottom ditch line toward south end of embankment. Previously documented earthen bulge location midway across slope face. Slope is stable and well vegetated (looking southeast).</p>	
<p>Photograph #5</p>

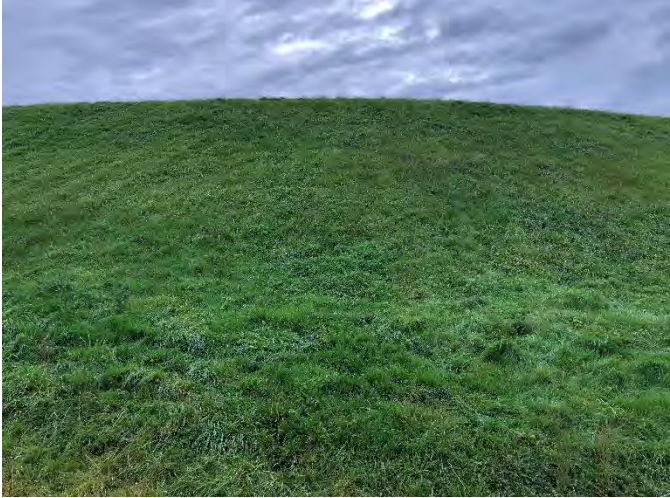
<p>View of slope face from the bottom at exterior SW corner of BAP. Slope is stable and well vegetated (looking east).</p>	
<p>Photograph #6</p>

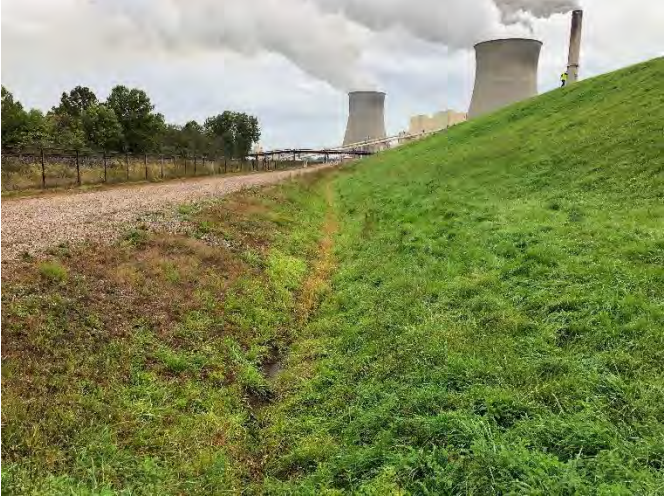
4. The drainage ditch along the exterior toe of the western embankment contained no indications of slope instability and was well vegetated (Photograph 6). The pipe culvert observed toward the end of the ditch in the southwestern corner appeared to be in good working condition and free of debris. Only a slight bend at the top of the pipe was observed in the SW corner culvert, which is not currently affecting its operation (Photograph 7).

<p>View of western embankment and bottom drainage ditch from SW corner of BAP. Slope and ditch channel are stable and well vegetated. Localized areas of slope cuts and bare ground documented last year have been properly restored (looking north).</p>

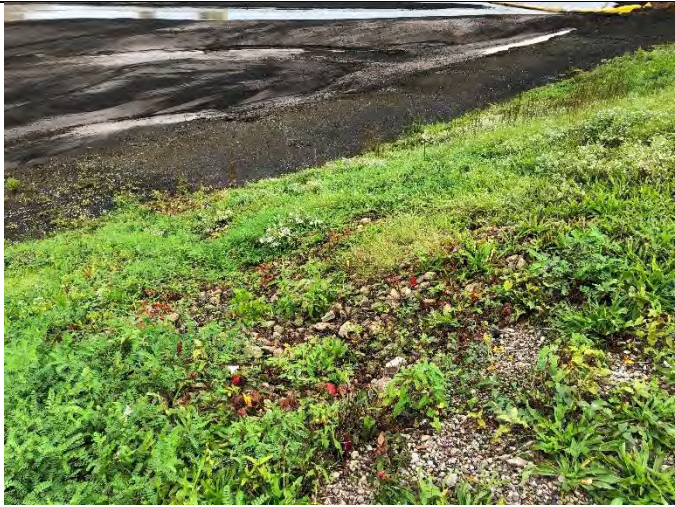
2. Areas of sparse vegetation and some early indications of forming rills were observed along the top of the interior slope toward the southeast corner of the BAP (Photograph 26).

<p>View of interior southern embankment slope toward SE corner of BAP. Sparse vegetation cover and indications of rill erosion observed in a few areas midway across BAP embankment (looking northeast).</p>	
<p>Photograph #27</p>

1. Promptly repair identified erosion rills/gullies to prevent expansion and further erosion (Photographs 14, 26, 40, 55, and 57). Continue monitoring areas where rills and gullies have formed.

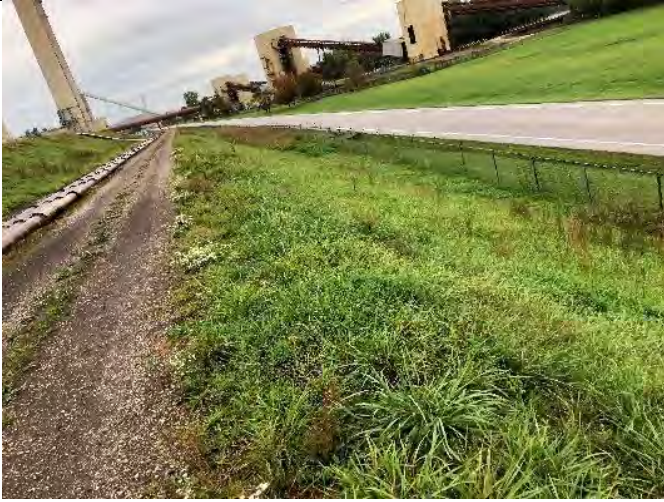
View of previously identified scarp along the bottom of exterior eastern embankment slope, near SE corner of BAP. Area observed stable and is well vegetated. Unchanged from previous inspections. (looking east).

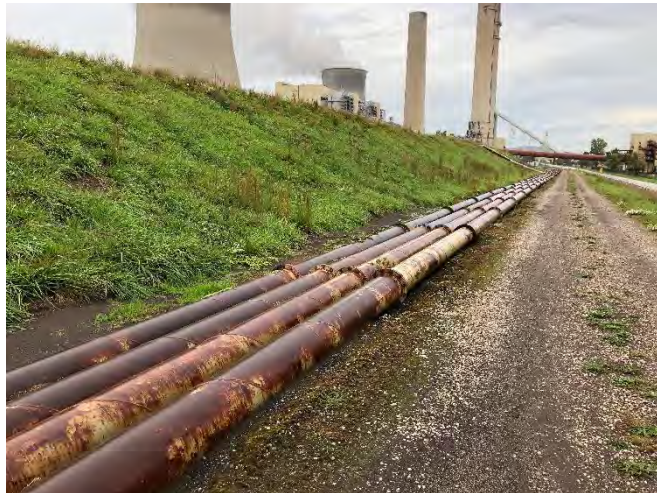
View of recent pipeline repair/reinforcement observed along eastern embankment exterior slope (top view).

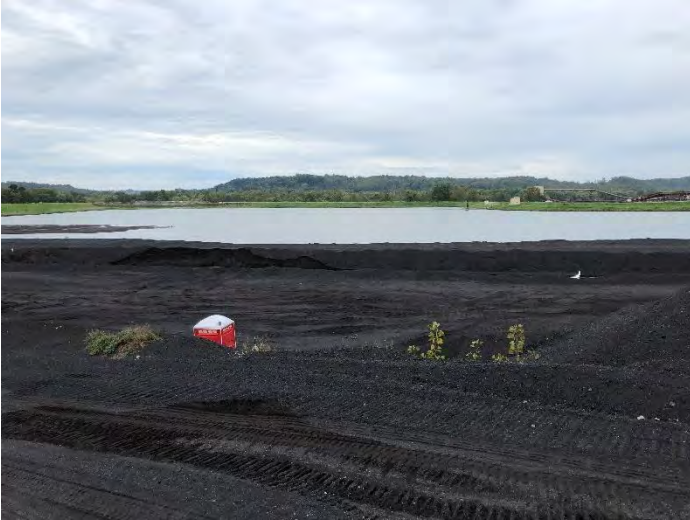
<p>View of interior eastern embankment maintenance area from SE corner of BAP. Some forming minor erosion rills observed in bottom ash (looking northwest).</p>

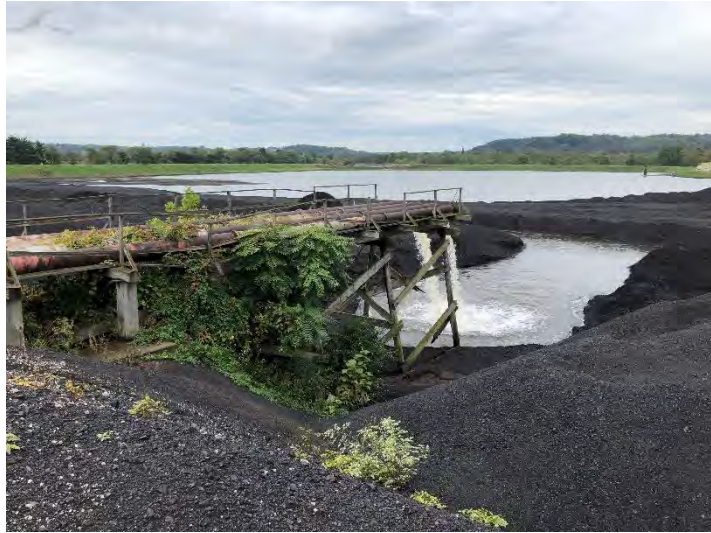
Photograph #43

4. From the top of the interior embankment slope, the wooden platform, slated for removal in 2023, supporting the slurry lines at Unit 1 point of discharge was observed to have a few loose supports, and some instances of apparent missing supports, in addition to displaying general signs of material decay (Photograph 43).
5. The eastern embankment access road was found in stable condition and remains well maintained (Photograph 42).

View of Unit 1 bottom ash sluice inlet. Tall vegetation growth under platform and loose/broken platform frame members observed (looking west).

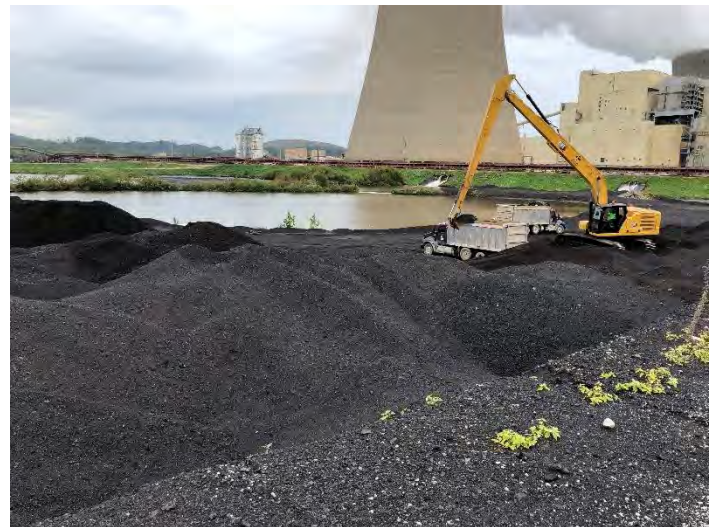
Photograph #44

View of dredging operations along interior eastern embankment of BAP. Ash stockpiles and bordering banks appear stable (looking northwest).

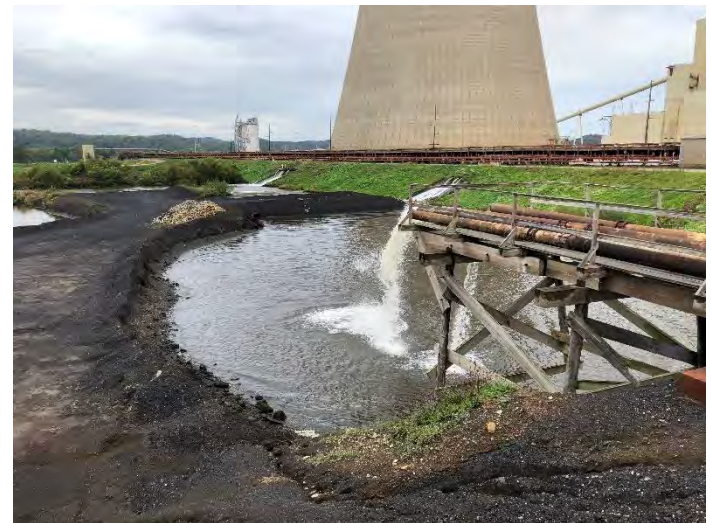
Photograph #45

View of coal reject and pyrite line discharges and access road expansion at NE corner of BAP. Access appears stable with a few forming erosion rills in ash observed at road bends (looking northwest).

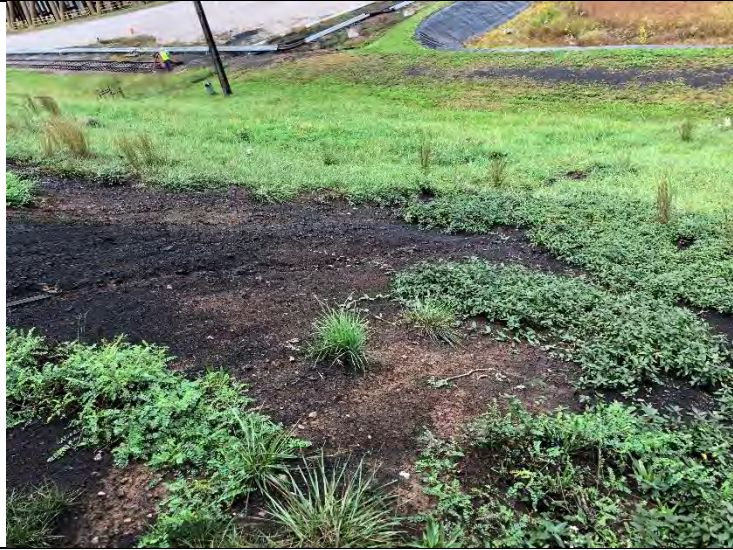
Photograph #49

View of bare ground area along the top of exterior northern embankment slope (looking northwest).

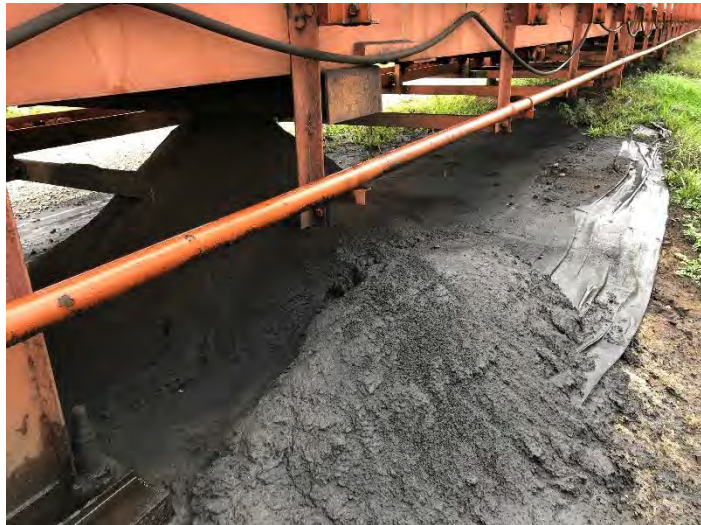
Photograph #50

View of coal fines accumulation pile observed under conveyor belt along top of exterior northern embankment slope (top view).

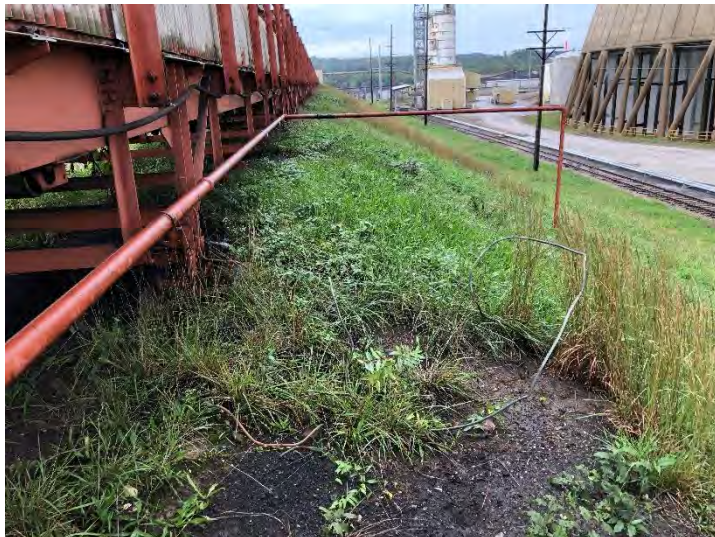
Photograph #51

View of bare ground area and some loose wiring remnants observed by conveyor belt path along top exterior northern embankment slope (looking west).

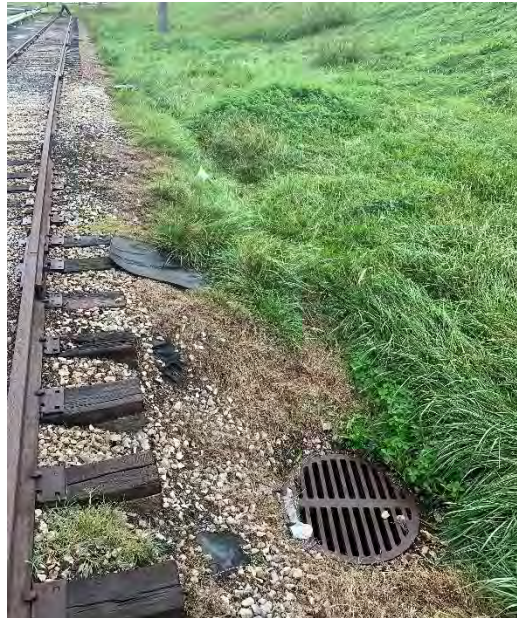
Photograph #52

3. A slight ground bulge was observed within the channel of the vegetated ditch along the toe of the exterior embankment slope toward inlet. The ditch was found in stable condition and is well-vegetated. No water pooling was observed at time of inspection (Photograph 52).

View of drainage ditch channel and drainage inlet along the bottom of the exterior northern embankment slope. Slight ground bulging observed within channel toward inlet (top view).

4. Monitor the drainage ditch along the toe of the northern embankment exterior slope. If the identified ground bulge is observed to be hindering positive flow drainage toward ditch inlet, efforts should be made to relocate or realign the ditch (Photograph 52).

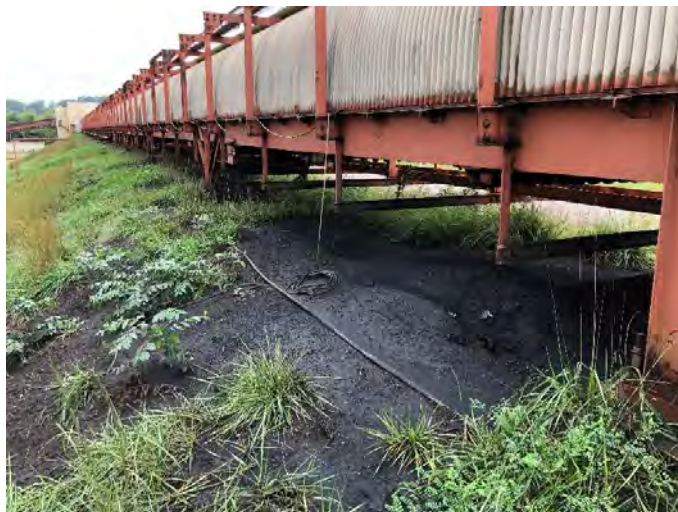
Photograph #53

View of coal fines accumulation and loose wiring observed under conveyor belt along top exterior northern embankment slope (looking east).

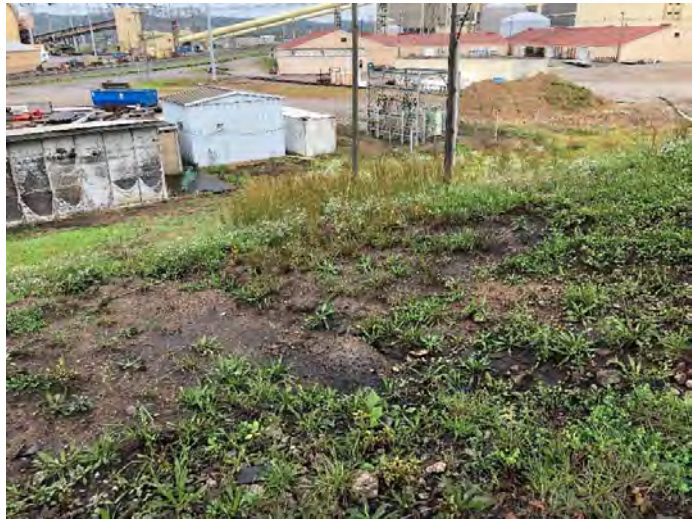
2. Two forming erosion rills, documented in the 2020 report, were observed on the exterior slope near the northwest corner of the embankment (Photographs 55 and 57). These rills follow the entire distance from the head to the toe of the slope, and may partially be a result of rainfall and runoff flow from the conveyor belt at the crest.

<p>Photograph #55</p> <p>View of bare ground area and forming erosion rill observed from top of exterior slope at NW corner of BAC (looking north).</p>

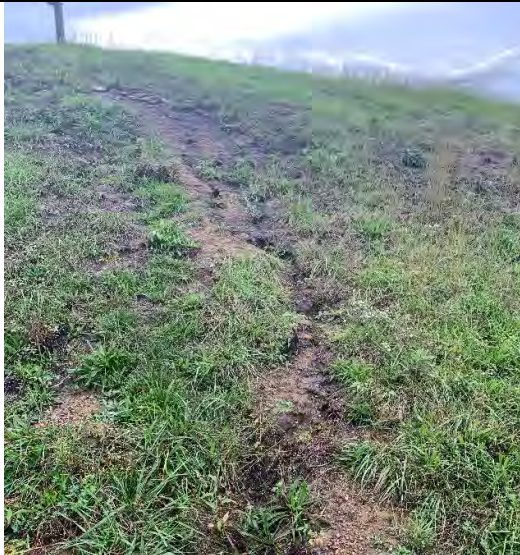
<p>Photograph #57</p> <p>View of erosion rills at NW corner of BAC, observed from the bottom of the exterior northern embankment slope (looking southwest).</p>

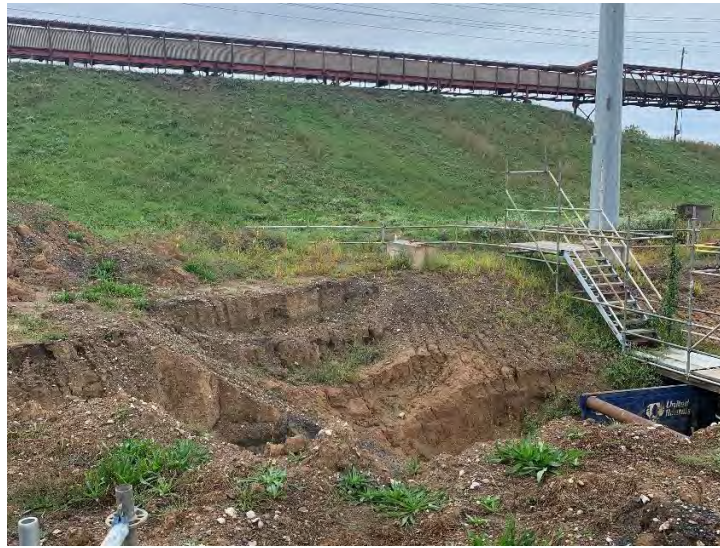
Photograph #58

4. An area of open excavation was observed at the toe of the exterior embankment slope near the NW corner (Photograph 58). These excavation activities were occurring for replacement of a water valve not associated with the BAP,

View of open excavation observed along bottom of northern embankment exterior slope (looking southwest).

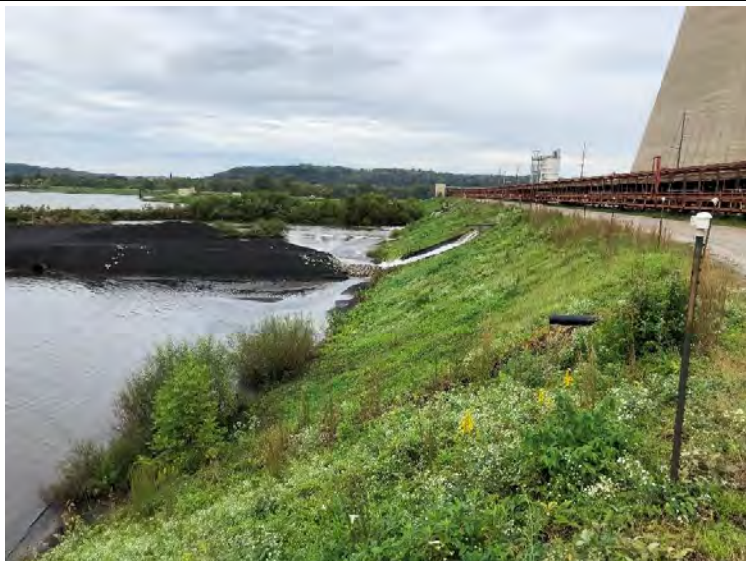
Photograph #60

View of interior northern embankment slope from NE corner of BAP. Slope is stable and well vegetated. Growing woody vegetation patch observed at toe (looking west).

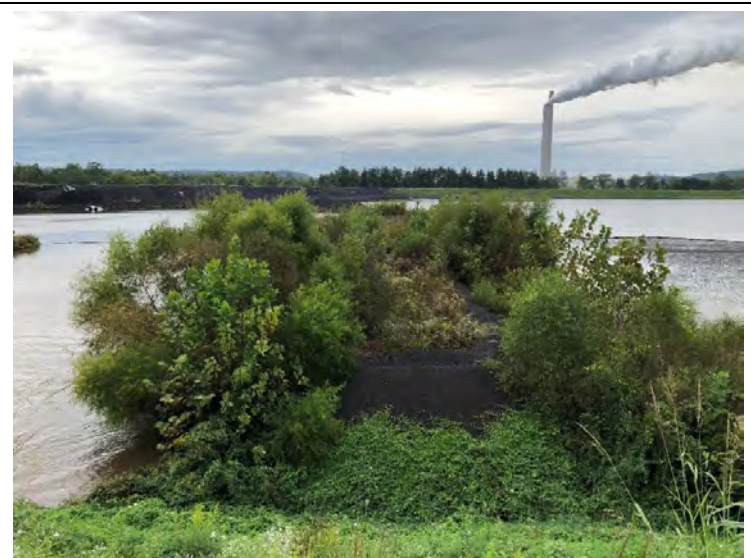
Photograph #63

View of ash accumulation and tall woody vegetation growing midway across BAP from top of interior northern embankment slope (looking south).
