2022 Annual Inspection Report

Gavin Power, LLC

Residual Waste Landfill

Gavin Power Plant
Cheshire, Ohio

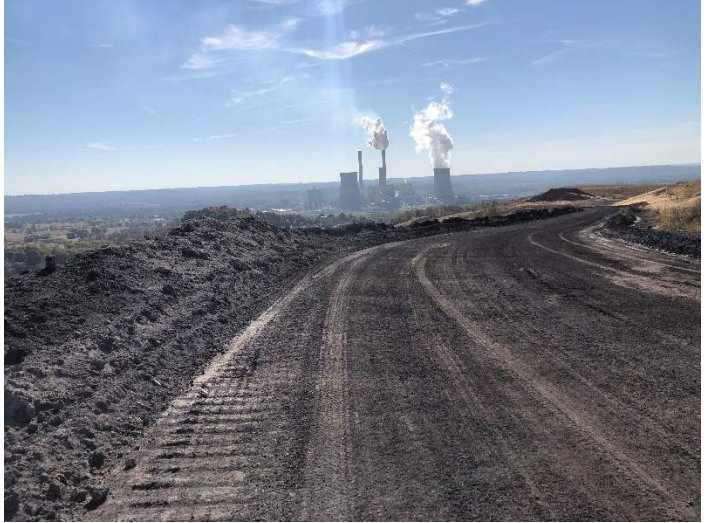
Photograph #1

The haul roads in active areas of CCR placement use bottom ash as a base course (as observed in Photographs 1, 2, and 3). This base course compacts well and withstands repeated heavy equipment traffic based on experience. The haul roads observed by ERM appeared to be stable during the site drive/walkthrough, and there was no visual evidence of significant distress (i.e., rutting or pumping). The roads had positive drainage from the centerline or are sloped to an adjacent drainage channel and there was no visible evidence of ponding water on the roadway surface. Drainage channels paralleling the roadways also capture storm water runoff from adjacent slopes, which is directed to stable outlets that ultimately discharge to the surrounding site treatment ponds. ERM observed sporadic evidence of minor erosion in the channel bottoms or at the connection point/confluence of drainage berms that collect water from the landfill side slopes. Overall, roadside channels appeared well maintained. ERM observed active cleaning of roadside channels along the eastern haul road during the site visit, reportedly completed as needed.

Main haul road constructed of bottom ash. Picture taken from summit of landfill. (looking southeast)	
Photograph #2

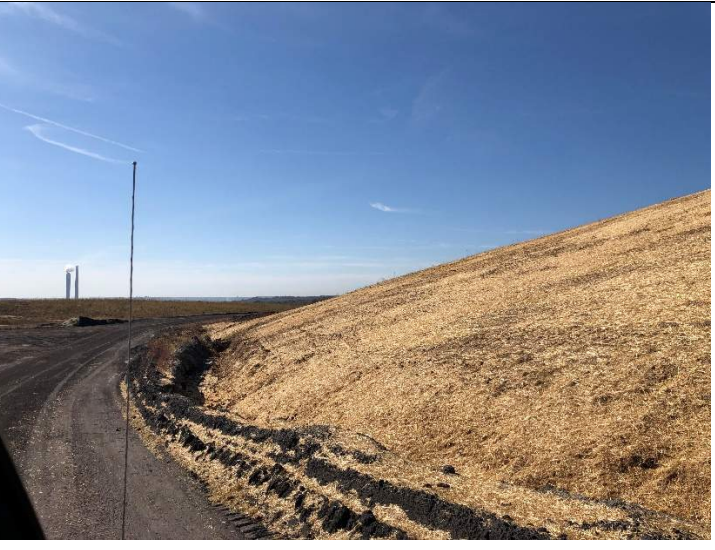
Main haul road constructed of bottom ash heading up the northeastern side of the landfill (looking south)	
Photograph #3

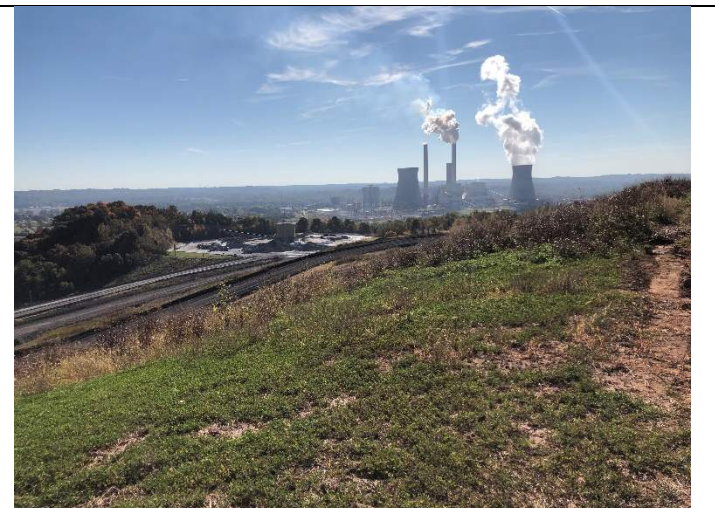
Main haul road constructed of bottom ash near east side of landfill. Example of areas needing potential spot seeding in foreground and on right (looking south)

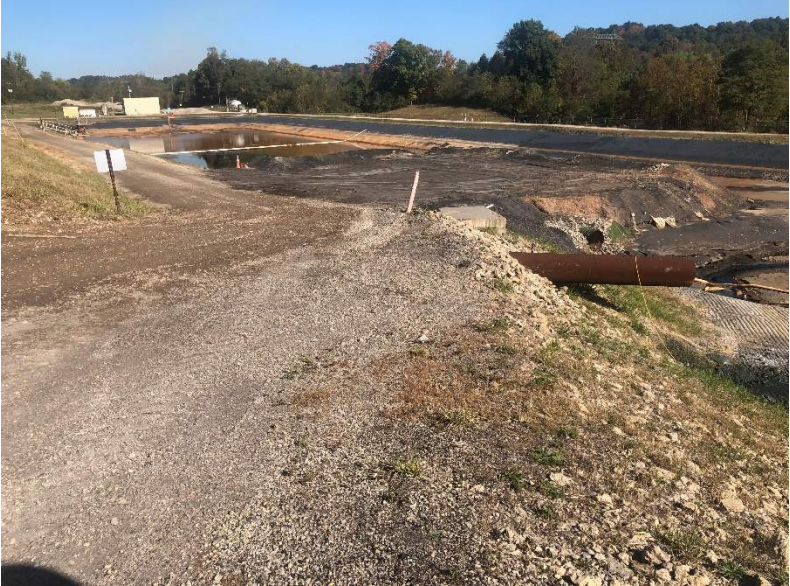
<p>Photograph #4</p>

There were several sections of permanent roads that have a limestone gravel base course, as depicted in Photographs 4, 6, 8, and 9. These roads also were observed to be stable with no visible evidence of distress. More frequently used roadways incorporate robust drainage channels adjacent to slopes, which were positively graded and include rock check dams (Photograph 6).

<p>Access road leading to Pond 2 (looking east)</p>	
<p>Photograph #5</p>

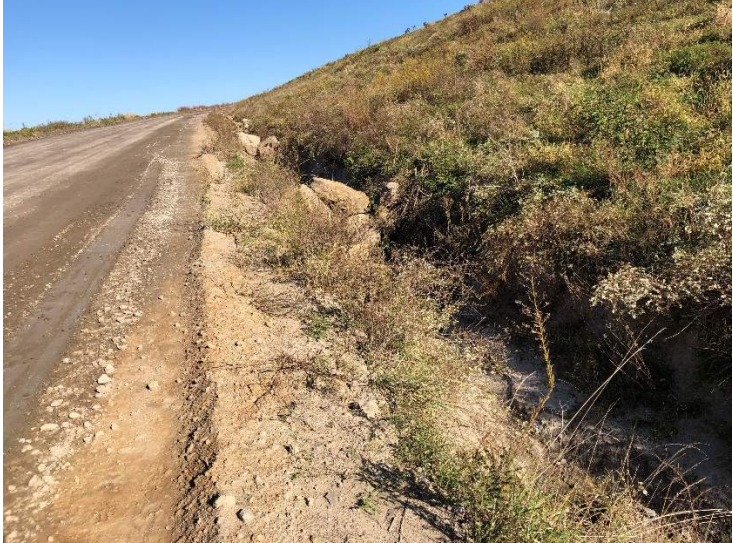
<p>Southwest gravel access road and roadside channel with rock check dams. (Looking north)</p>

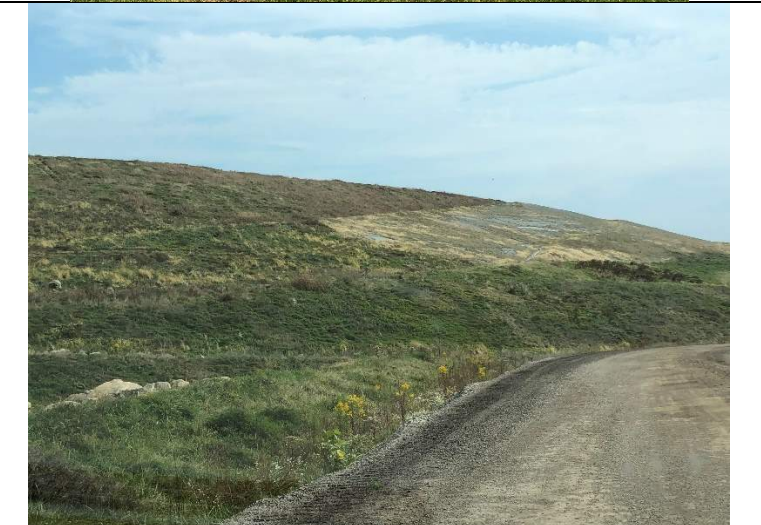
In the past, the Gavin Power Plant team performed direct seeding of FGD material, which was only partially successful in establishing vegetation. The Gavin Power Plant team thereafter began covering these areas with soil to promote more vigorous stands of vegetation. Some areas with FGD direct seeding still exhibit poor vegetative growth, as indicated in Photographs 3 and 9, but this was observed to a much-reduced extent when compared to previous inspections. These isolated areas of the slopes, where direct seeding of the placed FGD was attempted, continue to be covered incrementally with an intermediate layer of soil to aid in the establishment of vegetation. The application of this intermediate soil layer as slopes are completed or meet their interim grades are depicted in Photograph 9 (left side of photo).

<p>View of southern slope. Direct seeded fly ash visible in the center right (looking southeast)</p>

2. Complete the placement of intermediate soil cover, seed, and mulch on areas of direct FGD seeding where poor vegetative growth has been experienced. Soil pH and nutrient tests are recommended to target appropriate amounts of lime and fertilizer application to accomplish successful vegetative growth while minimizing the potential for over application.

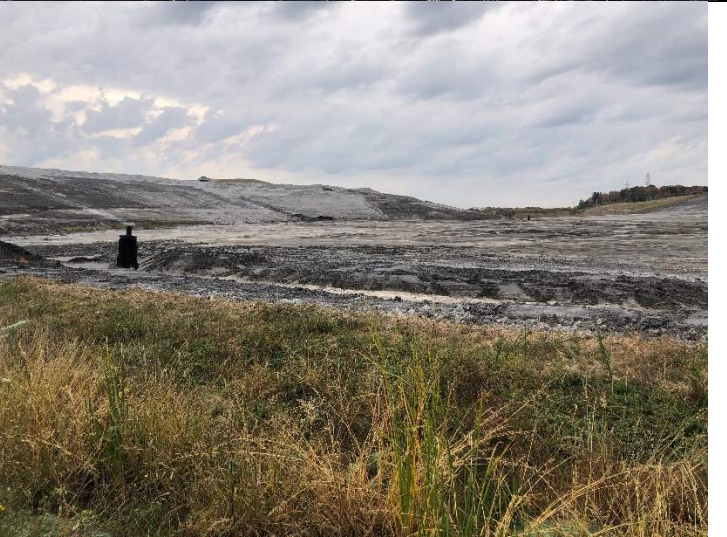
During the 2022 annual inspection, the geonet composite leachate collection layer was observed along the perimeter of Phase I and a protective layer of CCR had already been placed across the entire remainder of the cell. Bottom ash was actively being placed near the center of Phase I south of Pond 6. (Appendix A, Photograph 21).

<p>RWL overview (looking south)</p>

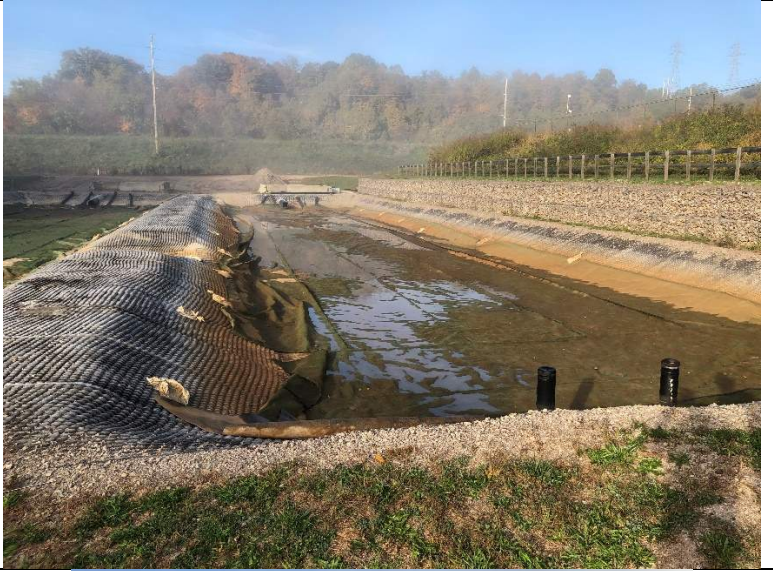
<p>Photograph #24</p>

The vertical flow wetlands for Pond No. 1 observed to be in general working order (Photographs 24, 25, 26, 27 and 28).

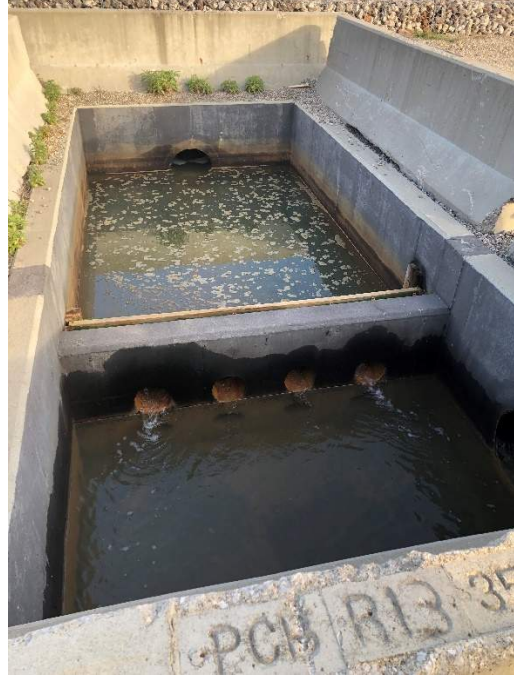
Photograph #26

View of inlet structures for Pond No. 1 vertical flow wetland.

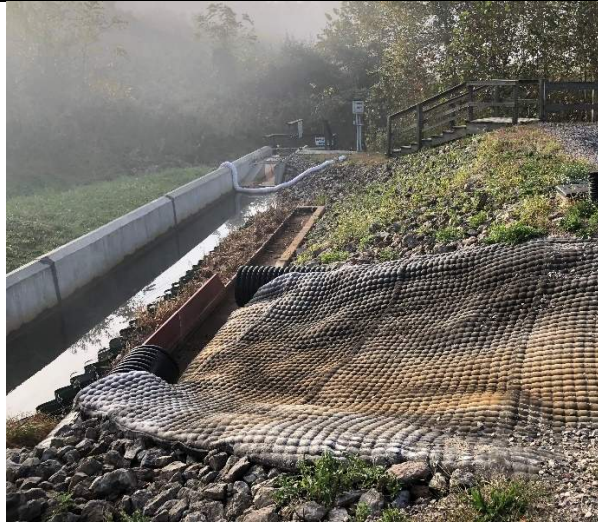
Photograph #27

Outlet for vertical flow wetland at Pond No. 1 (looking southeast)

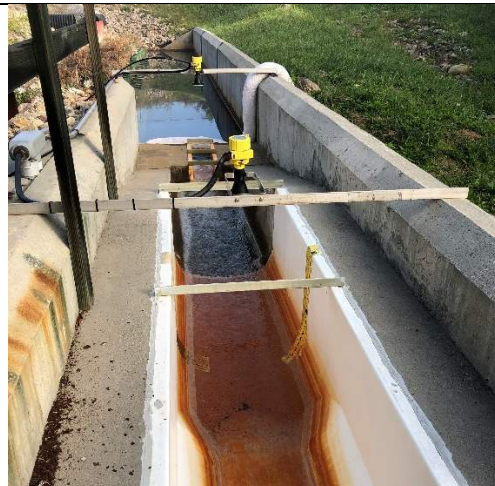
Photograph #28

Flow measurement flume at outlet for Pond No. 1 vertical flow wetlands (looking east)

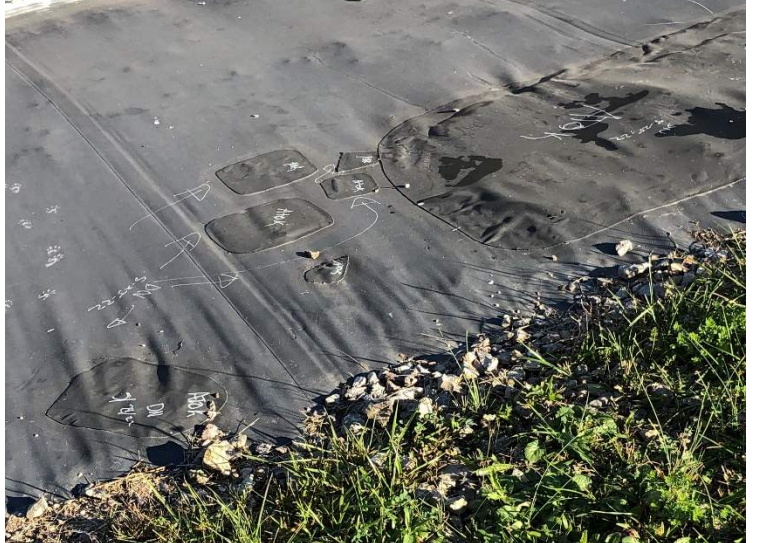
tears was observed. The small tears identified in the liner noted in the previous inspection have been repaired. ERM recommends that the new tears be repaired by a similar procedure as part of routine maintenance. The 2021 patched repairs were observed in Pond No. 1 (Photograph 31).

<p>View of sediment, vegetation, and patched repairs on Pond No. 1 west embankment. (looking east)</p>

10. Within Pond No. 1 continue as required maintenance and repairs. Clean channel inlets of stone and remove woody vegetation from inside pond limits. Continue to remove sediment buildup as needed for proper pond function.

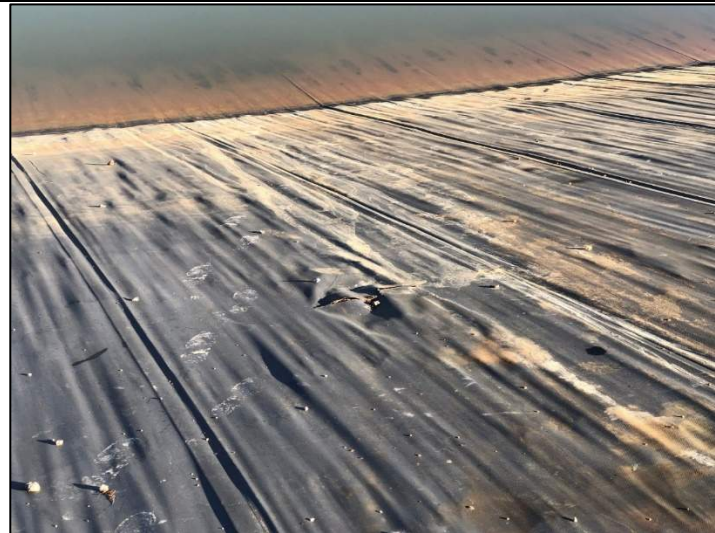
Photograph #33

Damaged liner side slope of Pond No. 1 clarifying pond

11. Repair small tears and minor perforations identified in the geomembranes at Pond No. 1, No. 2, and No. 5. Remove any vegetation prior to repairs. Routinely monitor all ponds for any additional tears and promptly repair when identified. Pond No. 1 and No. 2 should be repaired with similar (i.e. "Hypalon" product) geomembrane using either welding or adhesive techniques. Pond No. 5 is HDPE and will require spot welding techniques (i.e. extrusion gun or similar). Repairs should be completed prior to the next annual inspection in October 2023. The facility should continue to maintain current water operating levels below the level of identified perforations.

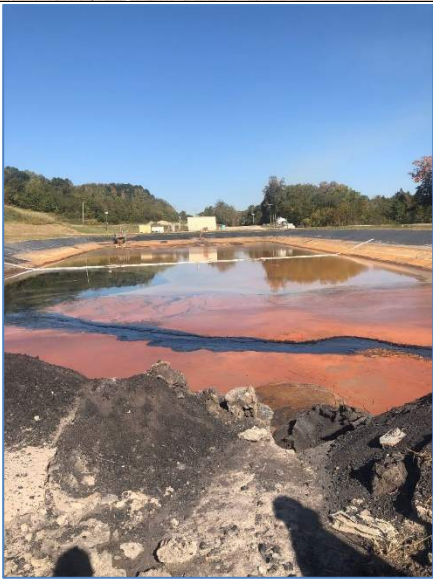
Orange staining and black water were observed on the western part of the clarifying pond (Photograph 35).

<p>Pond No. 2 clarifying pond from bottom ash working pad on south end of pond. (looking north)</p>	
<p>Photograph #36</p>

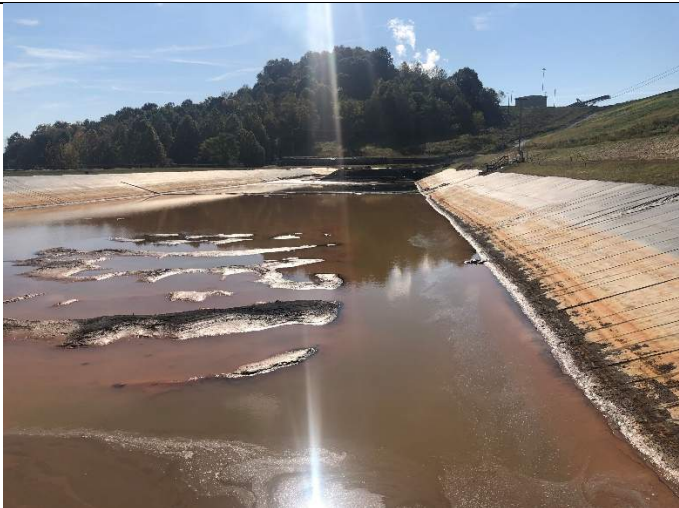
The primary treatment pond was observed to be in satisfactory working condition following the maintenance adjustments that continued after the 2020 annual inspection. During 2020 and early 2021 significant spot repairs were made to the geomembrane liner system of this pond. No rips or tears were observed but in two isolated areas a “bunching” of the geosynthetic material was observed. The bunched areas appeared to be intact with no evidence of holes or leakage. ERM recommends that these areas continue to be monitored for 2023 (Photographs 36 and 37).

<p>Pond No. 2 primary pond overview (looking south)</p>

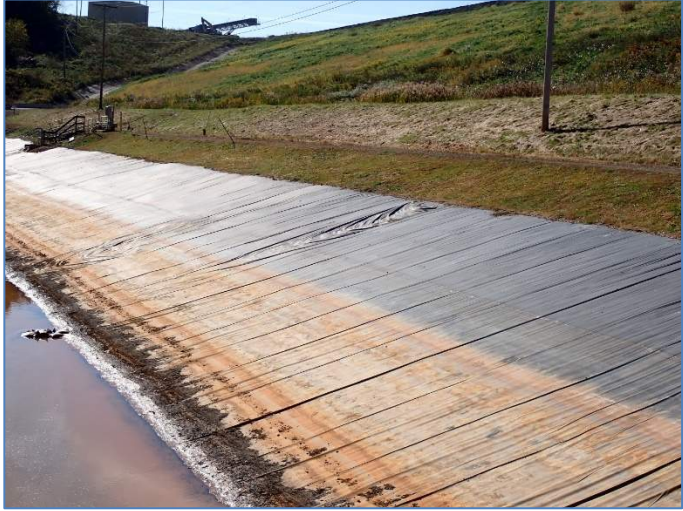
<p>Photograph #37</p> <p>Pond No. 2 primary pond liner was observed to have two areas of “bunching” that should continue to be monitored. (looking south)</p>

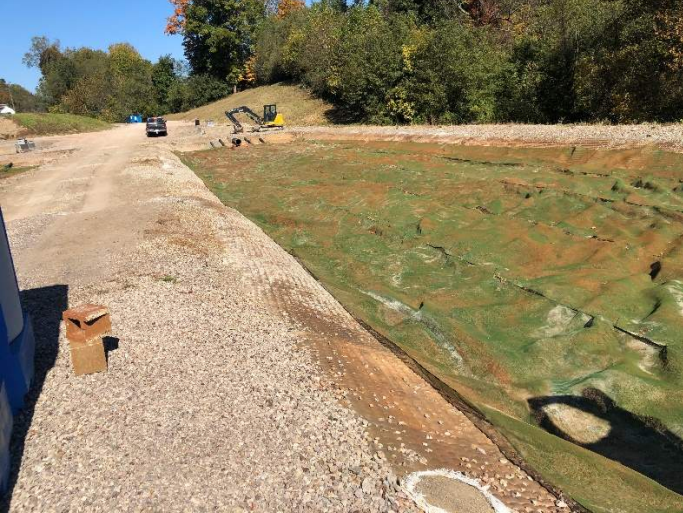
The vertical flow wetland cells for Pond No. 2 were observed to be in satisfactory condition (Photograph 38). The westernmost wetland was functioning during the inspection. The rock lined outflow channel for the system to the South of the vertical ponds appeared to be functioning properly from a flow standpoint with no signs of erosion or distress. During the inspection the discharge at Outfall 008 exhibited a cloudy discoloration and sulfur odor (Photograph 39). Inquiry of Gavin personnel indicated that treatment chemical adjustments were in progress and the observed discoloration would be rectified as adjustments were made.

<p>Photograph #38</p> <p>Vertical flow wetlands for Pond No. 2. (looking north)</p>

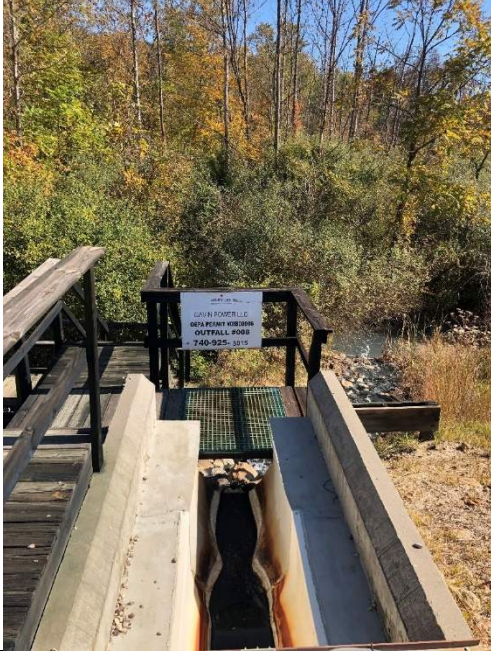
<p>Photograph #39</p> <p>Flume at outlet for Pond No. 2 vertical flow wetlands. Noticeable cloudiness and odor. (looking east)</p>

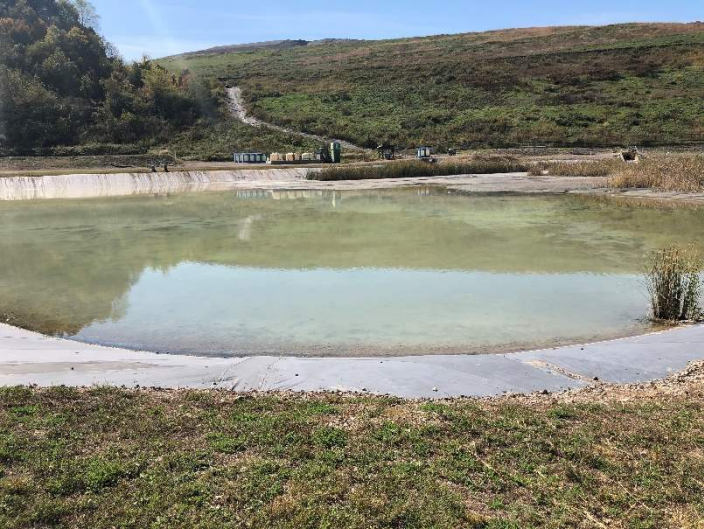
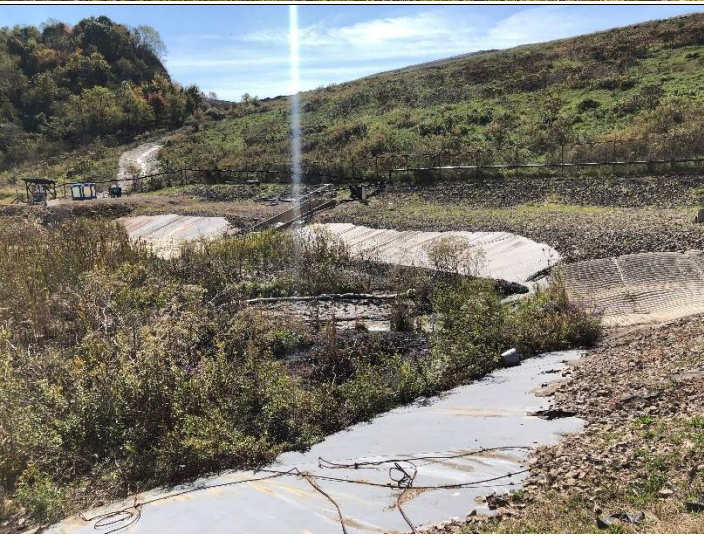
Within the primary treatment pond there was significant sediment accumulation and vegetation observed within the central portion and along multiple embankments as indicated in Photographs 40 and 41, having increased from observations in the 2021 inspection. This is based on observation that the solids level appeared to be just below the operating water level in several locations. Mr. Colin McKean, the Landfill Process Owner at Gavin Power, indicated that sediment from Pond No. 3 will be cleaned out in 2023. A small number of minor holes and tears were noted above the operating level of the sedimentation pond.

8. Continue to schedule maintenance and replacement of media in the vertical flow wetlands for Pond No. 1, Pond No. 2, and Pond Nos. 3 and 5.
9. Further schedule and commence maintenance of Pond No. 3 in 2023. This will include culvert repair, removal of vegetative growth, removal of sediments and liner system repair and/or replacement where necessary from both the primary treatment and clarifying portions of Pond No. 3.

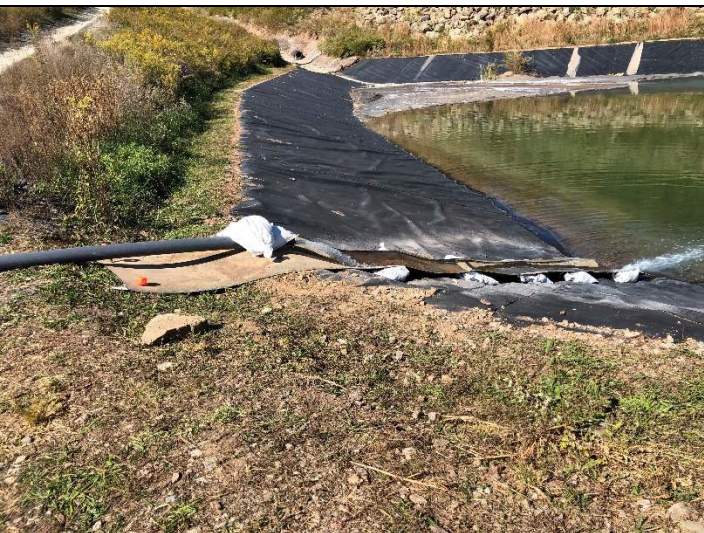
<p>Photograph #42</p>

During the inspection a new discharge into Pond No. 5 was observed coming from the inflow to Pond No. 3 (Photograph 42). A temporary pump system has been installed that directs collected leachate influent to Pond No. 3 and redirects it through an aboveground PVC force main into the head (Western end) of Pond No. 5. Temporary force main supports consisting of pallets were in use at the time of the inspection but have reportedly been replaced with steel pipe stands.

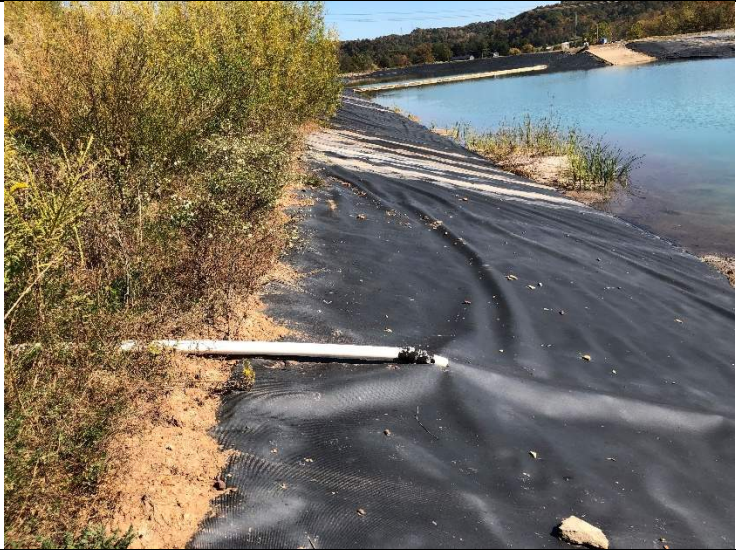
Further, the source of water under the Pond No. 5 liner system should also be explored to alleviate the need for continued attention to withdraw water. The facility should continue to frequently inspect for new perforations after currently proposed repairs are complete and anticipate additional geomembrane maintenance requirements in the future.

<p>Looking down northern edge of Pond No. 5. Pipe used for periodic removal of water under the liner in the foreground. (looking east)</p>	
<p>Photograph #44</p>

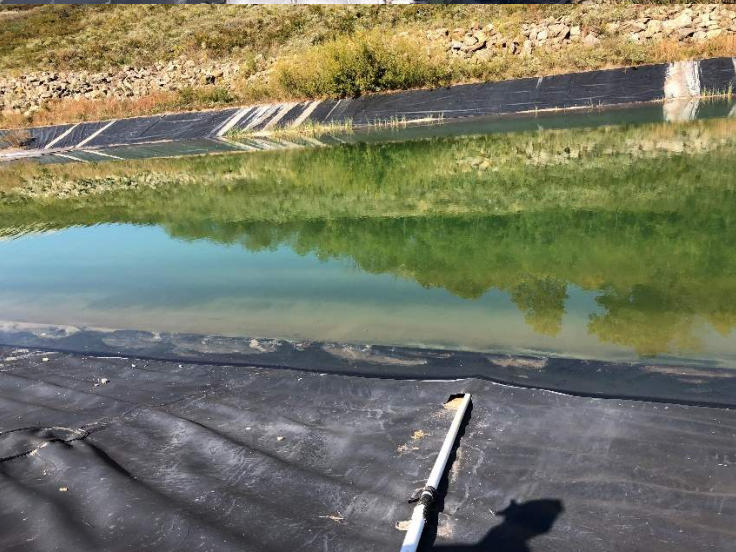
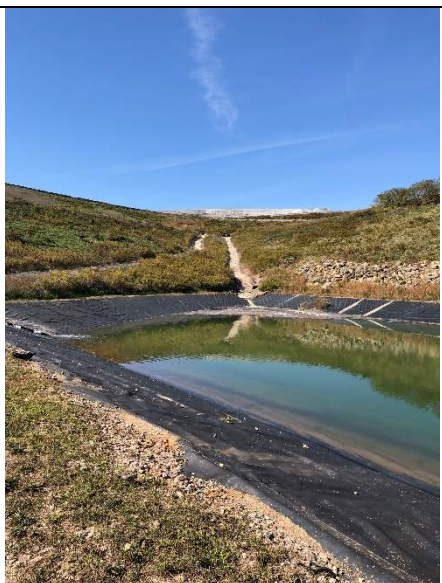
Pond No. 5 (Photographs 45 and 46) on the Northeast side of the RWL, adjacent to Pond No. 3, was observed to be functioning satisfactorily with respect to water flow and sedimentation during the annual inspection. There was no indication of tearing of the geomembrane within the basin (Photograph 43). During this inspection it was noted, similar to the 2021 inspection, that there was accumulated water under the Pond No. 5 liner system along a limited section of the southwest edge adjacent to Pond No. 3. This accumulation was evidenced by floating liner at the water interface at the pond operating level. It was also noted that the floating liner was minimal compared to previous inspections.

<p>Pond No. 5 West embankment. (looking west)</p>

<p>Photograph #46</p>			
<p>Pond No. 5 north & west embankment (looking northwest)</p>

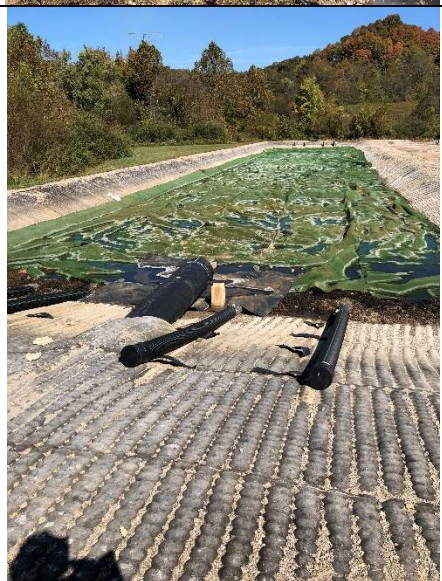
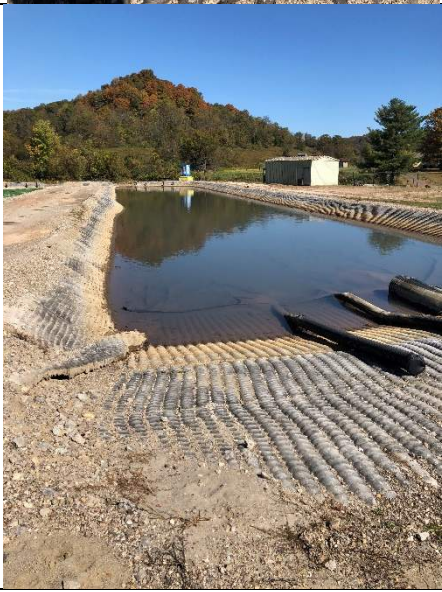
The vertical flow wetlands for Pond No. 3/Pond No. 5 were observed to be functioning properly as evidenced by no observable discoloration, scour, or outlet instability below the permitted Outfall 009 (Photographs 47 and 48).

<p>Photograph #47</p>			
<p>Vertical wetlands for Pond Nos. 3 and 5- western pond (looking northeast).</p>

<p>Photograph #48</p>			
<p>Vertical wetlands for Pond Nos. 3 and 5- eastern pond (looking northeast).</p>

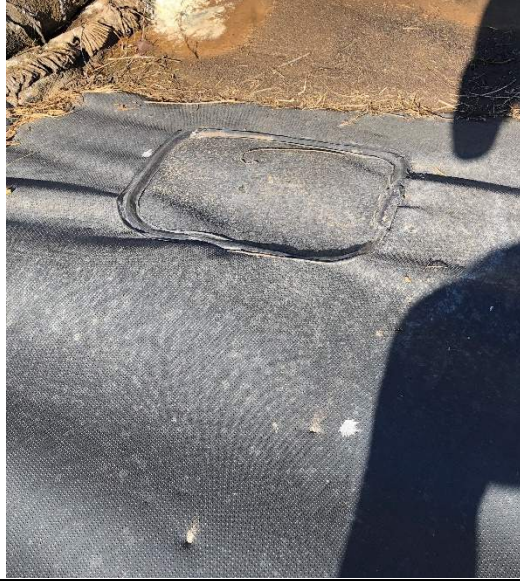
Photograph #49

There were minor punctures noted in the geomembrane near the concrete inflow channel to Pond No. 5 (Photograph 49) that may be the result of animal hoofs. Deer tracks were observed in the soil near this location. The holes are above the normal operating level of the pond and 2+ feet away from where leachate and stormwater flows enter the pond. These holes should be repaired as weather conditions allow in 2023. Additional measures for the exclusion of whitetail deer from this area should also be explored.

View of inflow channel to Pond 5 with multiple small liner perforations suspected of being related to wildlife. (looking west).

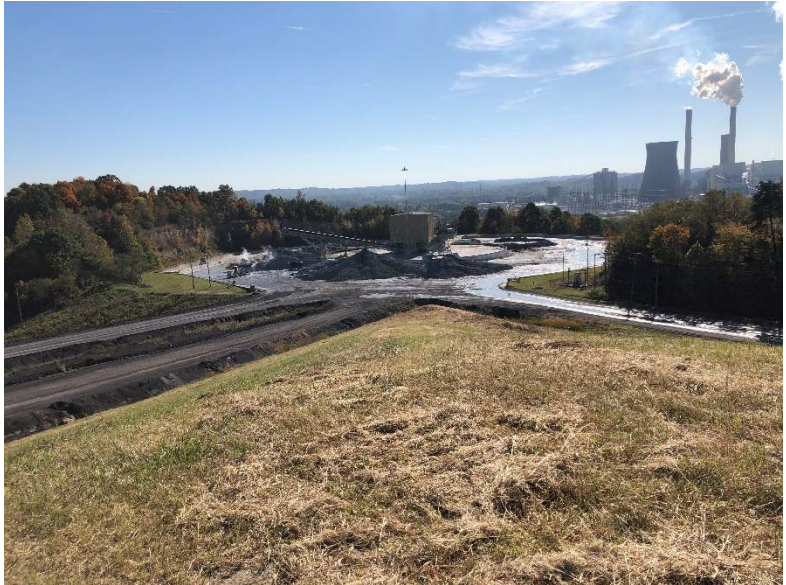
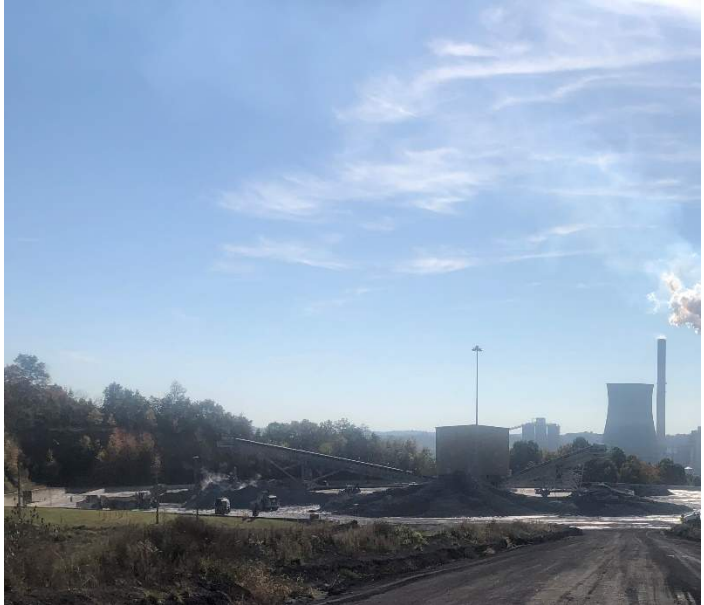
Photographs 50 and 51 depict operating conditions at the FGD stack-out pad during the annual inspection. There was minimal FGD production on the day of the inspection, and the material was satisfactorily handled and contained on the pad prior to being loaded into haul trucks for disposal in Phase H.
