# 2022 Annual Inspection Report

Gavin Power, LLC

## Bottom Ash Pond

Gavin Power Plant  
Cheshire, Ohio

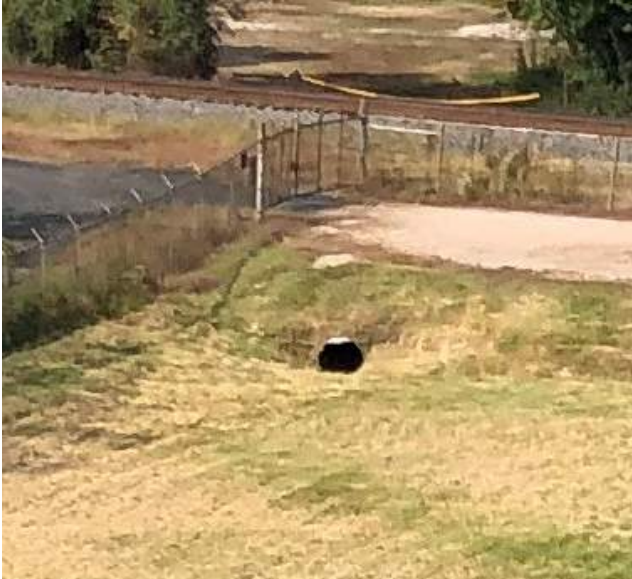
<p><b>Photograph #5</b></p> <p>View of drainage ditch culvert at SW corner of BAP. Slight top bend observed at culvert inlet, not affecting culvert's function (looking southwest).</p>

1. The western exterior embankment contained no indications of slope instability and was well vegetated, (Photographs 1 through 4).
2. The pipe culvert observed toward the end of the ditch in the southwestern corner appeared to be in good working condition and free of debris. Only a slight bend at the top of the pipe was observed in the SW corner culvert, which is not currently affecting its operation (Photograph 5).

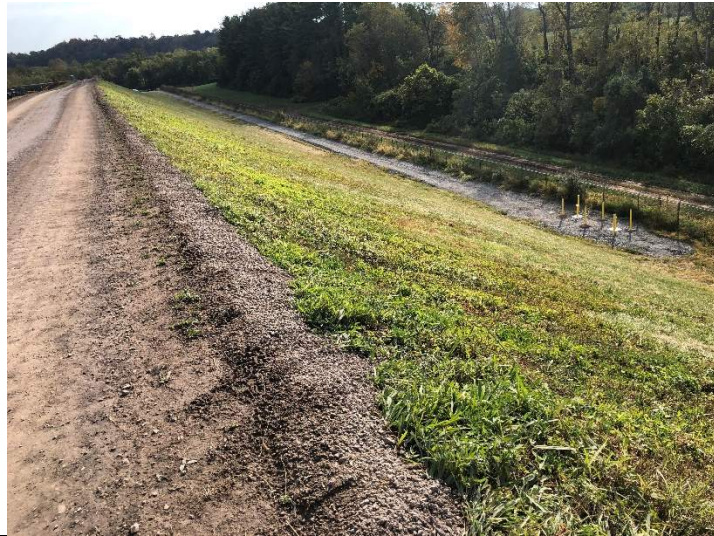
**Photograph #10**

View of southern embankment exterior slope from SW corner of BAP. Slope is stable and well vegetated (looking east). New gravel road leading and groundwater wells are visible in center right of the image, installed during 2022.

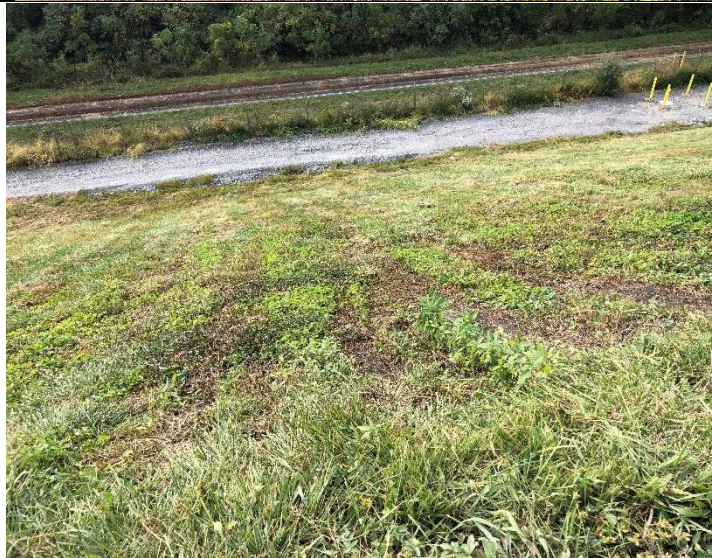
**Photograph #11**

View down exterior slope of southern embankment. Slope appears stable and is densely vegetated with a few minor areas of sparse cover (looking south).

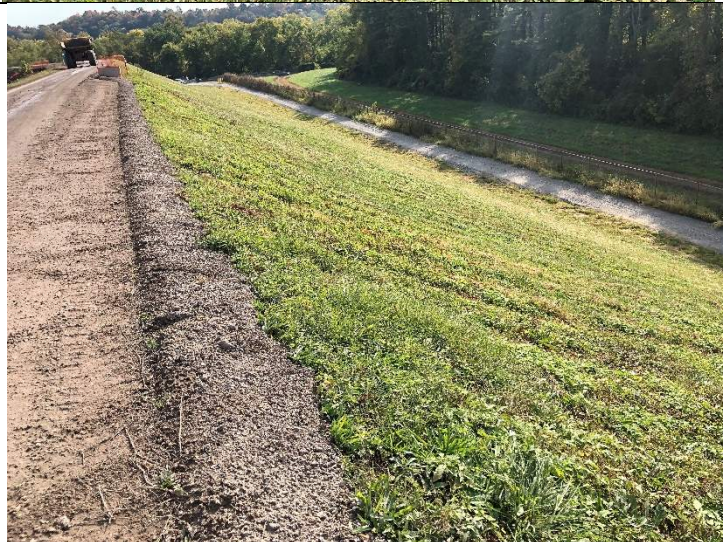
**Photograph #12**

View down exterior embankment slope at SE corner of BAP. Slope is stable and well vegetated with minor areas of sparse cover (looking southeast).

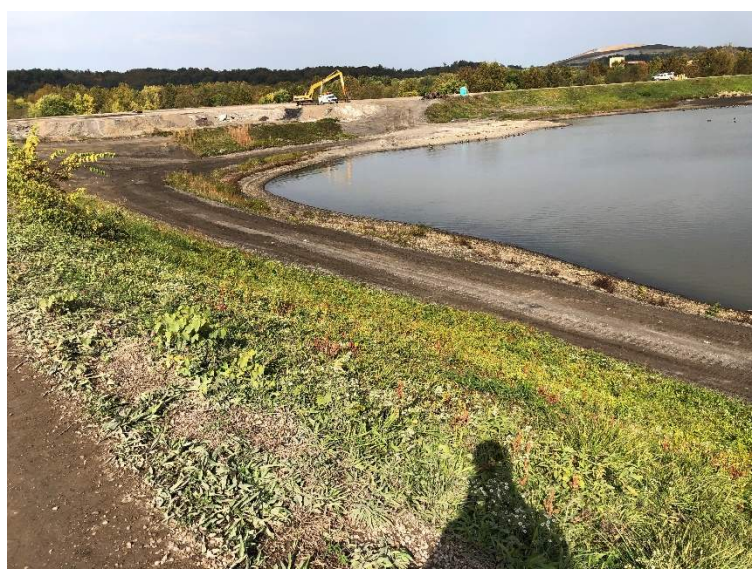
**Photograph #13**

View of interior southern embankment slope from SW corner of BAP. Slope is stable and well vegetated with small areas of sparse vegetation cover (looking west). Pond level has dropped due to ceasing bottom ash sluicing operations.

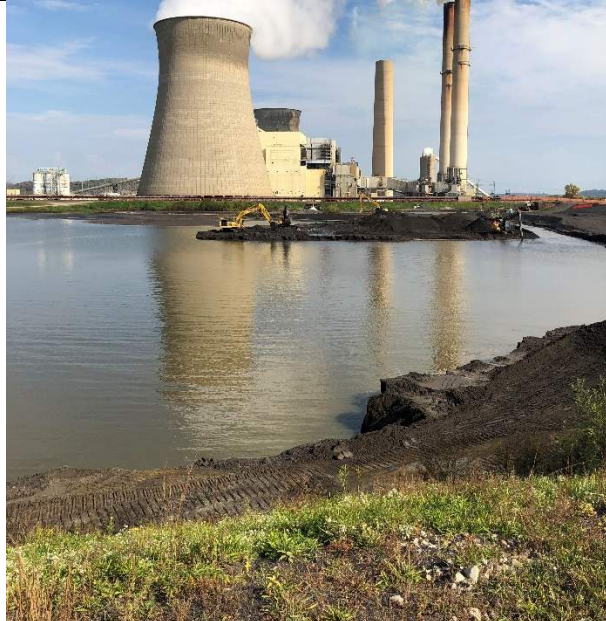
**Photograph #17**

View of interior southern embankment slope from SE corner of BAP. Slope is stable and well vegetated with some areas of sparse vegetation cover (looking north). Long reach excavators visible in center of image in process of removing bottom ash.

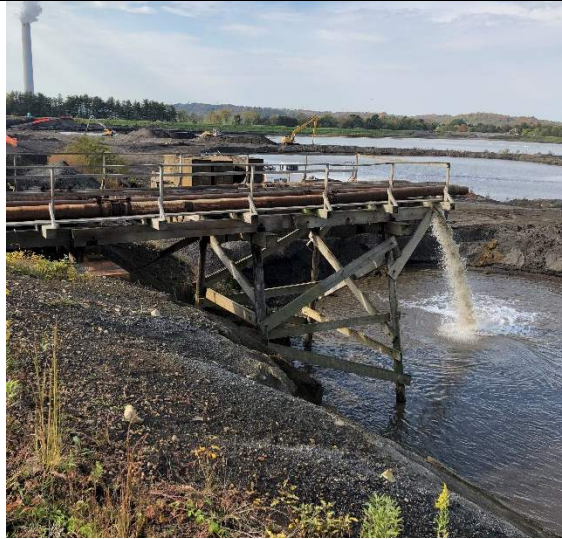
**Photograph #26**

4. From the top of the interior embankment slope, the wooden platform supporting the coal reject and pyrite line discharges look to have been fixed/replaced since the 2021 inspection when it was observed to have a few loose supports, and some instances of apparent missing supports, in addition to displaying general signs of material decay (Photographs 26 and 28).

View of coal reject and pyrite line discharges at NE corner of BAP. Tall vegetation growth under platform was removed and select platform frame members appear to have undergone maintenance and replacement since last year (looking west).

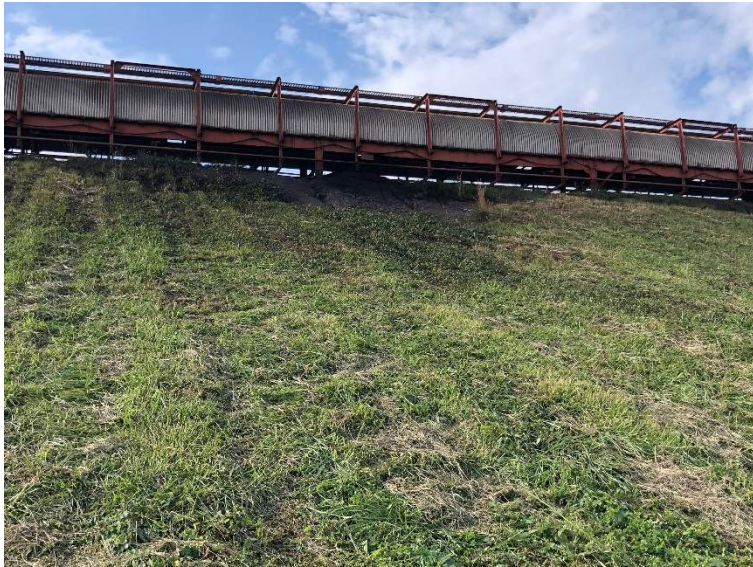
**Photograph #31**

View of exterior northern embankment slope near center of BAP. Slope is stable and well vegetated with some areas of sparse cover below coal conveyor along the top (looking south).

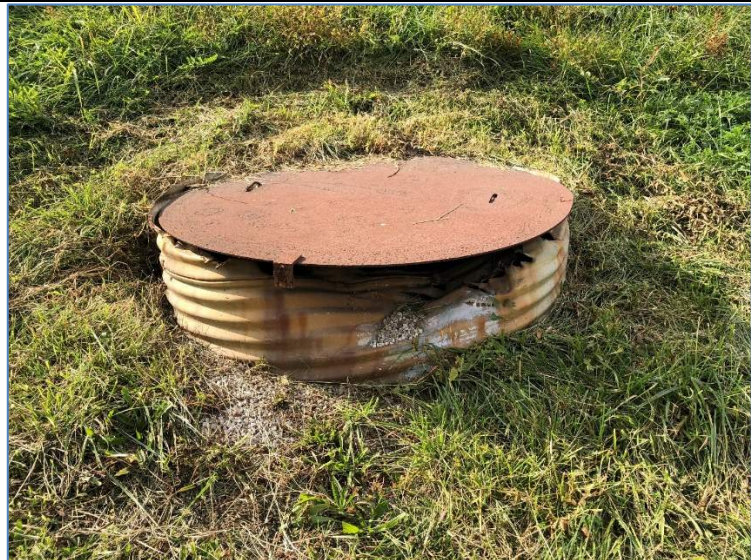
**Photograph #32**

2. A riser pipe on the northern exterior slope with a heavy steel lid was reported to be a valve or access cover. This was found to be rusted and broken (Photograph 32). This riser pipe should be confirmed regarding use and repaired as required.

Corrugated steel riser in exterior slope of northern embankment of BAP. Appears to have been damaged by mowing equipment.

2. A riser pipe on the northern exterior slope was found to be rusted and broken (Photograph 32). This riser pipe should be replaced.
3. Reseed identified localized bare spots along the slopes to re-establish vegetation. Revegetation and potential application of nutrients or pH adjustment may be applied as necessary to aid in addressing localized areas where bare ground spots were observed.

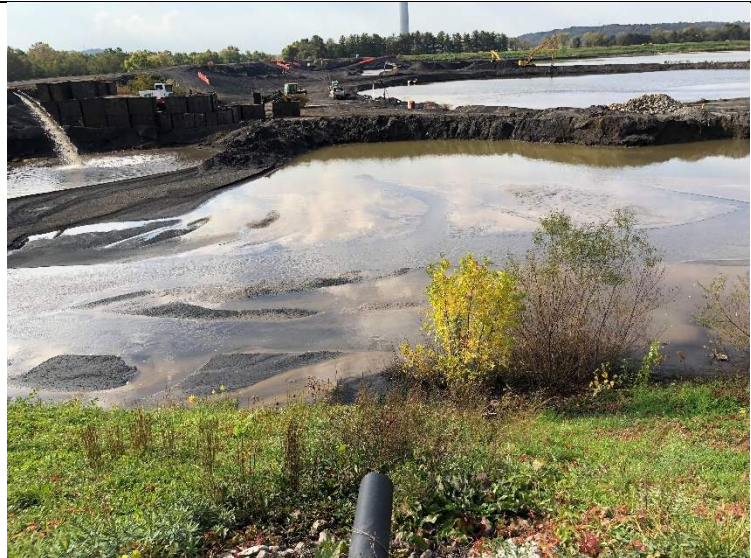
**Photograph #33**

View from the northern embankment at the washout from the coal conveyor tube that crosses Rt 7. Minor woody stemmed vegetation visible. Temporary bottom ash berm installed to allow for separation of flows while excavation is taking place (looking south).

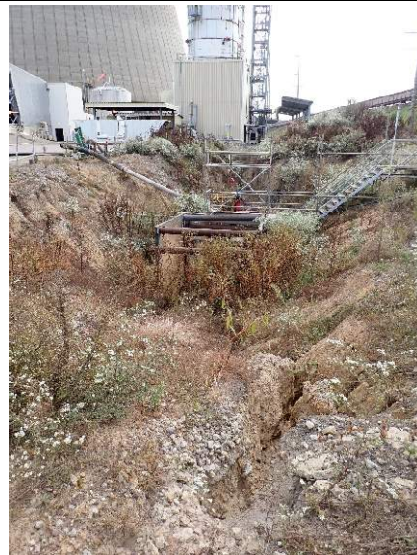
**Photograph #35**

3. Near the northwest exterior toe, an open excavation with trench boxes inside was observed. This excavation was open during the 2021 inspection. Site personnel indicated that this excavation was related to repairs to a pipeline associated with the power station and is unrelated to the BAP. The excavation is scheduled for backfill during 2023.

View of excavation just beyond toe of northern embankment associated with plant piping repair. Northern embankment is visible in the upper right of the image. No signs of embankment instability. This is adjacent to the reclaim pond area. Scheduled for backfill in 2023 (looking east).

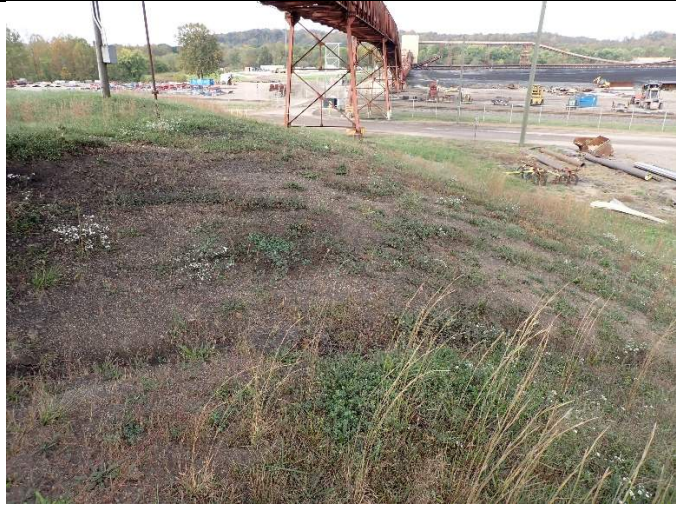
**Photograph #37**

5. The northern embankment access road was found to be in stable condition and remains well maintained (Photograph 34).
6. Spot seeding repair is needed under the conveyor (Photograph 37).

Spot seeding repair needed under conveyor at BAP.
