2023 Annual Inspection Report

Gavin Power, LLC

Residual Waste Landfill

Gavin Power Plant
Cheshire, Ohio

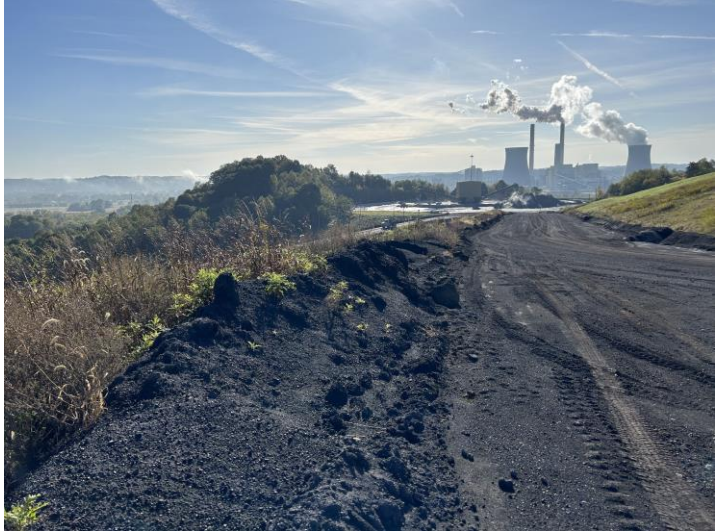
Photograph #1

A wide, dark, gravelly haul road stretches from the foreground into the distance. The road is flanked by sparse vegetation and a grassy embankment. In the background, a large industrial facility with several smokestacks emitting white plumes is visible under a clear blue sky.
Main haul road (looking southeast).	
Photograph #2

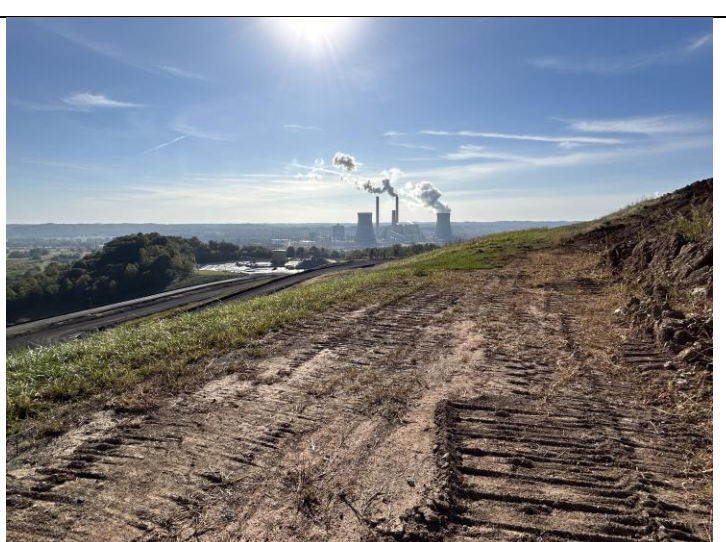
A dirt and gravel haul road runs along the edge of a landfill. The foreground and right side of the road are bare and eroded, showing deep tire tracks. In the background, a large industrial facility with smokestacks is visible under a bright sun in a clear blue sky.
Main haul road near east side of landfill. Example of areas needing potential spot seeding in foreground and on right (looking southeast).

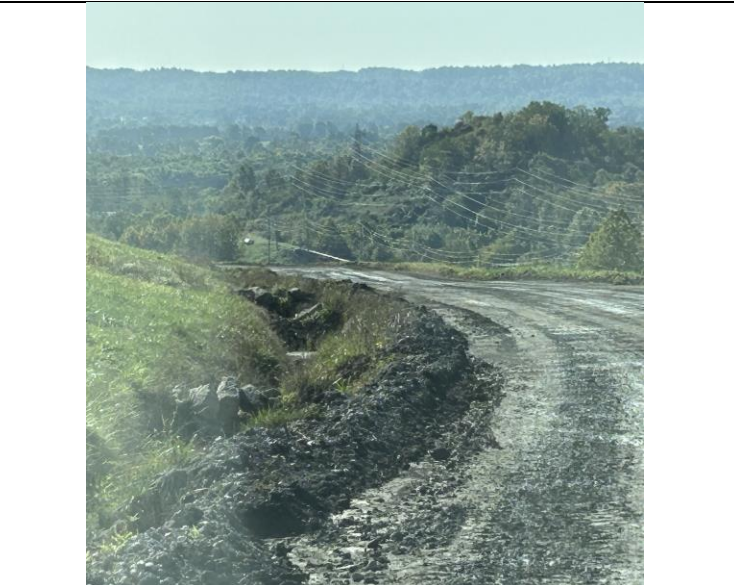
There were several sections of permanent roads that have a limestone gravel base course, as depicted in Photographs 4 and 9. These roads also were observed to be stable with no visible evidence of distress. More frequently used roadways incorporate robust drainage channels adjacent to slopes, which were positively graded and included rock check dams (Photograph 6).

<p>Southwest gravel access road and roadside channel with rock check dams (looking southeast).</p>

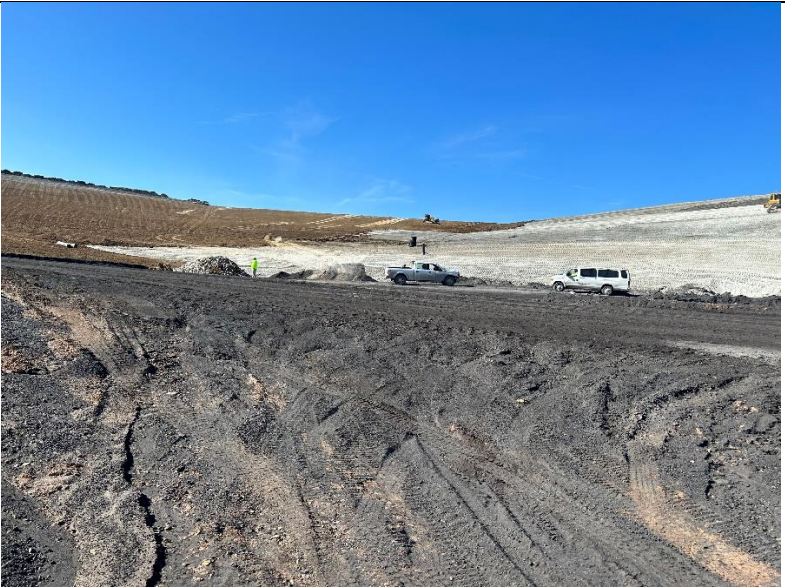
<p>Photograph #17</p> <p>View of Phase H intermediate slope cover (looking east).</p>

There were infrequent instances where notable erosion rills/gullies were observed (as indicated in representative Photograph 17) in the surface of the intermediate cover. Sedimentation was fully contained in these areas and directed toward the facility treatment ponds. There was no visible evidence that these isolated areas of erosion have the potential to disrupt the operation and safety of the RWL or that observed erosion features were creating an unstable situation. We recommend that these minor erosion areas be repaired and reseeded in the Spring of 2024. In the interim, to the extent practical, upslope runoff should be minimized in these areas through common industry standard maintenance practices such as reworking the area with temporary seeding or through run-off diversion to prevent water from flowing over the top of slope.

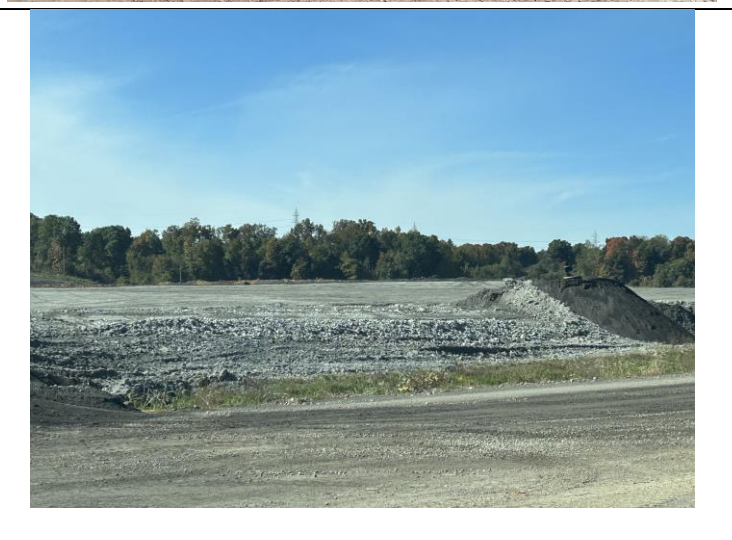
During the 2023 annual inspection, the geonet composite leachate collection layer was observed along the perimeter of Phase I and the protective layer of FGD had been placed across Phase I. ERM also observed bottom ash from the BAP was being placed near the center of Phase I south of Pond 6 (Appendix A, Photograph 21).

<p>RWL overview (looking west).</p>

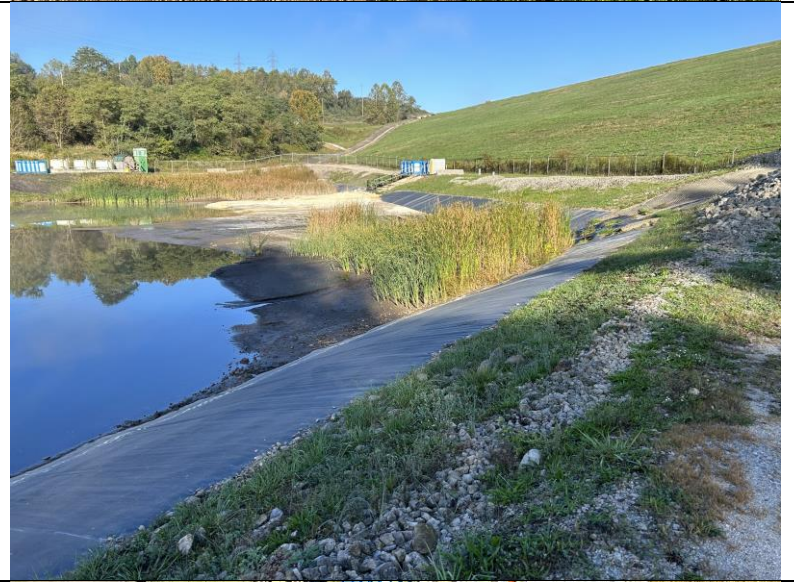
A build-up of sediments, aggregate, and vegetation was observed in the north end of the pond near the two inflow channels (Photograph 30). For maintenance purposes, these materials should be removed and properly disposed. Stone from the access roadway was observed to be deposited in these inflow channels areas. It is recommended that steps continue to be taken to mitigate the displacement of stone from the roadway by vehicles and during the application of maintenance aggregate to the surface. Also, the liner was observed with multiple small tears and holes in the liner identified around the perimeter of Pond No. 1 but were above the operating water level. No water was standing against these tears, and no discharge through these tears was observed. The small tears identified in the liner noted in the previous inspection have been repaired. ERM recommends that the new tears in the liner be repaired by a similar procedure as part of routine maintenance. The 2022 patched repairs were observed in Pond No. 1 (Photograph 31).

<p>View of vegetated sediment patch in Pond No. 1. Woody stem vegetation by edge of pond should be removed (looking west).</p>	
<p>Photograph #31</p>

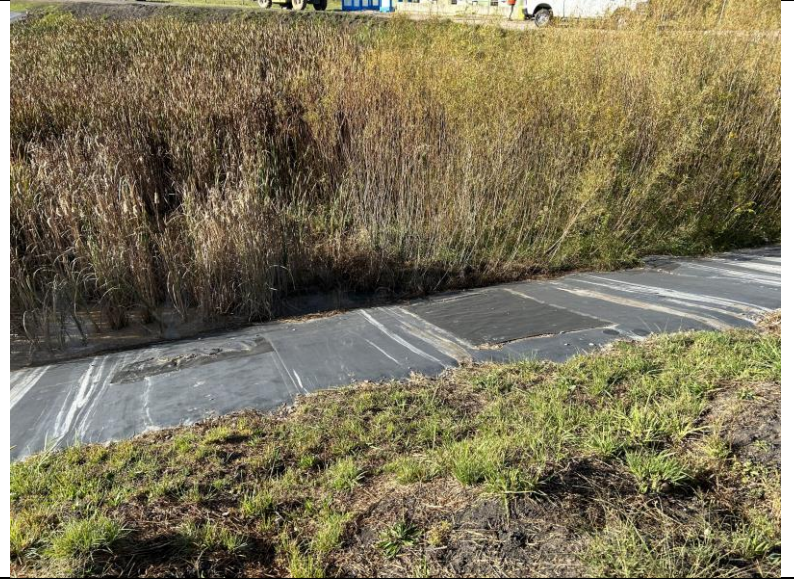
<p>View of sediment, vegetation, and patched repairs on Pond No. 1 north embankment (looking southwest).</p>

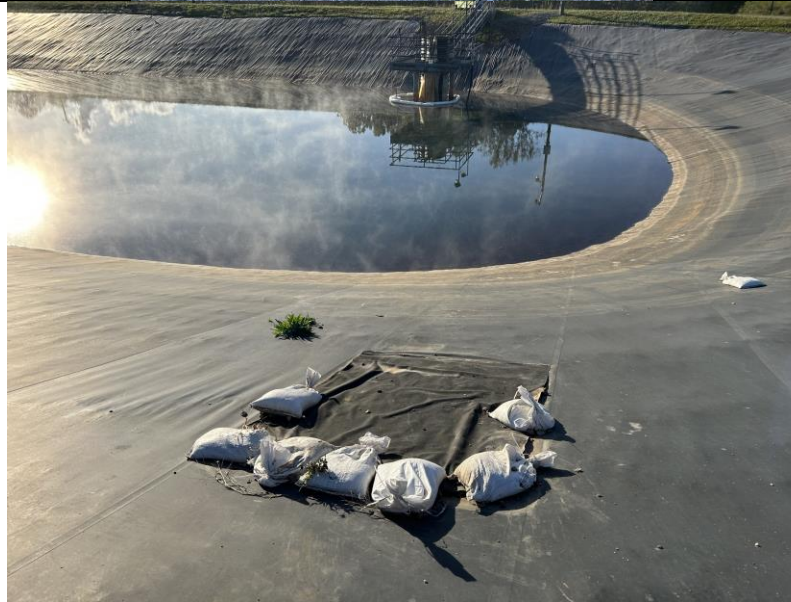
Photograph #33

Damaged liner side slope of Pond No. 1 clarifying pond with vegetation growth coming through liner.

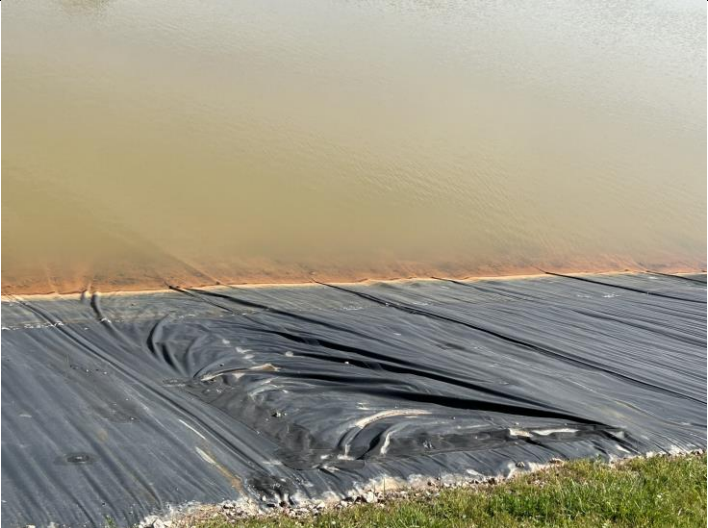
<p>Photograph #37</p>

The primary treatment pond was observed to be in satisfactory working condition following the maintenance adjustments that continued after the 2020 annual inspection. During 2020 and early 2021, significant spot repairs were made to the geomembrane liner system of this pond. No rips or tears were observed; however, in two isolated areas, a “bunching” of the geosynthetic material was observed. The bunched areas appeared to be intact with no evidence of holes or leakage. ERM recommends that these areas continue to be monitored in 2024 (Photographs 36 and 37).

<p>Pond No. 2 primary pond liner was observed to have an area of “bunching” that should continue to be monitored (looking east).</p>	
<p>Photograph #38</p>

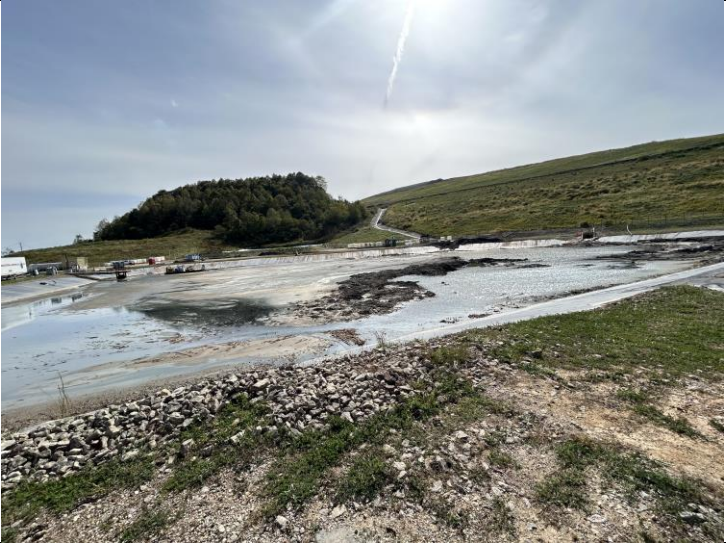
<p>Photograph #40</p>

Within the primary treatment pond there was significant sediment accumulation observed within the central portion and along multiple embankments (as indicated in Photographs 40 and 41), having increased from observations in the 2022 inspection. This is based on observation that the solids level appeared to be just below the operating water level in much of the pond. The primary treatment pond was undergoing cleanout, via floating dredge (Photograph 44), during the time of inspection; this cleanout activity is to continue into 2024. A number of minor holes and tears in the liner were noted above the operating level of the primary treatment pond.

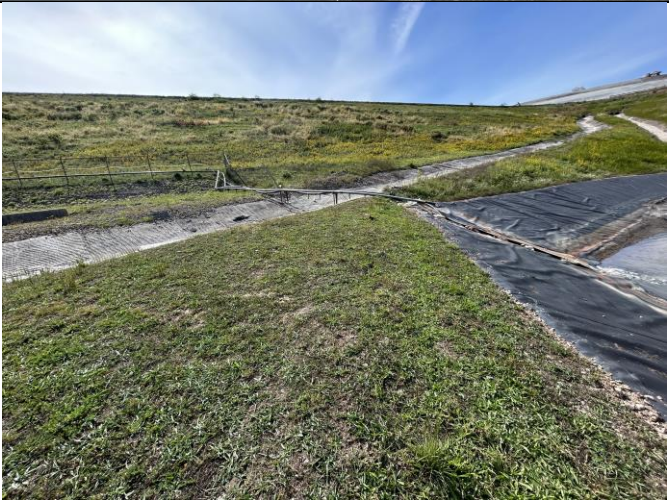
<p>Photograph #42</p>

During the inspection the same discharge into Pond No. 5 was observed coming from the inflow to Pond No. 3 (Photograph 42) as noted from last year's inspection. A temporary pump system has been installed that directs collected leachate influent to Pond No. 3 and redirects it through an aboveground PVC force main into the head (Western end) of Pond No. 5. Substantial force main supports consisting of steel pipe stands were observed under the force main during inspection replacing temporary wood material observed last year.

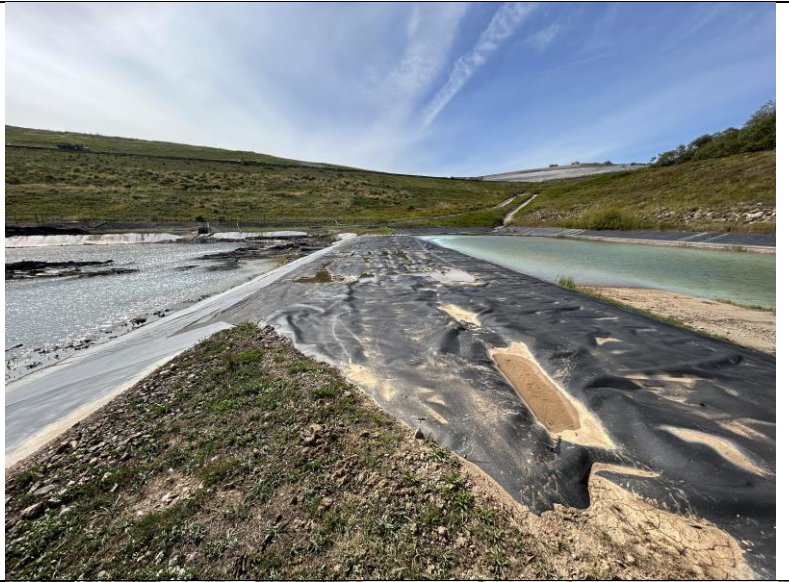
Photograph #46

Pond No. 5 (Photographs 45 and 46) on the Northeast side of the RWL, adjacent to Pond No. 3, was observed to be functioning properly with respect to water flow and sedimentation during the annual inspection. There was no indication of tearing of the geomembrane liner within the basin (Photograph 43). During this inspection it was noted, similar to the 2022 inspection, that there was accumulated water under the Pond No. 5 liner system along a limited section of the southwest edge adjacent to Pond No. 3. This accumulation was evidenced by floating liner at the water interface at the pond operating level. It was also noted that the floating liner was minimal compared to previous inspections.

Pond No. 5 north & west embankment. Minor sediment buildup on top of embankment liner (looking west).

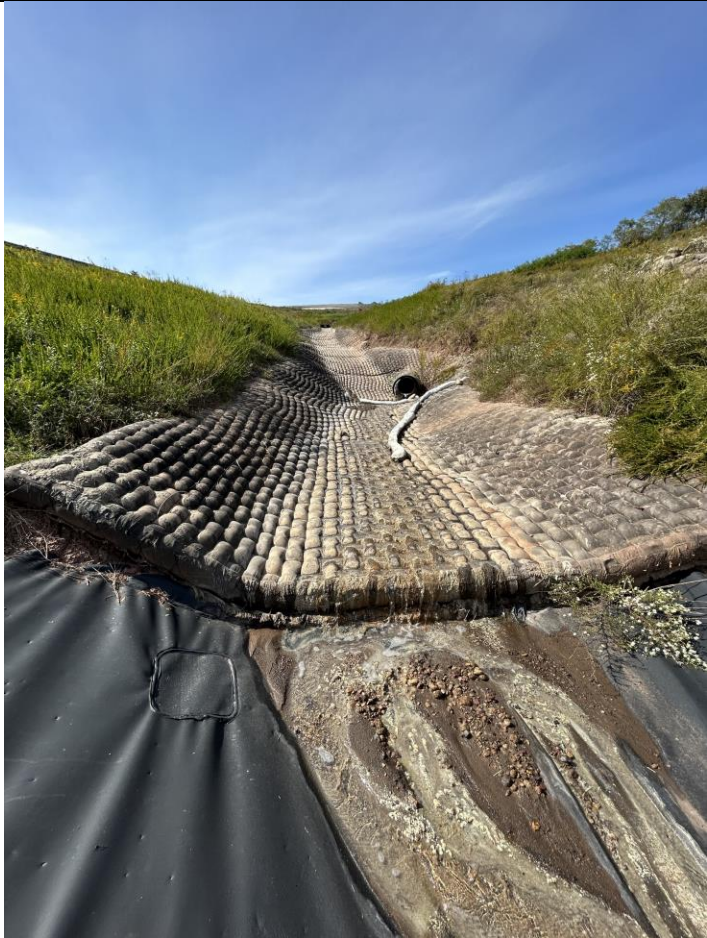
Photograph #49

There were minor punctures noted in the geomembrane liner near the concrete inflow channel to Pond No. 5 (Photograph 49) that may be the result of animal hoofs. Deer tracks were observed in the soil near this location as well as track marks across the liner (Photograph 43). The holes are above the normal operating water level of the pond and 2+ feet away from where leachate and stormwater flows enter the pond. These holes should be repaired as weather conditions allow in 2024. Additional measures for the exclusion and deterrence of whitetail deer from this area should also be explored.

View of inflow channel to Pond 5 with multiple small liner perforations suspected of being related to wildlife. (looking northwest).

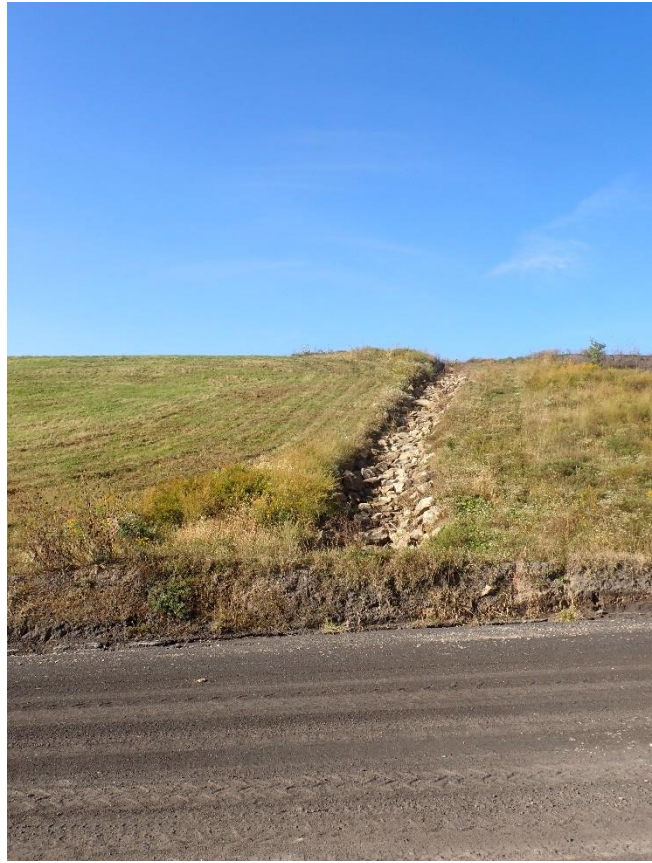
Photograph #54

View of channel on south side of RWL along access road (looking west).
