2023 Annual Inspection Report

Bottom Ash Pond

Gavin Power Plant
Cheshire, Ohio

5 January 2024

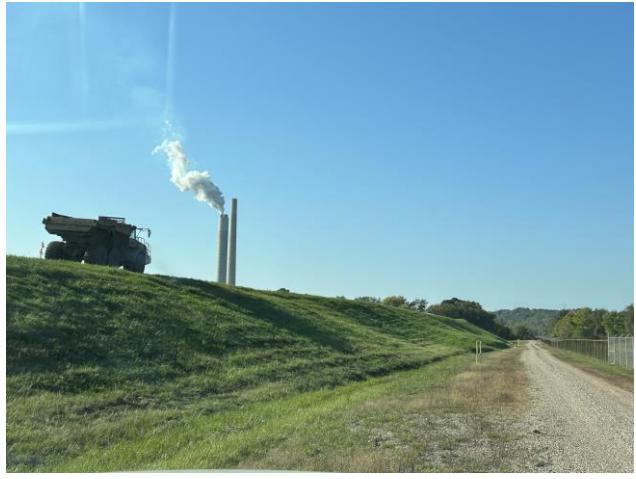
Photograph #1

1. The western exterior embankment contained no indications of slope instability and was well vegetated (Photographs 1 through 4 and 6 through 9). Previously identified isolated hummocky areas on the exterior slope have not shown any signs of movement or instability from the previous inspections.
2. The stormwater pipe culvert observed toward the end of the ditch in the southwestern corner appeared to be in good working condition and free of debris. Only a slight deformation (bend) at the top of the inlet pipe was observed in the SW corner culvert, which is not affecting its operation (Photograph 5).

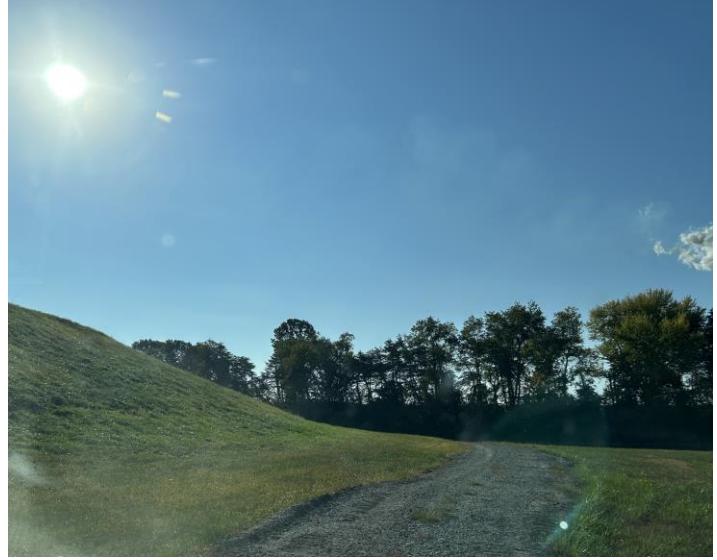
<p>Photograph #4</p> <p>View of exterior southwest corner of BAP. Slope is stable and well vegetated (looking south).</p>

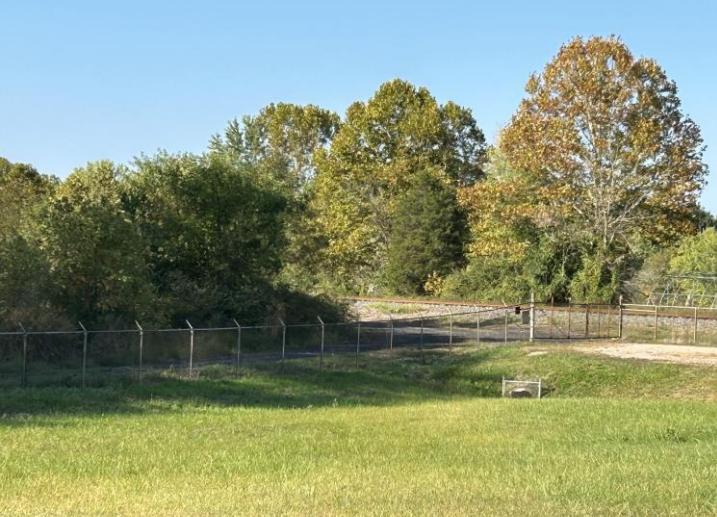
<p>Photograph #5</p> <p>View of drainage ditch culvert at SW corner of BAP. Slight top bend observed at culvert inlet, not affecting culvert's function (looking southwest).</p>

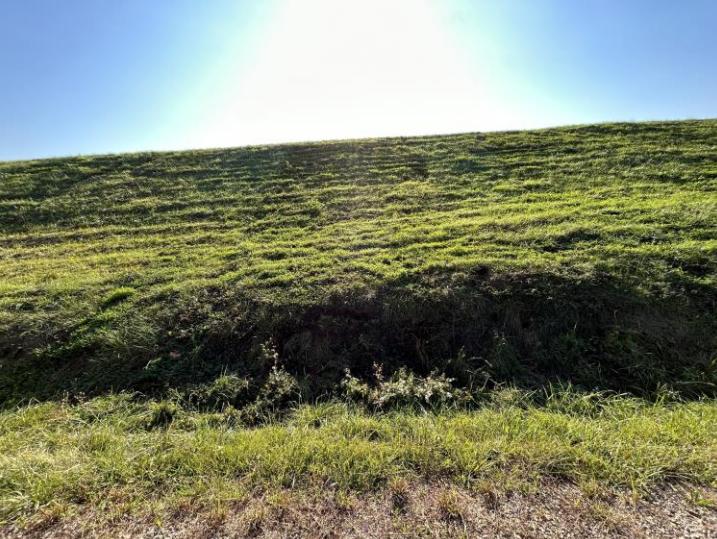
<p>Photograph #6</p> <p>Western embankment exterior slope and bottom ditch line of embankment. Slope is stable and well vegetated (looking east).</p>

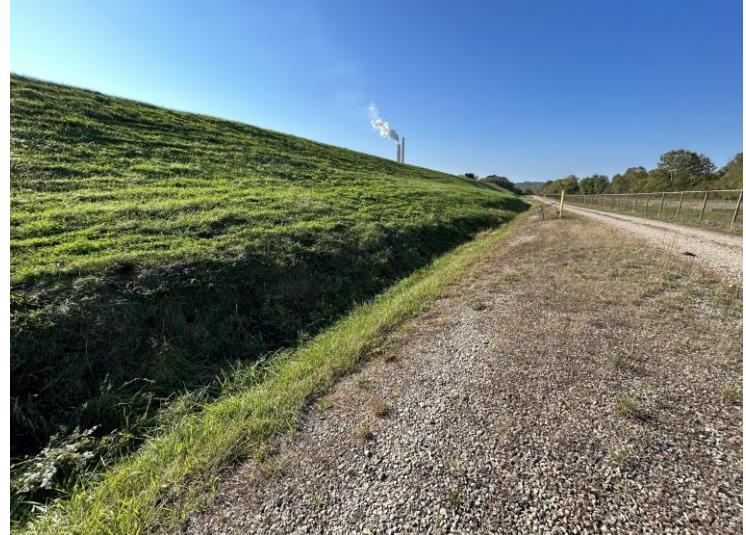
<p>Photograph #7</p>

<p>Western embankment exterior slope and bottom ditch line of embankment. Slope is stable and well vegetated (looking south).</p>
<p>Photograph #8</p>

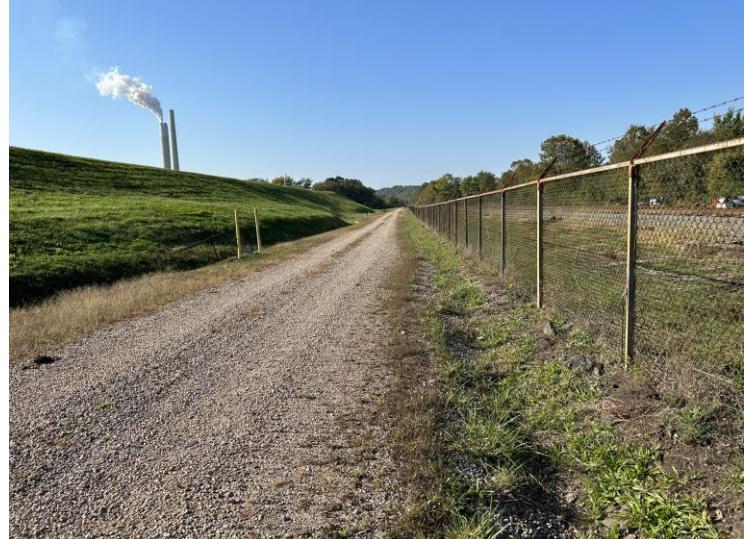
<p>Western embankment exterior slope and bottom ditch line of embankment. Slope is stable and well vegetated (looking south).</p>

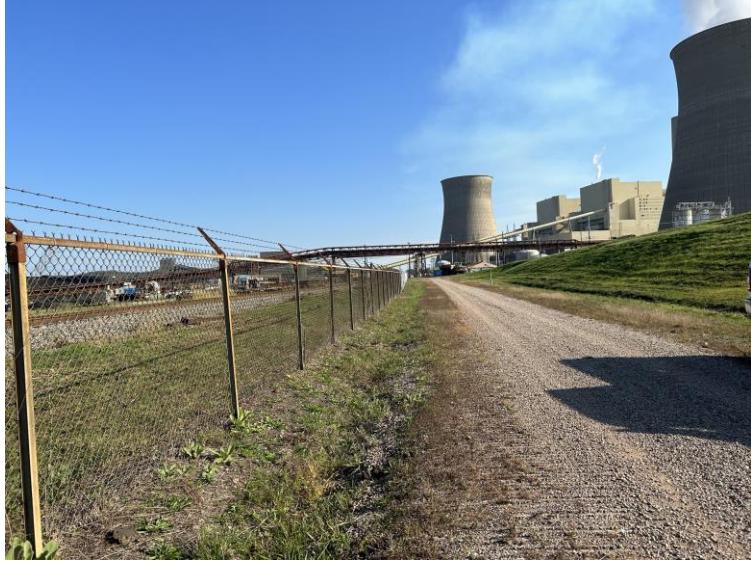
<p>Photograph #9</p> <p>Western embankment exterior slope and bottom ditch line of embankment. Slope is stable and well vegetated (looking north).</p>

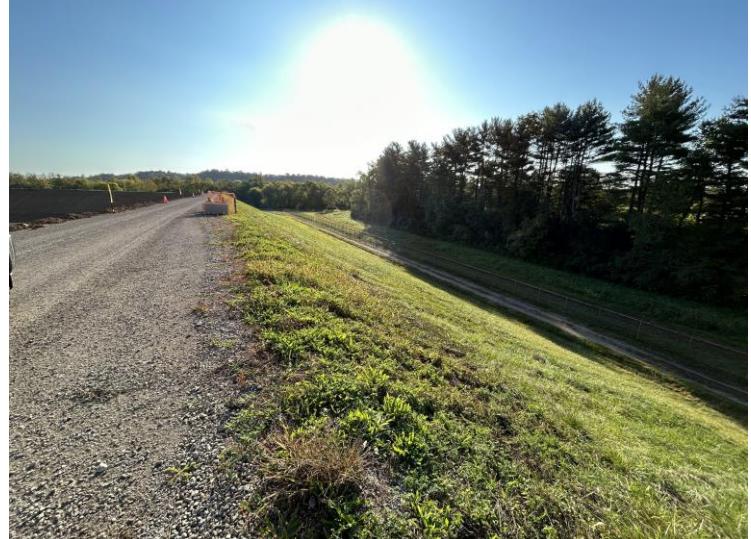
<p>Photograph #10</p> <p>View of southern embankment exterior slope from SW corner of BAP. Slope is stable and well vegetated (looking east). Gravel road leading to groundwater wells is well maintained. Wells are visible and stable.</p>

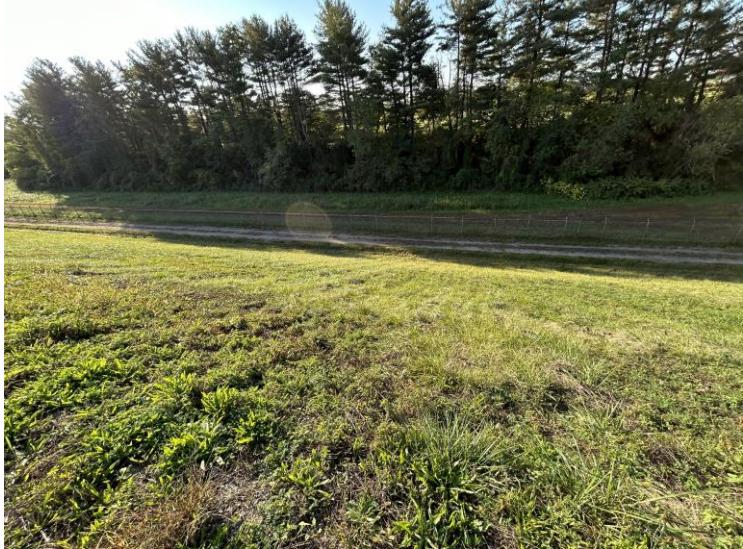
<p>Photograph #11</p> <p>View down exterior slope of southern embankment. Slope appears stable and is densely vegetated with a few minor areas of sparse cover (looking south).</p>

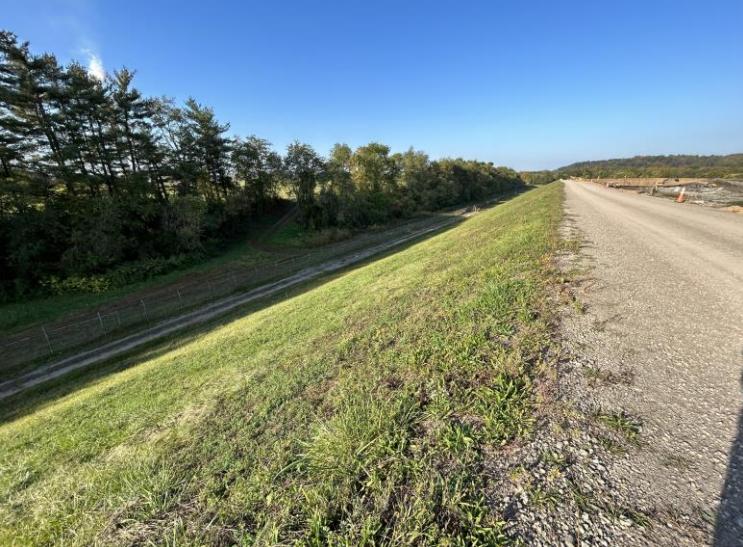
<p>Photograph #12</p> <p>View down exterior embankment slope at SE corner of BAP. Slope is stable and well vegetated with minor areas of sparse cover (looking southwest).</p>

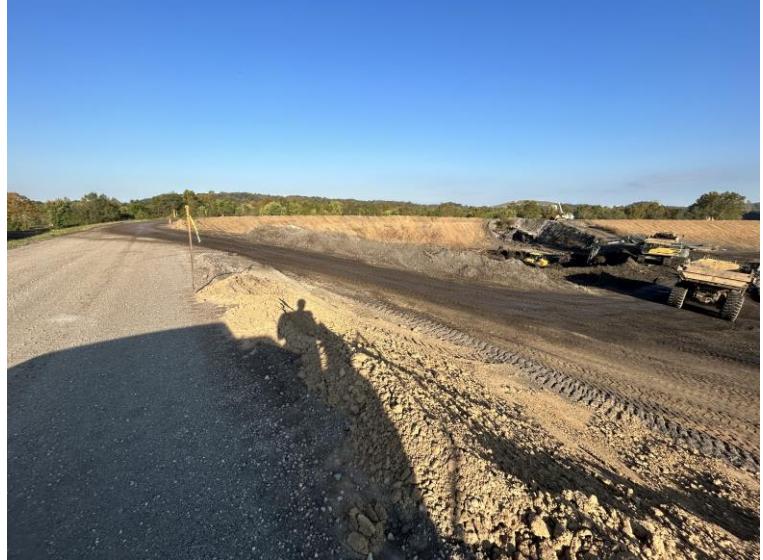
<p>Photograph #13</p> <p>View of interior southern embankment slope from SW corner of BAP. Slope is stable and bottom ash is about two thirds removed (looking west).</p>

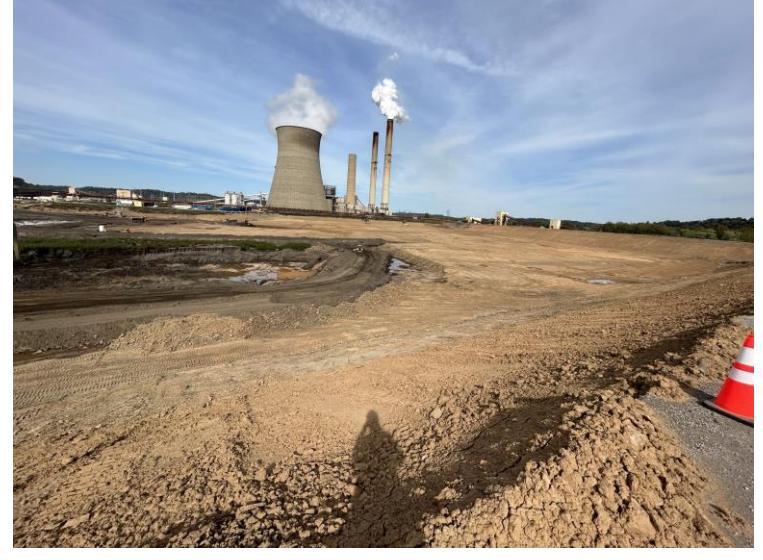
<p>Photograph #14</p> <p>View of Bottom Ash Pond (BAP) from SW corner. Slope is stable and bottom ash is about two thirds removed (looking northeast).</p>

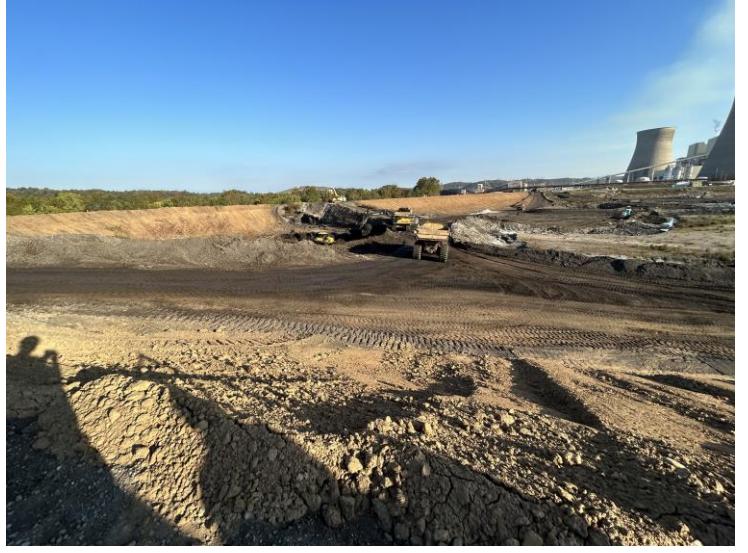
<p>Photograph #15</p> <p>View of interior southern embankment slope from SW corner of BAP. Slope is stable and bottom ash is about two thirds removed (looking west).</p>

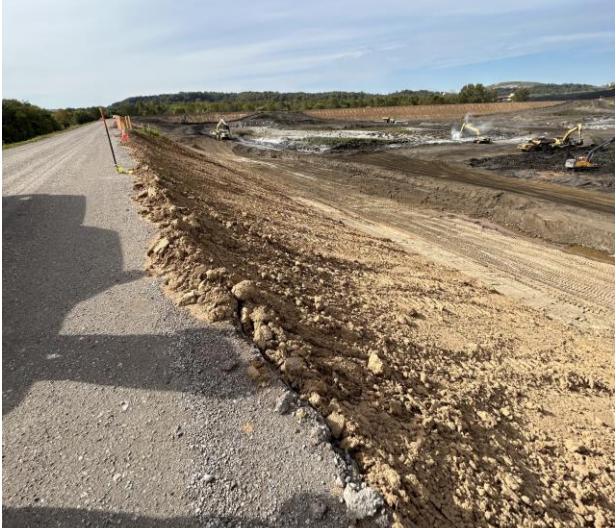
<p>Photograph #16</p> <p>View of interior southern embankment slope from SW corner of BAP. Slope is stable and bottom ash is being removed in this area (looking west).</p>

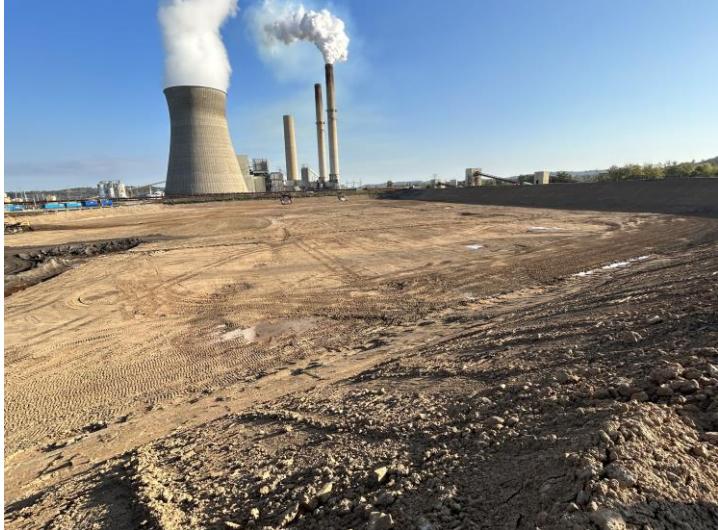
<p>Photograph #17</p> <p>View of interior southern embankment slope from SE corner of BAP. Slope is stable and bottom ash is being removed in this area (looking north).</p>

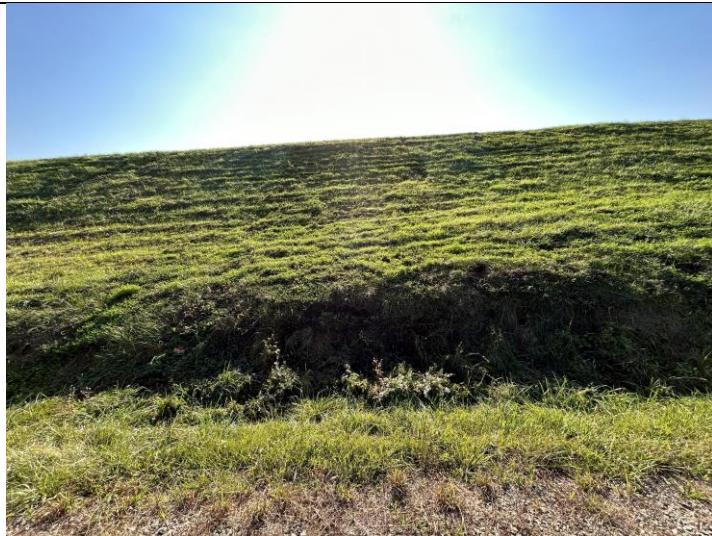
Photograph #18

View down exterior slope of southern embankment. Slope appears stable and is well vegetated (looking north).

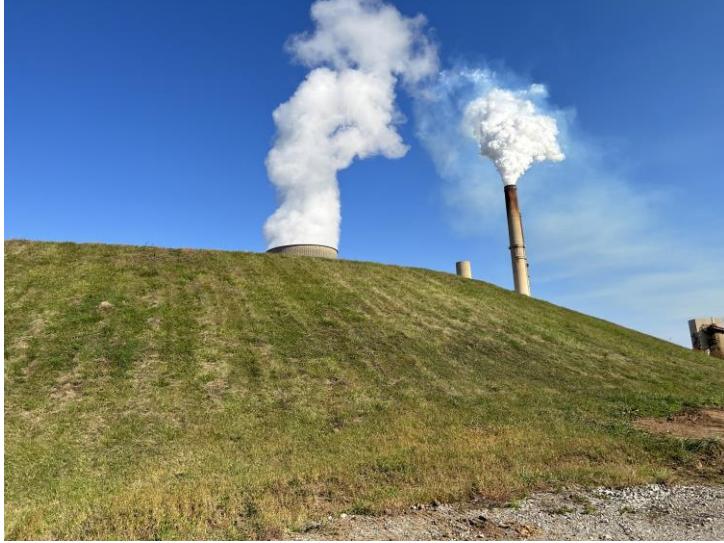
Photograph #19

1. The exterior slope appeared stable, and the majority of the slope had well-established vegetative growth with isolated areas of sparse vegetation coverage (Photographs 19 through 24). Previously identified small crescent shaped scarp areas were observed near the toe. These areas continue to be well vegetated and show no sign of seepage, instability or movement (Photographs 23 and 24).
2. Previously identified isolated areas of sparse vegetation near the crest of this slope remain. No significant erosion or sedimentation issues were observed.
3. The eastern embankment access road was found in stable condition and remains well maintained (Photograph 24).

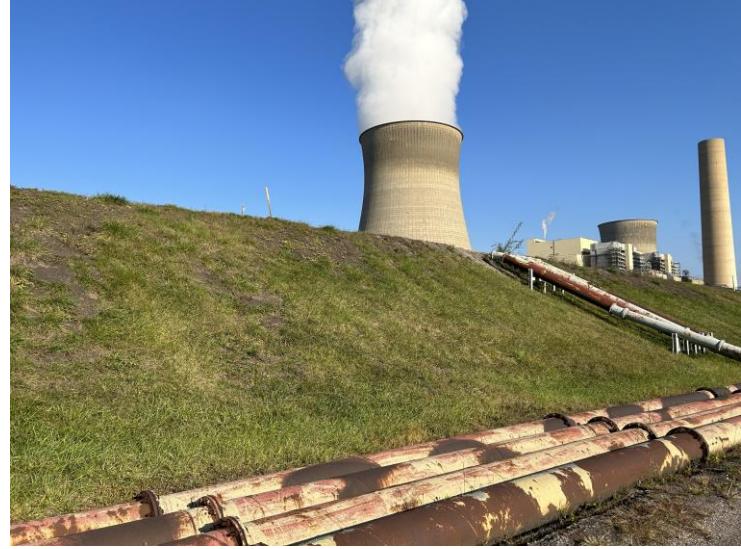
<p>Photograph #22</p> <p>View of pipeline along eastern embankment exterior slope with some areas of sparse vegetation cover (looking northwest).</p>

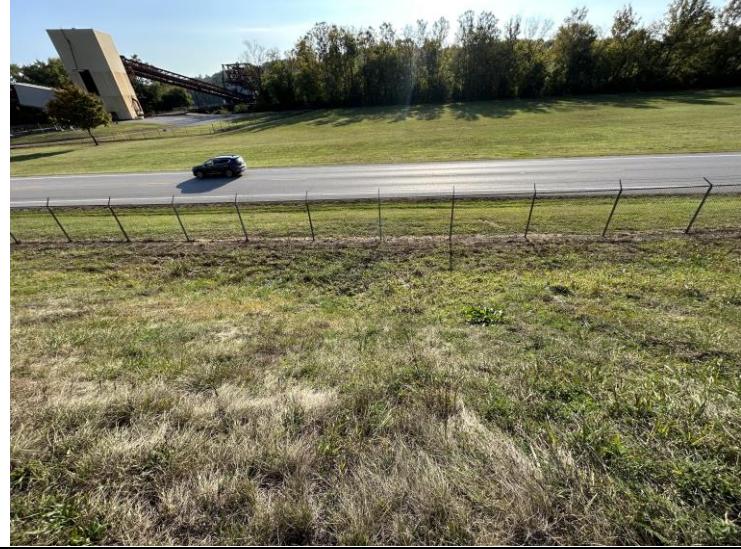
<p>Photograph #23</p> <p>View of exterior eastern embankment slope, at approximate midpoint of BAP. Previously observed crescent scarp shape is visible. No soil movement or signs of seepage were visible, consistent with previous years' inspections. Area appears stable and well vegetated (looking east). Ohio Route 7 visible on top half of image outside fence line.</p>

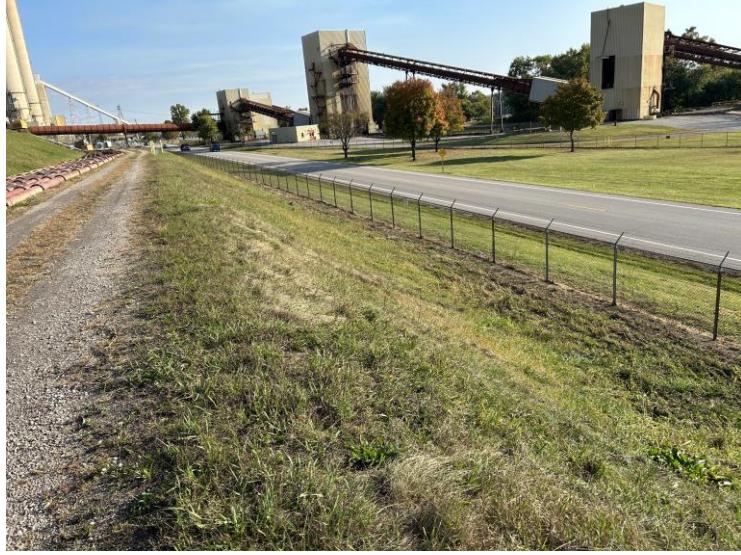
<p>Photograph #24</p> <p>View of exterior eastern embankment slope, at approximate midpoint of BAP. Previously observed crescent scarp shape is visible. No soil movement or signs of seepage were visible, consistent with previous years' inspections. Area appears stable and well vegetated (looking north). Ohio Route 7 visible on right side of image outside fence line.</p>

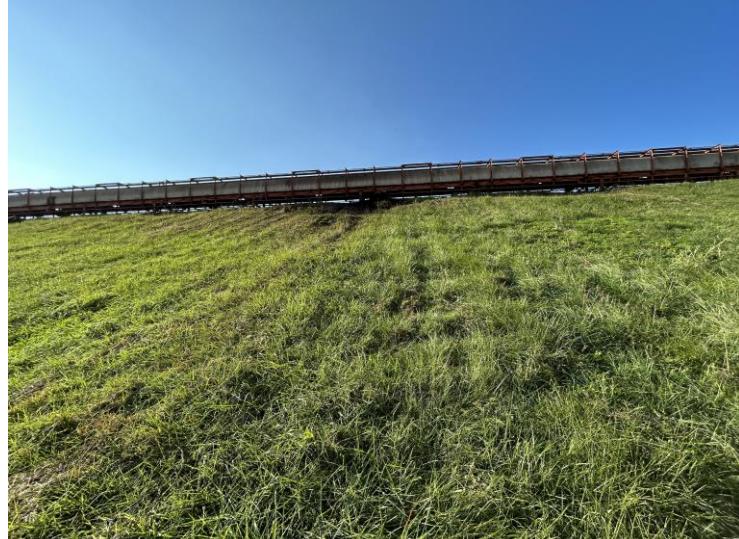
<p>Photograph #25</p> <p>View of exterior northern embankment slope from NE corner of BAP. Slope is stable and well vegetated (looking south).</p>

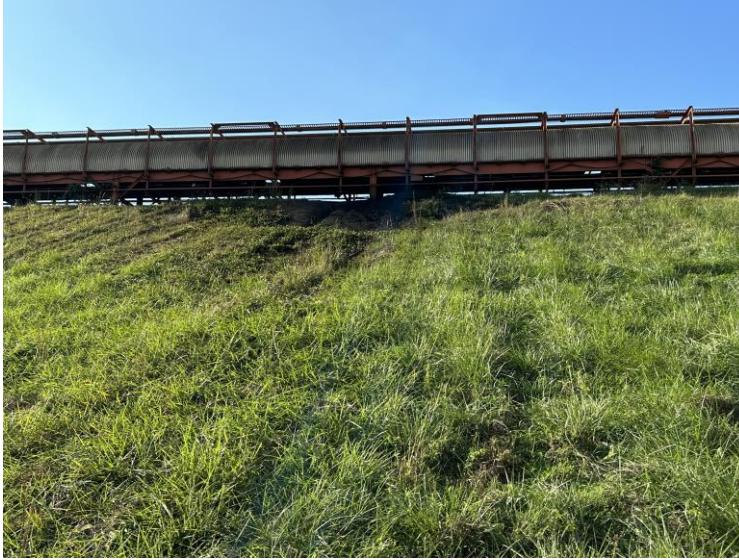
<p>Photograph #26</p> <p>View of exterior northern embankment slope near center of BAP. Slope is stable and well vegetated with some areas of sparse cover below coal conveyor along the top (looking south).</p>

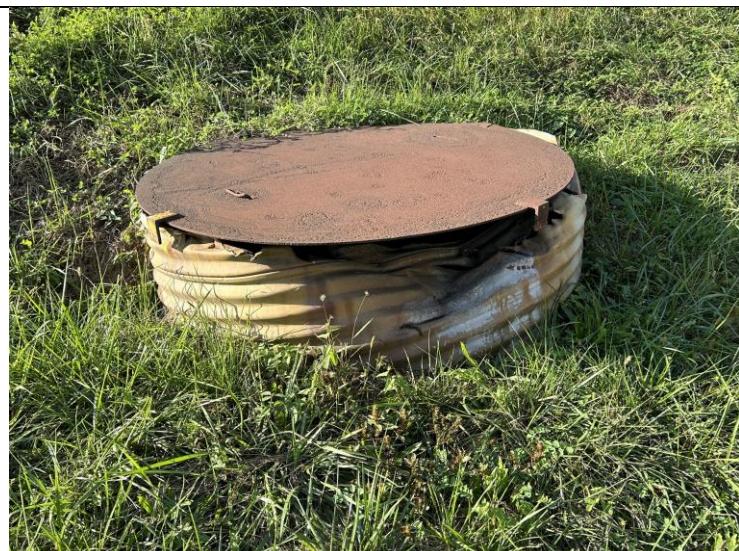
2. A riser pipe on the northern exterior slope with a heavy-steel lid was reported to be a valve or access cover. This was found to be rusted and broken (Photograph 27). This riser pipe should be confirmed regarding use and repaired as required.

<p>Photograph #27</p> <p>Corrugated steel riser in exterior slope of northern embankment of BAP. Appears to have been damaged by mowing equipment.</p>

2. The riser pipe on the northern exterior slope was found to be rusted and broken (Photograph 27). If the unit is converted into a process water pond, this riser pipe should be replaced.

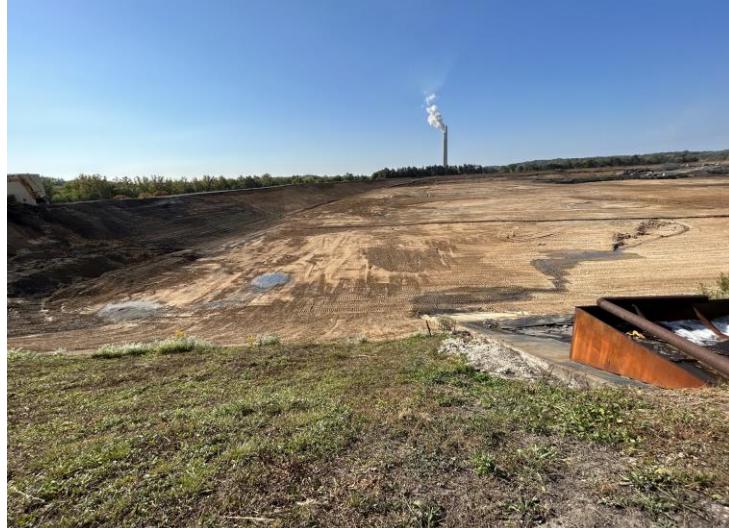
<p>Photograph #28</p> <p>View from the northern embankment. Minor woody stemmed vegetation visible (looking south).</p>

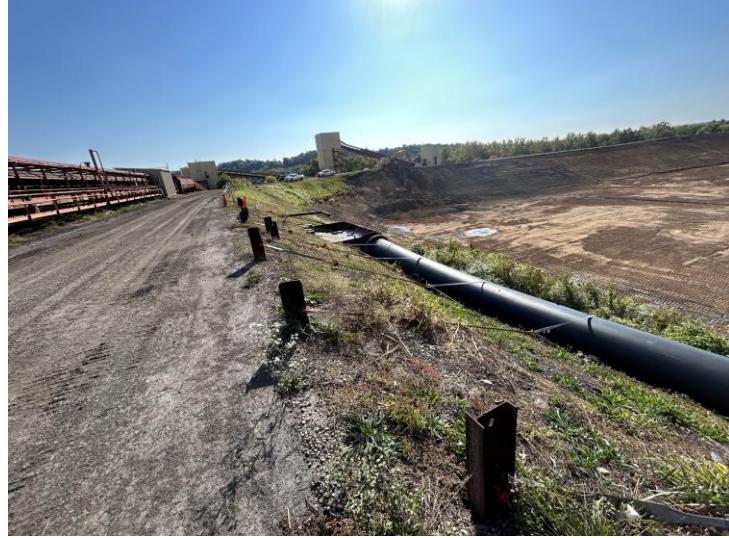
<p>Photograph #29</p> <p>View of interior northern embankment slope. Slope appears stable and vegetated (looking east). Coal conveyor on left side of the image.</p>

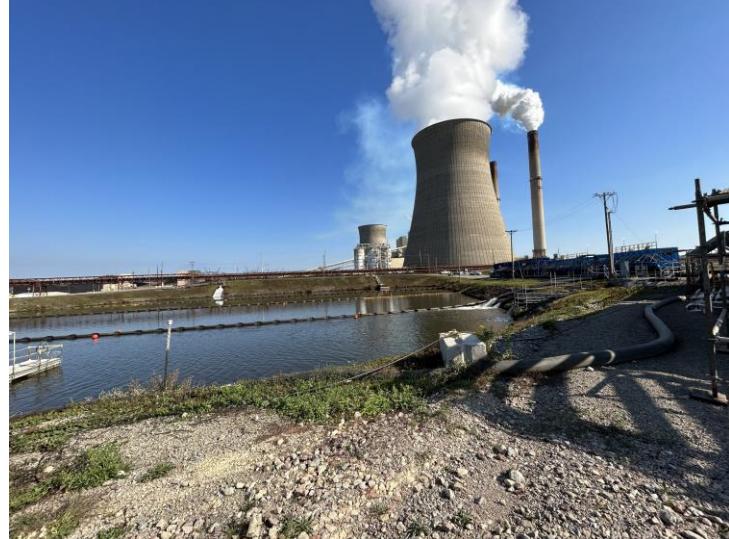
<p>Photograph #30</p> <p>View of Reclaim Pond. Embankment slopes are stable, well vegetated, and armored at toe level (looking north).</p>

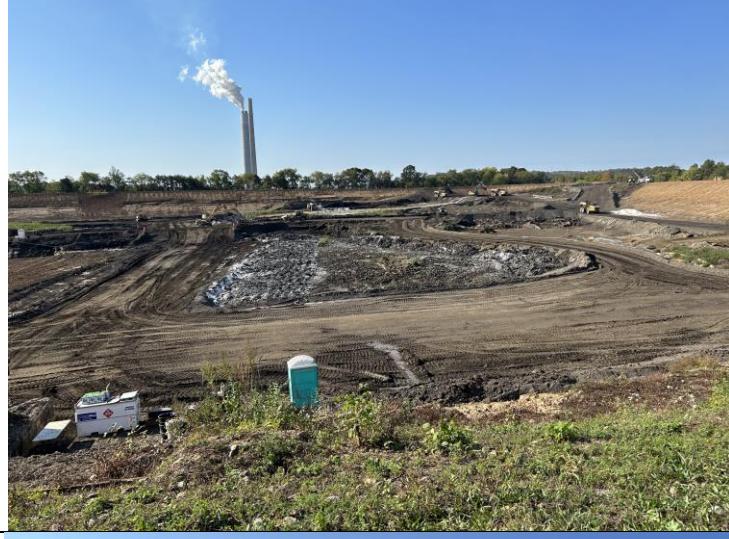
<p>Photograph #31</p> <p>View of interior embankment slope. Slope appears stable and vegetated (looking south).</p>

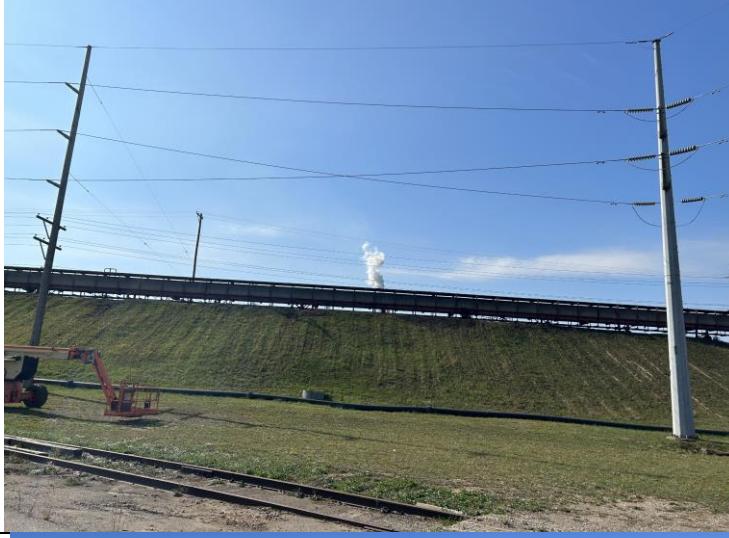
<p>Photograph #32</p> <p>View of exterior northern embankment slope from NW corner of BAP by conveyor. Slope is stable and well vegetated (looking south).</p>

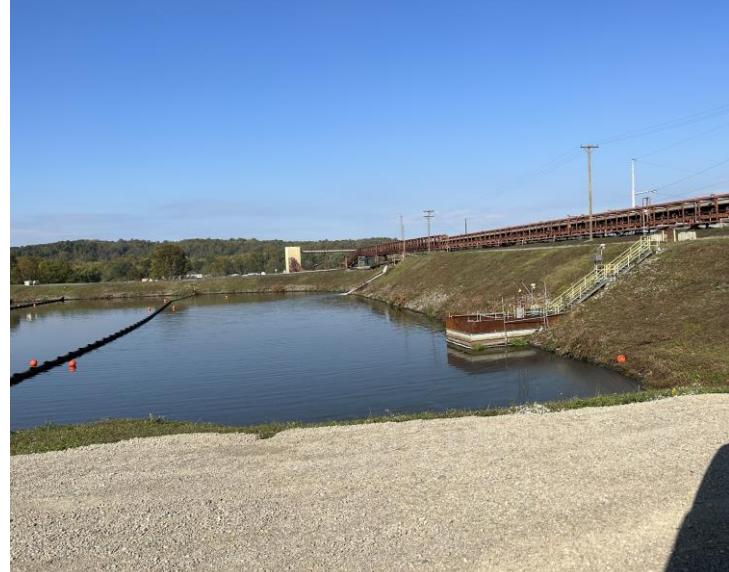
The Reclaim Pond internal embankments (Photograph 33) were found to be in satisfactory condition. No visible indications of settlement, instability or erosion were apparent. The crest and slopes along the interior were vegetated (with only minor isolated bare spots) and the toe was armored with riprap. The riprap-protected areas appeared to be in stable condition (Photographs 30, 33, and 35).

<p>Photograph #33</p> <p>View of Reclaim Pond. Embankment slopes are stable, well vegetated, and armored at toe level (looking west).</p>

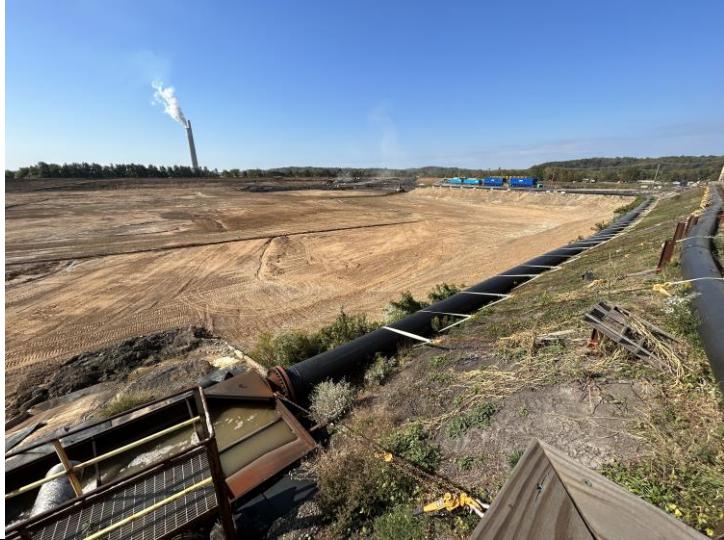
Non CCR process water is currently being discharged directly into the Reclaim Pond through use of diversion piping (Photograph 34). Within the Reclaim Pond a series of floating booms/turbidity curtains were observed to increase the flow path and retention time within the Reclaim Pond (Photograph 35).

<p>Photograph #34</p> <p>View from interior northern embankment slope showing non CCR process water being diverted from the BAP directly into the Reclaim Pond through the use of diversion piping (looking southwest).</p>

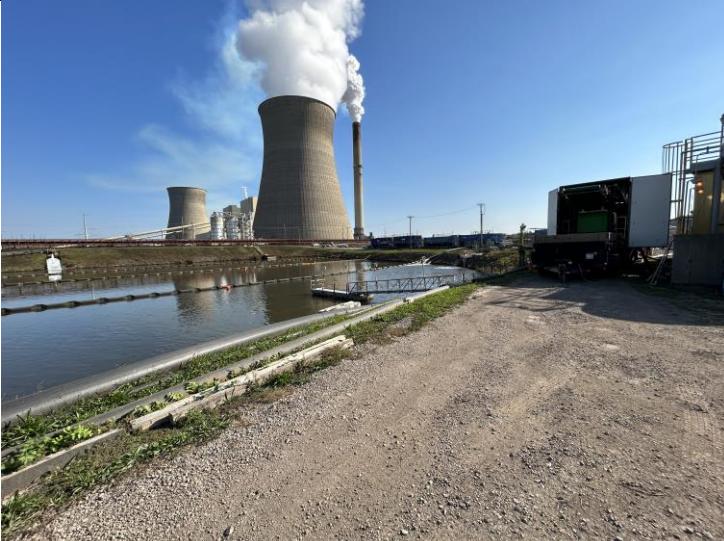
<p>Photograph #35</p> <p>View of Reclaim Pond. A series of floating booms/turbidity curtains were observed to increase the flow path and retention time within the Reclaim Pond (looking northeast).</p>
