2024 Annual Inspection Report

Residual Waste Landfill

PREPARED FOR
Gavin Power, LLC

DATE
10 January 2025

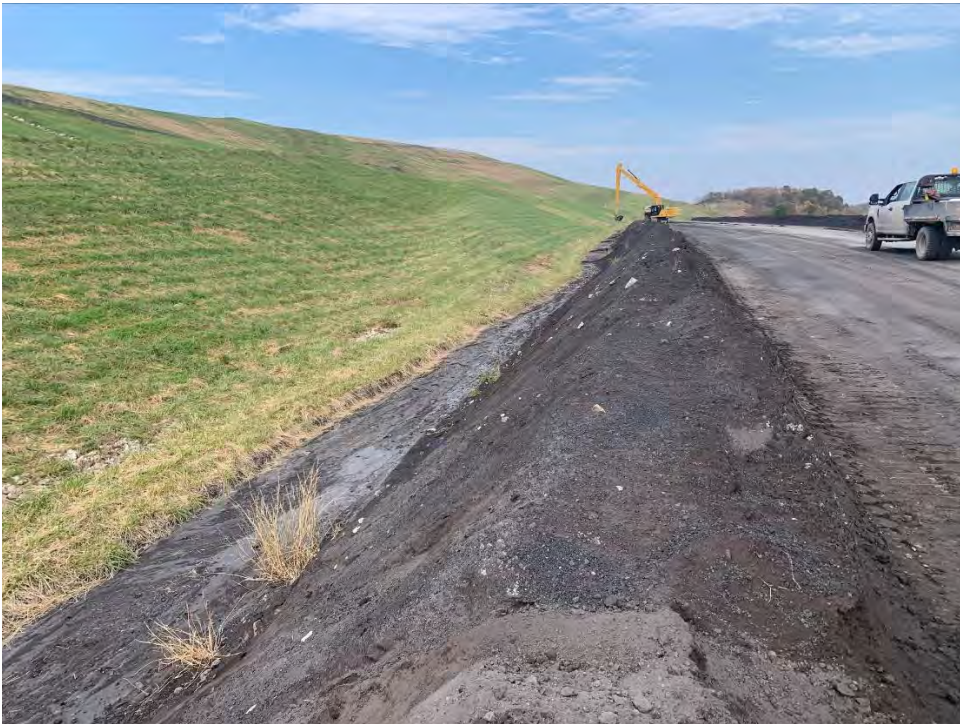
PHOTO NO. 12.	DATE 29 October 2024

DIRECTION PHOTO TAKEN North		
DESCRIPTION View of main haul road at the toe of the eastern slopes. Crew is cleaning out inner ditch line at the toe of slope. Slope is well vegetated and stable.

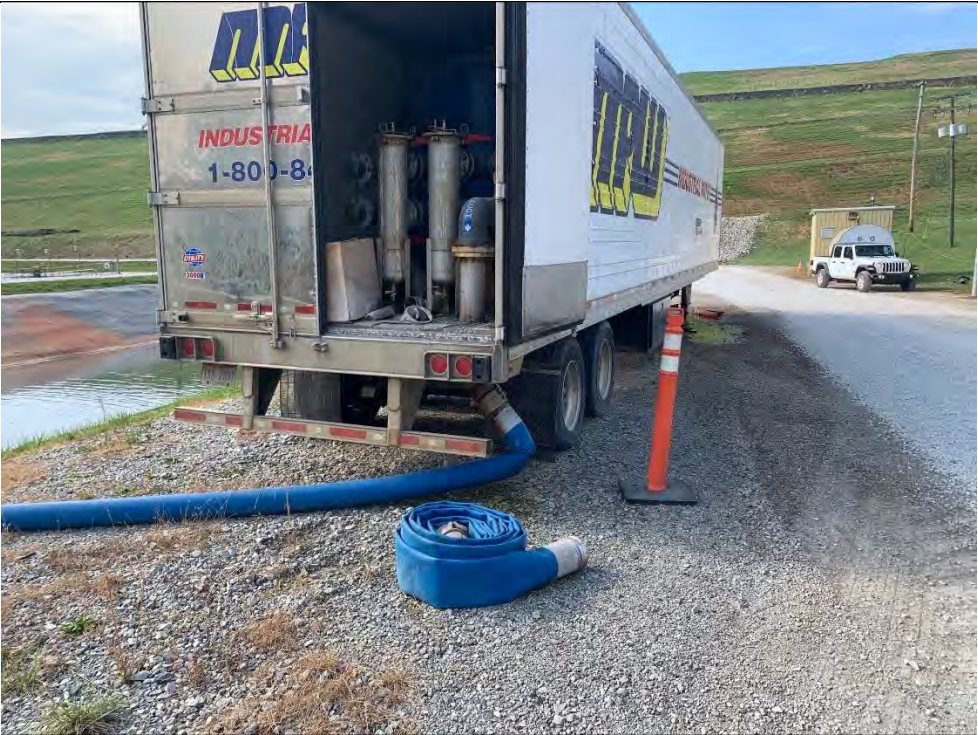
PHOTO NO. 16.	DATE 29 October 2024

Like at Pond 1, Gavin installed a supplemental, mobile trailer mounted temporary filter system identified during the 2023 inspection at the edge of the clarifying pond that is part of the Pond 2 complex (Photographs 16 and background of 41). There were no leaks observed, and the trailer appeared to be in satisfactory condition.

DIRECTION PHOTO TAKEN West		
DESCRIPTION View of Pond 2 water treatment process equipment located adjacent to Pond 2 clarifying pond. Limestone access road is visible to the right.

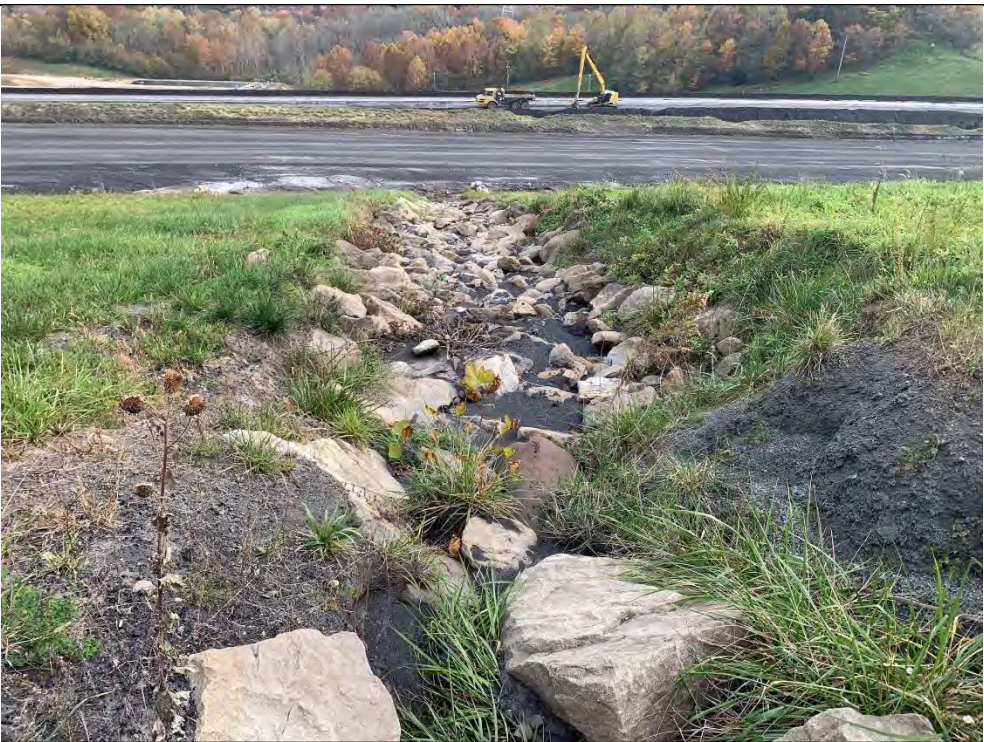
PHOTO NO. 17.	DATE 29 October 2024

DIRECTION PHOTO TAKEN East		
DESCRIPTION View of channel on south side of RWL along access road.

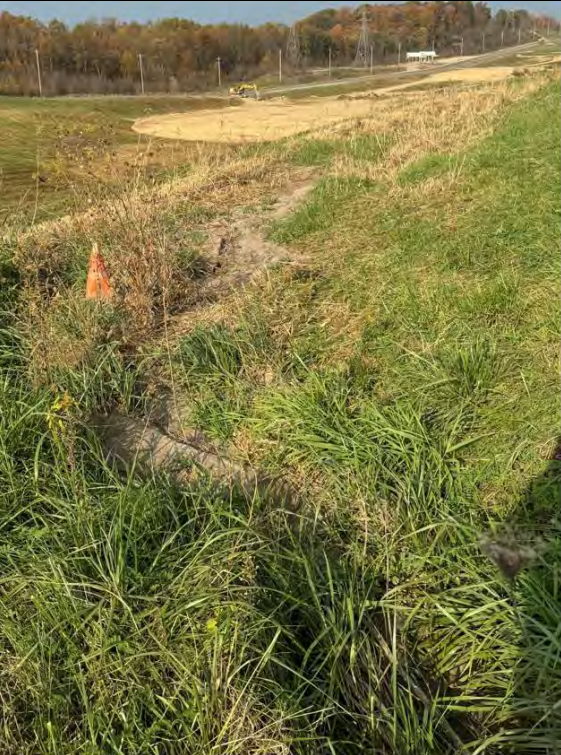
PHOTO NO. 19.	DATE 29 October 2024

DIRECTION PHOTO TAKEN Northwest				
DESCRIPTION Sediments in flow line of drainage bench needing clean out on western slope.

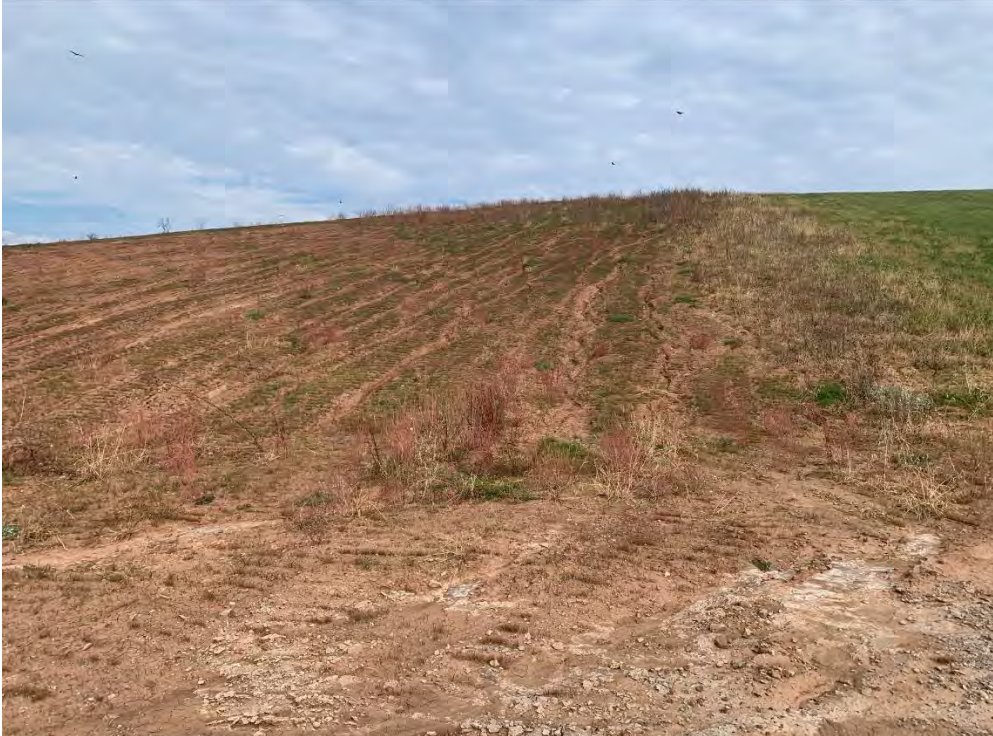
PHOTO NO. 22.	DATE 29 October 2024

There was a single area along a portion of the southern RWL slope where minor erosion rills were observed (Photograph 22) in the surface of the intermediate cover. Sedimentation was fully contained in this area and directed towards Pond 1. There was no visible evidence that this isolated area of erosion has the potential to disrupt the operation and safety of the RWL or that observed erosion features were creating an unstable condition. ERM recommends that this minor erosion area be repaired and reseeded in the Spring of 2025. In the interim, to the extent practical, upslope run-on should be minimized in these areas through common industry standard maintenance practices such as reworking the area with temporary seeding or through run-off diversion to prevent water from flowing over the top of slope.

DIRECTION PHOTO TAKEN North		
DESCRIPTION View of portion of southern vegetated slope of summit. Minor rills observed.

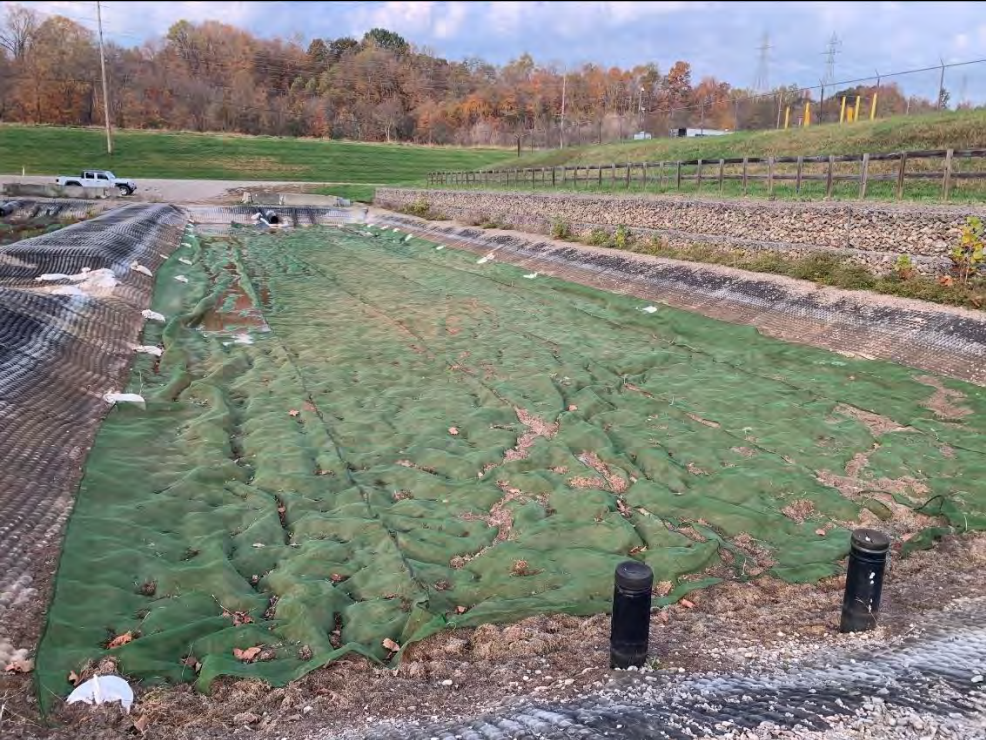
PHOTO NO. 25.	DATE 29 October 2024

The vertical flow wetlands for Pond 1 were observed and appeared to be in satisfactory working order (Photographs 25 through 29). Vegetation is beginning to build up in the weir area at the downstream end of the features that should continue to be removed as part of the routine maintenance of the facility. The flume is beginning to show a slight algal buildup and it is recommended that it be cleaned as well. A groundwater interceptor pipe designed to maintain the natural groundwater surface below the vertical flow wetland liner system elevation was observed to have some iron precipitation (Photograph 38). Discussions with RWL staff indicate that review of analytical results from this location indicated that this is naturally occurring iron.

DIRECTION PHOTO TAKEN West		
DESCRIPTION View of downgradient end of vertical flow wetland treatment adjacent to Pond 1.

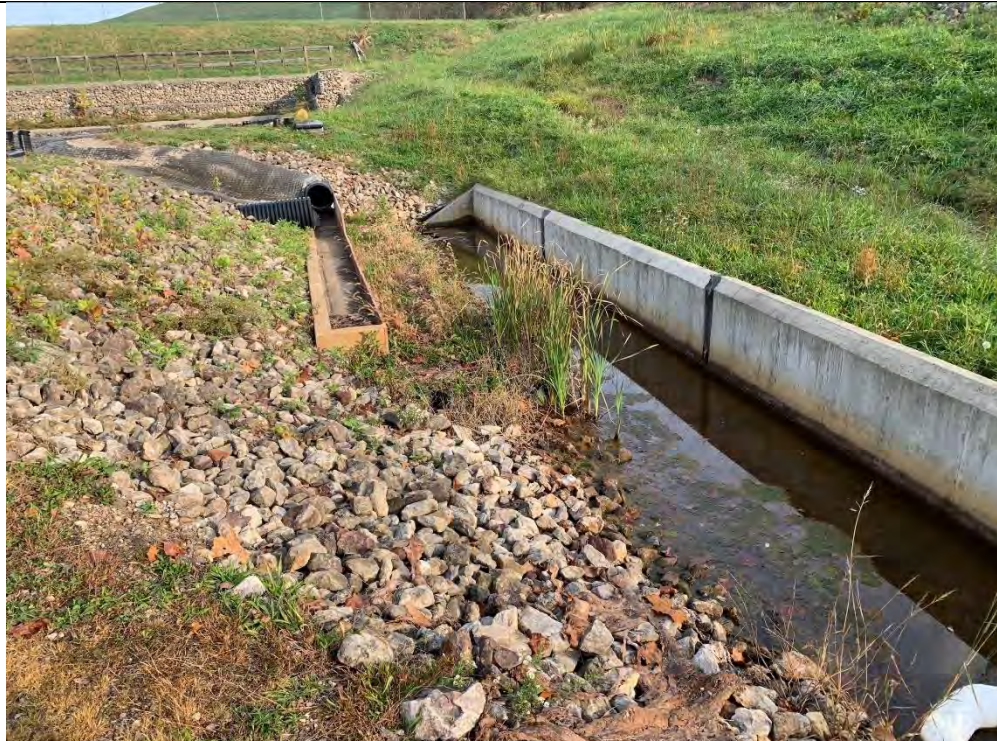
PHOTO NO. 28.	DATE 29 October 2024

DIRECTION PHOTO TAKEN North		
DESCRIPTION View of outlet for vertical flow wetland adjacent to Pond 1.

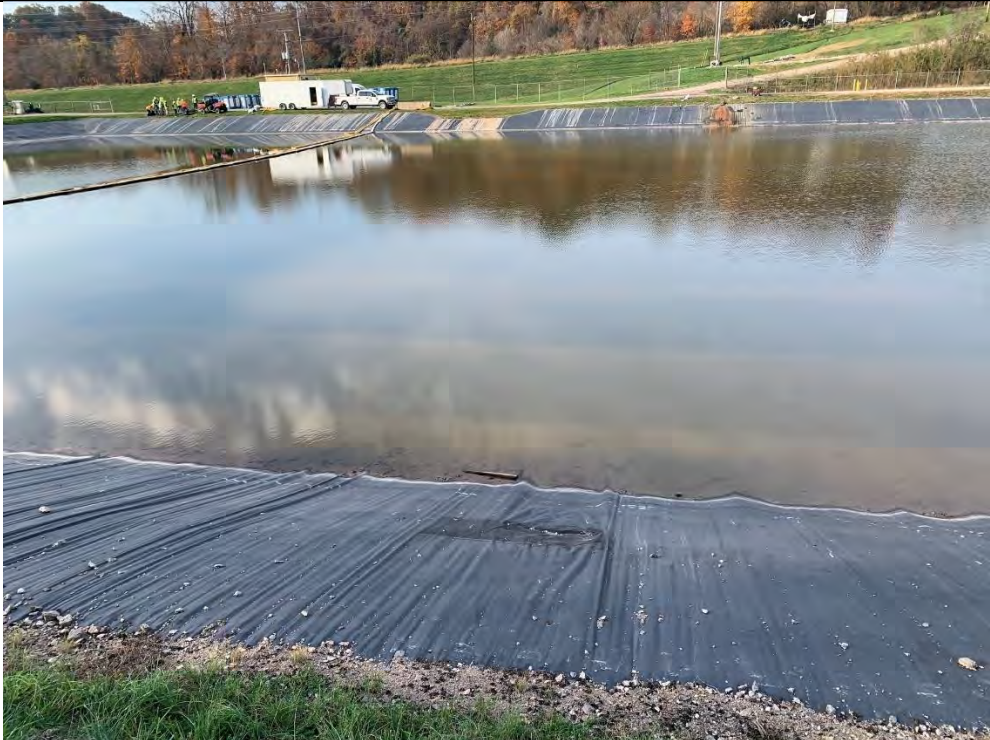
PHOTO NO. 33.	DATE 29 October 2024

DIRECTION PHOTO TAKEN West		
DESCRIPTION View of patched repair on Pond 1 eastern embankment. Liner repair crew trailer is in the background.

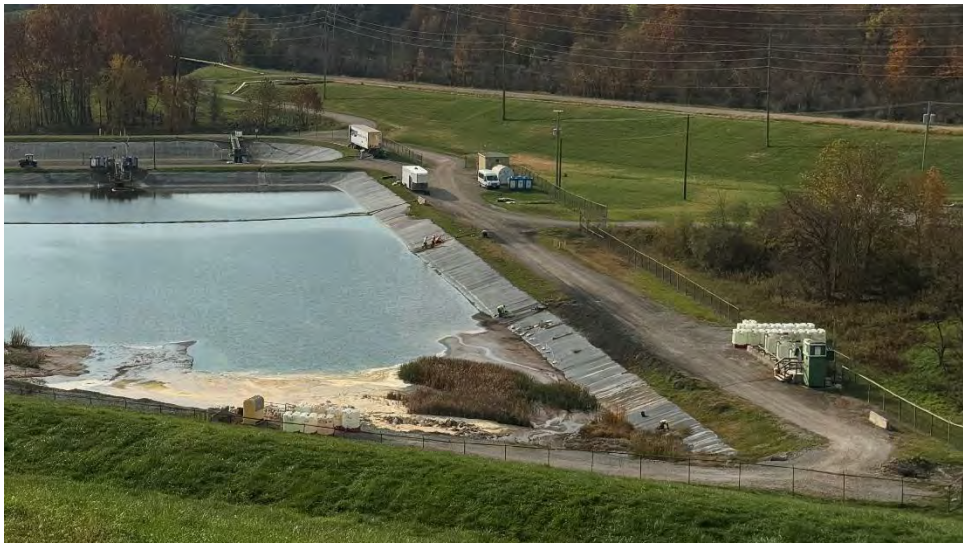
PHOTO NO. 36.	DATE 29 October 2024

DIRECTION PHOTO TAKEN South		
DESCRIPTION Overall view of Pond 1 - Liner repair crew working on western edge of Pond (right side).

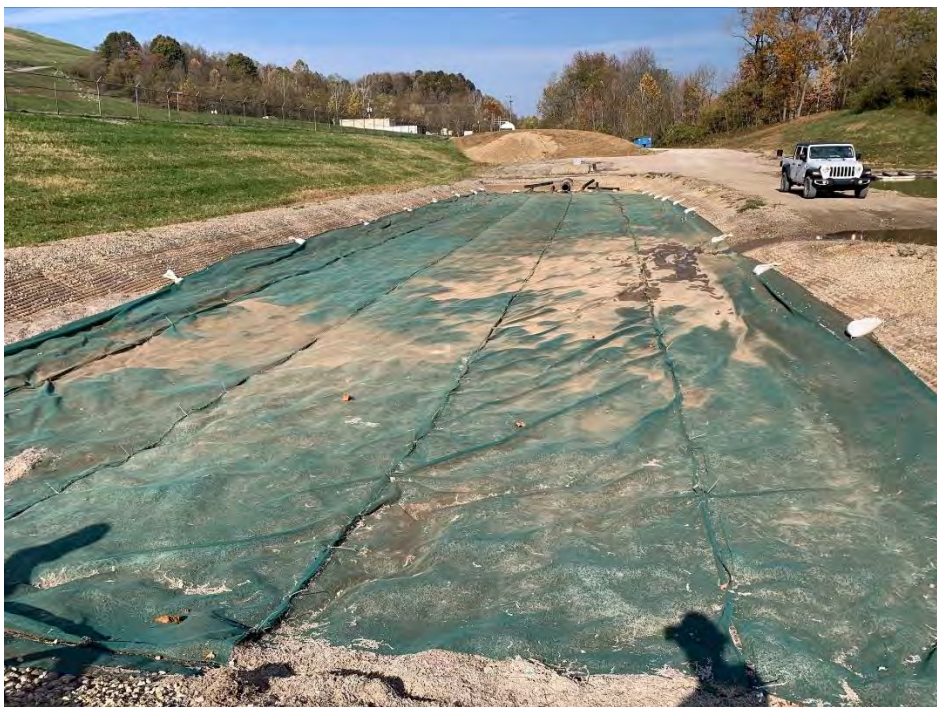
PHOTO NO. 42.	DATE 29 October 2024

The vertical flow wetland cells for Pond 2 were observed to be in satisfactory condition (Photograph 42). The easternmost wetland was functioning during the inspection. In addition, water from within the western cell was being dewatered into the eastern cell in advance of western cell maintenance. The rock lined outflow channel for the system to the south of the vertical ponds appeared to be functioning properly from a flow standpoint, with no signs of erosion or distress.

DIRECTION PHOTO TAKEN North		
DESCRIPTION View of western cell of the vertical flow wetland at Pond 2, which was dewatered to facilitate maintenance.

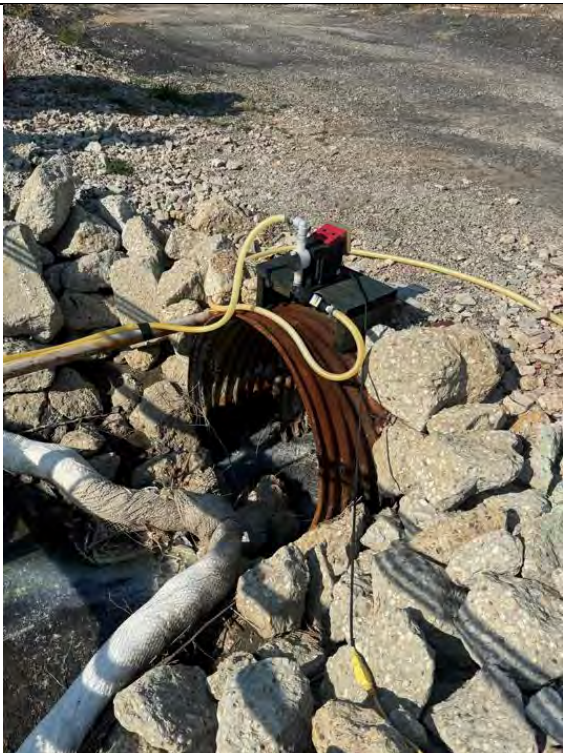
<p>PHOTO NO. 44.</p>	<p>DATE 29 October 2024</p>

<p>DIRECTION PHOTO TAKEN West</p>		
<p>DESCRIPTION Upstream end of corroded stormwater/leachate culvert in need of replacement.</p>

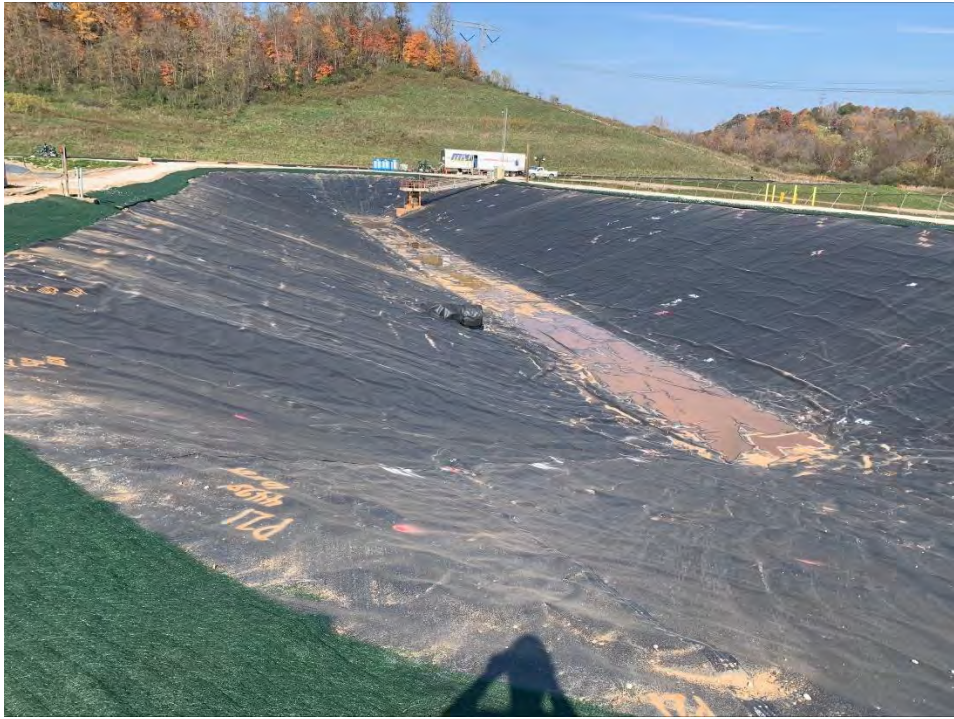
PHOTO NO. 47.	DATE 29 October 2024

The clarifying pond issues identified in 2023 have been rectified and the facility has been relined with a new geomembrane liner (Photograph 47) since the 2023 annual inspection. The geomembrane liner system has been installed and is in satisfactory condition. The facility is finalizing a geomembrane QA/QC report for the completed construction. A new construction detail to minimize roadway gravel from entering the pond has been installed consisting of a heavy-duty erosion control blanket around the crest of the Pond's embankment.

DIRECTION PHOTO TAKEN North		
DESCRIPTION View of newly lined Pond 3 clarifying pond with erosion control blanket installed at the top of embankment between the gravel access road and liner.

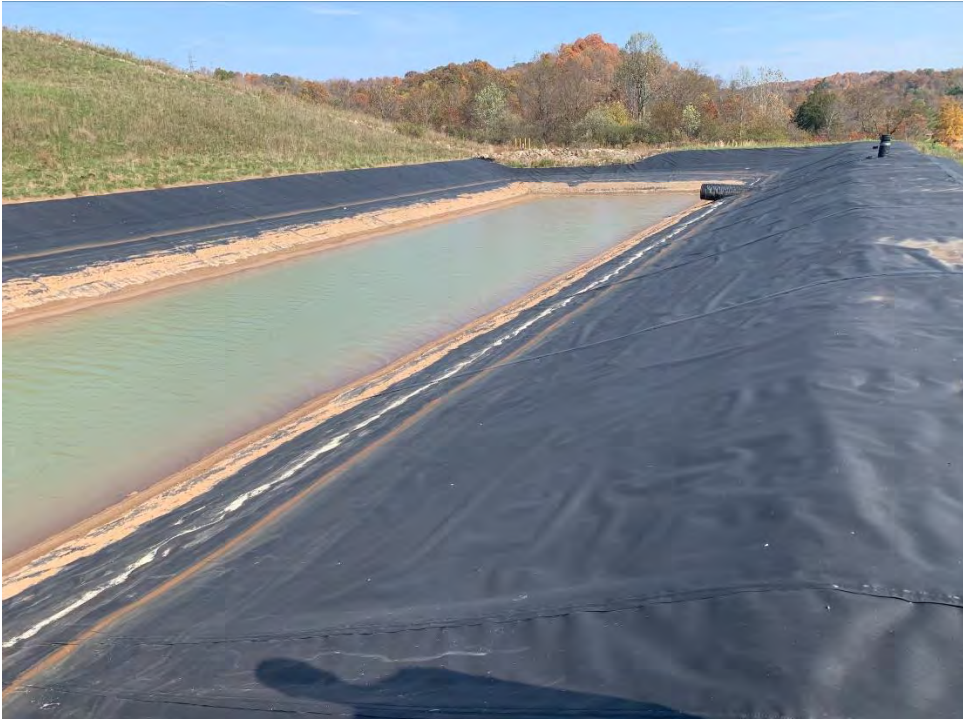
<p>PHOTO NO. 51.</p>	<p>DATE 29 October 2024</p>

Pond 5 (Photographs 50 and 51) on the northeast side of the RWL, adjacent to Pond 3, was observed to be functioning properly with respect to water flow and sedimentation during the annual inspection. A noticeable volume of accumulated sediments was visible near the inflow

<p>DIRECTION PHOTO TAKEN Northeast</p>		
<p>DESCRIPTION View of eastern portion of Pond 5.</p>

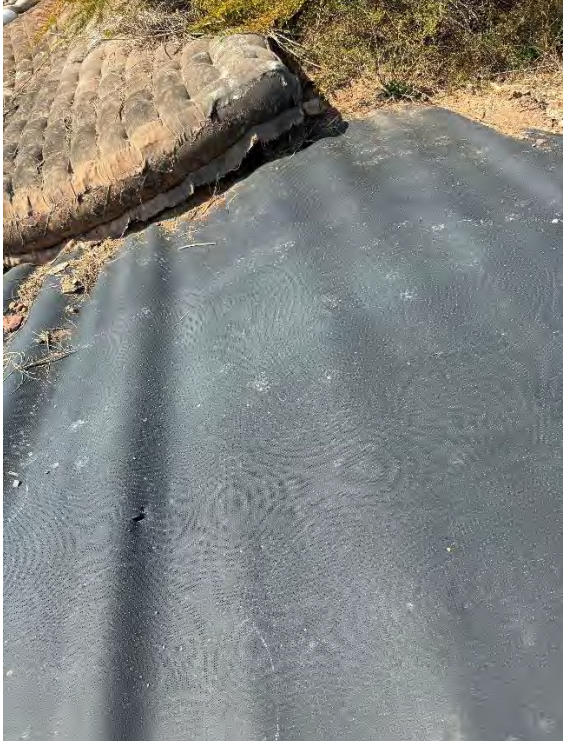
<p>PHOTO NO. 52.</p>	<p>DATE 29 October 2024</p>

There were punctures observed in the geomembrane liner near the concrete inflow channel to Pond 5 (Photograph 52) on the far western end that continue to appear to be the result of animal hoofs (i.e. white-tailed deer). Some holes are within the channel's flowline downstream of the concrete entrance channel to Pond 5 (Photograph 53). A changed condition from the 2023 annual inspection is that water is also accumulated under the liner system directly downstream of this stormwater inflow point that appears directly related to punctures in the flowline. The liner is bulging in this area similar to what is observed on the southwest edge (Photograph 54). ERM recommends that this situation be promptly investigated, water under the liner system removed and the geomembrane repaired.

<p>DIRECTION PHOTO TAKEN North</p>		
<p>DESCRIPTION View of inflow channel to Pond 5 with multiple small liner perforations suspected of being related to wildlife.</p>

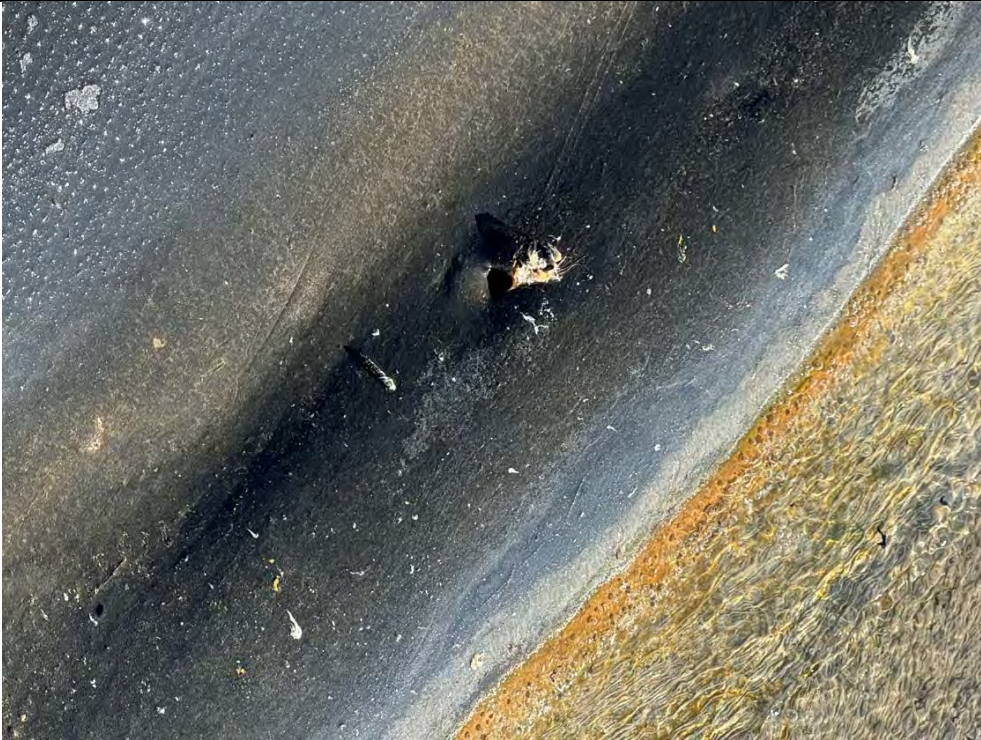
PHOTO NO. 53.	DATE 29 October 2024

DIRECTION PHOTO TAKEN East		
DESCRIPTION Perforation in HDPE liner near flow line in western inflow to Pond 5.

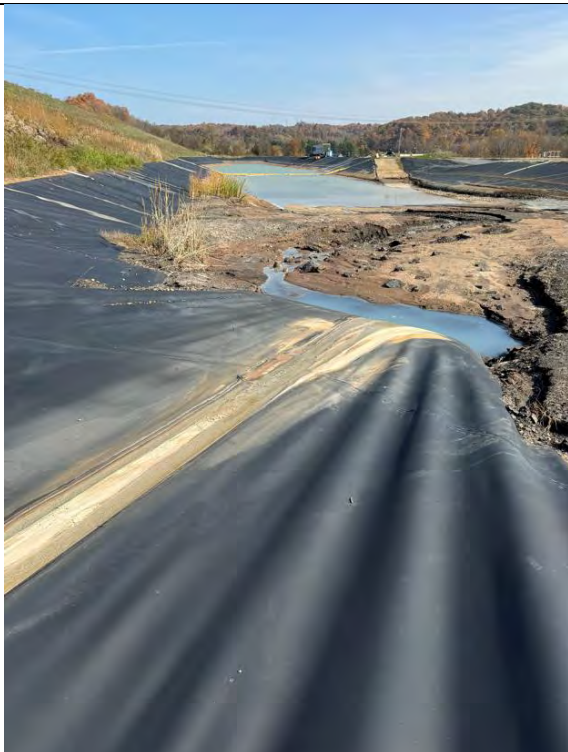
PHOTO NO. 54.	DATE 29 October 2024

The facility has made a slit in the geomembrane several feet above the operating level of the pond for purposes of inserting a suction withdrawal pipe for removal of accumulating water originating from beneath the geomembrane. A small pump is utilized to withdraw this water as needed to avoid stress and uplift pressures on the liner system from accumulated water. The facility monitors this accumulation and continues to utilize personnel to withdraw this water and discharge it into the pond on an as needed basis. This water is reportedly clear and appears to be groundwater but was not observed by ERM during the inspection. It appears, based on the continued reappearance of this condition, that a perched groundwater condition may exist with a connection to the Pond 5 area. The source of this water has not been identified but is apparently not from the pond, since it accumulates above the operating level within the pond, and groundwater results from down gradient monitoring wells do not indicate a release from Pond 5.

DIRECTION PHOTO TAKEN East		
DESCRIPTION Bulge in HDPE liner from buildup of water underneath at western inflow to Pond 5.
