2024 Annual Inspection Report

Bottom Ash Pond

PREPARED FOR
Gavin Power, LLC

DATE
10 January 2025

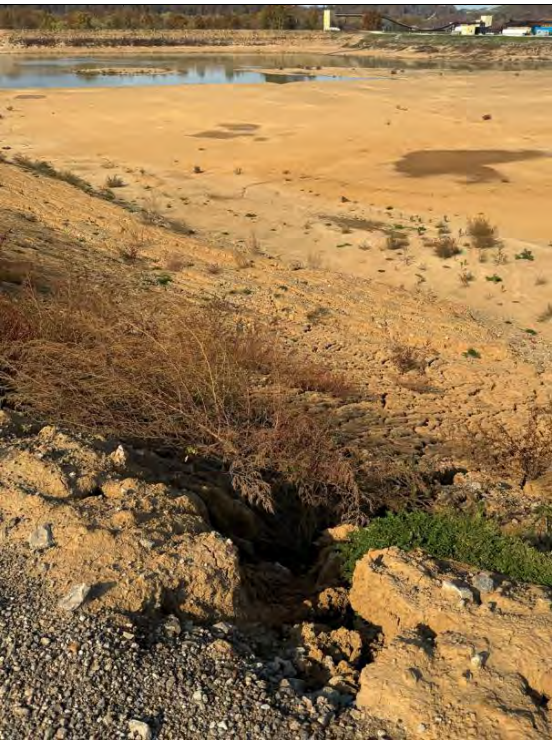
PHOTO NO. 1.	DATE 28 October 2024

Consistent shallow rill erosion was observed around the inside perimeter of the embankment (Photograph 1). Eroded soil from the side slope rill erosion is captured within the dewatered BAP

DIRECTION PHOTO TAKEN West		
DESCRIPTION View of interior southern embankment. Minor erosion rills observed throughout interior embankment.

6. Continue to monitor erosion rilling on the interior BAP slopes. Utilize rock fill to stabilize head cuts of deeper erosion features if they begin to advance into roadway embankment crests. If a decision on reuse of the BAP as a process water pond appears to be uncertain in the near term, ERM recommends applying seed and mulch to the interior to minimize erosion.

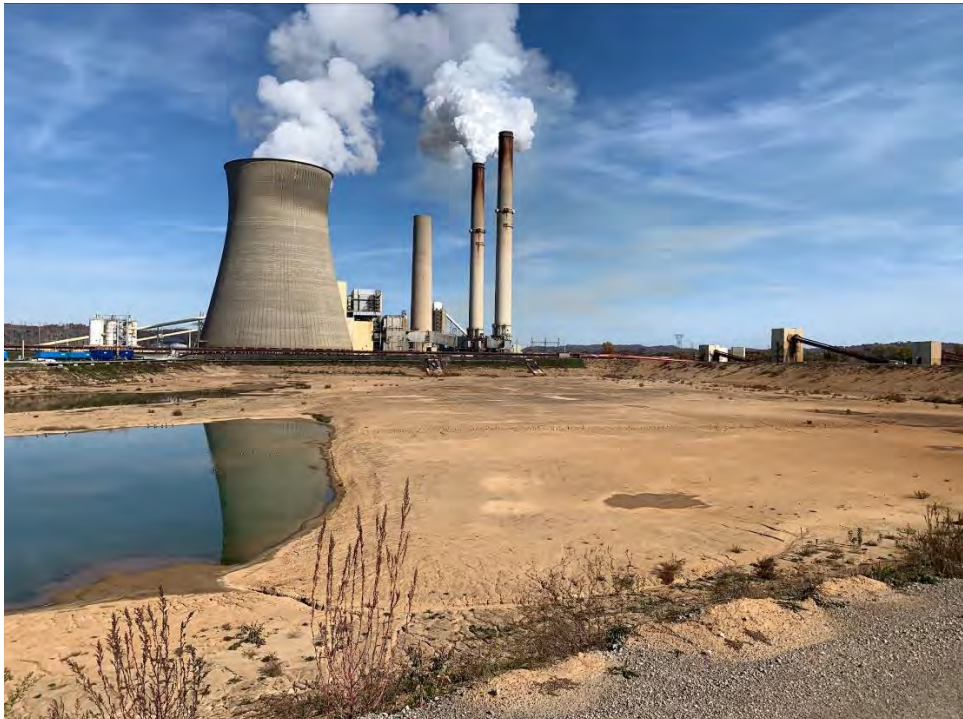
<p>PHOTO NO.</p> <p>3.</p>	<p>DATE</p> <p>28 October 2024</p>

<p>DIRECTION PHOTO TAKEN</p> <p>North</p>		
<p>DESCRIPTION</p> <p>View of BAP from southern embankment.</p>

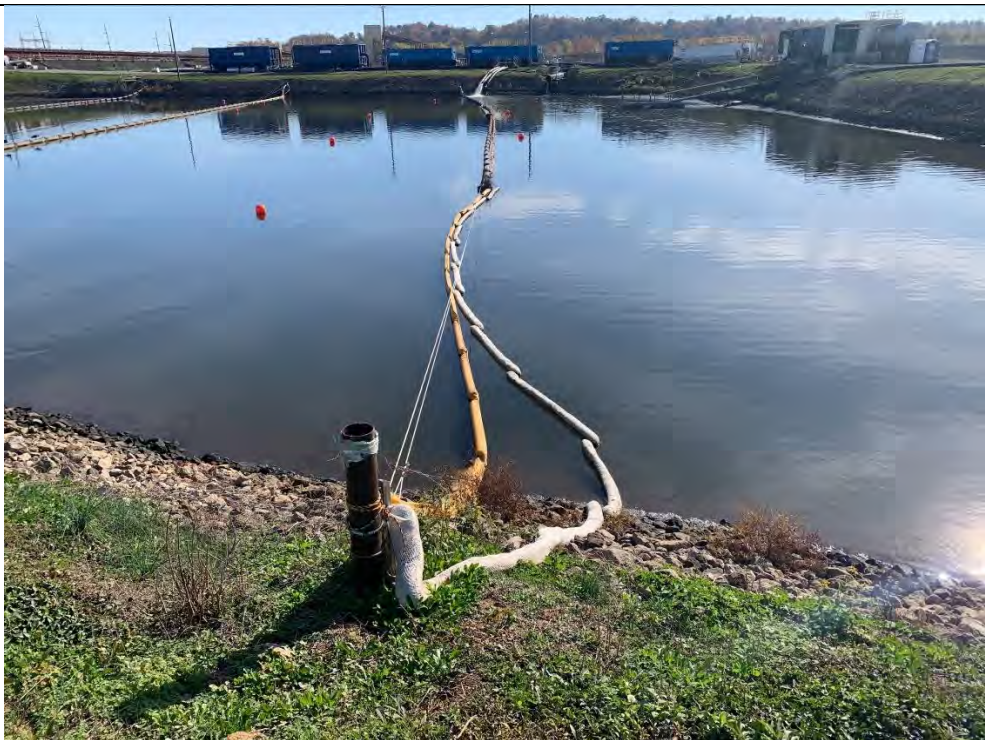
PHOTO NO. 7.	DATE 28 October 2024

DIRECTION PHOTO TAKEN East		
DESCRIPTION View of Reclaim Pond and water treatment process. Embankment slopes are stable, well vegetated, and armored at the toe near the water level. Turbidity curtains pictured in the middle of the pond.

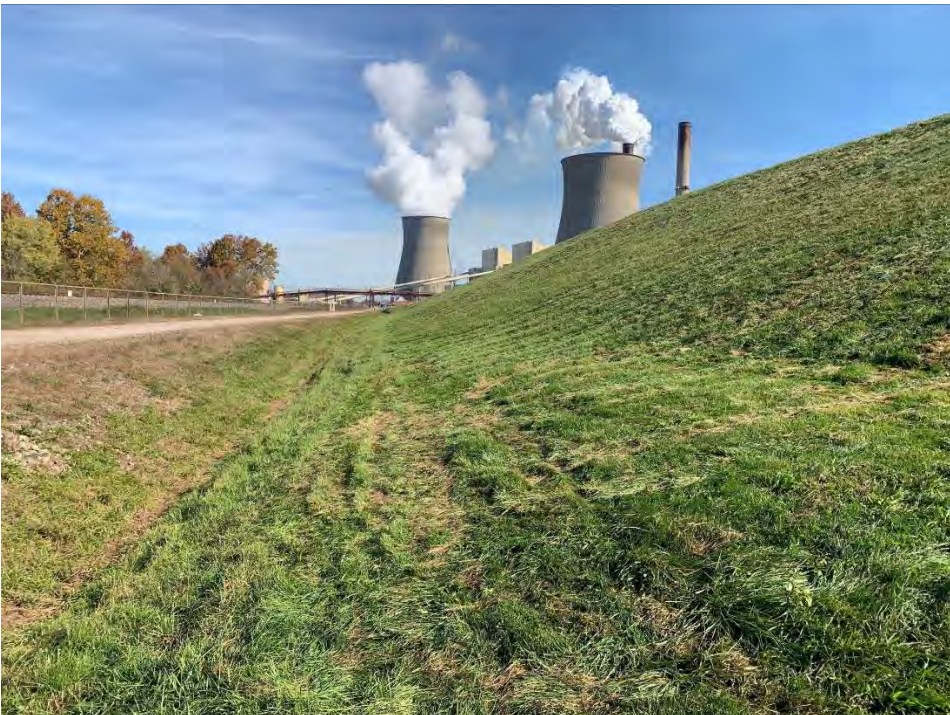
PHOTO NO. 9.	DATE 28 October 2024

DIRECTION PHOTO TAKEN North		
DESCRIPTION Drainage ditch along exterior base of western embankment, near west side of Reclaim Pond. Slope is stable and well vegetated.

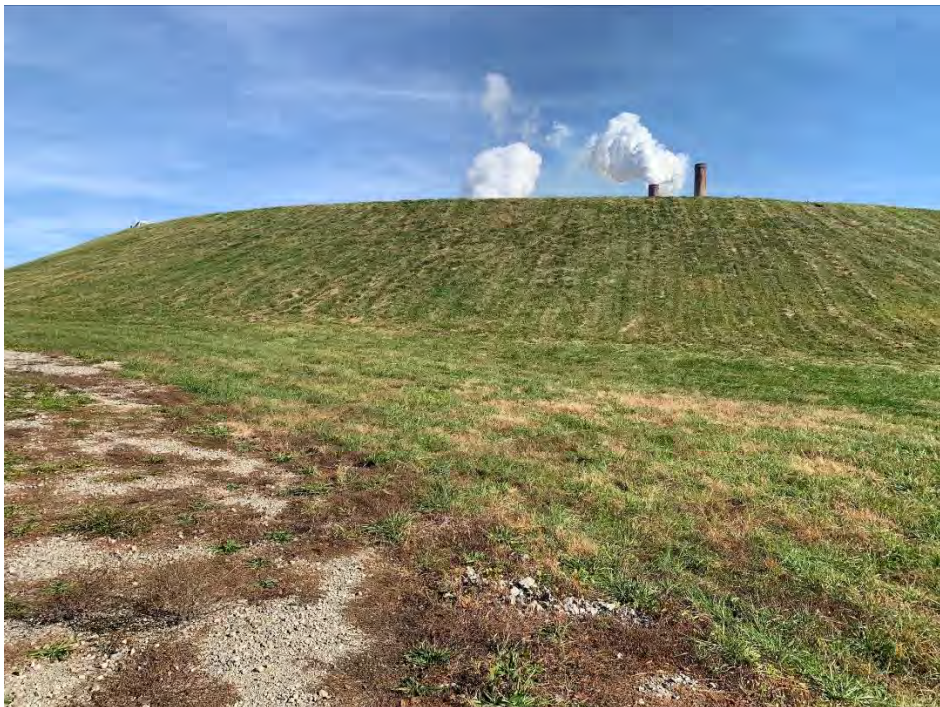
PHOTO NO. 11.	DATE 28 October 2024

DIRECTION PHOTO TAKEN North		
DESCRIPTION Exterior southwest corner of BAP. Slope is stable and well vegetated.

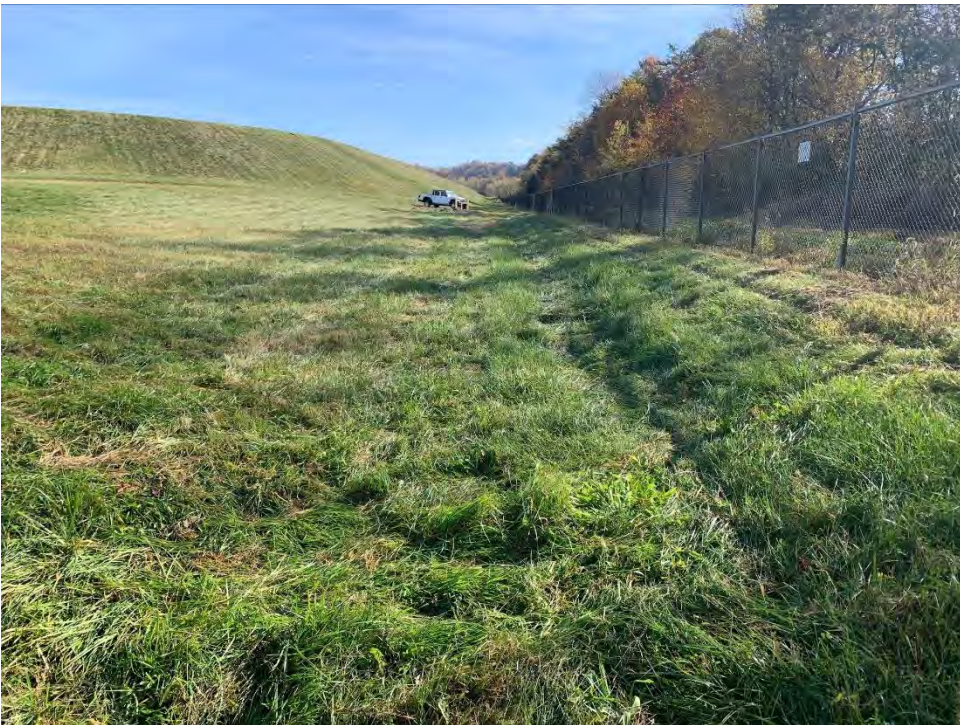
PHOTO NO. 13.	DATE 28 October 2024

DIRECTION PHOTO TAKEN East		
DESCRIPTION Southwest corner of BAP drainage ditch line.

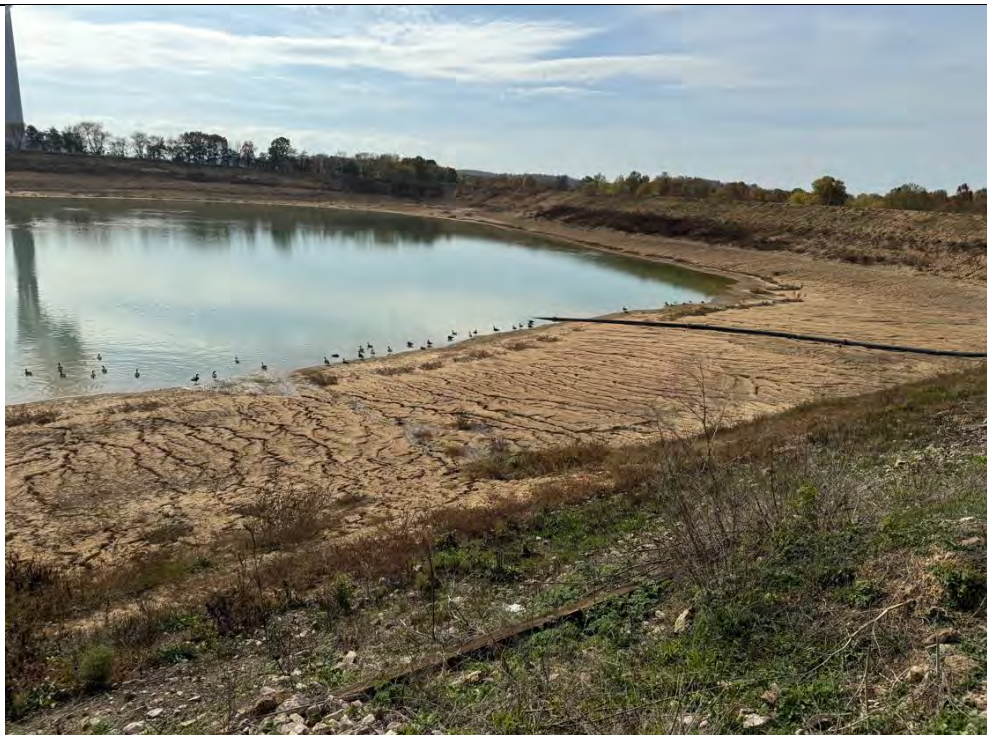
PHOTO NO. 39.	DATE 28 October 2024

DIRECTION PHOTO TAKEN South		
DESCRIPTION Southern embankment of the reclaim pond, interior to the BAP. The interior western embankment is visible to the right. A small point of potential seepage is visible in the center of the photo.

2. Potential seepage on the southern embankment of the Reclaim Pond should be investigated and monitored with the weekly inspections. If changes in flow, color, or soil conditions surrounding the source are observed, increase level of monitoring. Explore potential sources of the flow and repair options. Continue to manage water through pumping into the modular water treatment system.

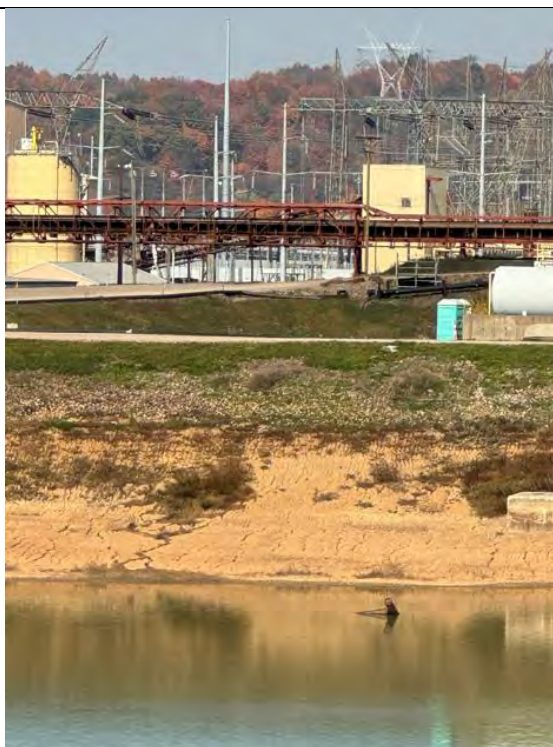
PHOTO NO. 40.	DATE 28 October 2024

DIRECTION PHOTO TAKEN North		
DESCRIPTION Southern embankment of the reclaim pond, interior to the BAP. Photograph taken from southern embankment of BAP. Small point of potential seepage is visible in the bottom-left quadrant of the photograph.
