2017 Annual Inspection Report

*Residual Waste Landfill
Gavin Power Plant
Cheshire, Ohio*

8 January 2018

Project No. 0402270

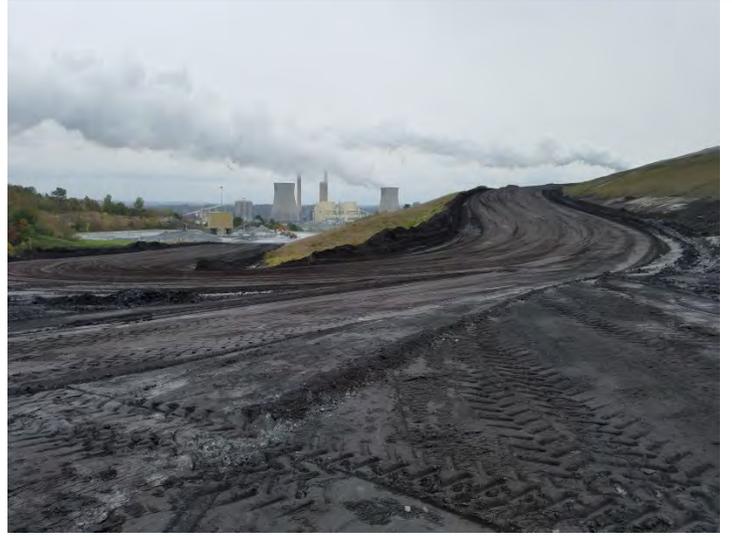
Photograph #5

In the vicinity of the vertical expansion, FGD material had been placed in a lift and pond cleanings were being placed within this excavated area. Photographs 5 and 6 show the placement of the CCR material at this location. At the time of ERM's inspection, CCR material placement was being conducted in a satisfactory manner. A series of chimney drains (typical chimney drain shown in Photograph 7) were observed within the vertical expansion area to assist in draining excess surface water and collect potential future leachate as the landfill continues expanding upward. CCR material containing a higher moisture content (e.g., pond cleanings and lime) was being placed within stable excavated areas of FGD away from outer slopes for mixing with dry materials shown in Photograph 9. The contractor also maintained a stockpile of construction materials including pipe, gravel, and geotextile separation fabric within a storage area on an inactive area of the landfill to use for incremental construction activity as shown in Photograph 10.

View of active filling operations within vertical expansion area near center of landfill.
FGD and pond cleanings being placed (looking south).

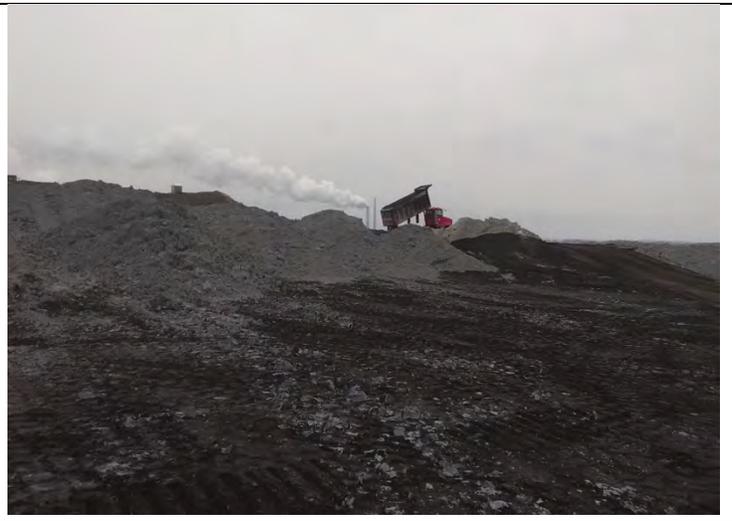
Photograph #6

View of placement of Pond Cleanings within excavated portion of FGD in vertical expansion area (looking south).

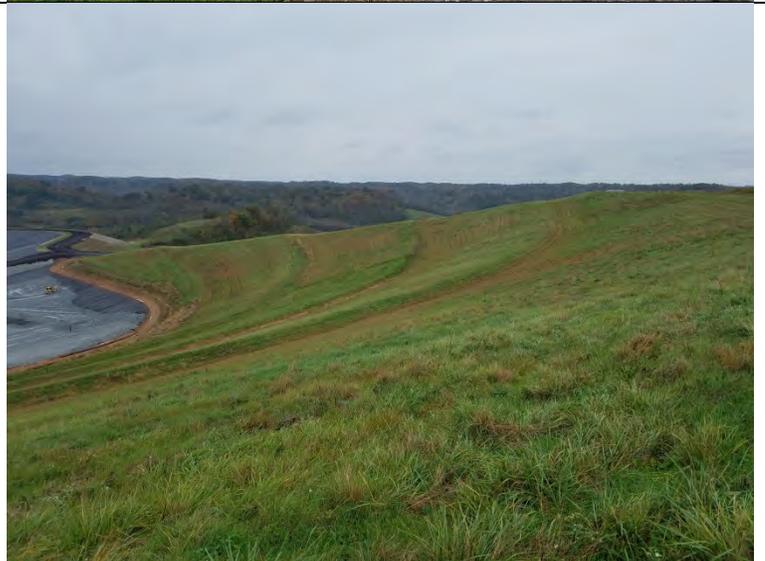
Photograph #12

Within the lateral expansion, the layer of CCR material was being placed to complete construction activities in advance of winter conditions. Fine-grained FGD was observed being placed in a thick initial lift on a grid pattern, following commonly accepted liner system protection procedures, and in general conformance with PTI Drawing 4F. This procedure promotes avoidance of large or sharp materials near the geosynthetic components, eliminates point loads from construction and hauling equipment during initial lift placement, and avoids concentration of forces and wrinkling of the liner system through spreading of the material in multiple directions. A view of the lateral expansion currently under construction is shown in Photographs 12, 13, 14, and 19.

View of northern slope and lateral expansion area of landfill (looking north).

Lift of FGD being placed in general grid pattern as protective cover for liner system.

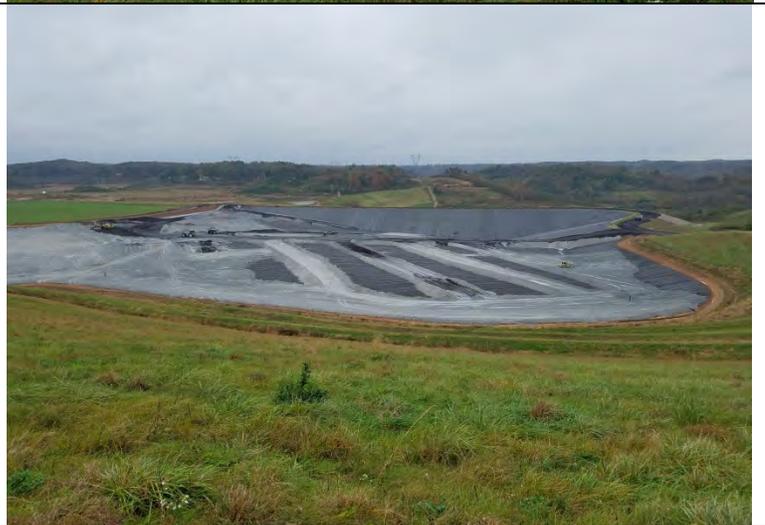
Photograph #13

View of the northern slope of landfill and western edge of lateral expansion (looking northwest).

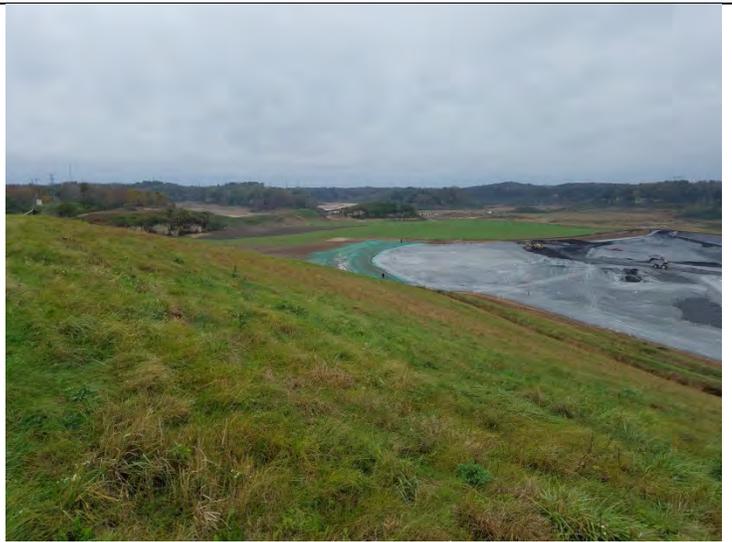
Photograph #14

Additional area for the next stage of lateral expansion is to be seeded along the western edge of the facility. This area is shown on Photograph 14.

View of the northwest edge of landfill and western lateral expansion (looking west).

Next stage of construction about to be seeded.

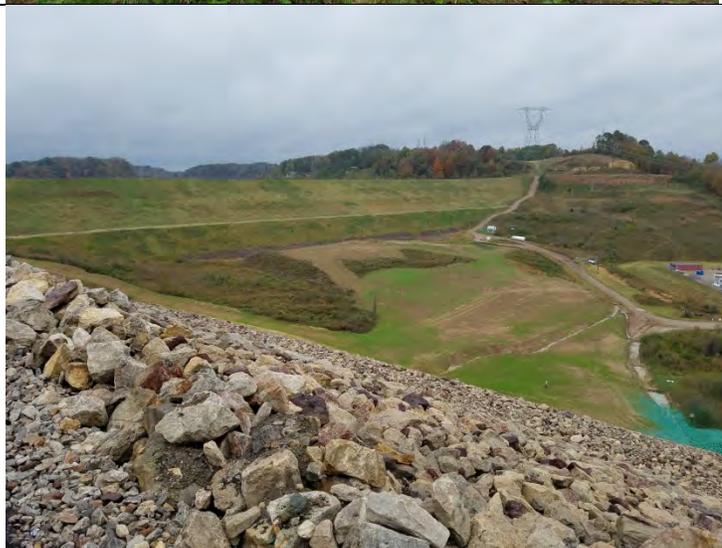
Photograph #19

View of lateral expansion from eastern perimeter access road (looking northwest).

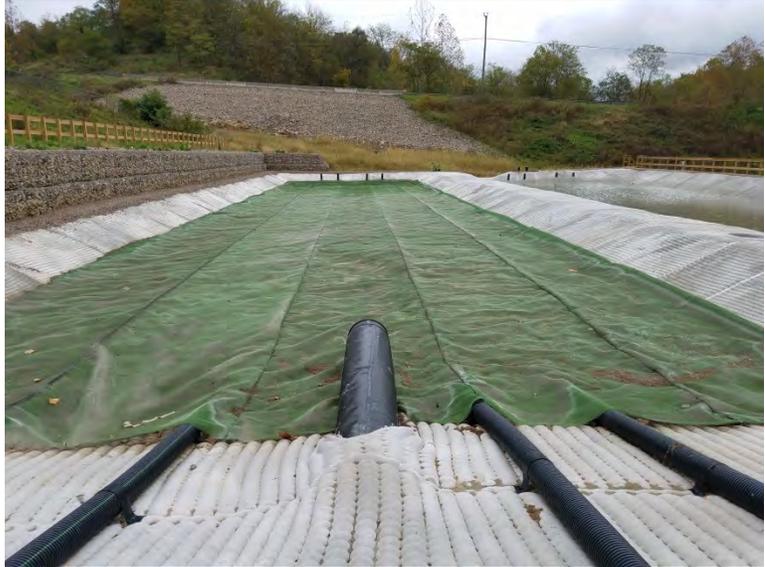
Photograph #29

Overall, the clarifying portion of the pond systems, and the associated vertical flow wetland systems, were largely clear of debris and/or sediment buildup. This is shown on Photographs 26, 27, 28, 31, and 37 through 41. The various outlet structures for the ponds and vertical flow wetlands were also observed to be largely clear of sedimentation and debris as shown on Photographs 25, 26, 28, 29, 36, and 39.

Outlet for vertical flow wetland at Pond No. 1 (looking east)

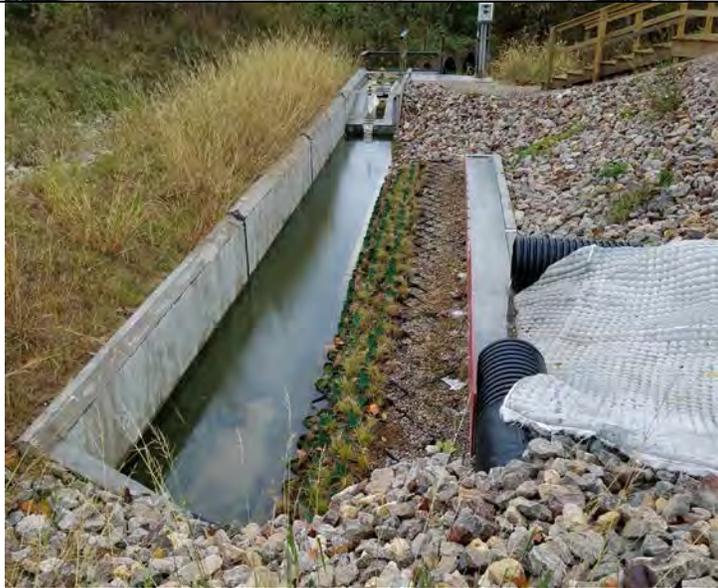
Photograph #30

The sedimentation/treatment portion of Ponds 1, 2, and 3 were observed to have varying amounts of solids within their limits, as shown in Photographs 31, 37 and 38. The clarifying portion of Pond 3 was also observed to have a minor amount of sedimentation seen in Photograph 39. These ponds are routinely cleaned of accumulated solids through draining and removal of sediments with low ground contact pressure equipment or while still containing water through use of extended-reach excavators or use of a floating dredge. ERM observed dredging activities in Pond 2 during the site inspection; dredging activities are shown in Photographs 30 and 31.

View of slope and Pond No. 1 (looking southwest).

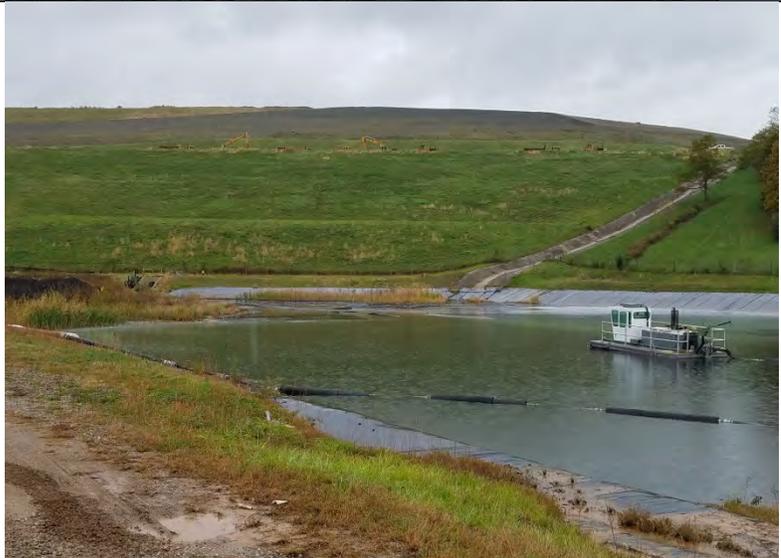
Photograph #31

View of Pond No. 1 and southwest slope into pond (looking southwest).

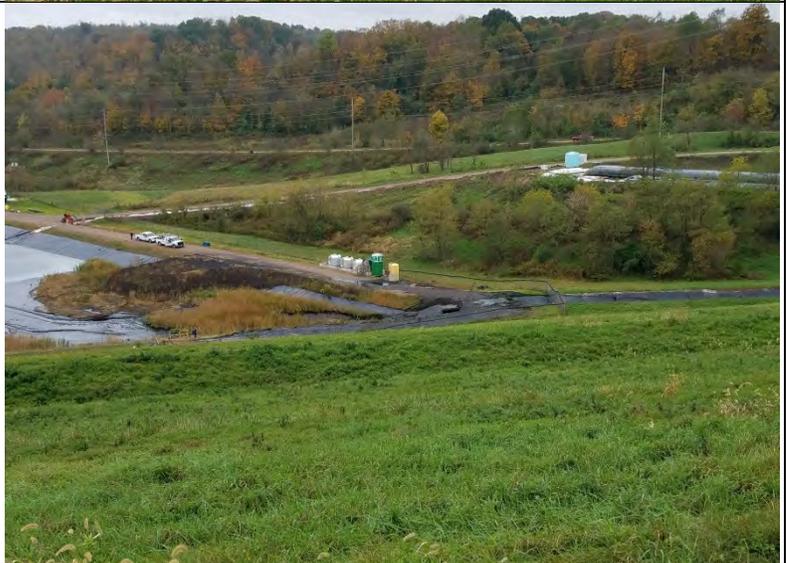
Photograph #33

The dredged material from the pond cleaning is typically pumped into dewatering bags located within a geomembrane-lined containment area. When a bag is filled, the bag is opened, the contents are removed, and the collected material is disposed in the landfill. An active dewatering bag observed during inspection is shown on Photograph 33.

View of dewatering bag for collected sludge (looking east).

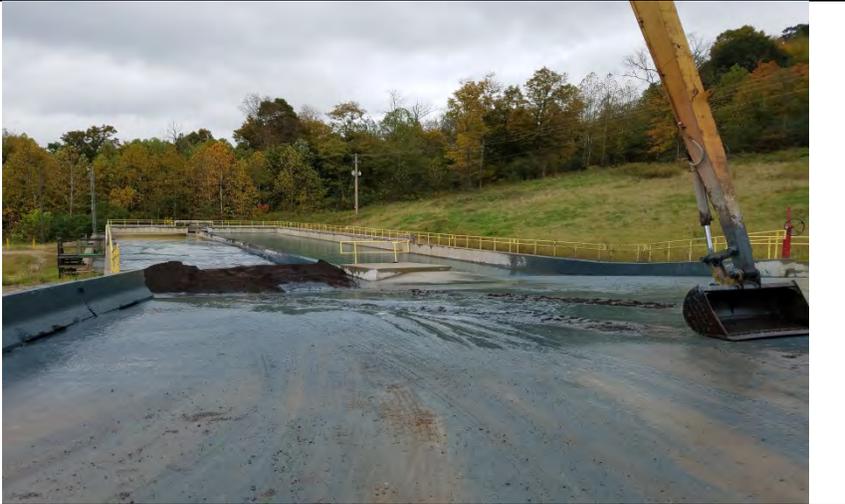
At Pond 2, to assist with the removal of FGD solids coming from the stack out pad and to minimize what has to be dredged, Gavin Power operates a concrete settling basin. This basin is routinely cleaned with an extended-reach excavator. This process was observed by ERM and the facility is shown in Photograph 35. Within the sedimentation/treatment portion of Pond 2, it was noted that some rock from maintenance and grading operations on the adjacent western roadway were present on the geomembrane liner system.

A wide-angle photograph of a large, rectangular concrete settling basin. The basin is filled with a thick, dark brown sludge. A yellow excavator with a long boom is positioned on the right side of the basin, with its bucket lowered into the sludge. The background shows a grassy hillside with trees under a cloudy sky.
Dredging of sludge from settling basin adjacent to Pond No. 2.	
Photograph #36

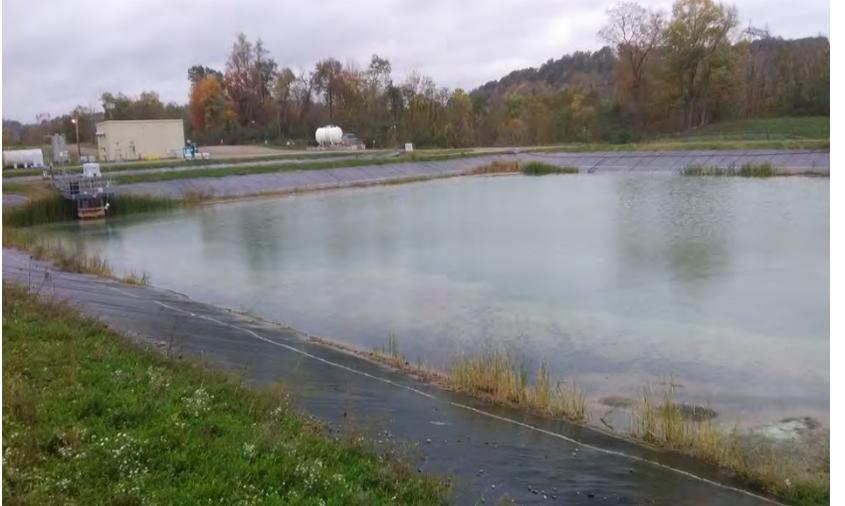
View of northern banks of Pond No. 2 (looking northeast).

7. Large gravel material observed along the length of the geomembrane liner on the west side of Pond 2 should be removed and a means of preventing this material from continuing to fall onto the liner system identified and implemented.
8. With completion of the work at Ponds 3 and 5, resume solids removal from Pond 3 and re-establish satisfactory access around the perimeter of the pond.
9. Consult with the filter bag manufacturer regarding the isolated seam issue experienced at Pond 1 and determine if improvements or operational considerations for future filter bags are necessary.
10. To minimize hauling and associated costs and provide opportunity for beneficial reuse, it is recommended that as the northern lateral expansion is filled the existing soil cover on the north facing slope of the existing landfill be removed and stockpiled for reuse as cover.

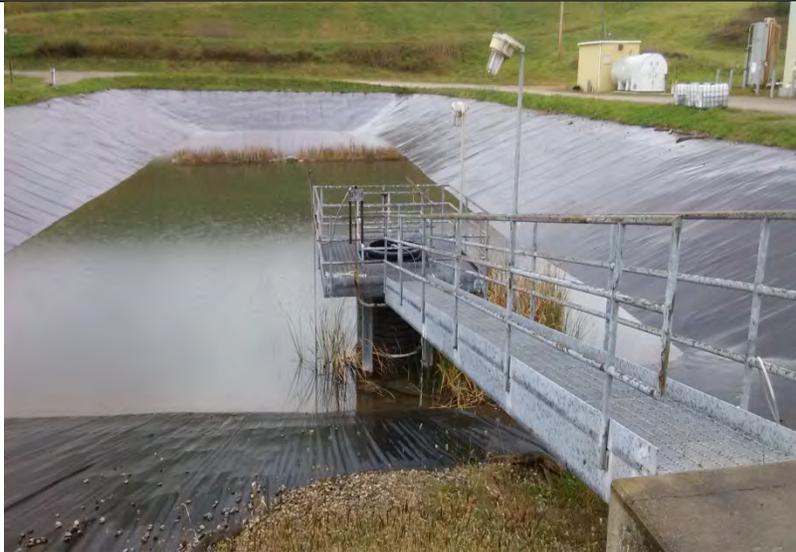
A close-up view of a settling basin. The basin is lined with a dark, flexible material, likely geomembrane. A metal walkway with railings runs along the edge of the basin. In the background, there are some utility structures, including a yellow tank and a white tank, and a light pole.
<p>Photograph #39</p>	<p>View of adjacent settling basin to Pond No. 3 and bank into pond (looking north).</p>
<p>Photograph #40</p>

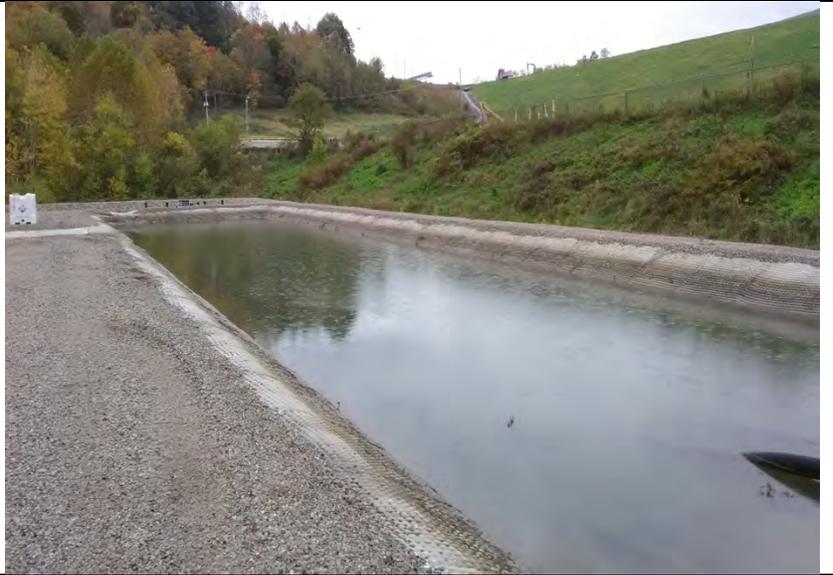
Photograph #41

View of eastern basin of constructed vertical flow wetland for Pond No. 3. (looking southeast)
