# 2018 Annual Inspection Report

Gavin Power, LLC

## Residual Waste Landfill

Gavin Power Plant  
Cheshire, Ohio

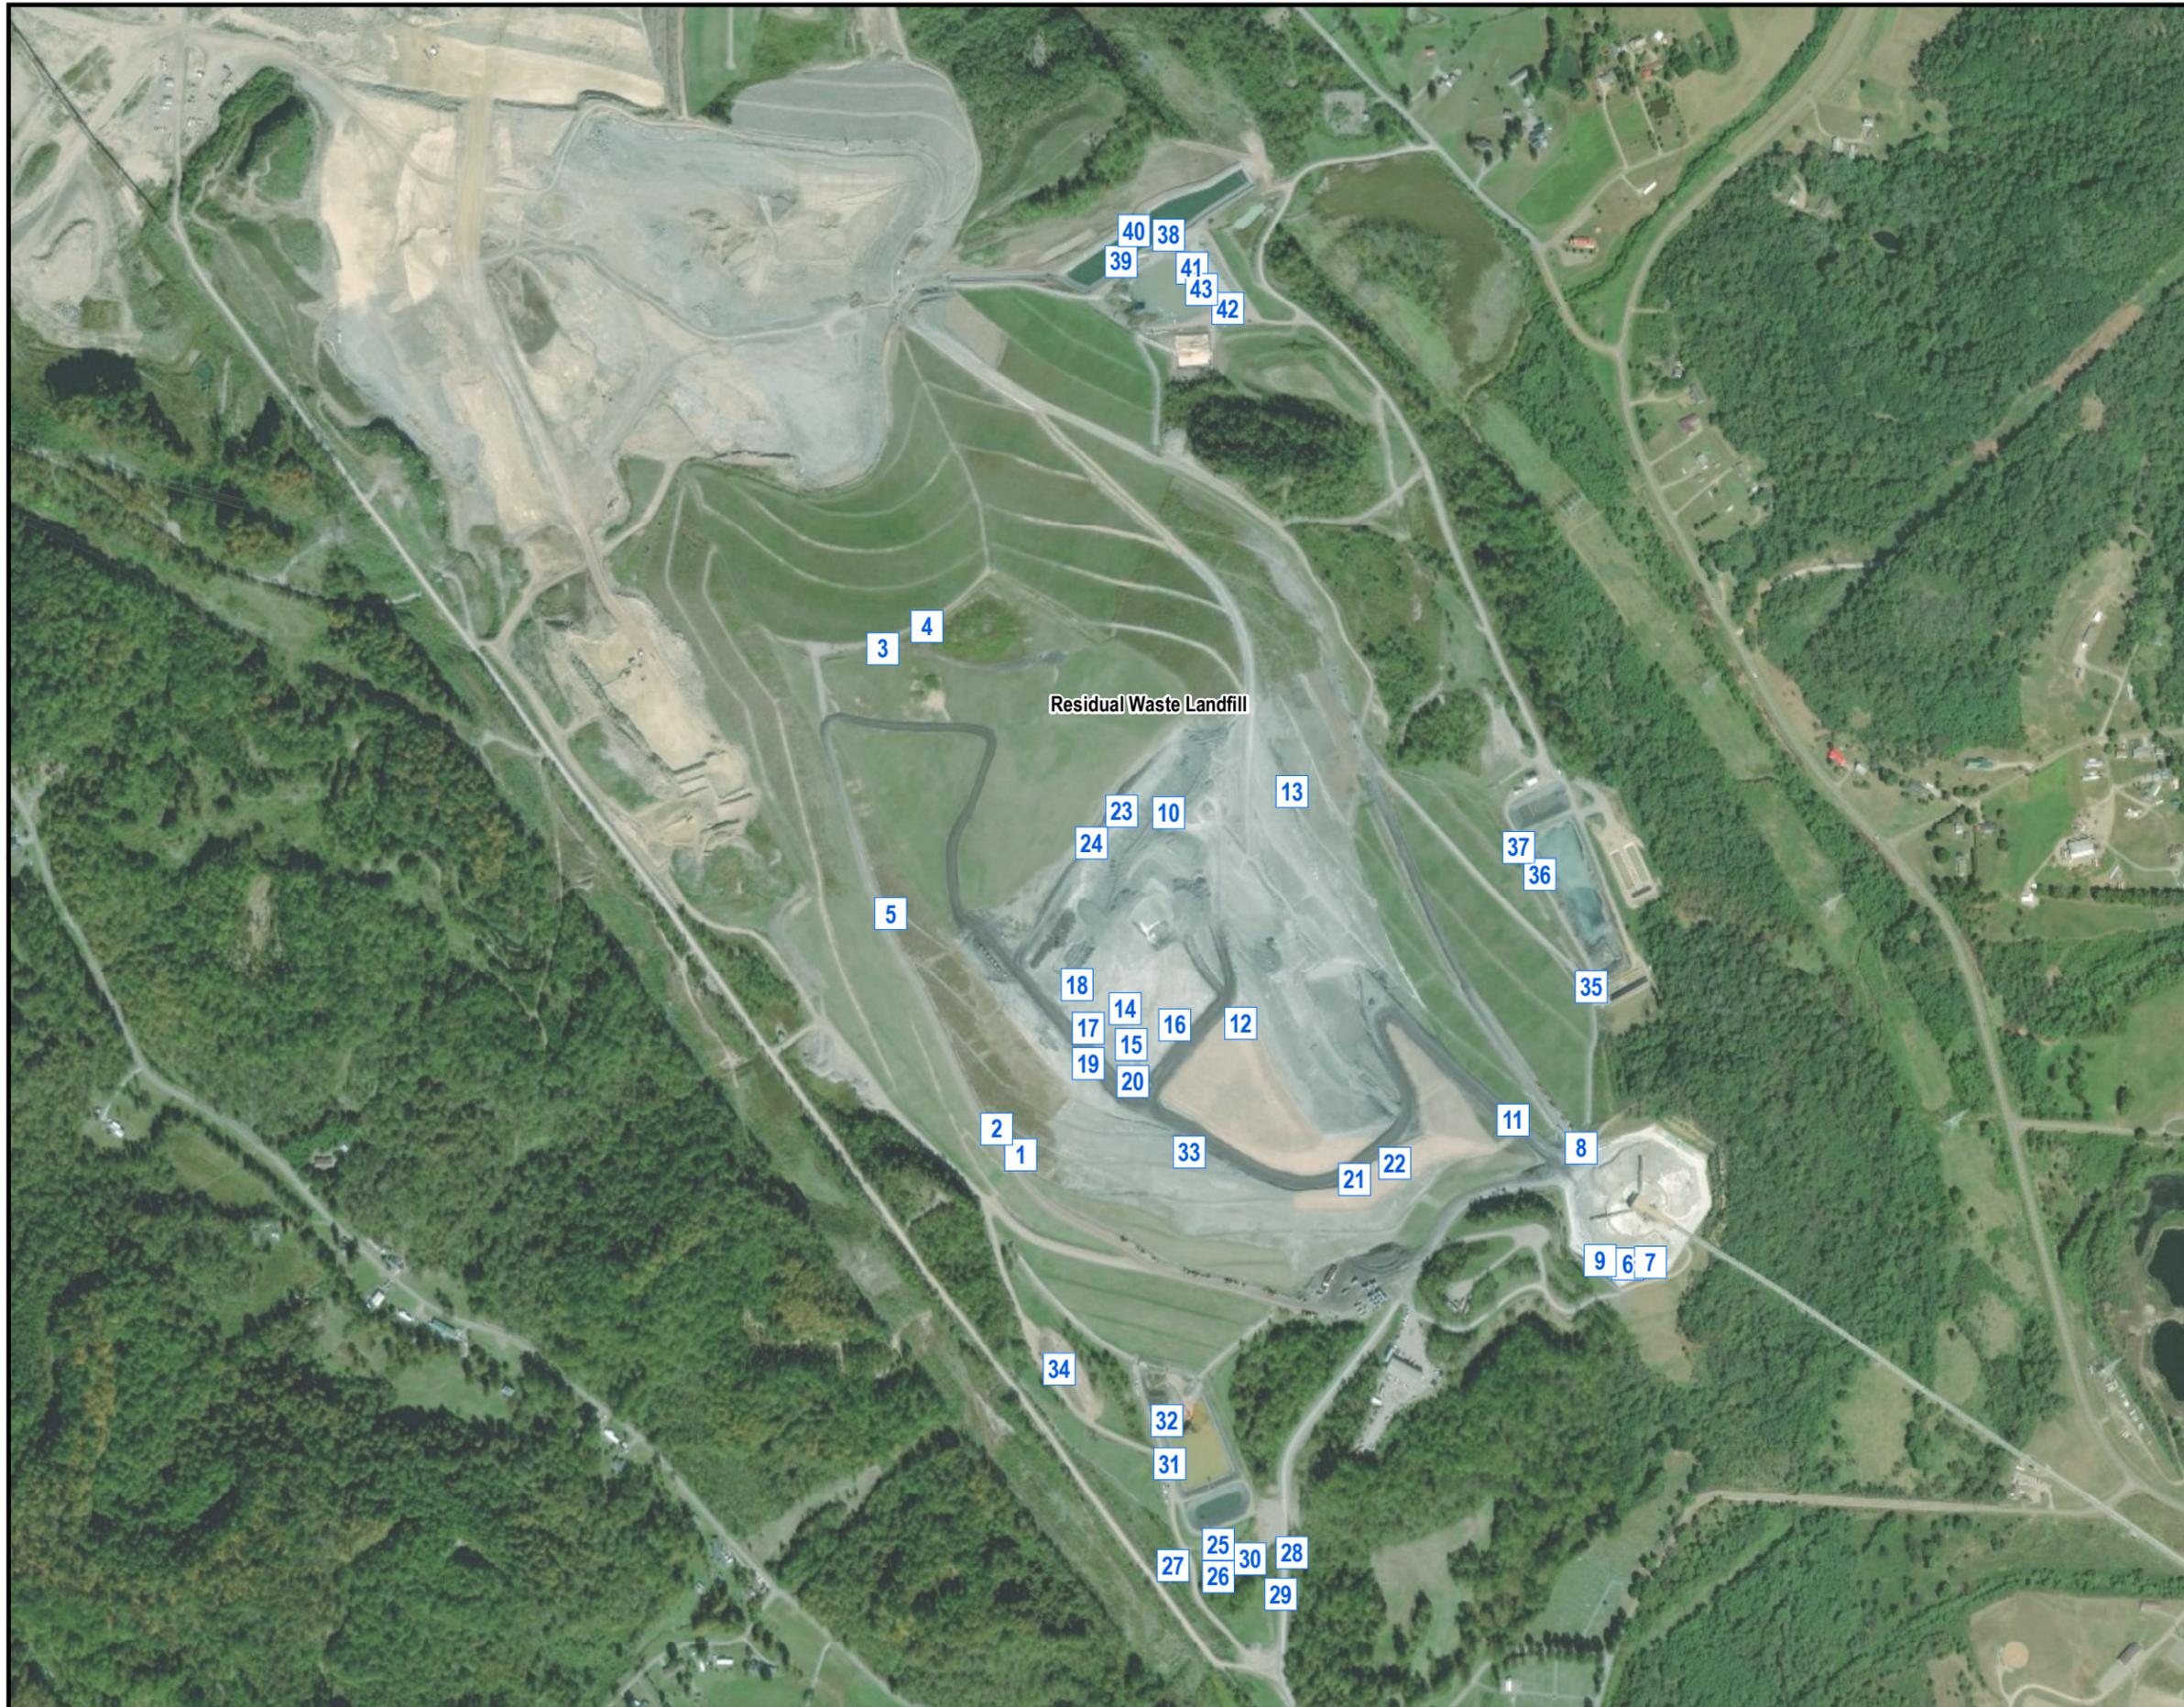
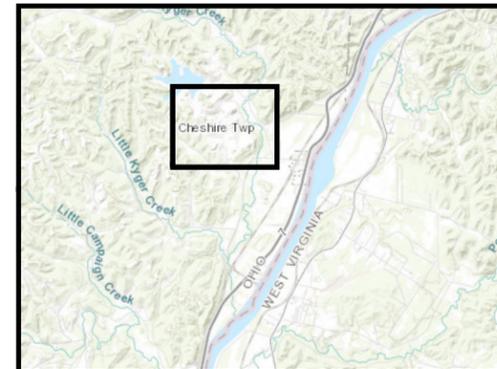
Construction under the PTI has been ongoing since 2016 and will proceed in phases until completion, which should occur over the next several years. The RWL has already completed construction of leachate/sedimentation Pond No. 5 and vertical flow wetlands associated with all three landfill pond outfalls. Since the last inspection, the RWL has been engaged in lateral expansion construction activities in the approximate areas shown on Figure 2.

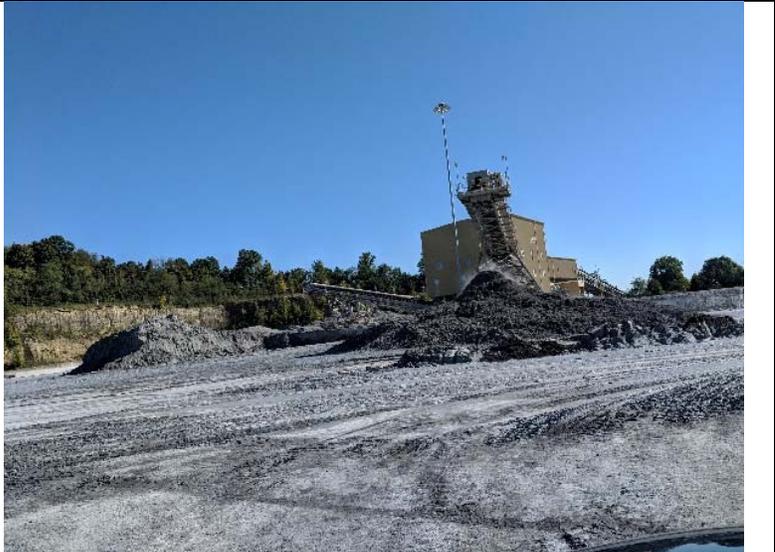
<p><b>Photograph #8</b></p>

<p>View of FGD stack out pad operations (looking east).</p>

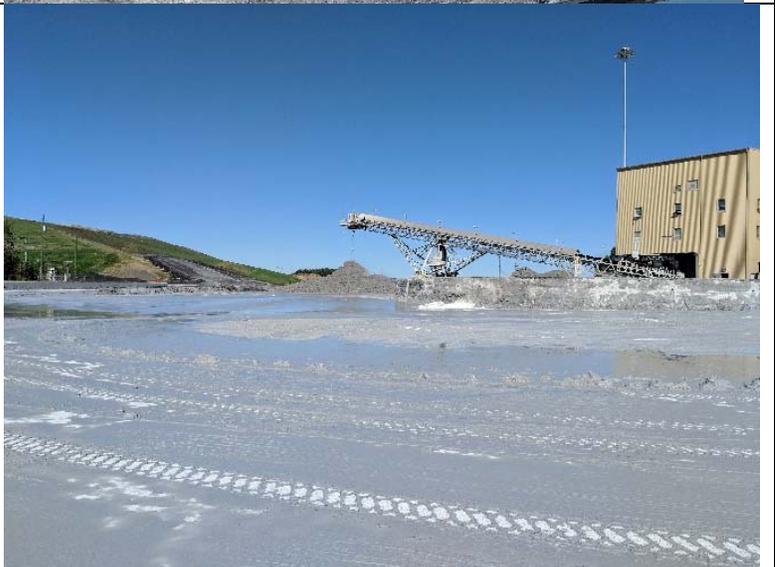
<p><b>Photograph #9</b></p>

<p>View of FGD stack out pad operations (looking south).</p>

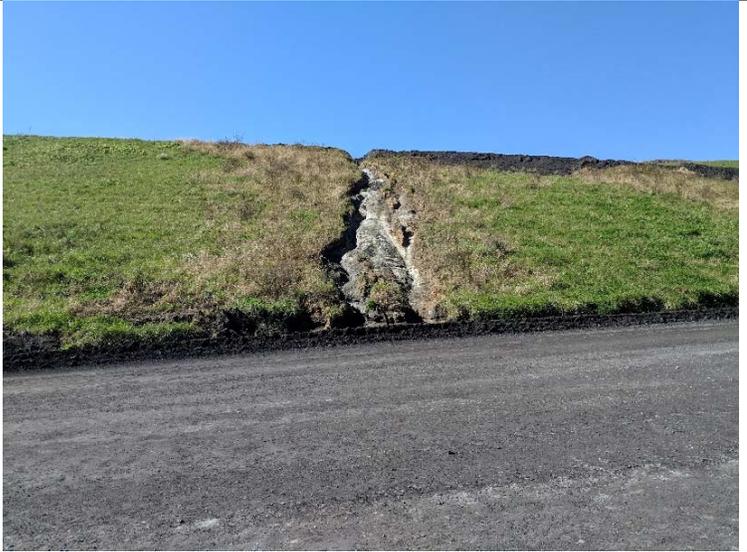
<p><b>Photograph #14</b></p>

The haul roads use bottom ash as a base course (as shown in Photographs 14, 17, and 20). The base course appears to compact well and holds up to repeated heavy equipment hauling. The haul roads observed by ERM appeared to be stable during the site drive/walkthrough and there was no visual evidence of significant distress (i.e., rutting or pumping). In addition, the roads generally had positive drainage from the centerline and there was no visual evidence of pooling water on the road surface. Storm water runoff from adjacent slopes is caught by drainage channels running parallel to the roads, and directed to stabilized outlets at the surrounding site treatment ponds. Sporadic evidence of minor erosion in the channel bottoms was observed, but overall roadside channels appeared to be well maintained.
