2025 Annual Inspection Report

Residual Waste Landfill

PREPARED FOR
Gavin Power, LLC

DATE
10 January 2026

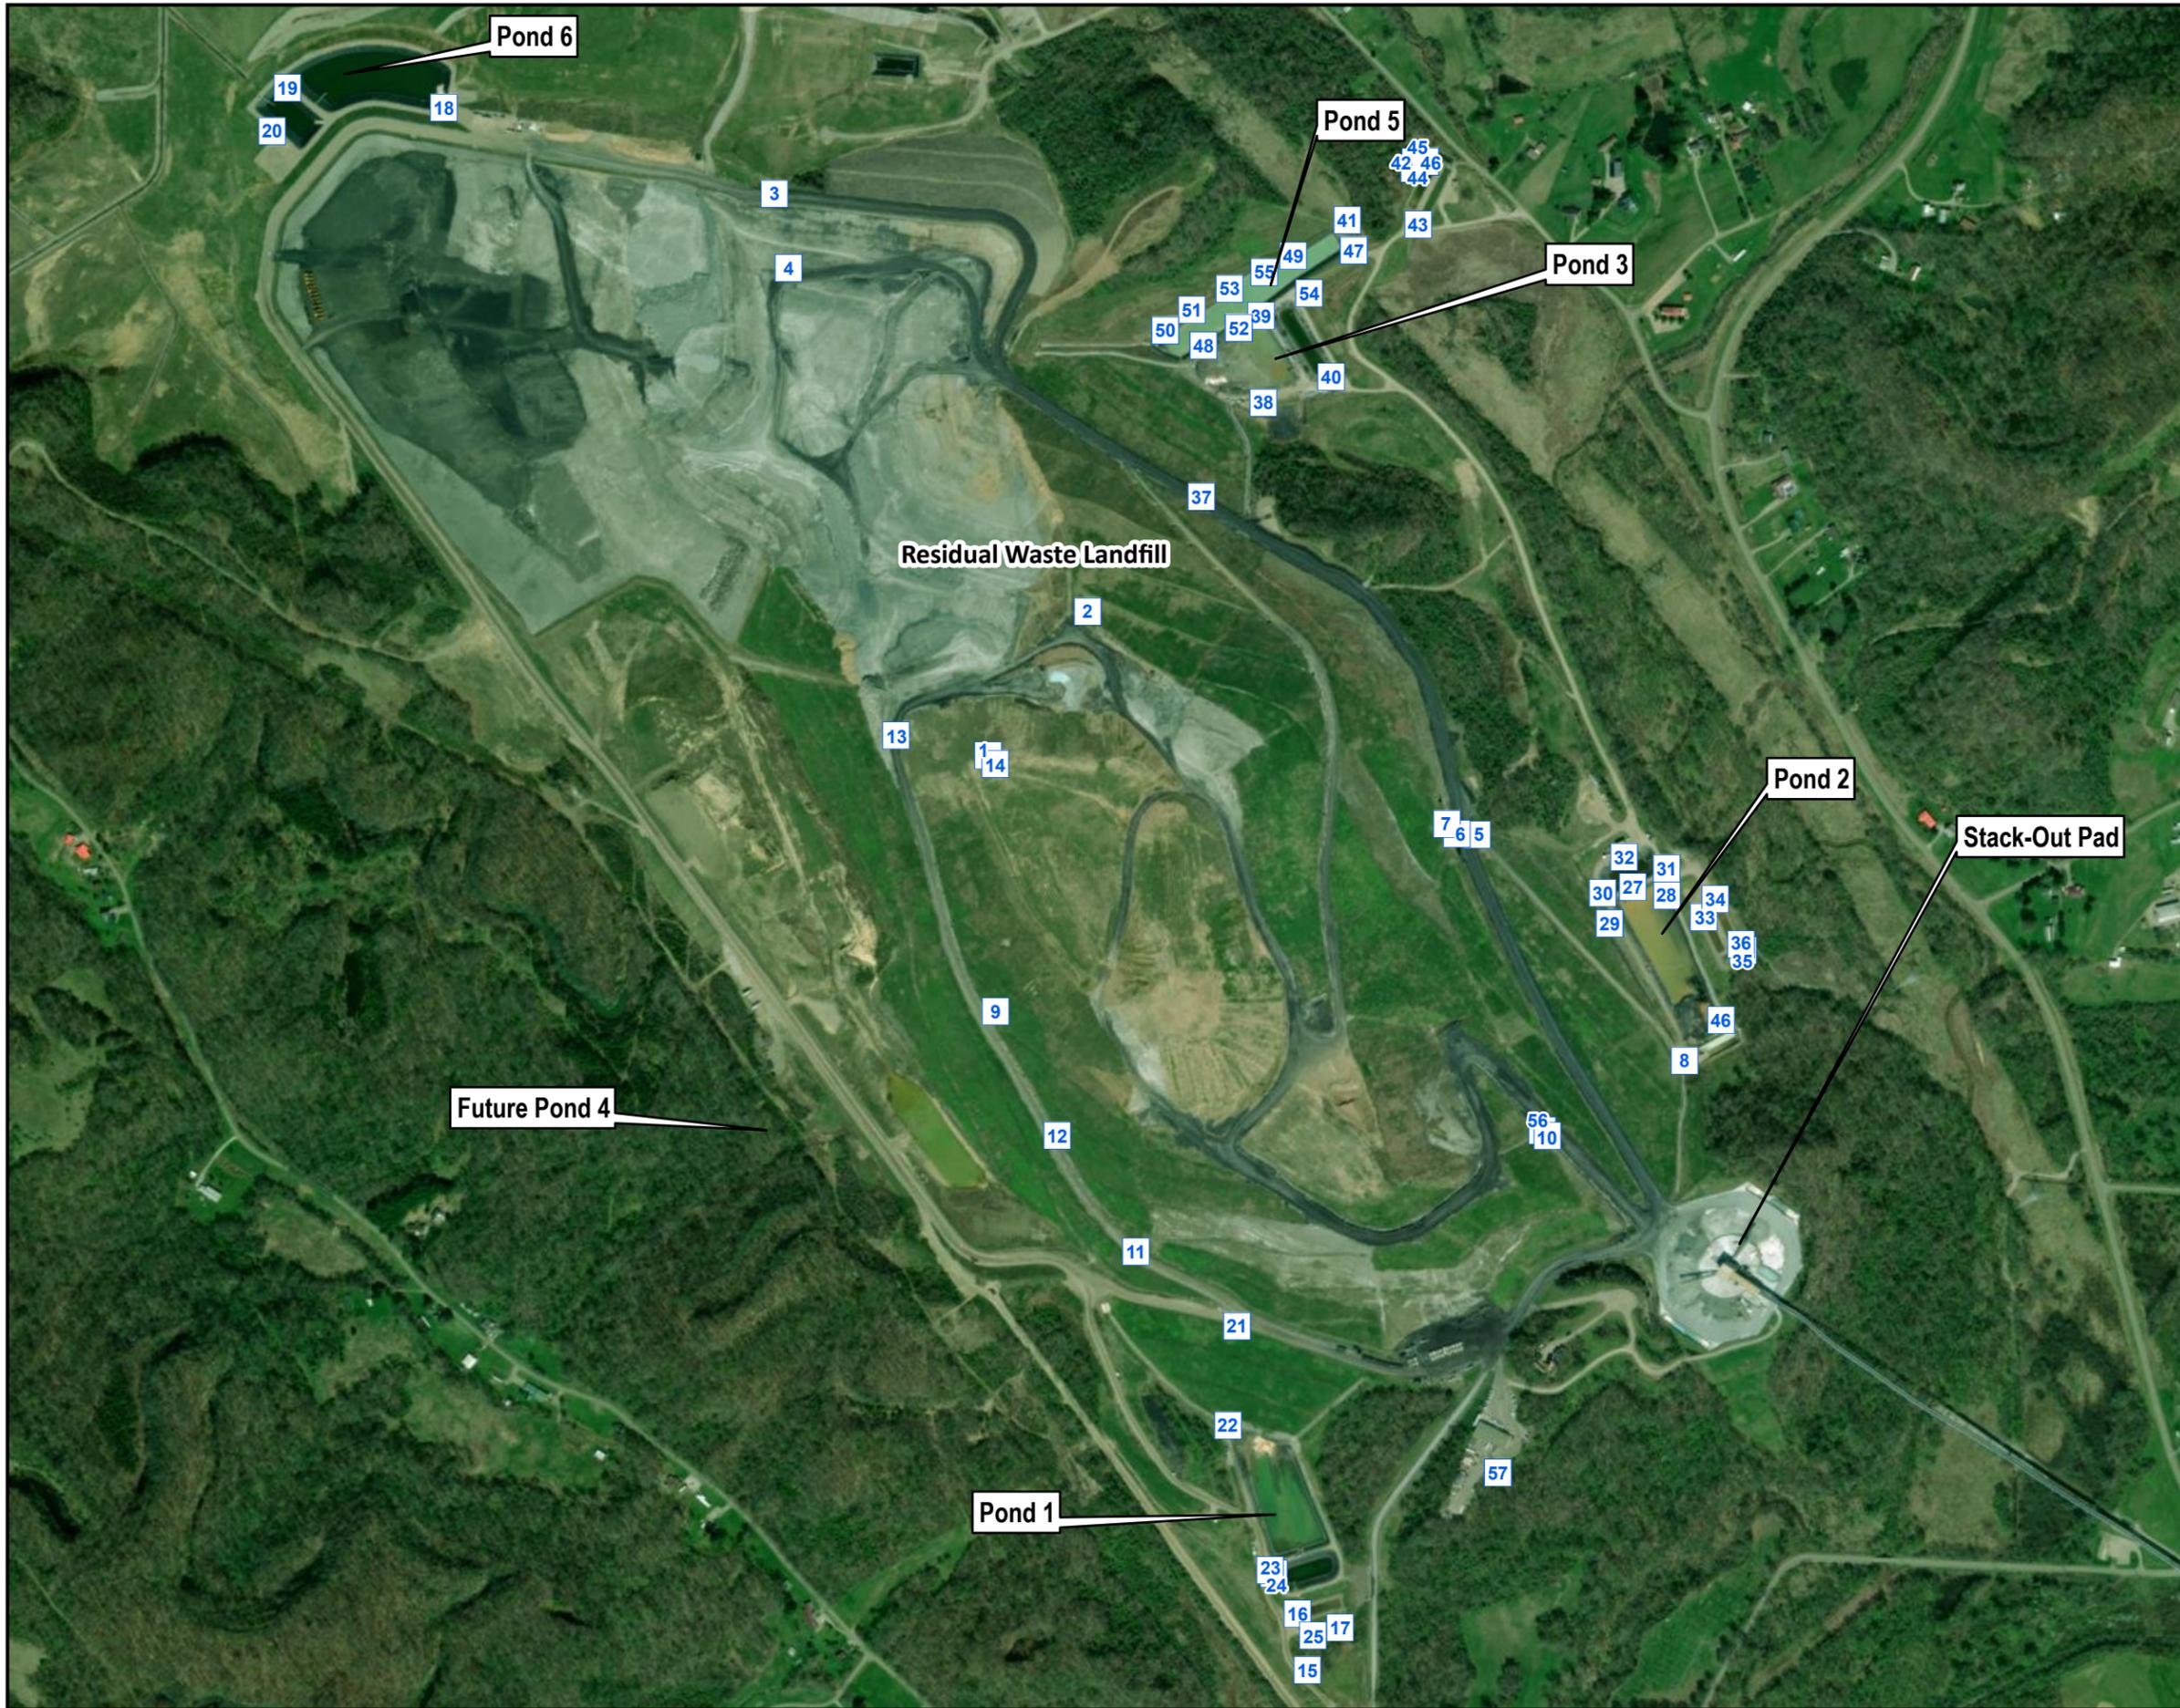
Figure 3: Visual Inspection Map
Residual Waste Landfill
Gavin Power LLC
Cheshire, Ohio

The 2025 annual visual inspection conducted for the RWL on 21 October 2025 is summarized below. Photographs referenced herein are located in **Appendix A**. The approximate locations where the photographs were taken are indicated in **Figure 3**. Qualitative terms used herein to describe the inspection are summarized in **Appendix B**.
