2025 Annual Inspection Report

Bottom Ash Pond

PREPARED FOR
Gavin Power, LLC

REFERENCE
0767401

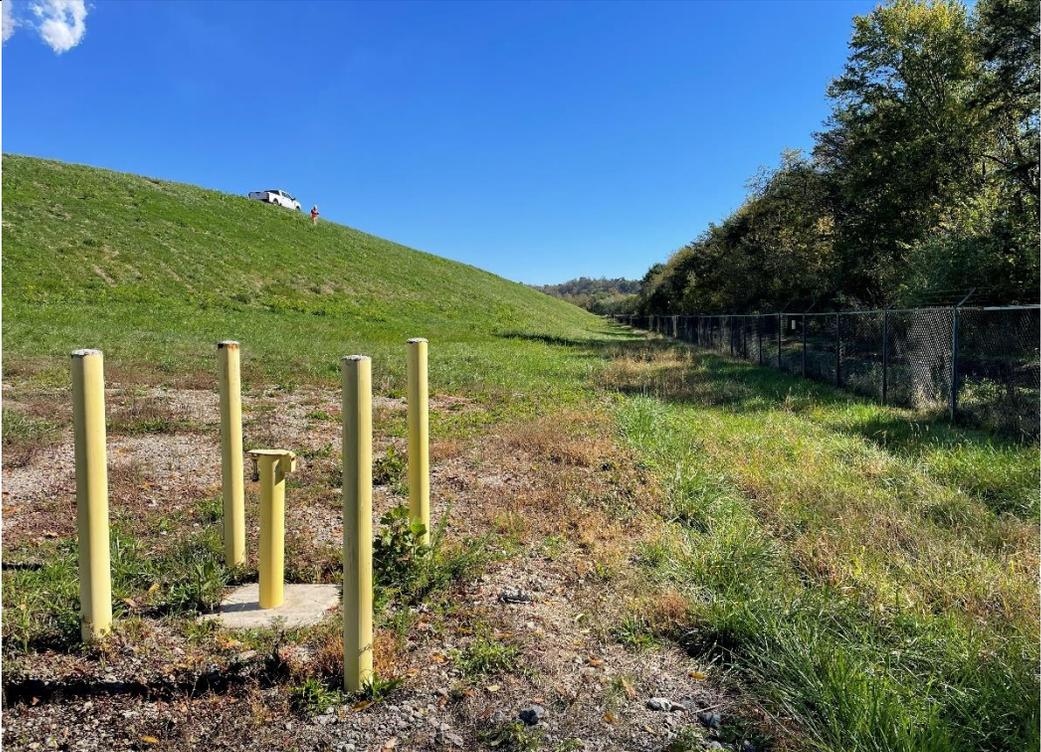
PHOTO NO. 15.	DATE 20 October 2025

DIRECTION PHOTO TAKEN East.		
DESCRIPTION View of BAP southern embankment exterior slope bottom near SW corner. Monitoring wells observed in good condition and locked.

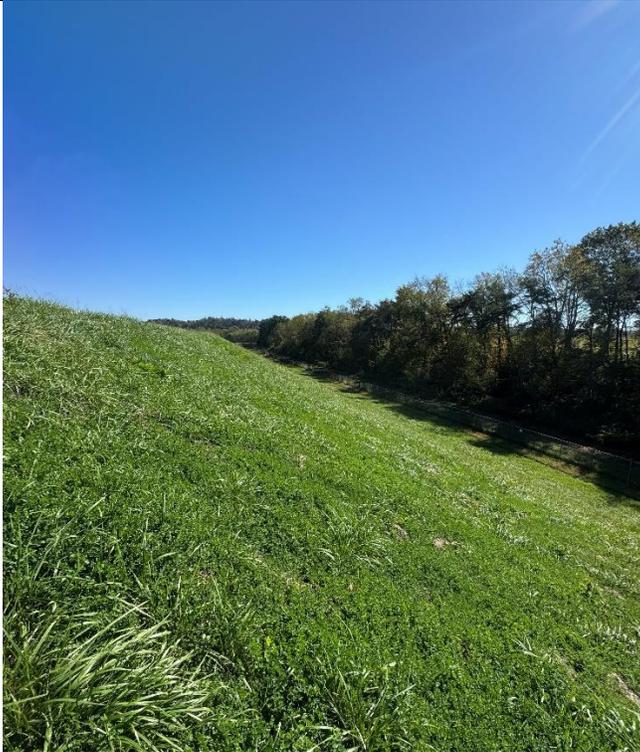
PHOTO NO. 17.	DATE 20 October 2025

1. No evidence of seeps along the toe of the embankment were observed.
2. The exterior slope exhibited no visual indications of significant misalignment, erosion, rutting or settlement and was well vegetated (Photographs 15 through 21).
3. The interior embankment slope appeared stable (Photographs 3 and 14). In several isolated locations, the shallow rill erosion has progressed into deeper erosion features approximately 12 inches deep on average. These deeper features appear to be related to preferential runoff pathways from the crest access road. Monitoring of the progression of these deeper features is

DIRECTION PHOTO TAKEN East.		
DESCRIPTION View of BAP southern embankment exterior slope. Vegetation cover observed in general good condition.

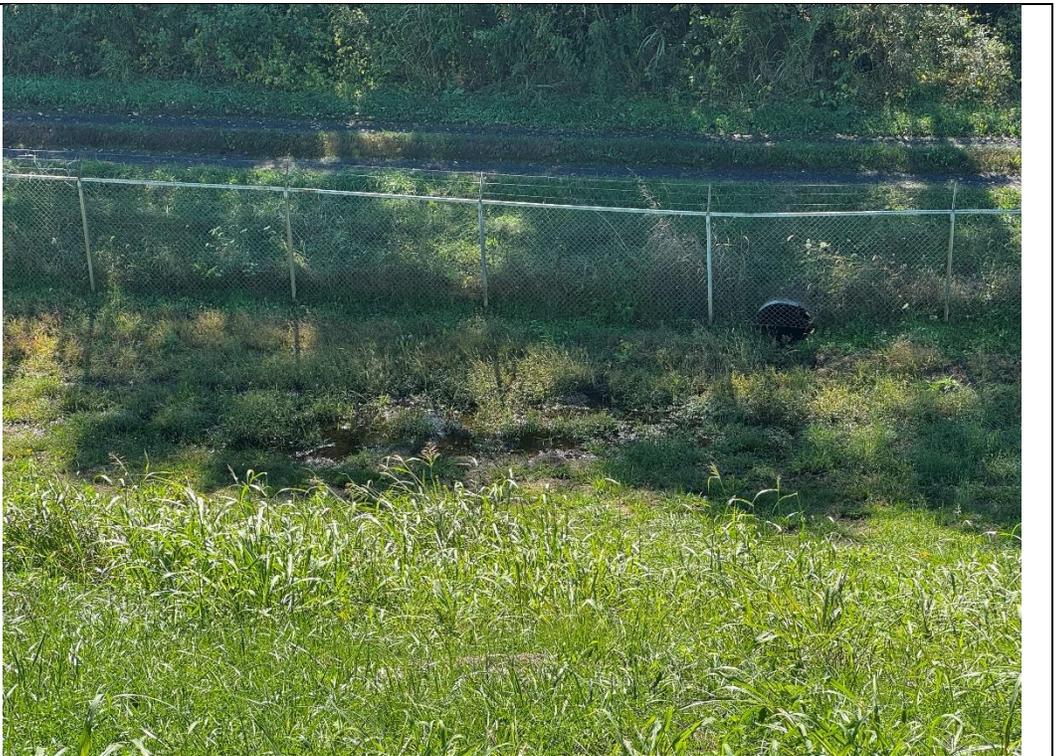
<p>PHOTO NO. 19.</p>	<p>DATE 20 October 2025</p>

<p>DIRECTION PHOTO TAKEN Top view.</p>		
<p>DESCRIPTION View of BAP southern embankment exterior slope from top.</p>

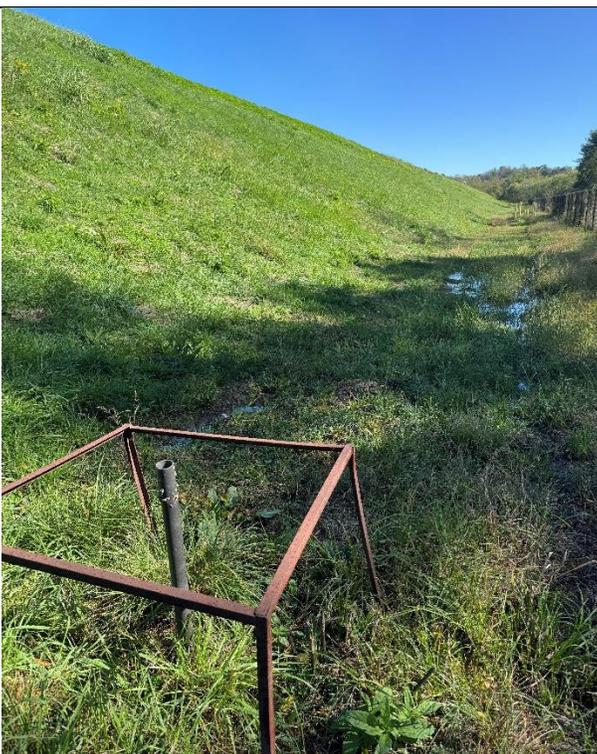
<p>PHOTO NO. 20.</p>	<p>DATE 20 October 2025</p>

<p>DIRECTION PHOTO TAKEN East.</p>		
<p>DESCRIPTION View of BAP southern embankment exterior slope from bottom. Remnant water from rainfall the morning of the inspection.</p>

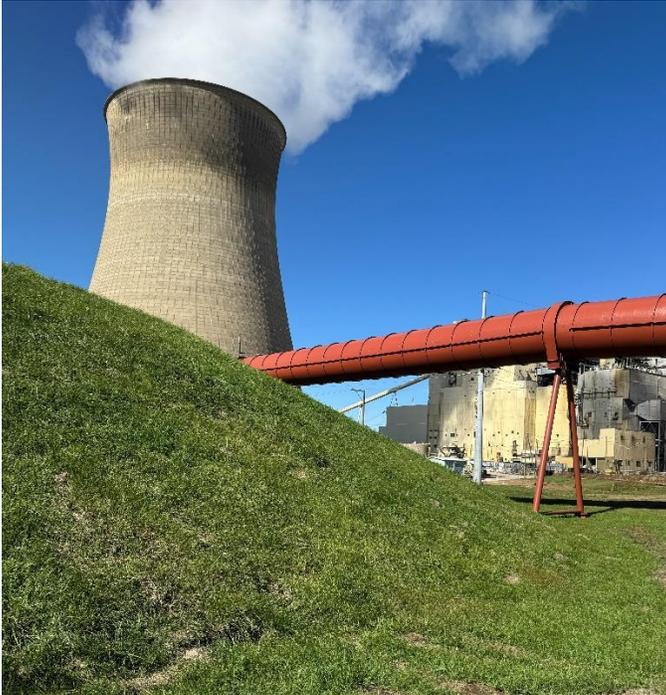
PHOTO NO. 29.	DATE 20 October 2025

DIRECTION PHOTO TAKEN Northwest.		
DESCRIPTION View of BAP eastern embankment exterior slope at NE bottom corner. Generally good condition and vegetation cover observed.

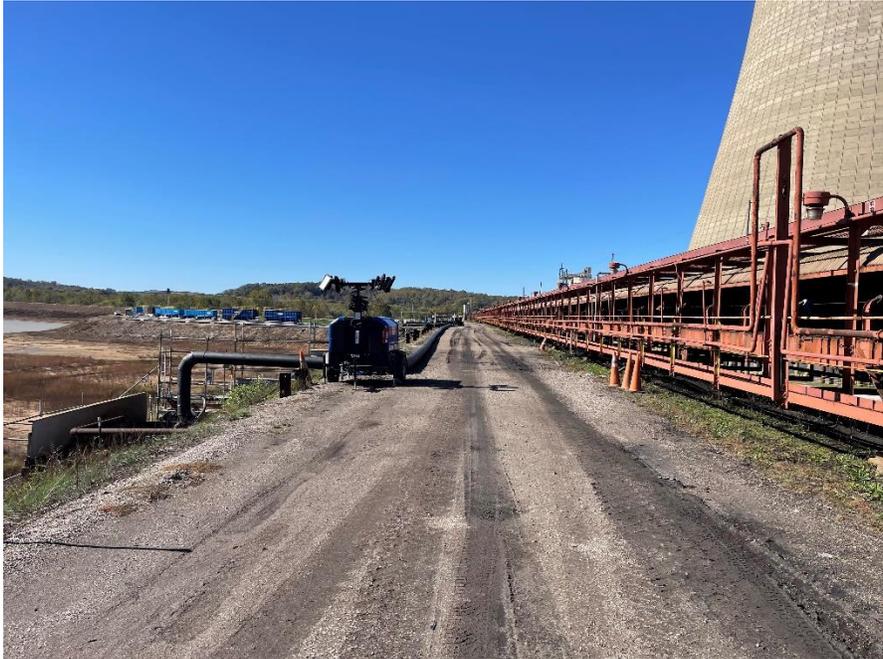
PHOTO NO. 30.	DATE 20 October 2025

1. No evidence of seeps along the toe of the embankment were observed.
2. The northern embankment access road was found to be in stable condition and remains well maintained (Photo 30).

DIRECTION PHOTO TAKEN West.		
DESCRIPTION Northern embankment access road, from NE corner of BAP.

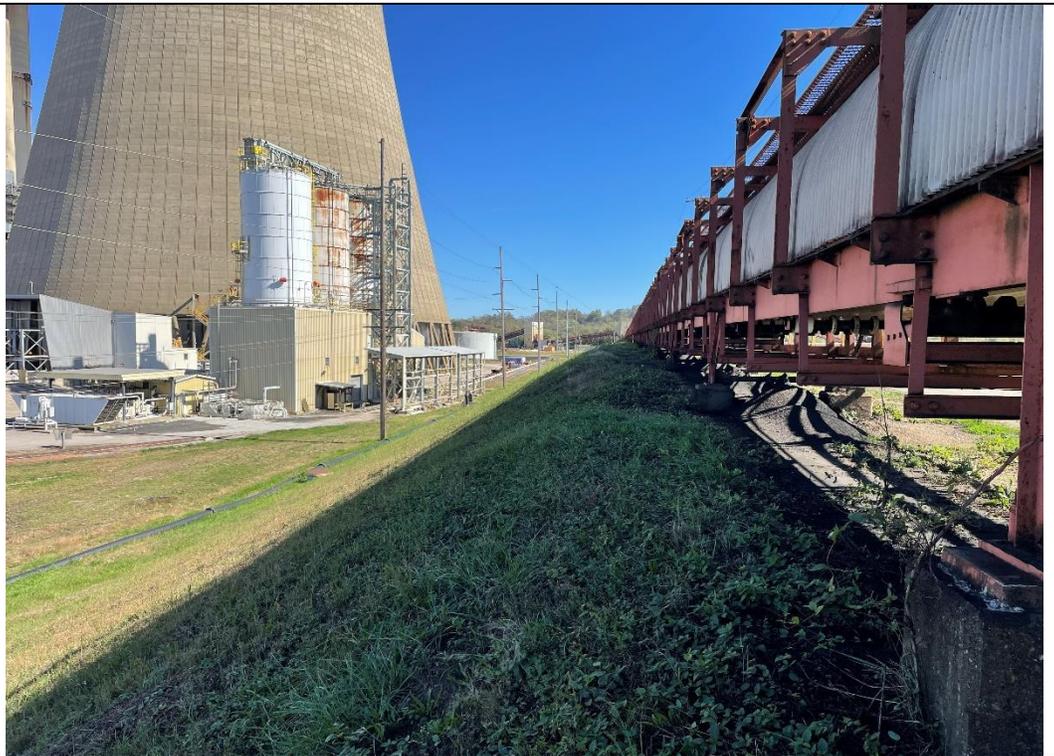
<p>PHOTO NO. 37.</p>	<p>DATE 20 October 2025</p>

<p>DIRECTION PHOTO TAKEN East.</p>		
<p>DESCRIPTION View of BAP northern embankment exterior slope from NW top corner. Generally good vegetation cover observed.</p>

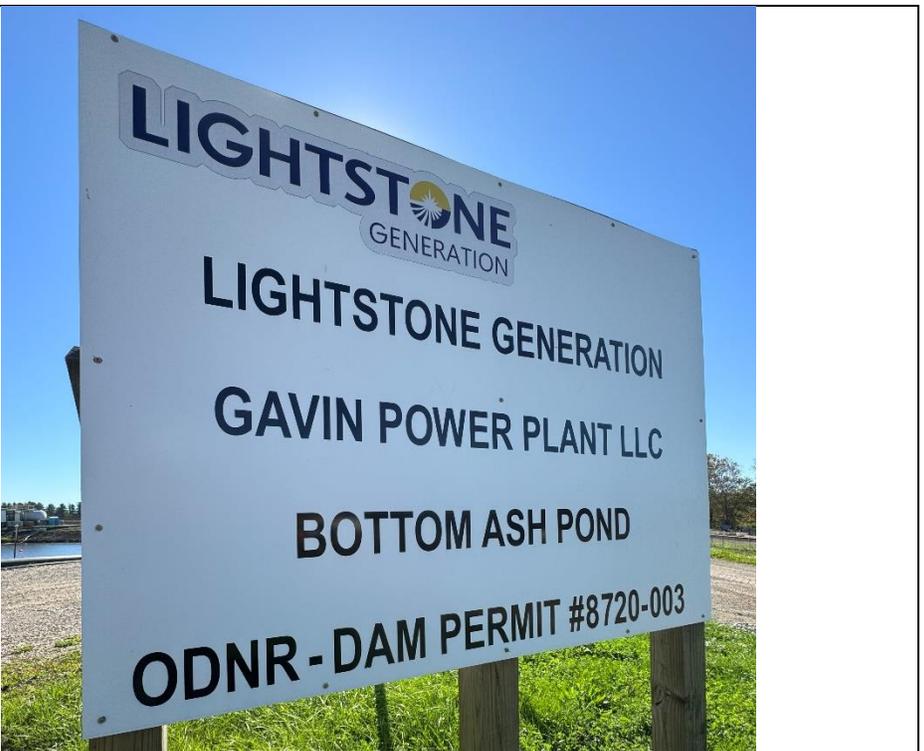
<p>PHOTO NO. 40.</p>	<p>DATE 20 October 2025</p>

<p>DIRECTION PHOTO TAKEN Front view.</p>		
<p>DESCRIPTION View of BAP permit sign at entrance.</p>
