2020 Annual Inspection Report

Gavin Power, LLC

Residual Waste Landfill

Gavin Power Plant
Cheshire, Ohio

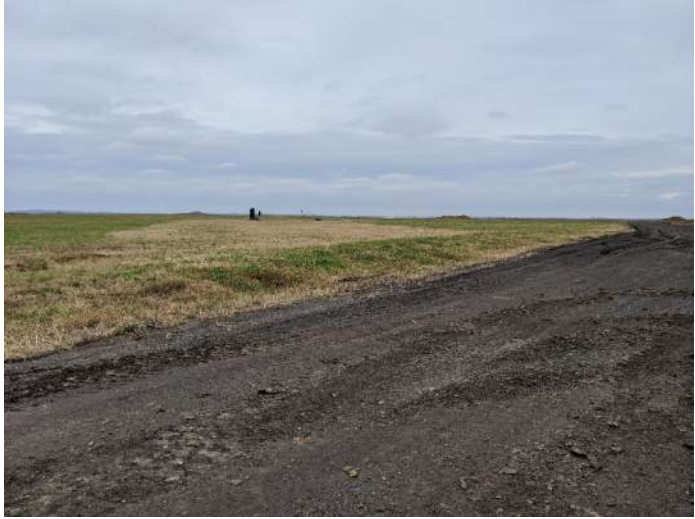
<p>Photograph #10</p>

<p>View of interim summit of landfill with intermediate soil cover and vegetation growing. (looking north).</p>	
<p>Photograph #11</p>

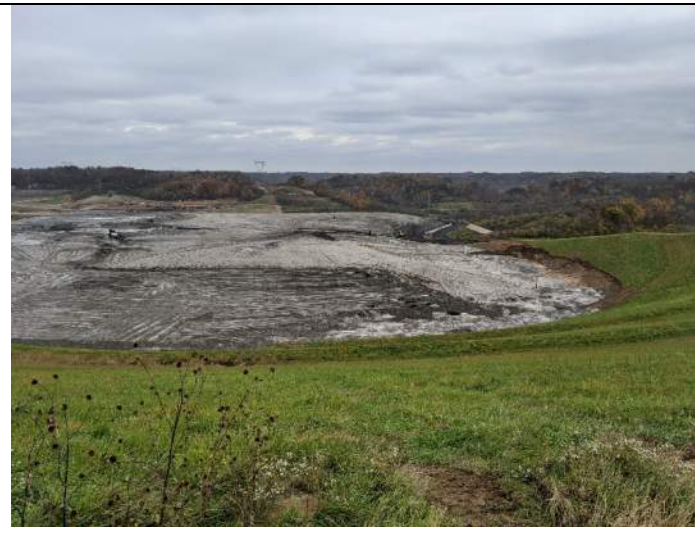
<p>View of Phase H and intermediate soil covered and vegetated northern slope. (looking east)</p>	
<p>Photograph #12</p>

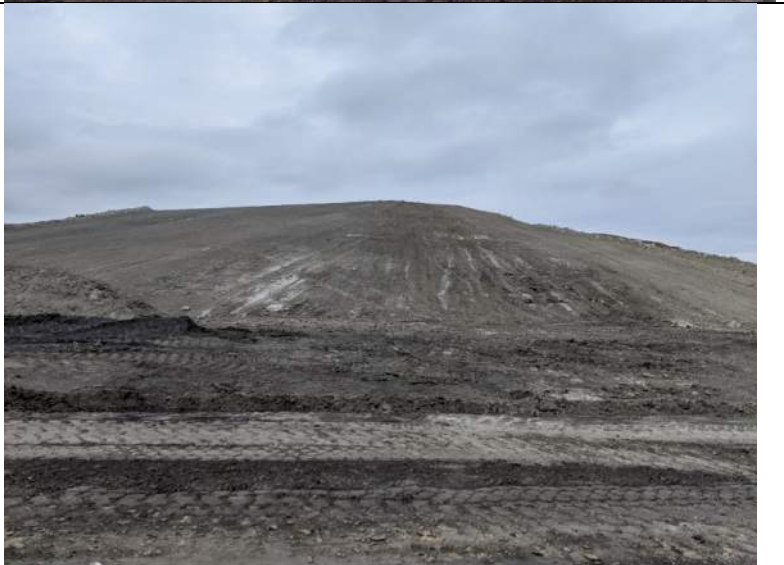
<p>Southern slope of FGD summit being regraded. (looking north)</p>	
<p>Photograph #18</p>

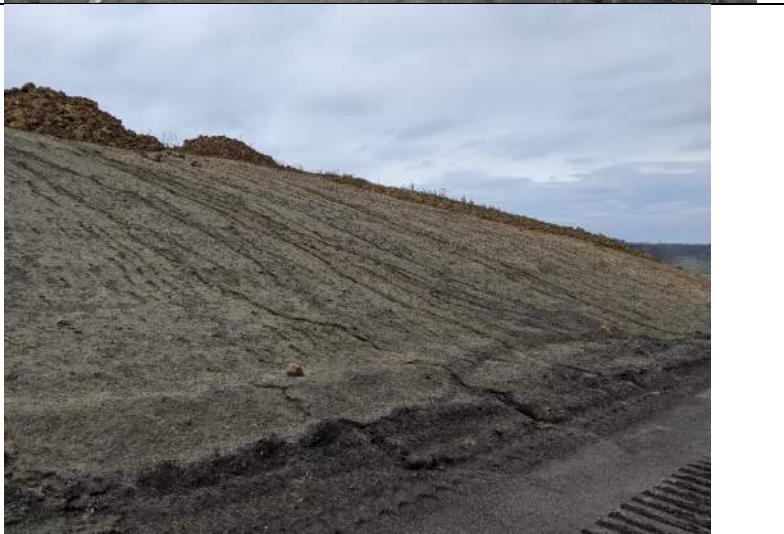
<p>Southern slope of FGD summit with placement of intermediate soil cover in progress. (looking northwest)</p>

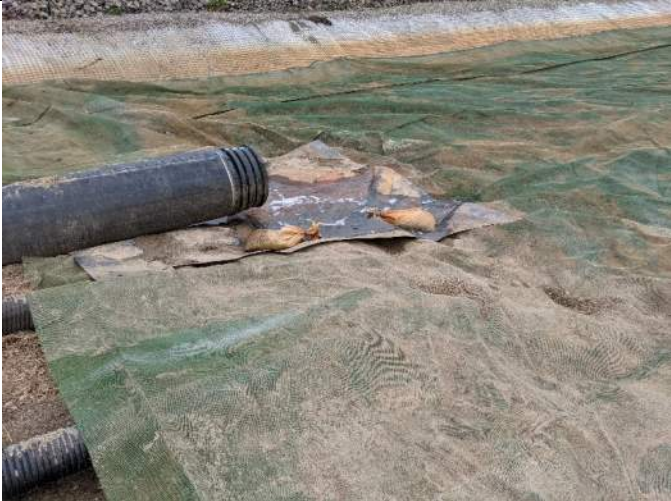
<p>Photograph #24</p>

<p>View of inlet pipes for vertical flow wetland treatment adjacent to Pond No. 1 (looking northeast).</p>	
<p>Photograph #25</p>

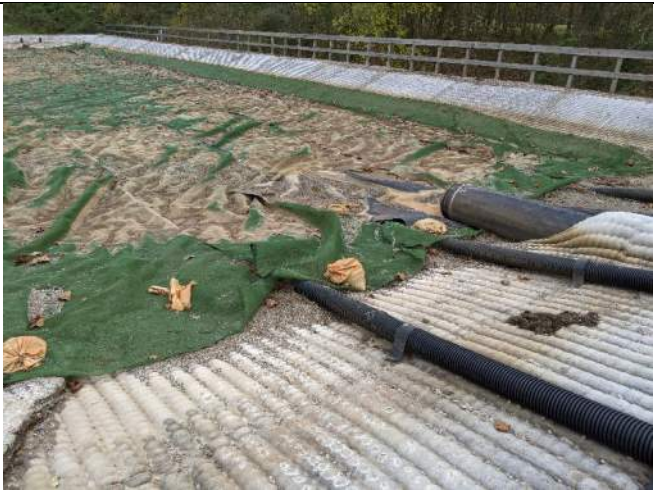
<p>View of Pond No. 1 vertical flow wetland (looking southeast).</p>	
<p>Photograph #26</p>

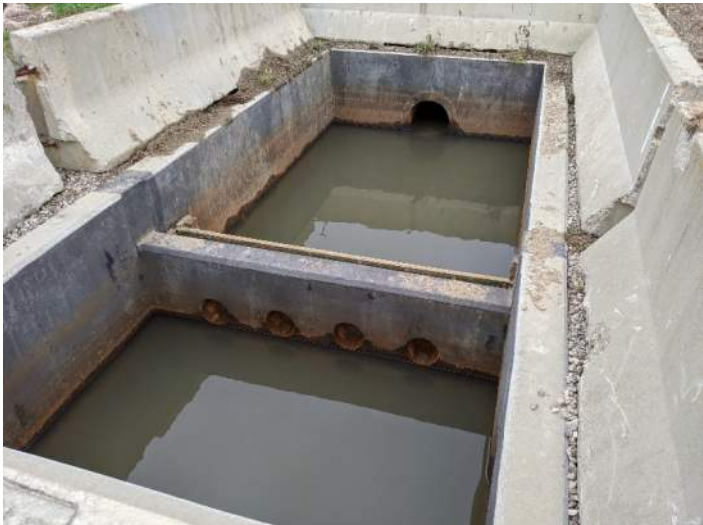
<p>View of inlet structures for Pond No. 1 vertical flow wetland.</p>

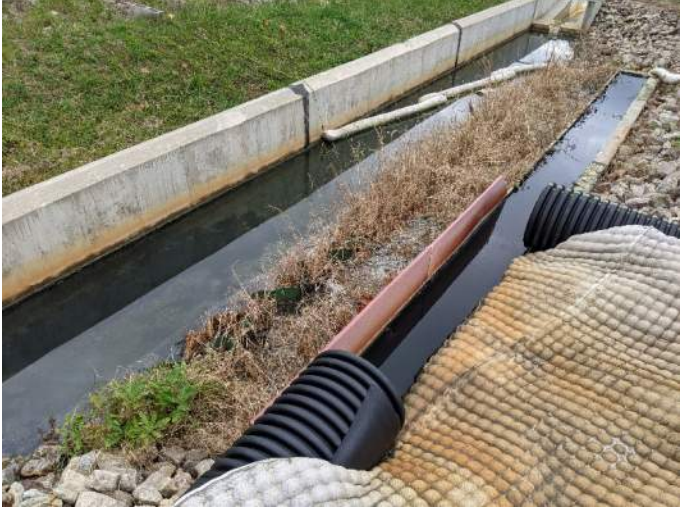
<p>Photograph #27</p>

<p>Outlet for vertical flow wetland at Pond No. 1 (looking southeast)</p>	<p>Photograph #28</p>
<p>Flow meter looking north at Pond 1 (looking north)</p>

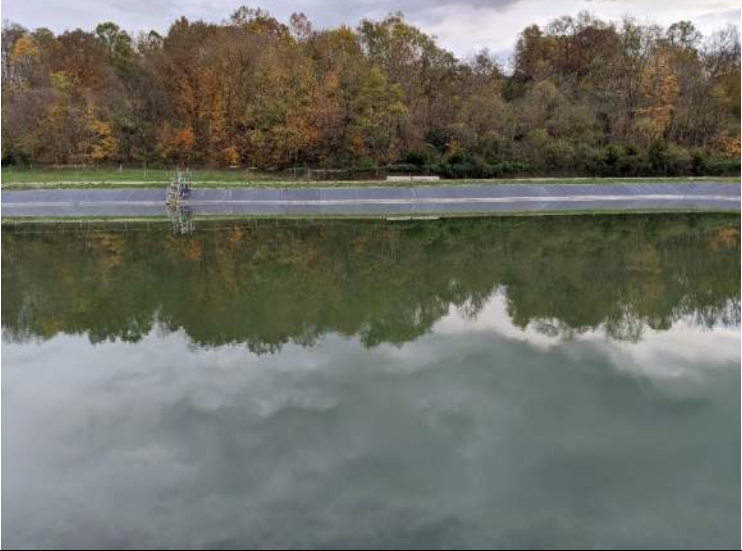
<p>Photograph #29</p>

Pond No. 1 on the south side of the RWL appeared to be functioning properly during the annual inspection. The sedimentation/treatment portion of Pond No. 1 was observed to contain varying amounts of solids within the limits, as observable in Photographs 29, 30, and 31. This pond is routinely cleaned of accumulated solids, typically through the use of extended-reach excavators or a floating dredge. Based on a visual assessment, Pond No. 1 was noted to have a similar amount of sedimentation as observed during the 2019 inspection.

<p>View of slope and Pond No. 1 (looking east).</p>

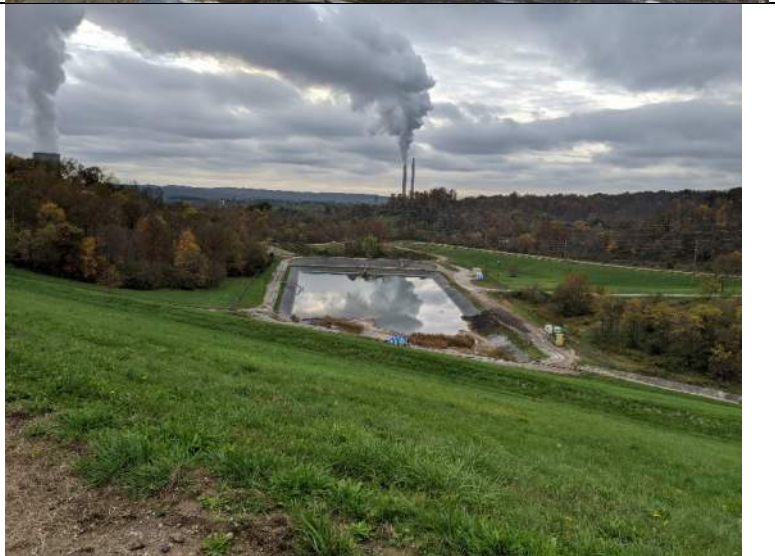
<p>Photograph #31</p> <p>View of Pond No. 1 and southwest slope into pond (looking south).</p>

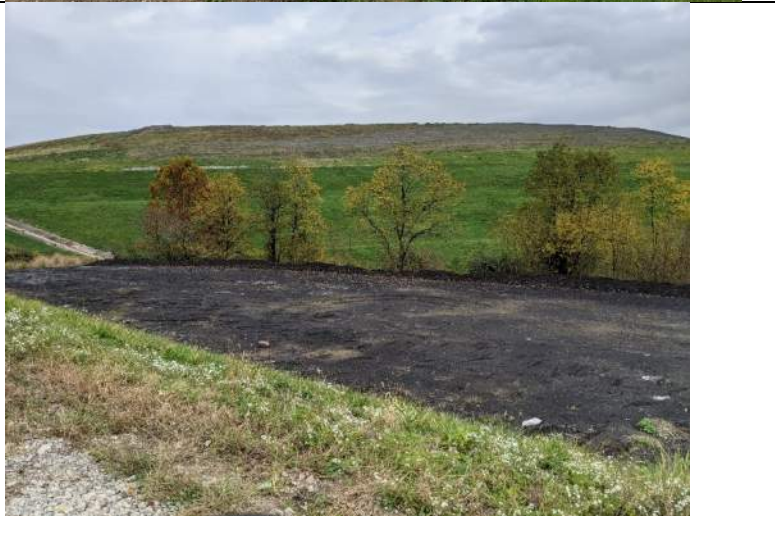
There was no active dredging during the inspection, so no dewatering bags were present. The current storage location for the dewatering bags for Pond No. 1 is depicted on Photograph 32. The containment area for the dewatering bags was not retaining stormwater.

<p>Photograph #32</p> <p>View of where the dewatering bags for sludge collected from Pond 1 are stored when in use. No dredging is currently taking place (looking north).</p>

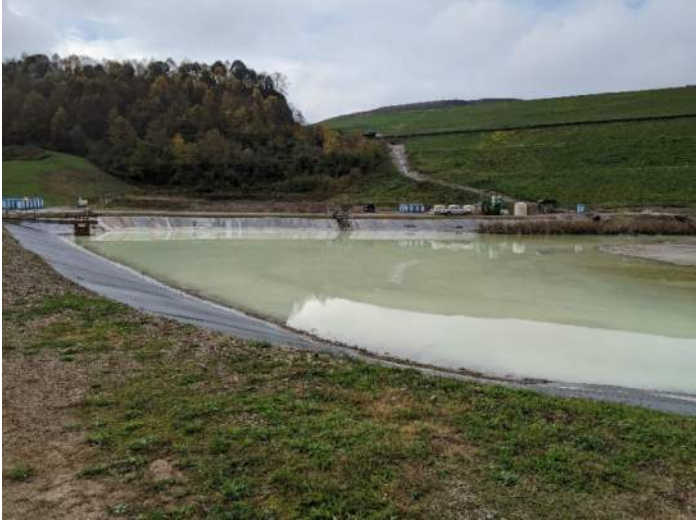
<p>Photograph #38</p>

Pond No. 3 on the northeast side of the RWL was observed to be functioning satisfactorily during the annual inspection. Within Pond No. 3 there was vegetation observed within the central portion and along the western end as indicated in Photographs 38 and 39 (closest to the RWL), similar to the observations in the 2019 inspection. Pond No. 3 appears to have accumulated more solids in the open water portion of the pond since the previous annual inspection. This is based on observation that the solids level appeared to be just below the operating water level in several locations. Hydrogen peroxide was observed being added at the leachate inflow point this pond resulting in elemental Sulphur and white colored solids accumulating near the headworks of the pond. A small number of minor holes and tears were noted above the operating level of the main pond.

<p>Pond 3 overview (looking southwest)</p>	
<p>Photograph #39</p>

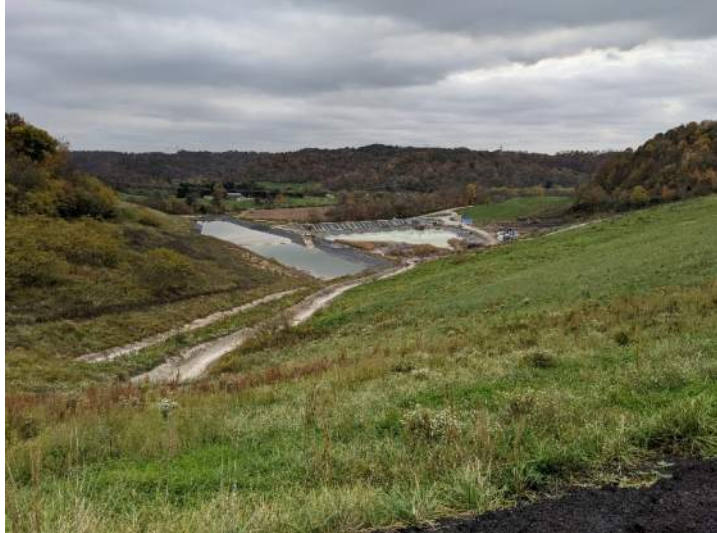
Photograph #43

Anchor trench on southern end has been repaired (looking east)

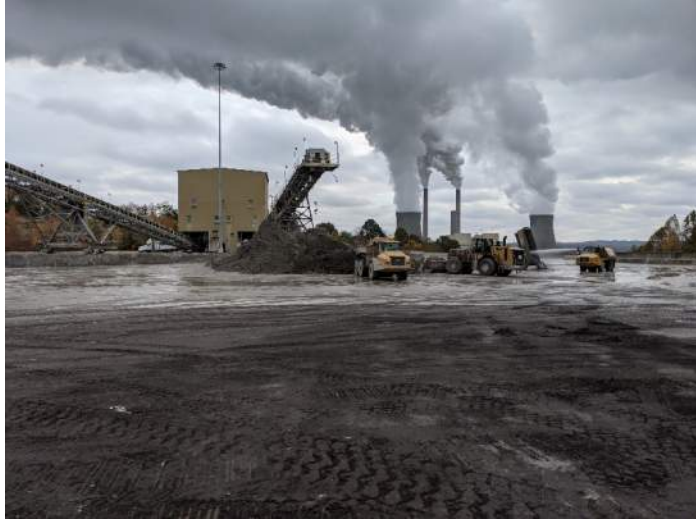
Photograph #47

Photographs 46 and 47 depict operating conditions at the FGD stack-out pad during the annual inspection. There was minimal FGD production on the day of the inspection, and the material was satisfactorily handled and contained on the pad prior to being loaded into haul trucks. Active disposal operations were occurring in Phase H.

View of FGD stack out pad operations (looking southwest).
