DAM & DIKE INSPECTION REPORT

Bottom Ash Complex Stingy Run Fly Ash Dam

**GAVIN PLANT
CHESHIRE, OHIO**

INSPECTION DATE October 25, 2016

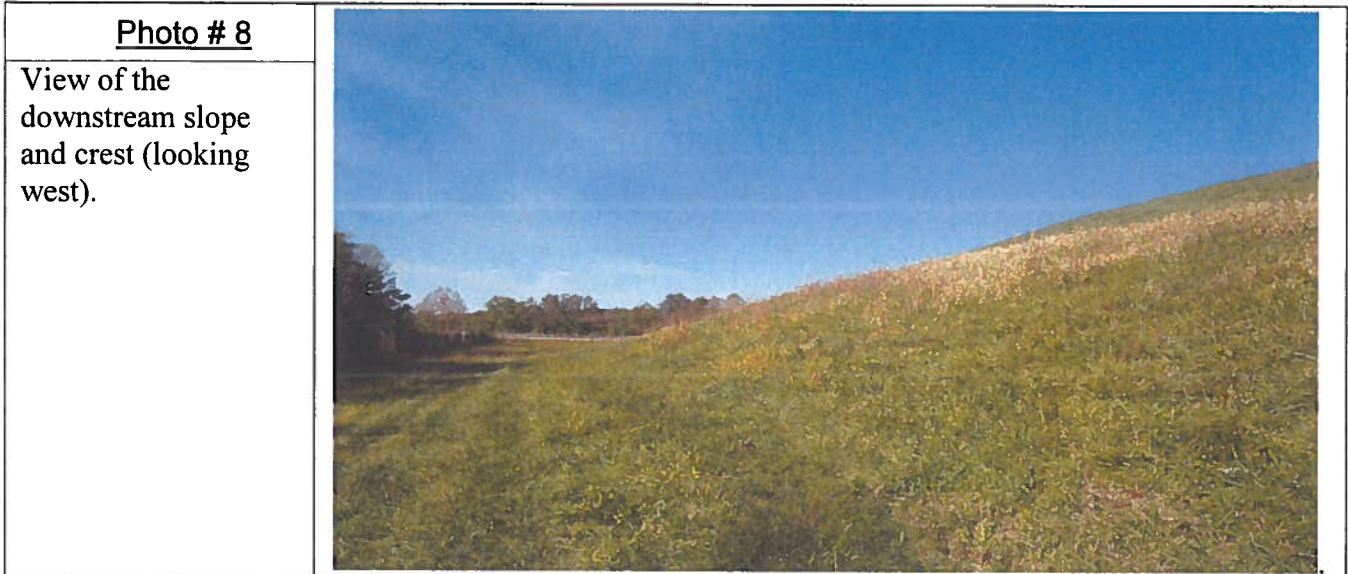
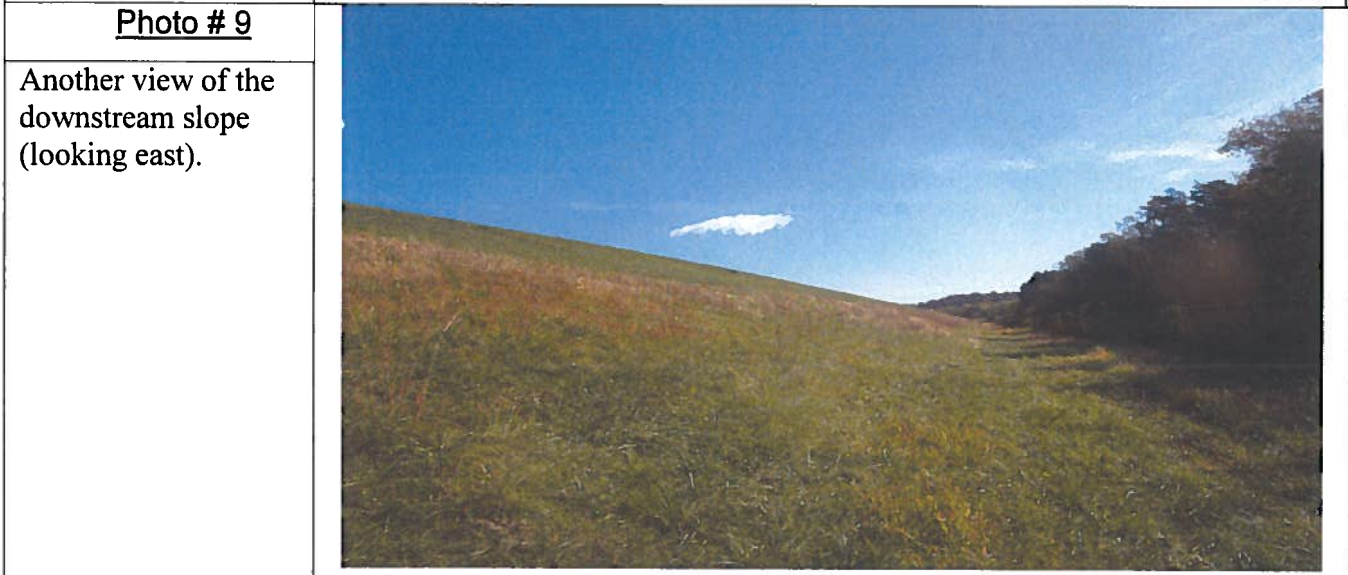
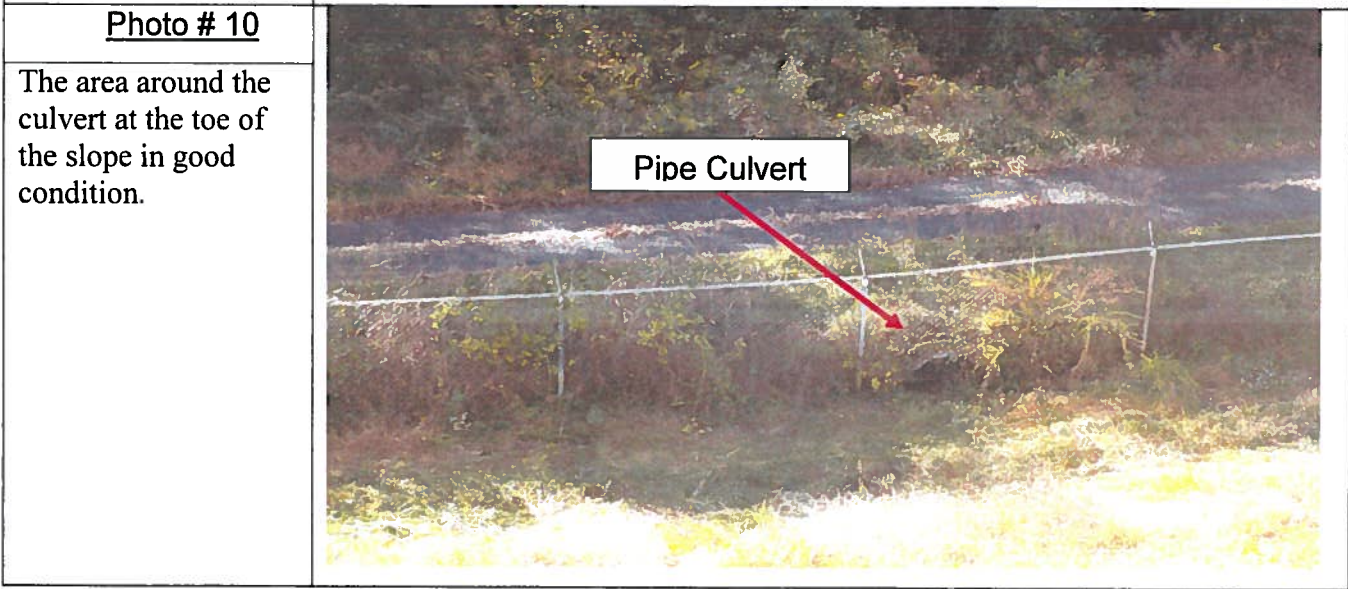
2016 Annual Dam and Dike Inspection
Gavin Plant – Bottom Ash Pond (South Dike)

- (i) An overall view of the downstream slopes of the south dike is illustrated in Photographs No. 8 and 9. Overall the vegetation cover on the slopes was well maintained and in good condition. The toe ditch along the chain link fence appeared clear, dry with positive flow.
- (ii) Photograph No. 10 shows an area where the underground culvert is located and collects the surface runoff and drains to the ditch on the other side of the property boundary. A chain link fence is located where the underground pipe culvert is present. The fence is the boundary line between the Gavin and Kyger Creek plants. The function of the culvert is to discharge surface runoff from this area at the toe of the dike (Gavin plant) to the ditch on the other side of the property

boundary (Kyger plant). The pipe indicated positive flow and in good functional condition.

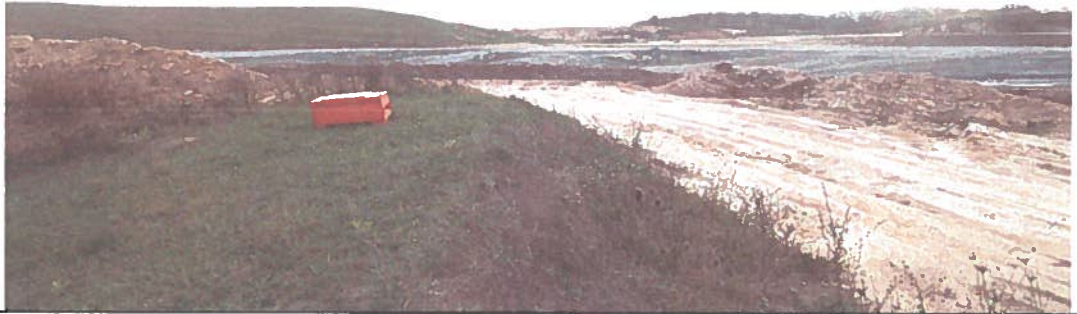
Photo # 34

- (i) Photograph No. 33 illustrates the hillside and right (south) abutment. The hillside is excavated to about the elevation of the crest for the construction of the landfill. The abutment and remaining hillside appeared in good and stable condition. Photograph No. 34 illustrate the north berm for the landfill at the groin of the downstream slope.

Right abutment, groin at the upstream slope.

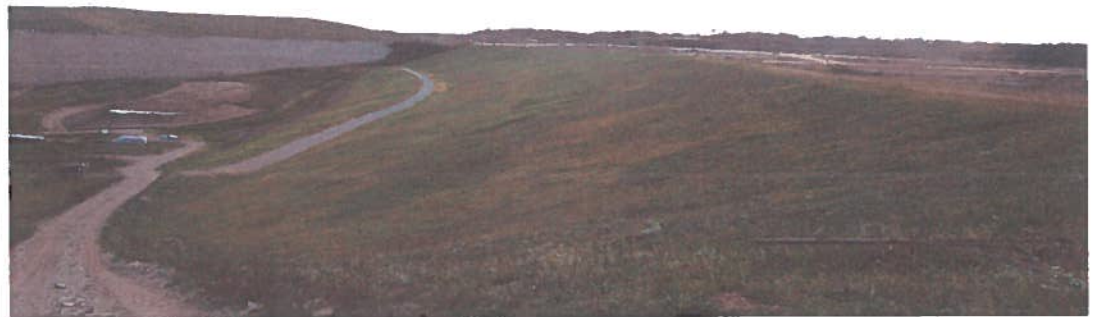
Photo # 47

Another view of the downstream slope (looking north).
