DAM & DIKE INSPECTION REPORT

Bottom Ash Complex Stingy Run Fly Ash Dam

**GAVIN PLANT
CHESHIRE, OHIO**

INSPECTION DATE December 1, 2015

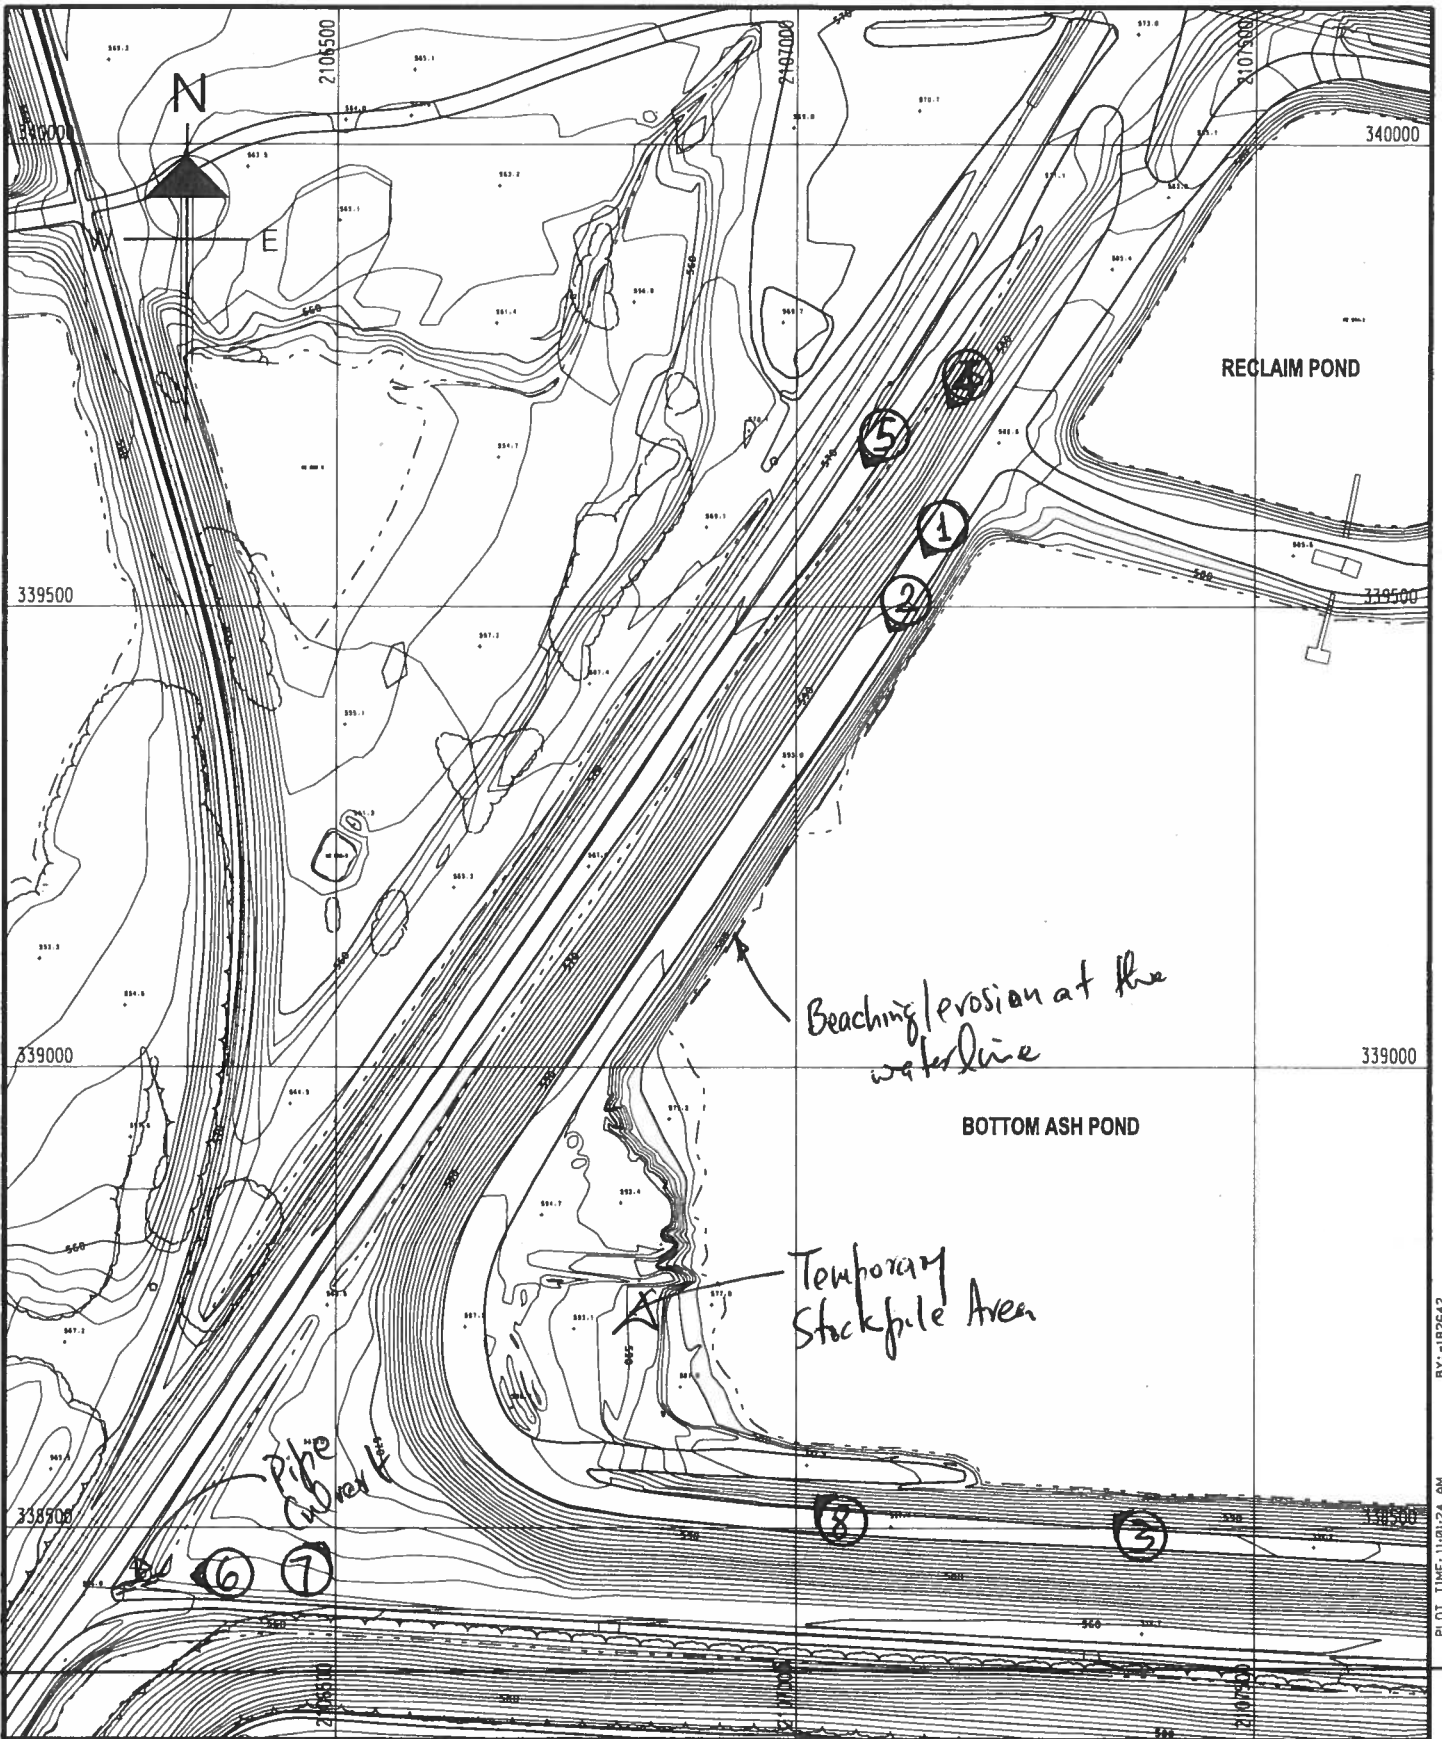
DRN BY:	GAVIN POWER STATION	DWG NO:	FIGURE 3
DATE:	WEST DIKE	AMERICAN ELECTRIC POWER AEP SERVICE CORP. 1 RIVERSIDE PLAZA COLUMBUS, OH 43215	
SCALE: 1"=200'	BOTTOM ASH COMPLEX

3.1 West Dike Section (Figure 3)

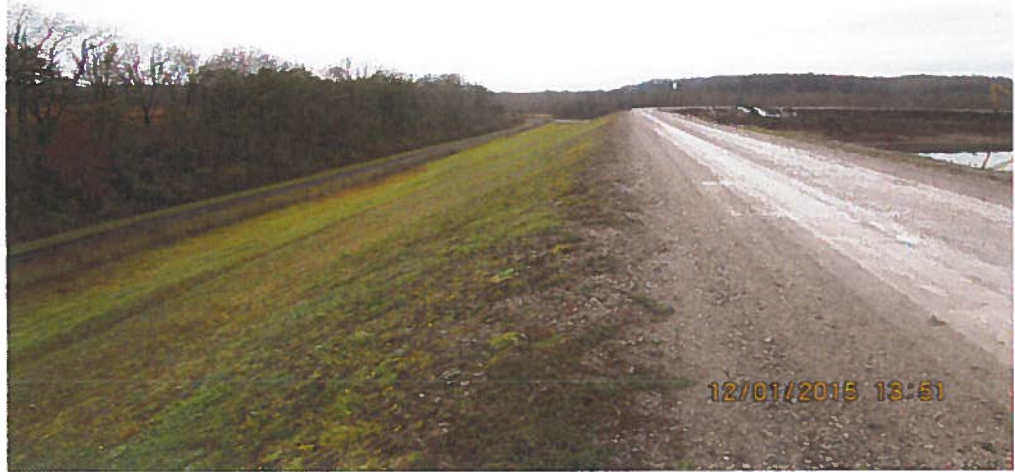
Photo # 10

- (i) An overall view of the downstream slopes of the south dike is illustrated in Photographs No. 9 and 10. Overall the vegetation cover on the slopes was well maintained and in good condition. The crest of the dike is illustrated in Photograph No. 9 appeared in good and stable condition without any signs of settlement, misalignment, and depression. The toe ditch along the chain link fence appeared in good condition with positive flow.
- (ii) Photograph No. 11 shows an area where the underground culvert is located and collects the surface runoff and drains to the ditch on the other side of the property boundary. A chain link fence is located where the underground pipe culvert is

Another view of the downstream slope (looking east).

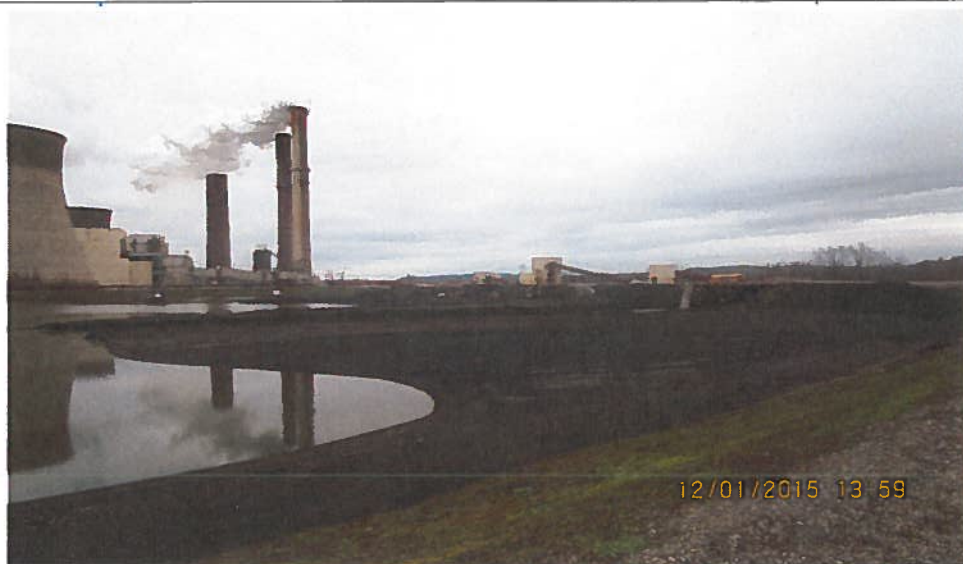
Photo # 15

- (ii) Photographs No. 15-17 illustrate the three sets of ash pipes and support structure. The pipes and structure appeared to be in good and functional condition.

Ash sluice pipes and support structure (south).

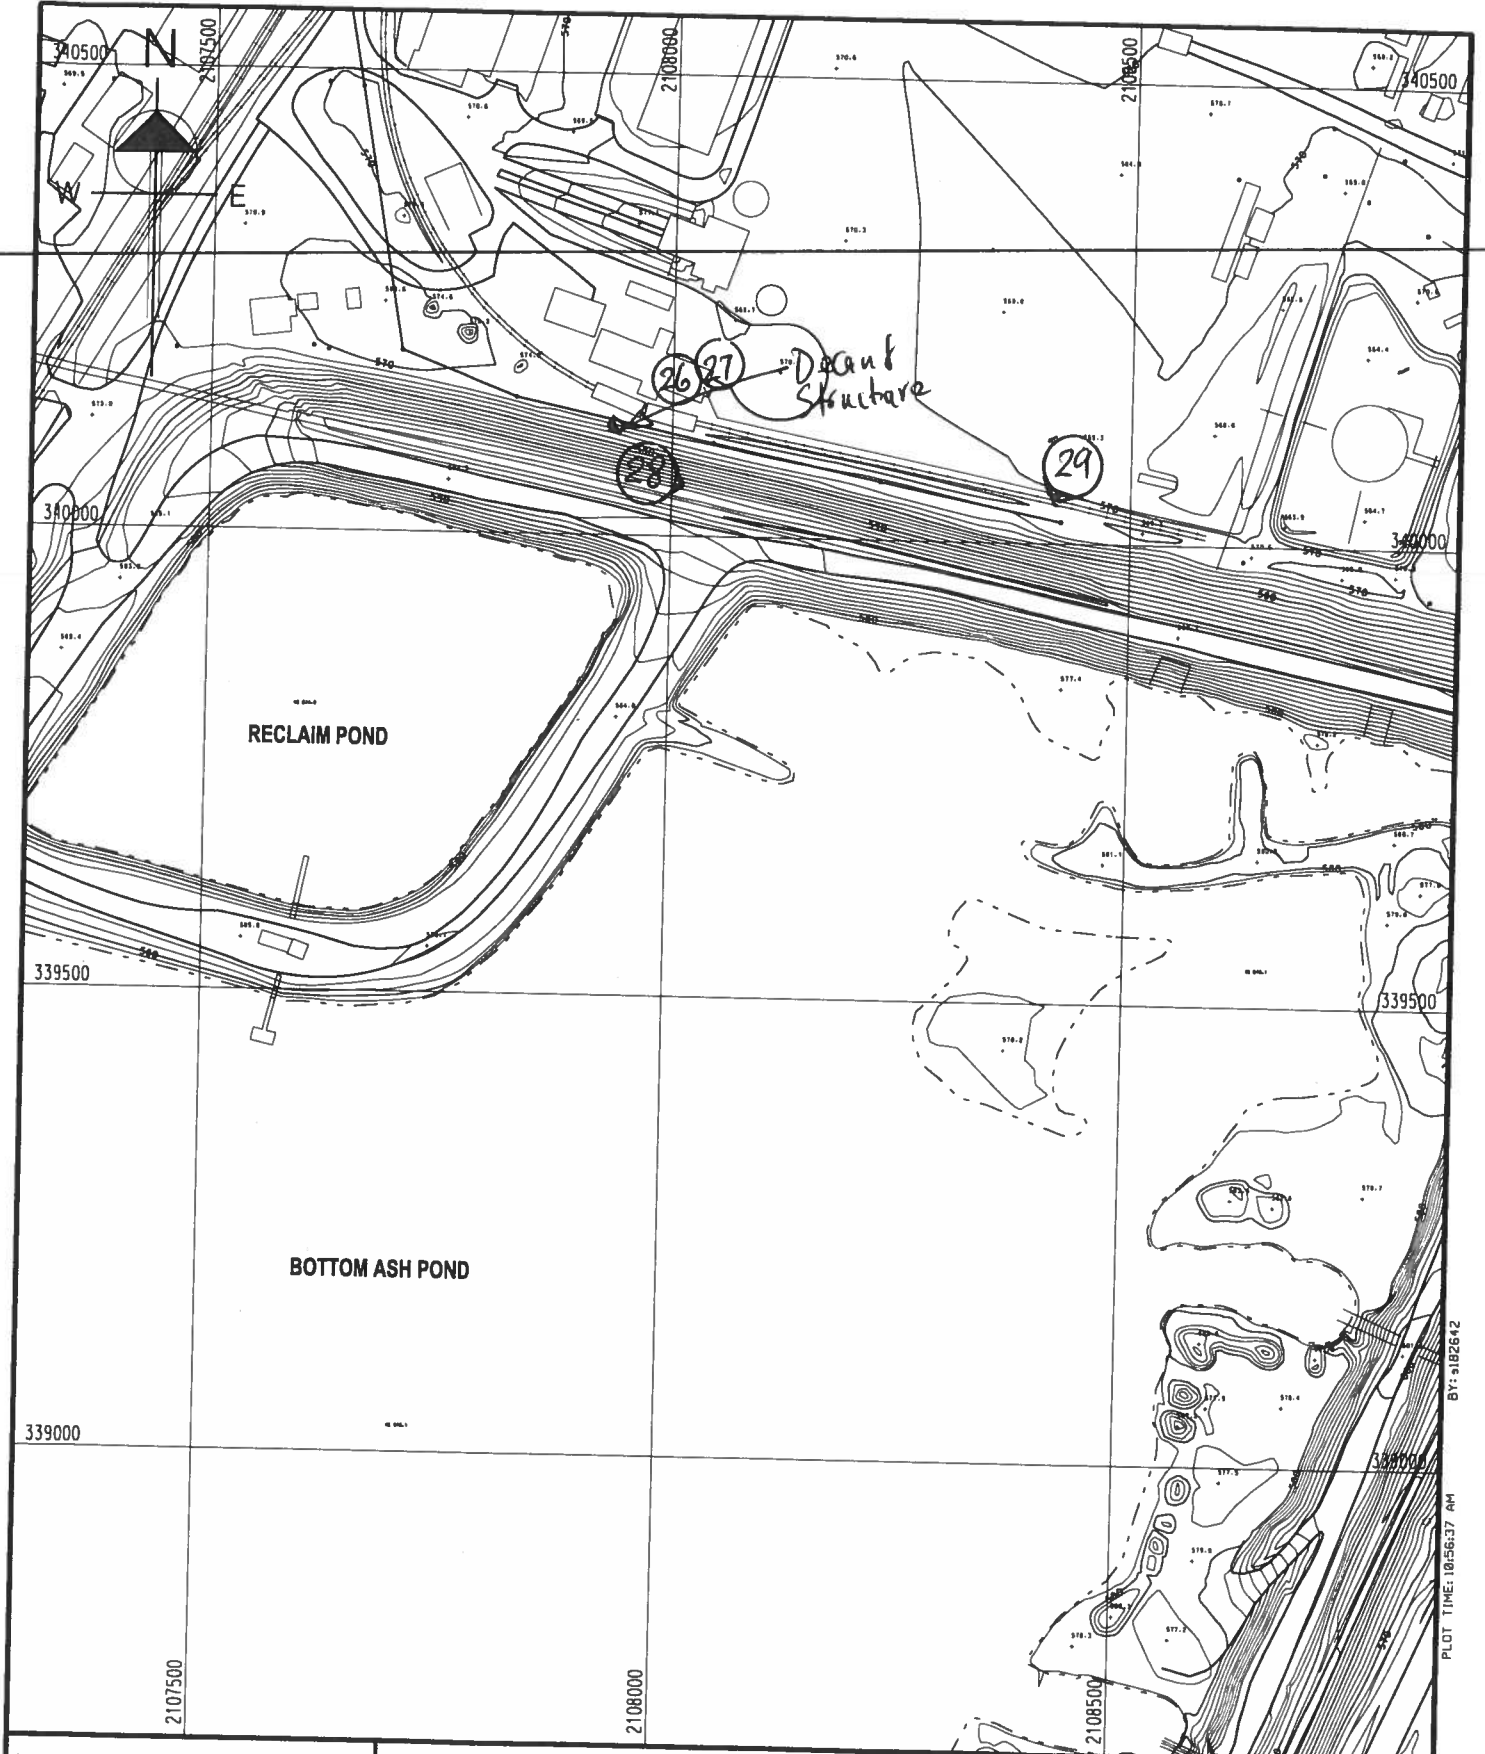
DRN BY:	GAVIN POWER STATION	DWG NO: FIGURE 6B
DATE:	NORTH DIKE

3.4 North Dike Section (Figure 6A and 6B)

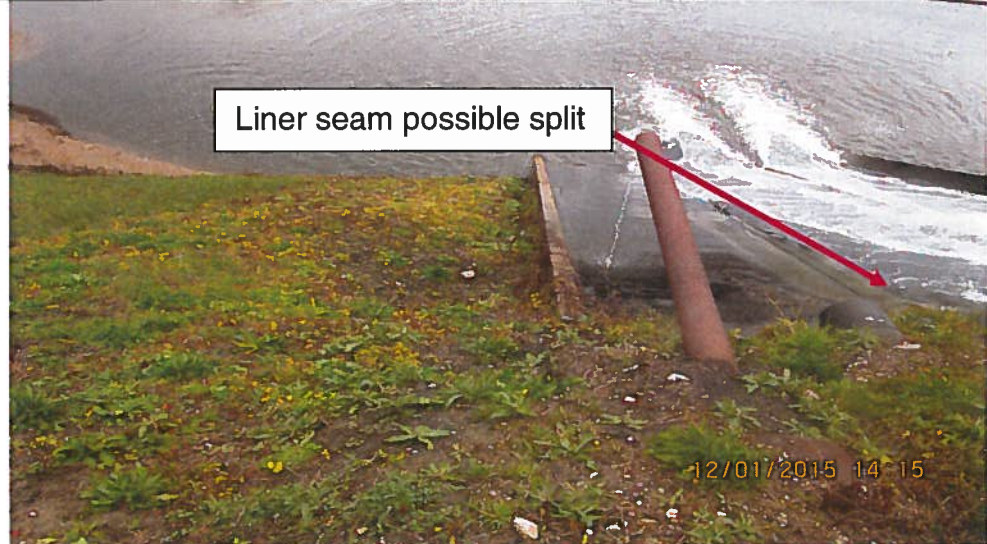
<p>12/01/2015 14:13</p>
<p><u>Photo # 23</u></p> <p>Discharge pipes (east).</p>

- (i) The upstream slope of the north dike is illustrated in Photograph No. 21. The slope appeared in good and stable condition. Several discharge pipes are present along this slope. Ash deposits were present along the toe of the upstream slope of the dike. The discharge pipes and support structures were in good functional condition. An erosion gully with depression (Photograph No. 22) was noticed at the northeast end. The two sets of discharge pipes and supports illustrated in Photographs No. 23 and 24 were functioning properly. It appears that the slope liner of the north east discharge pipes may have a split seam at one location (see Photograph No. 23).

<p>Liner seam possible split</p> <p>12/01/2015 14:15</p>

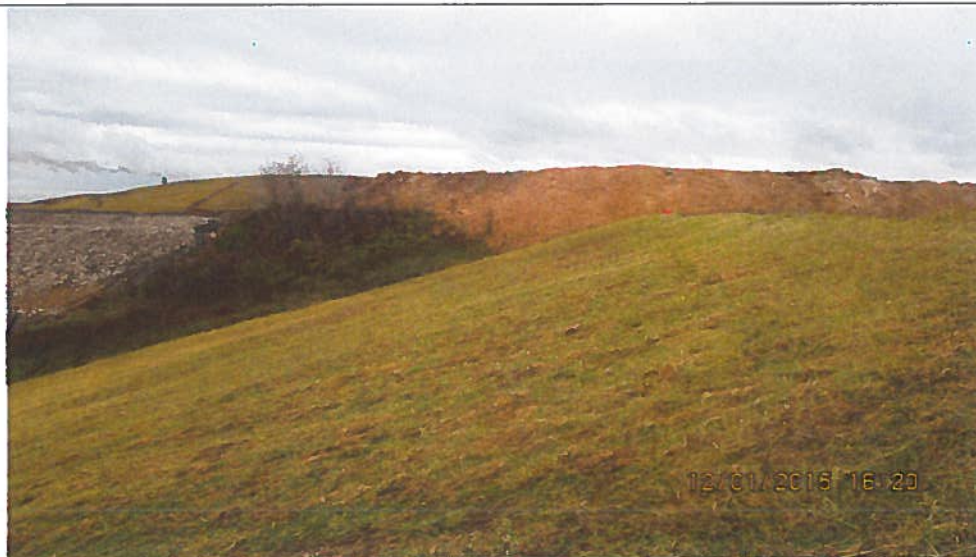
Photo # 47

The right groin at the downstream slope.

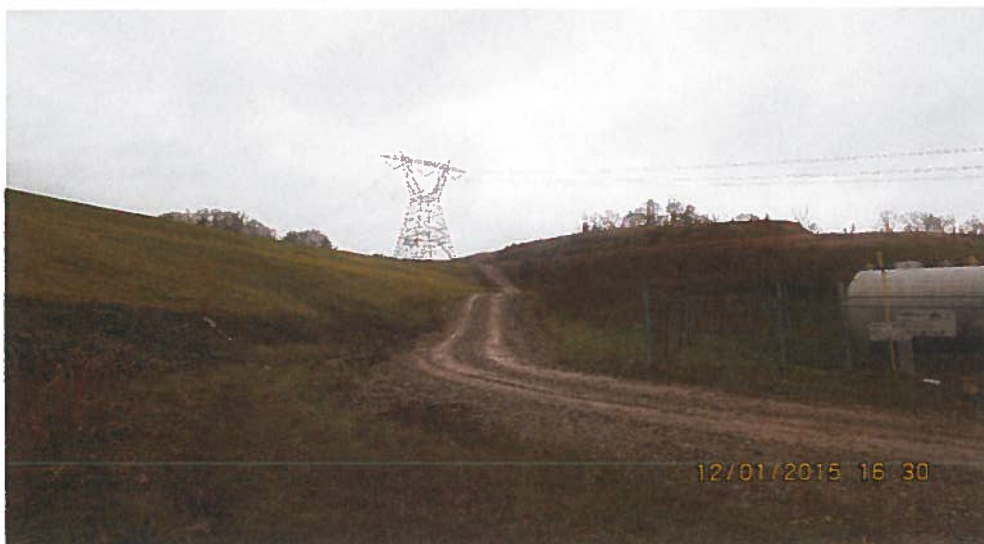
Photo # 53

New access road at the toe of the dam.

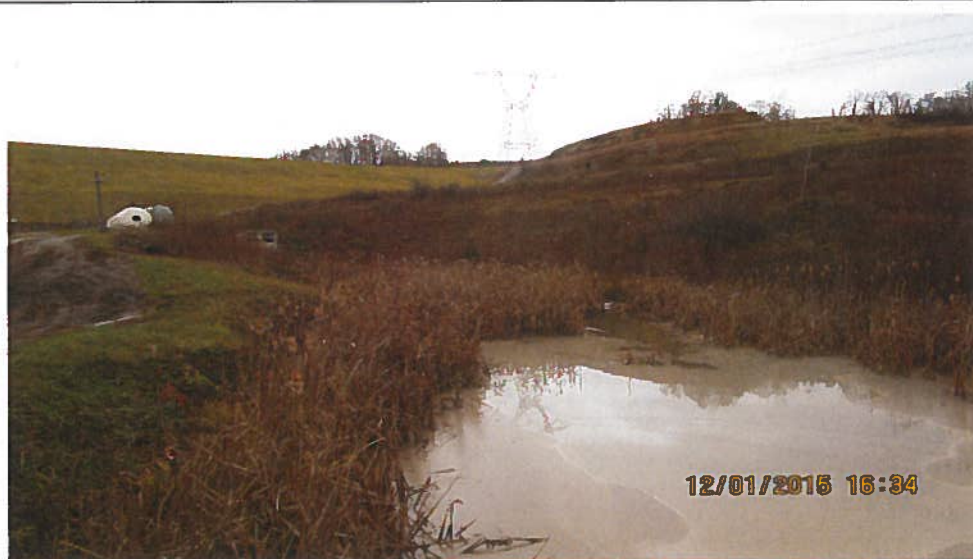
Photo # 54

The channel downstream of the chemical feed building.
