2021 Annual Inspection Report

Residual Waste Landfill

Gavin Power Plant
Cheshire, Ohio

7 January 2022

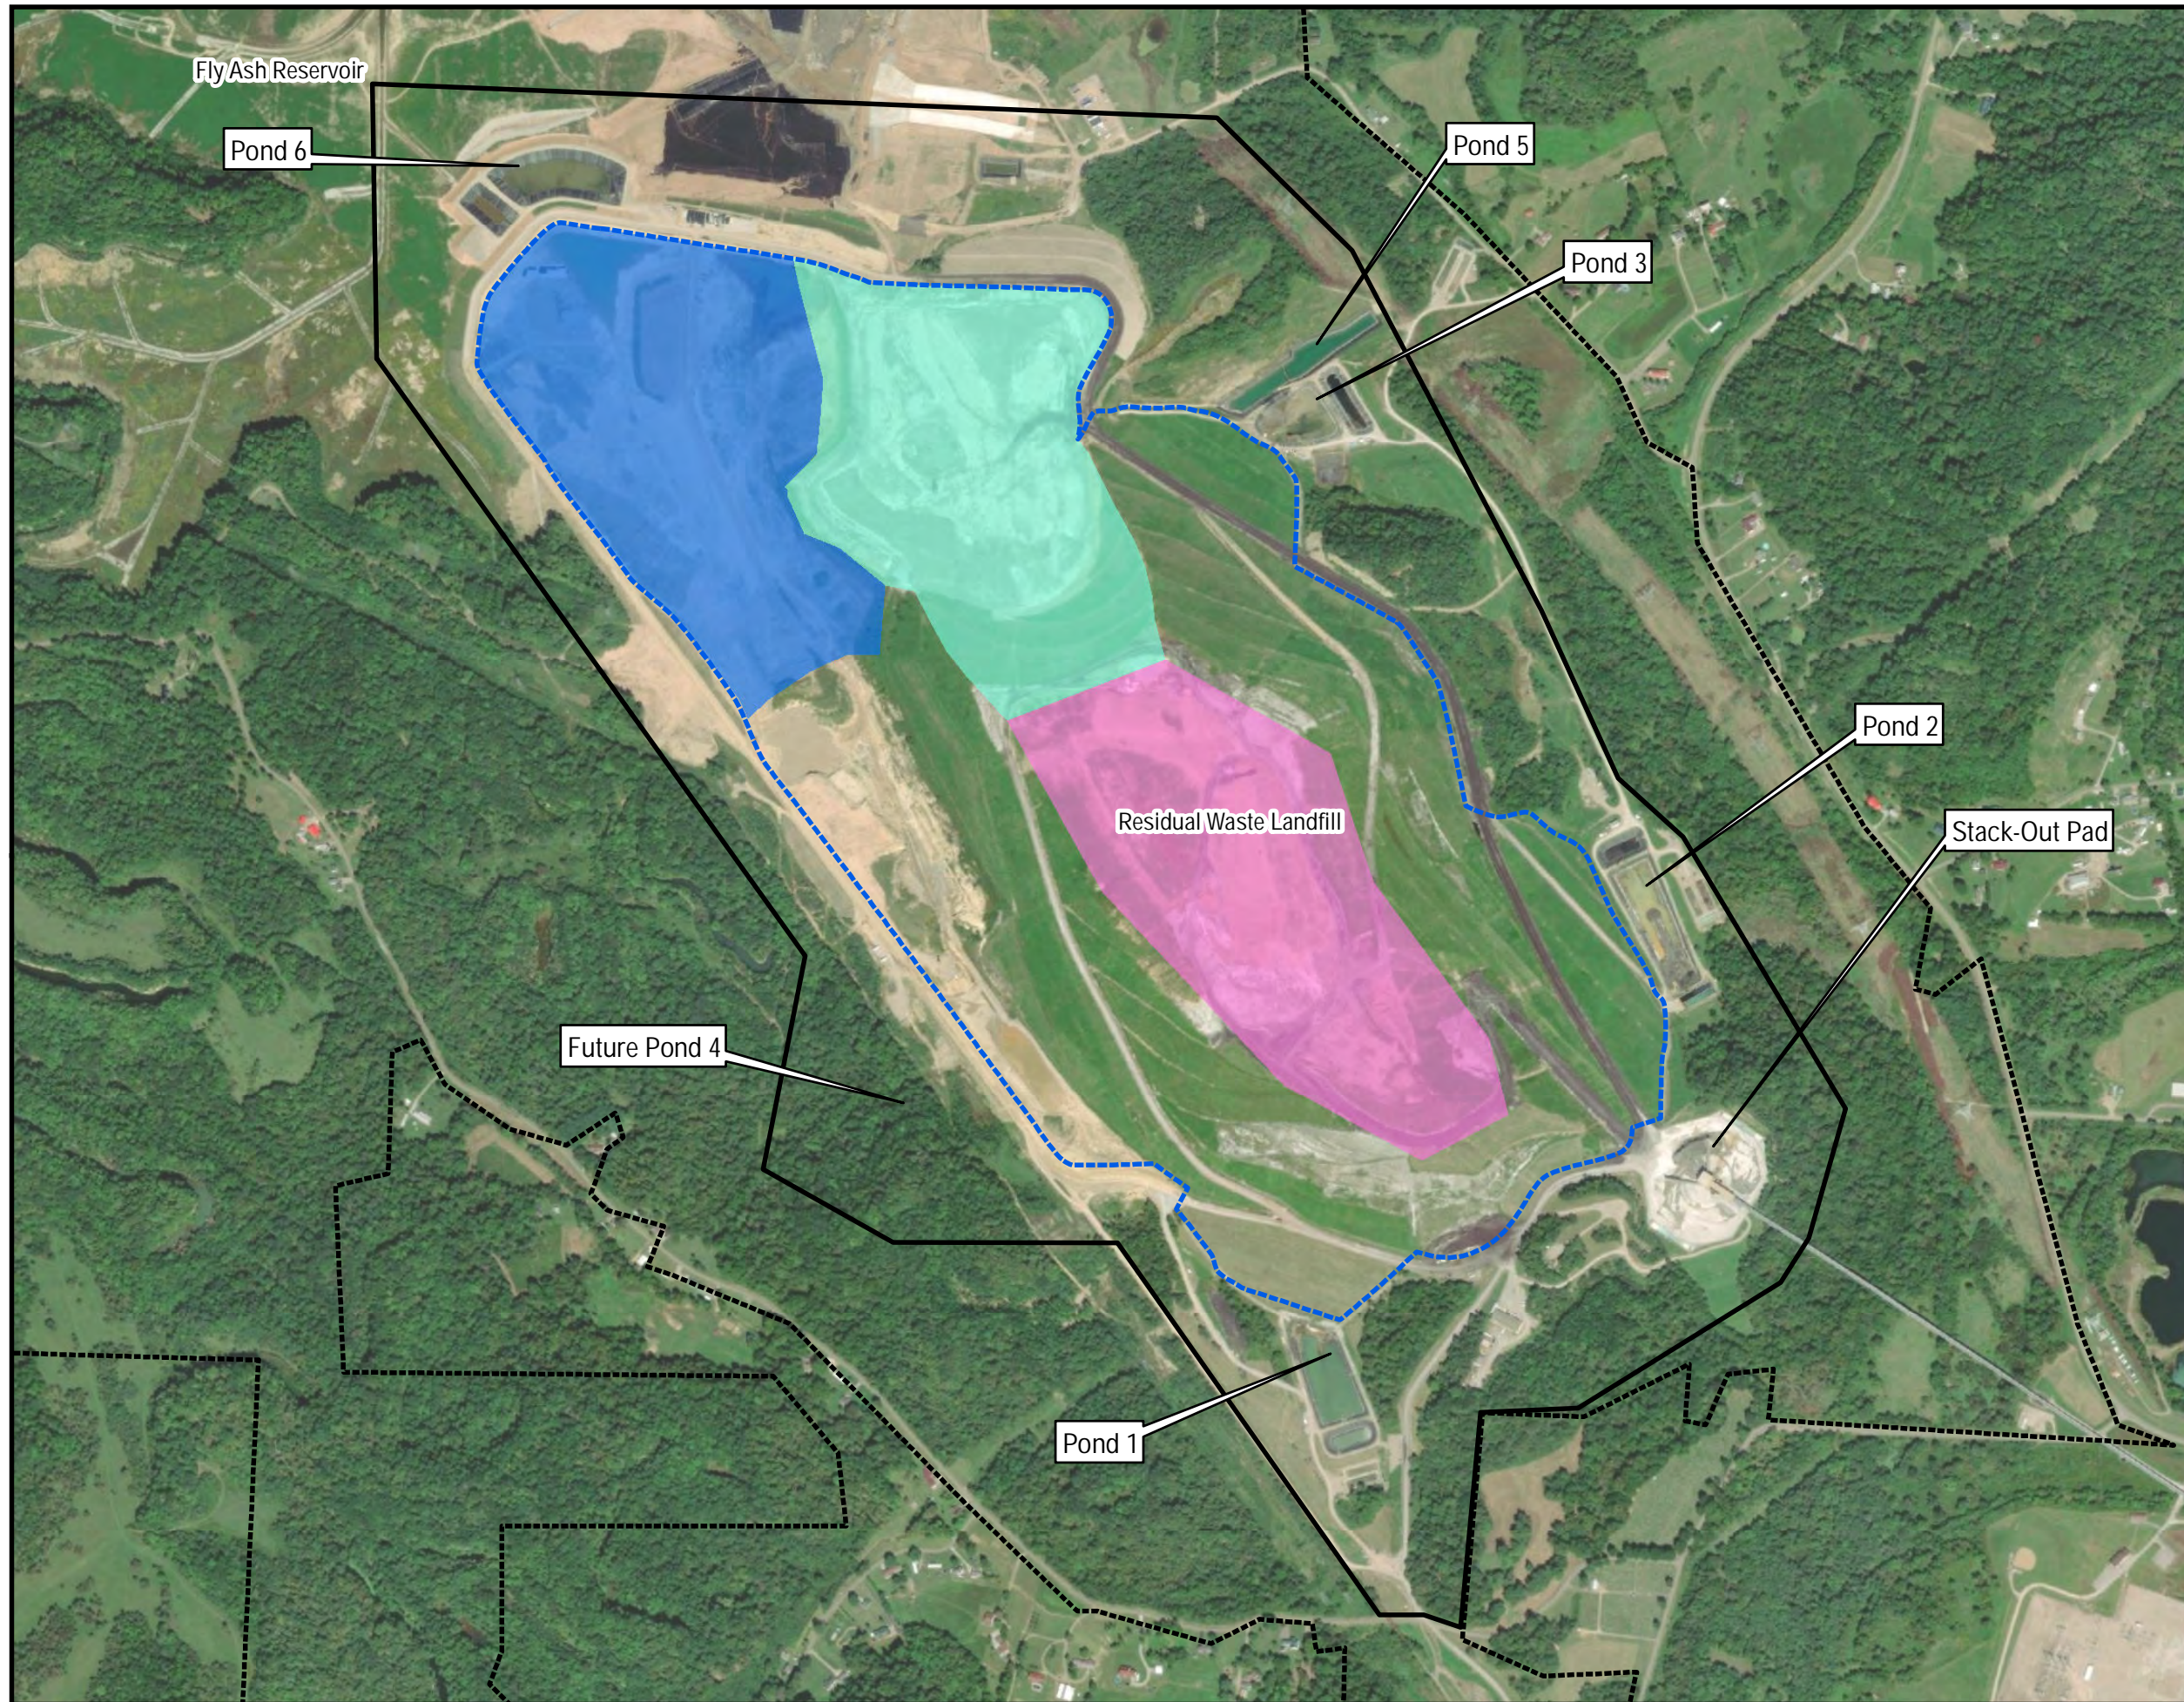
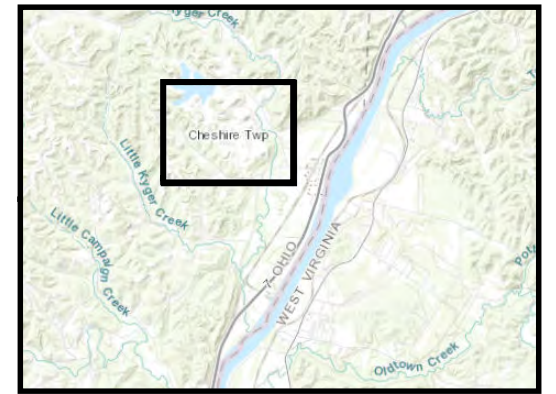
**Figure 2: Current Progress
Residual Waste Landfill**
Gavin Power LLC
Cheshire, Ohio

Construction under the PTI has been ongoing since 2016, performed and certified by a third party in phases until completion. The RWL has to-date completed construction of the leachate/sedimentation Pond No. 5 and vertical flow wetlands associated with the landfill pond outfalls for Ponds 1, 2 and 3. Since the 2020 inspection, the RWL has continued engaging in lateral expansion construction activities for Phase I and has completed installation of the leachate/sedimentation Pond No. 6 in the approximate areas depicted on **Figure 2**.

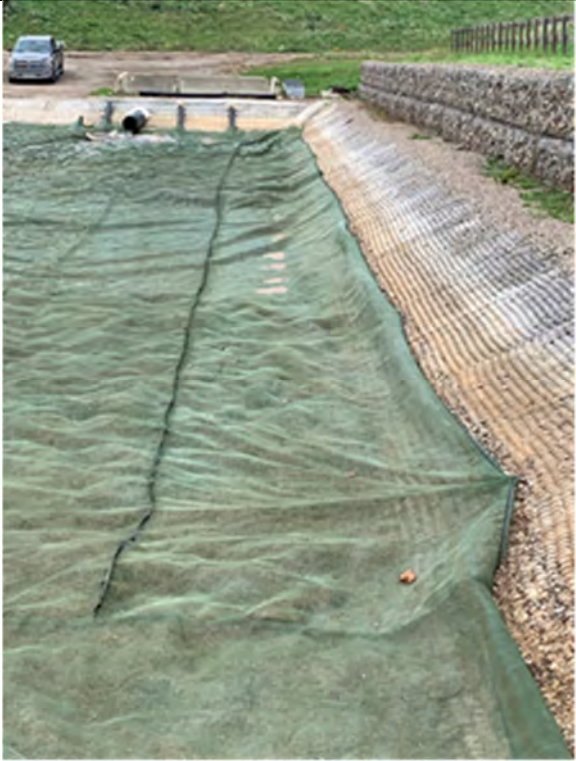
<p>Photograph #24</p>

The vertical flow wetlands for Pond No. 1 observed to be in general working order (Photographs 24, 25, 26, 27 and 28).

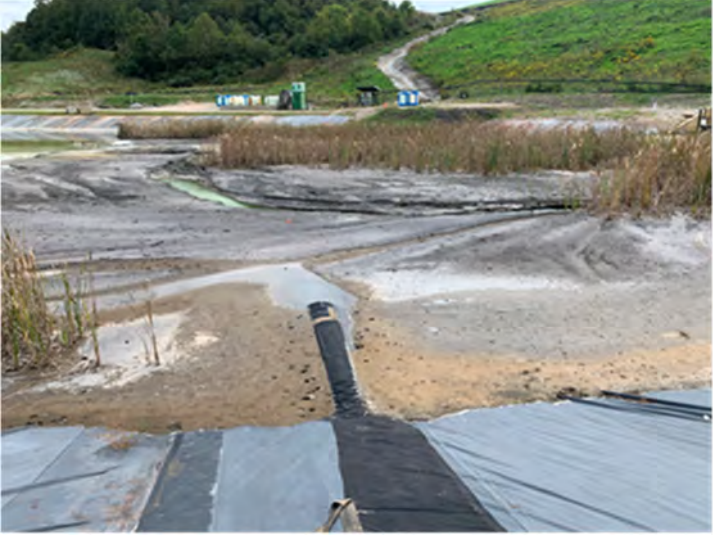
<p>Photograph #40</p>

Pond No. 3 on the northeast side of the RWL was observed to be functioning satisfactorily for treatment but poor conditions were observed regarding overall containment in the clarifying portion of the pond. Within the primary treatment pond there was significant sediment accumulation and vegetation observed within the central portion and along multiple embankments as indicated in Photographs 40 and 41, having increased from observations in the 2020 inspection. This is based on observation that the solids level appeared to be just below the operating water level in several locations. Hydrogen peroxide was observed being added at the leachate inflow point to this pond resulting in elemental sulphur and white colored solids accumulating at the pond (Photograph 41). A small number of minor holes and tears were noted above the operating level of the main pond.

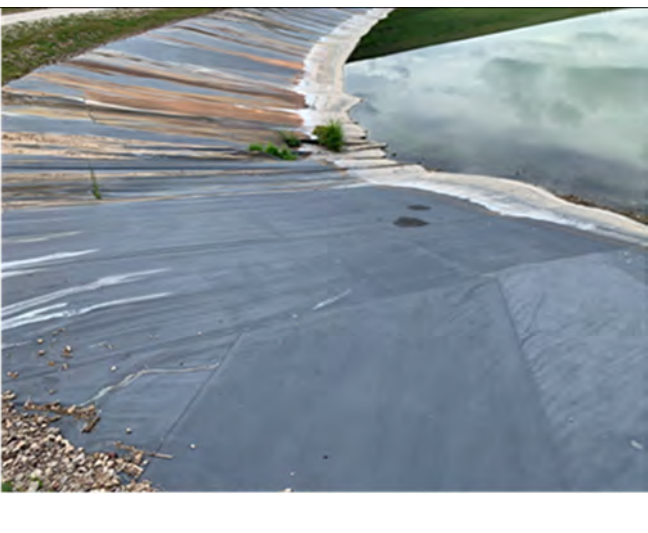
Within the clarifying pond, numerous holes and tears were identified in the geomembrane during the inspection with some exhibiting vegetative growth from beneath. Surficial layers of a protective PVC geomembrane were also suggesting significant levels of deterioration such as material stiffness due to UV exposure over time and rips/tears. This surficial PVC geomembrane was installed at some time in the past for ultraviolet protection over the primary geomembrane in the Pond No. 3 clarifying pond (Photograph 42, 43 and 44), and therefore is deemed to be a sacrificial layer. The tears and holes identified in the liner within the clarifying pond were observed to be above the normal operating level. Repair of the visible damage to the primary treatment and clarifying pond geomembrane may be necessary during suitable weather in 2022 based on testing results. Water levels within this pond should be kept below visible defects such as small holes and tears in the geomembrane until repairs can be made.

perforations after currently proposed repairs are complete and anticipate additional geomembrane maintenance requirements in the future.
