2021 Annual Inspection Report

Gavin Power, LLC

Bottom Ash Pond

Gavin Power Plant
Cheshire, Ohio

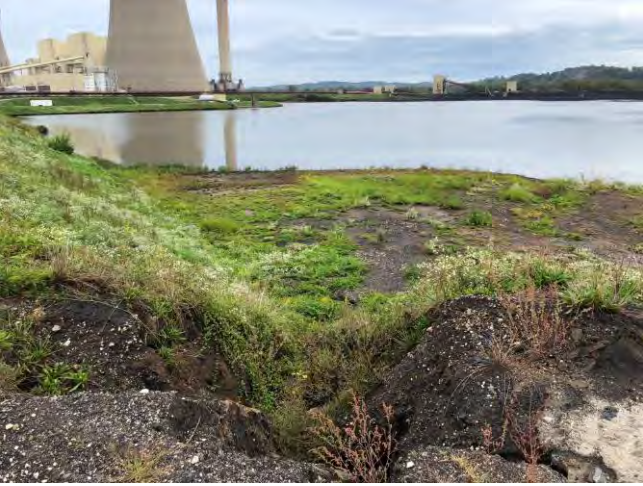
<p>Photograph #14</p>

<p>View of interior southwest corner embankment and spoils staging area. Some areas of downslope erosion from active maintenance activities (looking northeast).</p>

1. Promptly repair identified erosion rills/gullies to prevent expansion and further erosion (Photographs 14, 26, 40, 55, and 57). Continue monitoring areas where rills and gullies have formed.

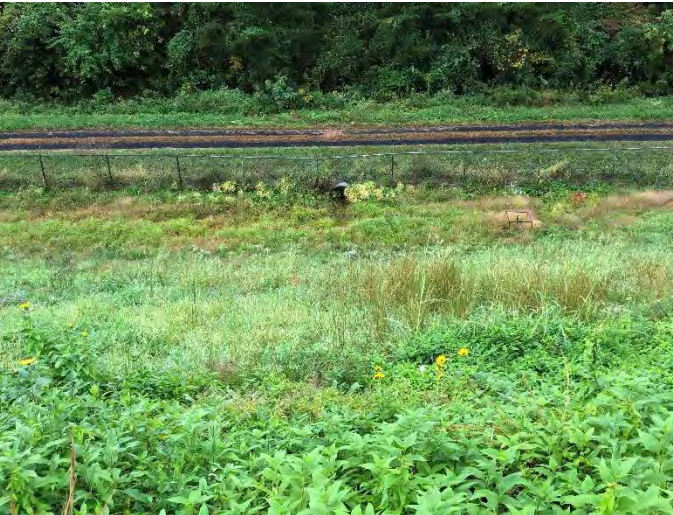
<p>Top view of drainage culvert located at the toe of the southern embankment exterior slope midway across BAP. Shallow pooling at culvert inlet. Densely vegetated slope with a few minor areas of sparse cover. Trimming is required (looking south).</p>

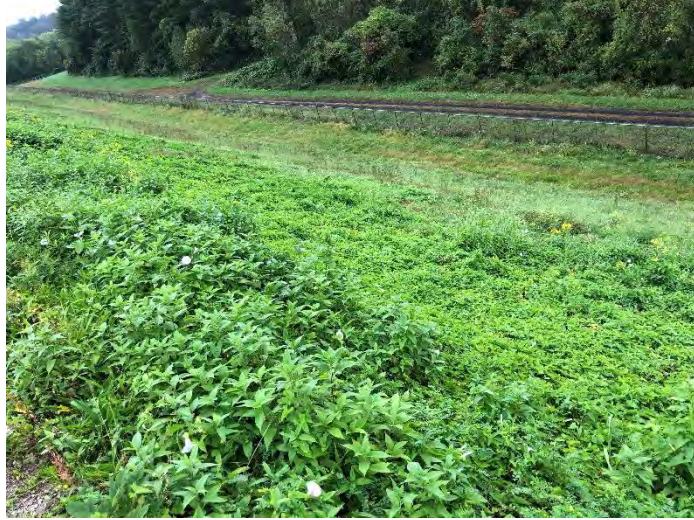
Photograph #19

View down exterior slope of southern embankment toward SE corner of BAP. Slope appears stable and is densely vegetated with a few minor areas of sparse cover. Trimming is required (looking southeast).

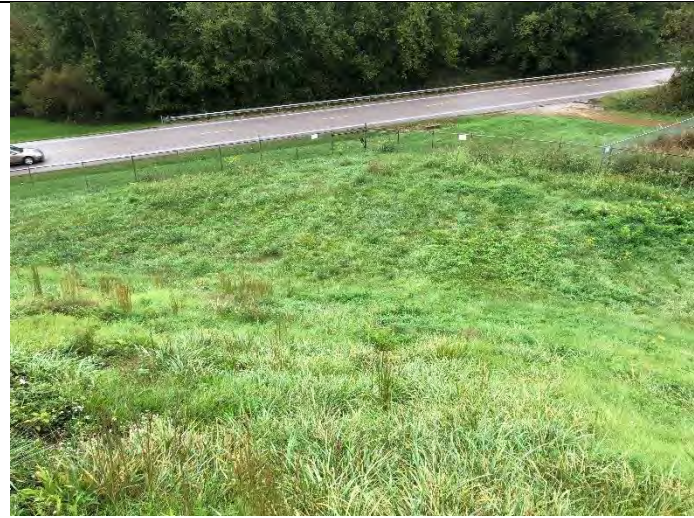
Photograph #20

View down exterior embankment slope at SE corner of BAP. Slope is stable and well vegetated with minor areas of sparse cover (looking southeast).

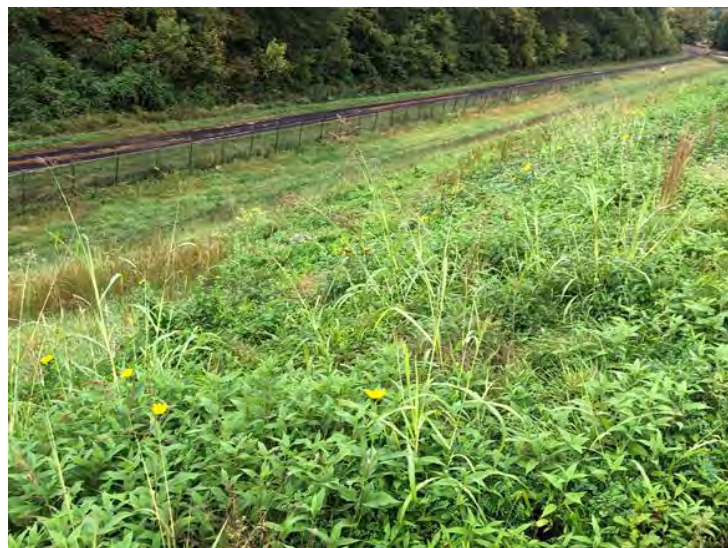
Photograph #21

View of southern embankment exterior slope from SE corner of BAP. Slope is stable and well vegetated, with minor areas of sparse vegetation (looking southwest).

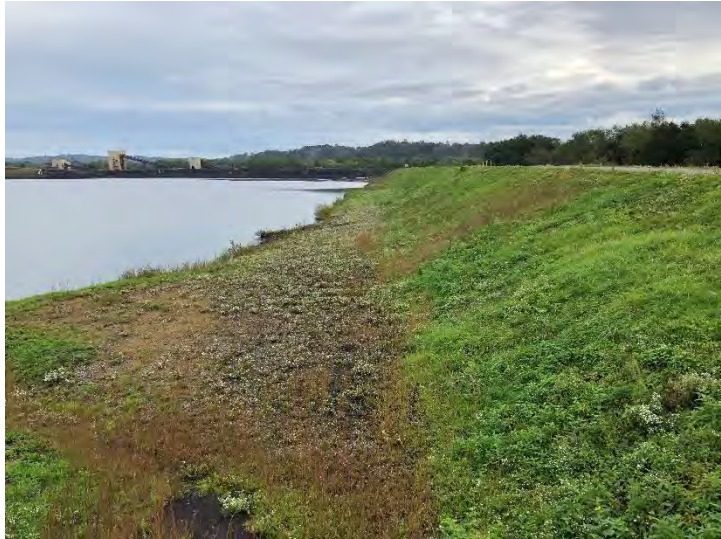
Photograph #22

View of interior southern embankment slope from SW corner of BAP. Slope is stable and well vegetated with small areas of sparse vegetation and hummocky terrain (looking east).

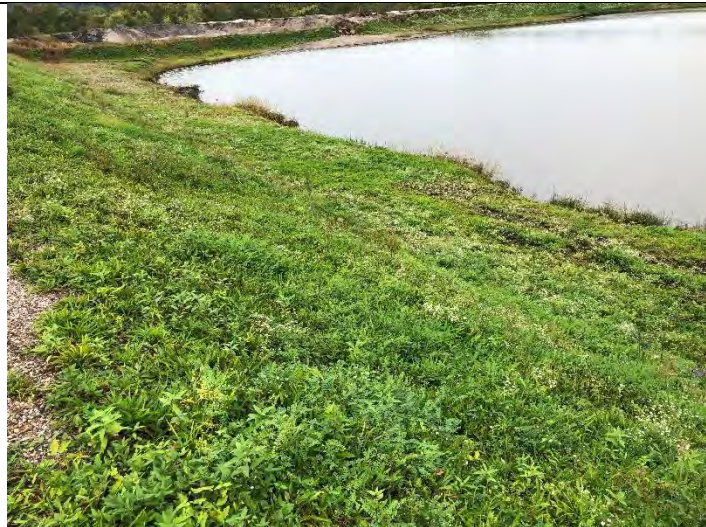
Photograph #24

View of interior southern embankment slope and previously documented small ground bulges. Slope is stable and well vegetated with small areas of sparse cover (looking west).

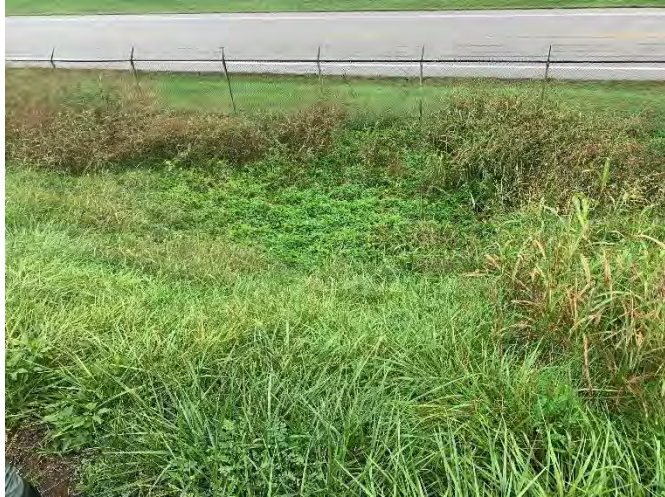
Photograph #31

View of previously identified scarp along the bottom of exterior eastern embankment slope, near SE corner of BAP. Area observed stable and is well vegetated. Unchanged from previous inspections. (looking east).

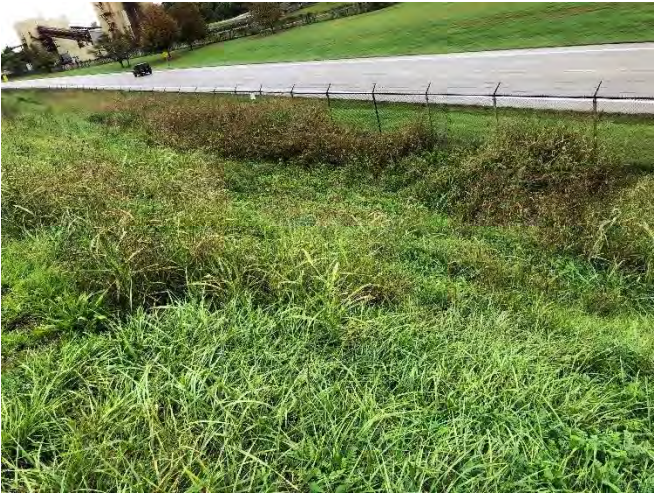
<p>Photograph #35</p> <p>View of steep slope cut down bottom exterior eastern embankment slope, midway across BAP. Area remains stable without discernible signs of erosion (looking east).</p>

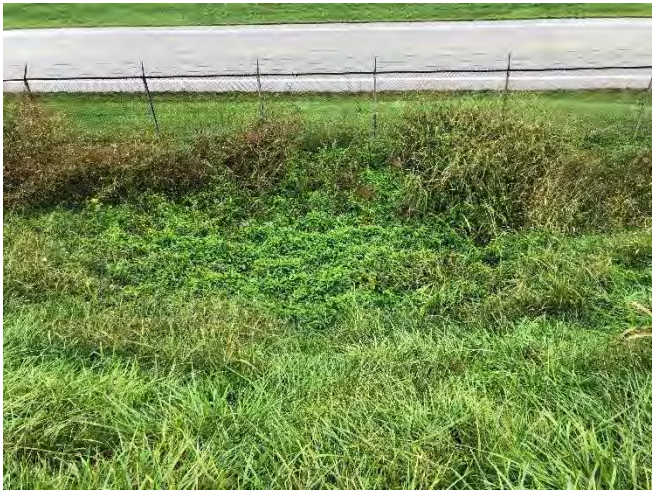
<p>Photograph #36</p> <p>Front view of steep slope cut down bottom exterior eastern embankment slope, midway across BAP. Area remains stable and well vegetated without signs of erosion (looking west).</p>

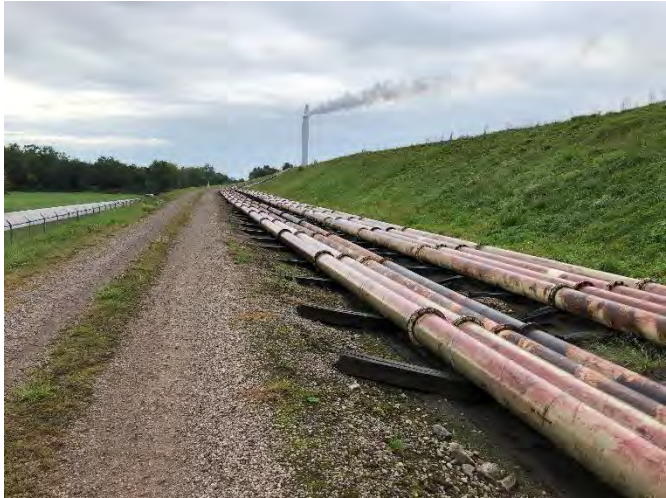
<p>Photograph #38</p> <p>View of bottom exterior eastern embankment slope from NE corner of BAP. Slope appears stable and well vegetated. Trimming is required (looking south).</p>

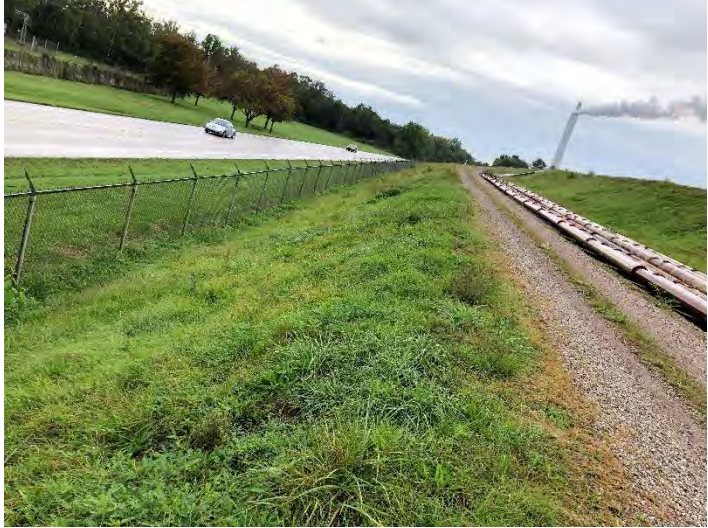
<p>Photograph #39</p> <p>Front view of exterior NE corner slope of BAP. Slope is stable and well vegetated with a few areas of sparse cover (looking southwest).</p>

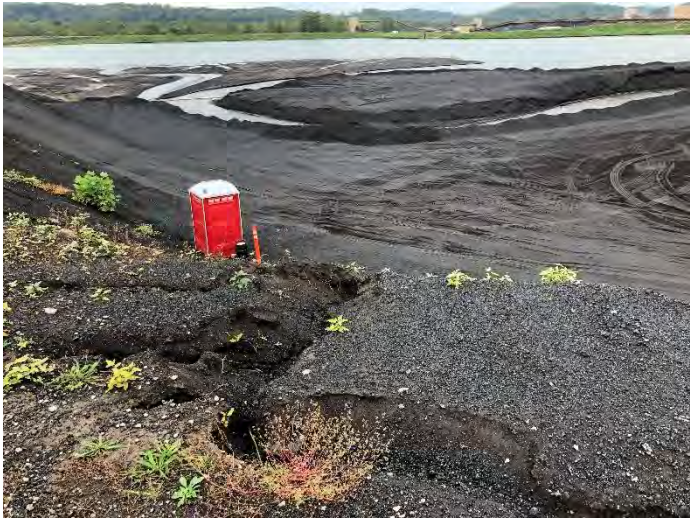
<p>Photograph #40</p>

3. Active material deposition and dredging operations remain evident along the interior embankment slope. Portions of the interior slope continue to be buttressed by stockpiles of bottom ash; exposed surfaces are all contained within the embankment. Surface slopes appeared generally stable at the time of inspection. Some forming erosion gullies were observed near the SE corner of embankment (Photograph 40). The sparse vegetation coverage along the interior slope is a result of active

deposition activities in the area (Photographs 40 through 45). The inert nature of bottom ash and the associated lack of nutrients are likely additional contributors to the sparse vegetation in that area.

<p>View of interior eastern embankment maintenance area from SE corner of BAP. Some forming minor erosion rills observed in bottom ash (looking northwest).</p>

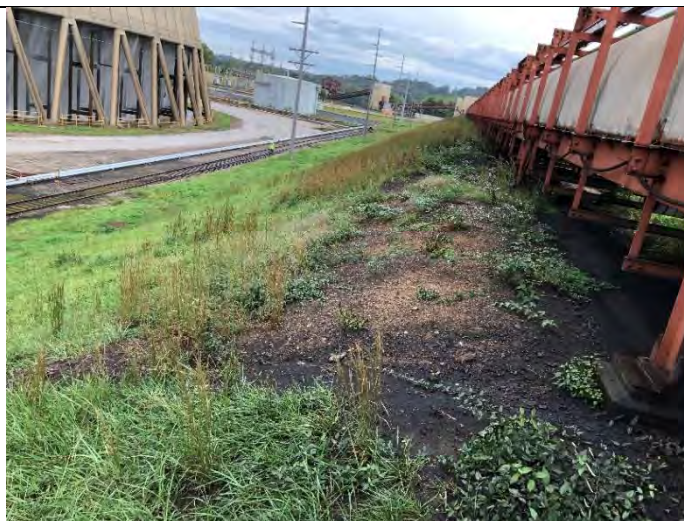
Photograph #54

View of exterior northern embankment slope near NW of BAP. Slope is stable and well vegetated with some areas of sparse cover along the top (looking east).

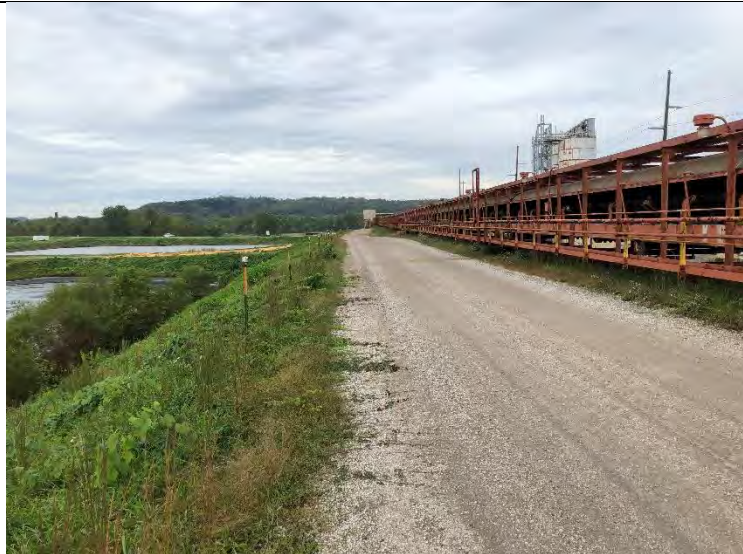
Photograph #59

6. The northern embankment access road was found to be in stable condition and remains well maintained (Photograph 59).

View of northern embankment main access road. Roadway is stable and well-maintained (looking west).

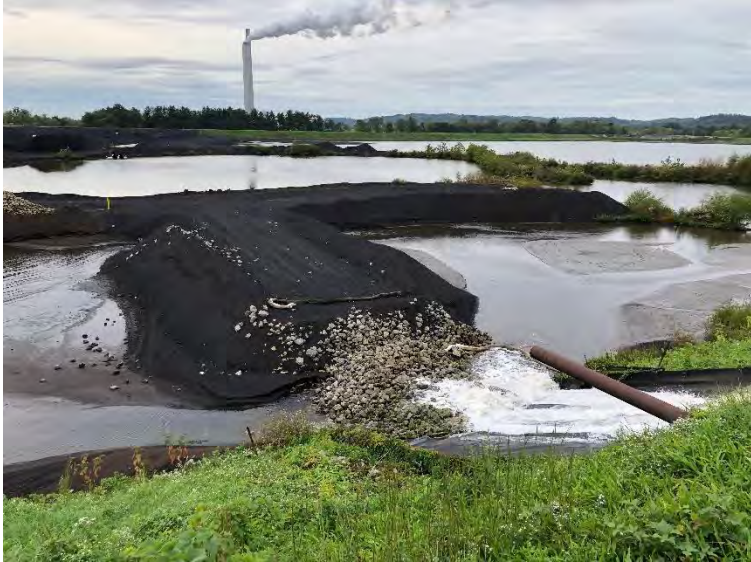
Photograph #61

5. The interior embankment slope was stable and well vegetated with only a few areas of sparse vegetation coverage, and a few instances of shallow hummocky terrain. No settling, rutting, or misalignment of the slopes was identified (Photographs 60 through 65). Multiple areas of overgrown woody vegetation were observed along the toe of the interior slope, including vegetation growth within the pond (Photographs 63 and 64). The discharge pipes and support structures along the interior slope appeared functional and in satisfactory operating condition (Photographs 61 and 62).

View of maintenance access road extension across northern effluent inlet from top of interior northern embankment slope (looking south).

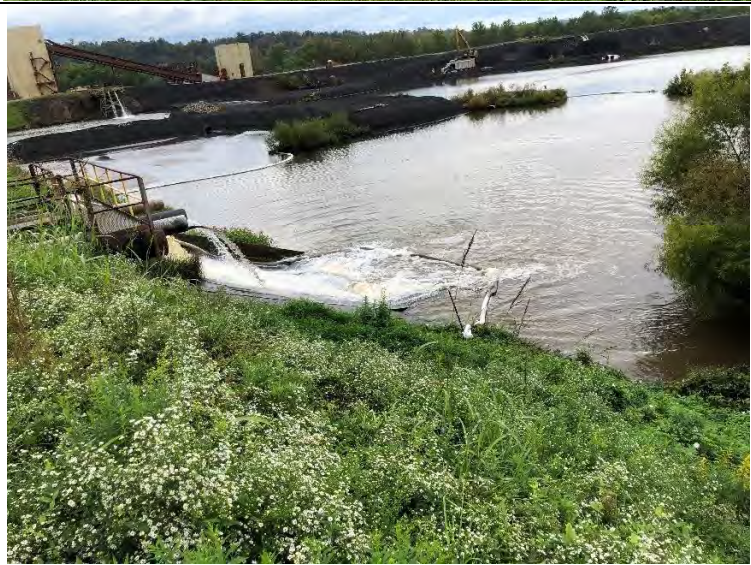
Photograph #62

View of interior northern embankment slope and effluent inlet. Slope appears stable and densely vegetated. Trimming is required (looking east).

7. Ensure regular trimming of embankment slope vegetation. Grass was generally overgrown on all embankment slopes at the time of inspection. Particular attention should be given to tall woody vegetation growth documented along the northern embankment interior slope, which should continue to be mowed on a yearly basis (Photographs 60, 63, and 64). Woody vegetation on peninsula of bottom ash should be removed during closure activities in 2023.

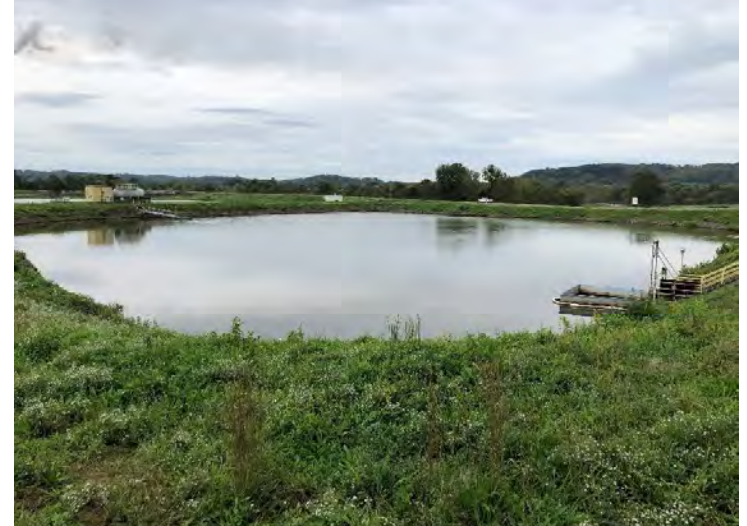
<p>Photograph #66</p>

The Reclaim Pond embankments were found to be in generally satisfactory condition. No visible indications of settlement or erosion were apparent. The crest, and slopes along the interior were vegetated (with only minor isolated bare spots) and the toe was armored with riprap. The riprap protected areas appeared to be in stable condition (Photograph 66).
