2022 Annual Inspection Report

Gavin Power, LLC

Residual Waste Landfill

Gavin Power Plant
Cheshire, Ohio

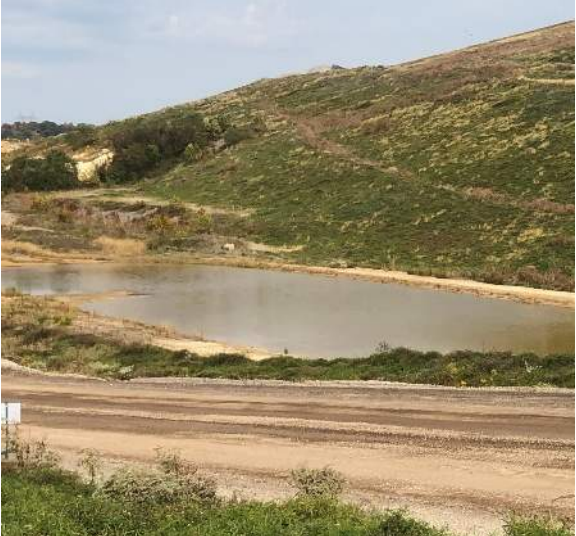
<p>Northeast vegetated slope and temporary sediment basin from landfill construction activities (looking northeast)</p>	
<p>Photograph #6</p>

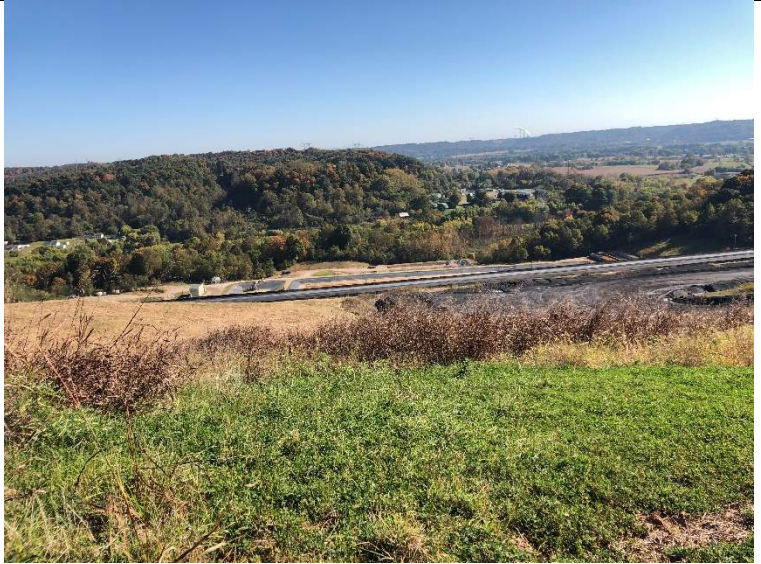
<p>Main haul road constructed of bottom ash near east side of landfill (looking east)</p>	
<p>Photograph #8</p>

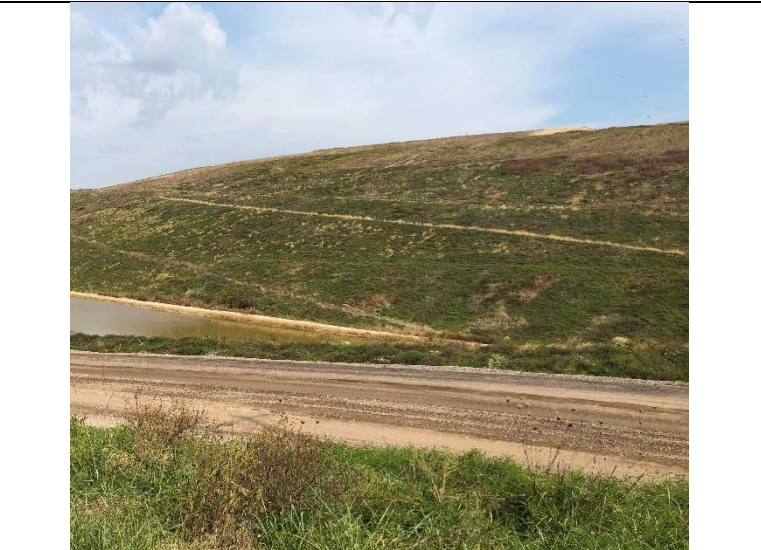
<p>East vegetated slope and temporary sediment basin from landfill construction activities (looking east)</p>	
<p>Photograph #9</p>

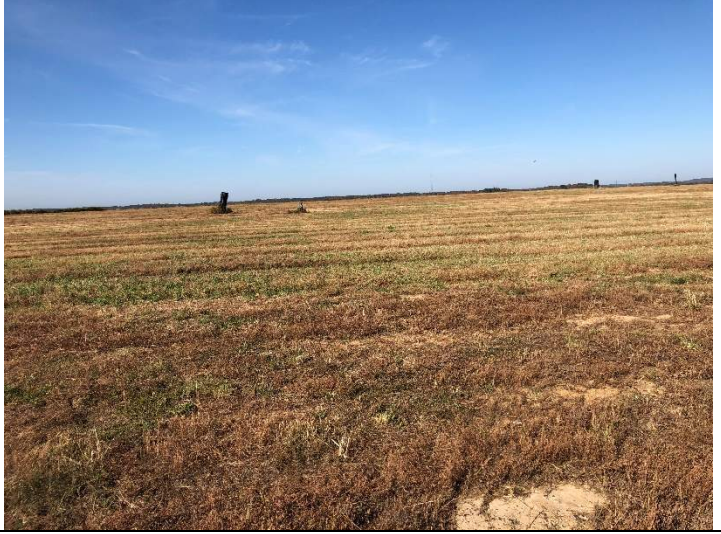
<p>View of interim summit of landfill with intermediate soil cover and vegetation growing. (looking north).</p>	
<p>Photograph #11</p>

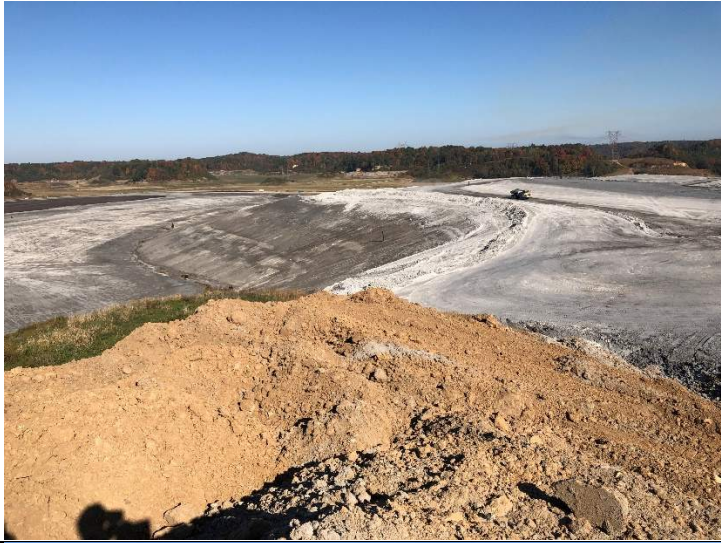
<p>View of Phase H intermediate soil cover and vegetated northern slope. (looking northwest)</p>	
<p>Photograph #12</p>

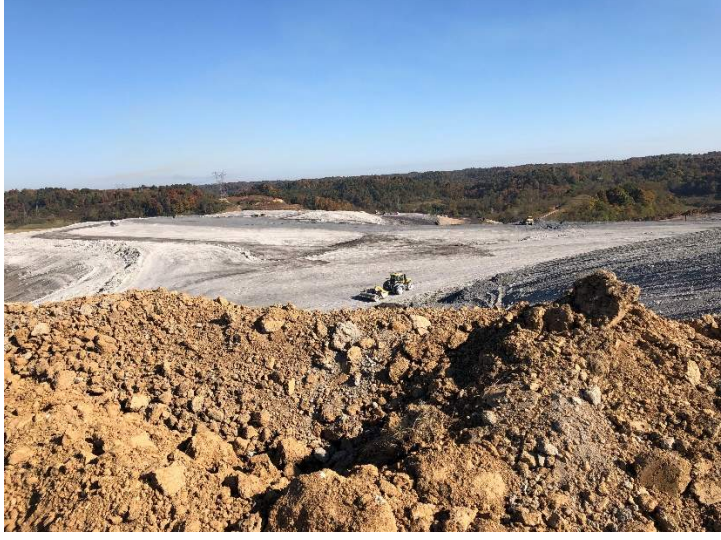
<p>View of Phase H intermediate slope cover and vegetated eastern slope (looking east)</p>

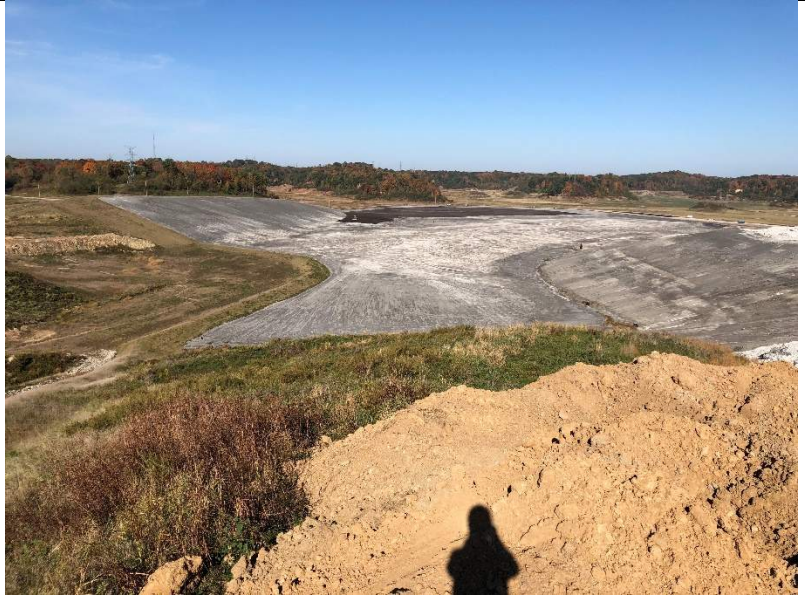
<p>View of Phase H vegetated eastern slope, and intermediate soil cover (looking north)</p>	
<p>Photograph #14</p>

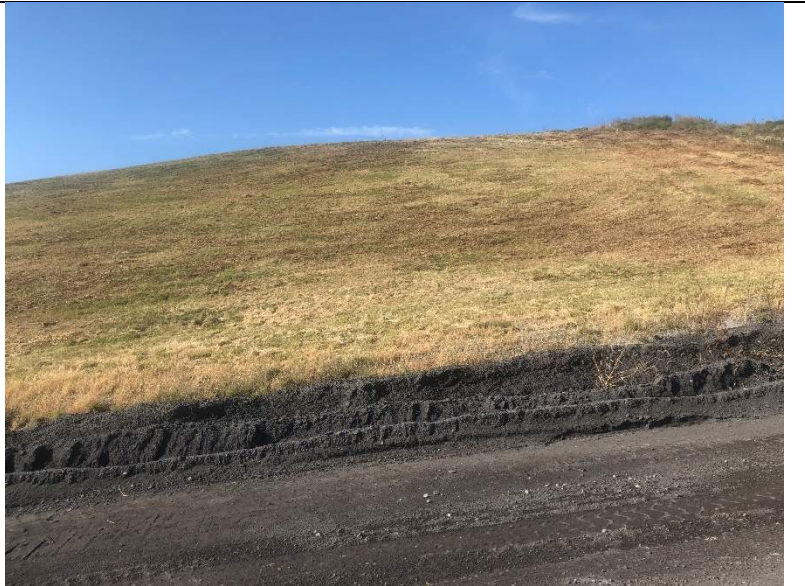
<p>Eastern slope near summit elevation. (looking west)</p>	
<p>Photograph #15</p>

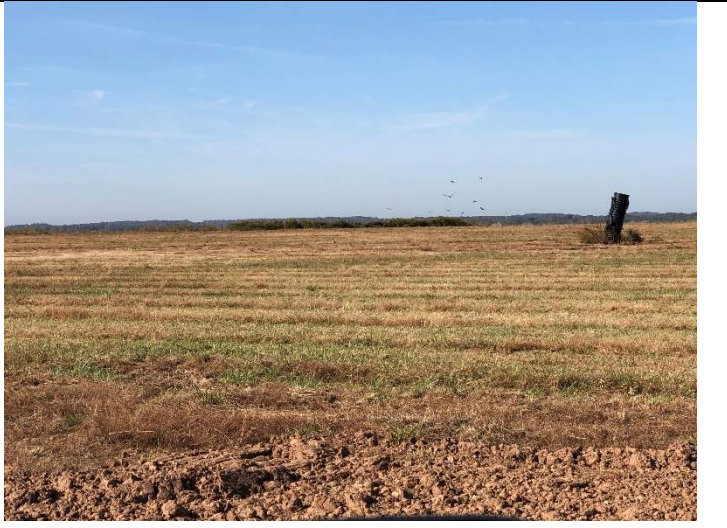
constructed cells achieves an approximate equivalent elevation. Surface water at the summit of Phase F2 is managed by chimney drains (Photograph 19) that are connected and flow to the leachate collection system at the bottom of the landfill.

<p>View of interim summit with chimney drain (looking southeast)</p>	
<p>Photograph #20</p>

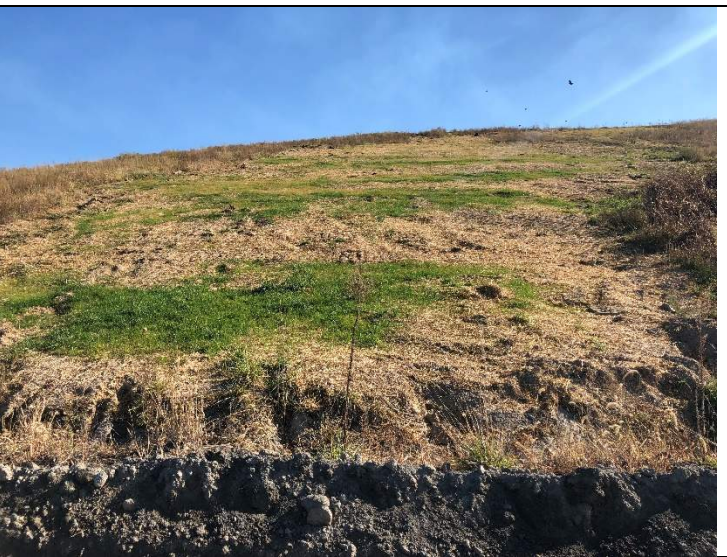
<p>Western vegetated slope of summit and RWL grading during landfill construction activities. (looking west)</p>	
<p>Photograph #21</p>

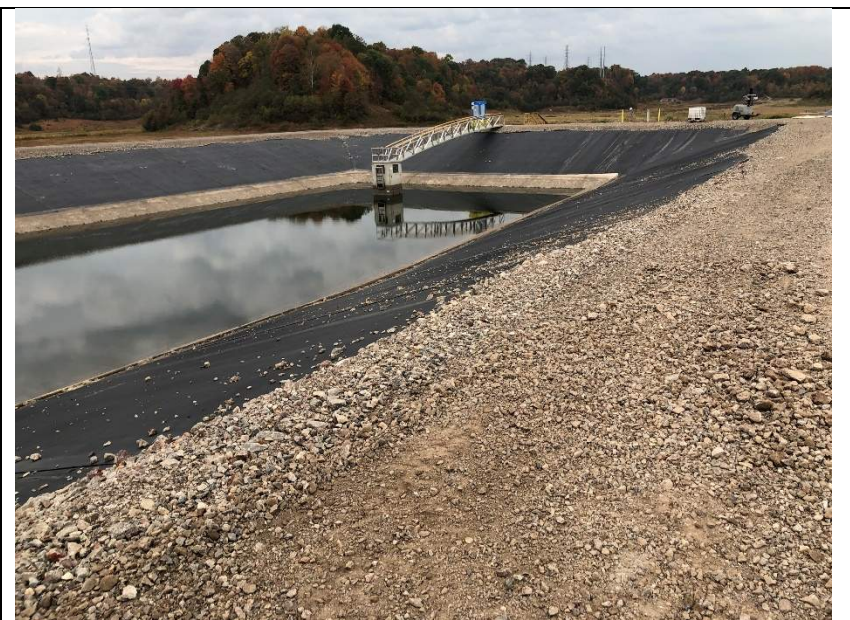
<p>Newly constructed Pond No. 6 clarifying pond (looking north)</p>	
<p>Photograph #23</p>

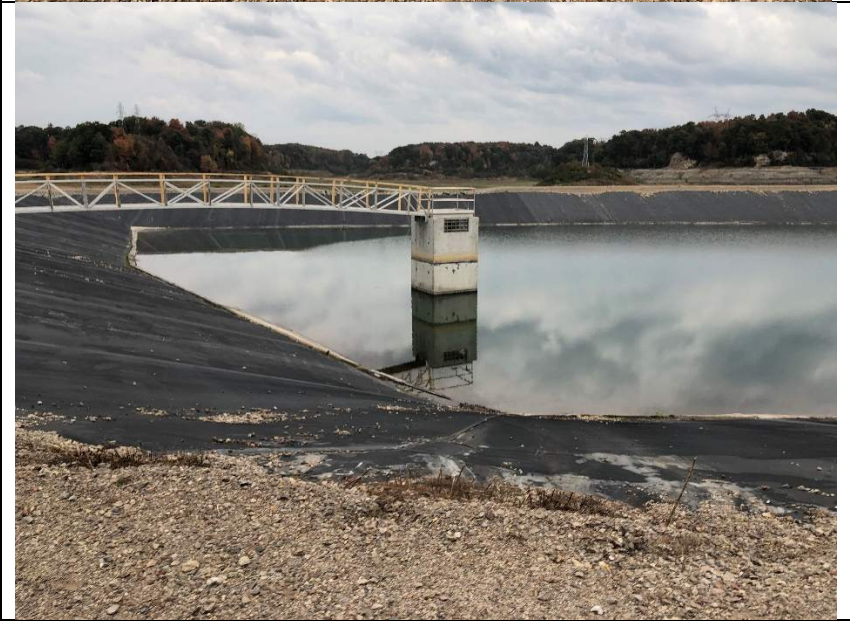
<p>Newly constructed Pond No. 6 primary pond (looking northeast)</p>

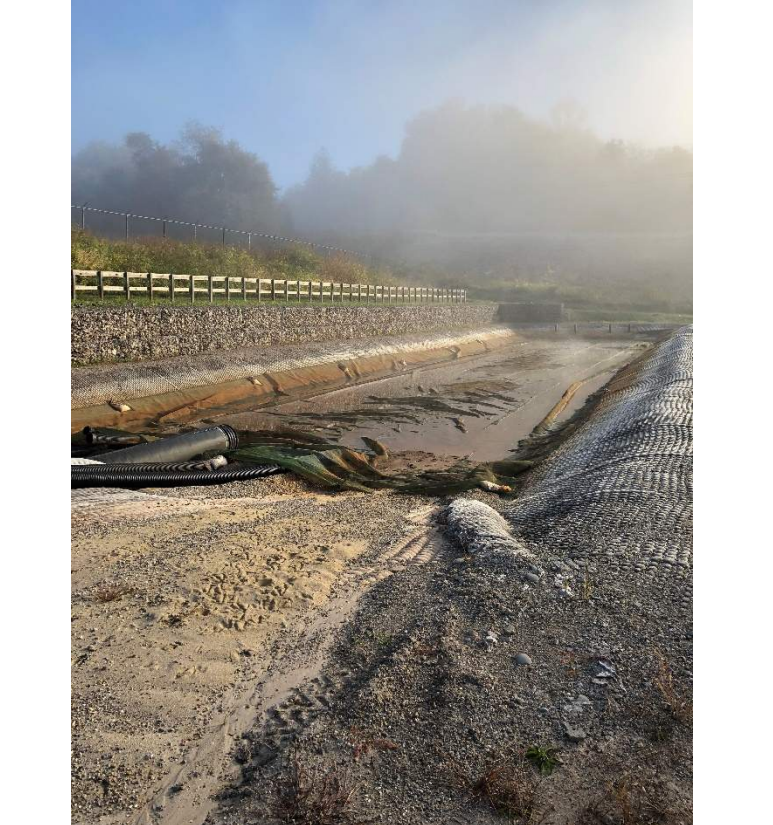
The vertical flow wetlands for Pond No. 1 observed to be in general working order (Photographs 24, 25, 26, 27 and 28).

A photograph showing a long, narrow channel of water with a gravel bed, similar to the one in Photograph #24. The water is a murky brown color. In the foreground, there is a large, black, corrugated pipe that has been laid out on the gravel bed. The background shows a line of trees and a clear blue sky.

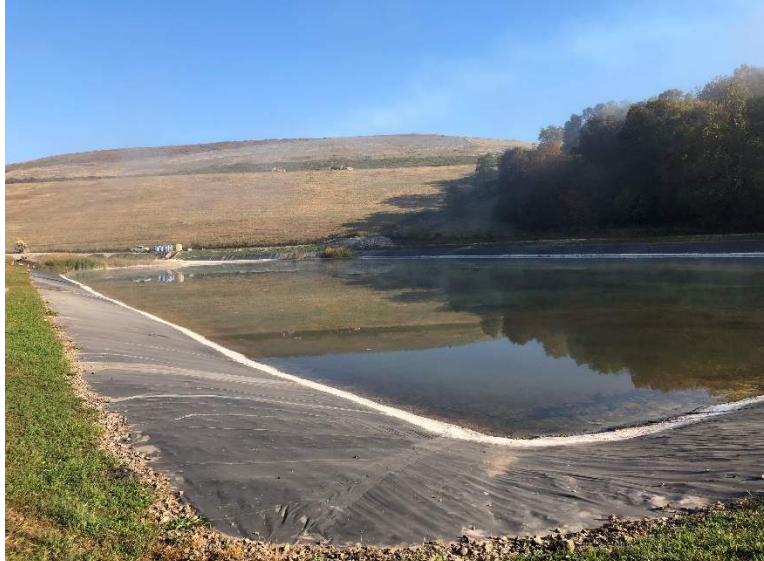
Pond No. 1 on the south side of the RWL was observed to be functioning properly during the annual inspection. The sedimentation/treatment portion of Pond No. 1 was observed to contain varying depths of solids, as observable in Photographs 29 and 30. This pond is routinely cleaned of accumulated solids, typically through the use of extended-reach excavators or a floating dredge. Based on a visual assessment, Pond No. 1 was noted to have accumulated sediments below 2021 levels.

A build-up of sediments, aggregate, and vegetation was observed in the north end of the pond near the two inflow channels (Photograph 30). For maintenance purposes, these materials should be removed and properly disposed. Stone from the access roadway was observed to be deposited in these inflow channels areas. It is recommended that steps continue to be taken to mitigate the displacement of stone from the roadway by vehicles and during the application of maintenance aggregate to the surface. Also, there were multiple small tears and holes identified around the perimeter of Pond No. 1 but were above the operating water level. No water was standing against these tears, and no discharge through these

<p>View of Pond No. 1 (looking north).</p>	
<p>Photograph #30</p>	 
<p>View of vegetated sediment patch in Pond No. 1. Woody stem vegetation by edge of pond should be removed (looking west)</p>	
<p>Photograph #31</p>

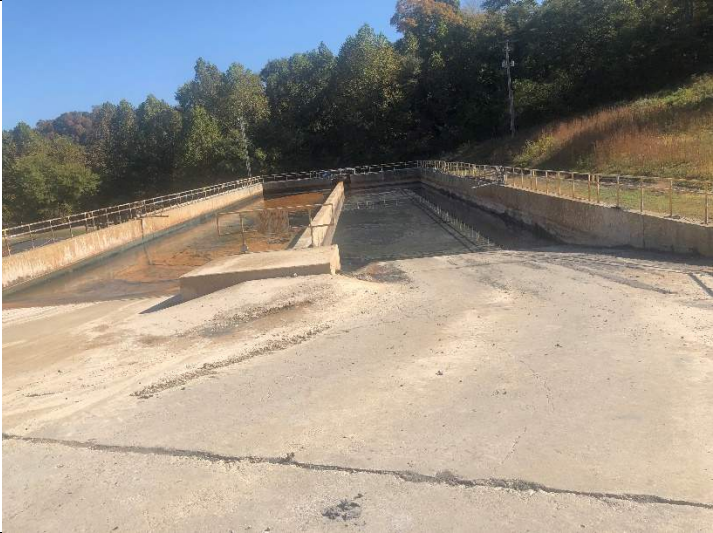
Pond No. 2 on the southeast side of the RWL was observed and appeared to be functioning properly during the inspection. To assist with the removal of FGD solids derived from the stack-out pad and to minimize dredging, Gavin Power operates a concrete settling basin at Pond No. 2 (Photograph 34). This basin is routinely cleaned with an extended-reach excavator. The leachate inflow pipe located on the west side of the Pond No.2 sedimentation basin has been connected to a pump station which directs the flow into the concrete headworks settling basin for initial treatment prior to entering the southern end of the geosynthetic lined pond.

<p>Concrete headworks settling basin adjacent to Pond No. 2. (looking east)</p>	
<p>Photograph #35</p>

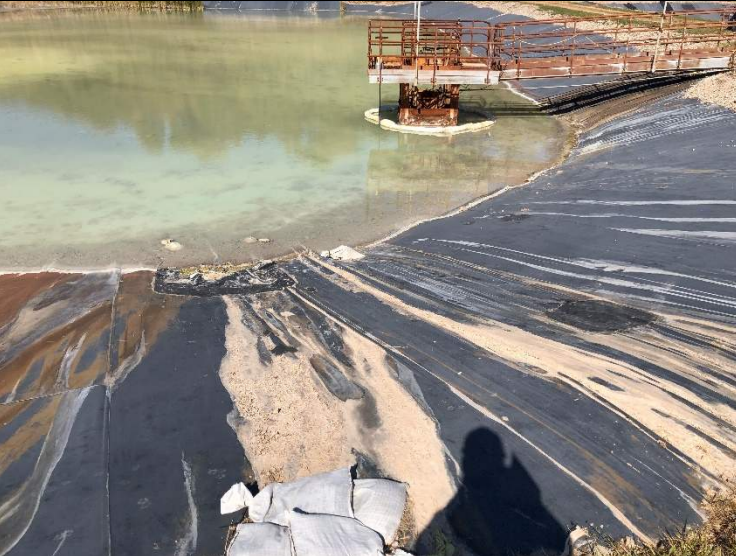
<p>Primary Treatment Pond No. 3 spillway. (looking north)</p>	
<p>Photograph #45</p>
