# 2022 Annual Inspection Report

Gavin Power, LLC

## Bottom Ash Pond

Gavin Power Plant  
Cheshire, Ohio

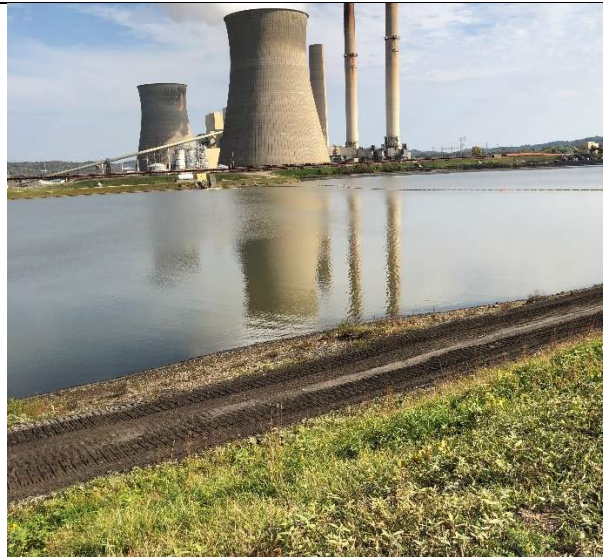
**Photograph #14**

View of Bottom Ash Pond (BAP) from SW corner (looking northeast). Turbidity boom visible crossing the BAP from north to south.

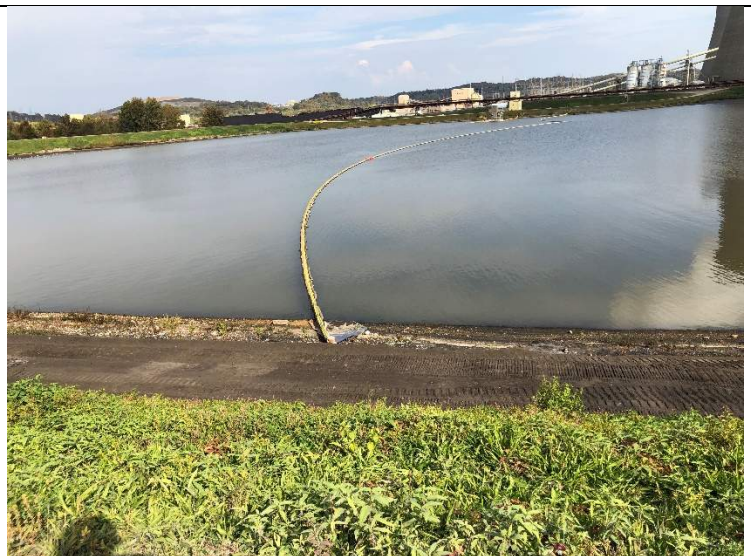
**Photograph #15**

View of interior southern embankment slope of BAP near its center, with intentionally placed bottom ash along the toe to prevent wind erosion. Slope is stable and well vegetated (looking north). Turbidity boom visible in center of image.

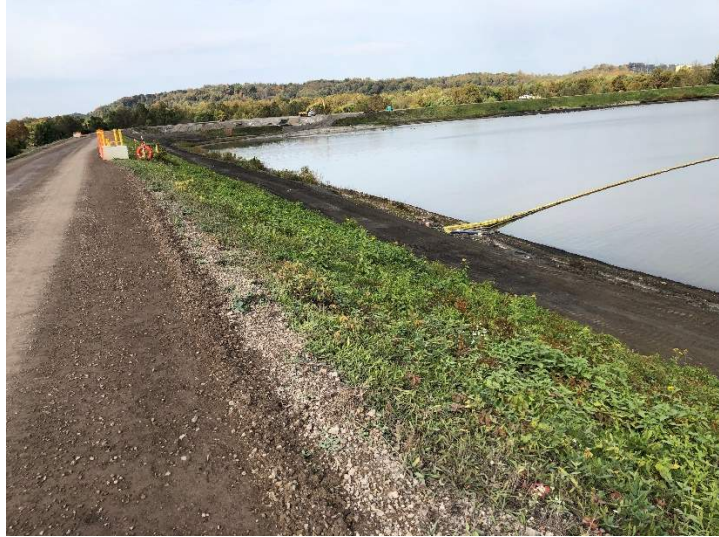
**Photograph #16**

View of interior southern embankment slope of BAP. Slope is stable and well vegetated (looking northwest).

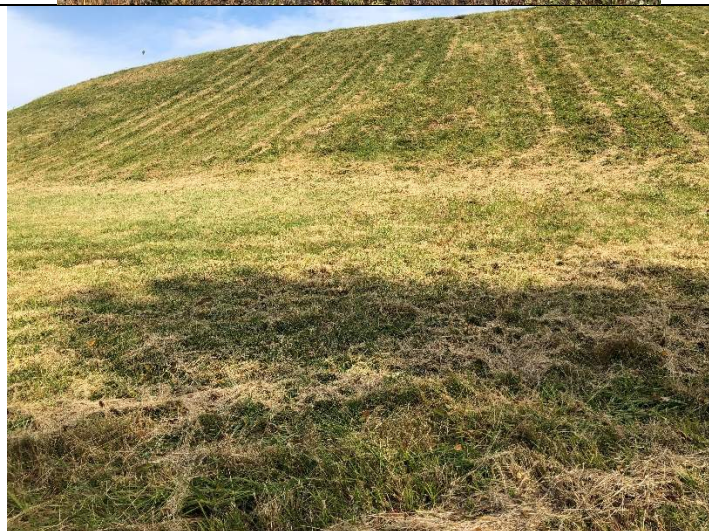
**Photograph #18**

sparse cover areas identified in the 2021 inspection was observed in 2022. A few minor areas of sparse vegetation coverage remain (Photographs 10 through 12 and 18).

View down exterior slope of southern embankment. Slope appears stable and is well vegetated (looking north).

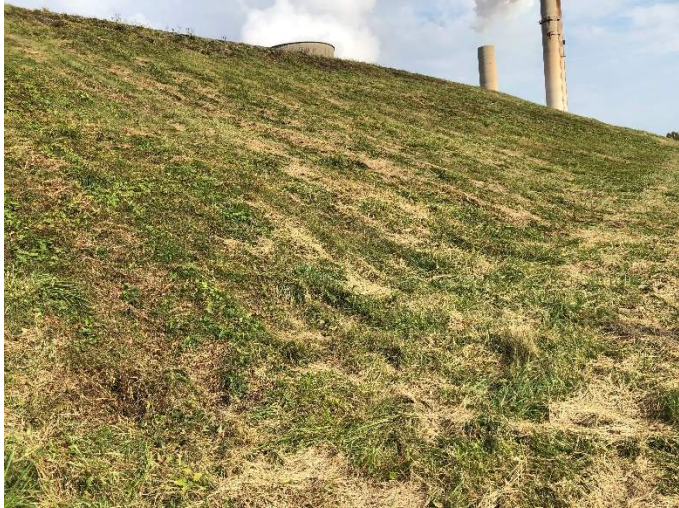
<b>Photograph #19</b>

View of top exterior eastern embankment slope and access road near SE corner of BAP. Slope is stable and well vegetated (looking north).	
<b>Photograph #20</b>

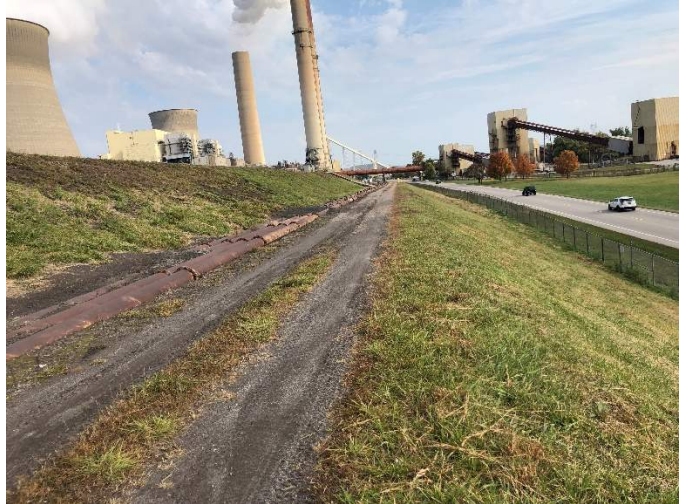
5. The eastern embankment access road was found in stable condition and remains well maintained (Photograph 20).

View of top exterior eastern embankment slope and BAP effluent pipelines and mid slope access road. Slope is stable and well vegetated with some areas of sparse cover (looking north). Ohio Route 7 visible on right side of image outside fenceline.	
<b>Photograph #21</b>

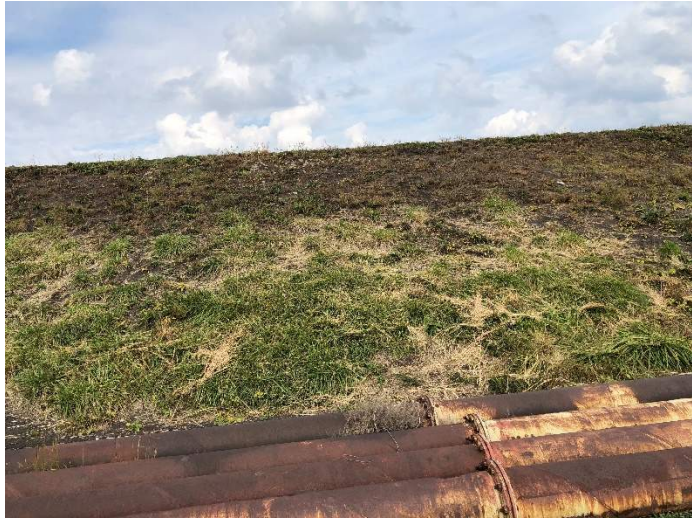
2. The pipe and support structures for the two nests of slurry pipelines entering the pond had surface rust in localized areas but appeared to be structurally sound and in satisfactory condition. Recent piping repairs were observed at the time of inspection (Photographs 21 and 22). The coal reject (pyrite) pipes were discharging from the Plant into the BAP during the inspection and no signs of leaking from the pipes were observed along the eastern face of the embankment. Note that the Unit 1 structure and piping was dismantled, and the Unit 2 structure and piping were removed the week after the inspection took place.

View of pipeline along eastern embankment exterior slope with some areas of sparse cover (looking west).

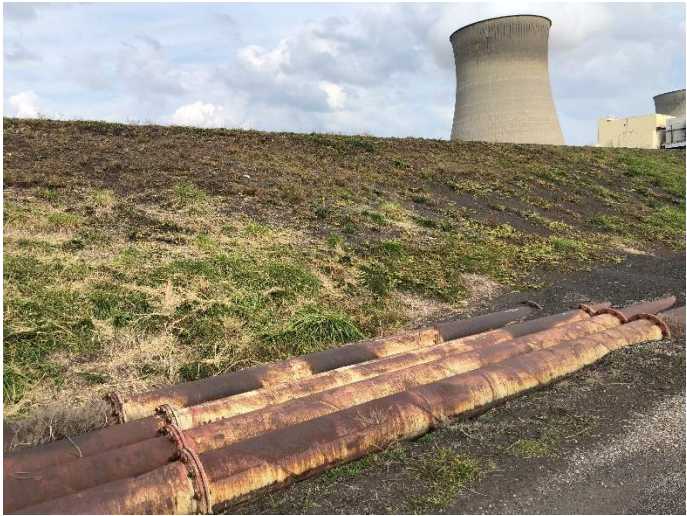
<p><b>Photograph #22</b></p>

<p>View of pipeline along eastern embankment exterior slope with some areas of sparse cover (looking north).</p>

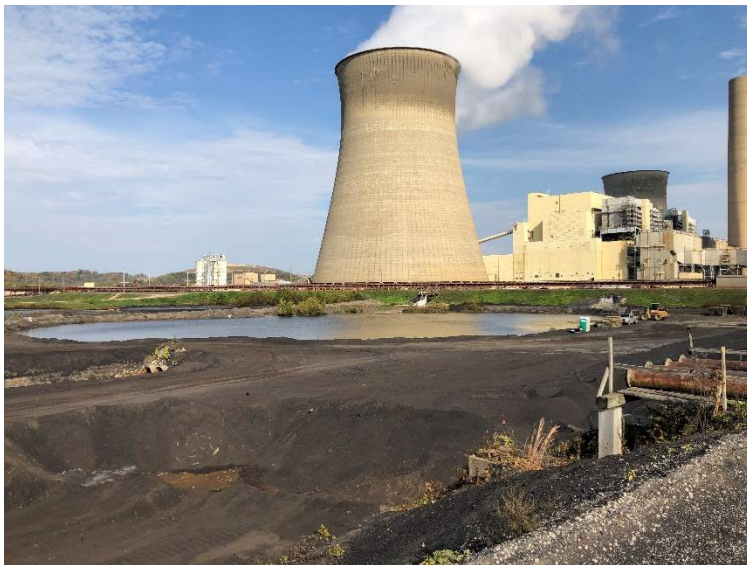
**Photograph #28**

4. From the top of the interior embankment slope, the wooden platform supporting the coal reject and pyrite line discharges look to have been fixed/replaced since the 2021 inspection when it was observed to have a few loose supports, and some instances of apparent missing supports, in addition to displaying general signs of material decay (Photographs 26 and 28).

View of coal reject and pyrite line discharges at NE corner of BAP. Banks appear stable (looking northwest).

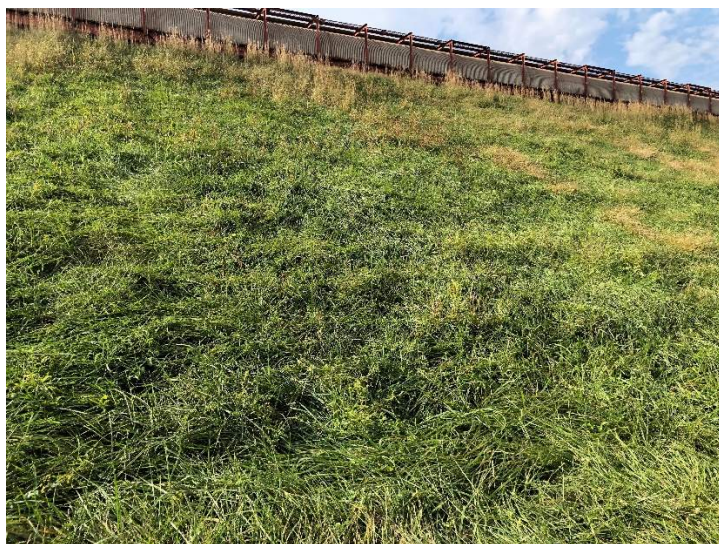
**Photograph #31**

1. The condition of the exterior slope appeared stable and generally well vegetated with some isolated areas of sparse vegetation (Photographs 30 and 31). This embankment in the vicinity of the discharge pipe had previously documented settlement repairs along the toe of the exterior slope and exhibited no further indication of ground settlement. No evidence of seeps along the toe of the embankment were observed.

View of exterior northern embankment slope near center of BAP. Slope is stable and well vegetated with some areas of sparse cover below coal conveyor along the top (looking south).

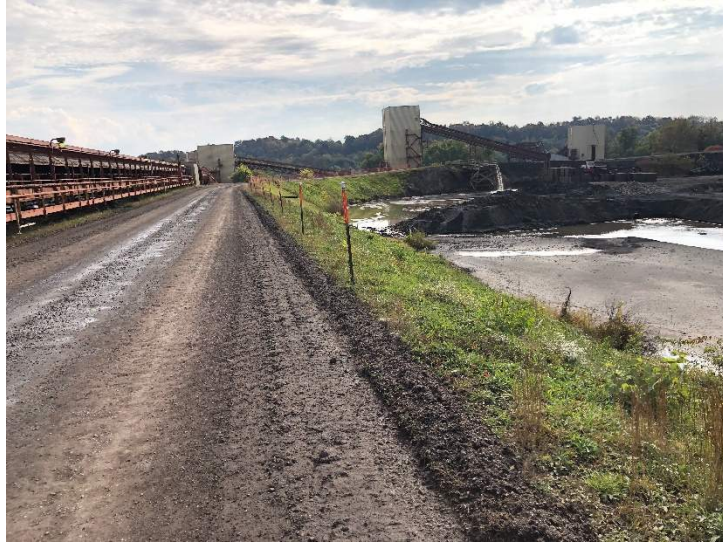
**Photograph #35**

View of excavation just beyond toe of northern embankment associated with plant piping repair. Northern embankment is visible in the upper right of the image. No signs of embankment instability. This is adjacent to the reclaim pond area. Scheduled for backfill in 2023 (looking east).

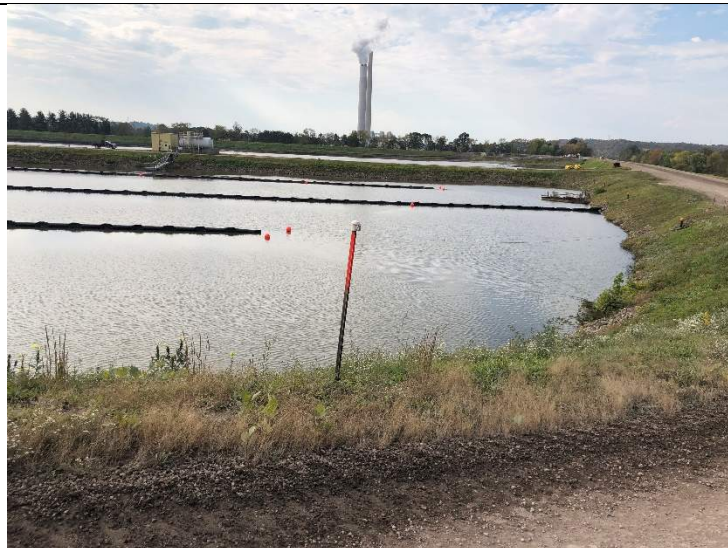
**Photograph #37**

Spot seeding repair needed under conveyor at BAP.

5. The northern embankment access road was found to be in stable condition and remains well maintained (Photograph 34).
6. Spot seeding repair is needed under the conveyor (Photograph 37).
