2023 Annual Inspection Report

Gavin Power, LLC

Residual Waste Landfill

Gavin Power Plant
Cheshire, Ohio

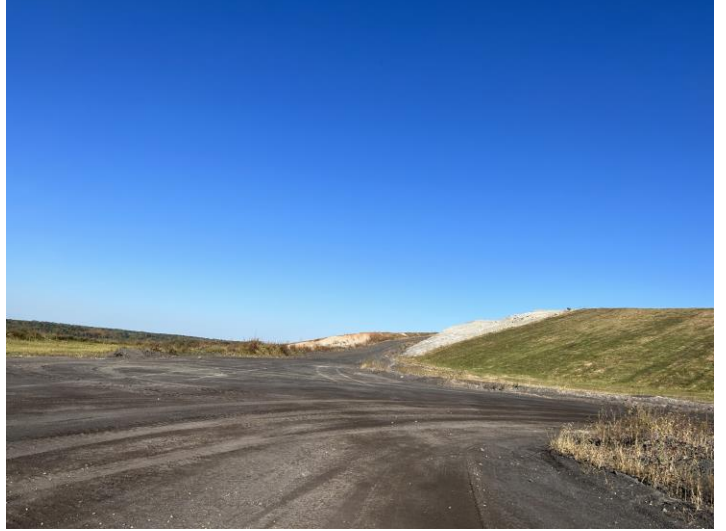
A wide, dark, gravelly haul road curves to the right, heading up a grassy embankment. The road surface is uneven and shows signs of heavy use. The sky is a clear, bright blue.
Main haul road heading up the southwestern side of the landfill (looking northwest).	
Photograph #3

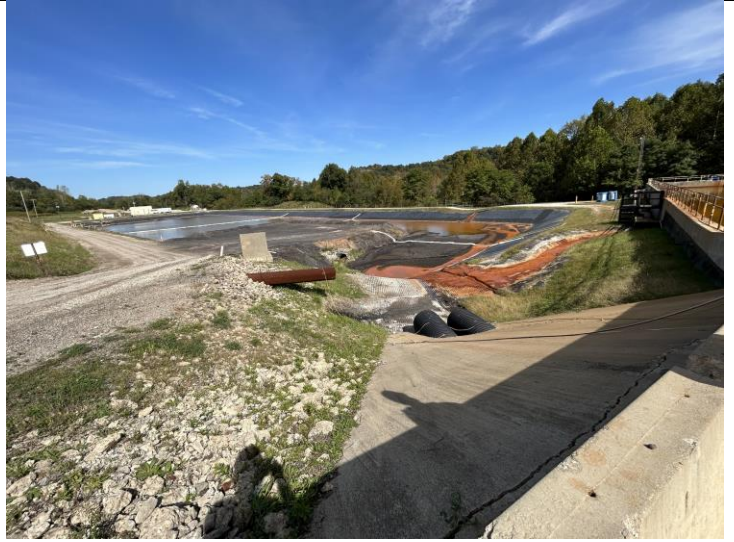
<p>Photograph #4</p>

<p>Access road leading to Pond 2 (looking east).</p>	
<p>Photograph #5</p>

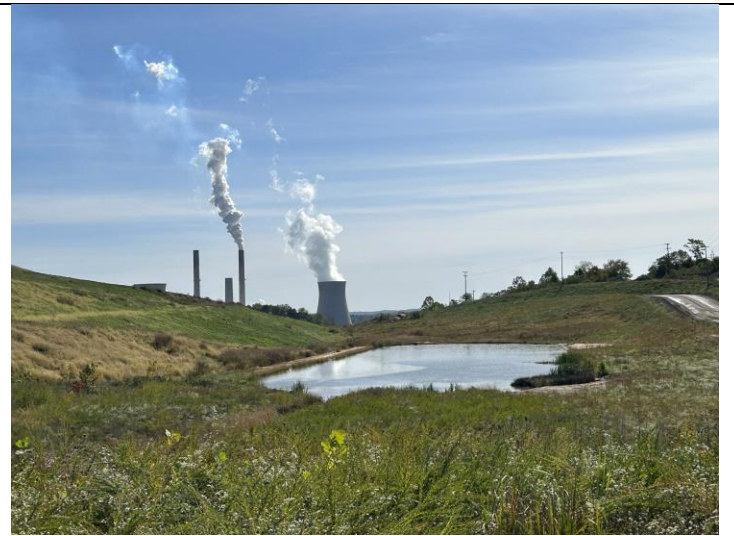
<p>Northwest vegetated slope and temporary sediment basin from landfill construction activities (looking south).</p>	
<p>Photograph #6</p>

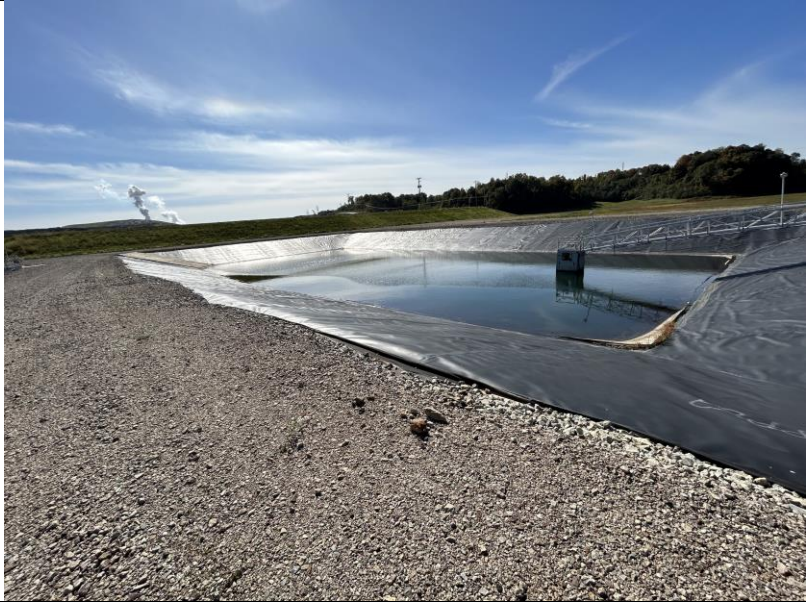
Photograph #22

cover and will allow sediment to be removed more efficiently. The concrete cover on the bottom of the pond and partially up the sides to the operating level were observed to be in satisfactory condition where exposed (Photographs 22 and 23). Stone from the access roadway was observed to be present on isolated portions of the pond liner. It is recommended that steps be taken to mitigate the movement of stone from the roadway by vehicles and during the application of maintenance aggregate to the road surface.

16. Stone from the access roadway to Pond No. 6 was observed to be on the pond liner. It is recommended that steps be taken to mitigate the displacement of stone from the roadway by vehicles and during the application of maintenance aggregate to the surface.

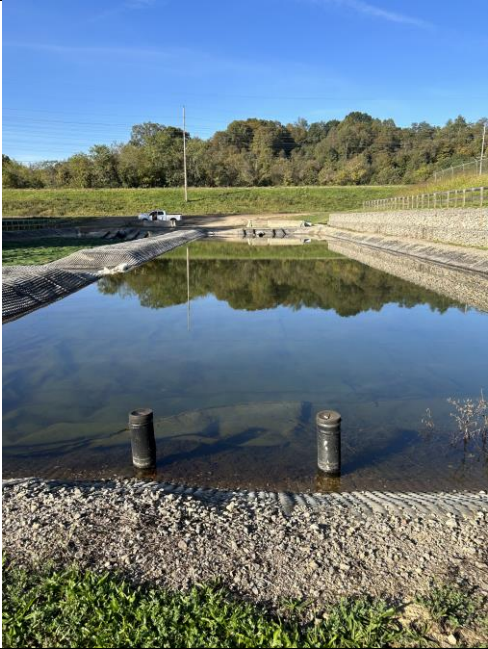
<p>Photograph #24</p>

The vertical flow wetlands for Pond No. 1 were observed to be in working order (Photographs 24 through 28).

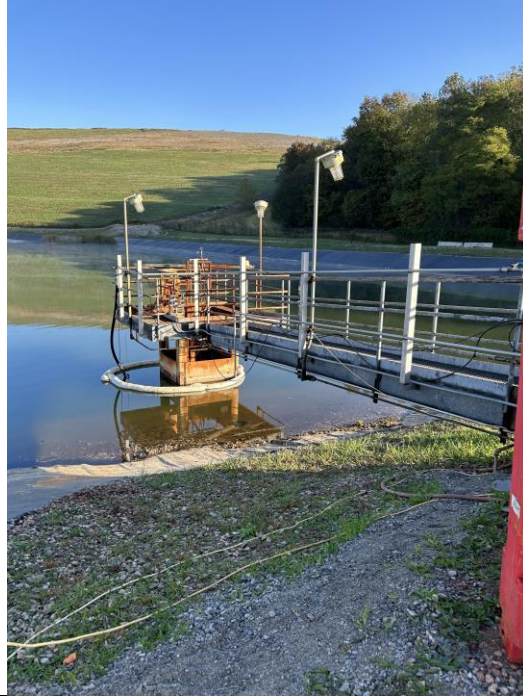
Photograph #33

Damaged liner side slope of Pond No. 1 clarifying pond with vegetation growth coming through liner.

10. Within Pond No. 1 continue maintenance and repairs as required. Clean channel inlets of stone and remove woody vegetation from inside pond limits. Continue to remove sediment buildup as needed for proper pond function.

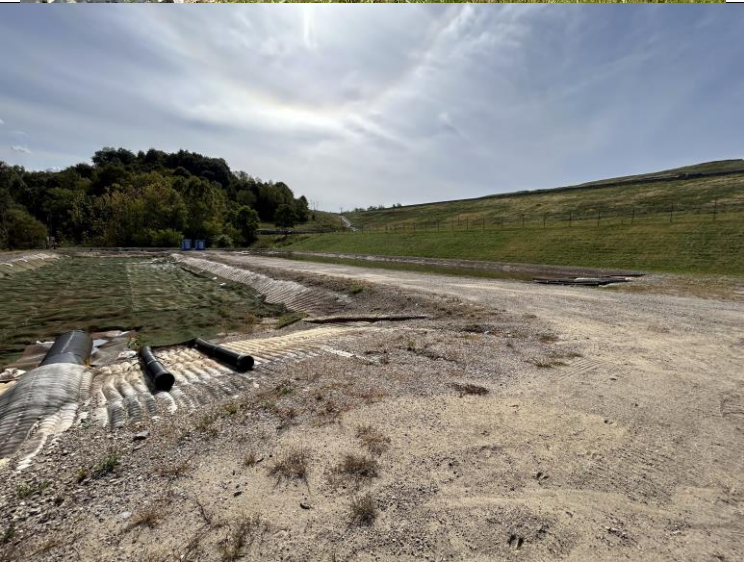
The vertical flow wetland cells for Pond No. 2 were observed to be in satisfactory condition (Photograph 38). The westernmost wetland was functioning during the inspection. The rock lined outflow channel for the system to the South of the vertical ponds appeared to be functioning properly from a flow standpoint, with no signs of erosion or distress.

<p>Vertical flow wetlands for Pond No. 2 (looking south).</p>	
<p>Photograph #39</p>

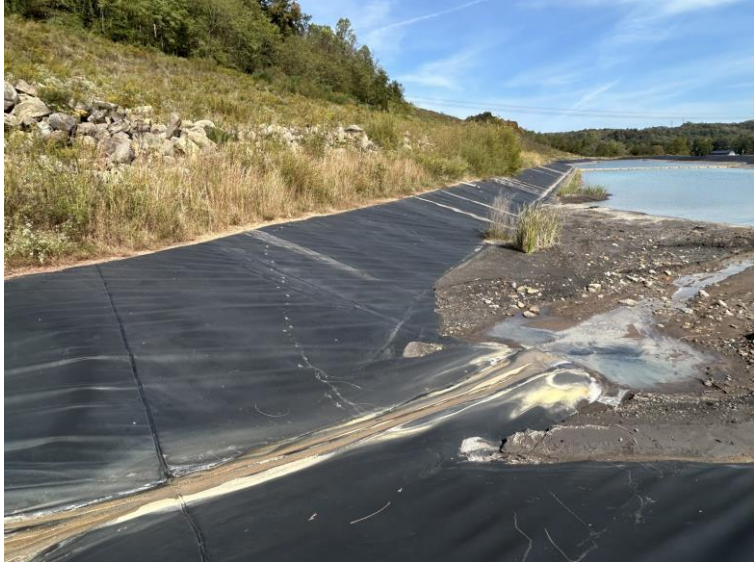
<p>Photograph #43</p>

There were minor punctures noted in the geomembrane liner near the concrete inflow channel to Pond No. 5 (Photograph 49) that may be the result of animal hoofs. Deer tracks were observed in the soil near this location as well as track marks across the liner (Photograph 43). The holes are above the normal operating water level of the pond and 2+ feet away from where leachate and stormwater flows enter the pond. These holes should be repaired as weather conditions allow in 2024. Additional measures for the exclusion and deterrence of whitetail deer from this area should also be explored.

<p>Looking down northern edge of Pond No. 5. Pipe used for periodic removal of water under the liner in the foreground (looking east).</p>	
<p>Photograph #44</p>

14. Drain water from underneath the pond liner system on the southwest and northwest corner of Pond No. 5 via dewatering perforations. Continue to visually monitor these portions of the pond for water buildup and drain water buildup where identified to avoid the addition of tension into the geomembrane until a permanent solution is implemented. During 2024, it is recommended to further assess the source of the water gaining entrance underneath the liner system and to identify potential steps to prevent the build-up of water under the liner system from recurring. If a correction is identified and implemented, repair the geomembrane dewatering perforations using appropriate patching and leak detection methods once the water source has been identified and further build-up is mitigated.

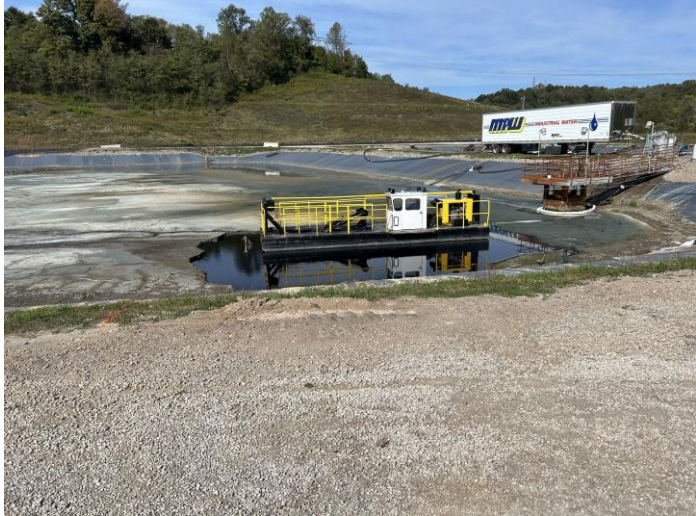
An area had been excavated within the sediments using a long reach excavator near the outlet structure for the primary treatment pond going to the clarifying pond. This excavated area is intended to provide sufficient space and depth for the floating dredge to begin removing sediments. The dredge was floating in this space during the time of the visit (Photograph 44) but was not operating. A dewatering area has been set up and lined with plastic sheeting to the south of Pond 3. The dewatering area has been designed to return water through a channel into the primary treatment pond. Geotubes for collecting sediment from dewatering activities were present on site but not deployed at the time of the inspection.

<p>Primary Treatment Pond No. 3. Area excavated for floating dredge to begin sediment removal (looking north).</p>	
<p>Photograph #45</p>

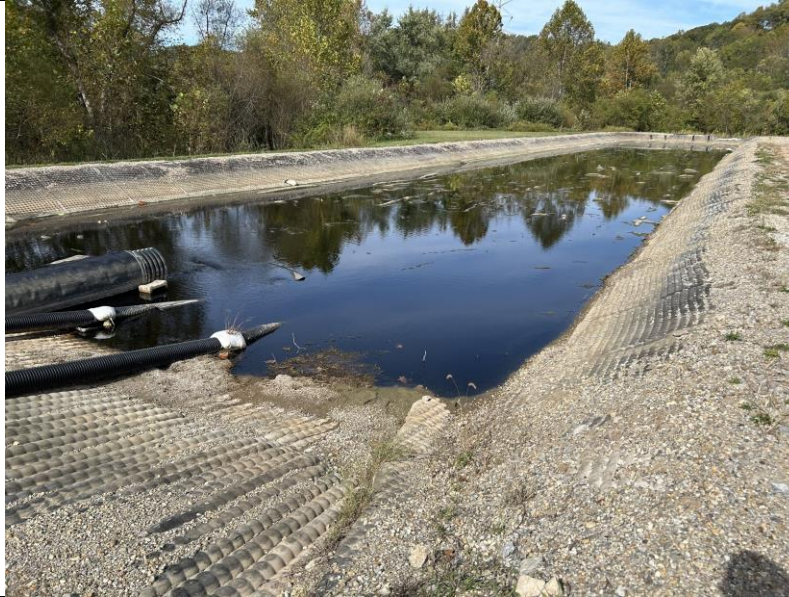
Photograph #48

The vertical flow wetlands for Pond No. 3/Pond No. 5 were observed to be functioning properly. However, the discharge seemed to be slightly tinted in color, but there was no observable scour or outlet instability below the permitted Outfall 009 (Photographs 47 and 48). Chemical dosing at the outfall was being inspected during the time of our visit.

Vertical wetlands for Pond No. 3 and 5 – eastern pond (looking northeast).

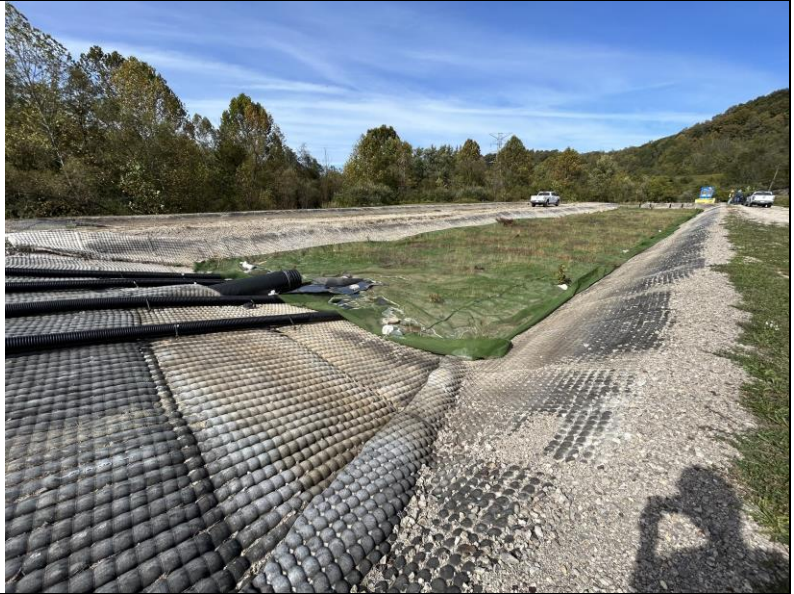
Photograph #49

View of inflow channel to Pond 5 with multiple small liner perforations suspected of being related to wildlife. (looking northwest).

12. Attempt to deter wildlife from the pond areas and make repairs to the liner materials and/or fence as needed.
 13. Maintain drainage stone placement around the existing current chimney drains and protect these from sedimentation as intermediate and final cover is placed.

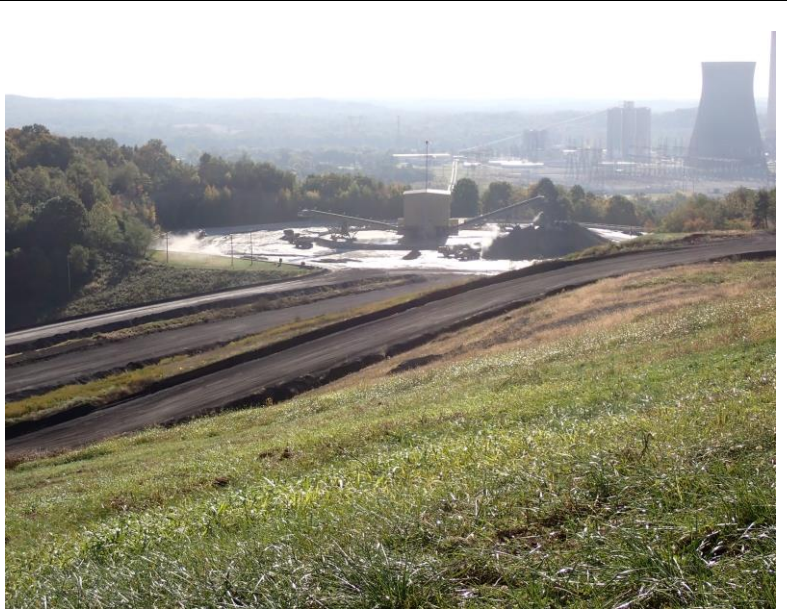
Photograph #51

Photographs 50 and 51 depict operating conditions at the FGD stack-out pad during the annual inspection. There was minimal FGD production on the day of the inspection, and the material was satisfactorily handled and contained on the pad prior to being loaded into haul trucks for disposal in Phase H.

View of FGD stack out pad operations (looking southeast).
