2023 Annual Inspection Report

Bottom Ash Pond

Gavin Power Plant
Cheshire, Ohio

5 January 2024

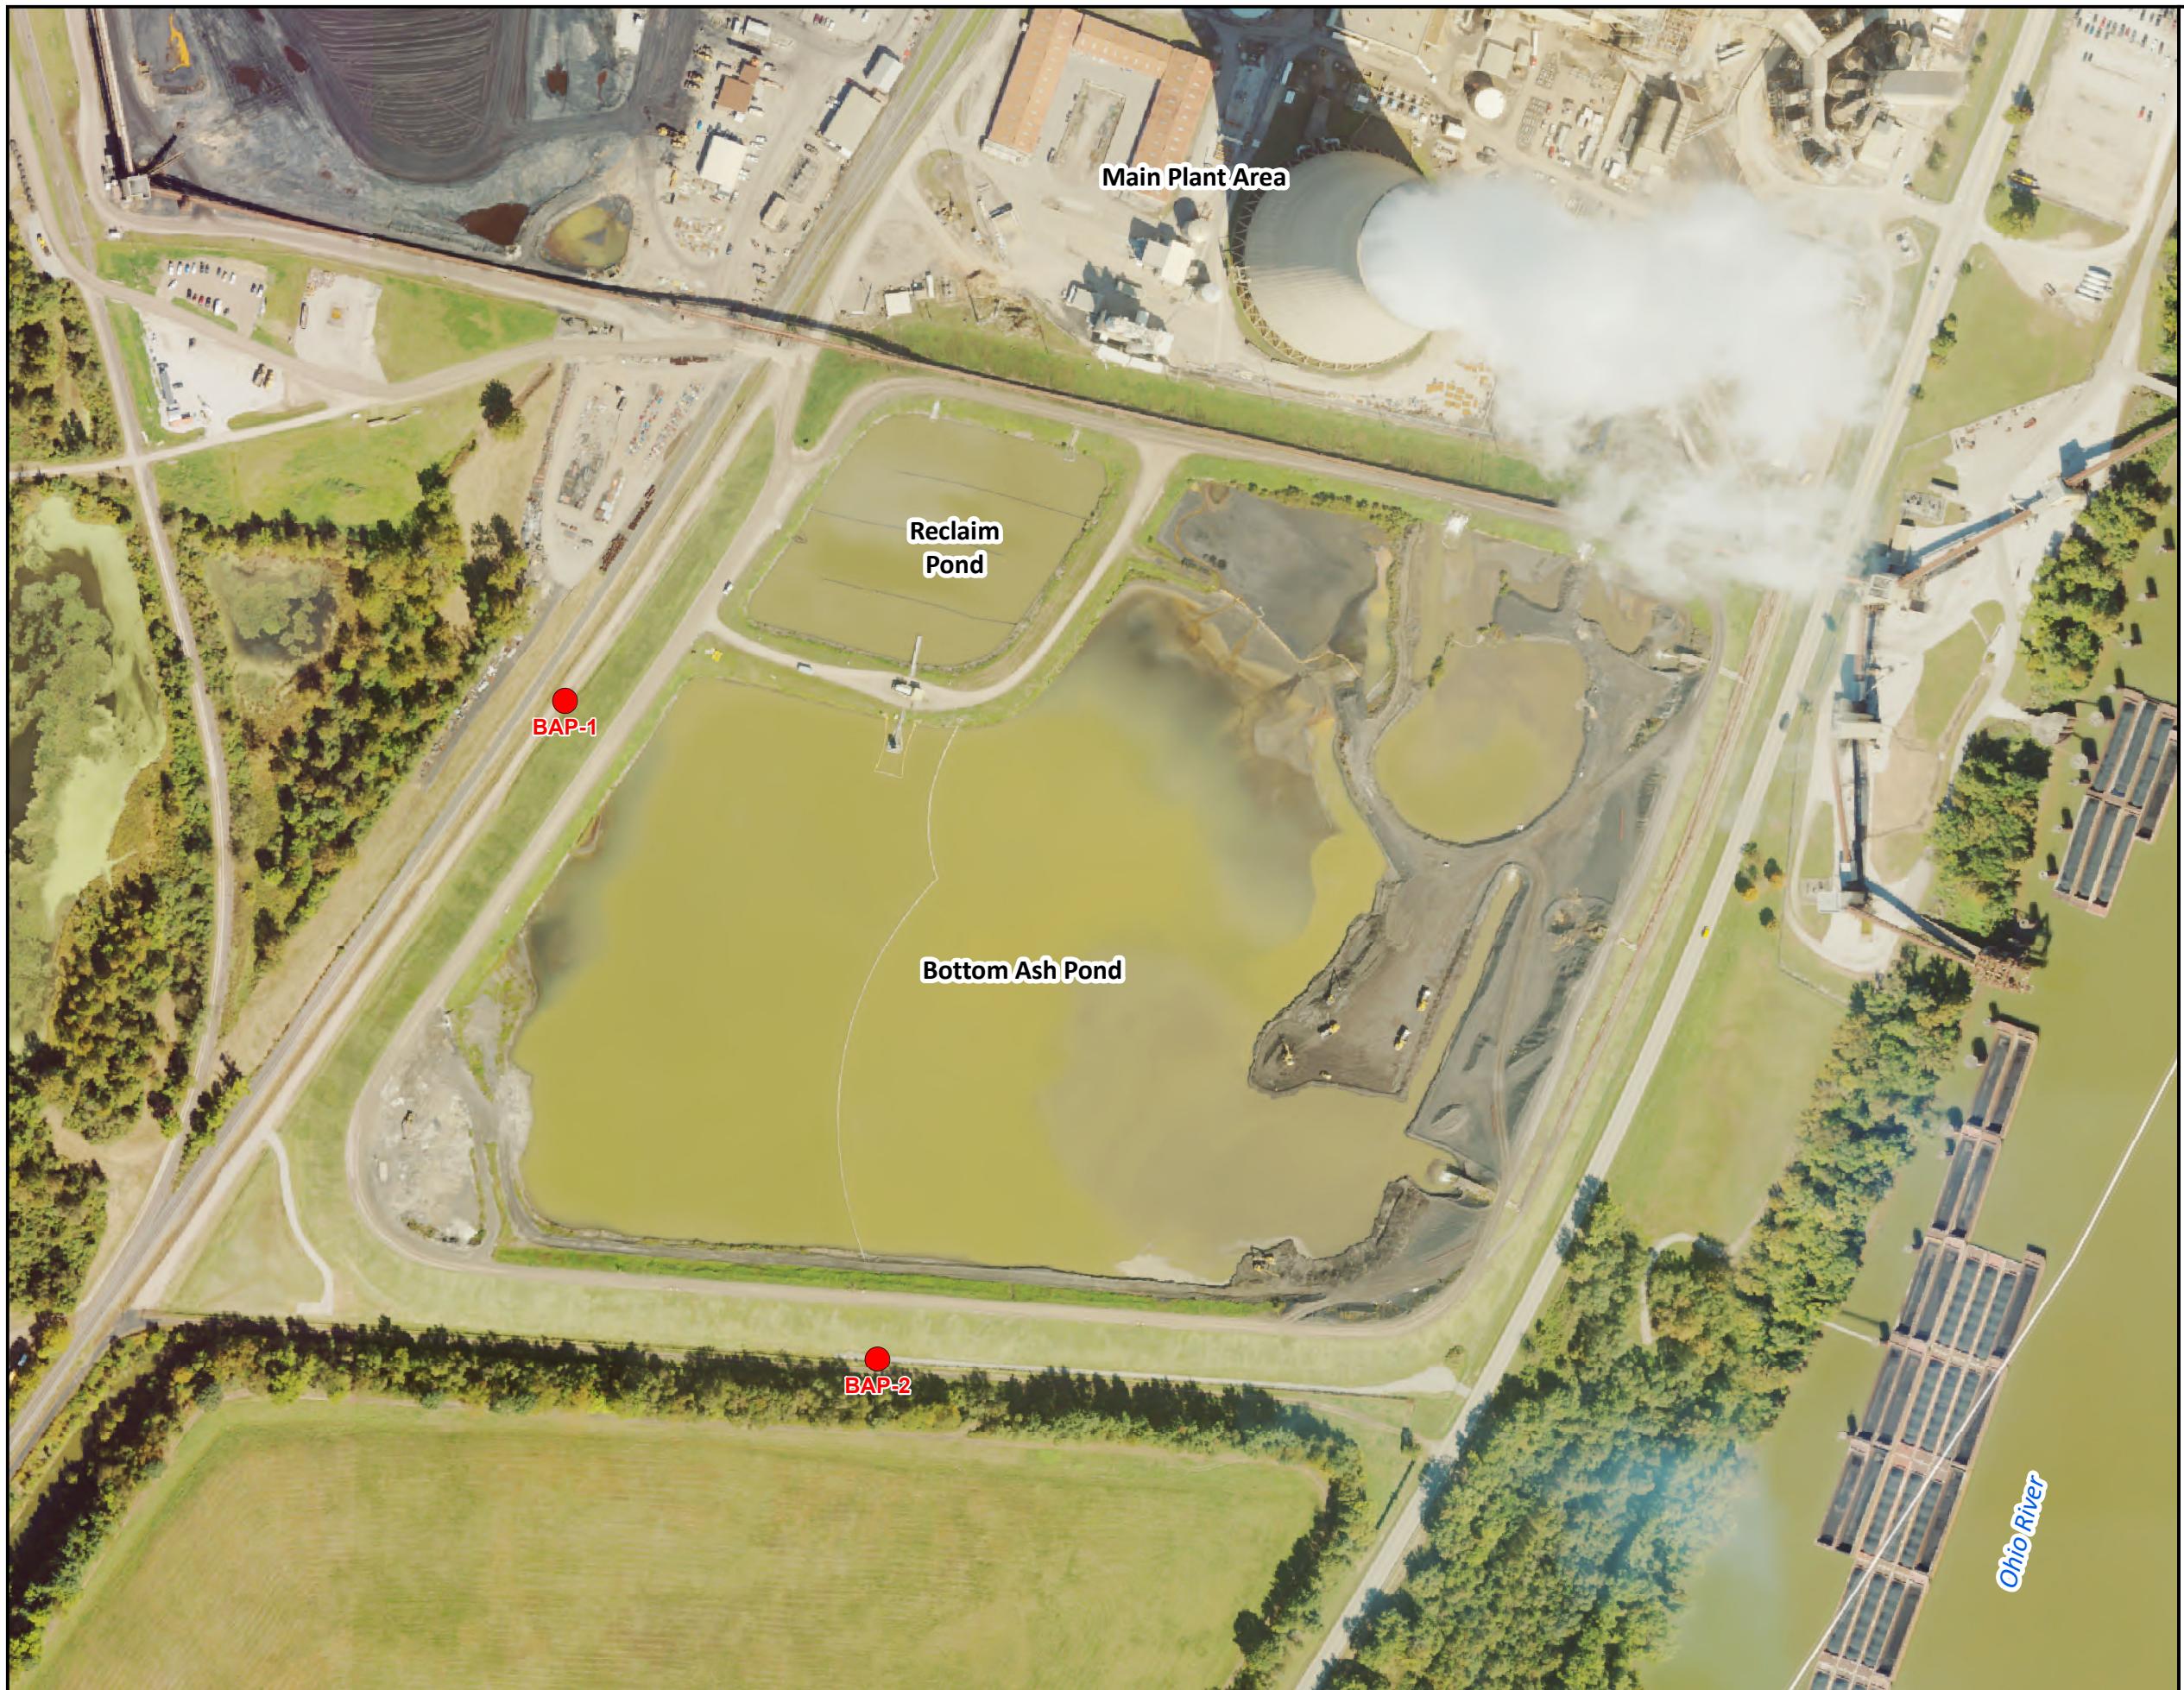
Figure 2: Bottom Ash Complex Site Layout
Gavin Power LLC
Cheshire, Ohio

Two piezometers, labeled BAP-1, and BAP-2, are located at the BAC as indicated on **Figure 2**. Water level readings were obtained from piezometers BAP-1 and BAP-2, and from inside the BAP itself. BAP-1 is near the drainage ditch along the western dike and BAP-2 is near the toe of the exterior slope of the southern dike. A plot of the monthly recorded readings from these piezometers and the pond surface is presented in **Appendix C**, in accordance with 40 CFR § 257.83(b)(2)(ii). From January 2023 through April 2023, groundwater levels in BAP-1 and BAP-2 exhibited average elevations of +541.34 and +540.60 feet MSL, with standard deviations of 0.3 and 0.1 feet, respectively. Also, the maximum reading for BAP-1 was +541.62 MSL while the maximum reading for BAP-2 was +540.69 MSL.

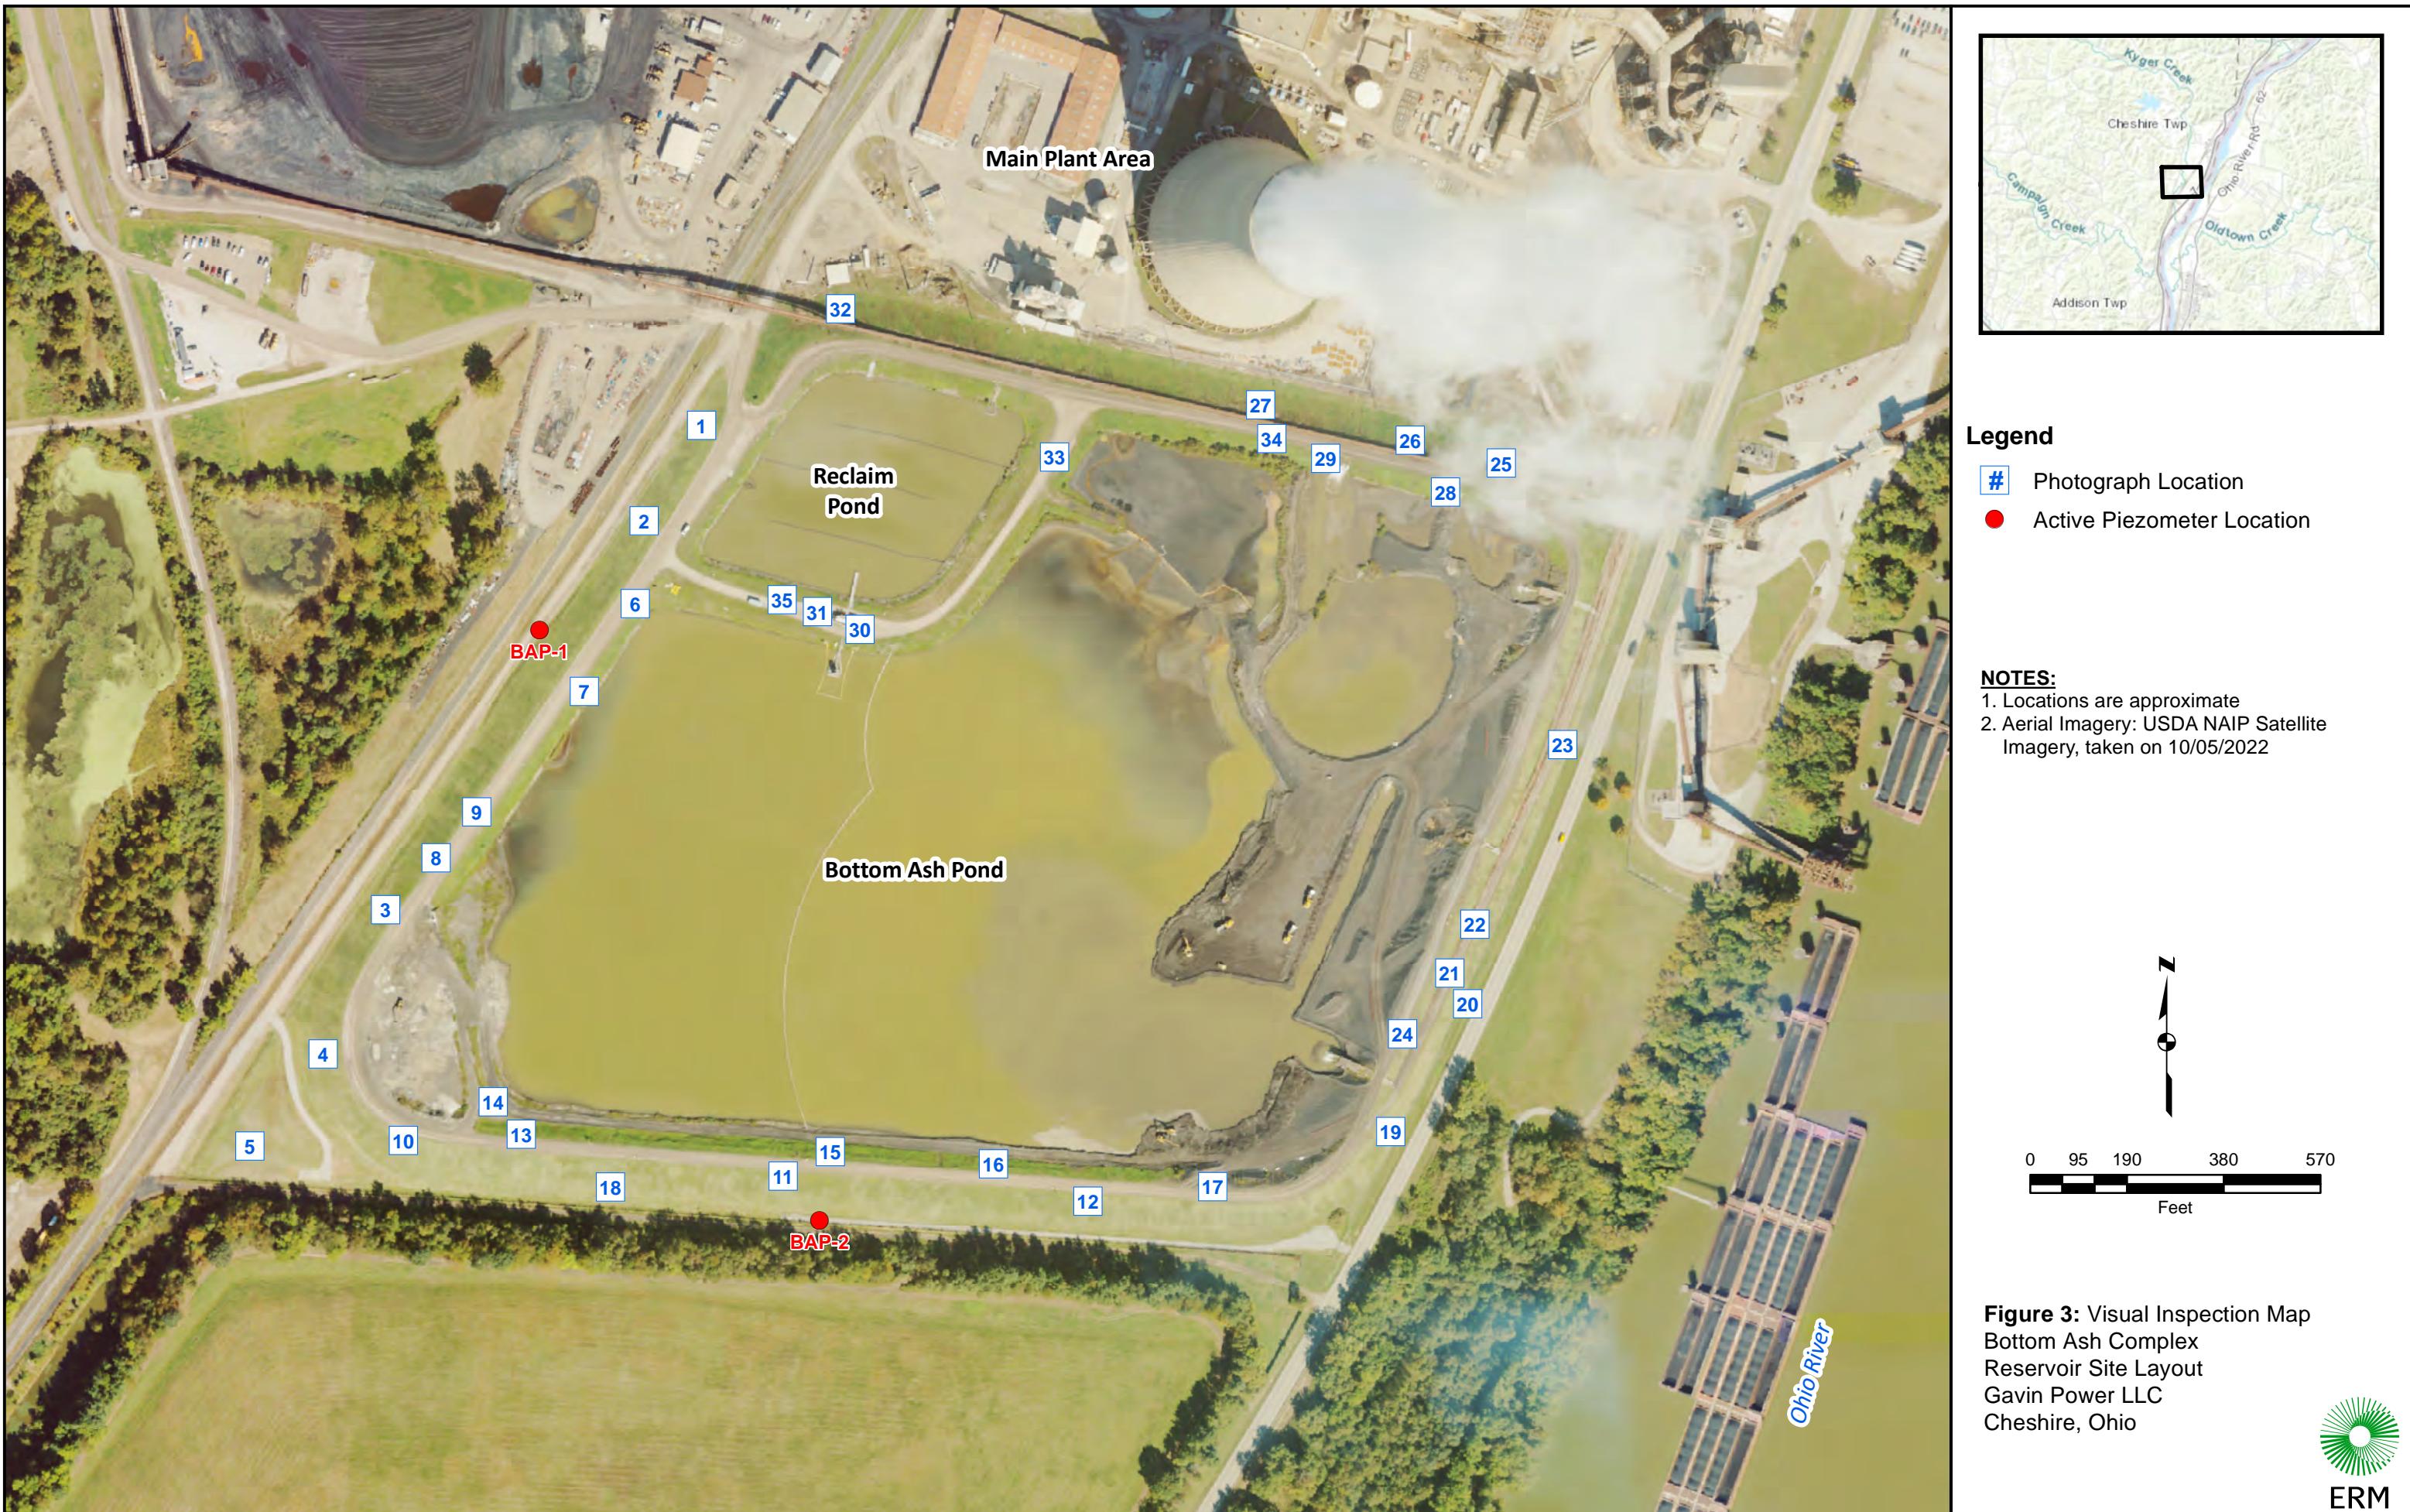
Figure 3: Visual Inspection Map
Bottom Ash Complex
Reservoir Site Layout
Gavin Power LLC
Cheshire, Ohio

The 2023 annual visual inspection conducted for the BAP is summarized below. All referenced photographs are in **Appendix A**; **Figure 3** shows the approximate locations where they were taken. Qualitative terms used to describe the inspection are summarized in **Appendix B**.
