2024 Annual Inspection Report

Residual Waste Landfill

PREPARED FOR
Gavin Power, LLC

DATE
10 January 2025

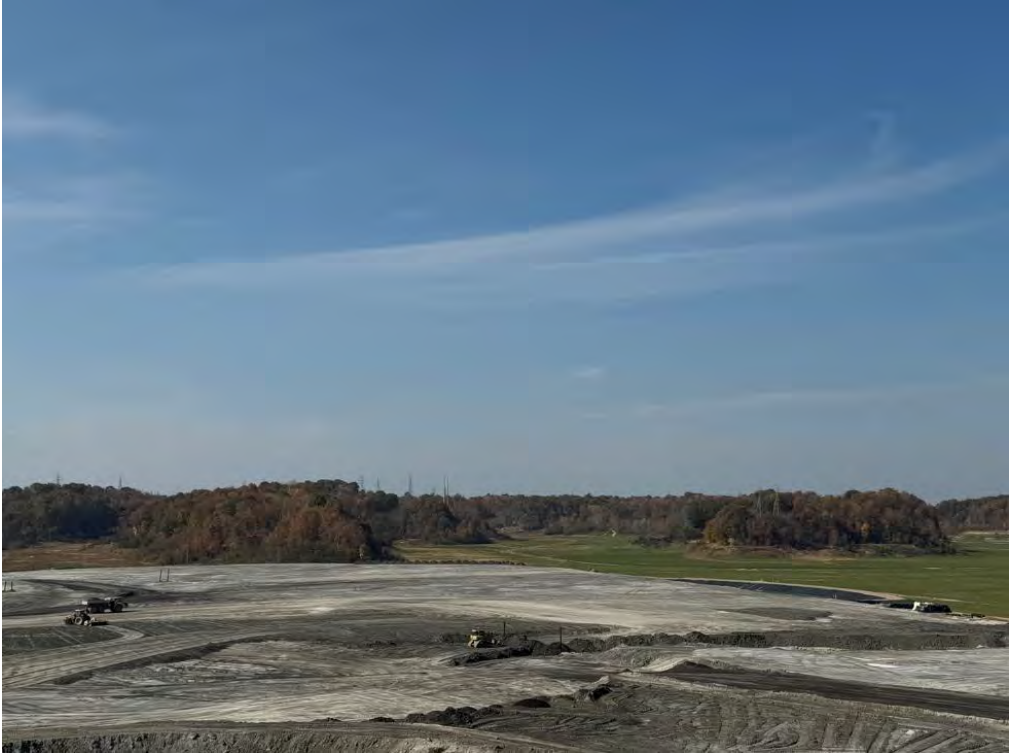
PHOTO NO. 1.	DATE 29 October 2024

DIRECTION PHOTO TAKEN Northwest		
DESCRIPTION Looking at Center of Phase H/I from top of Phase J

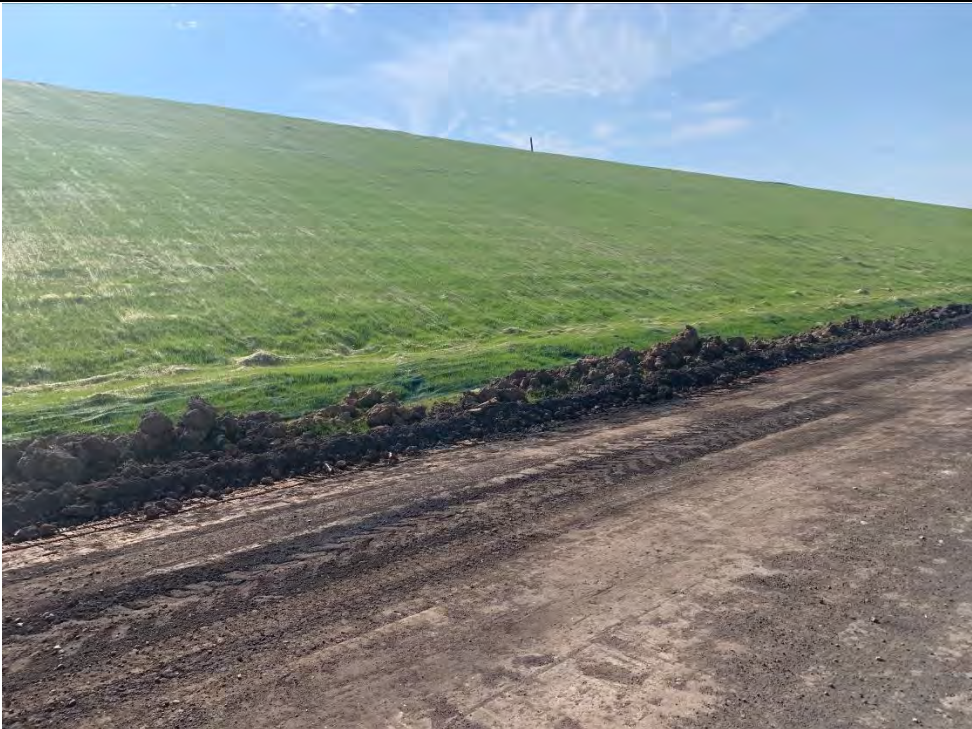
PHOTO NO. 21.	DATE 29 October 2024

An alternate cap system was installed in 2024 over 5.5 acres of the landfill, including the northern slopes of Phase H (Photograph 21). The alternate cap on the side slopes is composed of three layers:

DIRECTION PHOTO TAKEN West		
DESCRIPTION View of well-vegetated northern slopes of Phase H lateral expansion

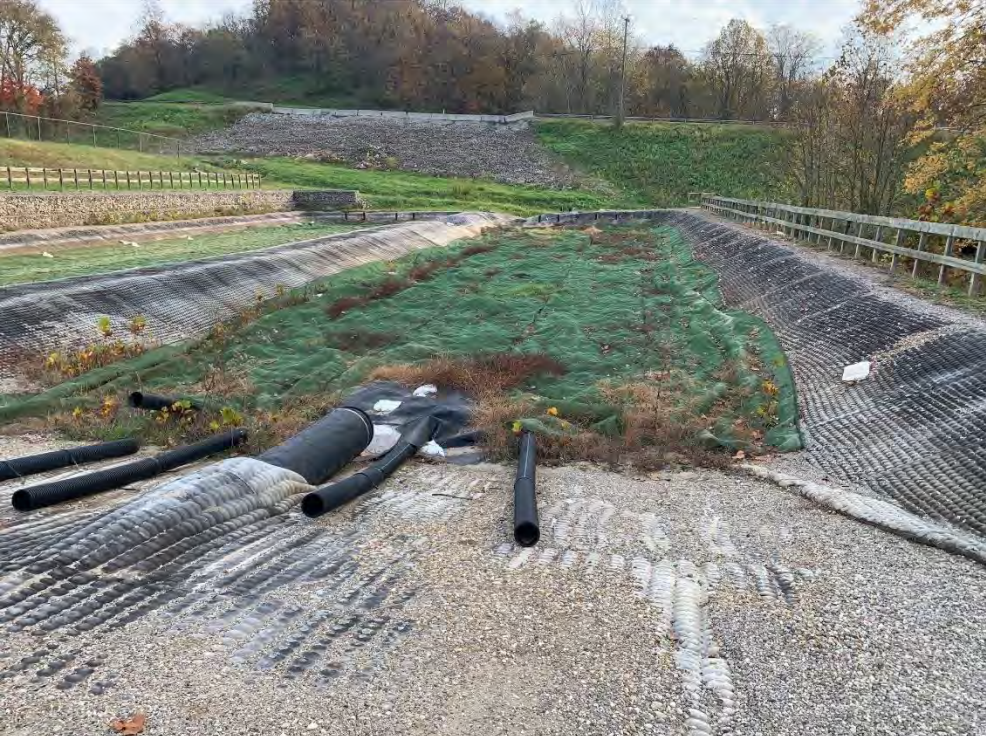
PHOTO NO. 26.	DATE 29 October 2024

DIRECTION PHOTO TAKEN East		
DESCRIPTION View of inlet pipe for vertical flow wetland treatment adjacent to Pond 1.

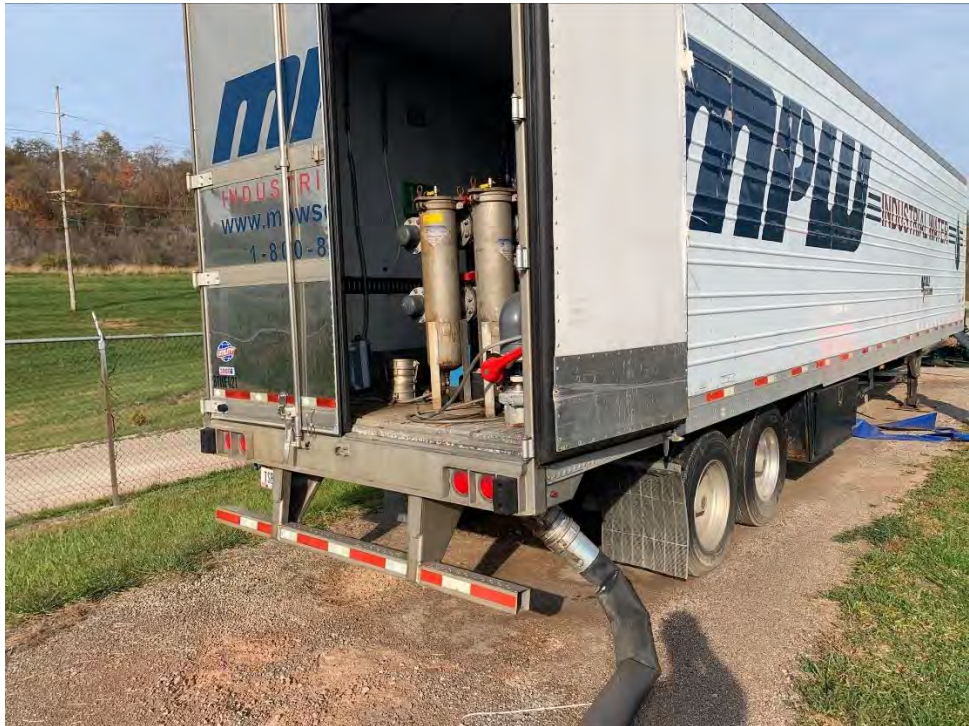
PHOTO NO. 34.	DATE 29 October 2024

A build-up of sediments, aggregate, and vegetation continues to be observed in the north end of the pond near the two inflow channels (Photograph 32). A mobile trailer mounted temporary filter system was staged adjacent to Pond 1 clarifying pond (Photograph 34). This filter system continues to transfer water from the clarifying pond using a suction hose, filters the water and then pumps it into the inflow structures to the vertical flow wetland system. The filter was installed as a supplemental measure to improve water quality going to the next stage of treatment. The filter system was secured in the interior of the trailer and was not observed. There were no leaks observed, and the trailer appeared to be in satisfactory condition.

DIRECTION PHOTO TAKEN Northwest		
DESCRIPTION View of Pond 1 water treatment process equipment located adjacent to Pond 1 clarifying pond.
