Gavin Power, LLC
Cheshire, Ohio

Emergency Action Plan

*Stingy Run Fly Ash Pond and
Bottom Ash Complex
Gavin Power Plant
7397 State Route 8 North
Cheshire, Ohio 45620*

April 2017

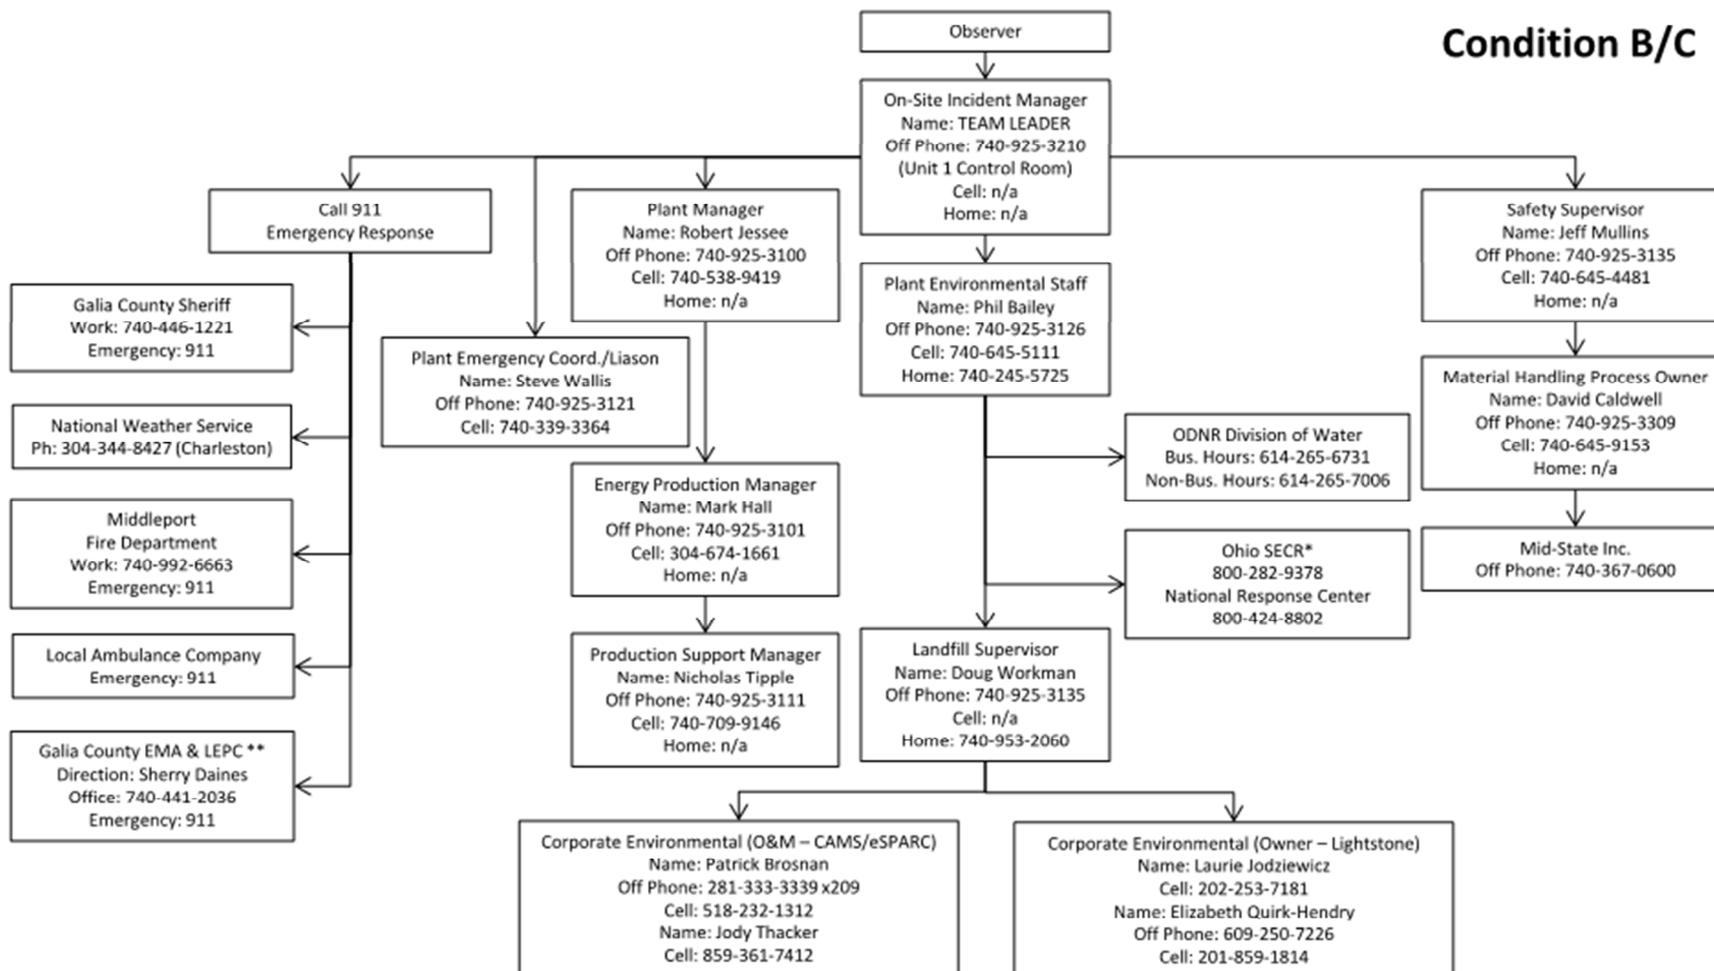
Condition B/C

EMERGENCY CONDITIONS A, B AND C

B: POTENTIAL FAILURE EMERGENCY

C: IMMINENT FAILURE OR FAILURE HAS OCCURRED EMERGENCY
