Bottom Ash Pond
Periodic Structural Stability Assessment
General James Gavin Power Plant
Cheshire, Ohio
S&ME Project No. 20-5506

October 14, 2021

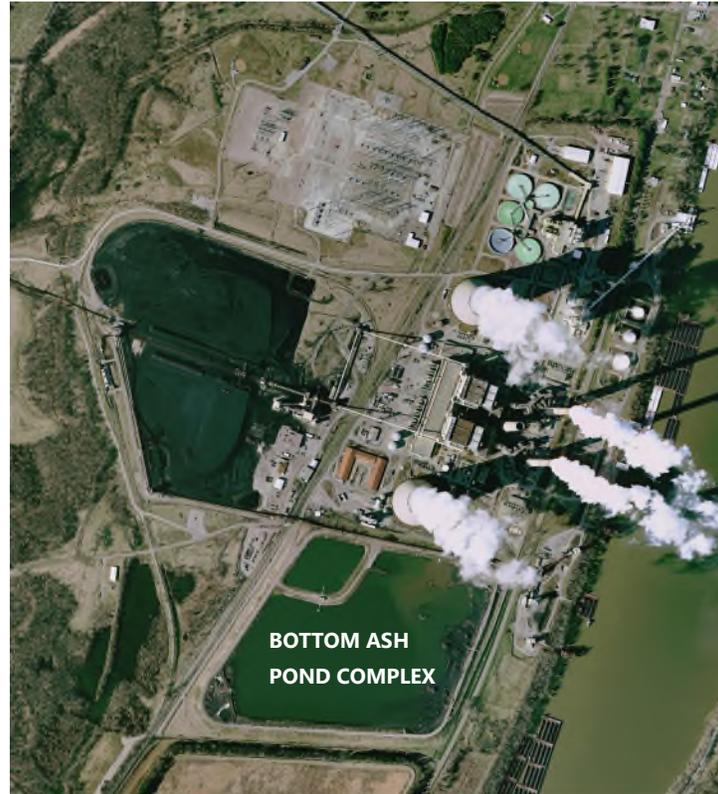
Figure 1-1 – Gavin Plant

The Gavin Power Plant, as shown in Figure 1-1, is located along the Ohio River, approximately 10 miles north of Gallipolis, Ohio. The Bottom Ash Pond Complex, which was put into service in 1974, is located immediately south of the generating plant and consists of a four-sided upground earthen embankment structure. Within the overall complex is a smaller, non-structural, embankment separating the main pond from the recirculation pond. The bottom ash pond is used to manage bottom ash which is sluiced to the pond from the two units. The total length of the exterior embankment is 6550 feet and the embankment varies in height, as measured above the exterior grade, from 28 to 39 feet. The pond is completely isolated from exterior surface water inflow. The main pond covers a footprint of approximately 58 acres and the smaller reclamation pond covers a footprint of approximately 1.3 acres. The original construction drawings indicated that the inboard and outboard slopes were designed with 2H:1V slope angles. Survey data taken at the boring locations reveal a range of outboard slope angles from 1.8H:1V to 2.2H:1V. The embankment was constructed as a homogenous dam.
