# 2019 Annual Inspection Report

Gavin Power, LLC

Bottom Ash Pond and Stingy Run Fly Ash  
Reservoir

Gavin Power Plant  
Cheshire, Ohio

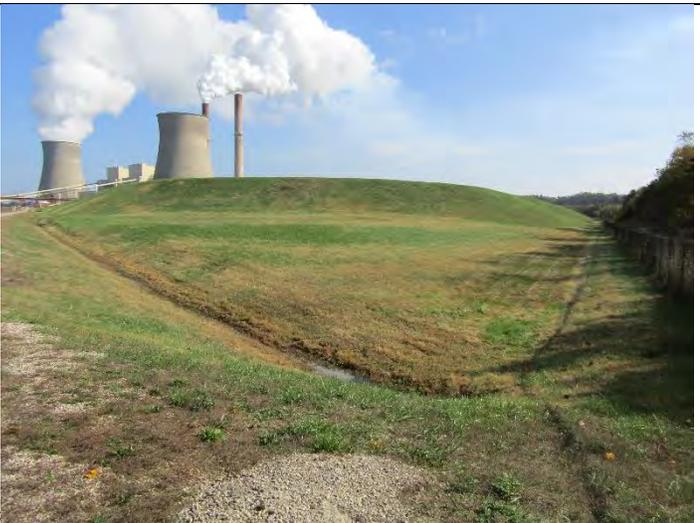
Condition of exterior southwest corner and drainage (looking northeast)

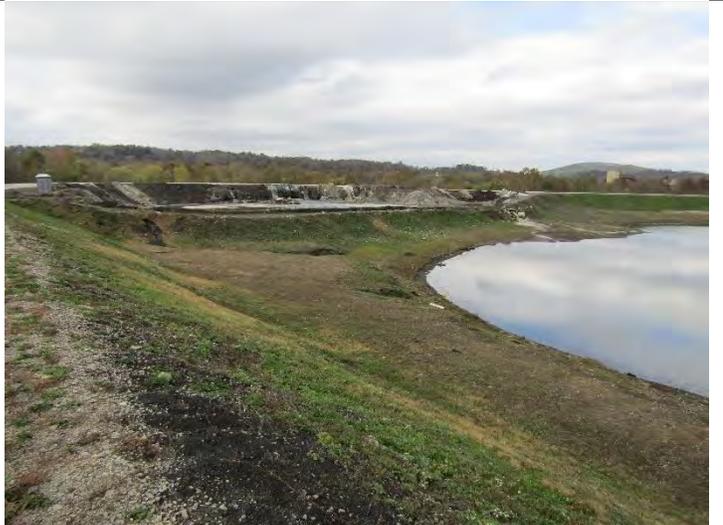
<p><b>Photograph #7</b></p>

<p>View of interior embankment including crest and slope (looking west).</p>	
<p><b>Photograph #8</b></p>

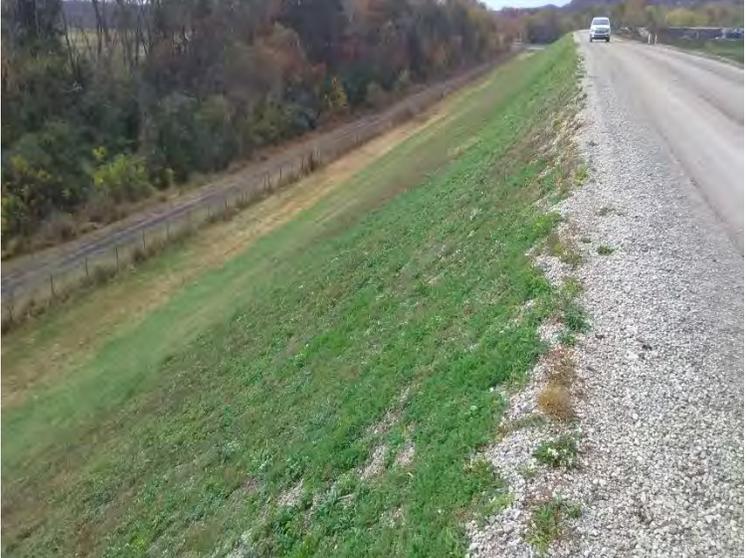
<p><b>Photograph #10</b></p>

<p>View of slopes on the western half of exterior embankment (looking east)</p>

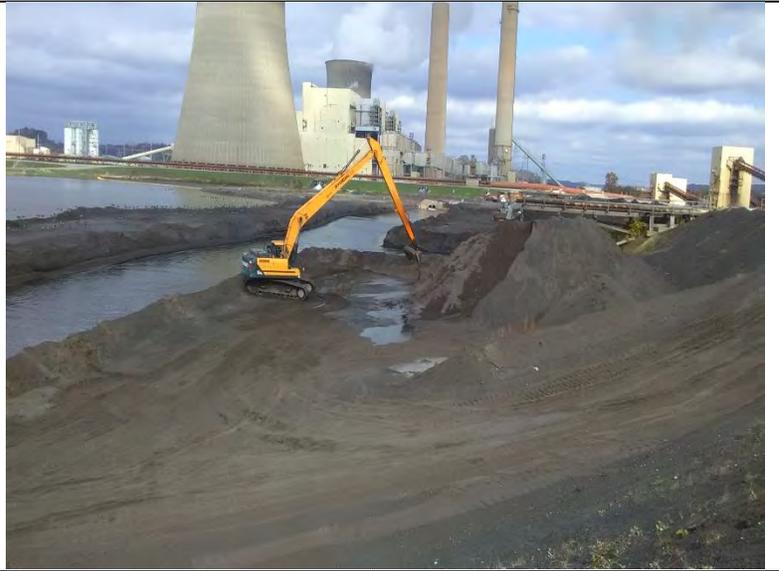
View along southeastern side during active dredging operation (looking southwest).

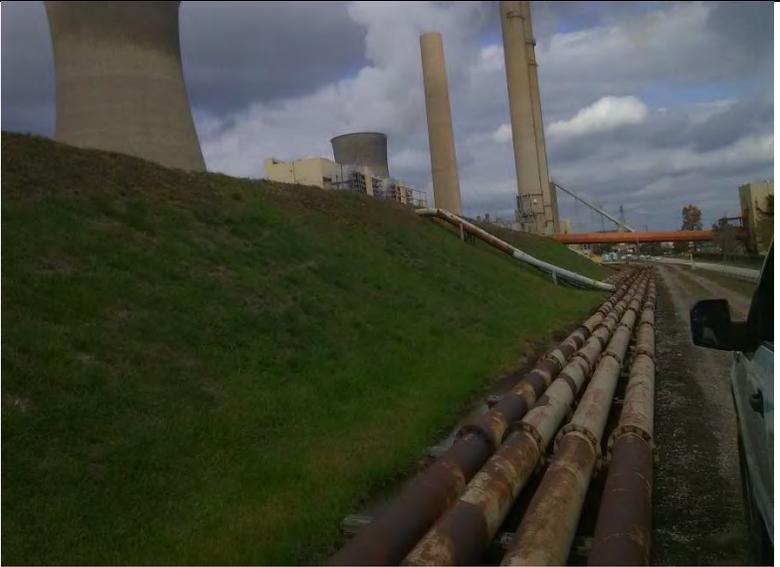
<p><b>Photograph #20</b></p>

<p>Conditions on northern side of eastern embankment and discharge pipes (looking north).</p>	
<p><b>Photograph #21</b></p>

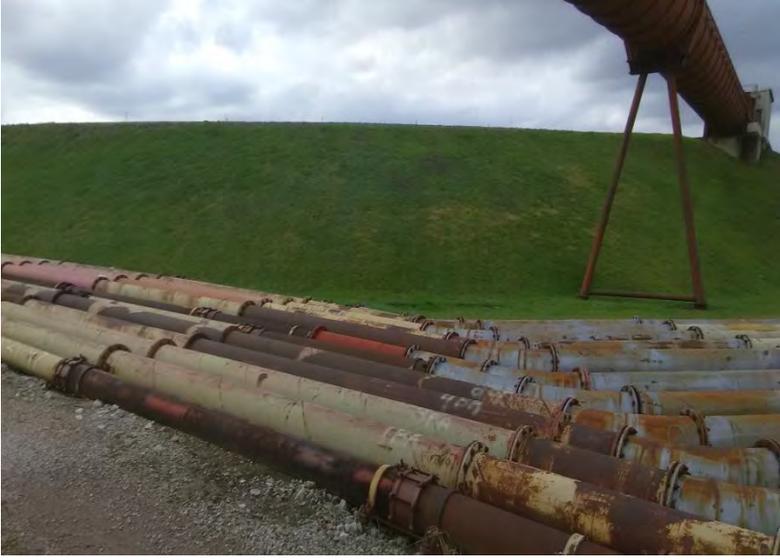
<p>Conditions on northeast side of eastern embankment and discharge pipes (looking southwest).</p>	
<p><b>Photograph #22</b></p>

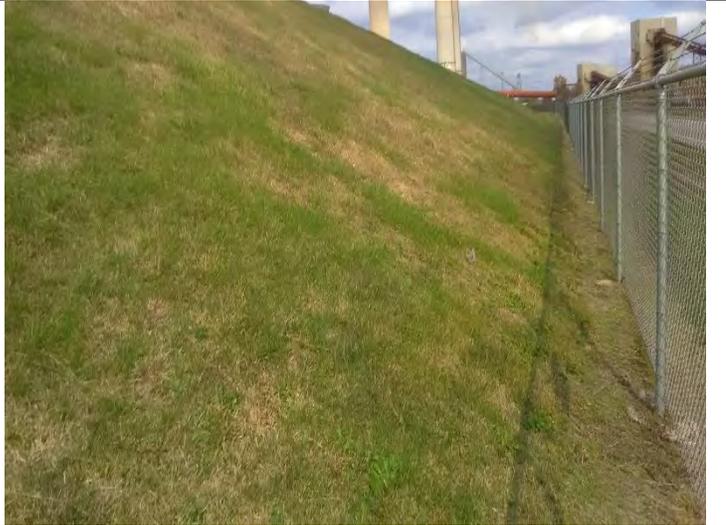
<p><b>Photograph #23</b></p>

<p>Condition of edge of eastern embankment along drainage swale and fence line (looking north).</p>	
<p><b>Photograph #24</b></p>

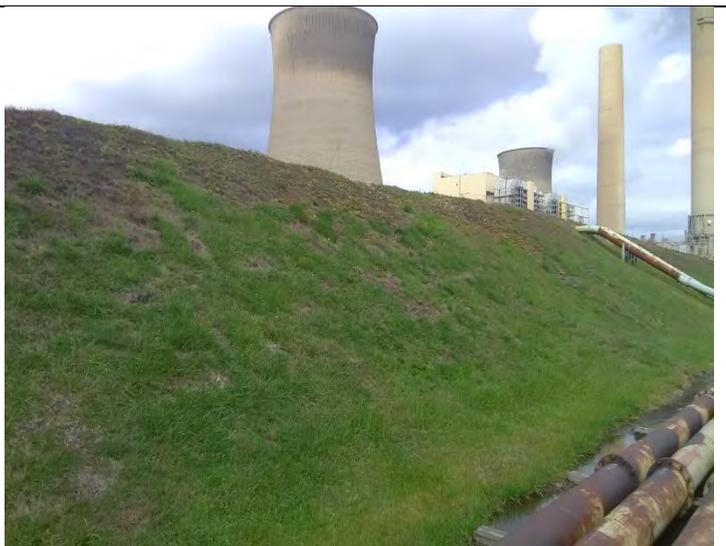
<p>View of vegetative coverage of upper exterior eastern embankment (looking northwest).</p>	
<p><b>Photograph #25</b></p>

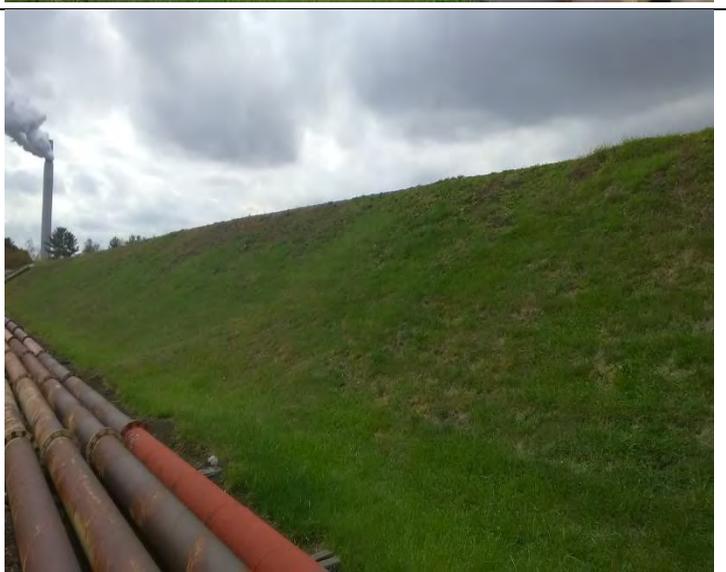
<p>View of vegetative coverage of upper exterior eastern embankment (looking southeast).</p>

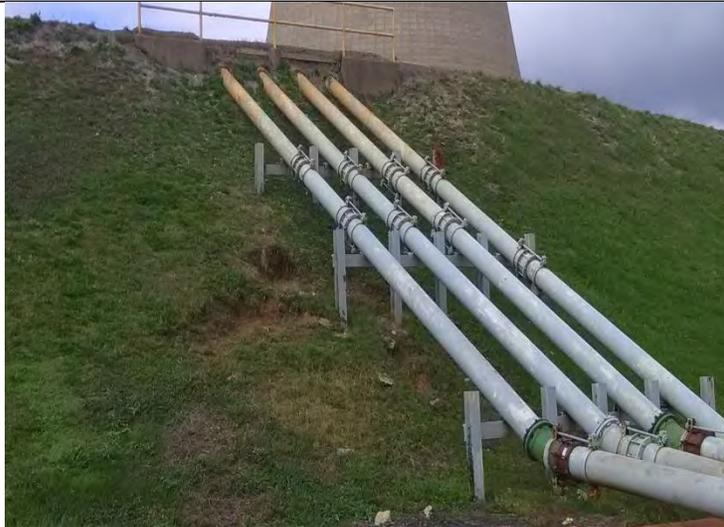
**Photograph #26**

View of discharge pipes and slope on eastern embankment (looking west).

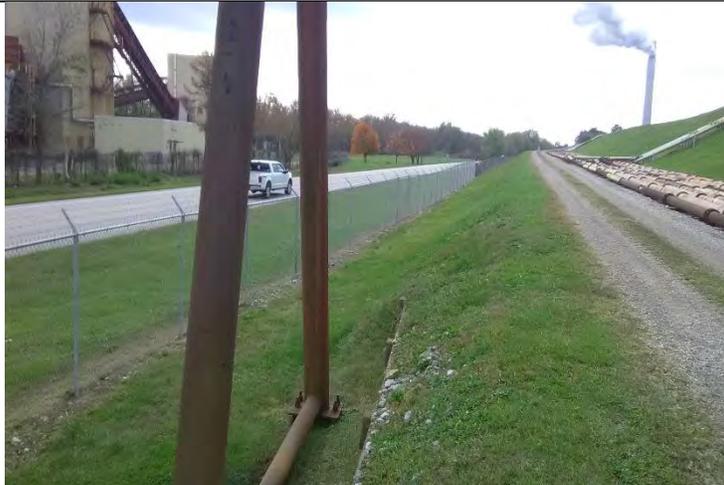
**Photograph #27**

View of toe along fence line (looking south).

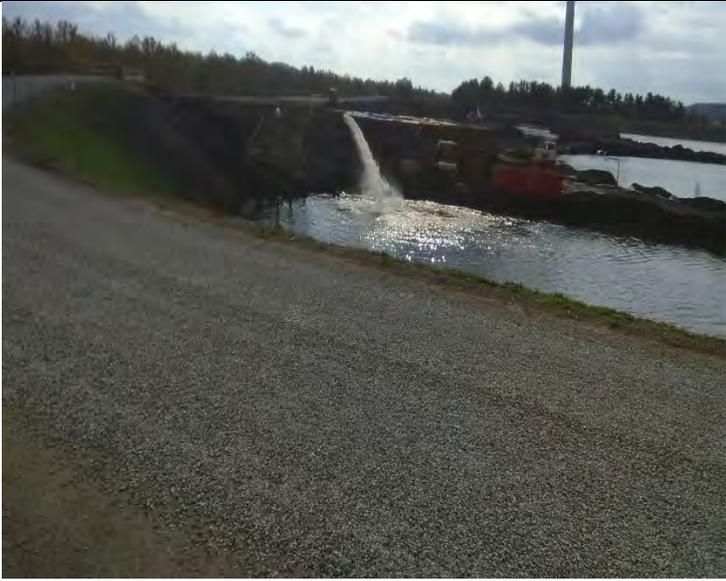
<p><b>Photograph #32</b></p>

<p>View of northeast exterior slope and access road (looking south).</p>

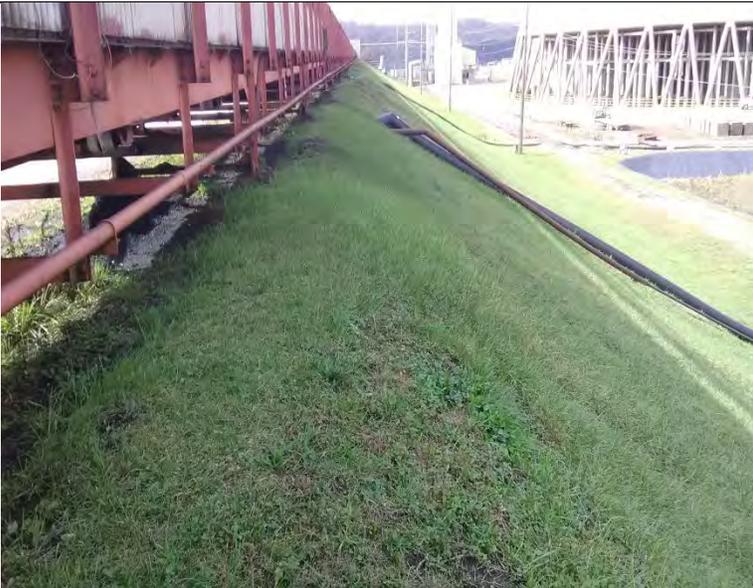
<p><b>Photograph #37</b></p>	<p>View of crest of exterior embankment (looking west).</p>

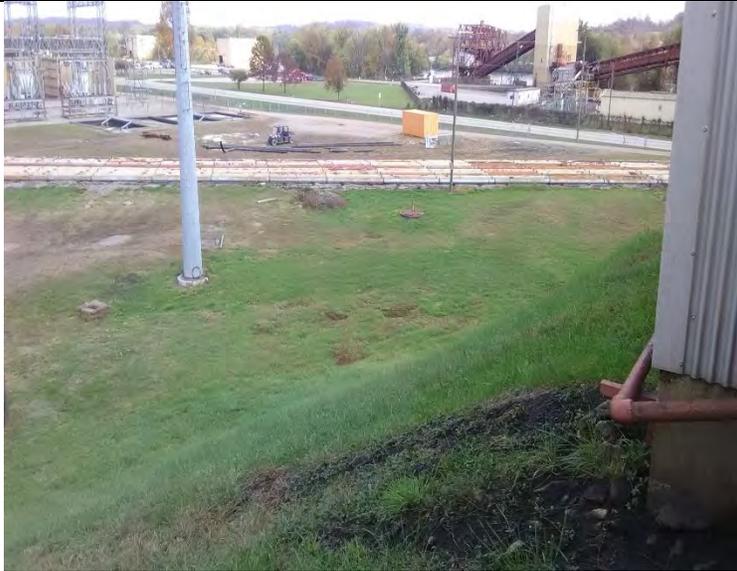
**Photograph #38**

View of exterior slope (looking north). At crest of the slope, there were localized bare spots.

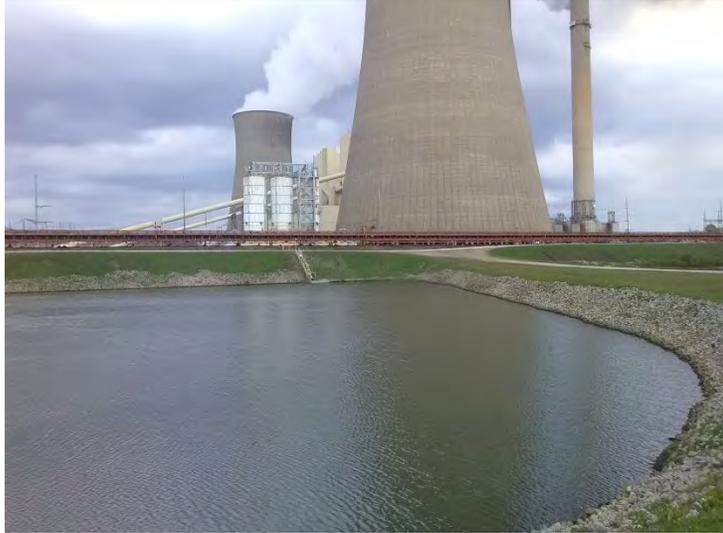
**Photograph #44**

View of interior embankment and discharge pipes and support structure (looking north).

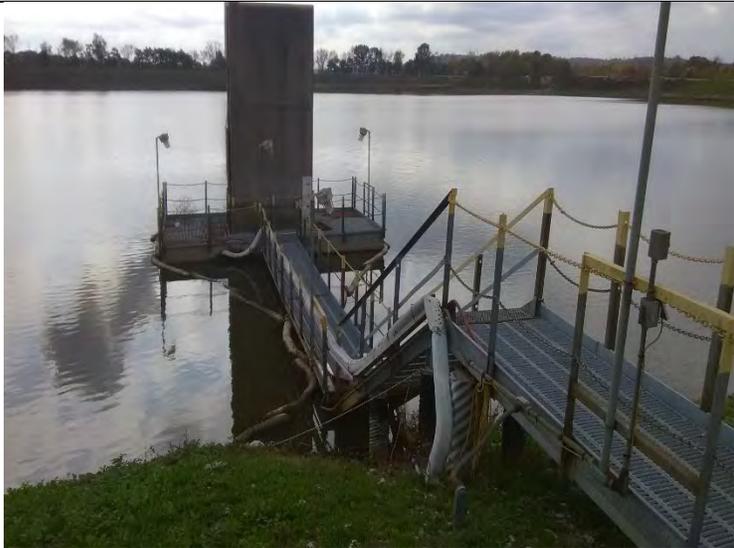
**Photograph #45**

View of inlet structure to BAC (looking east).

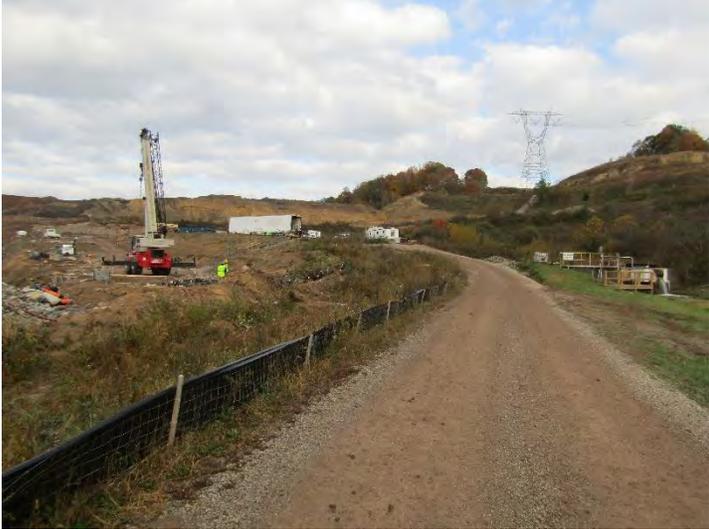
<b>Photograph #46</b>

1. The slope from the toe up to the intermediate bench appeared to be in satisfactory condition. Within ongoing construction activities, earthmoving activities appeared to be controlled and industry-standard earthwork construction methods were being practiced (Photographs 46, 49, and 51).

6. There were no signs of excessive erosion occurring on the maintained access roads, which were graded to assure positive drainage away from the road centerline (Photograph 46)

View of access road coming onto closure construction at FAR (looking west).	
<b>Photograph #47</b>

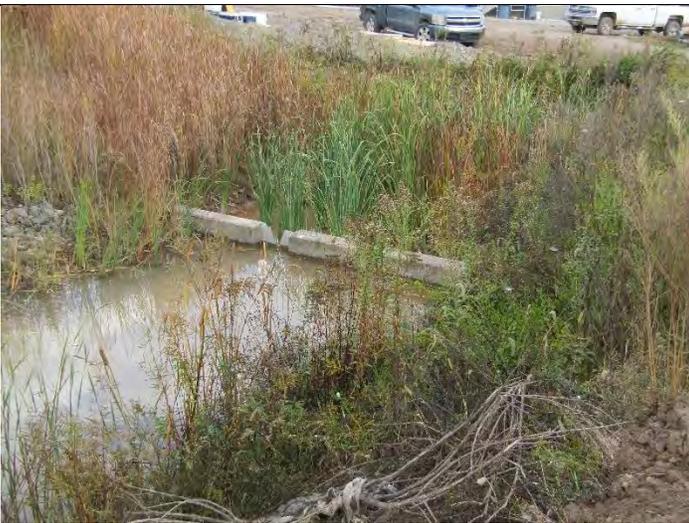
View of discharge coming out of V-notched weir, VW-3 (looking north).	
<b>Photograph #48</b>

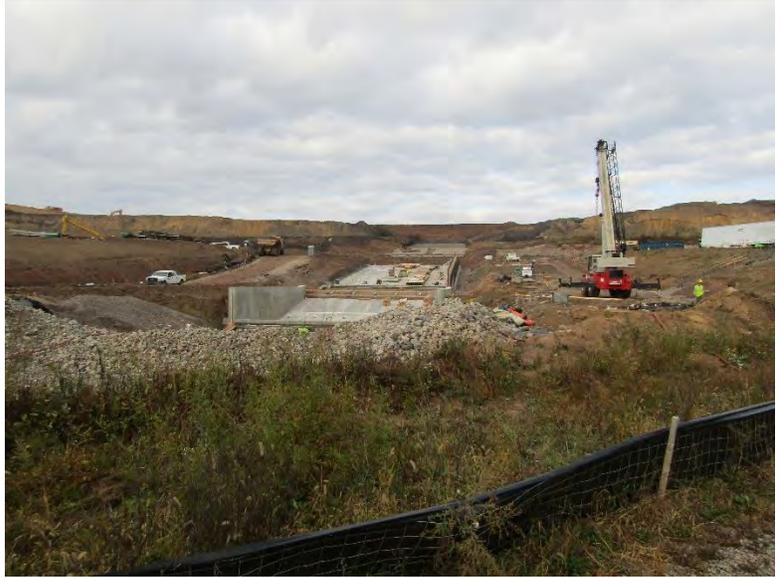
**Photograph 49**

Overview of FAR Closure construction process (looking west).

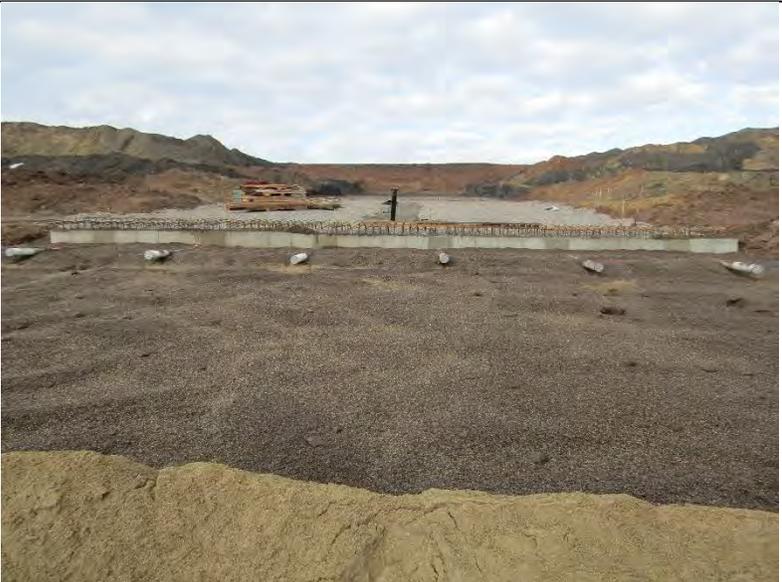
**Photograph #50**

View of northern portion of dam slope from toe looking at construction progress of spillway (looking north).

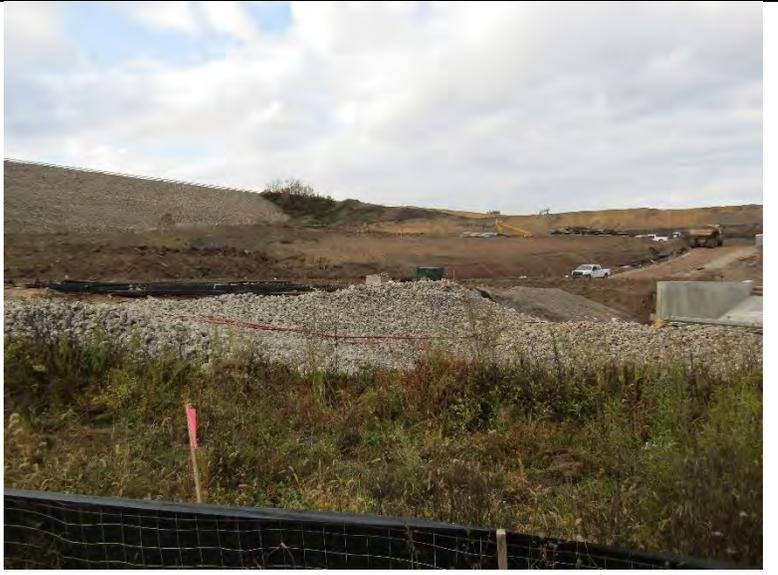
<p><b>Photograph #51</b></p>

<p>View at toe of construction near to the south groin (looking west).</p>	
<p><b>Photograph #52</b></p>

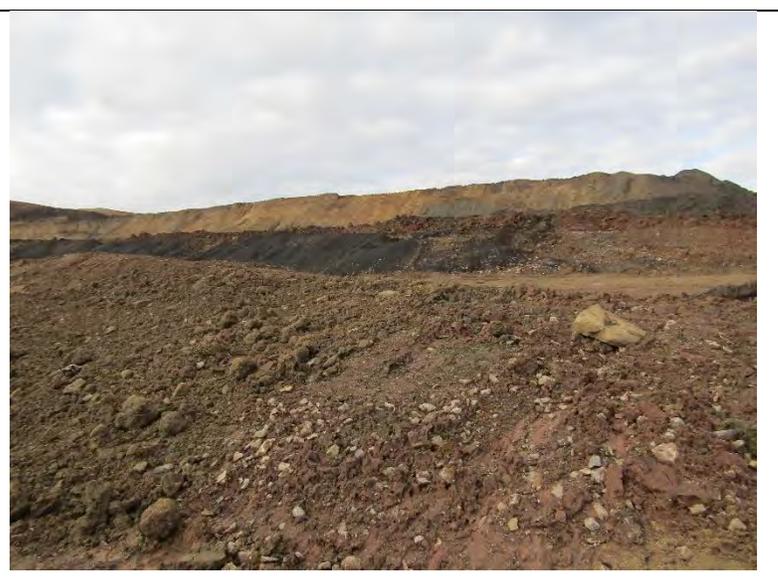
5. There were significant grading and earthmoving activities occurring at the former intermediate bench and slope areas (Photograph 52). The construction appeared to be controlled with industry-standard practices being employed. Construction haul roads appeared to be routinely graded to prevent excessive rutting and to promote the positive drainage of stormwater. Based on what could be

<p>View of construction activities and grading upslope of the spillway. This is approximately at the location where the middle bench existed during the previous 2018 annual engineering inspection. (looking west)</p>	
<p><b>Photograph #53</b></p>

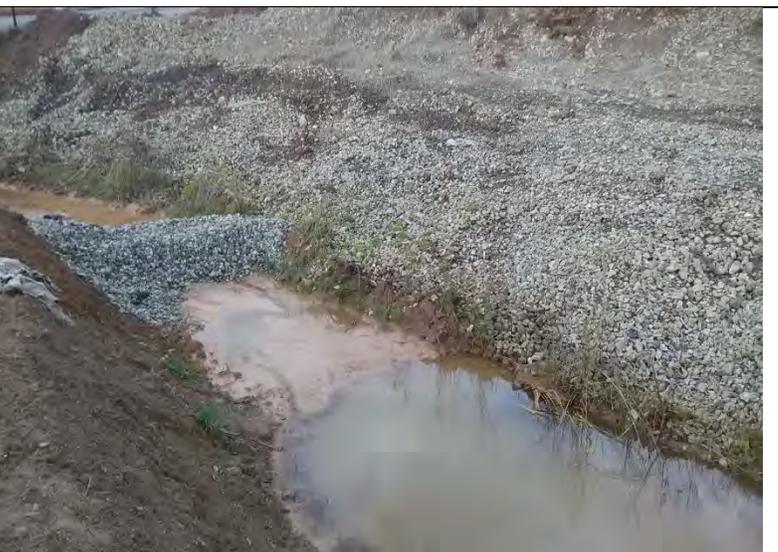
2. The toe ditch had a positive drainage to Stingy Creek. The ditch formerly had three V-notched weirs (VW-1, VW-2, and VW-3) used to measure seepage flow, and were observed to be functioning during the 2018 inspection. Weirs WV-1 and WV-2 along the drainage channel at the toe into Stingy Creek were removed by the time of the October 2019 inspection. The third V-notch weir appeared to be in working order (Photograph 47). Several rock check dams approximately evenly spaced had been placed in the toe channel to attenuate flow during large storms (Photograph 53).

<p>View of drainage channel along toe. V-notched weirs WV-1 and WV-2 have been taken out and rock check dams have been put in place (looking south).</p>

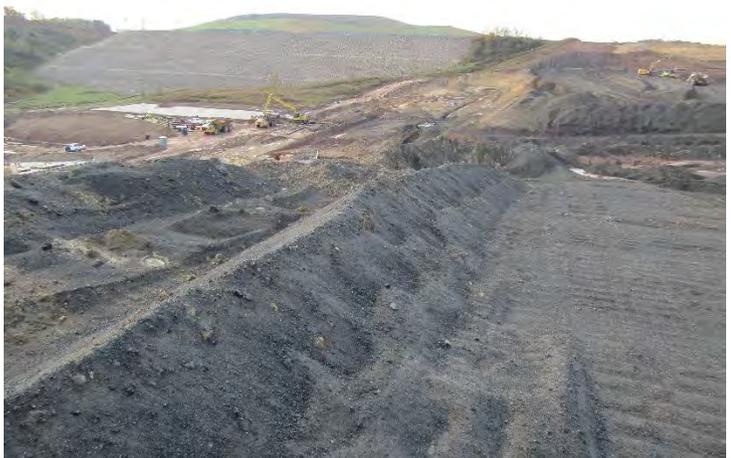
View of lowered crest and view of southern groin of dam (looking south).

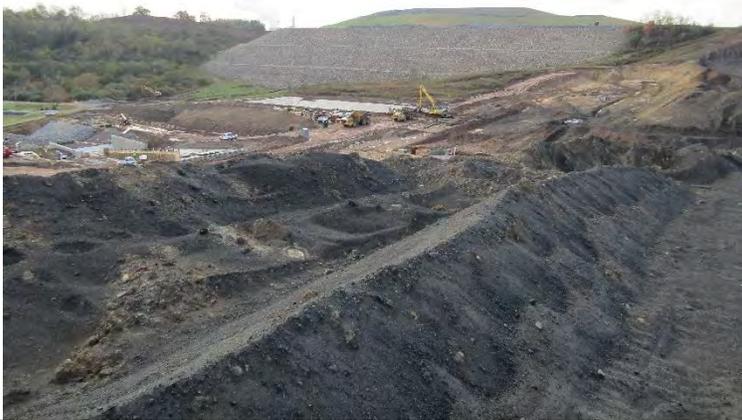
**Photograph #57**

View of grading activities from crest of dam (looking east).

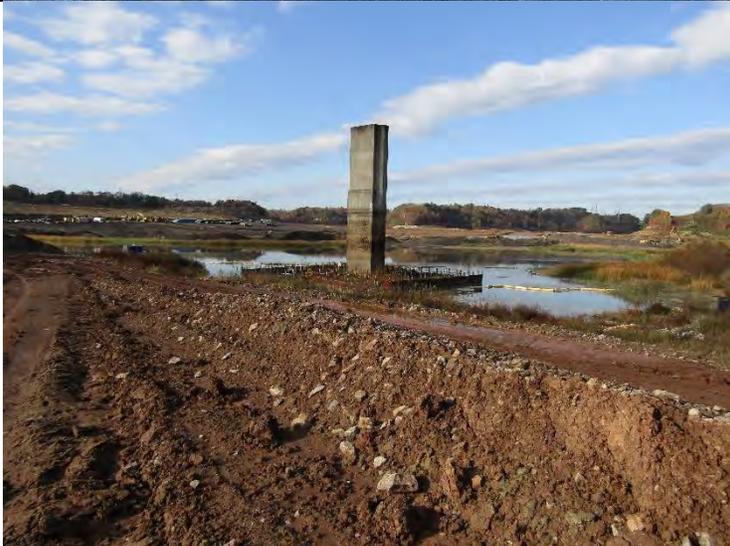
**Photograph #58**

View of grading along crest of dam to the east (looking southeast).

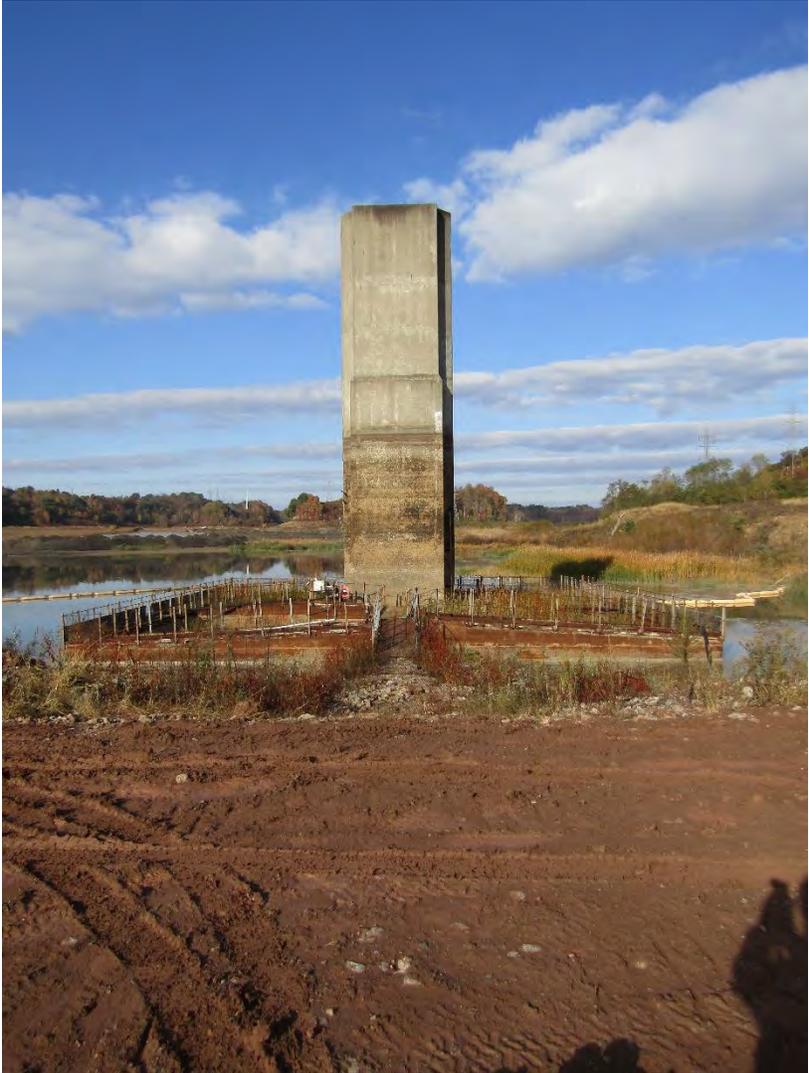
<p><b>Photograph #59</b></p>

<p>View of drain platform (looking southeast).</p>	
<p><b>Photograph #60</b></p>

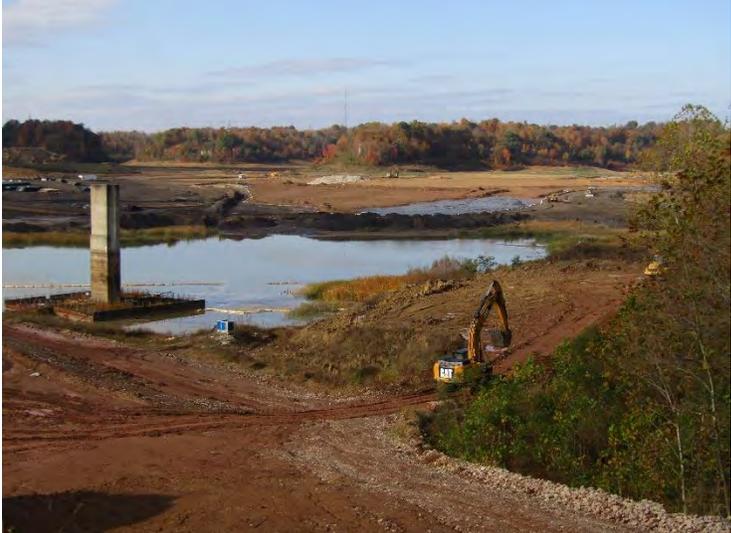
4. There was no indications of excess erosion or standing water observed along access roads, and the access roads had positive drainage toward the remaining impounded water for purposes of sedimentation (Photograph 60).

<p>View of siphon pump system used to control water level of pond and drain platform (looking southwest).</p>

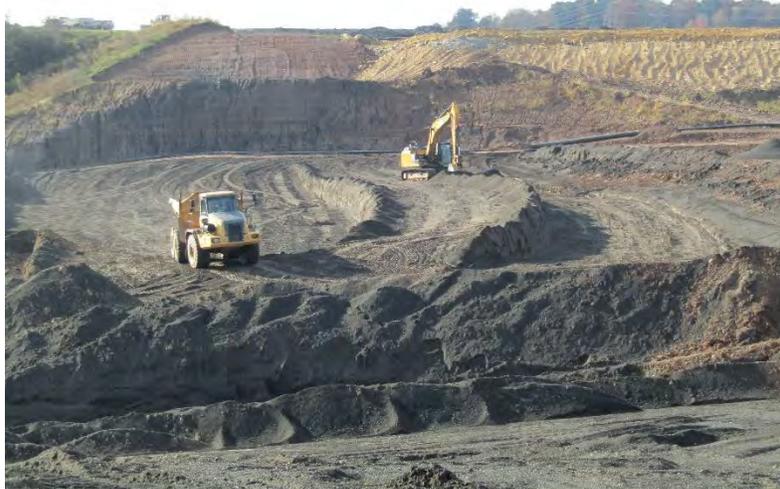
**Photograph #61**

2. Grading and hauling activities observed near the southern groin area appeared to be well managed, and industry-standard construction practices were evident at the time of inspection (Photograph 61).

Grading and hauling activities near south groin (looking south).

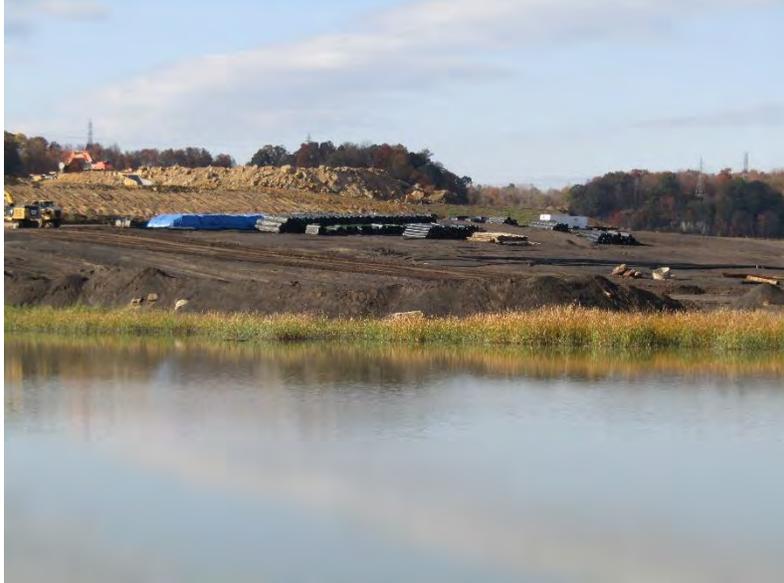
**Photograph #62**

3. The expansion of the FAR capping across and upstream of the Fly Ash Pond also appeared to be well managed, and effective staging and construction practices were evident at the time of inspection (Photograph 62).

View of expansion of landfill grading and capping across Fly Ash Pond (looking southwest).
