2018 Annual Inspection Report

Gavin Power, LLC

Bottom Ash Complex and Stingy Run Fly Ash
Reservoir

Gavin Power Plant
Cheshire, Ohio

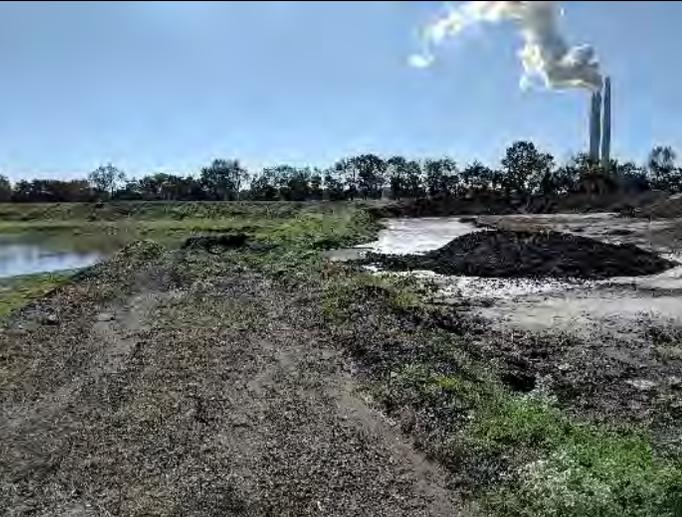
A photograph showing a close-up view of the inner slope of the dike. The ground is covered with dark, granular material, likely residual coal ash, interspersed with patches of green grass. A small stream or drainage ditch is visible on the left side. In the background, the same industrial smokestack from the first photograph is visible.
<p>Residual coal ash piles along inner slope of west dike (looking south).</p>	
Photograph #3

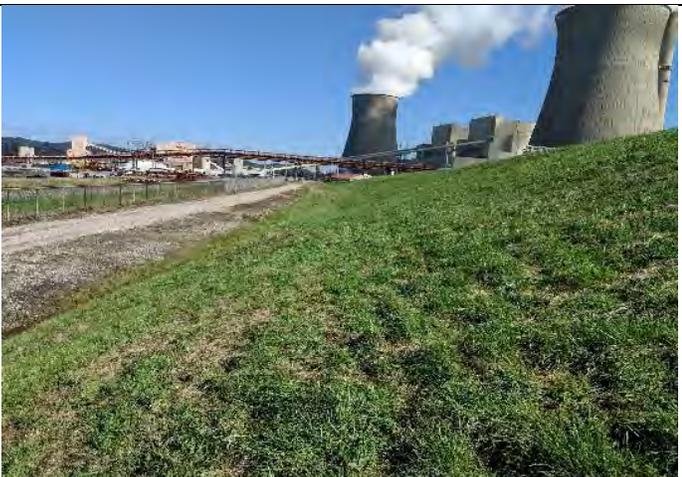
<p>Condition of outer bank and drainage ditch along west edge (looking north)</p>

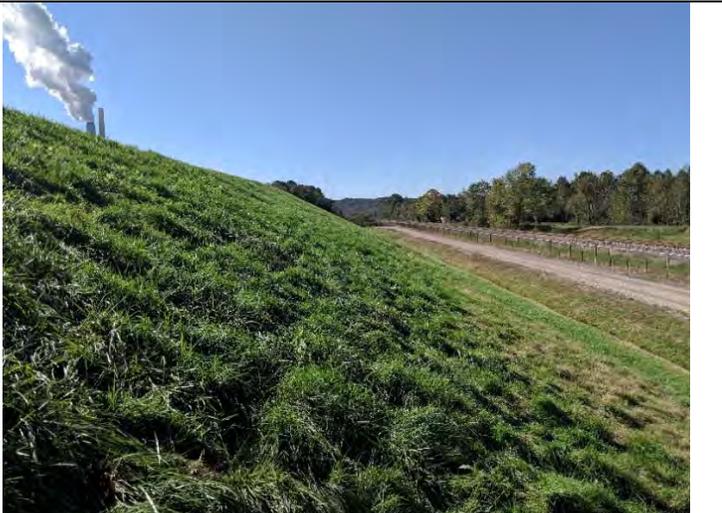
View western exterior slope (looking south).

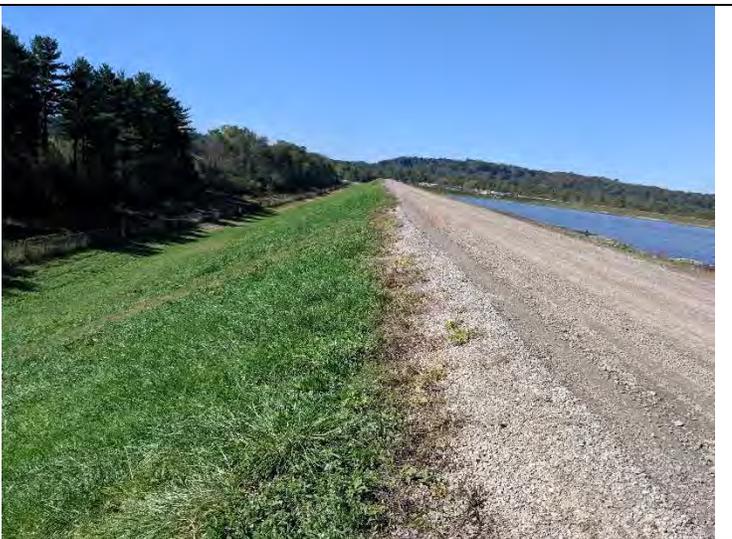
<p>View of exterior slope (looking west).</p>	
<p>Photograph #12</p>

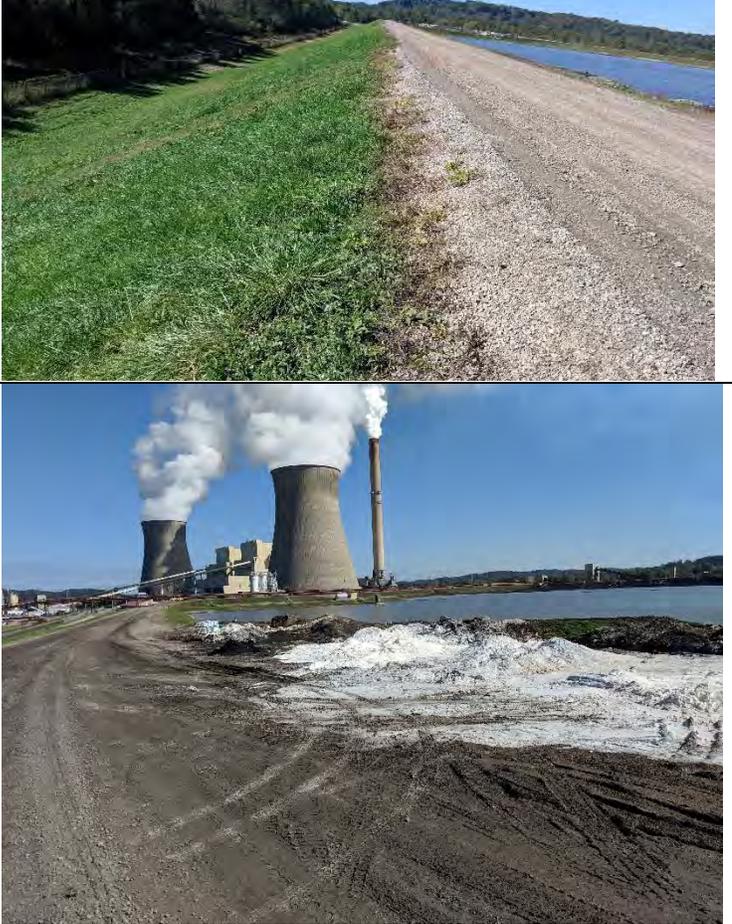
<p>View of lime stockpile adjacent to road (looking north).</p>

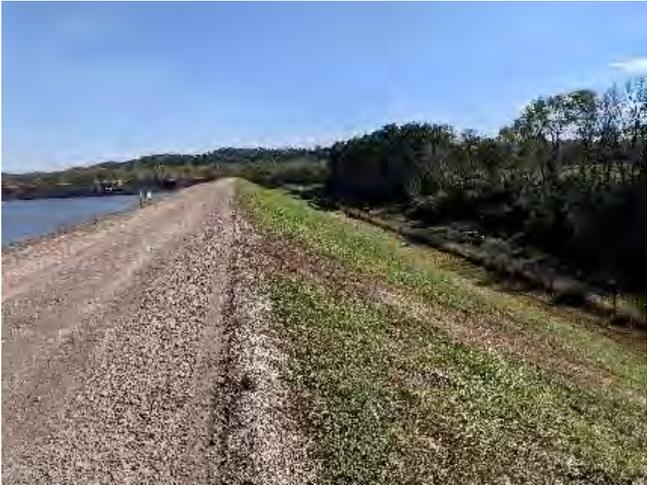
<p>View of the crest along exterior portion of embankment (looking east).</p>	
<p>Photograph #14</p>

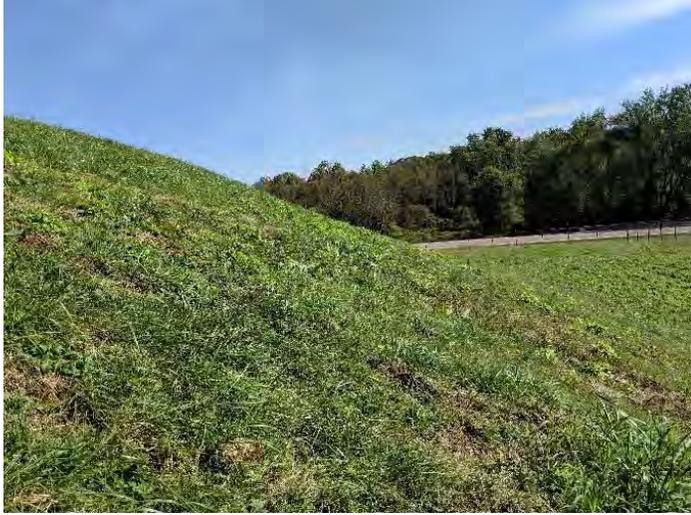
<p>View of sparsely vegetated low area at western toe of exterior bank (looking east).</p>	
<p>Photograph #15</p>

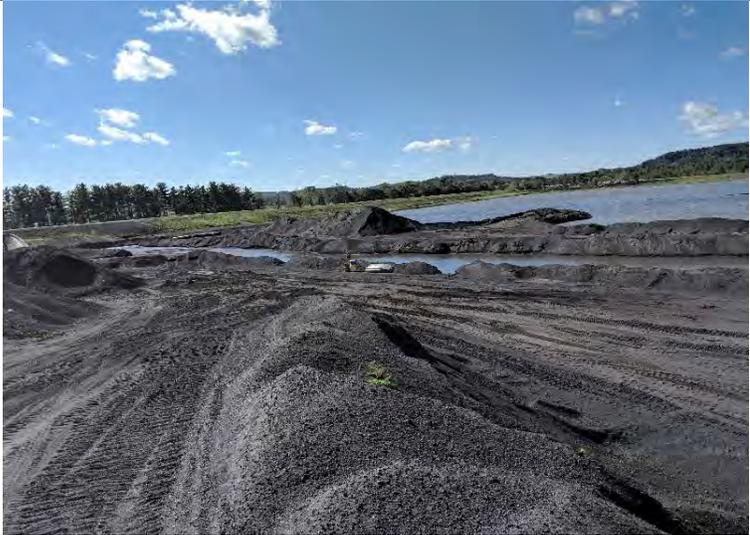
<p>Photograph #17</p>

1. The interior slope appeared to be stable and portions of the interior slope were buttressed by stockpiles of bottom ash (Photographs 17 through 22). The stockpiles of bottom ash also appeared to be stable.

A wide-angle photograph showing a large, flat, dark grey area covered in ash. The surface is marked with numerous tire tracks and some small puddles. In the background, there is a line of trees and a clear blue sky with scattered white clouds.
<p>Bottom ash management area (looking south).</p>	
<p>Photograph #18</p>

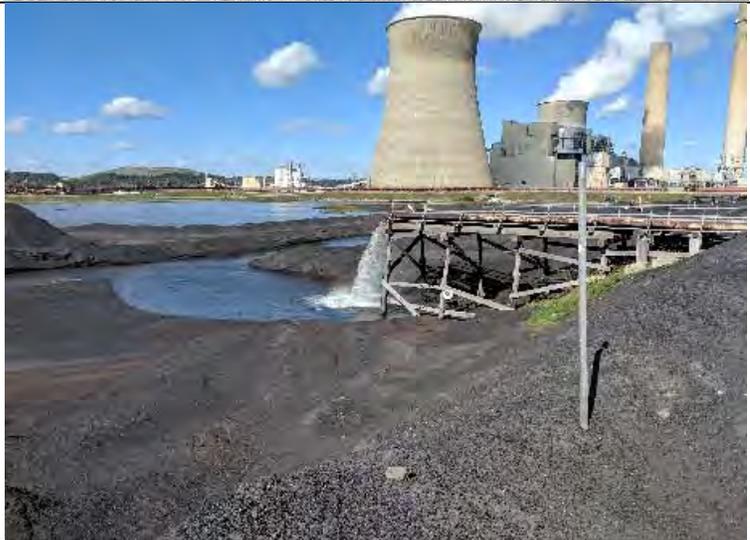
A photograph of an industrial facility. In the foreground, there is a concrete structure with a pipe that is discharging a white, slurry-like substance into a dark grey ash-filled area. In the background, several large, cylindrical cooling towers and other industrial buildings are visible under a blue sky with clouds.
<p>Ash slurry sluice pipes and support structure (looking north).</p>	
<p>Photograph #19</p>

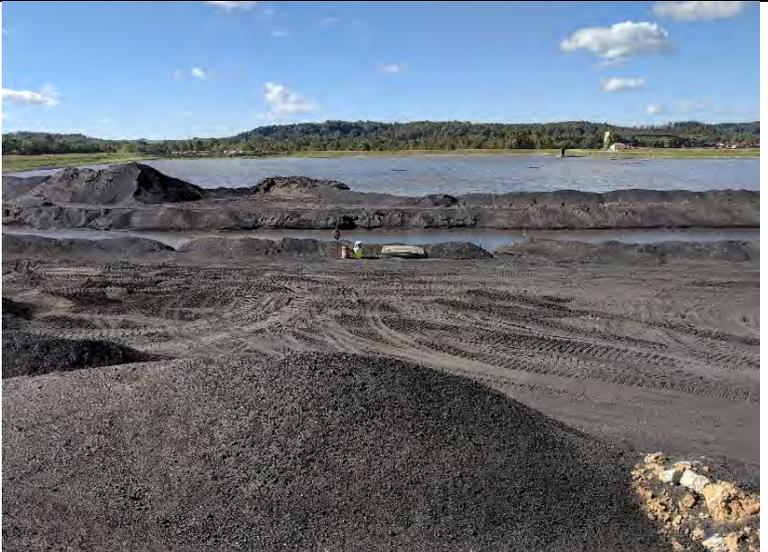
<p>Bottom ash management area (looking southwest).</p>	
<p>Photograph #21</p>

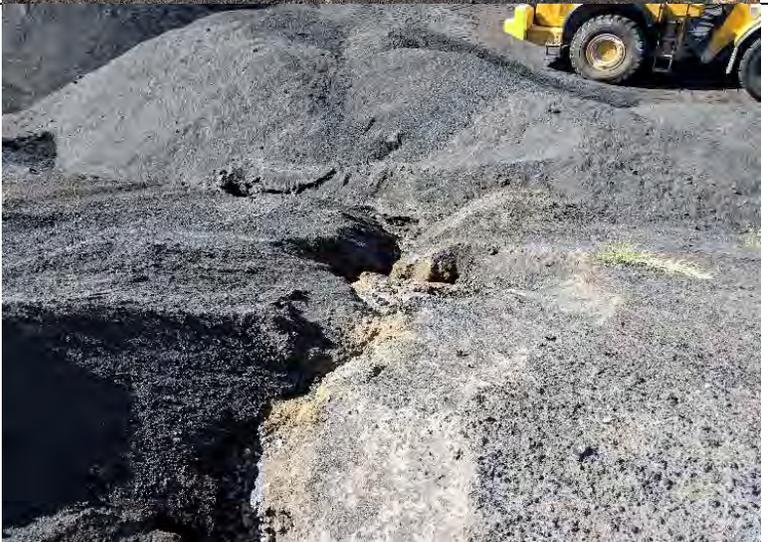
<p>Close up of earth moving activities for bottom ash management area (looking southwest).</p>	
<p>Photograph #22</p>

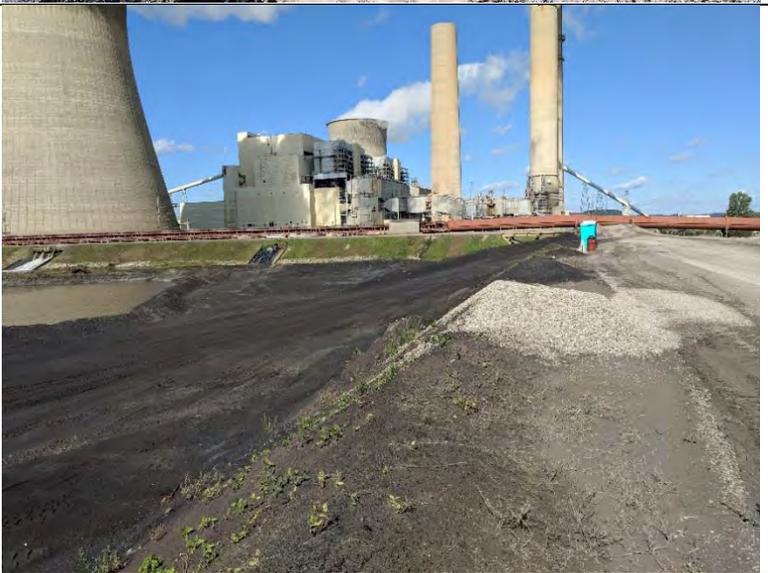
<p>Embankment next to bottom ash management area (looking north).</p>

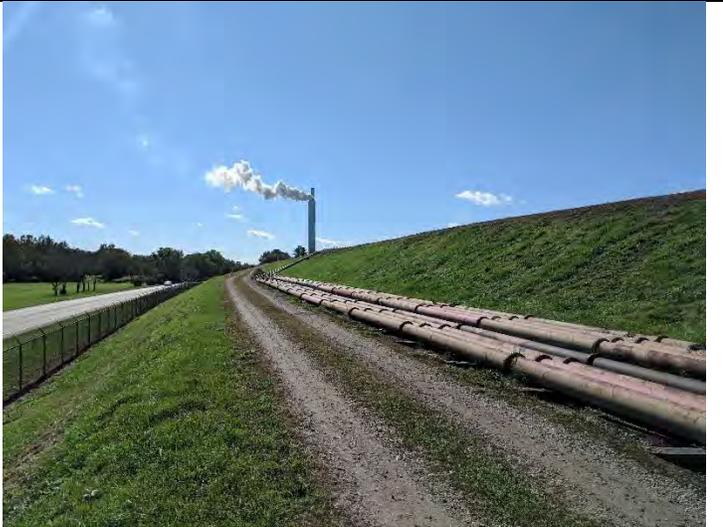
<p>Photograph #23</p>

<p>Conditions of eastern embankment and discharge pipes (looking south).</p>

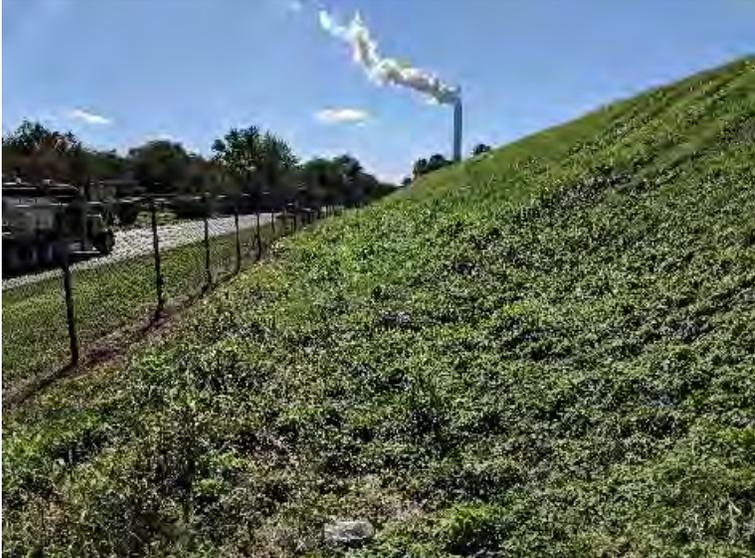
<p>View of localized rills along slope (looking south).</p>	
<p>Photograph #30</p>

3. Repair erosion rills promptly and continue to monitor areas where rills or gullies have formed.
4. Continue to monitor for locations along the slope where subsidence or sloughing might occur. Particular attention should be given to areas identified in this report that appear to have had some movement in the historical past but have since stabilized and show no sign of continued movement.

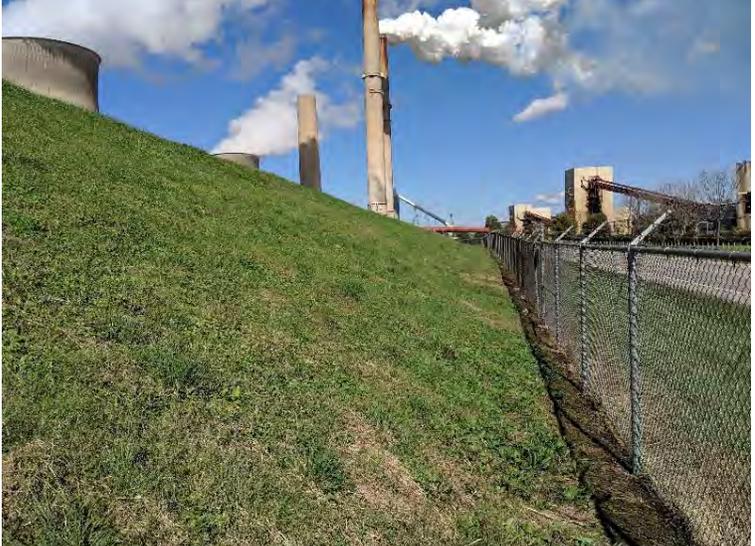
3. The exterior slope appeared stable and the majority of the slope had established vegetative growth. Along the exterior crest, localized areas of sparse vegetation were identified from the crest and approximately 5 feet vertically down the slope (Photographs 23). Along these localized bare spots, a few isolated rills and gullies were identified (Photographs 29). There was also some evidence of past sloughing along the exterior slope; however, these areas were vegetated and appeared stable, with no recent signs of movement (Photograph 30).

<p>View of slope where evidence of soil subsidence (not appearing to be active) was noted (looking north).</p>

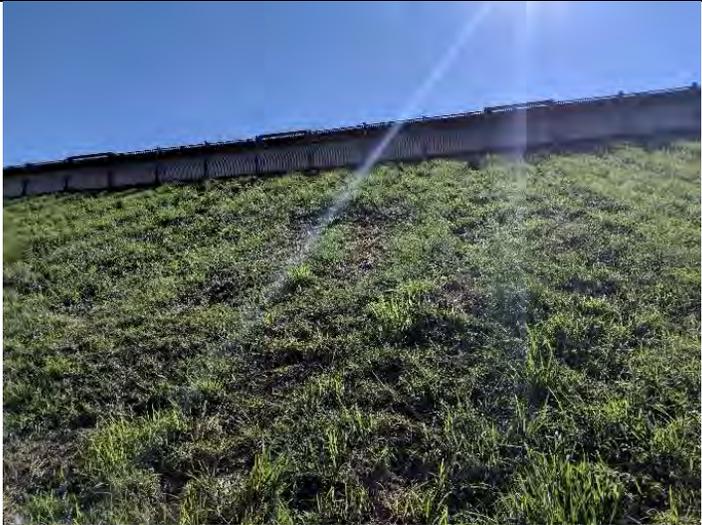
<p>View of exterior slope (looking south).</p>	
<p>Photograph #35</p>

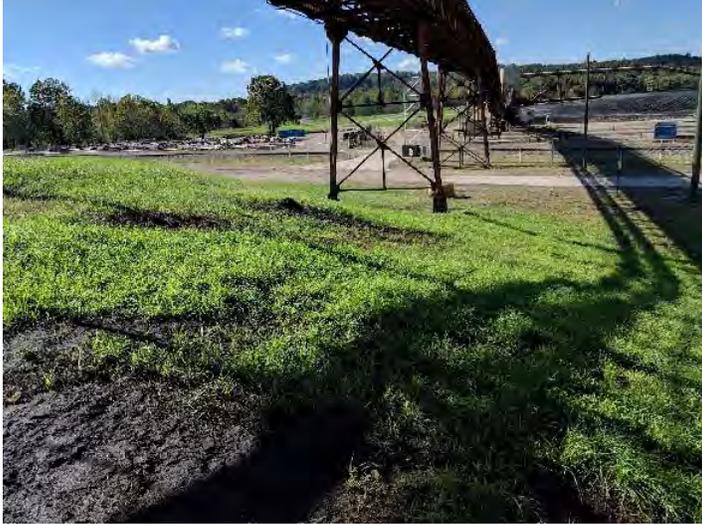
3. Along the exterior crest and top of the slope, localized bare spots were identified (Photographs 34 through 36). Along the exterior slope, rills and minor gullies had formed in localized spots along the slope and crest (Photographs 37 and 38). These minor gullies and rills appear to have been the result of recent erosion that may be partially a result of runoff from the roof of the conveyor. A bare spot was identified at the toe of the slope in the general vicinity of these rills and gullies (Photograph 36).

<p>View of bare spot with localized wet/saturated surface on exterior slope (looking west).</p>	
<p>Photograph #36</p>

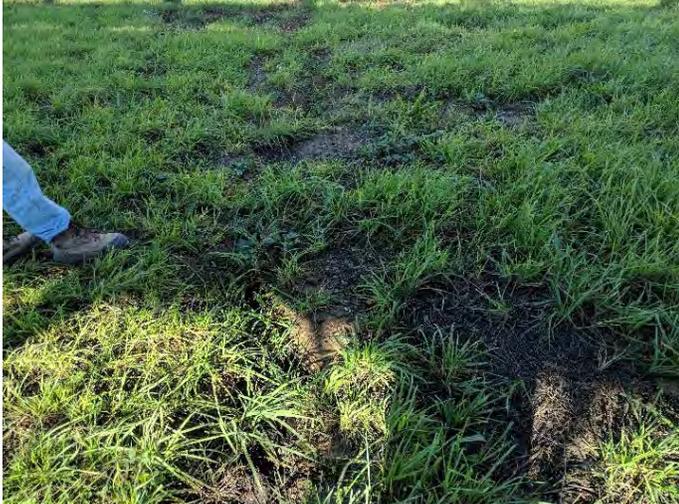
<p>View of bare spot and rill along top portion of embankment (looking west).</p>

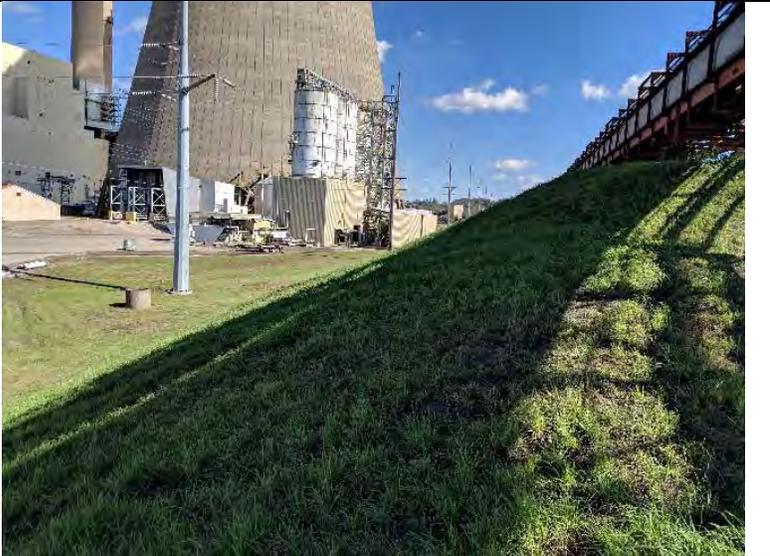
<p>View of toe, slope and crest of exterior embankment on eastern side (looking east)</p>	
<p>Photograph #38</p>

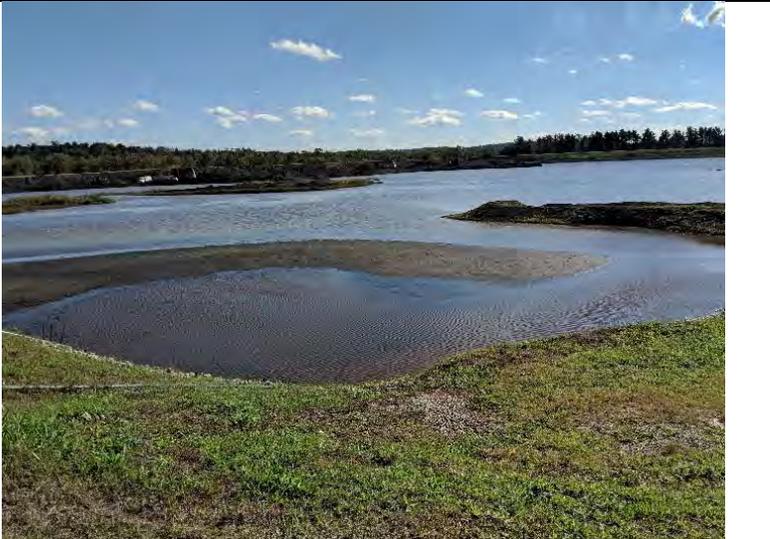
1. The conveyor system running along the crest appeared to be functional and in satisfactory operating condition (Photograph 31).
2. The interior crest, slope, and toe was vegetated or rip rapped and stable. No settling, rutting, or misalignment of terrain was identified (Photographs 40 and 41). Along the interior embankment crest, localized bare spots were identified (Photograph 42).

3. A limited area of shallow sloughing was identified along the interior slope in the northwest corner of the Recirculation Pond embankment (Photograph 41). This area was noted during previous inspections. This area was vegetated, and no tension cracks or other signs of recent soil movement were identified.

<p>View of BAC and interior embankment (looking south).</p>	
<p>Photograph #41</p>

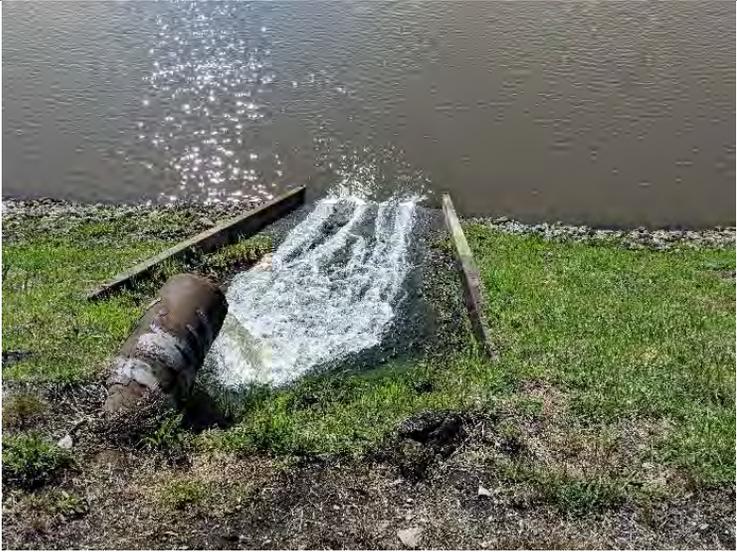
<p>View of discharge pipe and channel (looking south)</p>	
<p>Photograph #44</p>

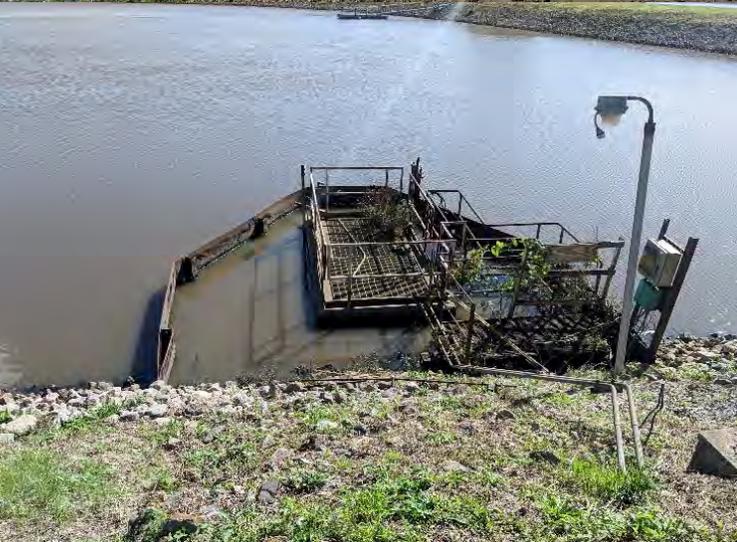
Photograph #46

2. The crest, slope, and toe along the interior were mostly vegetated or contained rip rap. The rip rap areas appeared to be in stable condition (Photographs 46 and 47).

<p>View of overflow structure (looking east).</p>

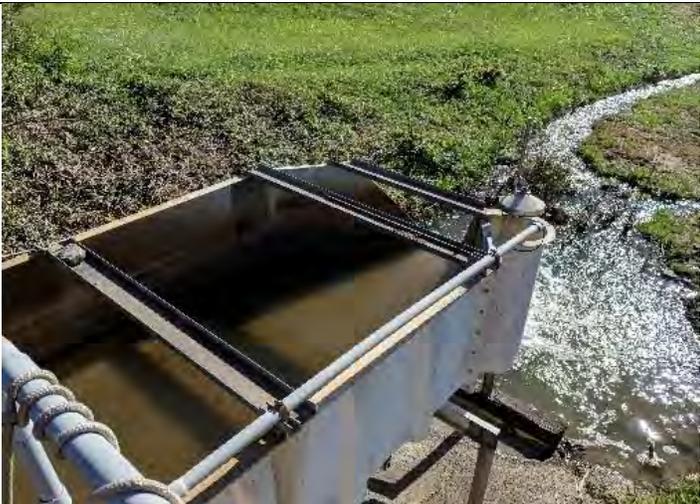
1. The toe ditch had a positive drainage to Stingy Creek. The ditch and three V-notched weirs (VW-1, VW-2, and VW-3) in the ditch were functioning (Photographs 48 and 49). The overflow weir and mixing point had an unobstructed flow condition and the supporting structure appeared to be in satisfactory condition (Photograph 50).

View of mixing point and overflow weir to Stingy Creek (looking east).

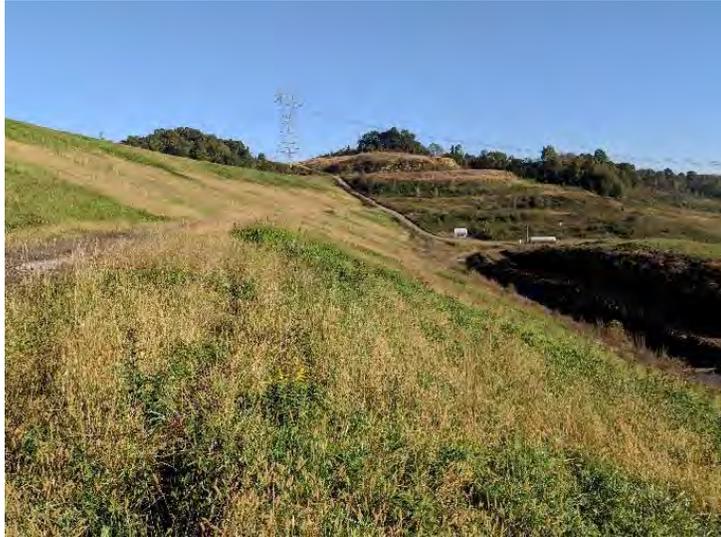
<p>Photograph #53</p>

The intermediate bench and upslope of the bench was in satisfactory condition (i.e., well vegetated) with no visible indication of rutting, settlement, or misalignment noted along the slope (Photograph 53). There was no excess sediment noted along access roads (which could be a sign of erosion from upslope), which had positive drainage away from the road centerline (Photograph 54).

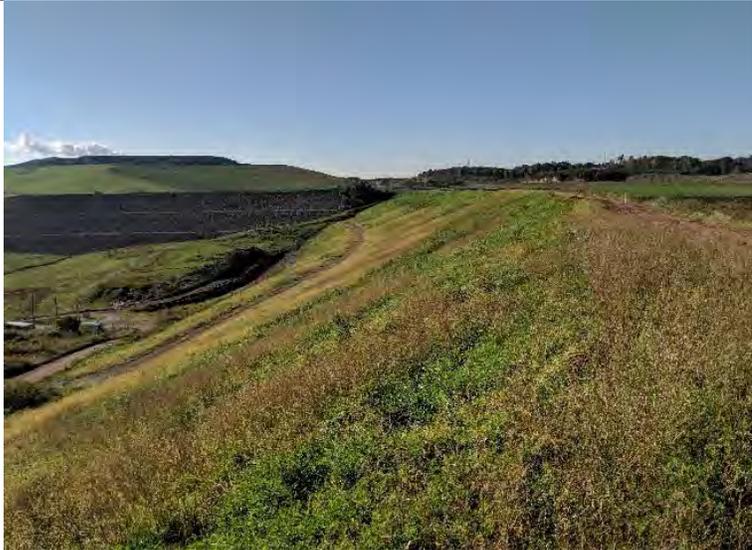
<p>View of crest and slope to the east of crest (looking south).</p>	
<p>Photograph #54</p>

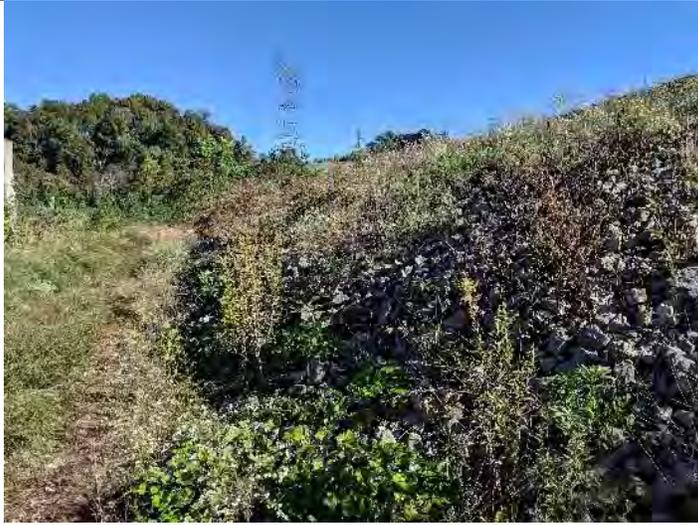
3. There was no excess sediment (i.e., no evidence of upslope erosion) or standing water observed along access roads, and the access roads had positive drainage toward the remaining impounded water for purposes of sedimentation (Photograph 61).

View of west slope (looking northeast).		
Photograph #61
