**2017 Annual Inspection Report**

*Bottom Ash Complex and  
Stingy Run Fly Ash Reservoir  
Gavin Power Plant  
Cheshire, Ohio*

*8 January 2018*

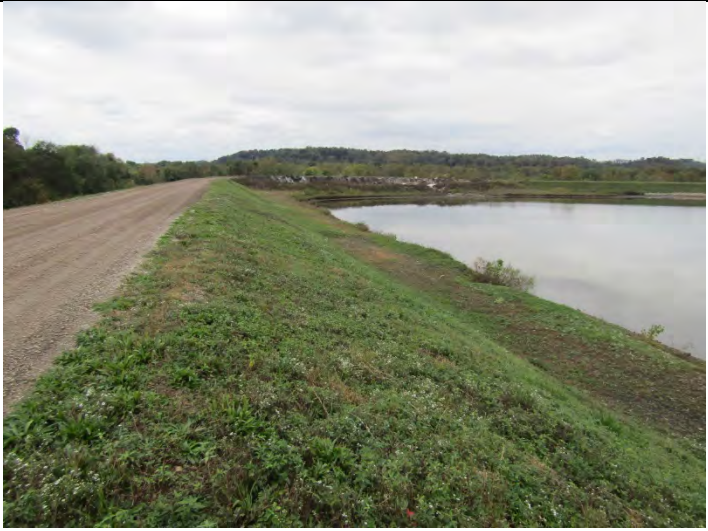
<b>Photograph #7</b>

1. Photograph 7 shows the condition of the access road and crest of the south dike section. Vegetated gullies were noted running along the interior slope as shown in Photograph 8 and the exterior slope as shown in Photograph 9. The gully in Photograph 8 was about 3 feet wide and 9 inches deep. Neither gully showed evidence of additional erosion.

View of interior embankment including crest and slope (looking west).	<b>Photograph #8</b>
View of interior embankment (looking east). A vegetated gully was noted running along the slope that was about 3 feet wide and 9 inches deep.	<b>Photograph #9</b>
View of vegetated gully along interior slope (looking south).

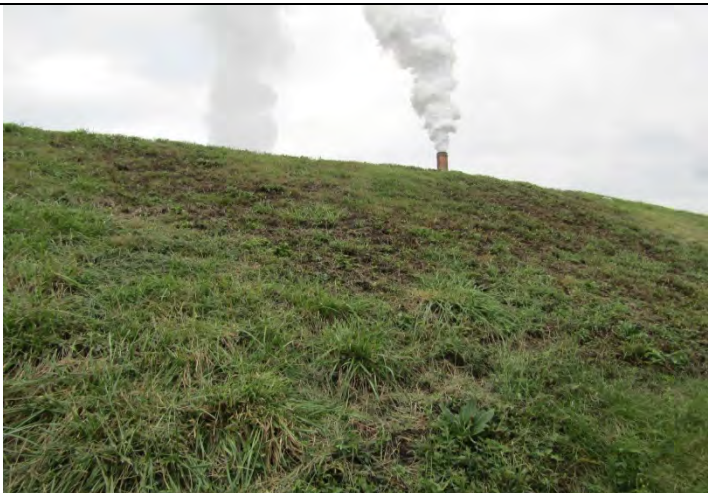
<p><b>Photograph #10</b></p>

2. To the east, sparser vegetation along the interior crest slope and toe was noted (Photograph 10). Where bottom ash had been recently placed, there was a lack of vegetation noted at the crest and along the interior slope (Photograph 11). A rill began to form where coal ash had been recently placed as noted in Photograph 12. There were some bare areas along the crest of the exterior portion of the embankment on the western side also noted during the inspection (Photograph 13). A sparsely vegetated low area was also noted at the toe of the exterior slope on western side (Photograph 14).

<p>View of slopes on the eastern half of interior embankment (looking west)</p>	
<p><b>Photograph #11</b></p>

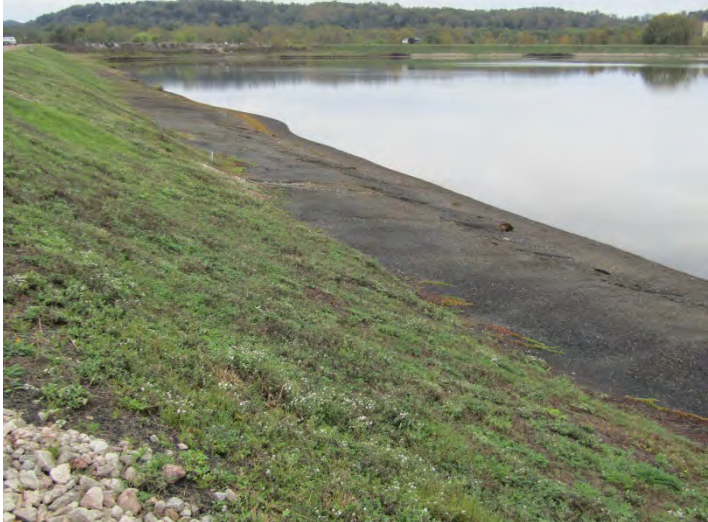
<p>View of slopes on eastern portion of interior embankment where coal ash had been recently placed (looking west).</p>	
<p><b>Photograph #12</b></p>

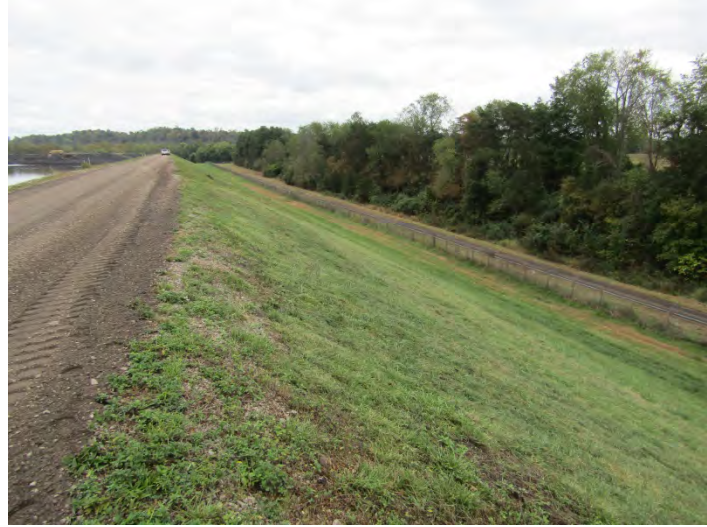
**Photograph #14**

View of sparsely vegetated low area at western toe of exterior bank (looking south).

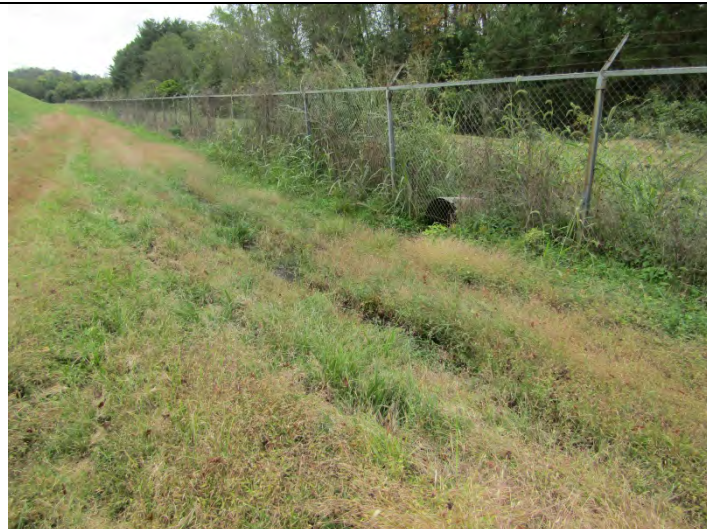
**Photograph #16**

4. There appeared to be no sign of seepage from the embankment.
5. The surface pad at Piezometer BAP-2 appeared to have been cracked and damaged. The casing was intact and was secure (i.e. had a lock) (Photograph 16). The piezometer itself still appeared to be in satisfactory working condition. This is one of two piezometers used to measure daily water levels near to the toe of the embankment.

View of Piezometer BAP-2 (looking east).

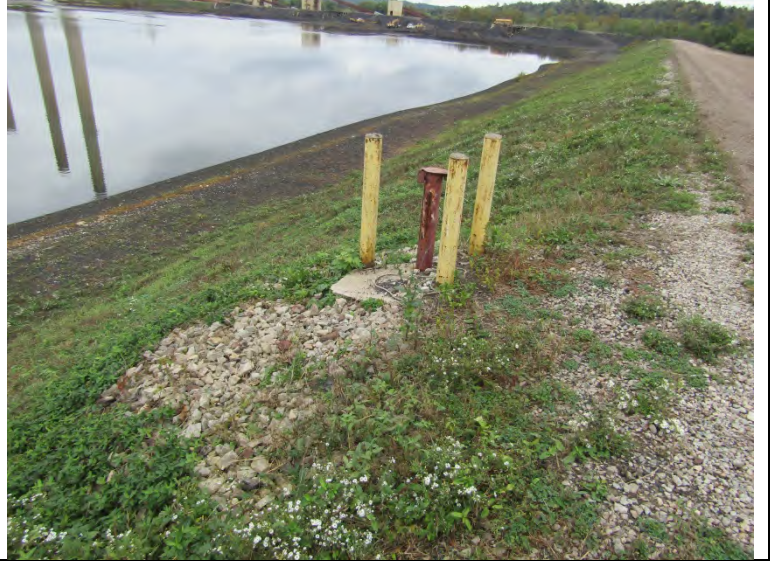
1. Photographs 17 through 19 shows conditions of the bottom ash management area as well as the condition of the sets of ash pipes and support structures. The interior slope appears to be stable and large portions of the interior slope are buttressed by stockpiles of the bottom ash. The pipe and support structures appear to be in satisfactory condition.

Bottom ash management area (looking south).	
<b>Photograph #18</b>

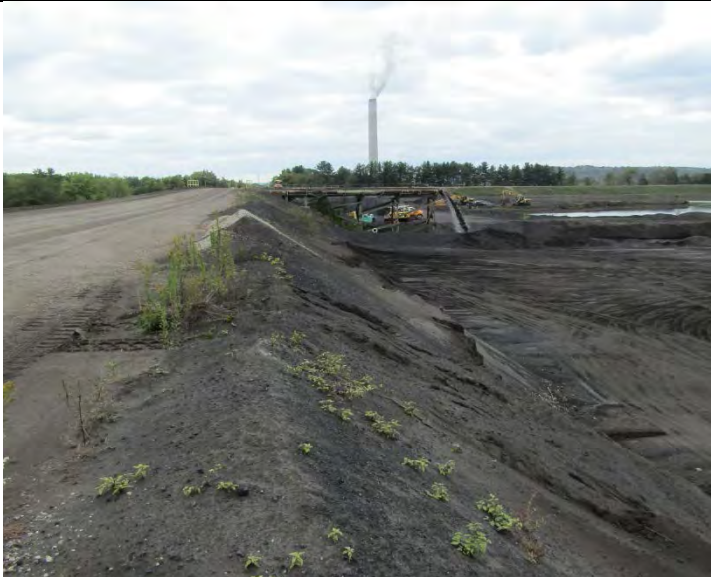
Ash slurry sluice pipes and support structure near north end (looking north).	
<b>Photograph #19</b>

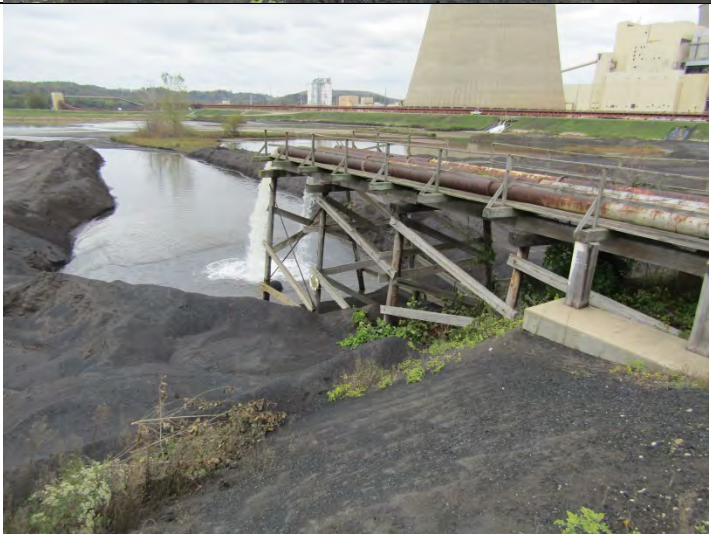
Ash slurry sluice pipes and support structure in middle of embankment (looking south).

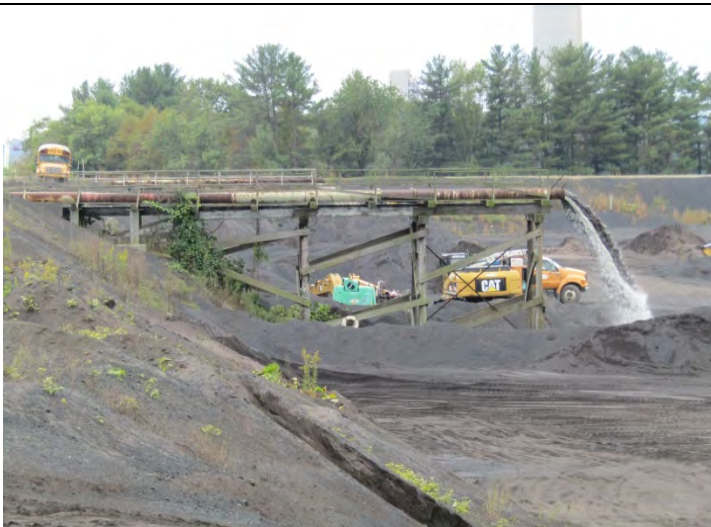
**Photograph #20**

2. Photographs 20 through 22 show the condition of exterior slope, toe and crest near the northern edge of this embankment section. Generally, the slope appears to be stable with vegetative growth. Along the crest as detailed in Photograph 22, there are some sparsely vegetated, patchy spots.

Condition of exterior slope at northern edge of this section (looking north).

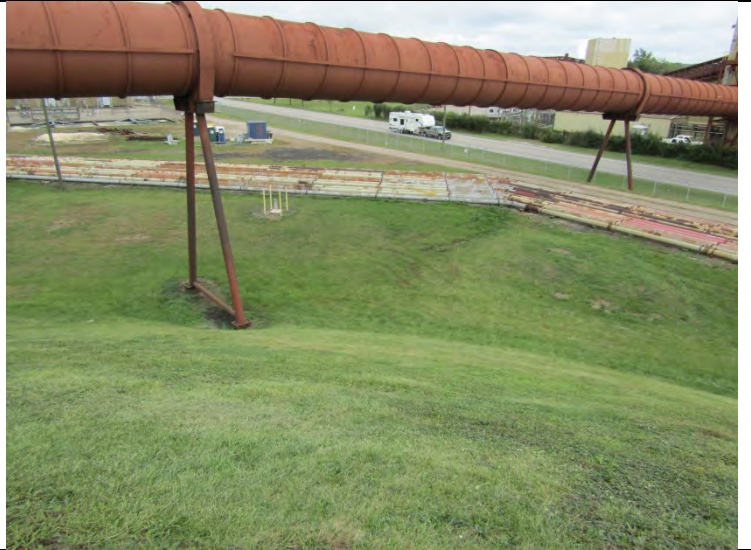
**Photograph #21**

Condition of toe at northern edge of this section (looking east).

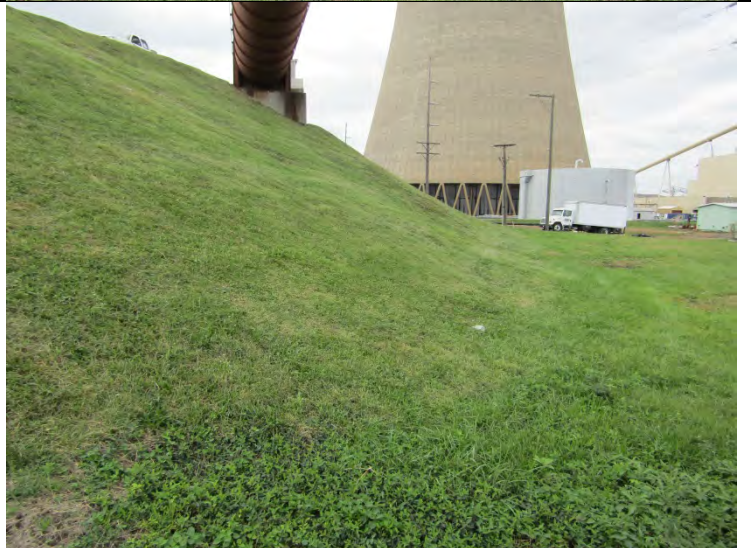
**Photograph #22**

3. Along the exterior crest spotty, sparsely vegetated and localized bare spots were noted as shown in Photographs 22 and 23.
4. A localized gully located on a predominately bare spot of the slope is shown on Photograph 24. The gully was not vegetated and appeared that it may have undergone erosion recently. Repair, revegetation and/or potential use of soil amendments are recommended. Further to the south on this section, a vegetated gully was noted along the exterior slope as illustrated in Photograph 25. There were no signs of recent disturbance or that this gully was further eroding.

Condition of exterior crest (looking south).

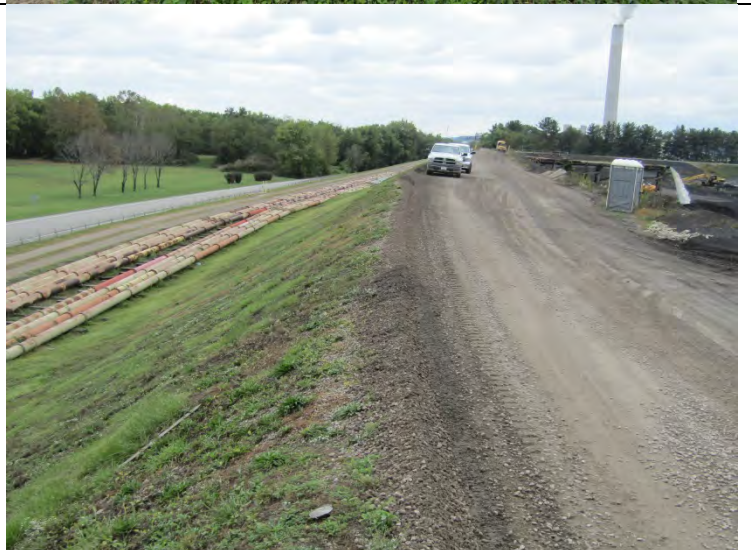
**Photograph #23**

Condition of exterior crest with localized bare spot (looking north).

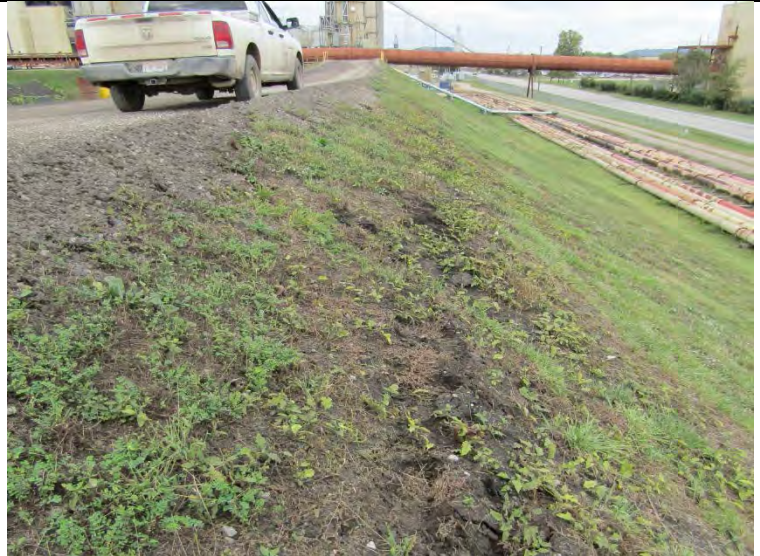
**Photograph #24**

Localized gully on bare spot of exterior slope (looking east).

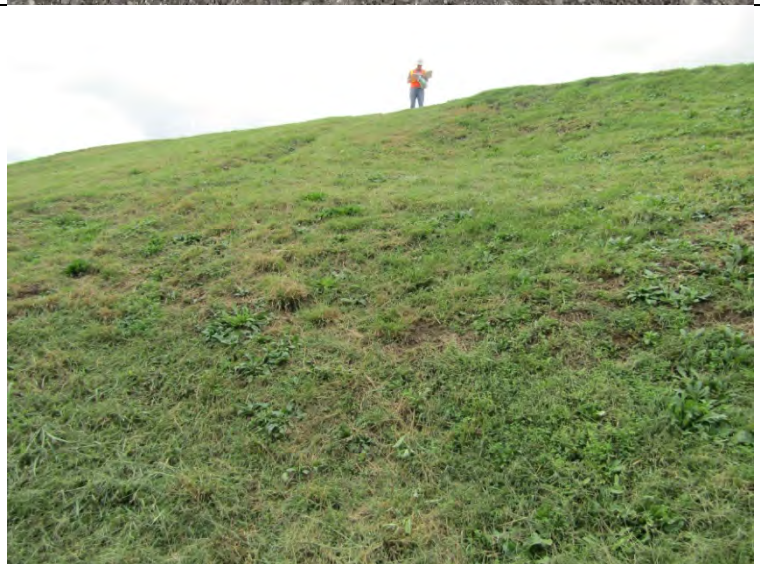
**Photograph #26**

5. Generally, the toe was well vegetated as shown in Photograph 26. There were a few isolated spots where bare soil was noted as shown in Photograph 27. Along the toe there were localized sections of wet to saturated soil, soft soil (Photograph 28) but there was no evidence of ruts or settlement and the toe had a positively draining slope.

View of toe and slope (looking north).

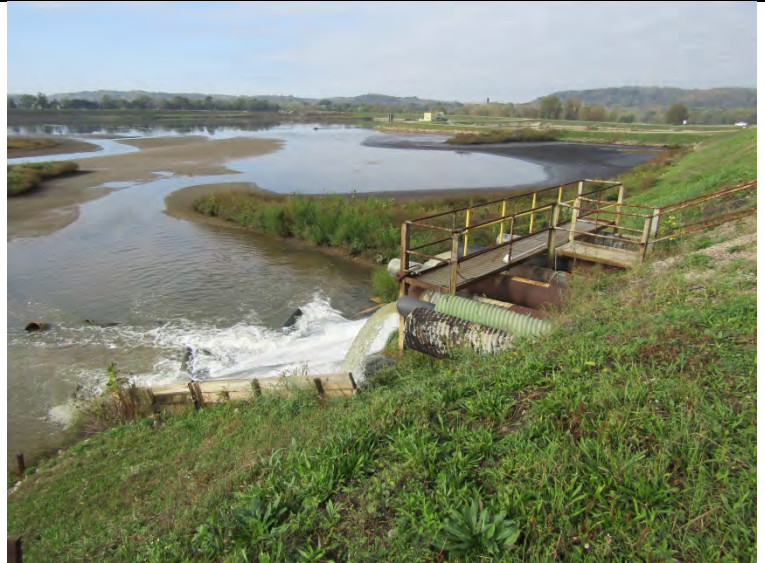
<p><b>Photograph #31</b></p>

1. Photograph 31 is a view of discharge pipes and support structure. The pipes and support structures observed appeared to be functional and in satisfactory operating condition. Photograph 32 is a view of the embankment near monitoring well BAC-02.

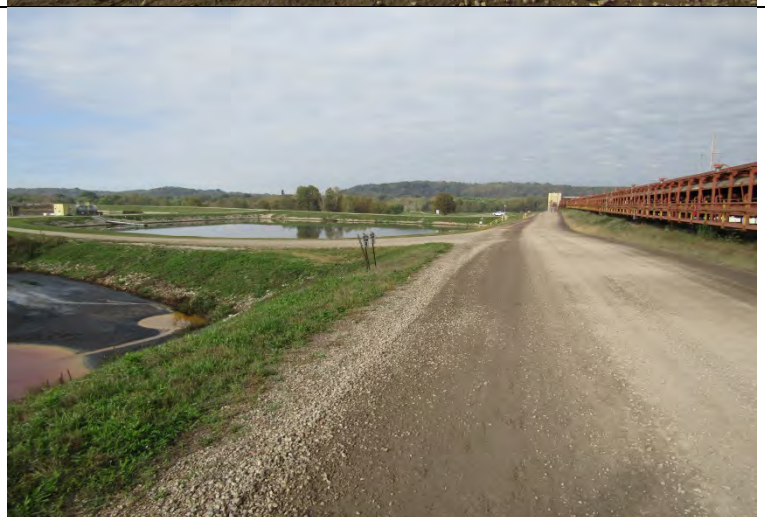
2. The crest, slope, and toe along the interior as evidenced in Photograph 33 appeared to be vegetated and stable. No subsidence, rutting, or misalignment of terrain was noted.

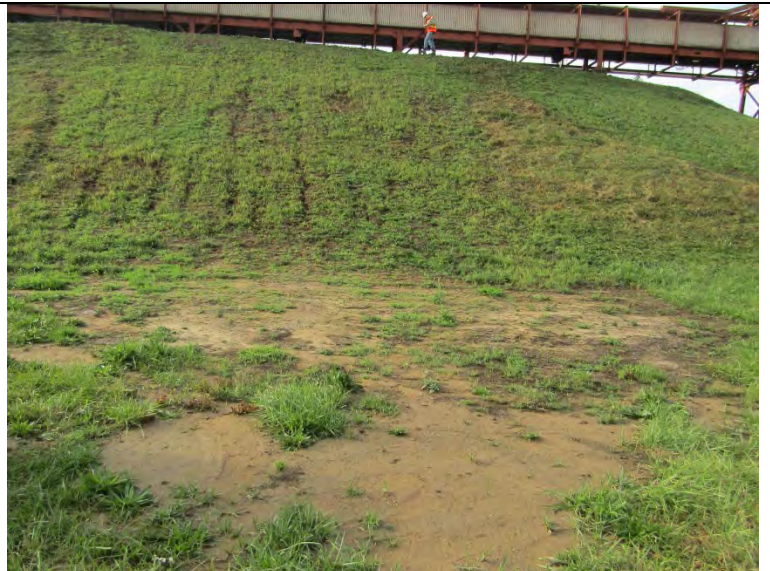
**Photograph #36**

View of slope and crest of exterior slope (looking south).

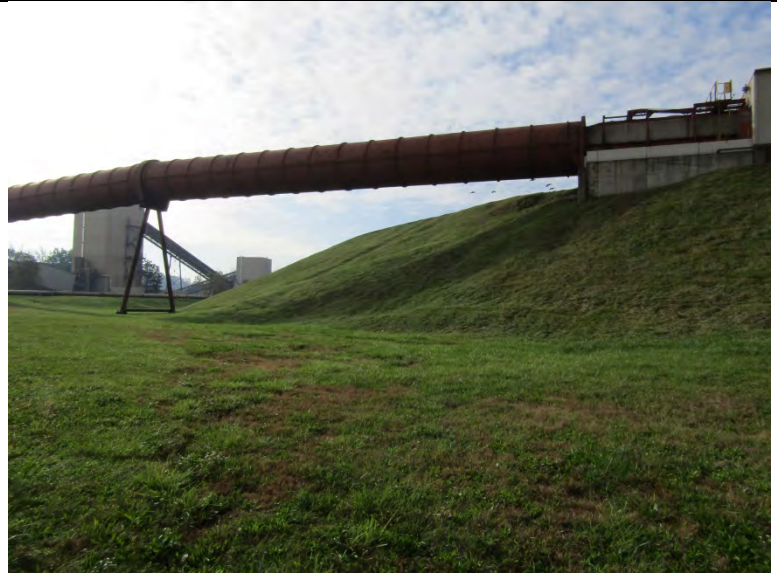
**Photograph #37**

View of toe, slope and crest of exterior embankment on eastern side (looking south)

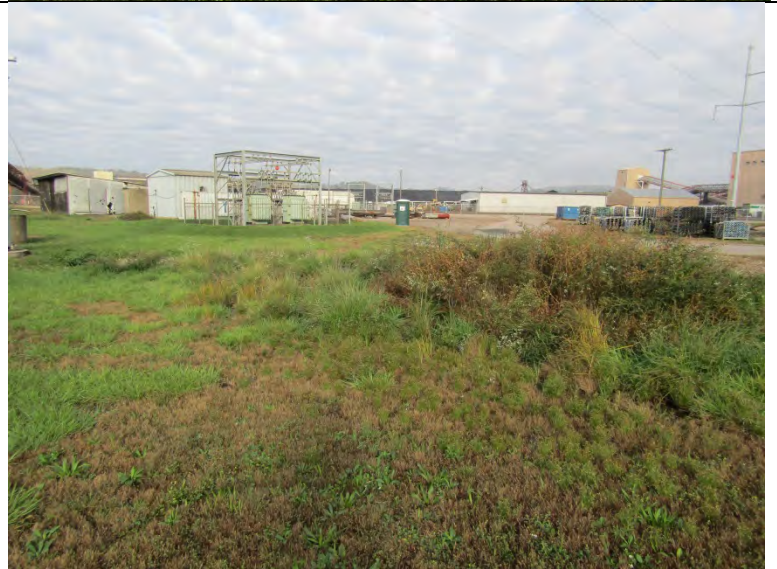
**Photograph #38**

View of drainage ditch (looking north).

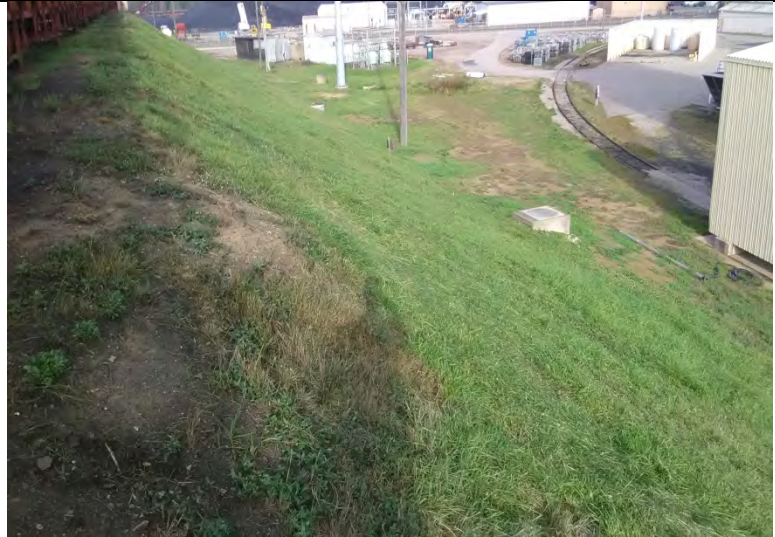
**Photograph #40**

View of embankment crest  
(looking west)

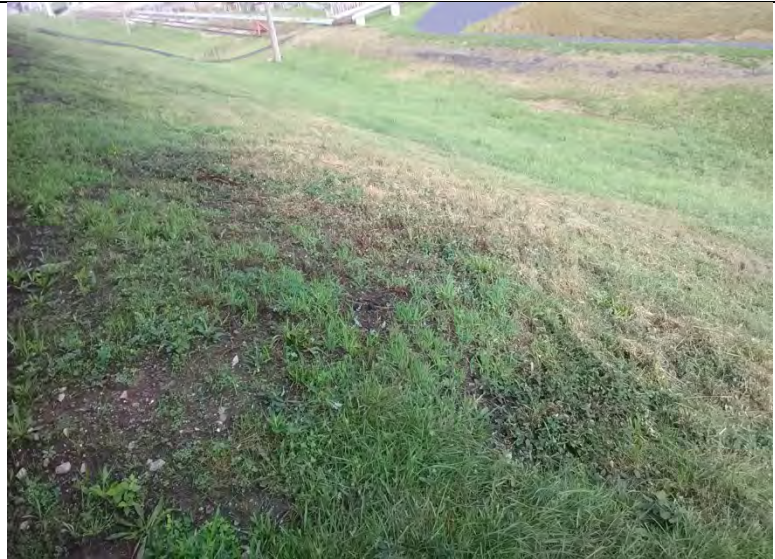
**Photograph #41**

View of slope at top of  
embankment (looking west).

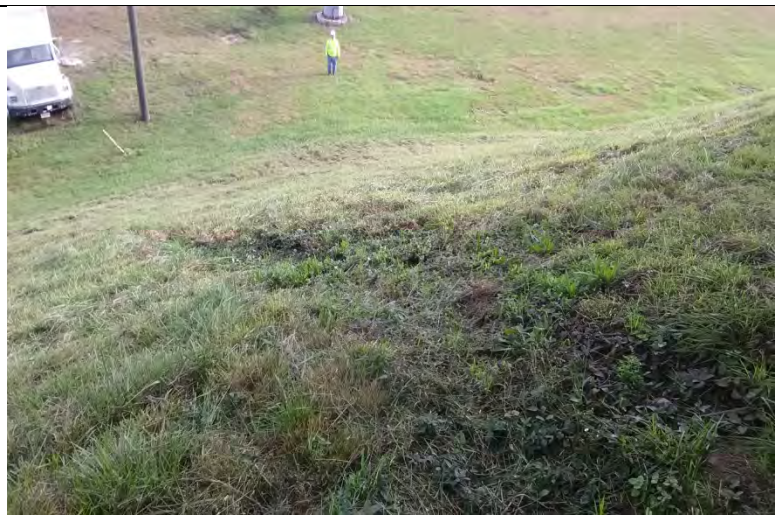
**Photograph #42**

View of slope at top of  
embankment and vegetated gully  
(looking east).

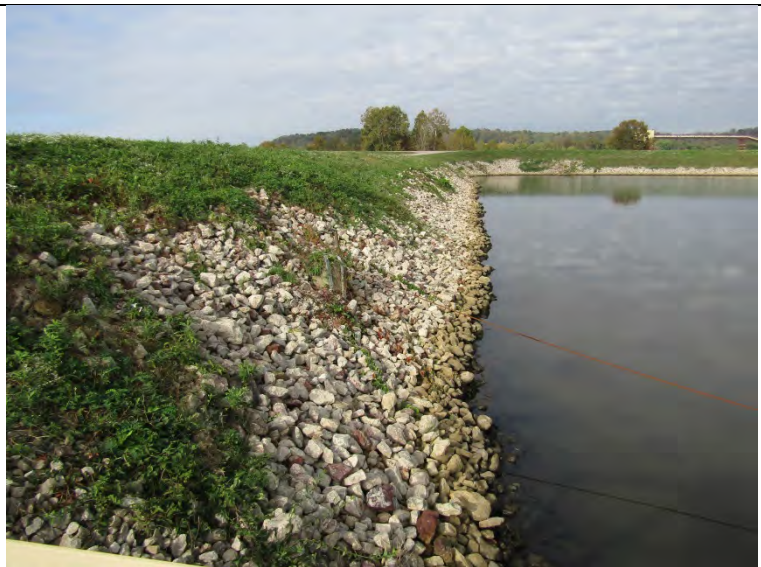
**Photograph #47**

View of slope with riprap placed at toe and lower portions of slope (looking west).

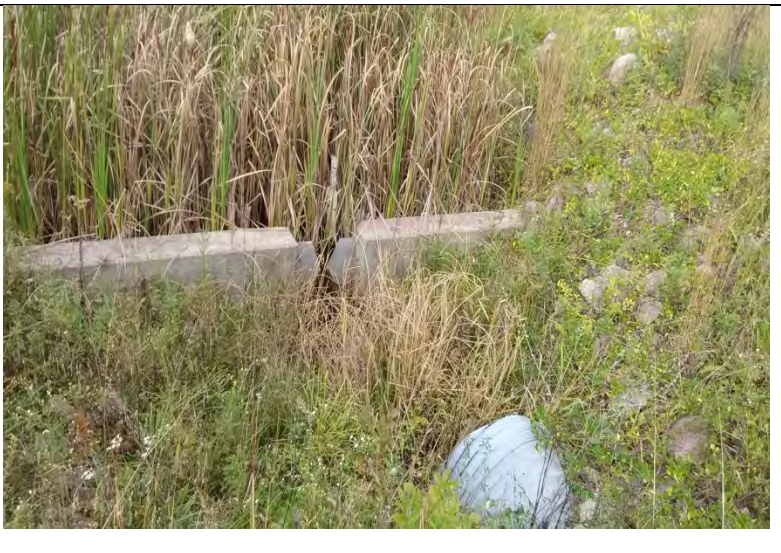
<b>Photograph #48</b>

1. The toe ditch has positive drainage to Stingy Creek. The ditch and its features located within the ditch are functioning well. Features include three V-notched weirs (VW-1, VW-2, and VW-3), two culvert pipes located at Outfall #001 and the overflow weir and mixing point connected downstream to the outfall of Stingy Creek. As shown in photographs 48 and 49, the V-notched weirs generally had an unobstructed flow condition, although vegetative growth next to the weirs could be having a slight impact on flow measurements. The overflow weir and mixing point had an unobstructed flow condition and the supporting structure appeared to be in satisfactory condition (Photograph 50).

View of seepage control weir VW-1 (looking west)	
<b>Photograph #49</b>

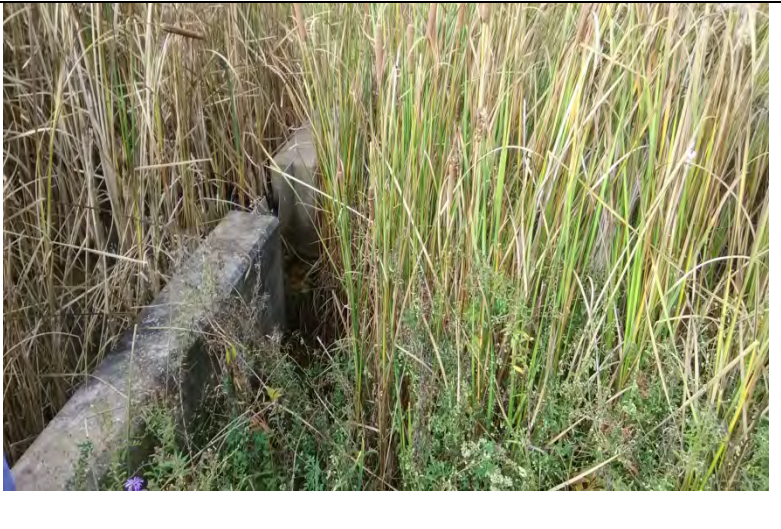
View of seepage weir control VW-3 (looking south).	
<b>Photograph #50</b>

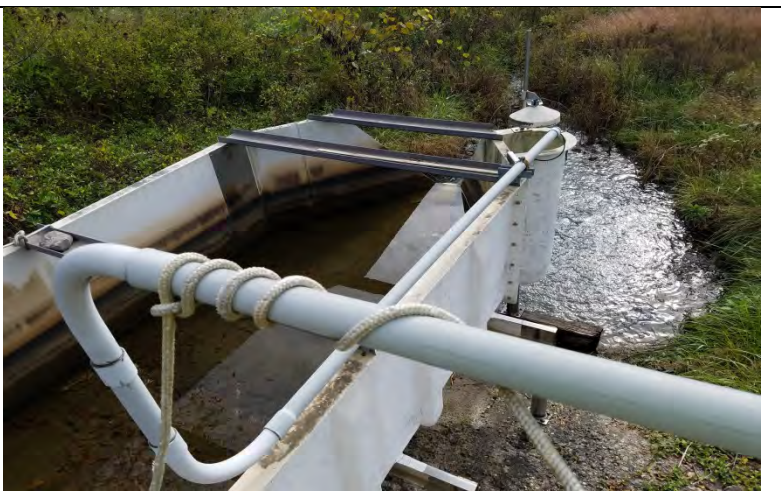
View of mixing point and overflow weir to Stingy Creek (looking east).

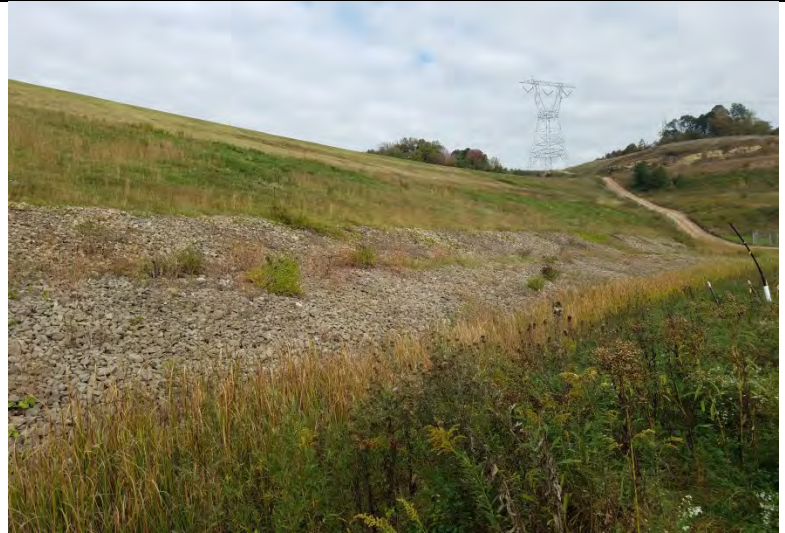
**Photograph #51**

2. The slope from the toe up to the intermediate bench appears to be in satisfactory condition as shown in Photographs 51 and 52. The toe and bottom portion of the slope is buttressed with riprap nearly halfway up to the intermediate bench. Following the riprap, the slope was well vegetated and appeared to be stable.

View of northern portion of dam slope from toe (looking west).

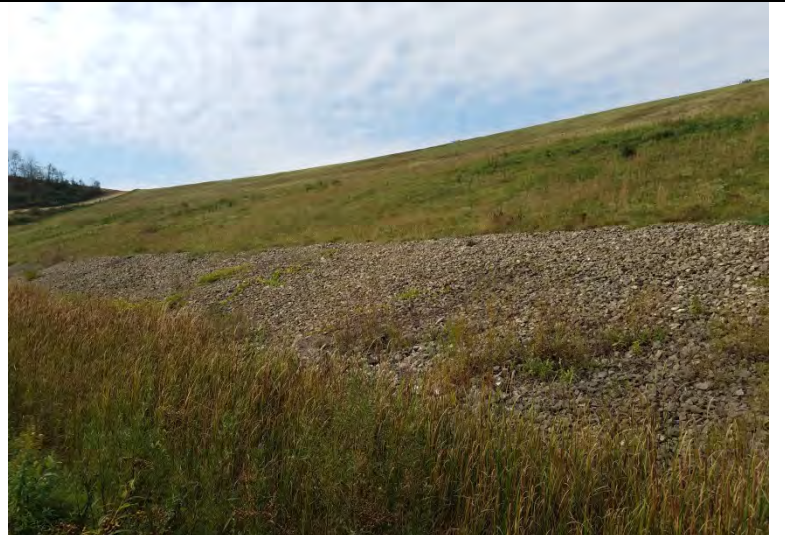
**Photograph #52**

View of southern portion of dam slope from toe (looking west).

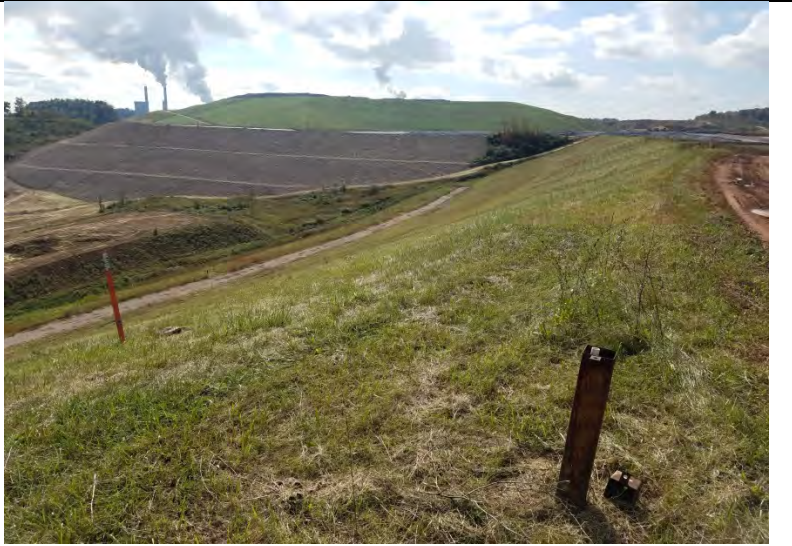
<p><b>Photograph #55</b></p>

The crest and immediately downslope to the east and west was in satisfactory condition. No rutting, settling, or misalignment was noted along the crest or immediately downslope of the crest as shown on Photographs 55 through 58. There was no excess sediment noted along access roads, and the access roads had positive drainage away from the road centerline.

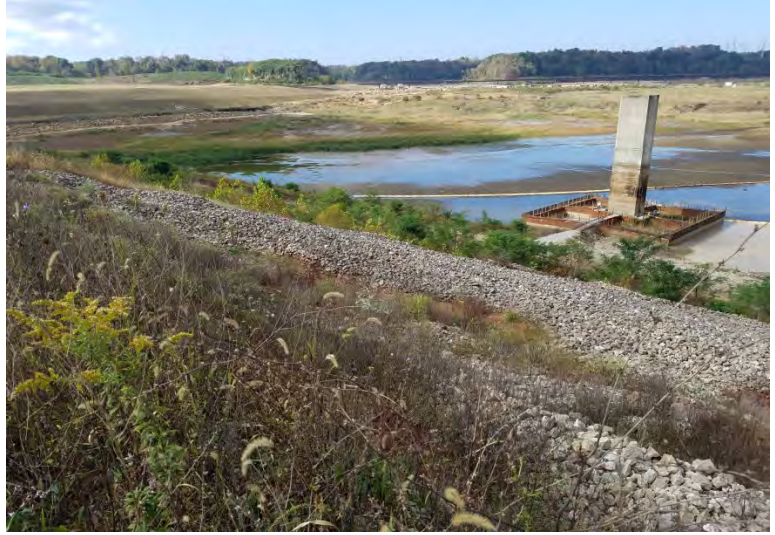
**Photograph #58**

3. A view of the spillway structure no longer in use is shown in Photograph 58. Instead, pond water level is controlled by a siphon pump system as shown in Photograph 65.

View of west slope (looking west).

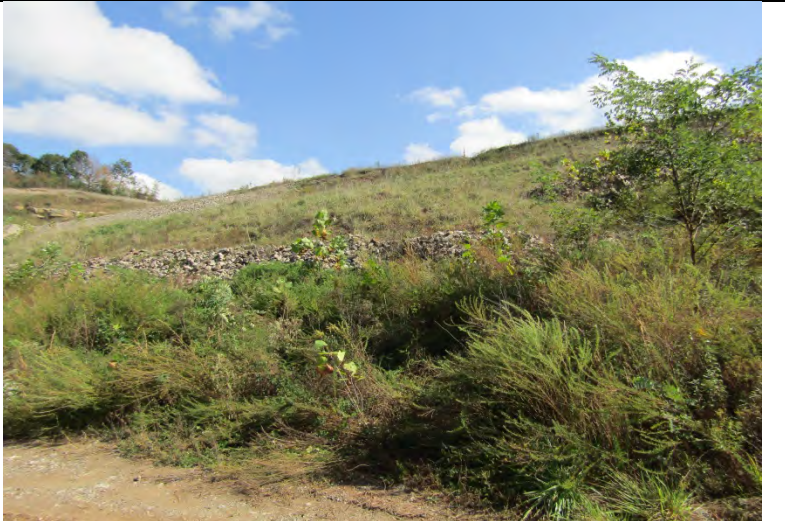
<b>Photograph #59</b>

1. The condition of this slope is illustrated on Photographs 59 through 62. Riprap along the surface of the slope acts as additional support and enhance stability. There were isolated areas where there was uneven terrain, but overall there was no evidence of instability or settling or rutting.

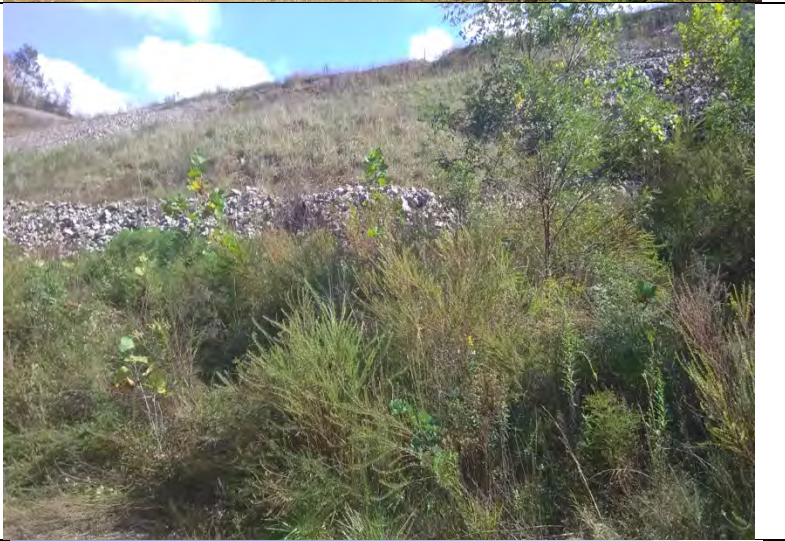
A photograph showing a grassy hillside with a dirt path in the foreground. The sky is blue with scattered white clouds. The vegetation is dense and green.
View of west slope (looking northeast).

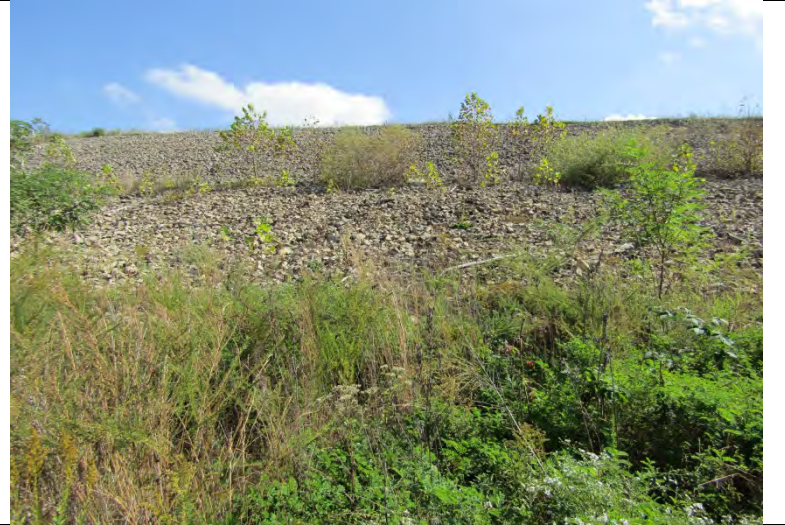
A photograph showing a grassy hillside with a dirt path in the foreground. The sky is blue with scattered white clouds. The vegetation is dense and green.
View of west slope (looking northeast).	
<b>Photograph #61</b>	
View of west slope (looking east).

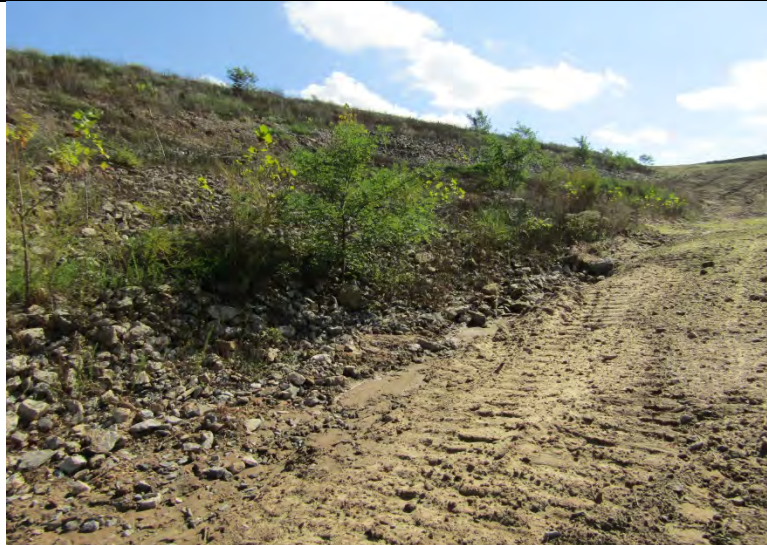
**Photograph #62**

View of west slope (looking south).

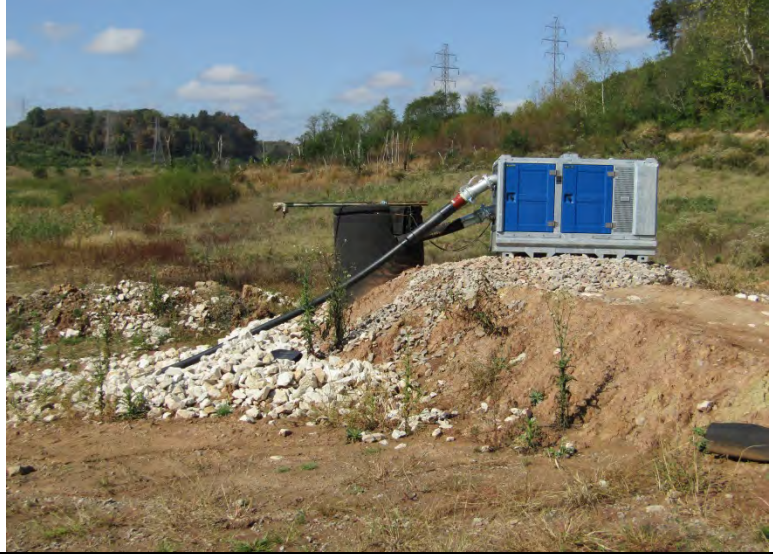
**Photograph #65**

View of siphon pump system used to control water level of pond (looking west).

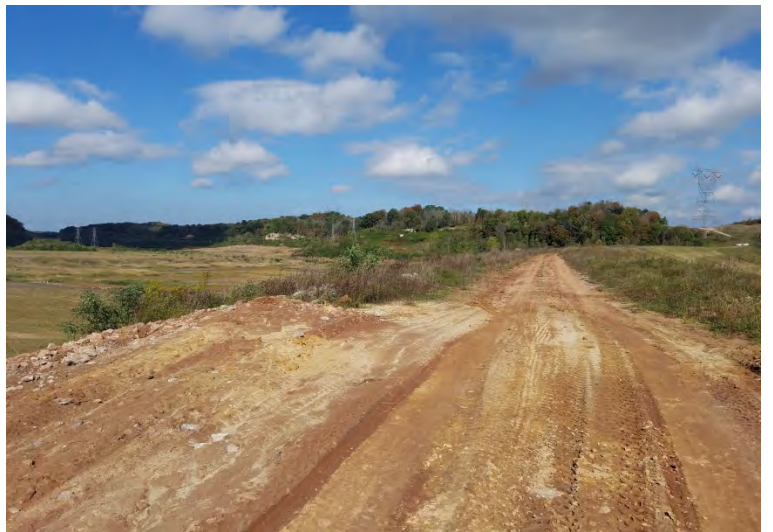
**Photograph #66**

4. No excess sediment and positive drainage away from the road centerline was noted along access roads at this complex. In addition, no standing water or localized low spots (where water could collect) were noted. An example of a view of the access road adjacent to the

shoreline of the Fly Ash Pond looking west is shown on  
Photograph 66.

View access road and shoreline (looking west).
